## Intervening Hedgerow Assessment

# Trimming Impact under Proposed 400kV Transmission Line

September 2012

**North South 400kV Interconnection  
Development**

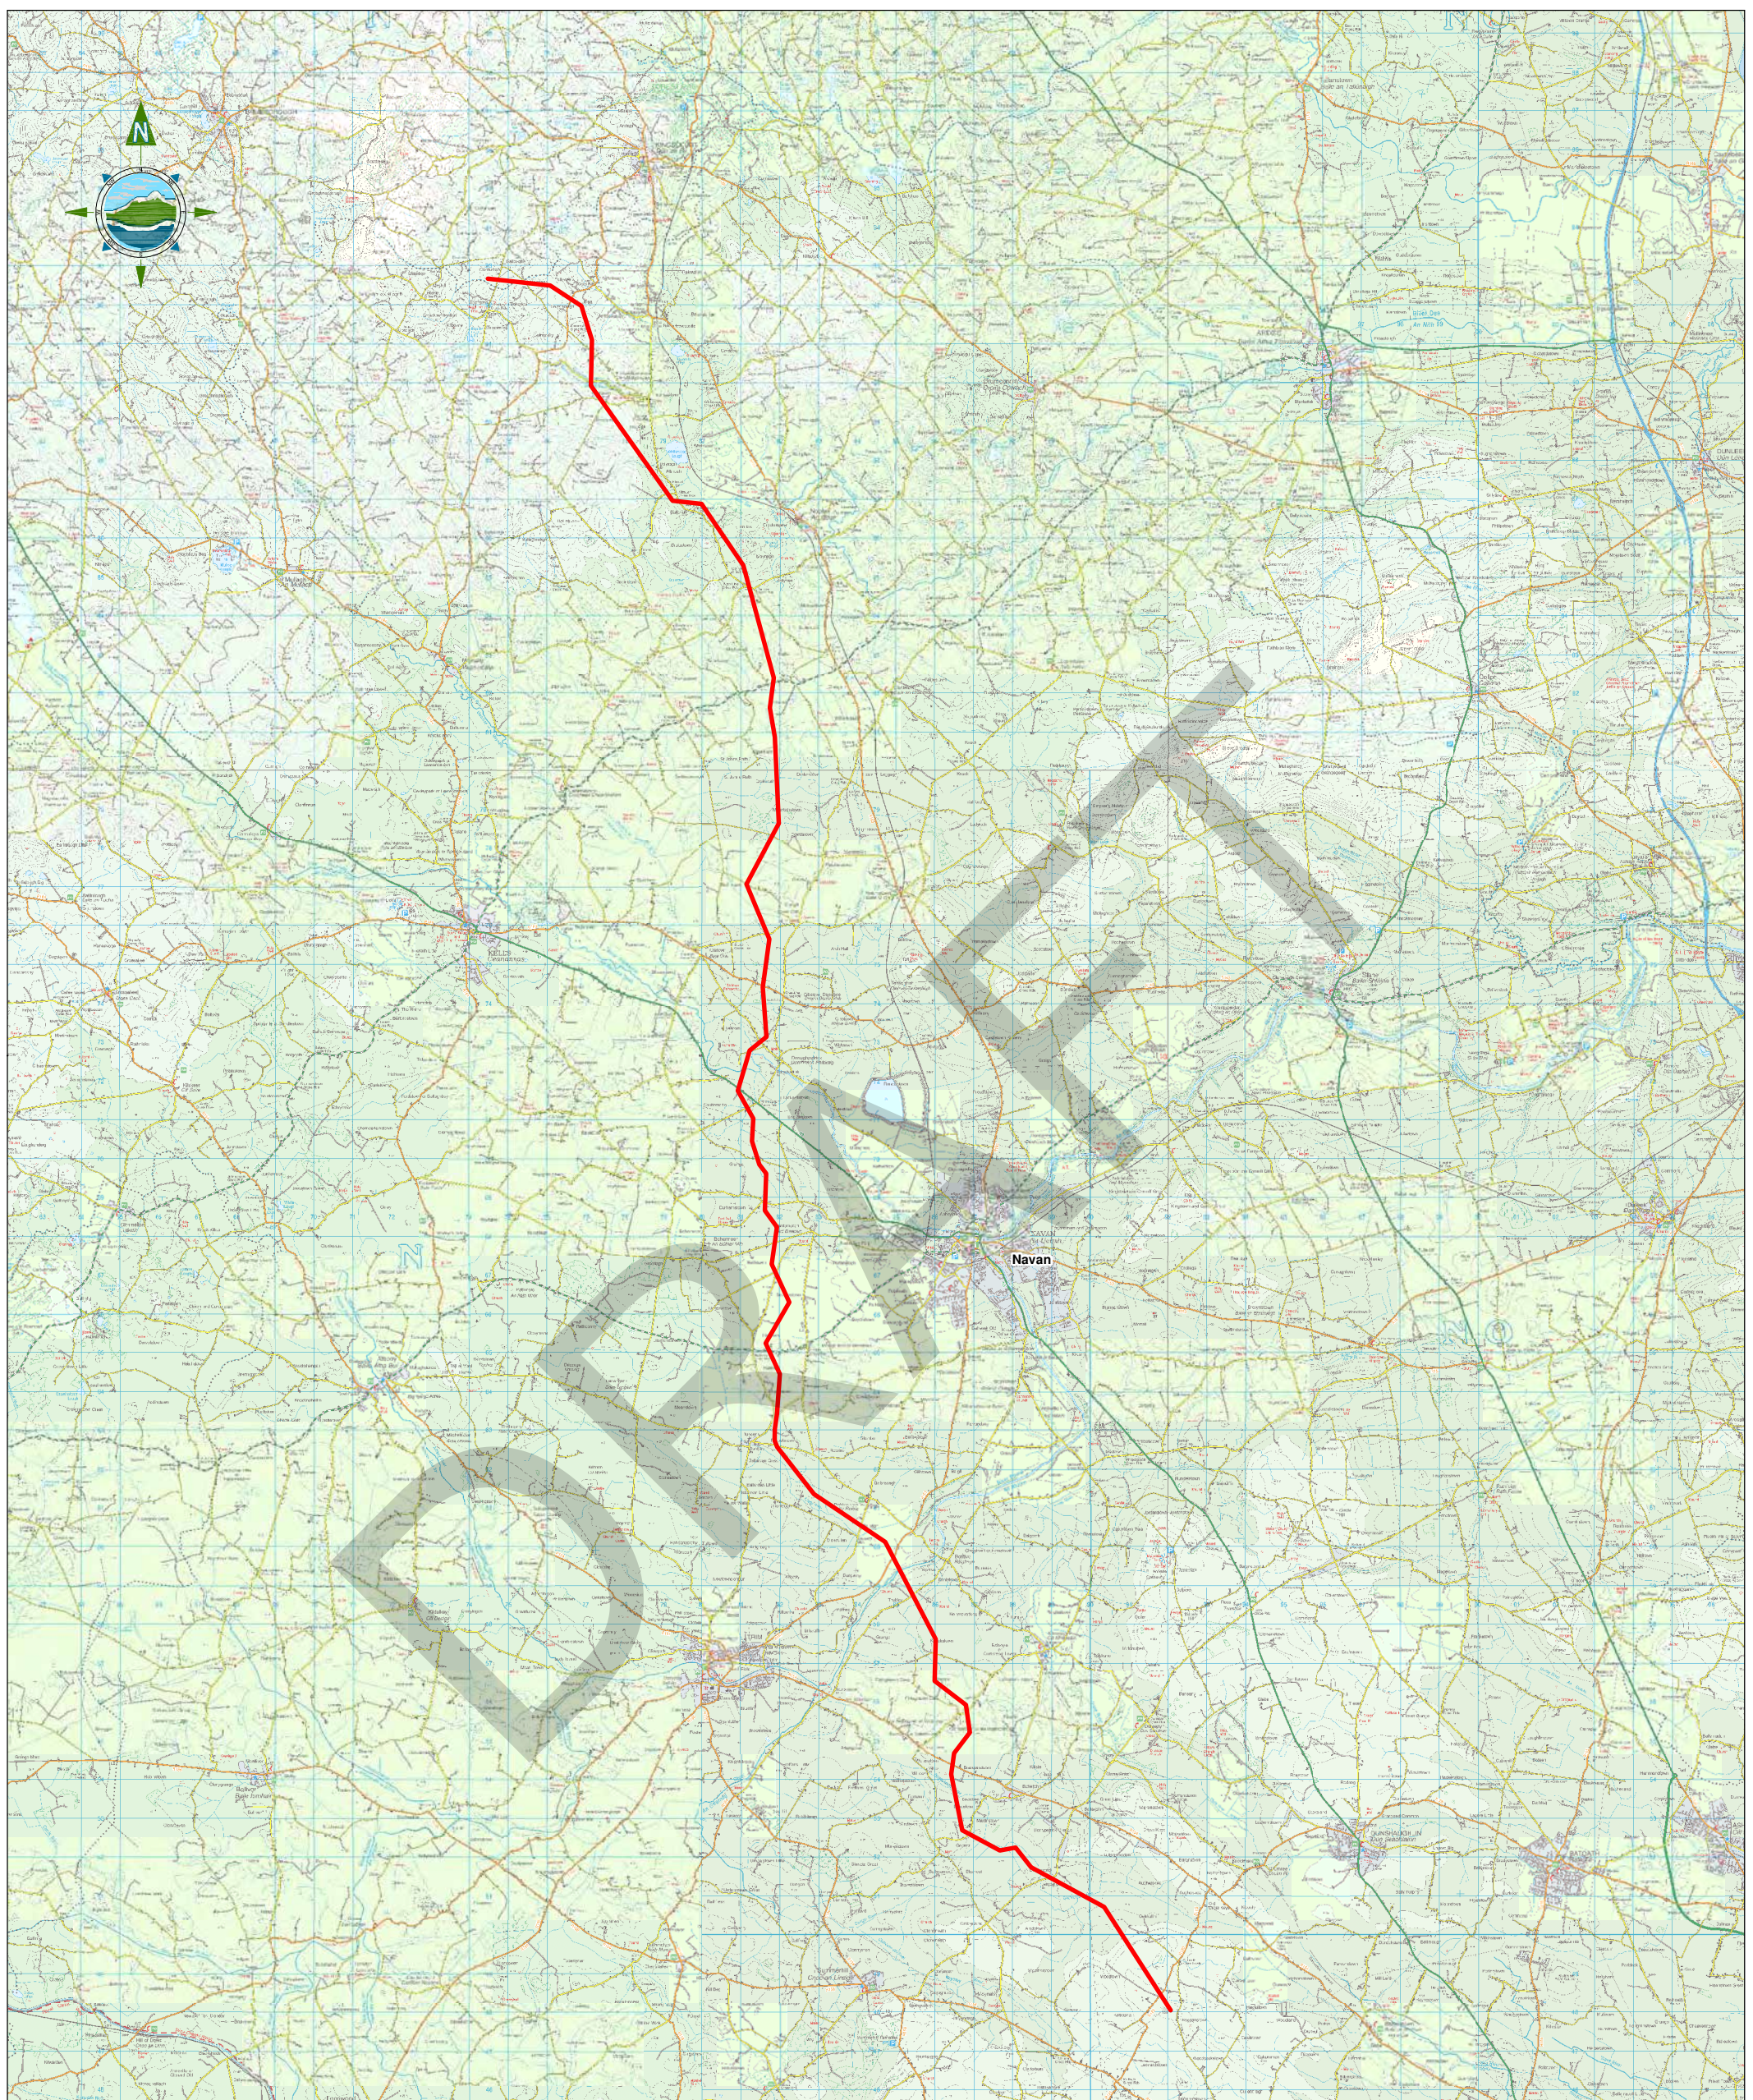
6244  
**Figure 1 (MSA) A**

**Legend**  
 Line Route – hedgerow study area

Title:  
 Intervening Hedgerow Study  
 Proposed transmission  
 line route in Co. Meath

This study was conducted at all locations where the proposed transmission line crosses (and runs close by and parallel to) hedgerows in Counties Meath, Cavan and Monaghan. A map detailing the route of the transmission line can be found in Figures 1 and 2 overleaf.

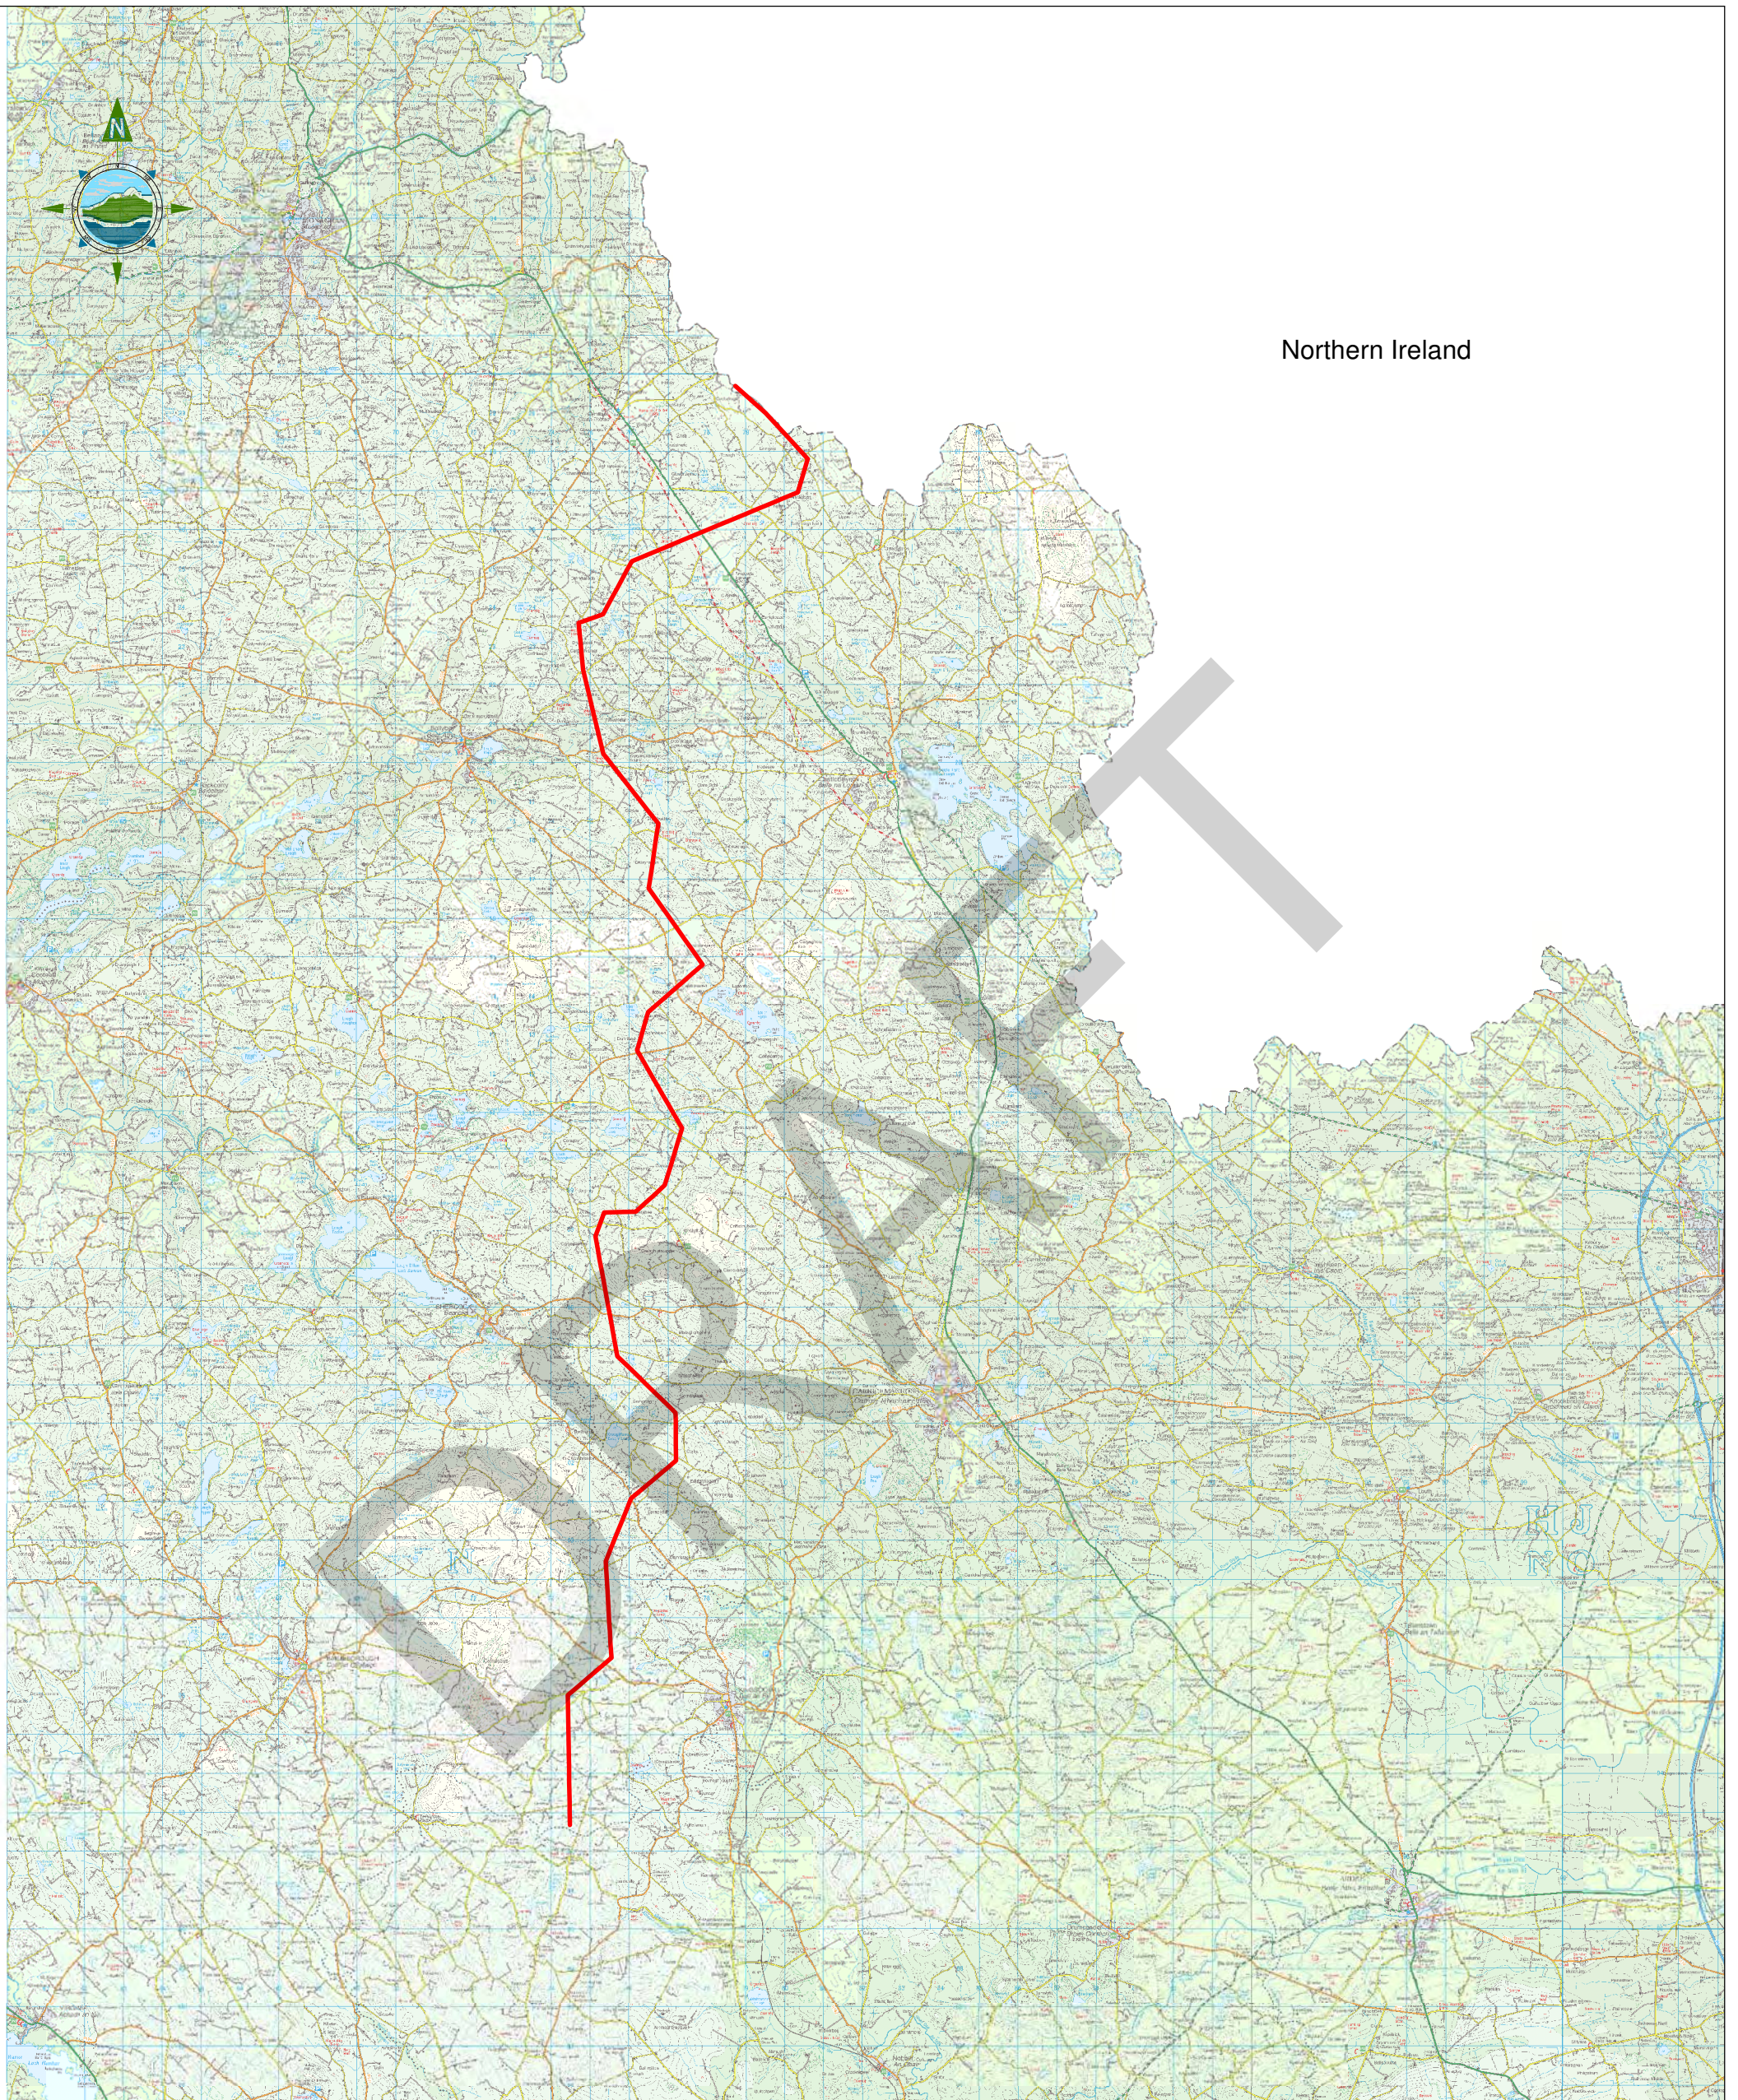
**Figure 2 (CMSA) A**

— Line Route

**Intervening Hedgerow Study  
Proposed transmission line route in  
Co's Cavan and Monaghan**

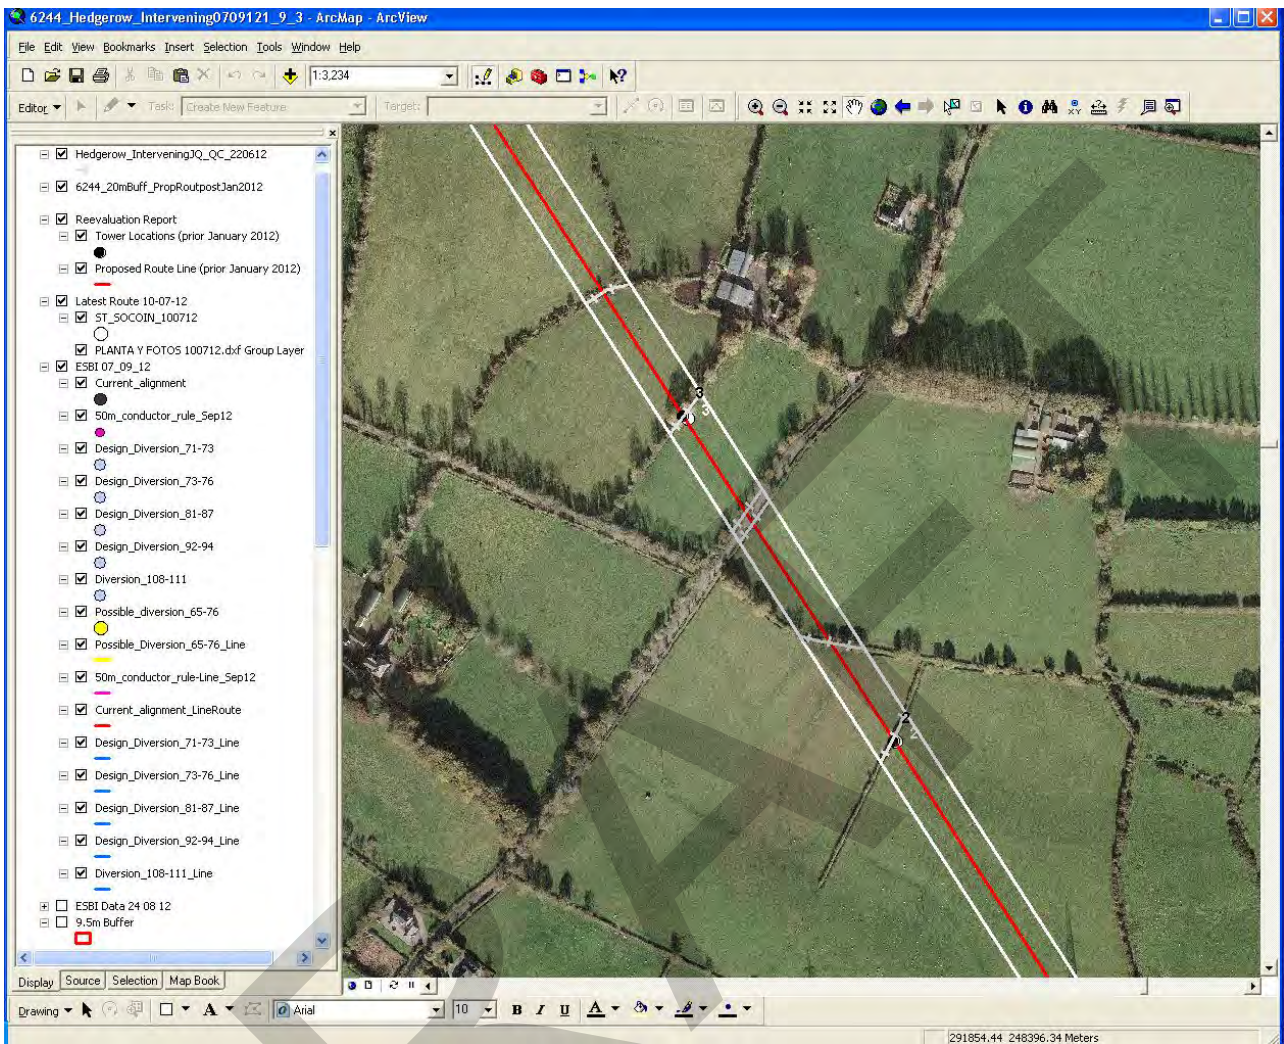
**Figure 3** GIS (ArcMap) screenshot of hedgerows traversed by proposed line (red line) and 40m zone of influence at hedgerow crossed (grey hatch).

Note: Each hedgerow crossed is categorised (into 3 types) and given a unique reference number for analysis in a database.

An example of the hedgerow sections determined in GIS is detailed in Figure 3 overleaf.

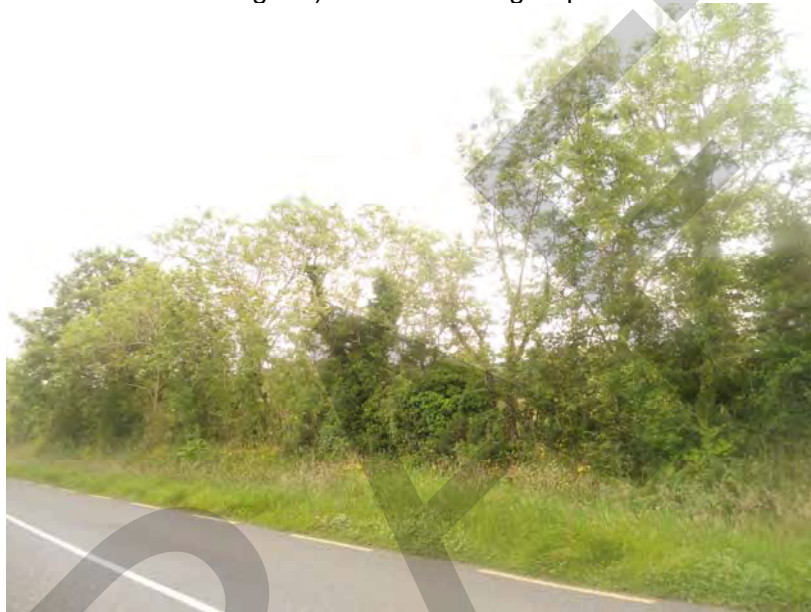
**Type 1:** Relatively unmanaged hedgerow dominated by immature ash (Co Monaghan). Minor trimming required.

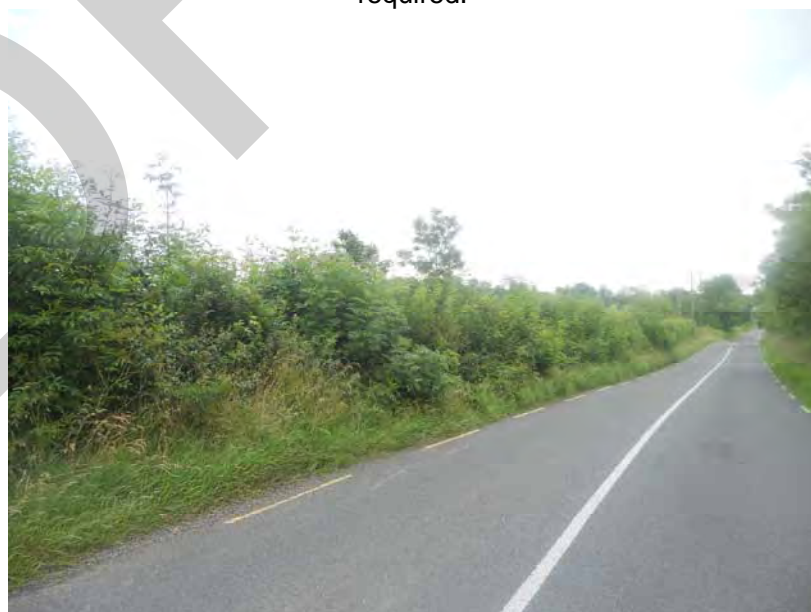
**Type 1:** Managed Hedgerow (left of picture) in Co Monaghan. No trimming required.

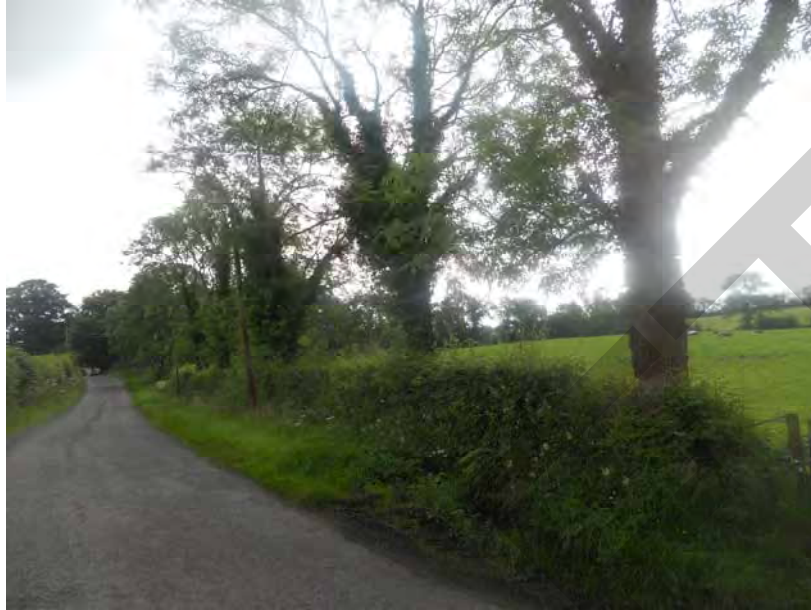
**Type 2:** Managed hedgerow and scattered mature ash tree which will require cutting within zone of impact. However given relatively scattered nature possibly only one or two trees will require cutting/ partial trimming.

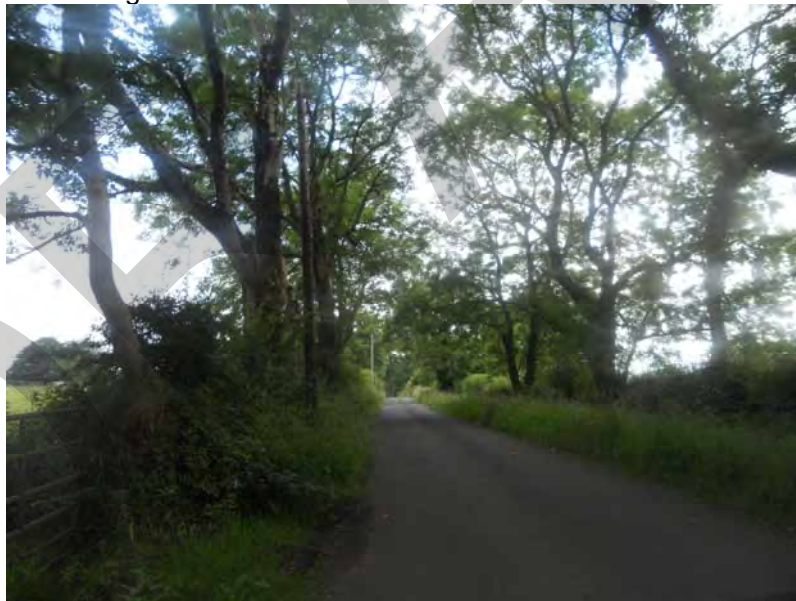
**Type 2:** Both sides of road. Note not closed canopy i.e. scattered but relatively dense mature trees at least 1 to 2 either side of road will require cutting/ significant trimming under the line.

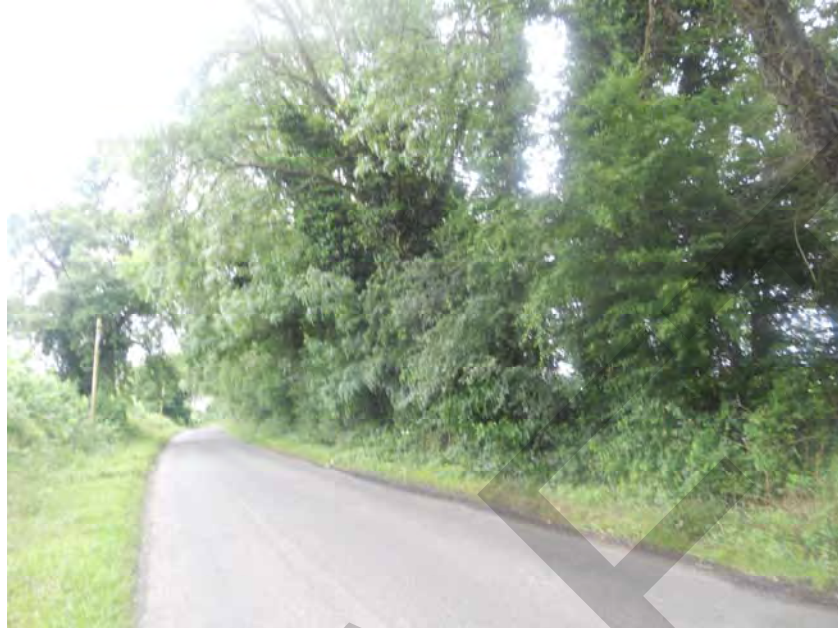
**Type 3:** category (right of picture). Very mature ash trees form a continuous treeline. At least several of these trees will require felling/ partial trimming within the zone of impact.
