- Appendix 6.4 Intervening Hedgerow Impact

# **Trimming Impact under Proposed 400kV Transmission Line**

**North South 400kV Interconnection  
Development**

**Title:** Intervening Hedgerow Assessment - Trimming Impact under Proposed 400kV Transmission Line

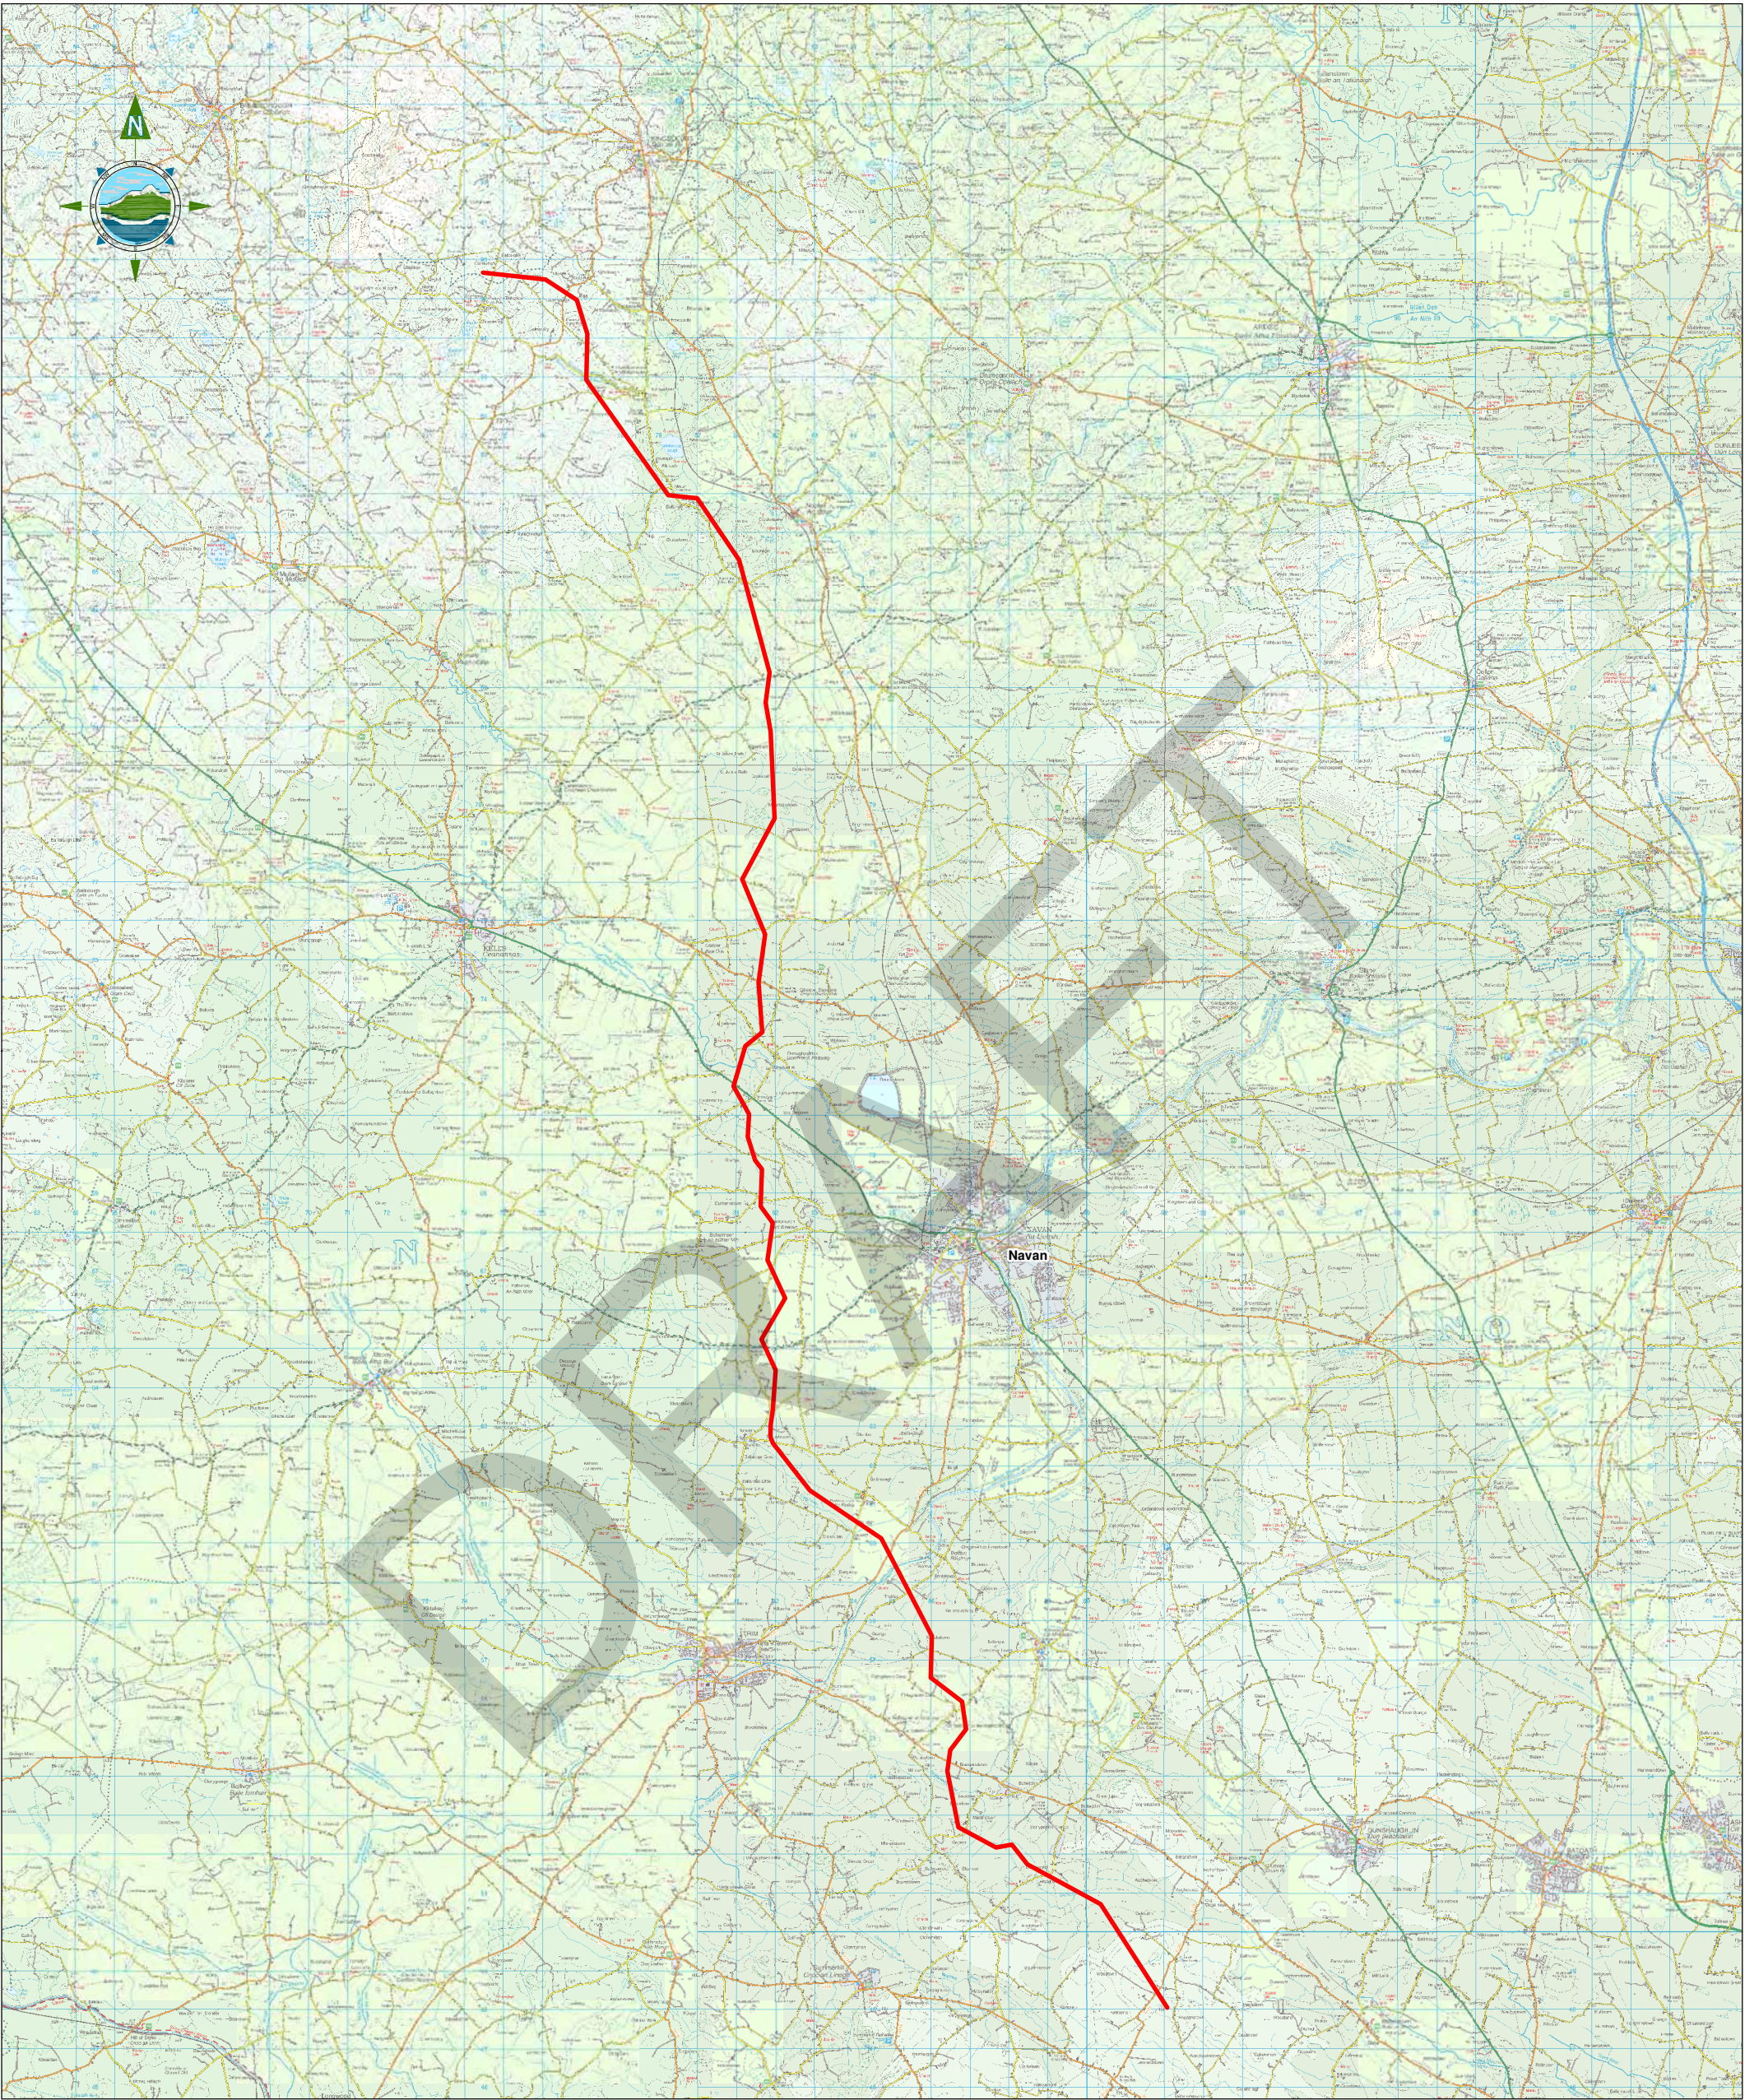
— Line Route – hedgerow study area

Intervening Hedgerow Study  
Proposed transmission  
line route in Co. Meath

This study was conducted at all locations where the proposed transmission line crosses (and runs close by and parallel to) hedgerows in Counties Meath, Cavan and Monaghan. A map detailing the route of the transmission line can be found in Figures 1 and 2 overleaf.

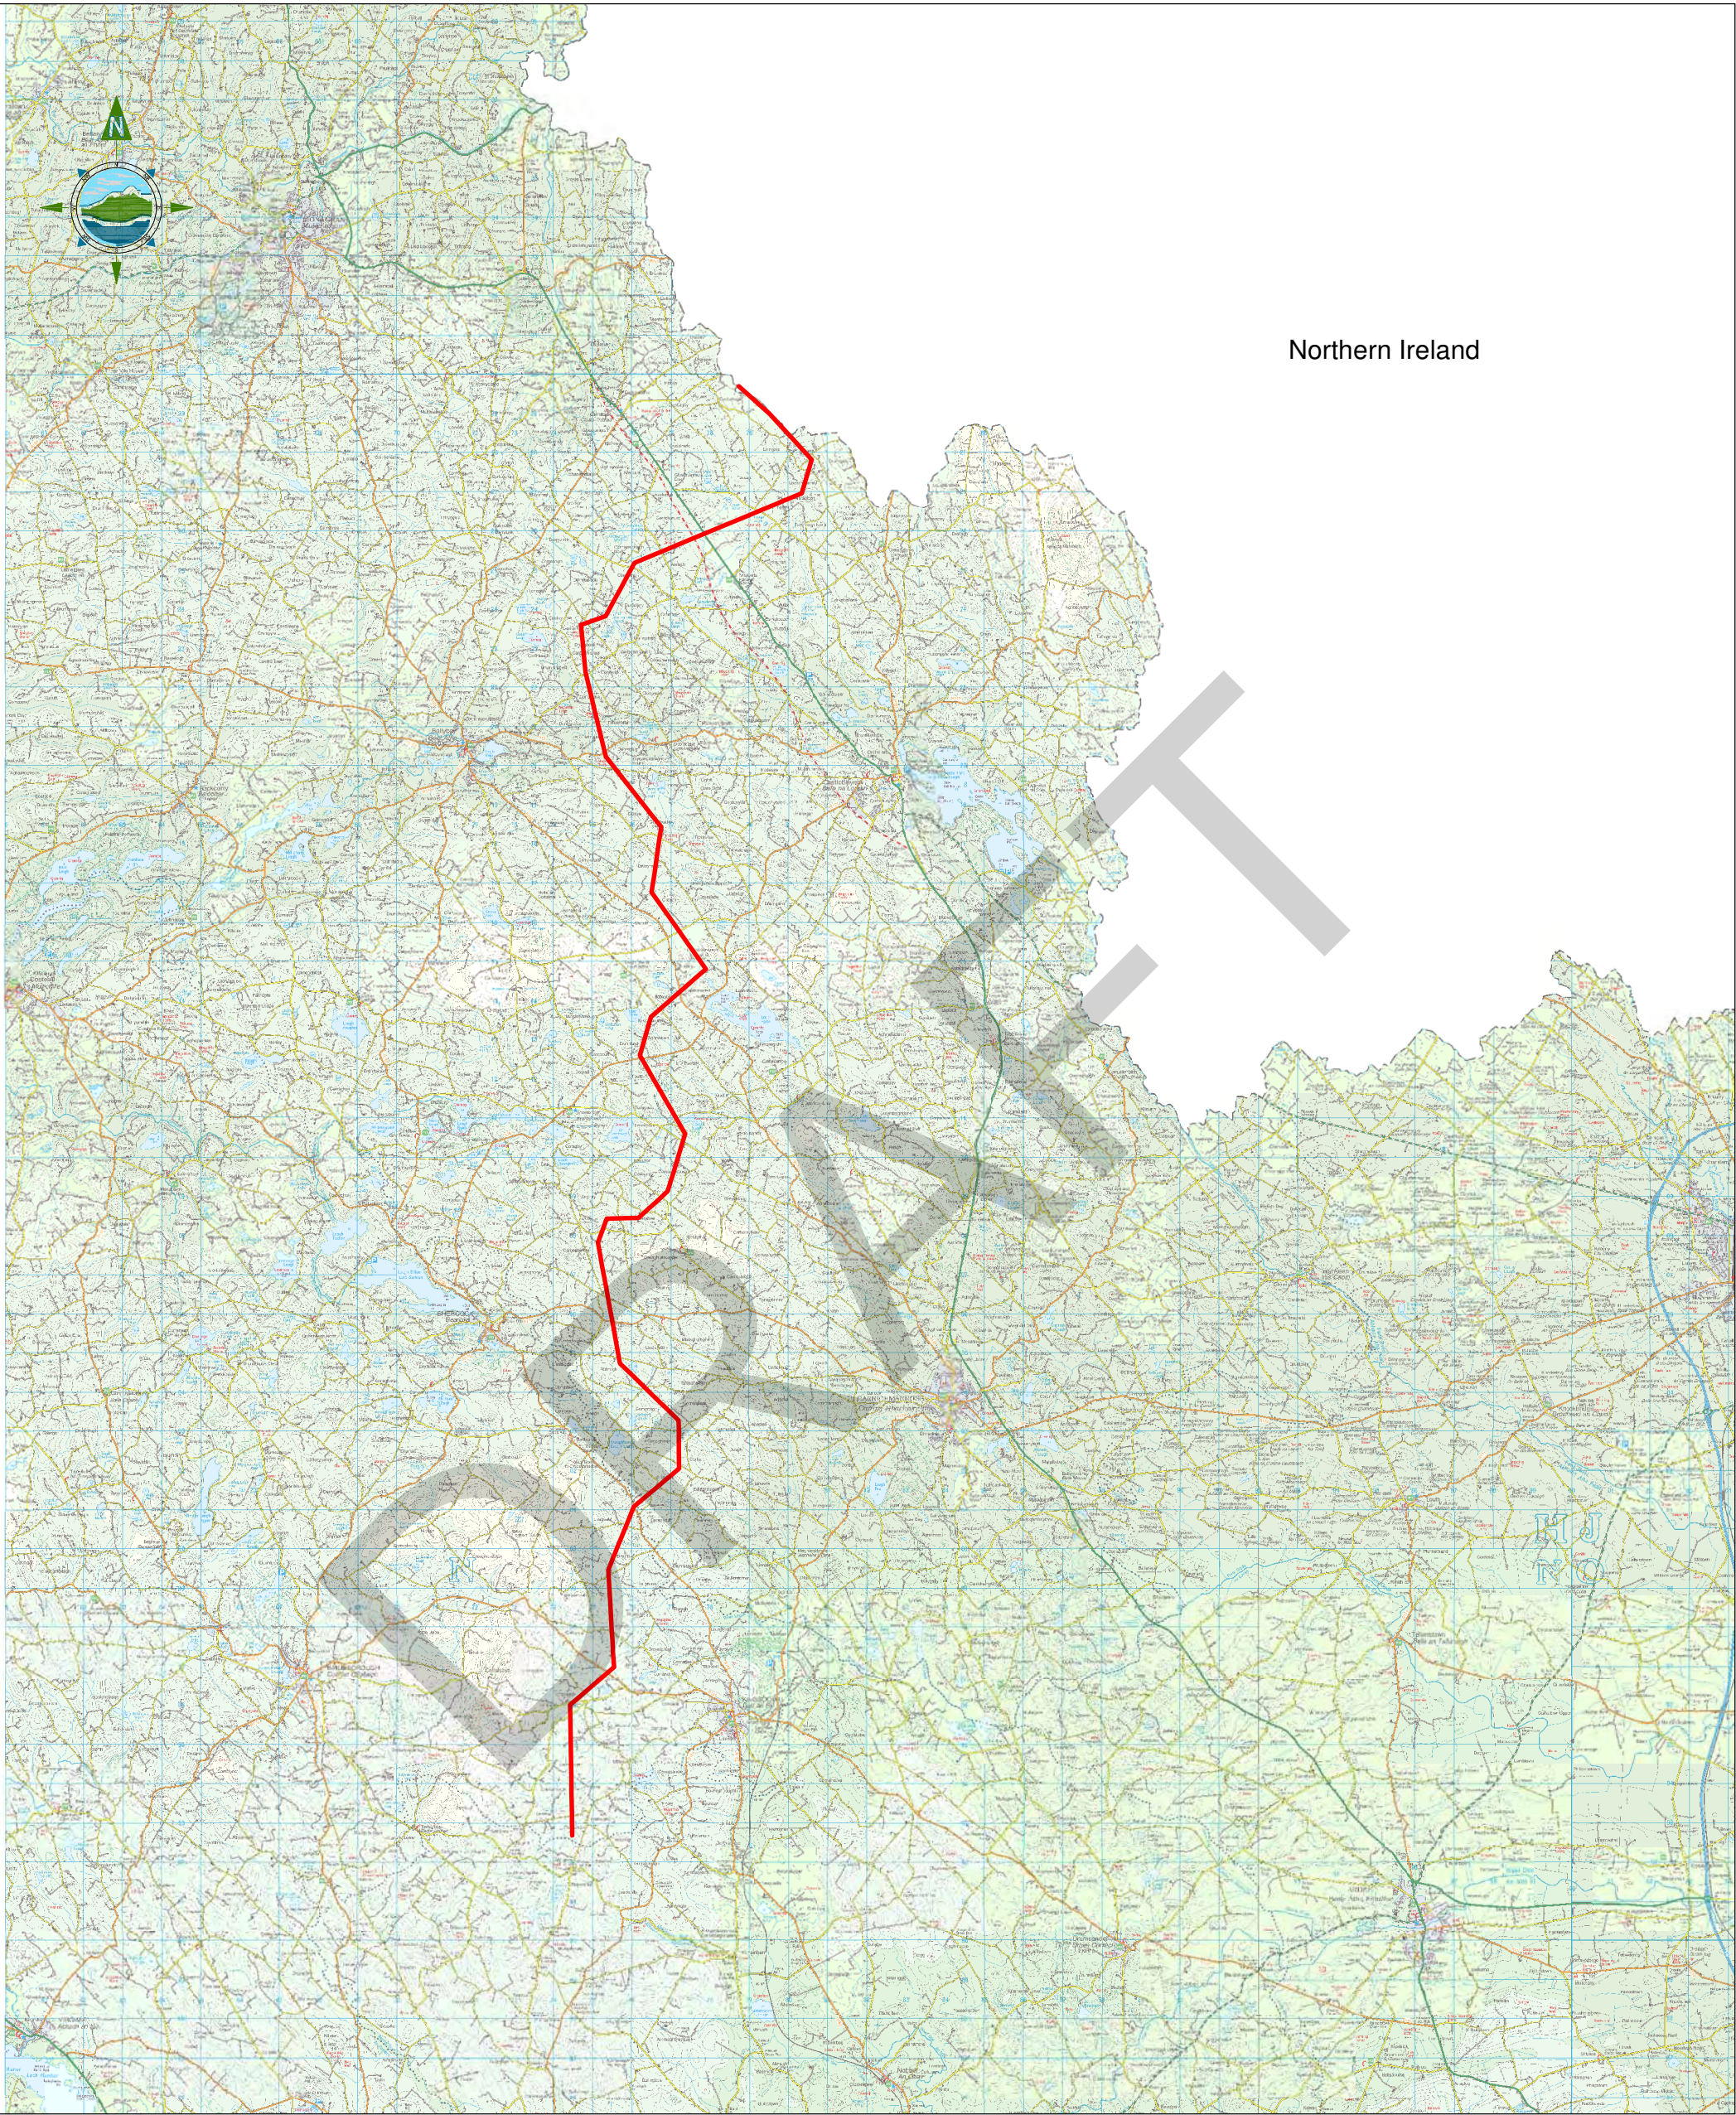
Figure 2 (CMSA) A

Intervening Hedgerow Study  
Proposed transmission line route in  
Co's Cavan and Monaghan

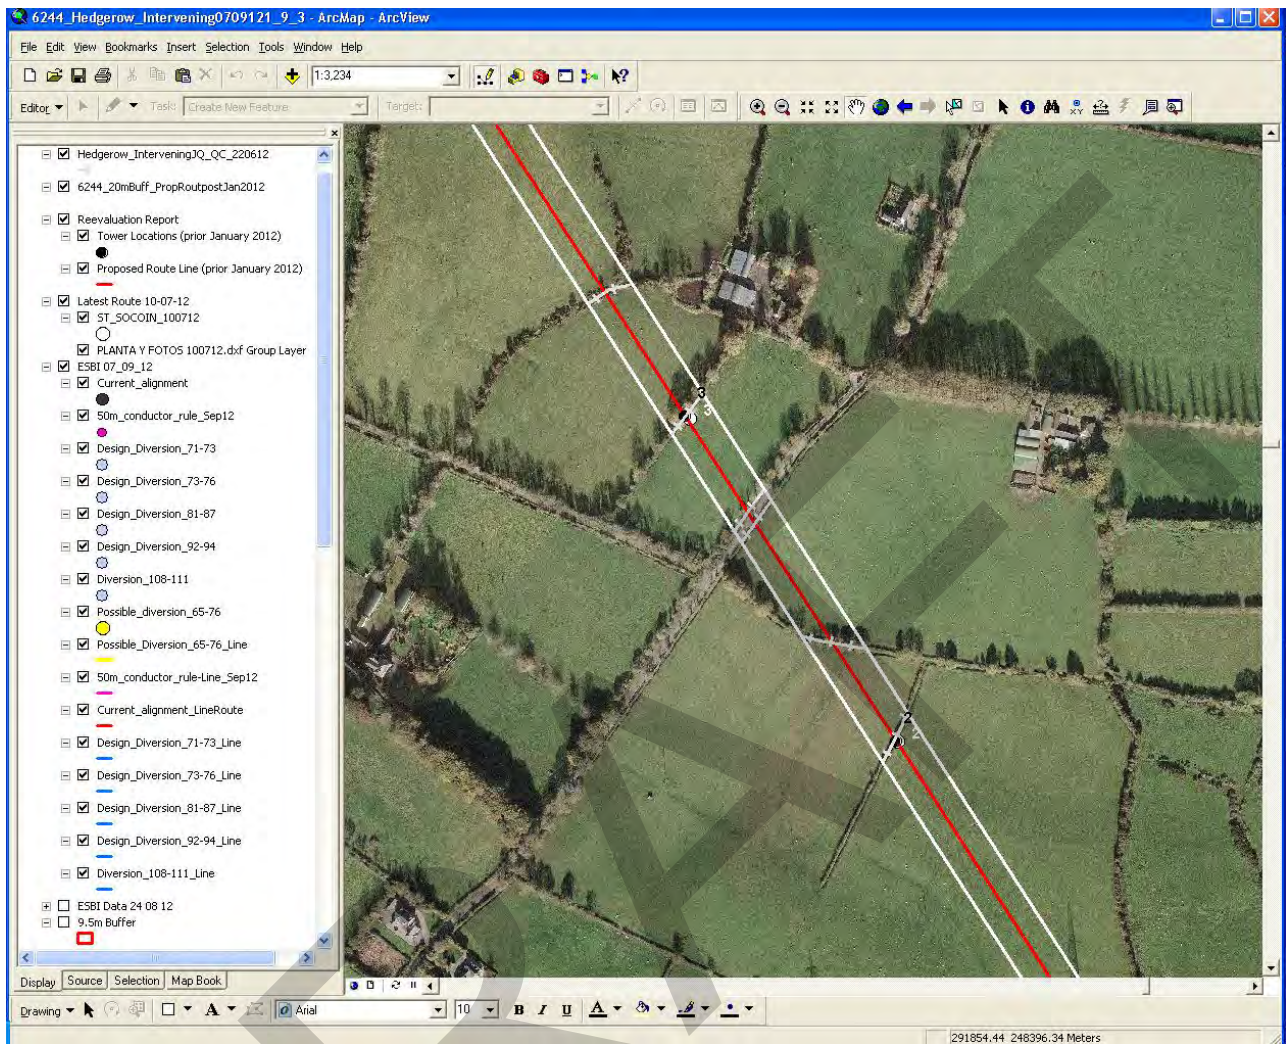
**Figure 3** GIS (ArcMap) screenshot of hedgerows traversed by proposed line (red line) and 40m zone of influence at hedgerow crossed (grey hatch).

Note: Each hedgerow crossed is categorised (into 3 types) and given a unique reference number for analysis in a database.

An example of the hedgerow sections determined in GIS is detailed in Figure 3 overleaf.

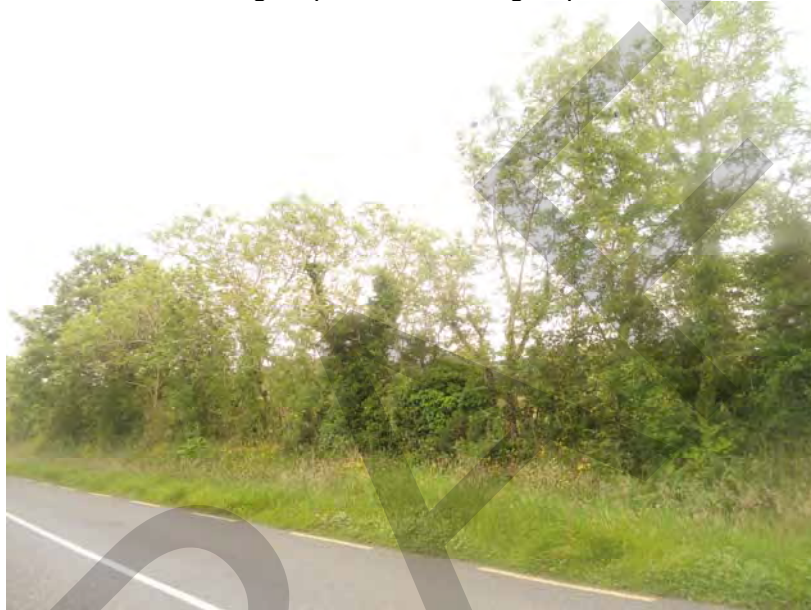
**Type 1:** Relatively unmanaged hedgerow dominated by immature ash (Co Monaghan). Minor trimming required.

- **Type 1:** Hedgerows typically < 9m in height, with no identified mature tree specimens and dominated by immature taller tree species (e.g. ash) or relatively lower growing tree species e.g. blackthorn, hawthorn and willow.

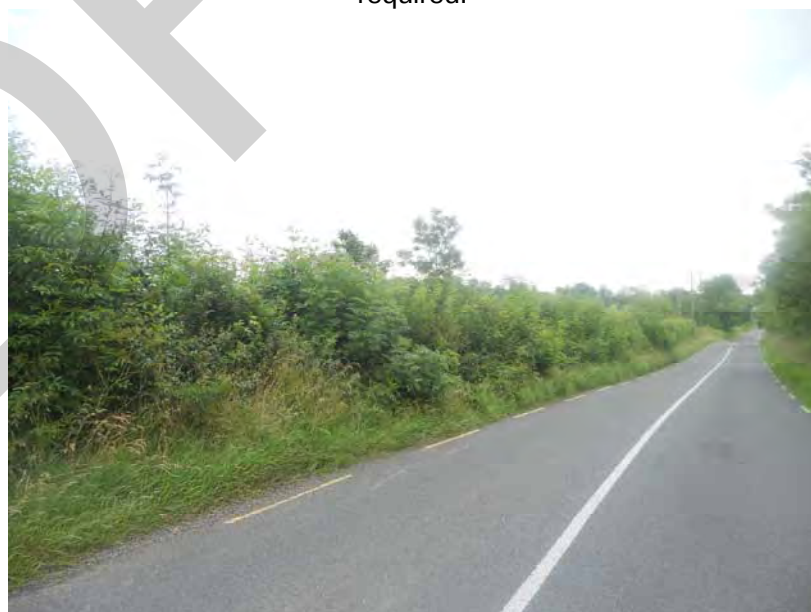
**Type 1:** Managed Hedgerow (left of picture) in Co Monaghan. No trimming required.

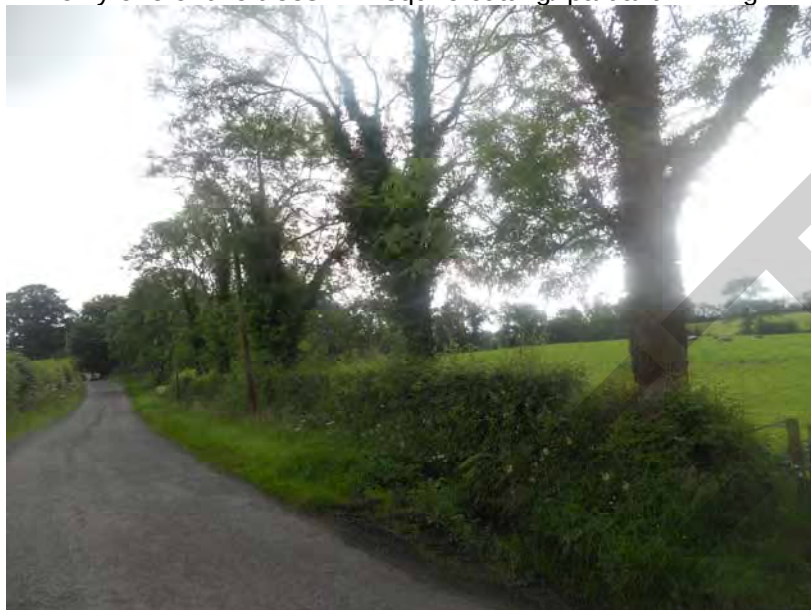
**Type 2:** Managed hedgerow and scattered mature ash tree which will require cutting within zone of impact. However given relatively scattered nature possibly only one or two trees will require cutting/ partial trimming.

- **Type 2:** This type is typically dominated by non mature trees or lower growing species but includes at least one (more typically several) identified mature tree specimen (typically >15m generally >20m) which will require cutting.
- **Type 3:** This type is dominated by mature trees which form a closed canopy treeline. Typical species include beech and oak tree lines are generally clustered around or in the vicinity of demesnes in Co. Meath.

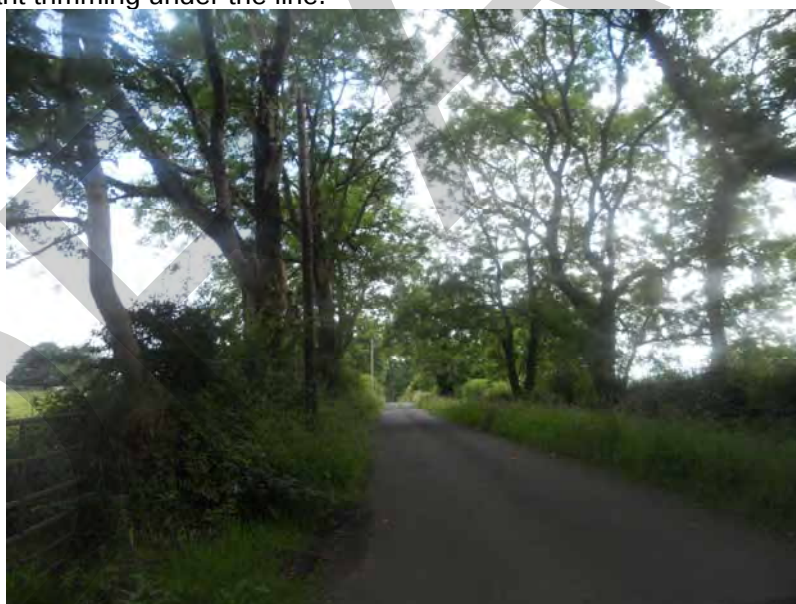
**Type 2:** Both sides of road. Note not closed canopy i.e. scattered but relatively dense mature trees at least 1 to 2 either side of road will require cutting/ significant trimming under the line.

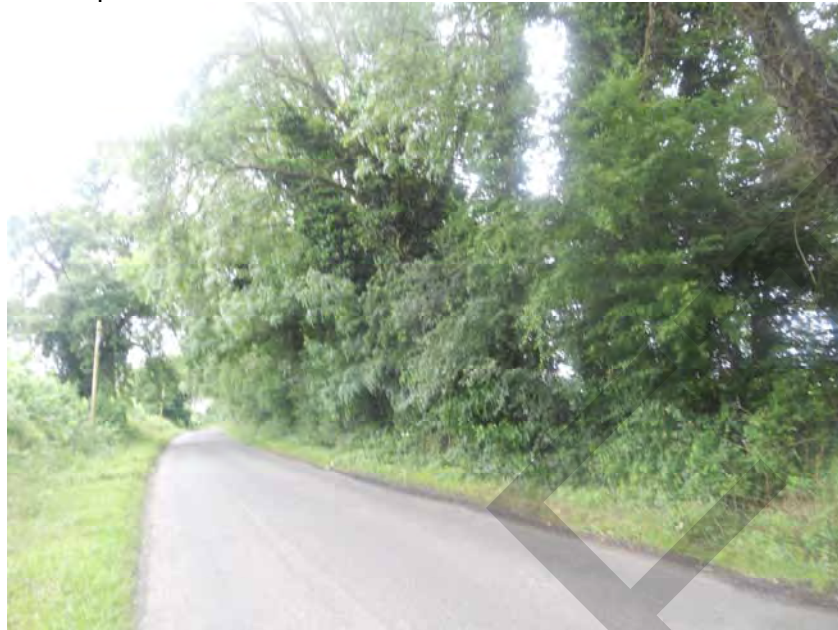
**Type 3:** category (right of picture). Very mature ash trees form a continuous treeline. At least several of these trees will require felling/ partial trimming within the zone of impact.
