Intervening Hedgerow Assessment

Trimming Impact under Proposed 400kV Transmission Line

September 2012

**North South 400kV Interconnection
Development**

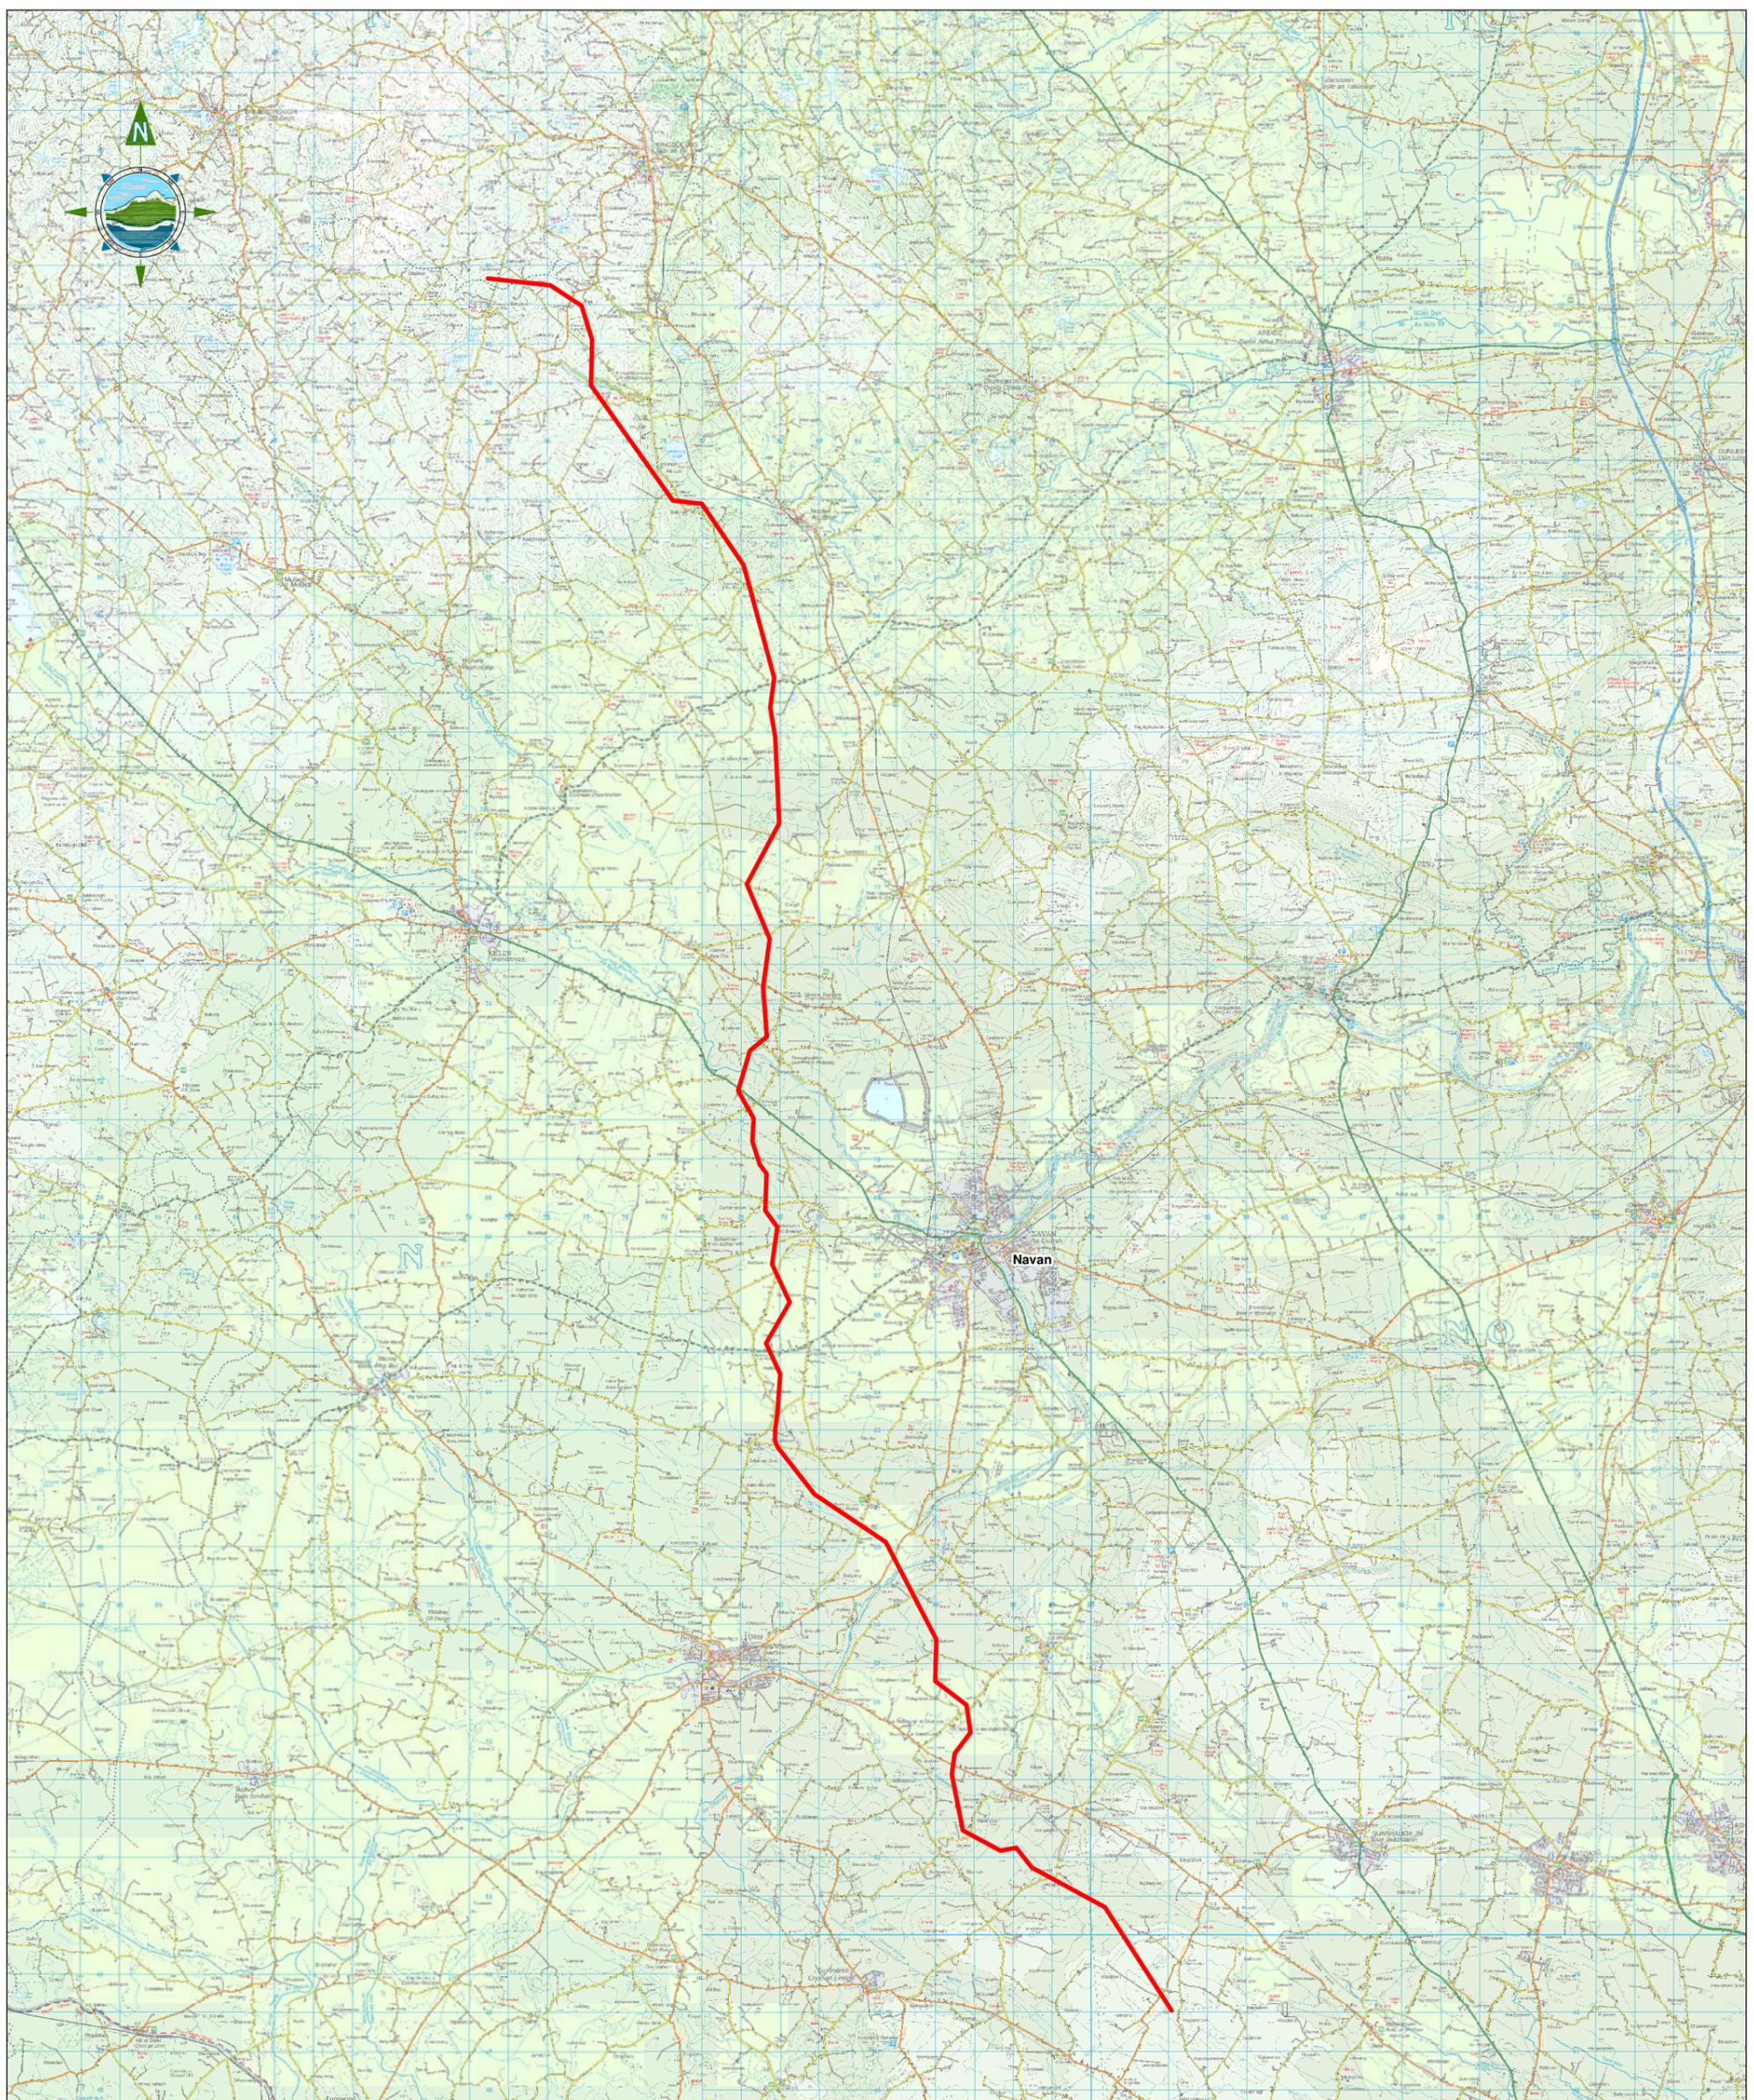
6244
Figure 1 (MSA) A

Title:
 Intervening Hedgerow Study
 Proposed transmission
 line route in Co. Meath

This study was conducted at all locations where the proposed transmission line crosses (and runs close by and parallel to) hedgerows in Counties Meath, Cavan and Monaghan. A map detailing the route of the transmission line can be found in Figures 1 and 2 overleaf.

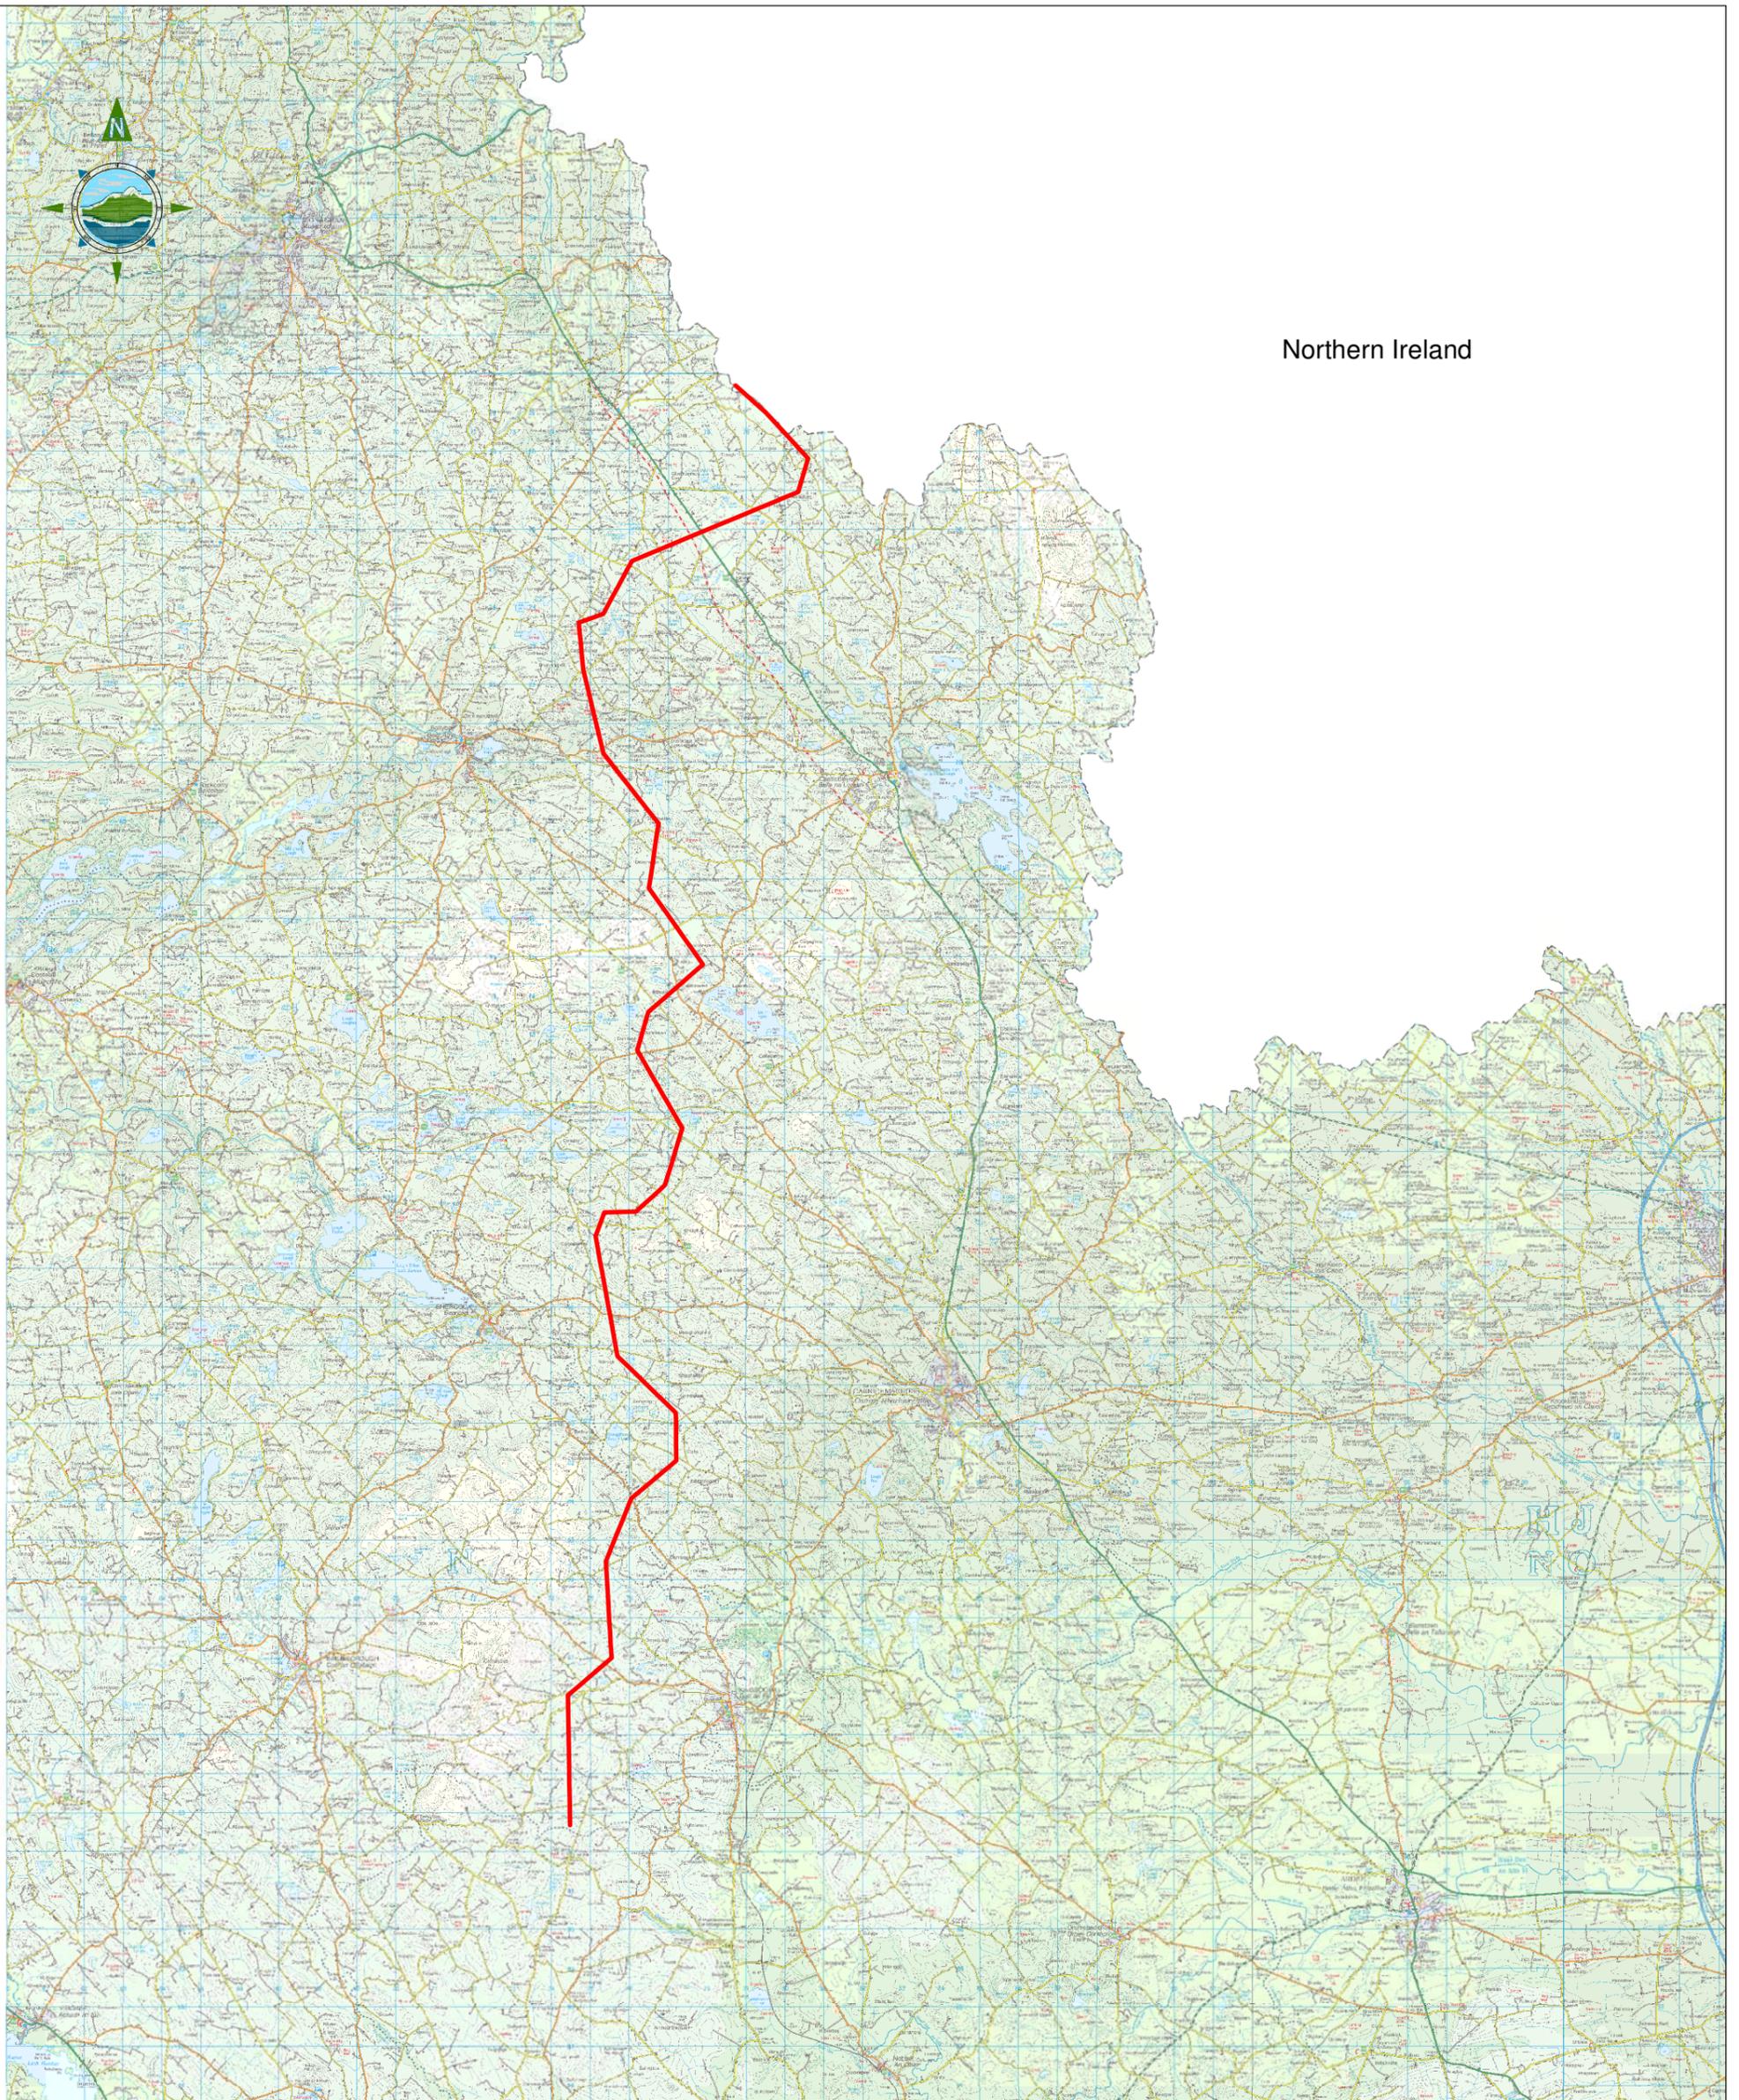
Figure 2 (CMSA) A

Intervening Hedgerow Study
Proposed transmission line route in
Co's Cavan and Monaghan

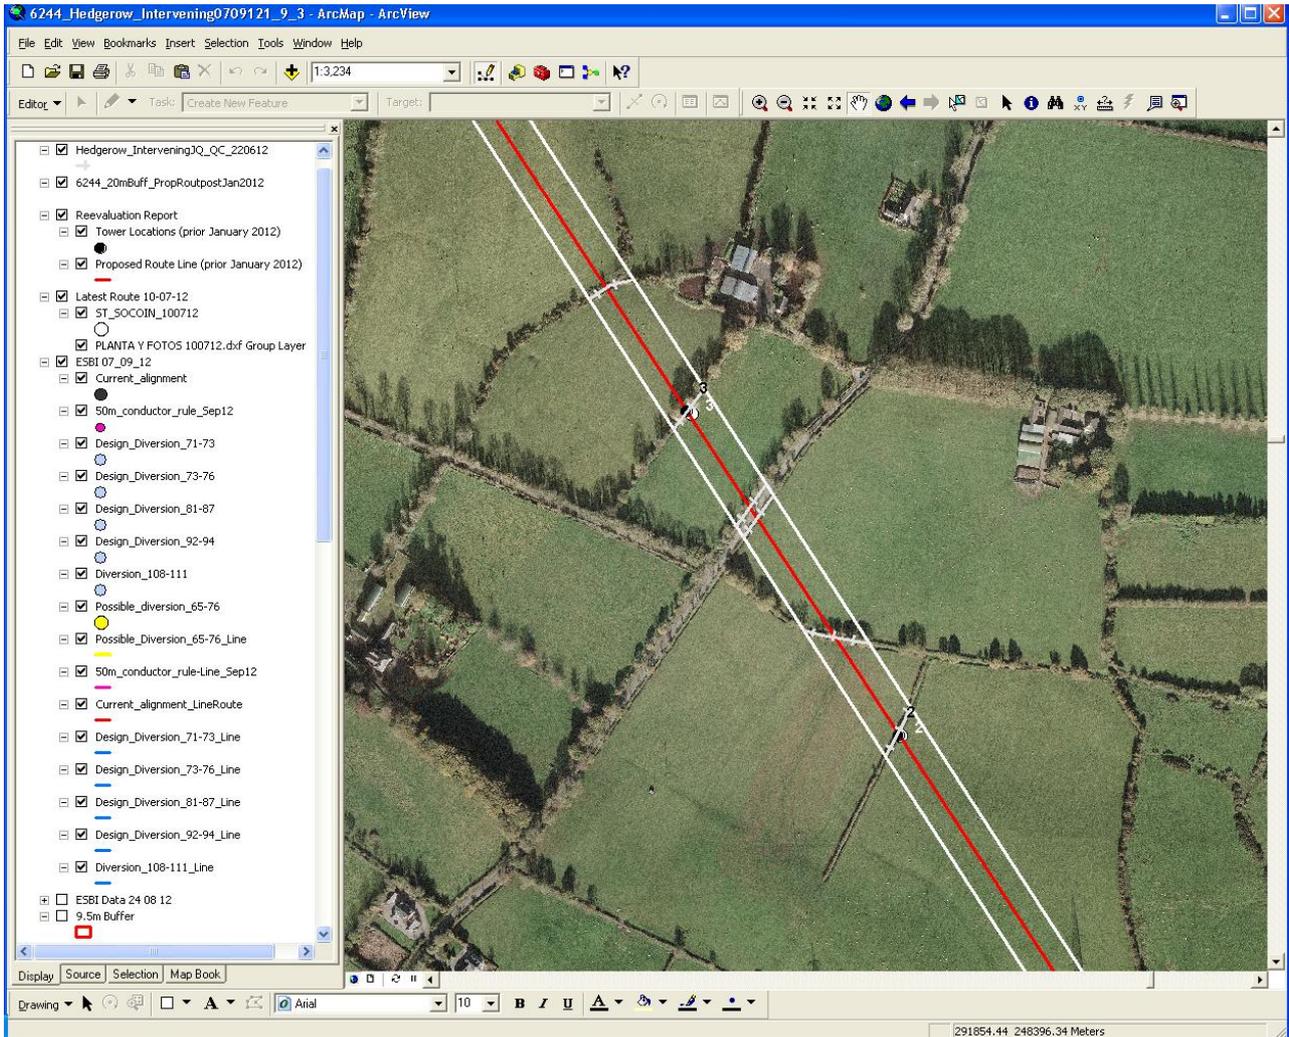
Figure 3 GIS (ArcMap) screenshot of hedgerows traversed by proposed line (red line) and 40m zone of influence at hedgerow crossed (grey hatch).

Note: Each hedgerow crossed is categorised (into 3 types) and given a unique reference number for analysis in a database.

It was agreed that the zone of impact should be 40m, allowing 19m for the 'wingspan' of a 400kV tower, plus an additional 10m buffer on each side. The lengths agreed on are considered a worst case scenario as it is not possible to be exact on the extent of clearing that would be required at each crossing.

An example of the hedgerow sections determined in GIS is detailed in Figure 3 overleaf.

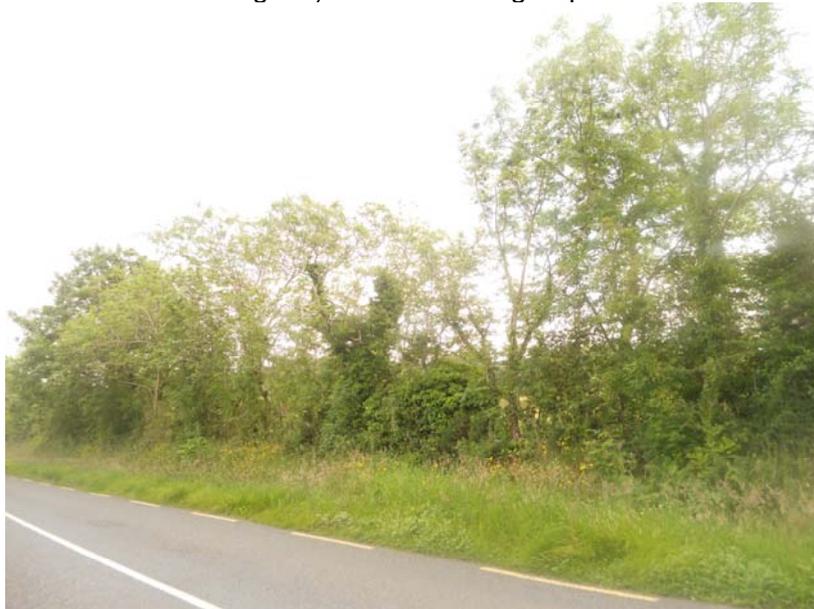
Type 1: Relatively unmanaged hedgerow dominated by immature ash (Co Monaghan). Minor trimming required.

- **Type 1:** Hedgerows typically < 9m in height, with no identified mature tree specimens and dominated by immature taller tree species (e.g. ash) or relatively lower growing tree species e.g. blackthorn, hawthorn and willow.

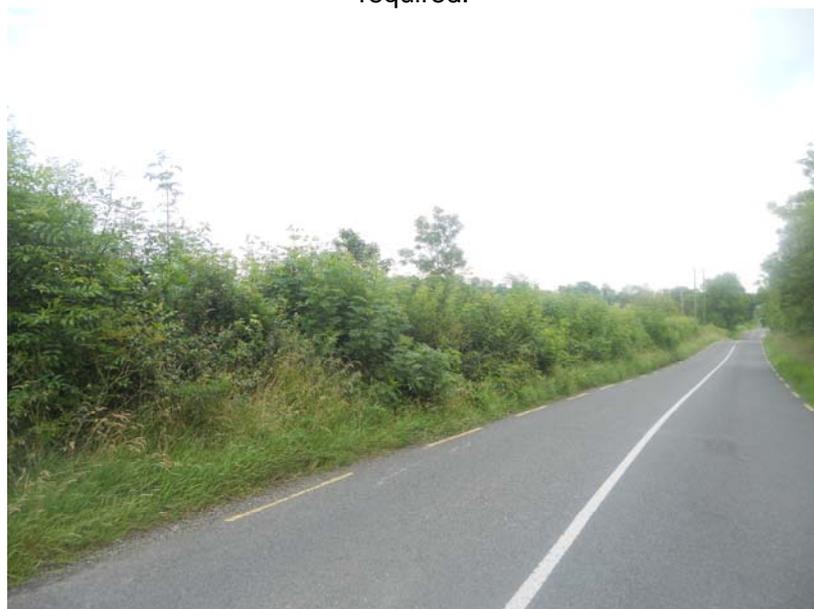
Type 1: Managed Hedgerow (left of picture) in Co Monaghan. No trimming required.

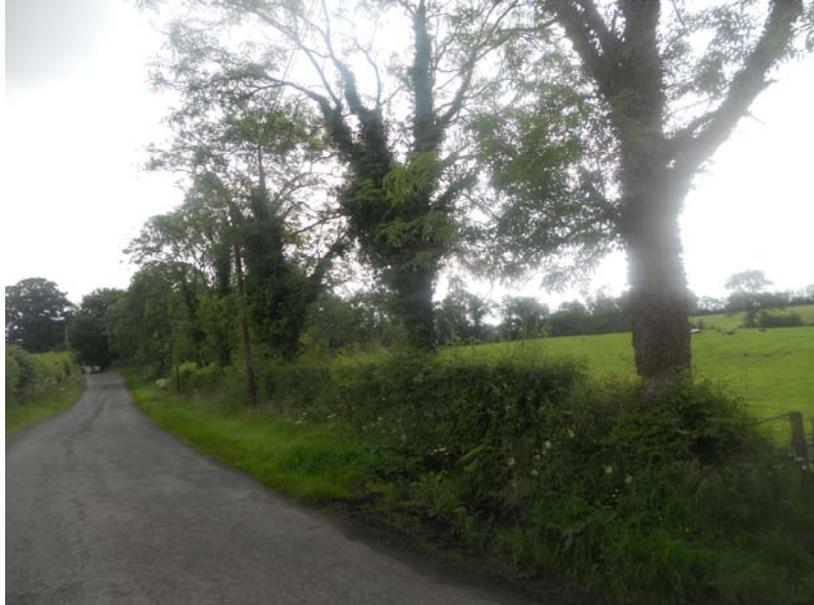
Type 2: Managed hedgerow and scattered mature ash tree which will require cutting within zone of impact. However given relatively scattered nature possibly only one or two trees will require cutting/ partial trimming.

- **Type 2:** This type is typically dominated by non mature trees or lower growing species but includes at least one (more typically several) identified mature tree specimen (typically >15m generally >20m) which will require cutting.
- **Type 3:** This type is dominated by mature trees which form a closed canopy treeline. Typical species include beech and oak tree lines are generally clustered around or in the vicinity of demesnes in Co. Meath.

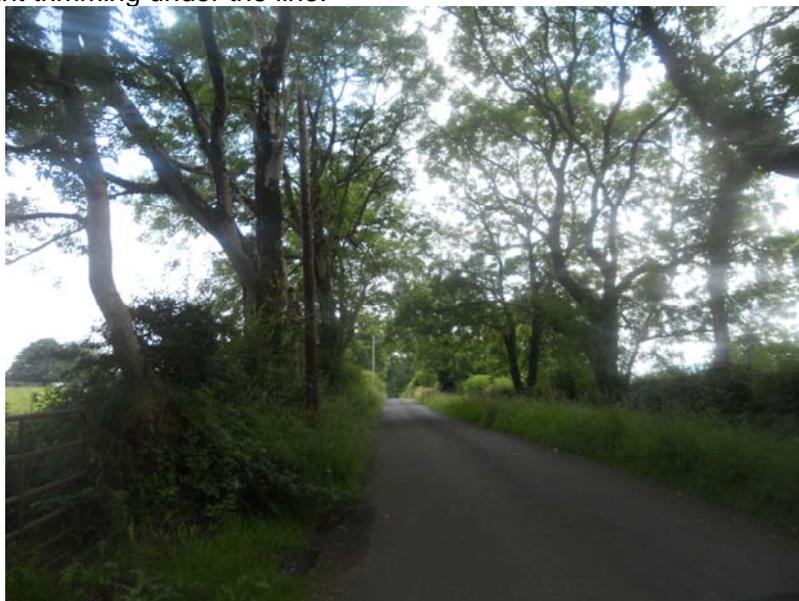
Type 2: Both sides of road. Note not closed canopy i.e. scattered but relatively dense mature trees at least 1 to 2 either side of road will require cutting/ significant trimming under the line.

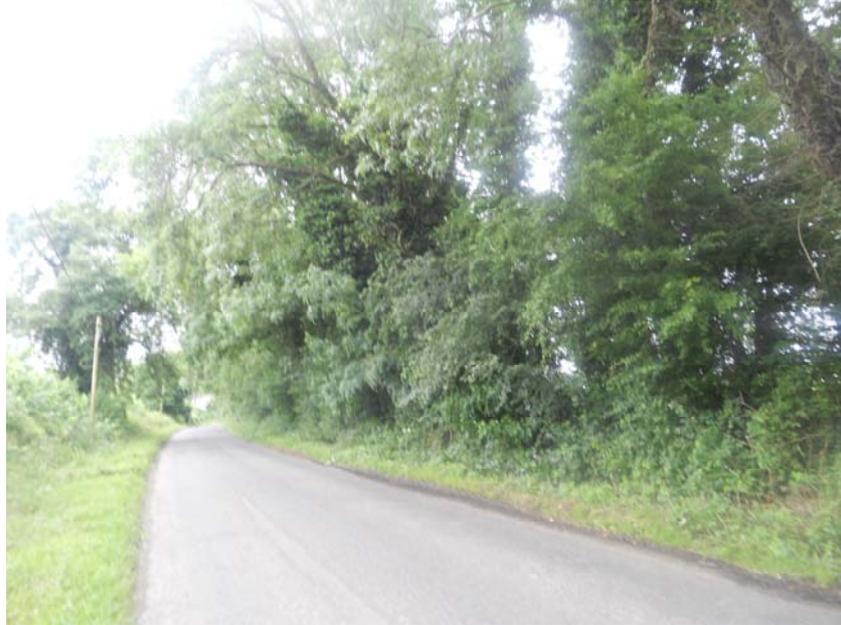
Type 3: category (right of picture). Very mature ash trees form a continuous treeline. At least several of these trees will require felling/ partial trimming within the zone of impact.
