Tyrone Cavan Interconnector Bat Survey Report (2013)

Tyrone Cavan Interconnector Bat Survey Report

The Proposed Development includes the construction of a 400,000 volt (400kV) overhead line in Counties Tyrone and Armagh, and an associated 275/400kV substation in the townland of Turleenan (near Moy), County Tyrone. The overhead line will run for a distance of approximately 34km to the Republic of Ireland border. The overhead line, the substation and associated development are referred to in this report as "the Proposed Development."

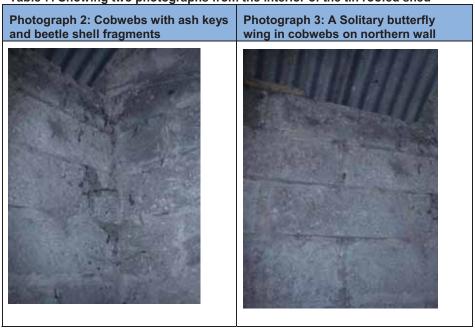
Table 7: Showing two photographs from the interior of the tin roofed shed

Internally, there were no live bats or corpses recorded, and no droppings were observed. There were no urine or grease marks present and no smell of bats. The shed floor was covered in mud/manure and bedding. There were beetles, beetle shell fragments, ash keys (seeds), and a single butterfly wing trapped in cobwebs on the northern wall and north-western corner, by the door (refer to Photographs 2 & 3 below).

The entire store area was covered in cobwebs to the extent they are collapsing off the walls, where this has happened other webs have been spun.

The likelihood of bats being present was considered to be defined as 'Lower', and as such a minimum of one dusk emergence /pre-dawn re-entry survey was recommended in accordance with BCT 2012 guidelines.
