Project Tree and woodland survey Greenlink Interconnector - Ireland				
Client ARUP				
Project ref	Report no	Client ref		
1991.1	1991.1	-		
DixonBrosnan 12 Steam Packet House, Passage West, Co. Cork. Tel 086 851 1437 carl@dixonbrosnan.com www.dixonbrosnan.com				
Date	Rev	Status	Prepared by	Reviewed
18/11/19	1	1 st Draft	Mark Donnelly BSc	Carl Dixon MSc.
13/03/20	5			
This report and its contents are copyright of DixonBrosnan. It may not be reproduced without permission. The report is to be used only for its intended purpose. The report is confidential to the client, and is personal and non-assignable. No liability is admitted to third parties. ©DixonBrosnan 2019. v180907

3. Introduction

This tree survey was carried out along the onshore route of the proposed Greenlink interconnector between Baginbun Beach and Great Island, County Wexford. The survey area can be divided into two types of tree cover: roadside trees and dense woodland, each requiring its own survey methodology and thus these categories are described separately. The purpose of the survey is to identify trees that could be adversely affected by the proposed works, assess these impacts and make recommendations includ

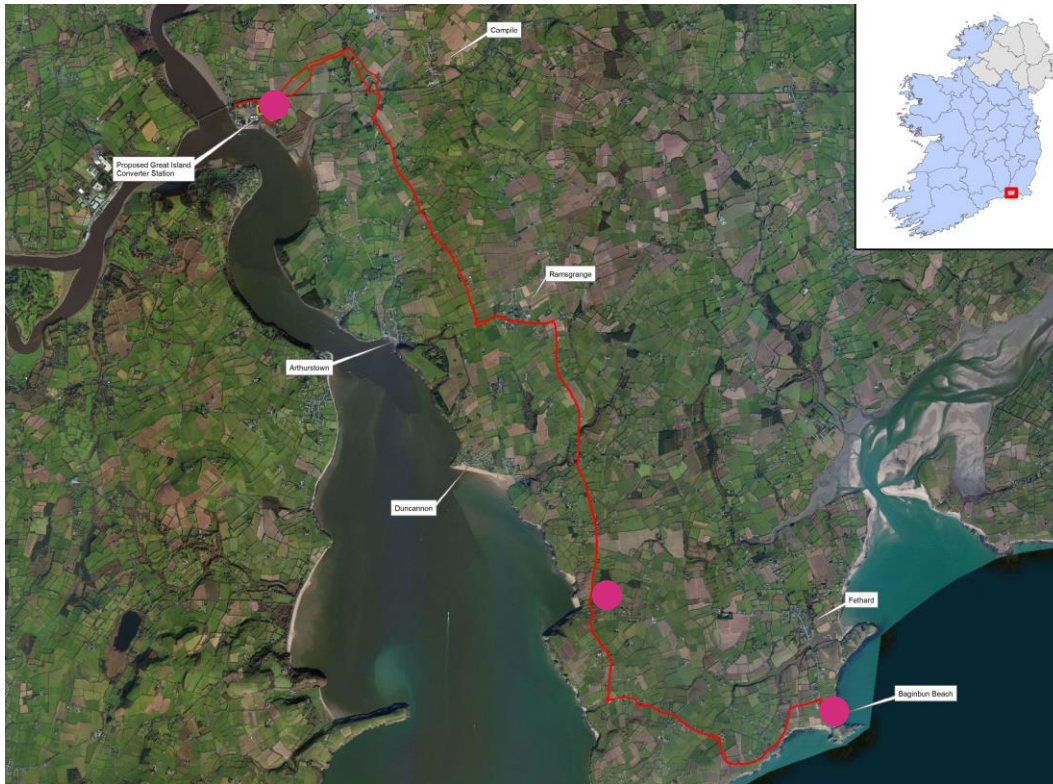
Figure 1: Cable Route and Locations of Construction Compounds (indicated thus ● | background mapping from Bing © Microsoft 2020)

At the Campile Estuary it is proposed that a horizontal directional drill (HDD) will pass under the estuary and woodland at a depth of >10m. An overview of the route is provided in **Figure 1**.
