GREENLINK MARINE ENVIRONMENTAL IMPACT ASSESSMENT REPORT- IRELAND

APPENDIX H - L

Greenlink Interconnector
- connecting the power markets
in Ireland and Great Britain

Environmental Survey Report

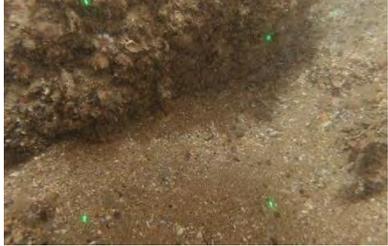
Mixed faunal turf communities on circalittoral rock	A4.13

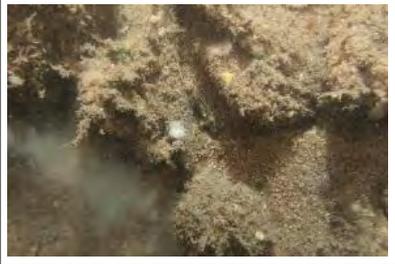
Mixed turf of bryozoans and erect sponges with <i>Dysidia fragilis</i> and <i>Actinothoe sphyrodeta</i> on tide-swept wave-exposed circalittoral rock	A4.1312

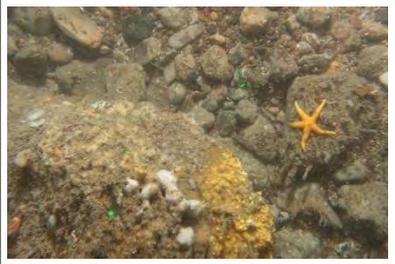
<i>Corynactis viridis</i> and a mixed turf of crisiids, Bugula, Scrupocellaria, and Cellaria on moderately tide-swept exposed circalittoral rock	A4.132

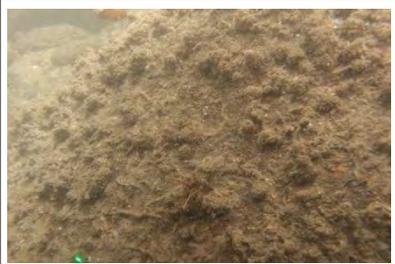
<i>Molgula manhattensis</i> with a hydroid and bryozoan turf on tide-swept moderately wave-exposed circalittoral rock	A4.138

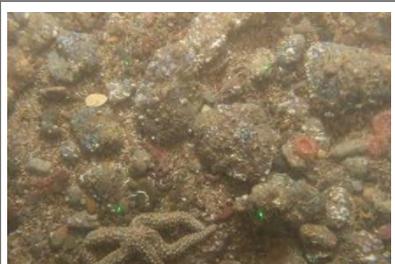
Echinoderms and crustose communities on circalittoral rock	A4.21

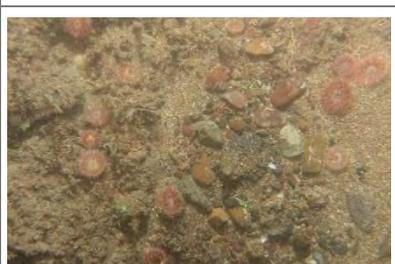
<i>Urticina felina</i> and sand-tolerant fauna on sand-scoured or covered circalittoral rock	A4.213

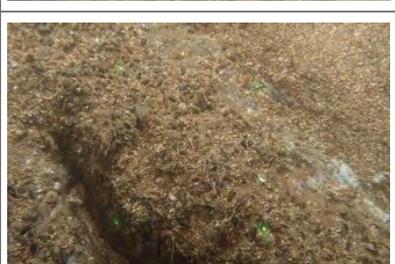
<i>Urticina felina</i> and sand-tolerant fauna on sand-scoured or covered circalittoral rock/ <i>Mytilus edulis</i> beds with hydroids and ascidians on tide-swept exposed to moderately wave-exposed circalittoral rock	A4.213/ A4.241

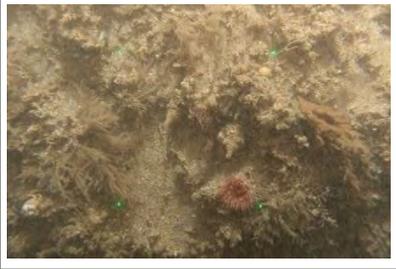
<i>Sabellaria spinulosa</i> encrusted circularittoral rock	A4.221

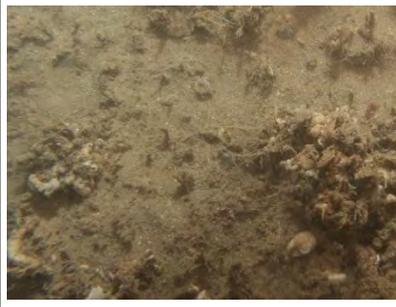
<i>Sabellaria spinulosa</i> , didemnid and small ascidians on tide-swept moderately wave-exposed circularittoral rock	A4.2212

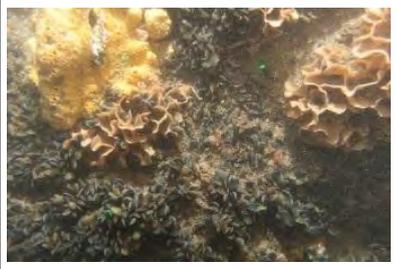
<i>Mytilus edulis</i> beds with hydroids and ascidians on tide-swept exposed to moderately wave-exposed circularittoral rock	A4.241

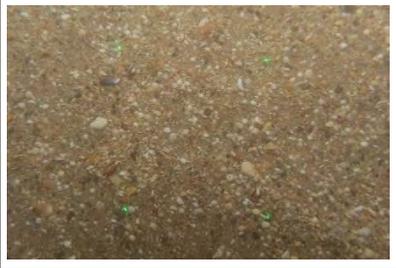
Circularittoral coarse sediment	A5.14

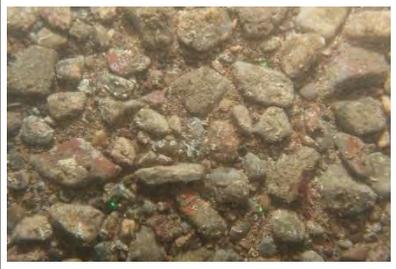
<i>Pomatoceros triqueter</i> with barnacles and bryozoan crusts on unstable circularittoral cobbles and pebbles	A5.141

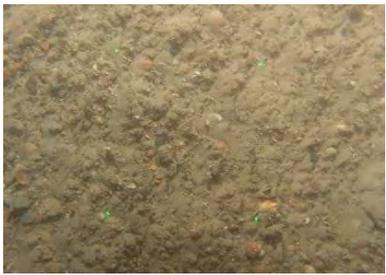
<i>Mediomastus fragilis</i> , <i>Lumbrineris spp.</i> and venerid bivalves in circalittoral coarse sand or gravel	A5.142

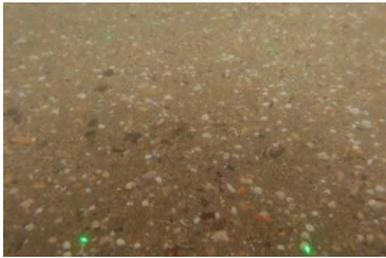
<i>Protodorvillea kefersteini</i> and other polychaetes in impoverished circalittoral mixed gravelly sand	A5.143

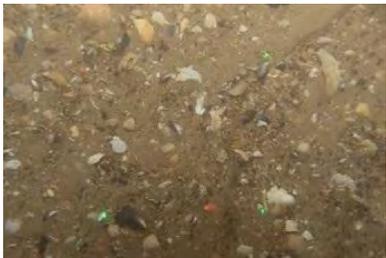
Deep circalittoral coarse sediment	A5.15

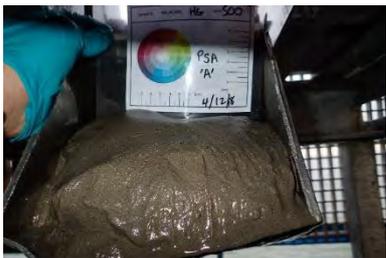
Infralittoral muddy sand	A5.24

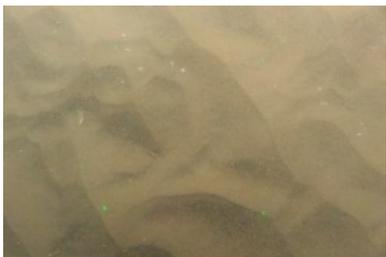
<i>Fabulina fabula</i> and <i>Magelona mirabilis</i> with venerid bivalves and amphipods in infralittoral compacted fine muddy sand	A5.242

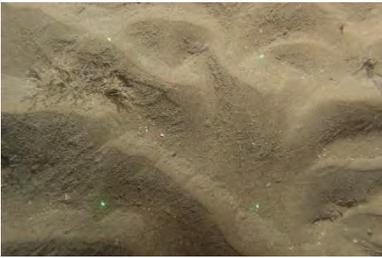
Circalittoral fine sand	A5.25

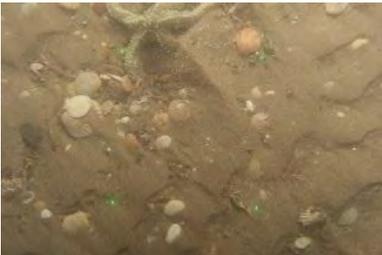
<i>Echinocyamus pusillus</i> , <i>Ophelia borealis</i> and <i>Abra prismatica</i> in circalittoral fine sand	A5.251

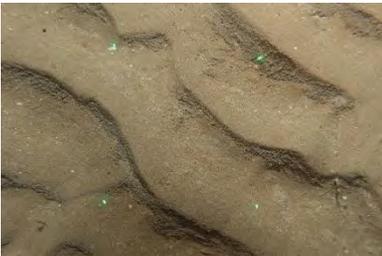
<i>Abra prismatica</i> , <i>Bathyporeia elegans</i> and polychaetes in circalittoral fine sand	A5.252

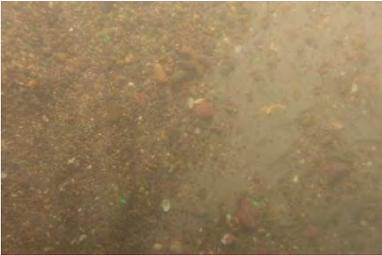
<i>Abra alba</i> and <i>Nucula nitidosa</i> in circalittoral muddy sand or slightly mixed sediment	A5.261

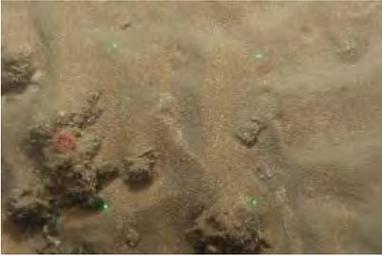
Deep circalittoral sand	A5.27

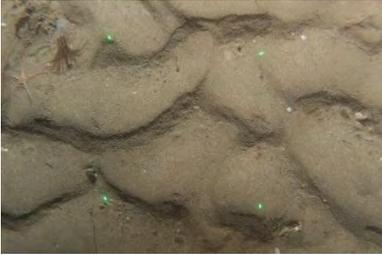
<i>Owenia fusiformis</i> and <i>Amphiura filiformis</i> in deep circalittoral sand or muddy sand	A5.272

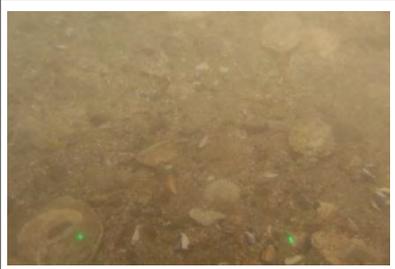
Polychaete-rich deep Venus community in offshore mixed sediments	A5.451

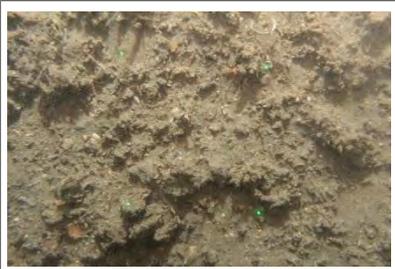
<i>Sabellaria spinulosa</i> on stable circalittoral mixed sediment	A5.611

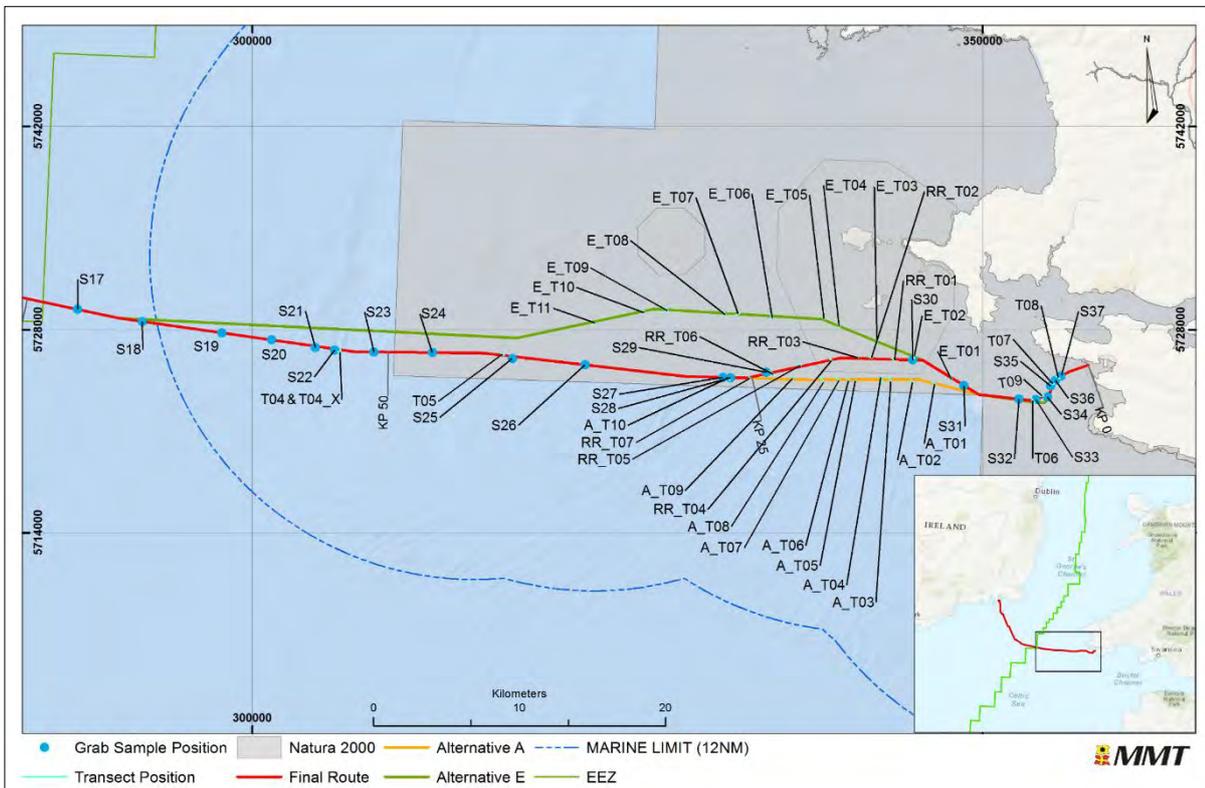
Figure 5 Overview of sampling and transect locations in the UK EEZ.

Grab sample site S17 to S37 (Table 15) was located within the UK EEZ. All grab sample sites were located within the Final Route corridor (Figure 5). See Appendix A| for a full list of positions of grab sample sites and transects. Field protocols are available in Appendix B| and Appendix C|. Grab identification protocols and Transect identification protocols are found in Appendix D| and Appendix E|.

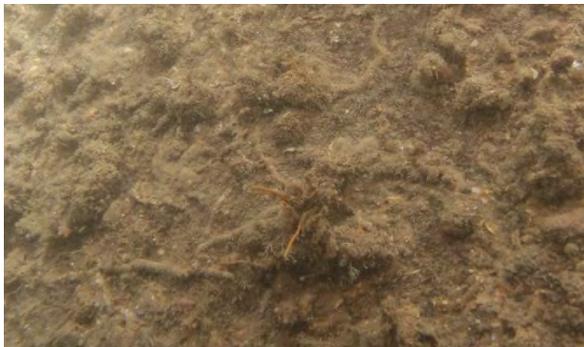
Figure 7 Example image DDV_T09_005.

Transects DDV_T06 to DDV_T09 (Figure 7 to Figure 10) were located in turbid waters on various sections of the bedrock feature A4.138.

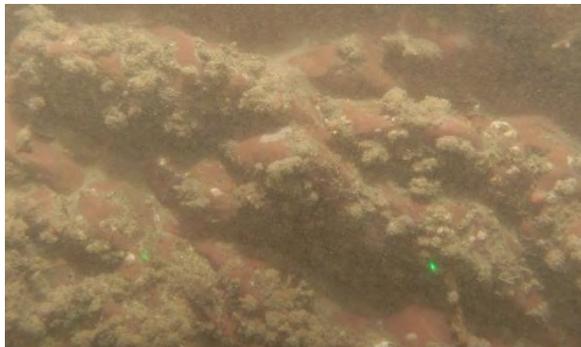
Figure 8 Example image DDV_T08_009.
(KP 2.220)

A few small outcrops are interpreted to cross the final route between KP 2.211 and KP 2.412, KP 2.783 with a larger section between KP 4.874 to KP 4.997 (DDV_T06).

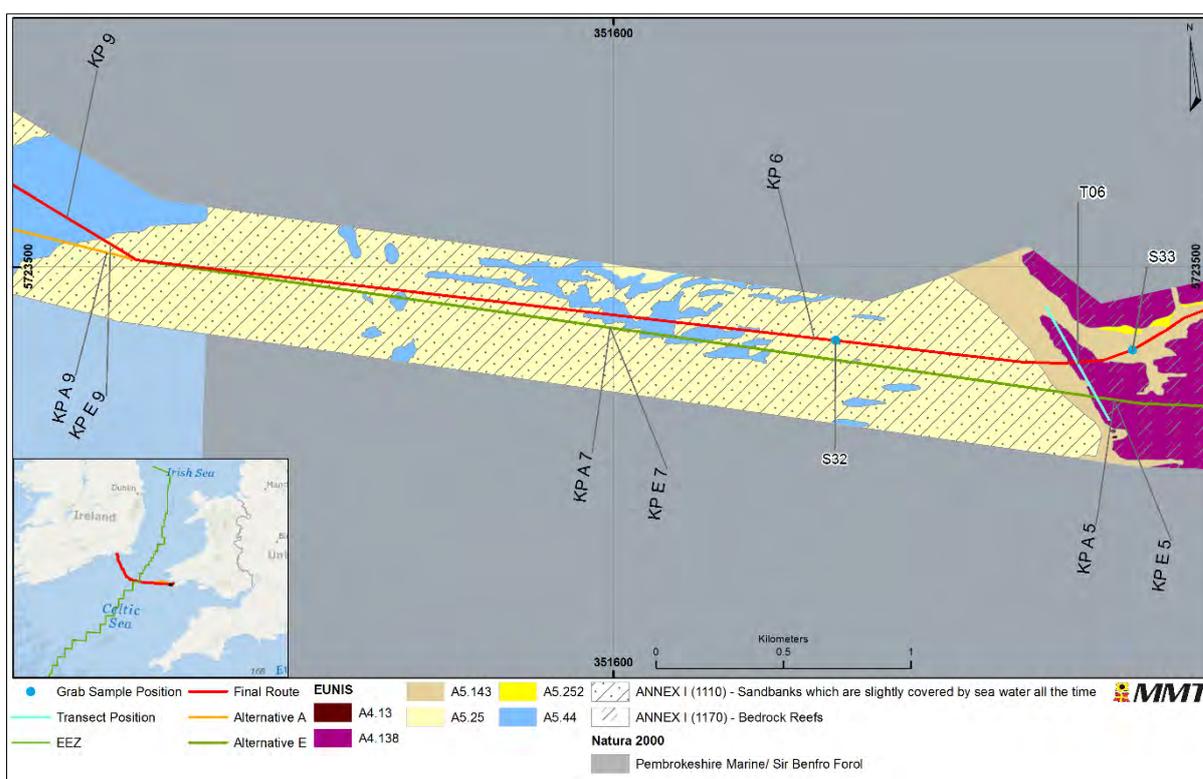
Figure 11 Overview of UK EEZ KP 5 to KP 9.

The seabed between KP 5.121 and KP 10.031 is dominated by fine sands, A5.25, with pockets and small sections, found from KP 6.220 to KP 6.882 and from KP 8.840 to KP 9.450, classified as A5.44 - Deep circalittoral mixed sediments (Figure 11). The areas classified as A5.44 were derived from the interpretations of geophysical data.

From KP 5.122 to KP 8.841 and from KP 9.405 to KP 10.029, two areas with sand and coarse sediment were classified as Annex I (1110) - Sandbanks which are slightly covered by sea water all the time (Figure 11 and Figure 12).

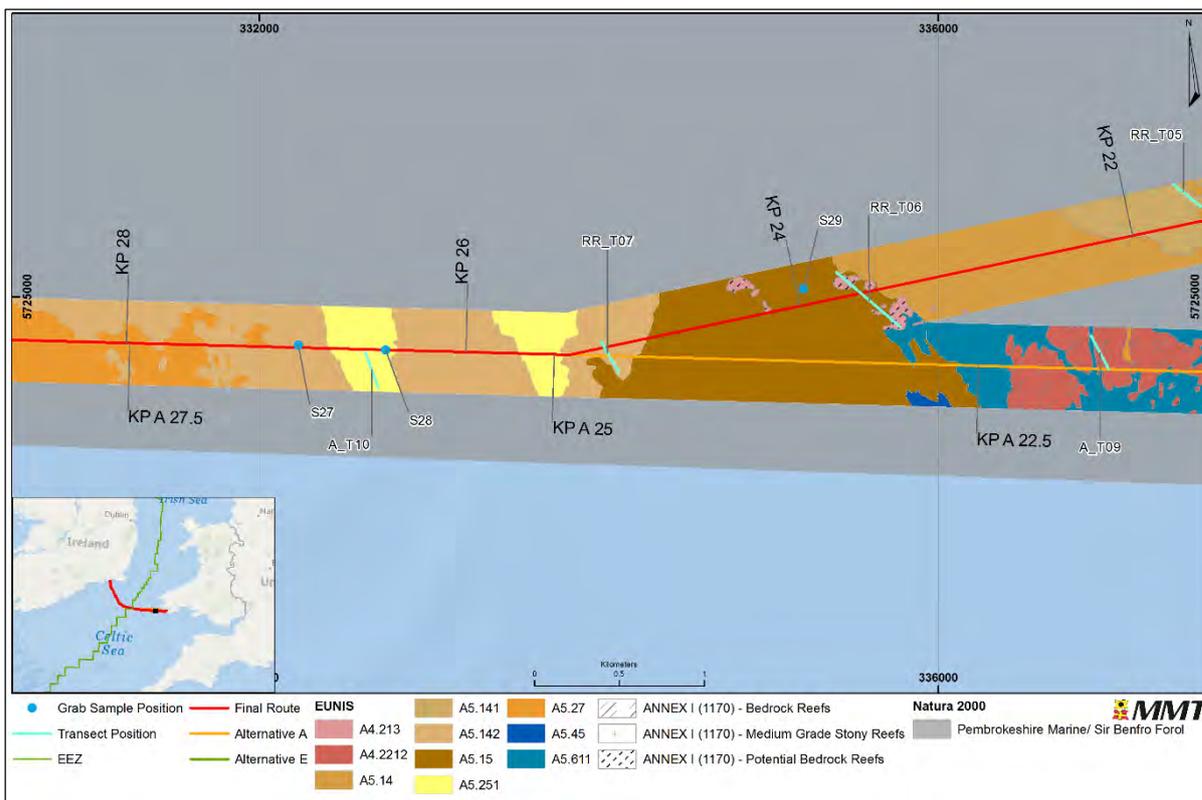
Figure 15 Overview of UK EEZ KP 22 to KP 28.

The seabed between KP 23.534 and KP 24.925 was classified as A5.15 - Deep circalittoral coarse sediment (Figure 15). Areas of A4.213 - *Urticina felina* and sand-tolerant fauna on sand-scoured or covered circalittoral rock were classified from KP 23.535 to KP 23.743 and crossing the final route at KP 24.192. An area classified as A5.611 - *Sabellaria spinulosa* on stable circalittoral mixed sediment was identified along the final route corridor, at the boundary of route Route A, KP 23.532 to KP 23.696.

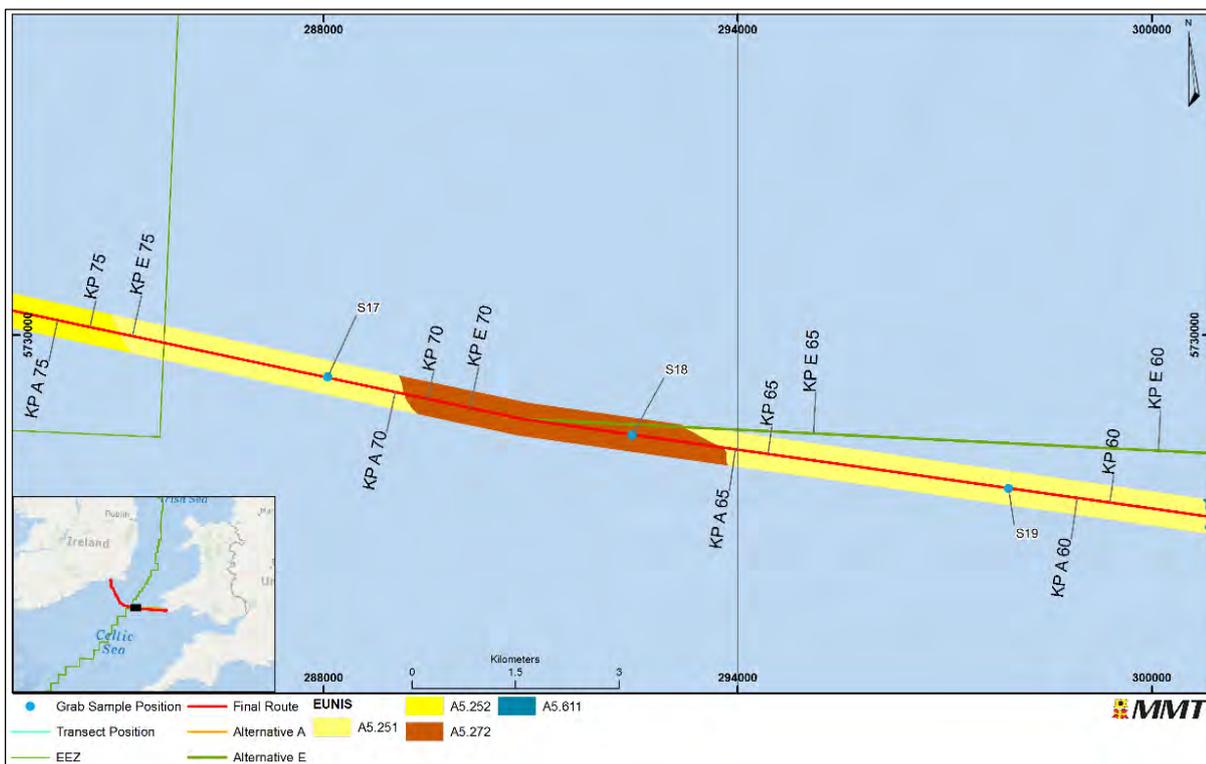
Figure 20 Overview of UK EEZ KP 58 to KP 75.

From KP 58.579 to KP 73.906 the seabed was composed of fine rippled sands and classified predominantly as A5.251 (Figure 20). A section between KP 65.660 and KP 70.350 was classified as A5.272 - *Owenia fusiformis* and *Amphiura filiformis* in deep circalittoral sand or muddy sand.

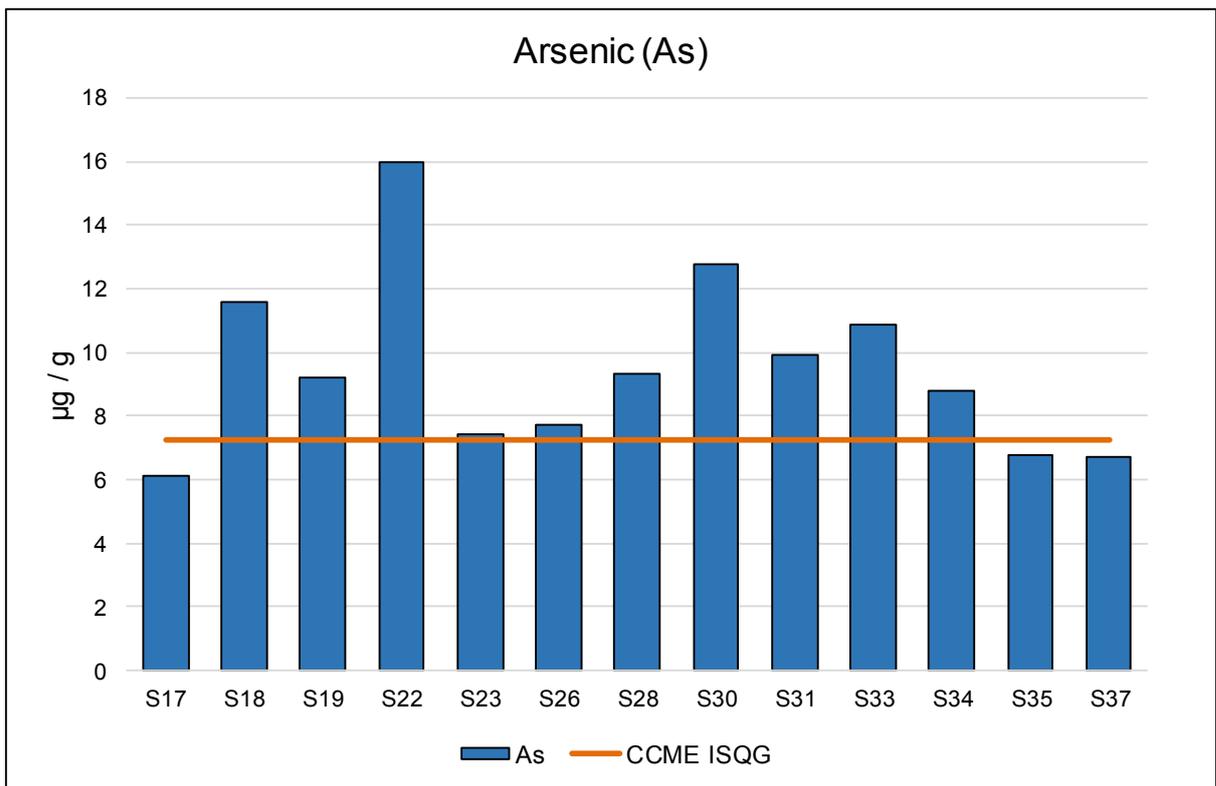
Figure 26 Arsenic (As) concentrations ($\mu\text{g/g}$ dry weight) in sediment across grab sample sites together with threshold values for CCME ISQG.

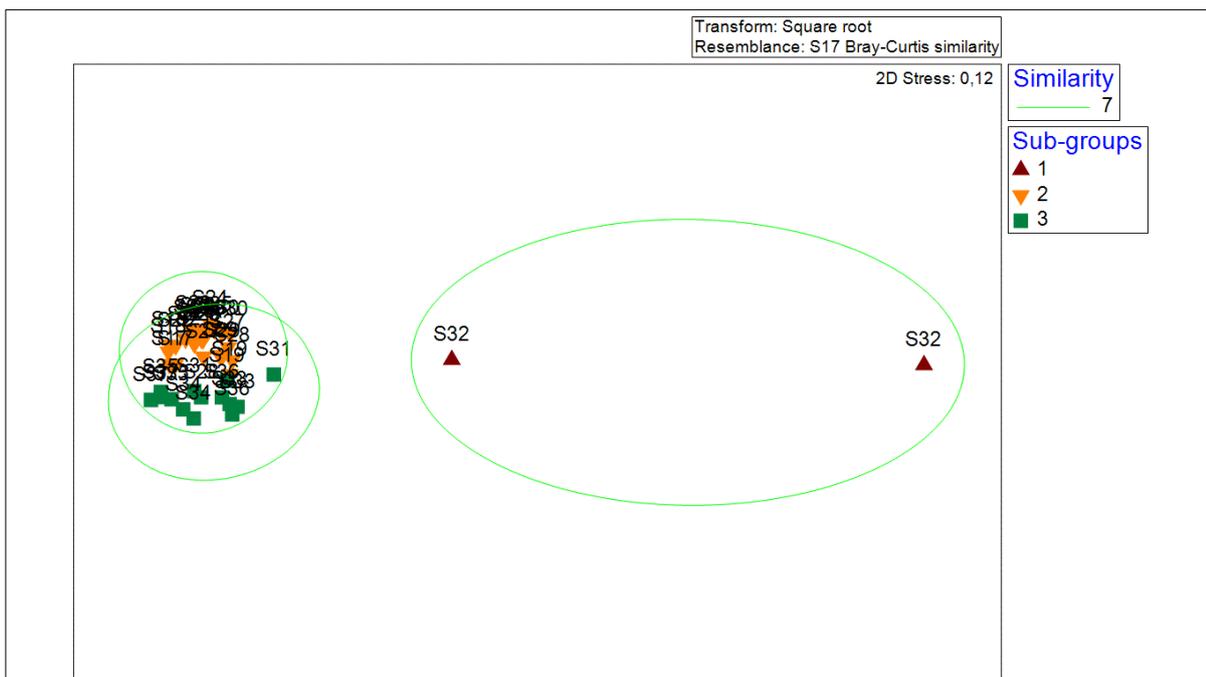
Figure 28 nMDS plot on faunal composition for each grab sample site and replicate, groups based on SIMPROF.

Group 1 consisted of both replicates from site S32 (S32_A, S32_B) and group 2 consisted of the majority of grab sample sites and group 3 was the group with the second most samples. There was no significant intra-variability within the replicates in the samples, except in sample S19 and S38, where one replicate (S19_A and S28_B) grouped into Group 2 and the other (S19_B and S28_A) grouped into Group 3. The highest average similarity was found in group 2 (26.32 %) and the lowest in group 3 (14.01 %). This low similarity within groups suggest a difference in faunal composition within the groups. Grab site S32 showed a big difference from the rest of the samples. This site was the only one with 100 % sand in the PSD, with a low diversity relative to the rest of the samples.

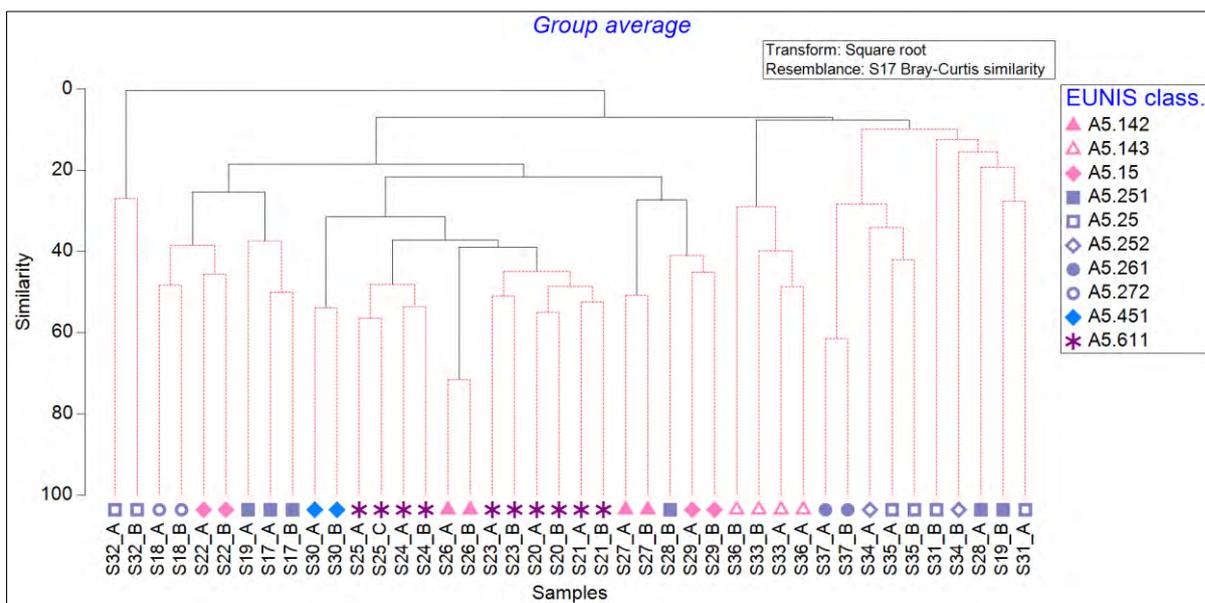
Figure 29 SIMPROF dendrogram based on faunal composition with EUNIS habitat classification overlay for each grab sample site and replicate.

The resulting EUNIS habitat classification for each site is presented in Figure 29. Sub-group 1, with grab sample site S32, was classified as A5.25. Sub-group 2, that contained most of the samples, included six different classifications (A5.142, A5.15, A5.251, A5.252, A5.451 and A5.611). Sub-group 3 contained five classifications (A5.143, A5.261, A5.25, A5.251 and A5.252). The different habitats do not have a strong relation to the identified sub-groups. EUNIS habitat classification A5.611 and A5.143 were the only two habitats (of those habitats that were found in more than one grab sample site) that were grouped in the same sub-group by the SIMPROF analysis.

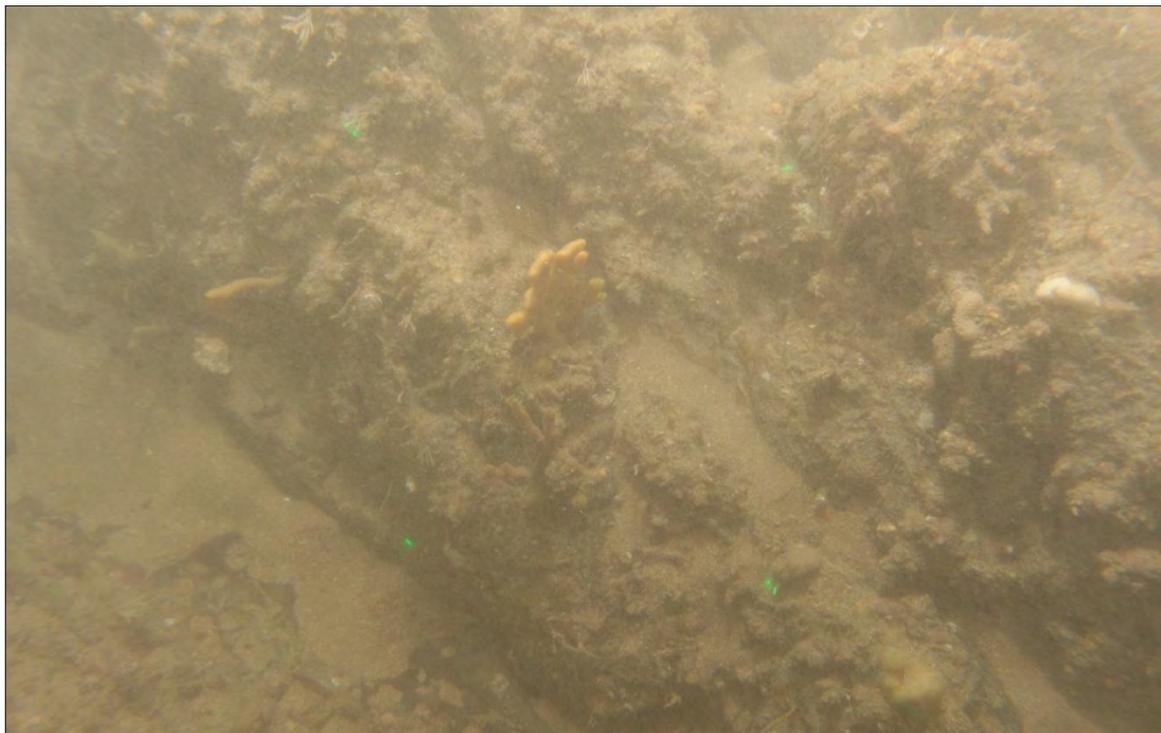
Figure 38 Image T06_014 of Annex I (1170) – Bedrock reefs with the habitat A4.138 – *Molgula manhattensis* with a hydroid and bryozoan turf on tide-swept moderately wave-exposed circalittoral rock.

Transect T07 (crossing the centre line at KP 2.786) and transect T06 (crossing the centre line at KP 4.961) showed similar characteristics and the bedrock surrounding the narrow channel of sand was also classified as Annex I (1170) – Bedrock Reefs (Figure 38).

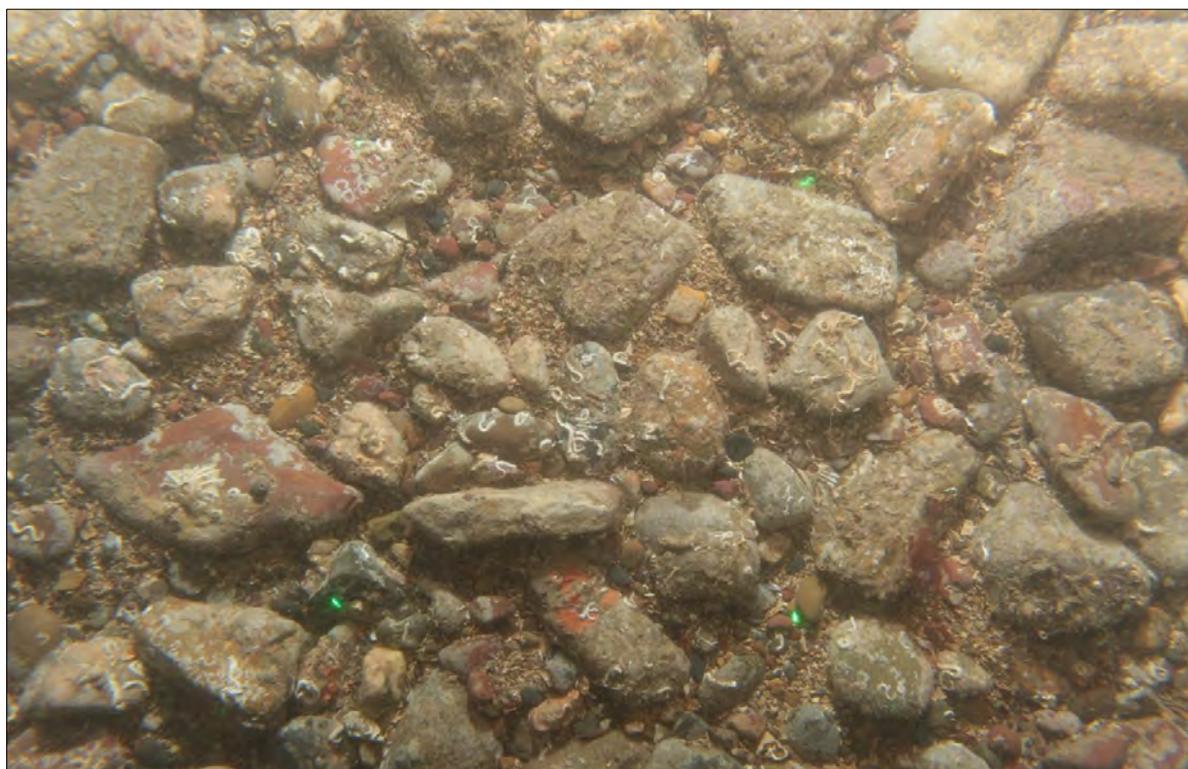
Figure 39 Image RR_T03_001 of Annex I (1170) – Medium Grade Stony Reef with the habitat A5.141 – Pomatoceros triqueter with barnacles and bryozoan crusts on unstable circalittoral cobbles and pebbles.

Transect RR_T01, RR_T02, RR_T03 (Figure 39), RR_T04 and RR_T05 were all located in an area with boulders and cobbles with a rich epifauna community. Cobbles greater than 0.064 m in diameter covered between 50 % to 80 % of the area along the transects, and were in general clast supported with a maximum elevation of approximately 0.2 m. The seabed in this area meets the criteria of a medium grade stony reef (Table 27 to Table 31).

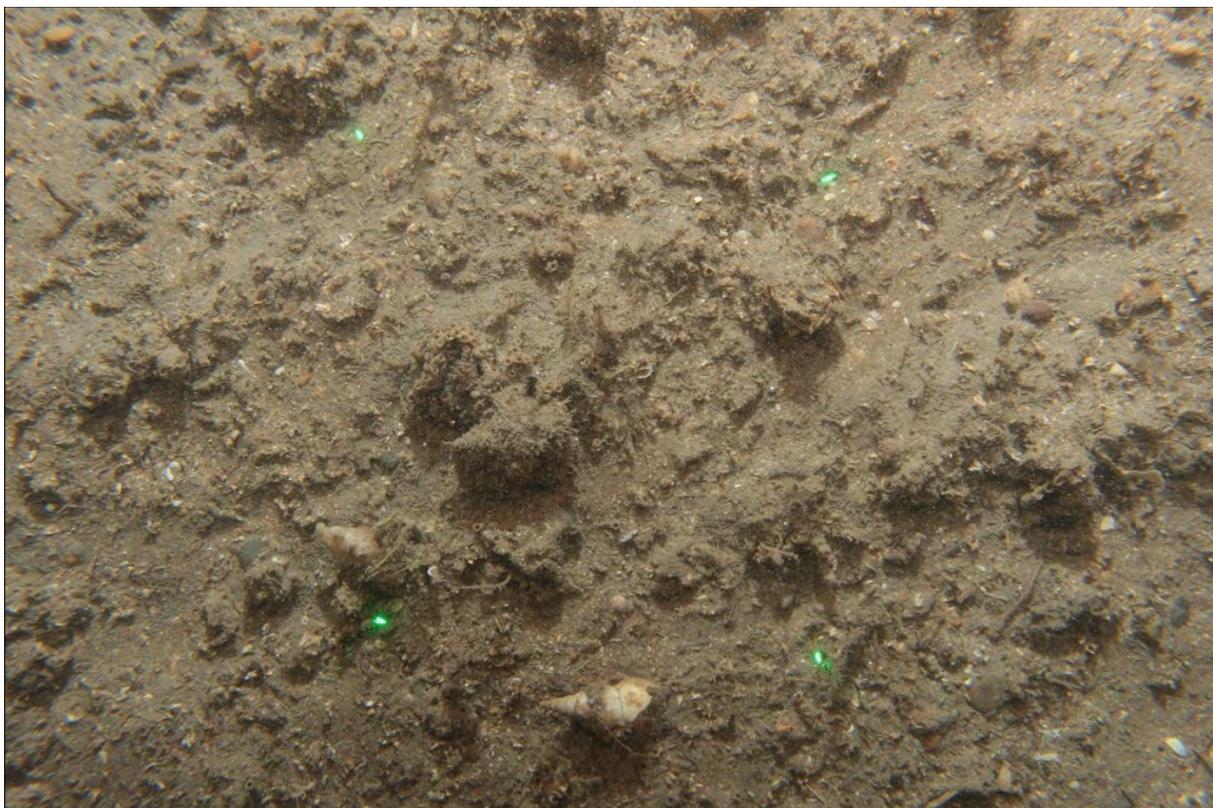
Figure 40 Image S25_003 of Annex I (1170) – Low Grade Biogenic reef with the habitat A5.611 – Sabellaria spinulosa on stable circalittoral mixed sediment.

Grab sample site S25, located further west at KP 40.990, showed a higher presence of *S. spinulosa*. An average abundance of 1495 specimens per m². The *S. spinulosa* aggregations visible in the images from the site showed a coverage between 7% and 17%, with an average coverage of 12% (Figure 40). The elevation of the tube aggregations was assessed to vary between flat seabed and 5 cm. The reef meets the criteria of an Annex I (1170) – Low Grade Biogenic reef according to the *S. spinulosa* reef assessment by Gubbay (2007) (Table 33).

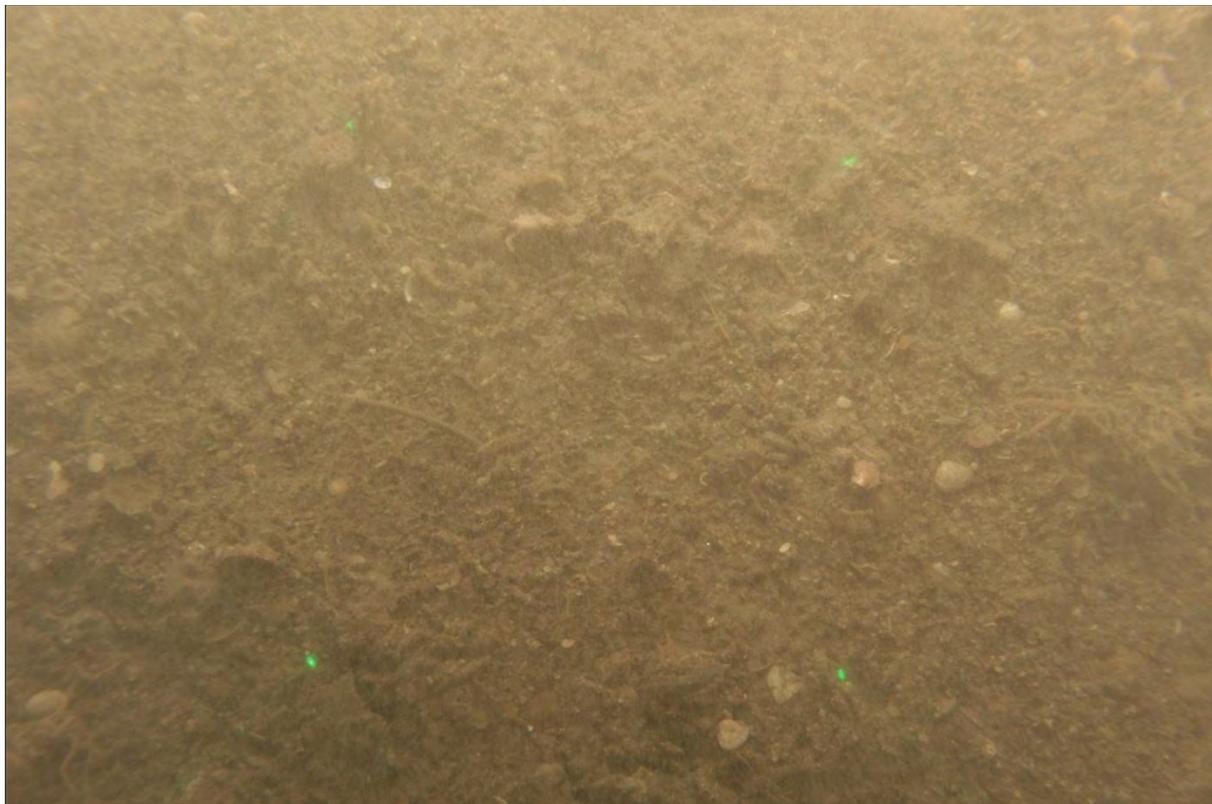
Figure 41 Image S24_001 of the habitat A5.611 – Sabellaria spinulosa on stable circalittoral mixed sediment.

Specimens of *S. spinulosa* were found in both grab samples from site S24, with an average abundance of 740 individuals per m². No *S. spinulosa* aggregations were identified in the grab sample site photos (Figure 41), but tubes of the species is scattered across the seabed. A homogenous seabed with coarse sediment was identified from the geophysical data in the area, with no indication of any elevated reef formations. Thus, the area is not considered meeting the criteria to qualify as a *S. spinulosa* reef.

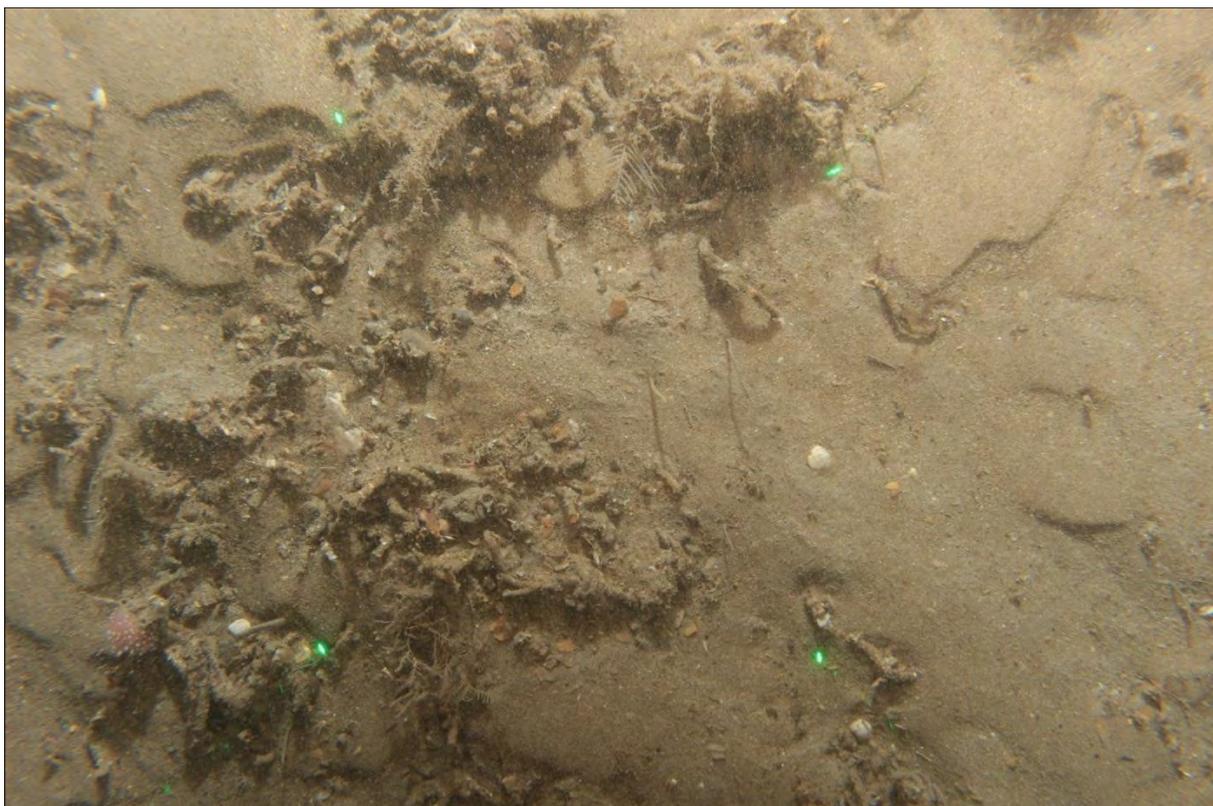
Figure 42 Image S20_005 of Annex I (1170) – Low Grade Biogenic reef with the habitat A5.611 – Sabellaria spinulosa on stable circalittoral mixed sediment.

Specimens of *S. spinulosa* were identified from both samples at site S20, located at KP 58.035. S20 had an average abundance of 1720 specimens per m². The *S. spinulosa* aggregations visible in the images from the site showed a coverage between 12 % and 35 %, with an average coverage of 24 % (Figure 42). The elevation of the tube aggregations was assessed to vary between flat seabed and 5 cm. Although the patchiness matched a Medium Graded *S. spinulosa* reef, the generally low elevation of the aggregations caused the reef to be assessed to meet the criteria of an Annex I (1170) – Low Grade Biogenic reef (Table 34).

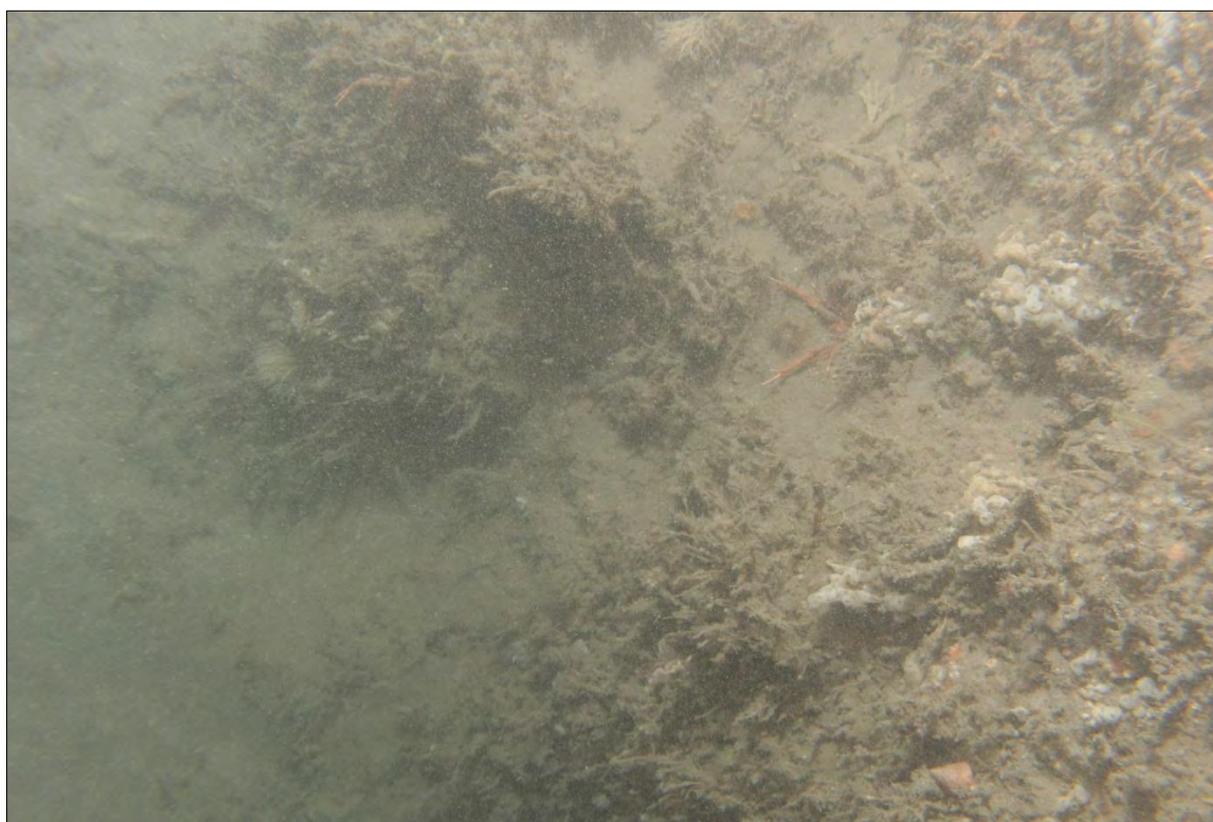
Figure 43 Raw image T05_013 of Annex I (1170) – Medium Graded Biogenic Reef on the habitat A4.2212 – Sabellaria spinulosa didemnid and small ascidians on tide-swept moderately wave-exposed circalittoral rock.

When reviewing all raw photo data from the transect, areas of *S. spinulosa* aggregations with considerably higher elevation and coverage were visible (Figure 43). The transect traversed bedrock, that was identified in the geophysical data. It is difficult to assess to what extent outcropping bedrock underneath the *S. spinulosa* aggregations added to the perceived elevation of the reef, as no bedrock were possible to identify due to the dense aggregations of *S. spinulosa*.

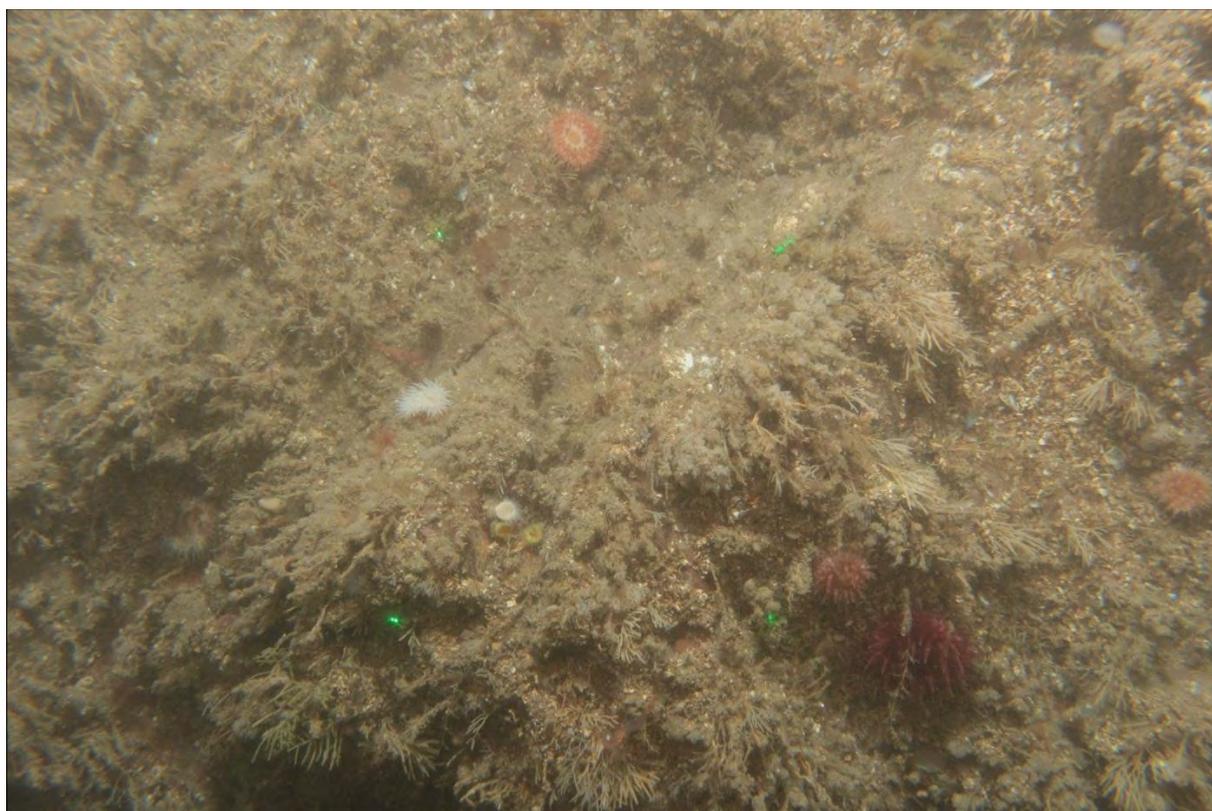
Figure 44 Annex I (1170) – Bedrock Reef at A_T05_009.

Transect A_T05 was performed across an area of bedrock on the route A. The bedrock was almost entirely covered by sediment in the beginning of the transect, then gradually transcended to bedrock only partly covered by sediment, with a high coverage by epifauna (Figure 44). Epifauna, such as anemones and hydrozoans, were also scattered in the beginning of the transect in areas with no visible protruding bedrock. Therefore, the bedrock in the beginning of the transect, including the adjacent areas with a similar appearance in the geophysical data, was classified as Annex I (1170) – Potential Bedrock Reefs. The remainder of the transect was classified as Annex I (1170) –Bedrock Reefs.

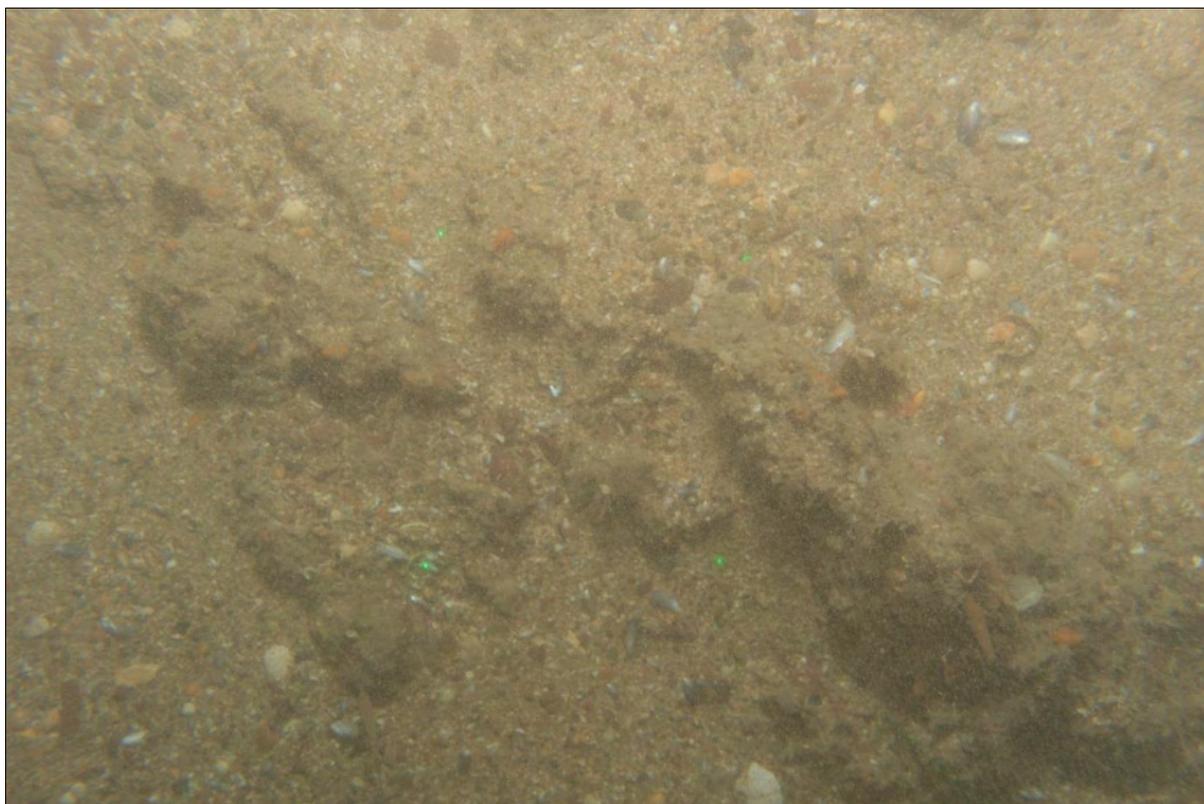
Figure 45 Image A_T01_008 of *S. spinulosa* encrusted circalittoral rock.

The transect A_T01 had a relatively high coverage of *S. spinulosa*, ranging from <1 % to 20 % coverage. The colonies were abraded with only minor patches of newly formed tubes. The *S. spinulosa* was in general found encrusting bedrock (Figure 45). The area was classified to A4.221 – *Sabellaria spinulosa* encrusted circalittoral rock, and was not considered being a biogenic reef, as the bedrock was the feature that dominated and characterised this area. Minor patches of *S. spinulosa* on bedrock was also present at transect A_T03 and A_T04.

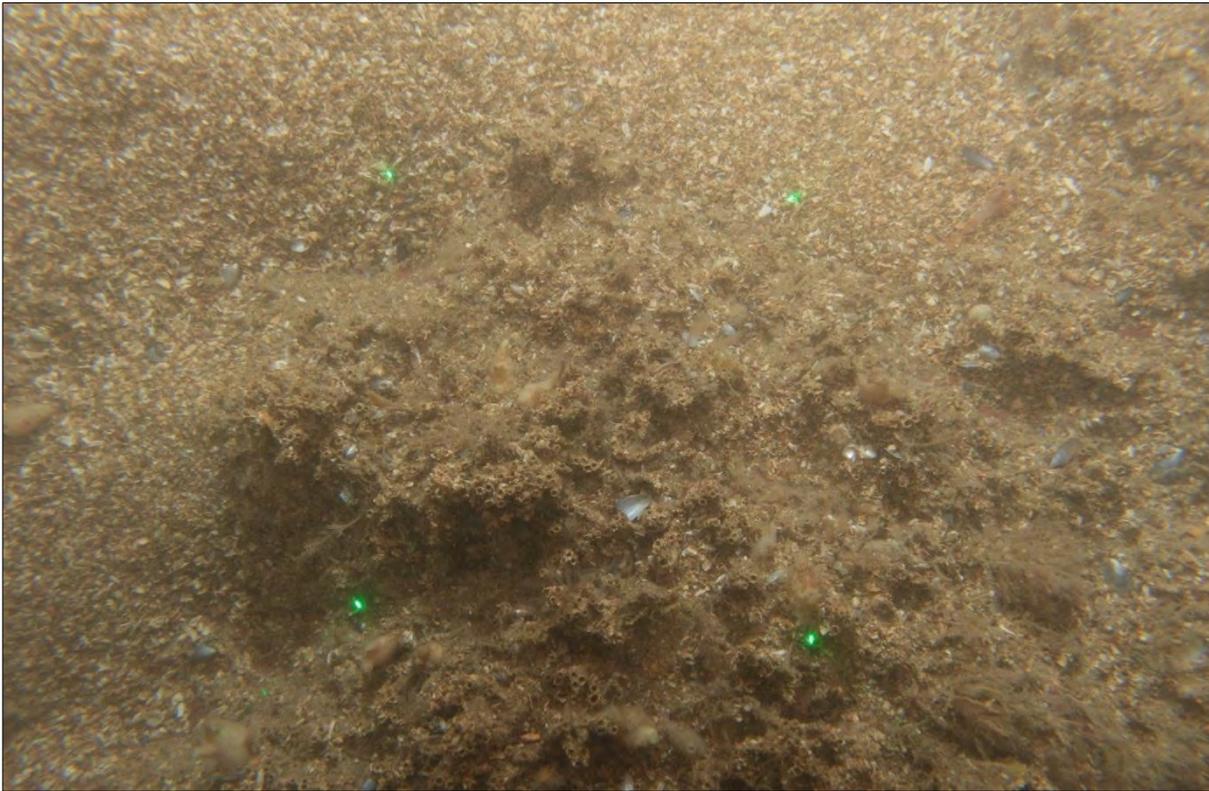
Figure 46 Image A_T07_010 of S. spinulosa on the habitat A4.21 – Echinoderms and crustose communities on circalittoral rock on Annex I (1170) – Bedrock reefs.

Similar occurrences of *S. spinulosa* on bedrock was also noted in transect A_T06 and A_T07, both classified as Annex I (1170) – Bedrock Reefs due to the predominance of rocky outcrops (Figure 46). Transect A_T07 had a higher coverage than A_T06, that varied from 0 % up to 80 %.

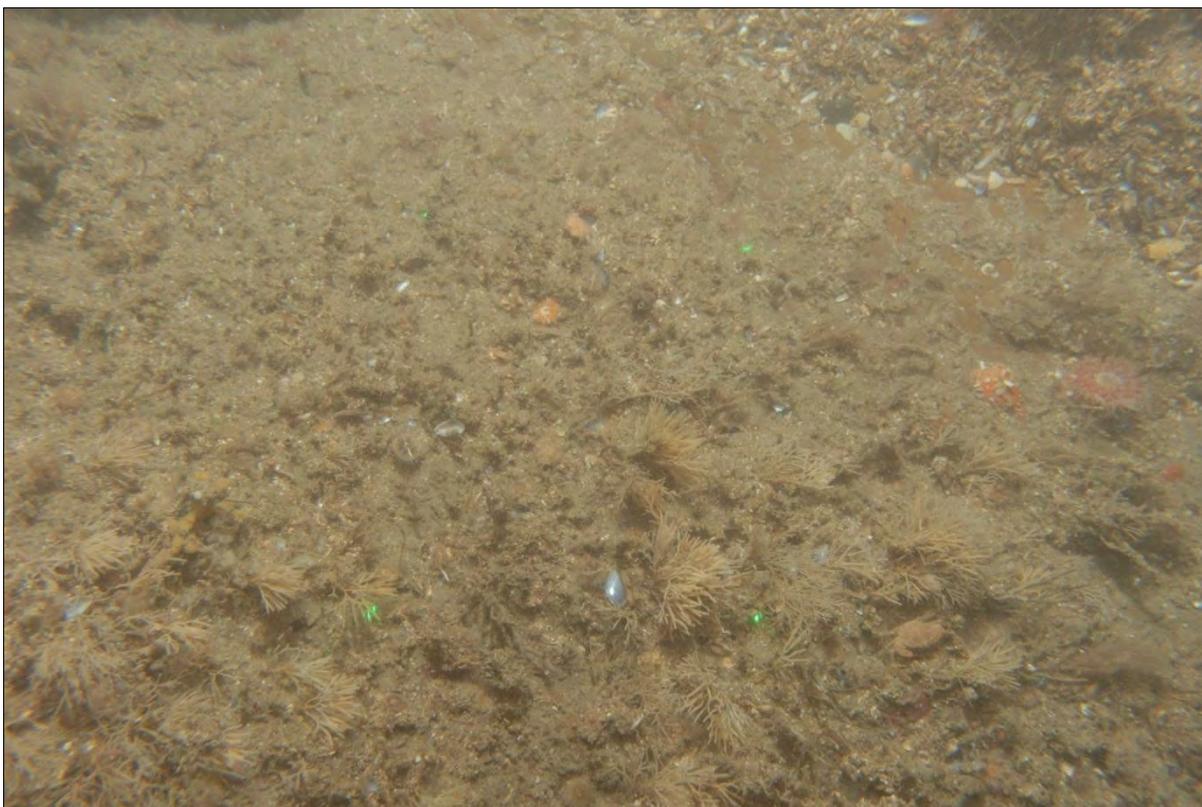
Figure 47 Image A_T09_001 of *S. spinulosa* on the habitat A4.13 – Mixed faunal turf communities on circalittoral rock, on Annex I (1170) – Bedrock reefs.

Transect A_T08 and A_T09 showed areas of relatively high coverage by *S. spinulosa* on bedrock outcrops, varying from 0 % coverage to 35 % coverage (A_T08) and 0 % coverage to 69 % coverage (A_T09). The conditions of the aggregations varied from abraded to newly formed classified as Annex I (1170) – Bedrock Reefs due to the predominance of rocky outcrops.
