GREENLINK MARINE ENVIRONMENTAL IMPACT ASSESSMENT REPORT- IRELAND

APPENDIX H - L

Greenlink Interconnector
- connecting the power markets
in Ireland and Great Britain

Environmental Survey Report

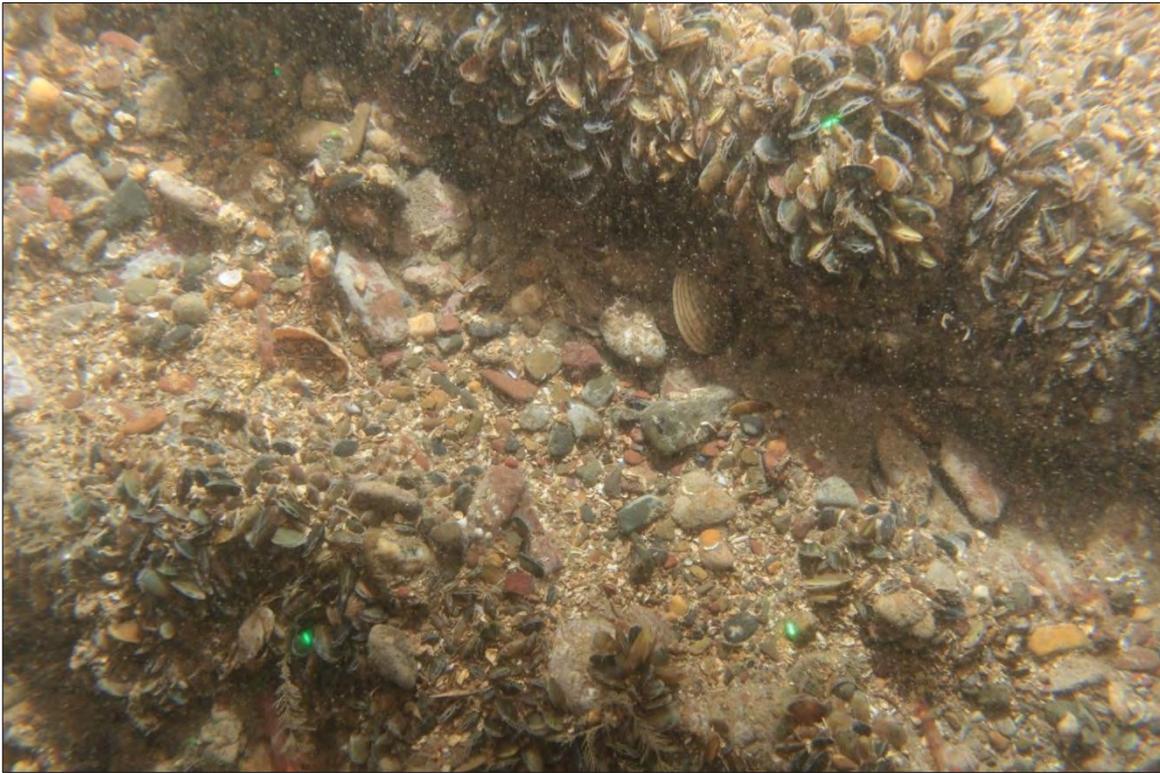
Figure 48 Image A_T02_008 of *M. edulis* on the habitat A4.13 – Mixed faunal turf communities on circalittoral rock, on Annex I (1170) – Bedrock reefs.

The imagery from A_T02 showed large patches of dense beds of *Mytilus edulis* on bedrock (Figure 48). The area around the transect A_T02 was classified as a bedrock reef, as the bedrock was the major epifauna supporting habitat. Transects T03 and T04 showed an average percentage coverage of 30 % and 12 %.

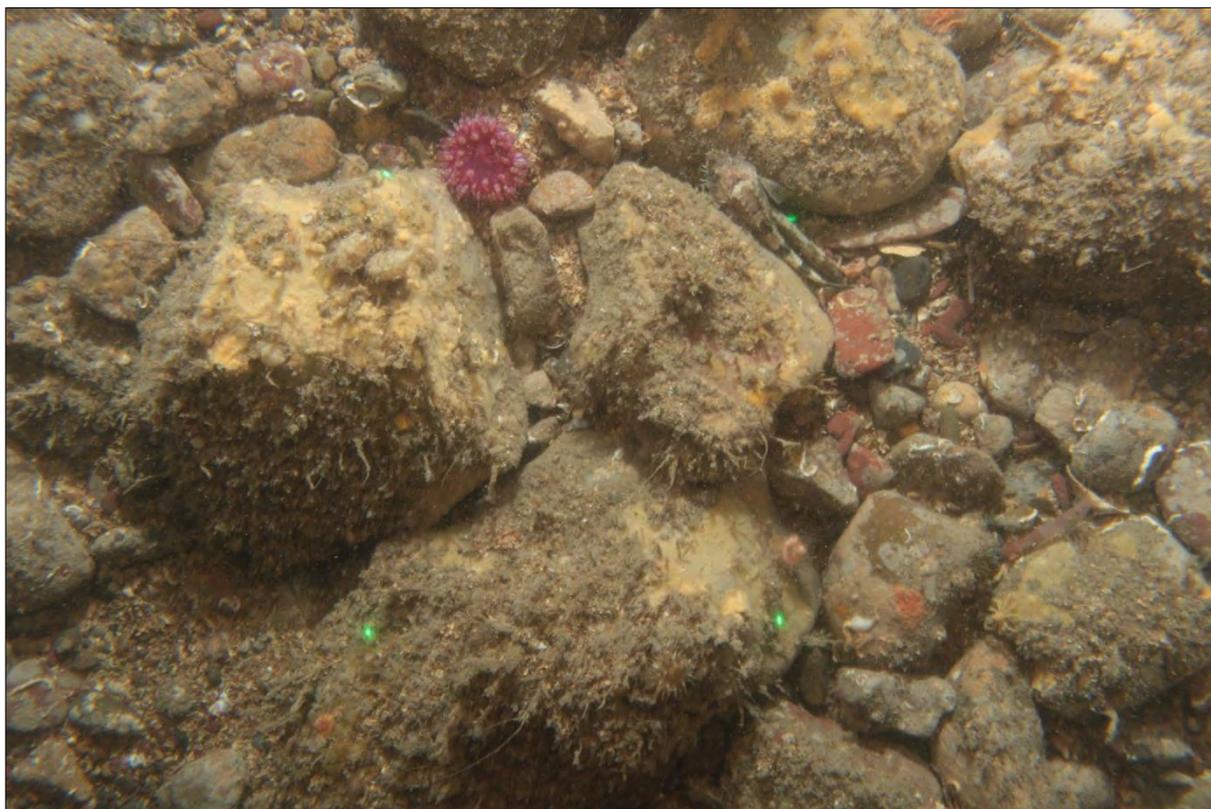
Figure 49 Image E_T04_004 of the habitat A4.132 –*Corynactis viridis* and a mixed turf of *crisiids*, *Bugula*, *Scrupocellaria*, and *Cellaria* on moderately tide-swept exposed circalittoral rock, on Annex I (1170) – Medium Grade Stony Reefs.

The seabed along E_T04 and E_T05 was dominated by pebbles, cobbles, and boulders with a high number of epifaunal species such as ascidians, and different species of bryozoans, poriferans and cnidarians (Figure 49). The habitat was classified as A4.132 and the area was evaluated according to Irvings (2008) reef assessment for stony reefs. The characteristics of the seabed along A_T02 are presented in Table 42. The seabed in this area meets the criteria of a medium grade stony reef.

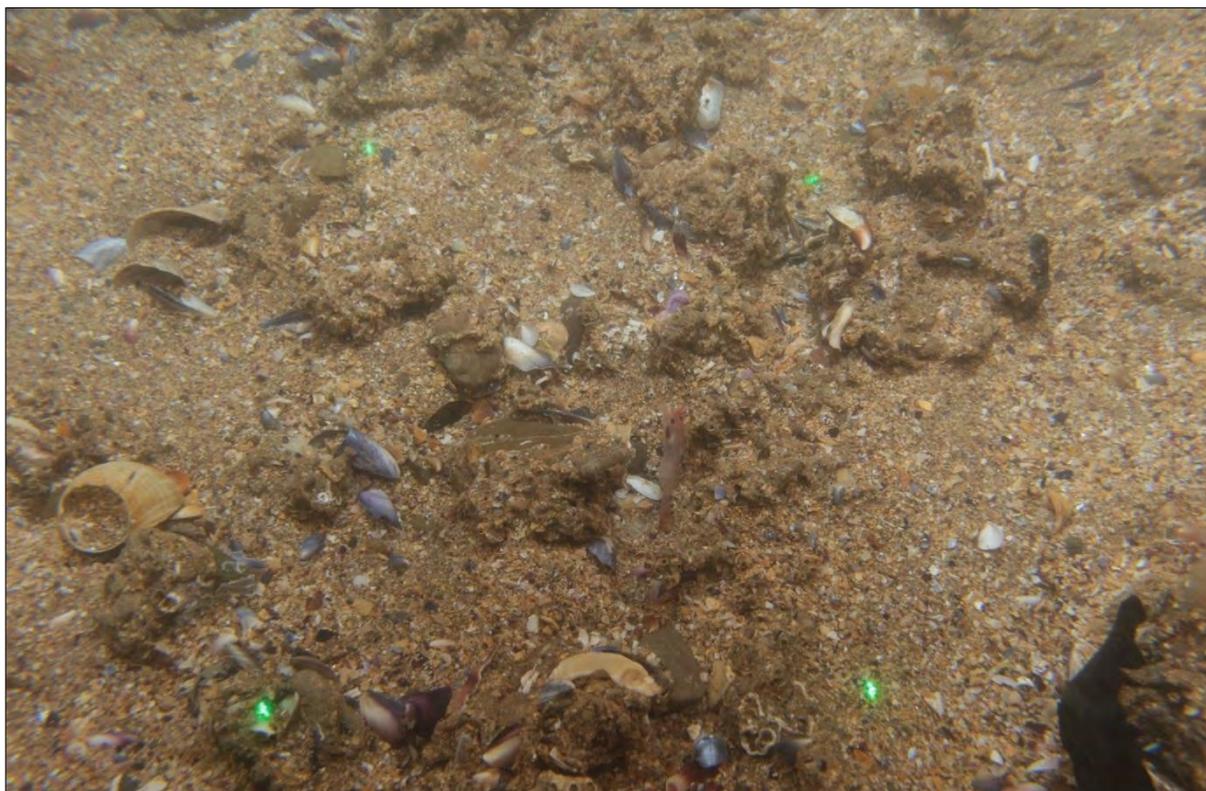
Figure 50 Image E_T03_009 of *S. spinulosa* on the habitat A5.611 – *Sabellaria spinulosa* on stable circalittoral mixed sediment.

Small aggregations of *S. spinulosa* was recorded in transect E_T03 (Figure 50). The elevation of the aggregations visible in the transect photos was <2 cm, and the coverage varied between 0 % and 9 %, with an average coverage of 2 %. Due to the low elevation and the patchiness of the aggregations visible in the photos, the area was not considered to meet the definition of a *S. spinulosa* reef. However, the geophysical data showed that the area was characterised by a coarse seabed, and it cannot be ruled out that areas of *S. spinulosa* aggregations meeting the reef definition is present within this section.

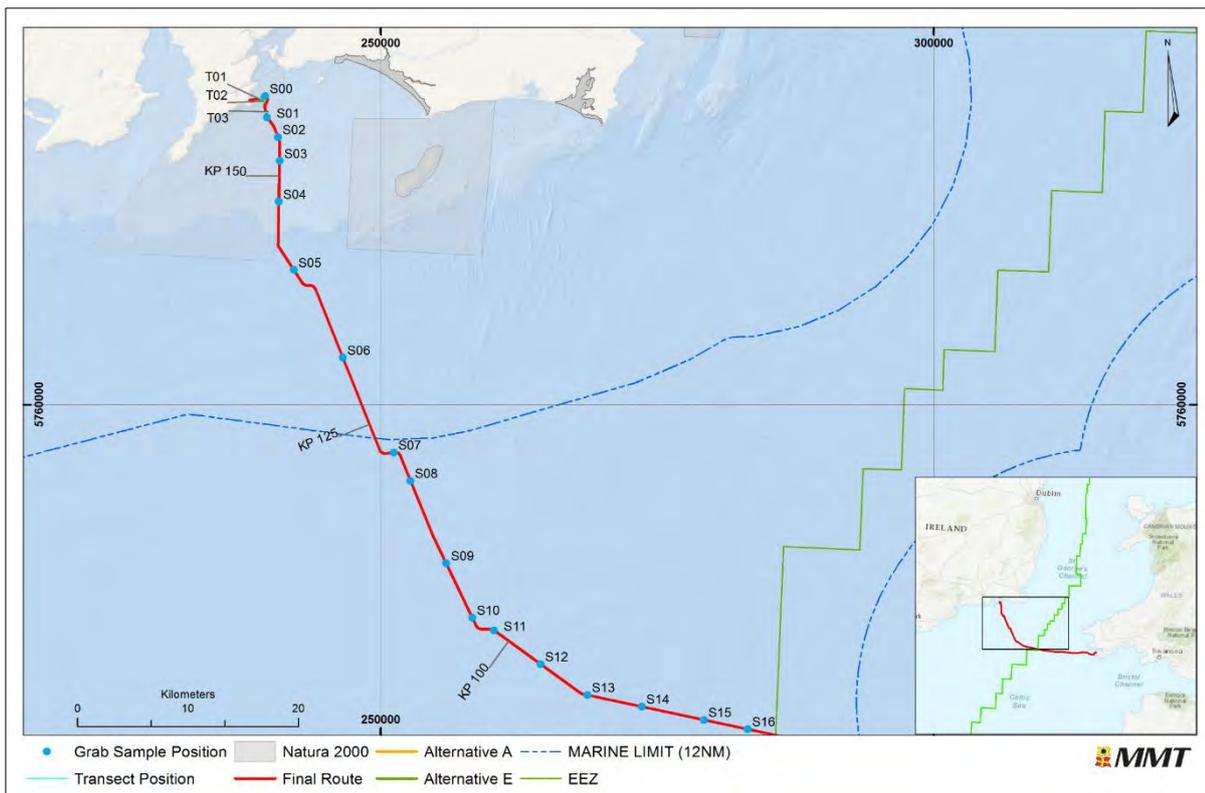
Figure 51 Overview of sampling and transect locations in the Irish EEZ.

Grab sample site S00 to S16 was located within the Irish EEZ. All grab sample sites were located within the Final Route corridor (Figure 51). See Appendix A| for a full list of positions of grab sample sites and transects. Field protocols are available in Appendix B| and Appendix C|. Grab identification protocols and Transect identification protocols are found in Appendix D| and Appendix E|.

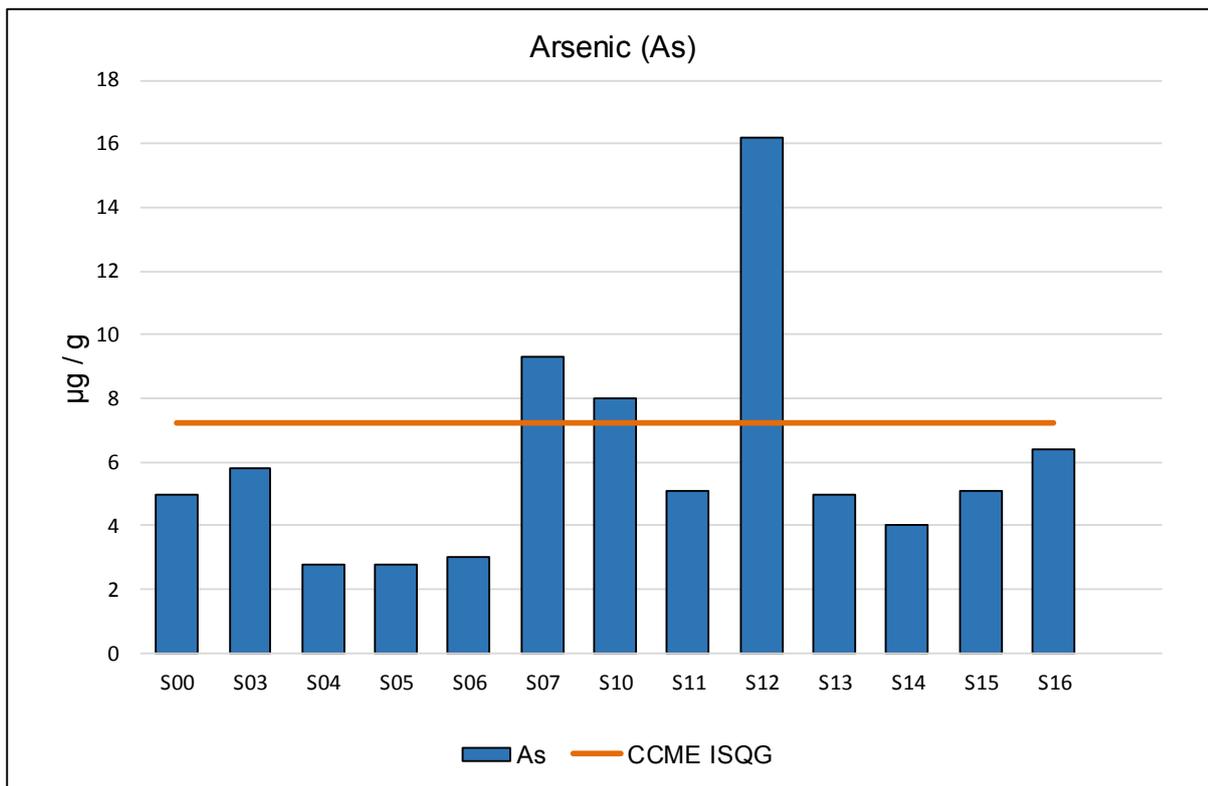
Figure 61 Arsenic (As) concentrations ($\mu\text{g/g}$ dry weight) in sediment across sample sites together with threshold values for CCME ISQG.

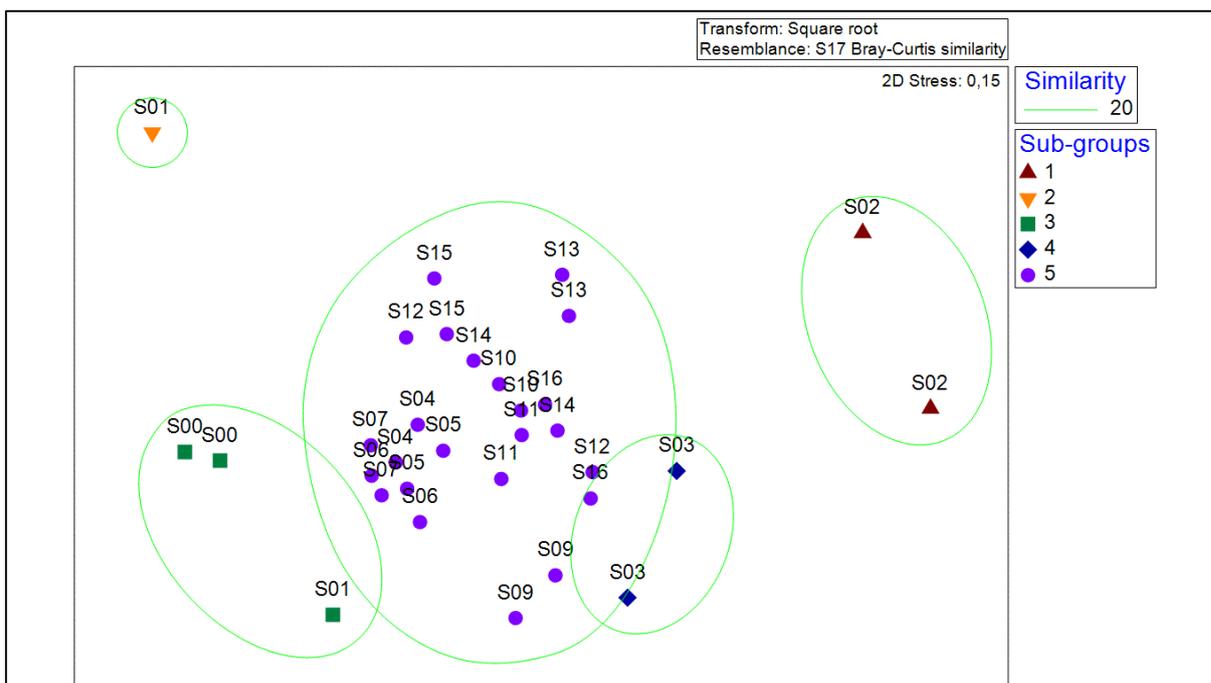
Figure 63 nMDS plot on faunal composition for each grab sample site and replicate, groups based on SIMPROF.

Group 1 consisted of both replicates from site S02 (S02_A, S02_B) and group 2 consisted of one replicate from site S01 (S01_B). Group 3 consisted of both replicates from site S00 (S00_A, S00_B) and the other replicate from site S01 (S01_A). Group 4 consisted of both replicates from site S03 (S03_A, S03_B). Group 5 was the largest group that comprised most samples and consisted of both replicates from site S04 to S16. The highest average similarity was found in group 3 (31.67 %) and the lowest in group 1 (24.73 %). This low similarity within groups suggest a difference in faunal composition in the groups.

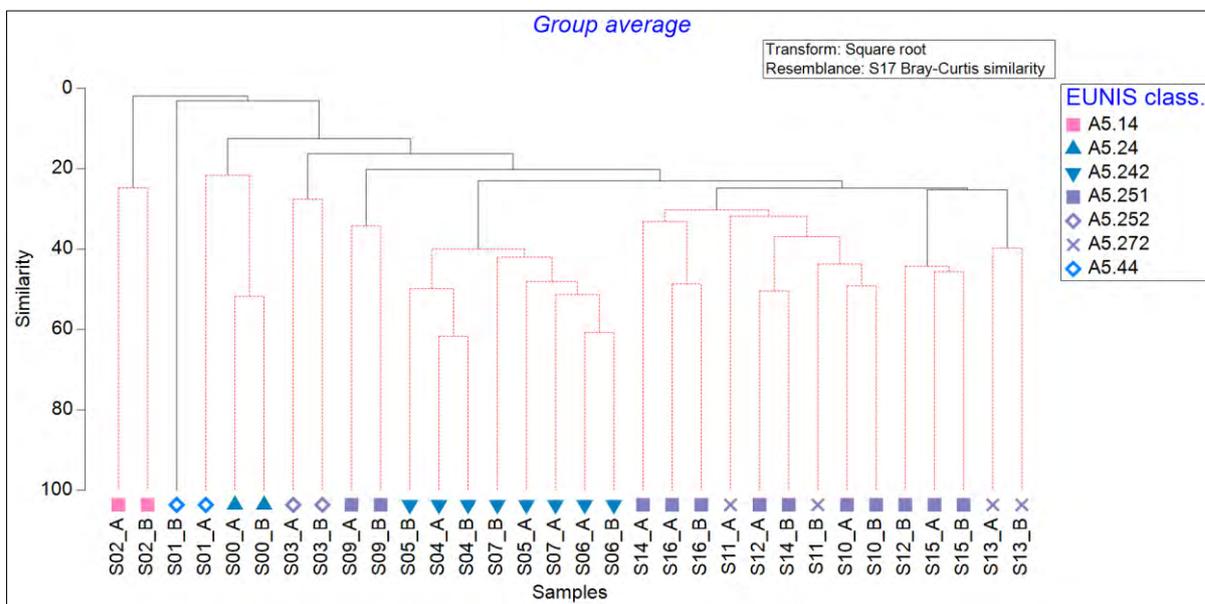
Figure 64 SIMPROF dendrogram based on faunal composition with EUNIS habitat classification overlay for each grab sample site and replicate.

The resulting EUNIS habitat classification for each site is presented in Figure 64. The different habitats can in some extent be related to the sub-groups identified in the SIMPROF analysis. EUNIS habitat classification A5.14 was the only habitat found within sub-group 1 (grab sample site S02). Habitat classification A5.242, A5.251 and A5.272 was found within sub-group 5. Habitat classification A5.252 was only found within sub-group 4 (grab sample site S03). Sub-group 2, with one replicate of S01, was classified as A5.44. Sub-group 3, with one replicate of S01 and site S00, included both A5.44 and A5.24.

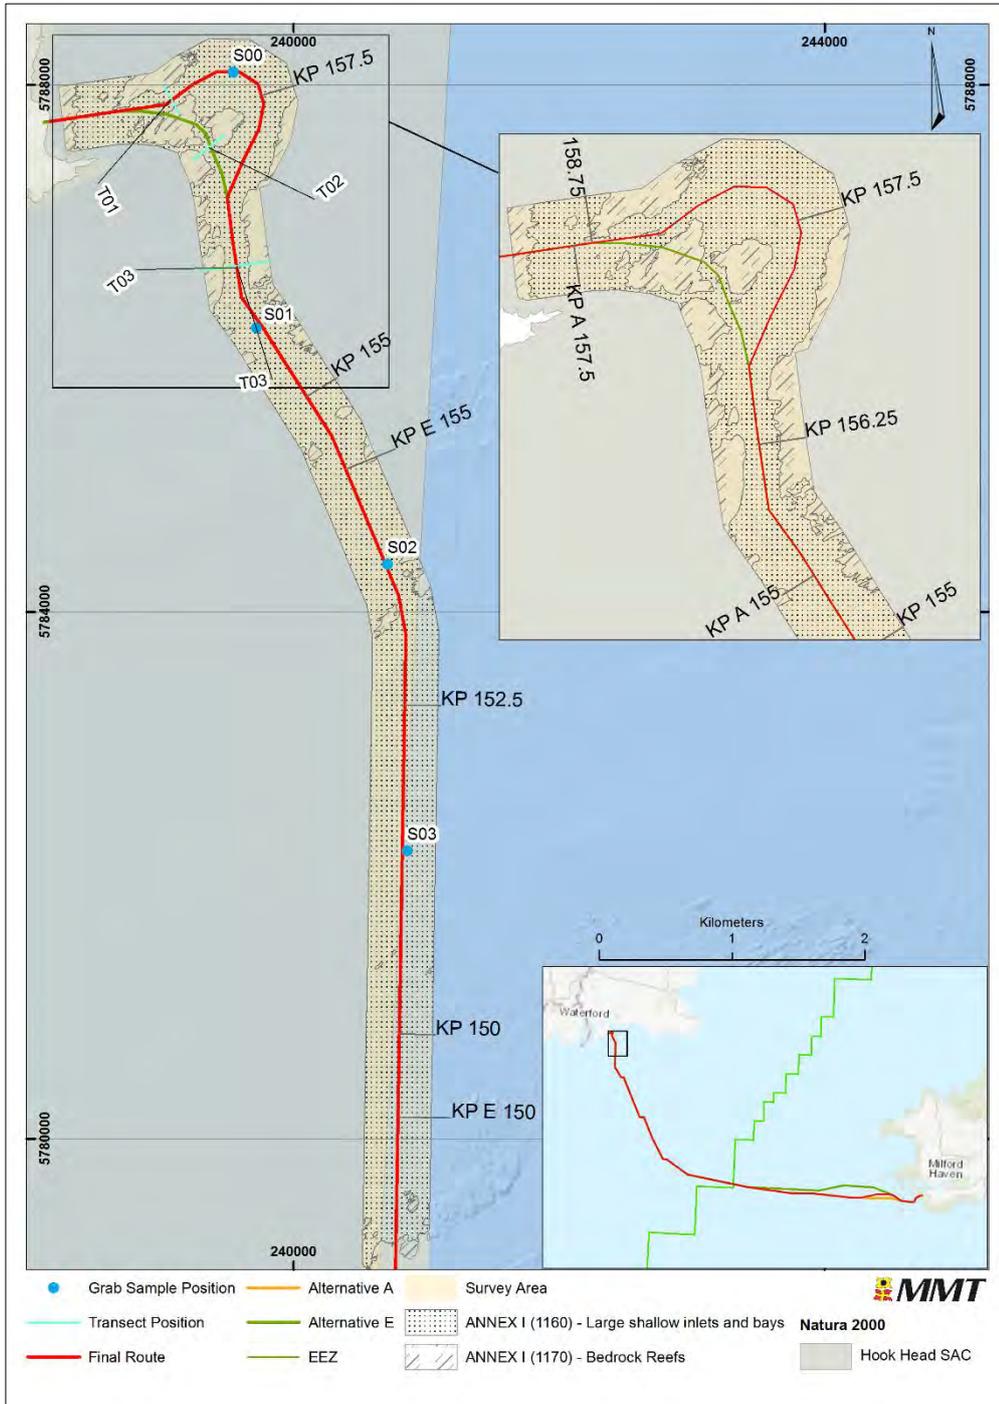
Figure 65 Overview of Annex I areas in Irish EEZ between KP 149 and KP 159.

Figures displaying detailed overview of the potential areas of conservation concern are displayed in Figure 65.

A total of 33 habitats were identified within the survey corridor (Table 14). An overview of the distribution of habitats and sample locations including areas of Annex I habitats within the UK are presented in Figure 6, Figure 11 to Figure 22 and within Ireland in Figure 52 to Figure 57 and Figure 65.

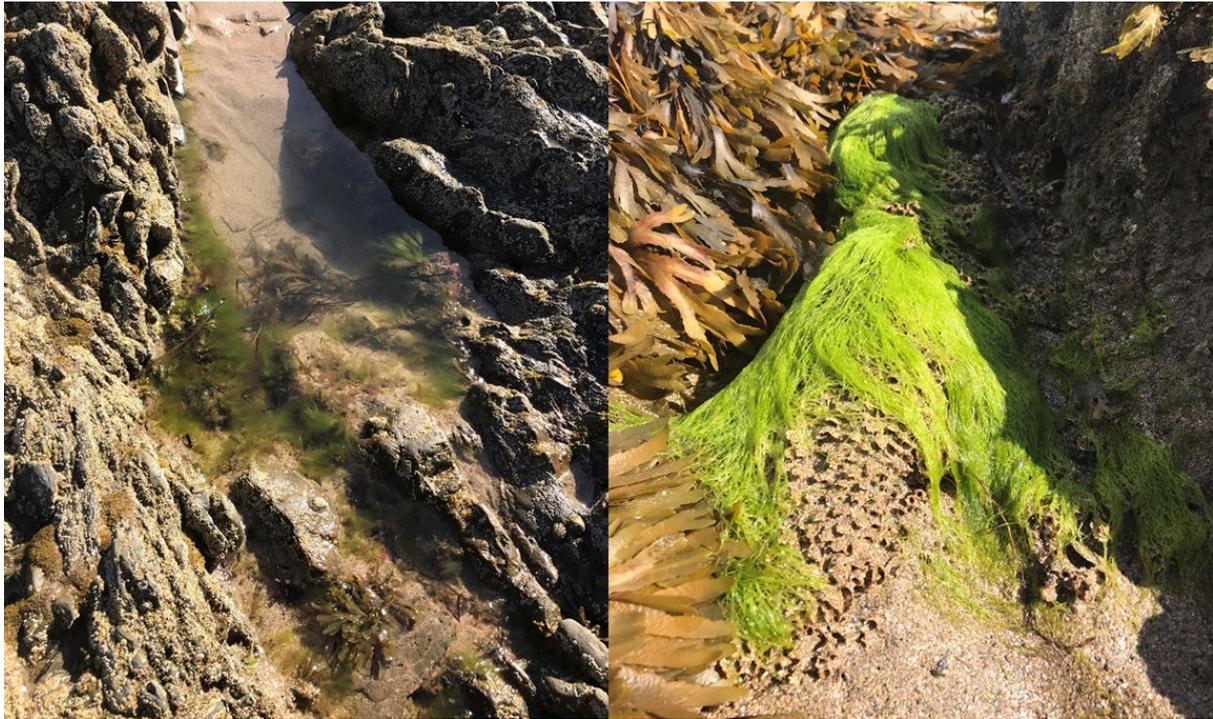
Figure 3.3: EUNIS biotope mapping and sampling locations visited during the intertidal survey of the proposed landfall at Freshwater West, Pembrokeshire.

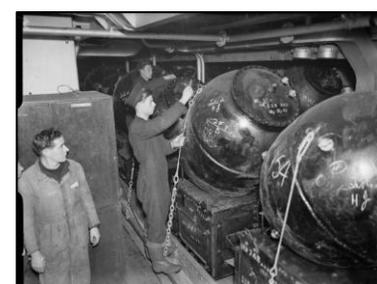
Left: Schematic of an LMA early pattern airborne parachute ground influence mine. Right: Mines aboard HMS Apollo ca 1945, likely to be M Mark I mines.

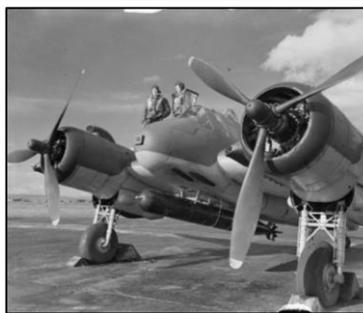
Deployed by	Aircraft
Date of design/service	1935/1937
Weight	1,548 lbs. (702kg)
Overall length	16 ft 3 in (4.95m)
Explosive charge	388 lbs. (176kg) TNT
Range / speed	1,500 yards (1,370m)/40 knots or 3,500 yards (3,200 m)/37 knots
Remarks	Standard British airborne torpedo for the first half of WWII and still in limited use at the end.

Left: A Mark XII torpedo fitted to a Bristol Beaufighter. Top right: Model of the torpedo. Bottom left: schematics.

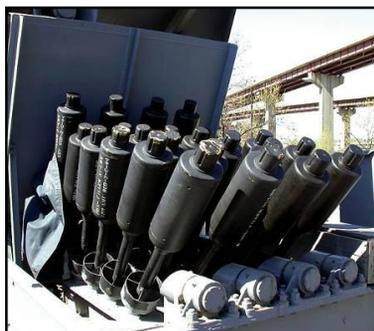
"Squid" Mortar

Weight	200 kg
Explosive Weight	94 kg
Diameter	30.5 cm diameter
Fuze Type	Timer fuze
Use	Fired from a launcher on the attacking ship, these projectiles were fired in an arc and were designed to land in a triangular pattern in the water to hit enemy submarines.
Remarks	Reportedly nine times more effective than standard depth charges in post-war trials, these bombs were designed to fall on either side of a submarine, with the resulting pressure wave crushing the enemy vessel.

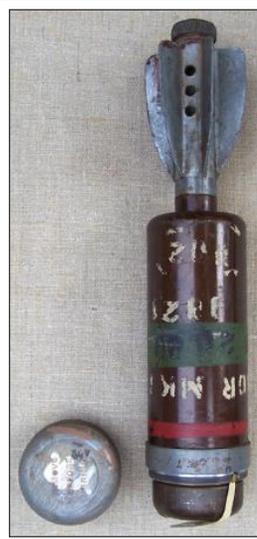
MARKINGS, BOMB, M.L. 2 INCH. MORTAR.

2 inch Mortar Smoke	
Weight	910g (2lb)
Maximum Range	460m (500yards)
Filling	White phosphorus and smoke fill
Dimensions	51 x 290mm (2in x 11.4 in)
Fuze Type	An impact fuze which initiates a bursting charge. This ruptures the mortar bomb's body and disperses the phosphorus filler
Identification	Smoke mortars have a recess and emission holes. May still see light green body paint. Look for stained ground around munition.
Use	As a screening devices for unit movement or to impair enemy field of vision.

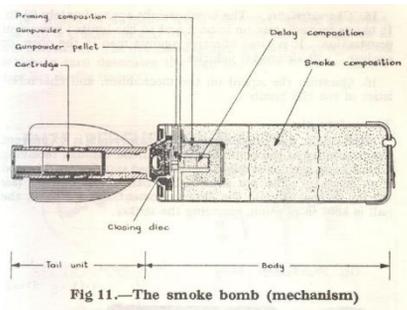
3 inch Mortar High Explosive	
Weight	4.5kg (10lb)
Maximum Range	1,460 (Mk1) – 2,560m (Mk2) (1,600 – 2,800yds)
Dimensions	81mm (3in)
Filling	Amatol
Firing Mechanism	Drop, fixed striker
Remarks	Fin-stabilised bomb fired by means of a charge consisting of a primary cartridge in the tail and four secondary cartridges
Identification	An old style mortar. No way of telling if HE or practice so treat as HE

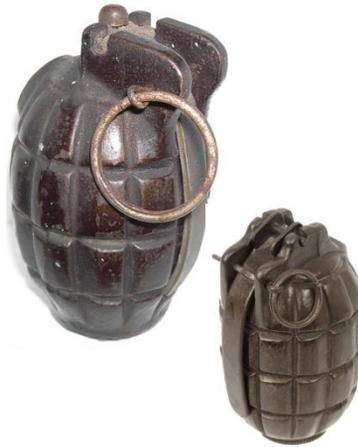
Weight	765g filled (1lb 11.25oz)
Explosive Weight	71g (2oz) filling.
Fuze Type	4-7 second delay hand-throwing fuze. No. 6 Detonator
Dimensions	95 x 61mm (4 x 2.4in)
Use	Fragmentation explosive at approx. 30m range 100m range of damage.
Remarks	First introduced in 1915 its classic grooved, cast-iron 'pineapple' design was designed to provide uniform fragmentation. The detonator is inserted before use after removing the base plug.

Left: baseplate and detonator removed

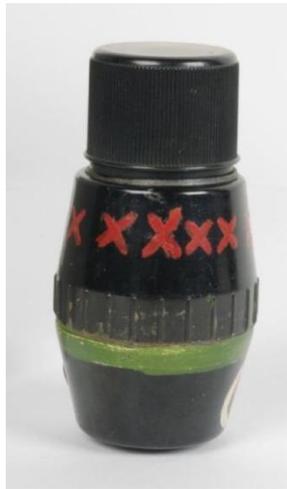
No. 69 Grenade

Weight	383g (13.5oz)
Fill Weight	93g (3.25 oz) of either Amatol, Baratol or Lyddite
Fuze Type	'All-ways' Fuze. Comprised of a safety cap, a weighted streamer attached to a steel ball bearing and a safety bolt designed to detonate from any point of impact.
Dimensions	115 x 60mm (4.5 x 2.4 in)
Use	A blast grenade for use as an offensive weapon. Detonator was inserted before use.
Remarks	Introduced December 1940 and made from the plastic Bakelite as opposed to conventional metals. Detection is difficult due to this low metal content.

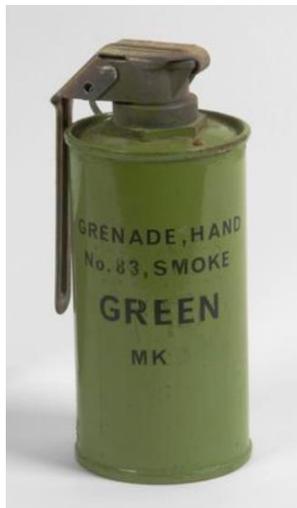
No. 83 Smoke Grenade

Weight	Approx. 680g (1.5lb)
Explosive Weight	Approx. 170-200g. (6-7 oz)
Fuze Type	Originally used a friction system using a match head composition. Later developed to a striker lever ignition system.
Dimensions	Approx. 62 x 140mm (2.44 x 5.5 in)
Use	Use as a target or landing zone marking device and as a screening method for troop / unit movement.
Remarks	This basic design stayed relatively unchanged up to the 1980's. The letters CCC were often etched into the body of the grenade in the colour of the smoke.

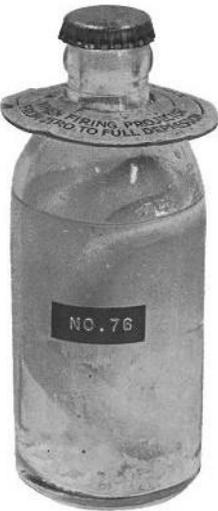
No. 76 Self Igniting Phosphorous (SIP) Grenade

Weight	1lb 3oz

Filling	White Phosphorous and Benzene		
Design	The filling was contained in a ½ pint sized glass bottle with water and a strip of rubber. Over time the rubber dissolved to create a sticky which would self ignite when the bottle broke.		
Use	Originally intended as an anti-tank incendiary weapon deployed by hand. Designed to be produced cheaply without consuming materials needed to produce armaments on the front line.		
Remarks	The Home Guard hid caches of these grenades during the war for use in the event of an invasion. Not all locations were officially recorded and some caches were lost and encountered post-war. In all cases, the grenades are still found to be dangerous.

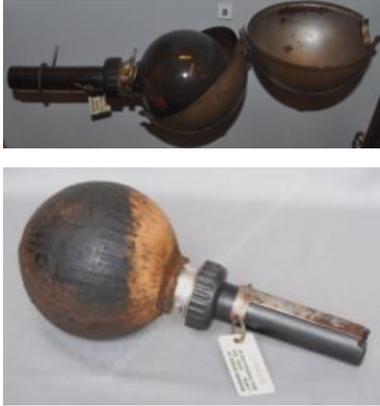
No. 74 Grenade ("Sticky Bomb") Mk1

Weight	Approx. 1.1kg (2.25lb)

Filling	Approx. 600g Nobel's No.283 (Nitroglycerine) (1.33lb)		
Design	A glass ball on the end of a Bakelite (plastic) handle. The inside of the ball would contain the explosive filling and the outside a very sticky adhesive coating.		
Use	An anti-tank grenade primarily issued to the home guard. It required the user to come in very close proximity with the target and smash the glass explosive container against it.		
Remarks	Timer fuze was located in the handle. This would explode after 3-6 secs. 9.5in Long 4.5in Diameter

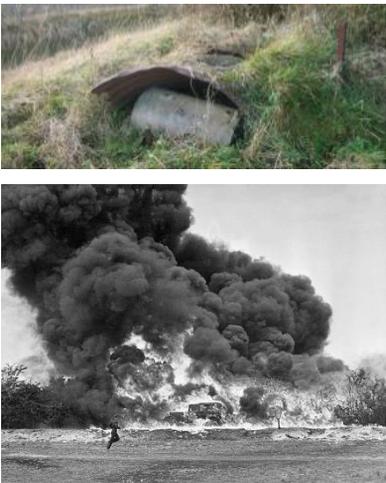
Flame Fougasse Bomb

Weight	Various

Filling	Initially a mixture of 40% petrol and 60% gas. Ammonal provided the propellant charge.		
Design	Usually constructed from a 40-gallon drum dug into a roadside and camouflaged.		
Use	As an improvised anti-tank bomb. When triggered the Fougasse could project a beam of burning sticky fuel in a fixed direction from up to 3m (10ft) wide and 27m (30yards) long.		
Remarks	A highly unorthodox weapon designed by the Petroleum Warfare Department to address a critical lack of weapons in 1940. 50,000 are estimated to have been distributed around the UK.

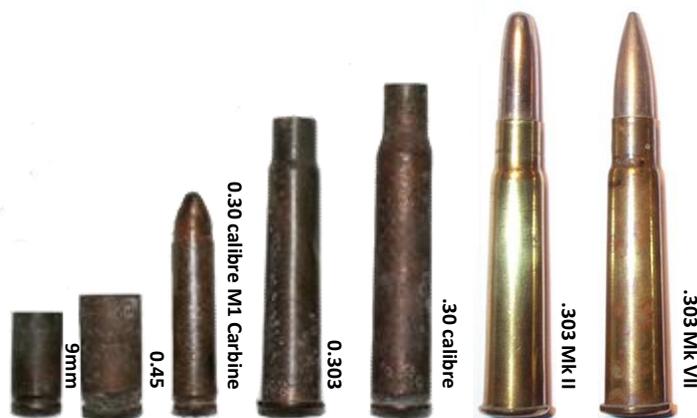
Examples of British Small Arms Ammunition

.303 Rifle

Bullet Diameter	7.92mm
Case length	56.44mm
Overall length	78.11mm
Type	Rifle Ammunition
Propellant	Originally black powder. Later Cordite followed by Nitrocellulose
Remarks	First produced in 1889 and still in use today, the .303inch cartridge has progressed through ten 'marks' which eventually extended to a total of around 26 variations.

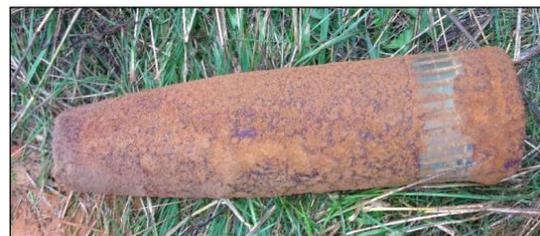
3.7 Inch QF Anti-Aircraft Projectile

Projectile Weight	28lb (12.6 kg)
Explosive Weight	2.52lbs
Fuze Type	Mechanical Time Fuze
Dimensions	3.7in x 14.7in (94mm x 360mm)
Rate of Fire	10 to 20 rounds per minute
Use	The 3.7in AA Mk 1-3 were the standard Heavy Anti-Aircraft guns of the British Army.
Ceiling	30,000ft to 59,000ft

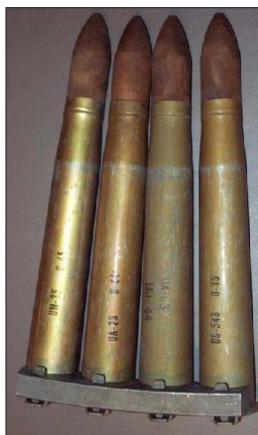
40mm Bofors Projectile

Projectile Weight	1.96lb (0.86kg)
Explosive Weight	300g (0.6lb)
Fuze Type	Impact Fuze
Rate of Fire	120 rounds per minute
Projectile Dimensions	40 x 180mm
Ceiling	23,000ft (7000m)
Remarks	Light quick fire high explosive anti-aircraft projectile. Each projectile fitted with small tracer element. If no target hit, shell would explode when tracer burnt out. Designed to engage aircraft flying below 2,000ft

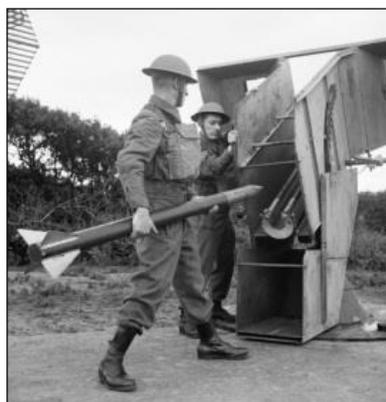
3in Unrotated Projectile (UP) Anti-Aircraft Rocket ("Z" Battery)

HE Projectile Weight	3.4kg (7.6lb)
Explosive Weight	0.96kg (2.13lb)
Filling	High Explosive – TNT. Fitted with aerial burst fuzeing
Dimensions of projectile	236 x 83mm (9.29 x 3.25in)
Remarks	As a short range rocket-firing anti-aircraft weapon developed for the Royal Navy. It was used extensively by British ships during the early days of World War II. The UP was also used in ground-based single and 128-round launchers known as Z Batteries. Shell consists of a steel cylinder reduced in diameter at the base and threaded externally to screw into the shell ring of the rocket motor

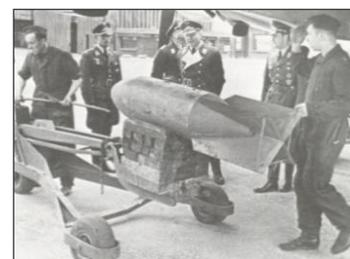
SC 250kg High Explosive Bomb

Bomb Weight	245-256kg (540-564lb)
Explosive Weight	125-130kg (276-287lb)
Fuze Type	Electrical impact/mechanical time delay fuze.
Bomb Dimensions	1640 x 512mm (64.57 x 20.16in)
Body Diameter	368mm (14.5in)
Use	Against railway installations, embankments, flyovers, underpasses, large buildings and below-ground installations.
Remarks	It could be carried by almost all German bomber aircraft, and was used to notable effect by the Junkers Ju-87 Stuka (Sturzkampfflugzeug or dive-bomber).

SC250 bomb being loaded onto German bomber

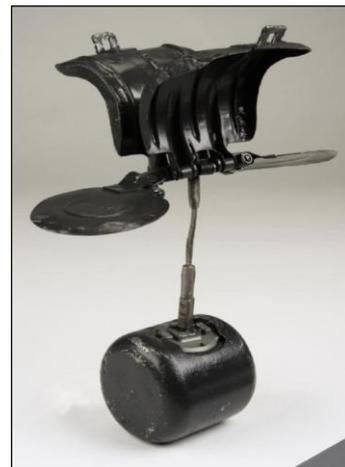
SD2 Anti-Personnel 'Butterfly Bomb'

Bomb Weight	2kg (4.41lb)
Explosive Weight	7.5oz (225 grams) of Amatol surrounded by a layer of bituminous composition.
Fuze Type	41 fuze (time) , 67 fuze (clockwork time delay) or 70 fuze (anti-handling device)
Body Diameter	3in (7.62 cm) diameter, 3.1in (7.874) long
Use	Designed as an anti-personnel/ fragmentation weapon. They were delivered by air, being dropped in containers of 23-144 sub-munitions that opened at a predetermined height, thus scattering the bombs.
Remarks	Very rare. First used against Ipswich in 1940, but were also dropped on Kingston upon Hull, Grimsby and Cleethorpes in June 1943, amongst various other targets in UK. As the bombs fell the outer case flicked open by springs which caused four light metal drogues with a protruding 5 inch steel cable to deploy in the form of a parachute & wind vane which armed the device as it span.

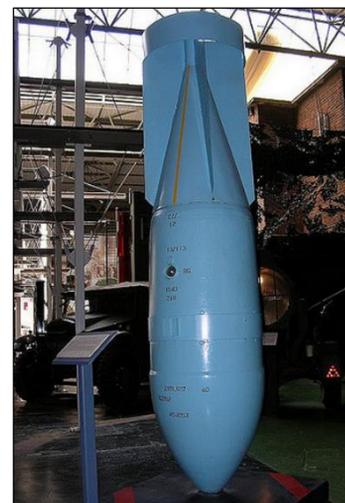
SC 1000kg

Bomb Weight	993-1027kg (2,189-2,264lb)
Explosive Weight	530-620kg (1168-1367lb)
Fuze Type	Electrical impact/mechanical time delay fuze.
Filling	Mixture of 40% amatol and 60% TNT, but when used as an anti-shipping bomb it was filled with Trialeen 105, a mixture of 15% RDX, 70% TNT and 15% aluminium powder.
Bomb Dimensions	2800 x 654mm (110 x 25.8in)
Body Diameter	654mm (18.5in)
Use	SC type bombs are General Purpose Bombs used primarily for general demolition work. Constructed of parallel walls with comparatively heavy noses. They are usually of three piece welded construction

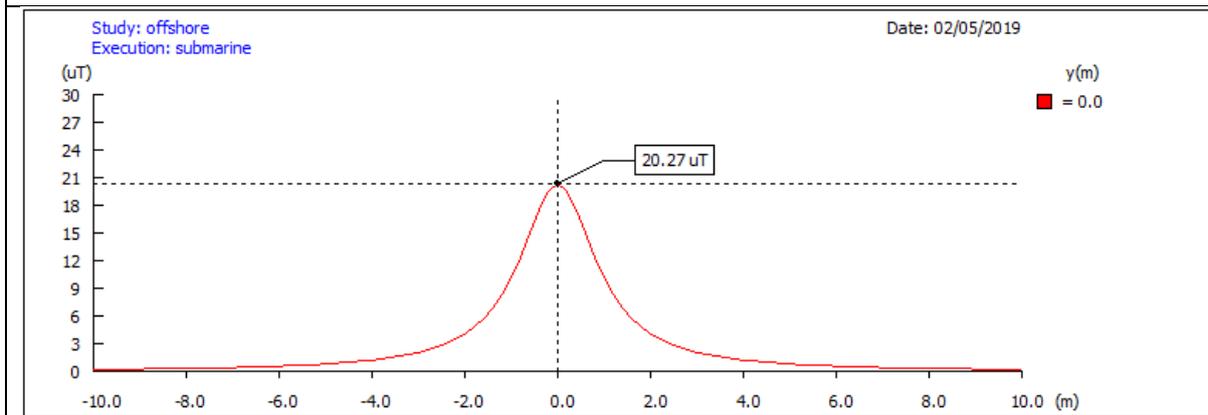
Figure 3: Greenlink Circuit, Magnetic field under full load condition

Please note, for DC circuits under normal operating conditions the magnetic field is stable (i.e. not rapidly changing) and therefore the induced voltages in the parallel telecom cables would be negligible.

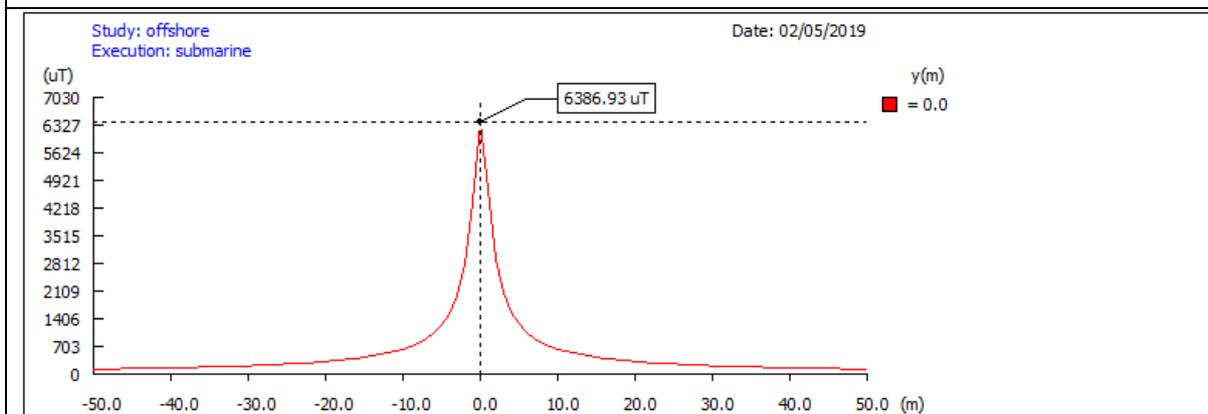
Figure 4: Greenlink Circuit, Magnetic field under fault condition

Therefore, even under fault conditions, because of the very large distance between the parallel telecom cables and the Greenlink circuit (i.e. 650 m), induced voltages would be negligible.

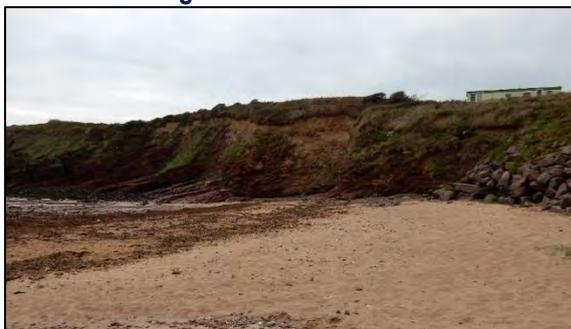
Figure 4-1: View of eroding cliffs from the rear of the cove looking east.

Rathmoylan Cove is an exposed beach facing due south. There are cliffs surrounding the cove on both sides approx. 15 m in height showing evidence of deep erosion, exposing red sandstone geological features including a sea cave on the eastern edge of the cove. Rock protection is installed along the rear of the beach and there is also rock outcrop along the shoreline which was covered in seaweed (see **Figure 4-1 and 4-2**).

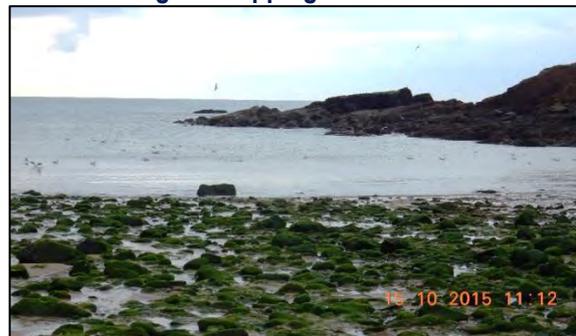
Figure 4-2: View of the shoreline looking south east including outcropping rock and birds.

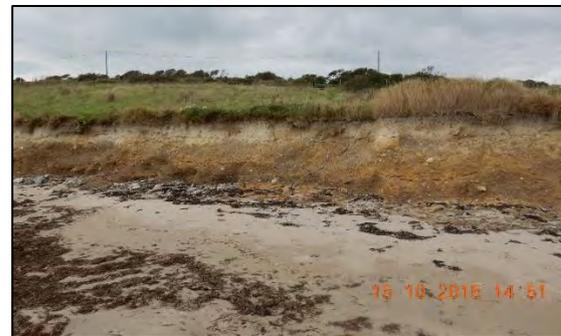
Figure 4-4: View of the eroding vegetation at the rear of the beach.

At the rear of the beach eroding vegetation on shallow cliffs is evident (see **Figure 4-4**). There was rock outcrop uncovered at low tide along the shoreline which was covered in seaweed. Birds were observed along the seashore including seagulls and oystercatchers.

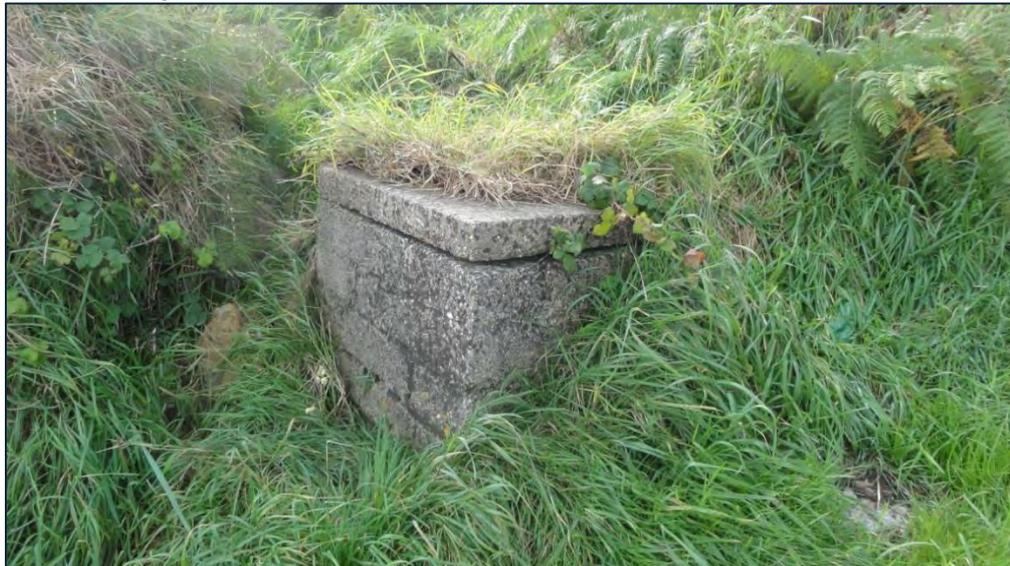
Figure 5-6: One of the drainage access points identified on the upper slope.

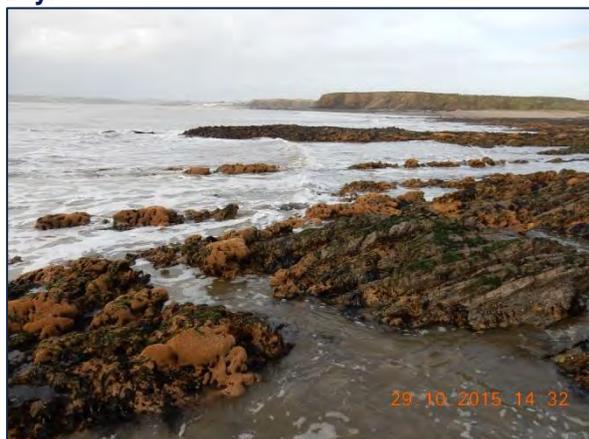
Figure 11-3: Honeycomb worm reefs on intertidal rock outcrop separating Dollar Bay and Booley Bay.

Similar to Booley Bay landfall, the rock outcrop separating Booley and Dollar Bay was covered with honeycomb reef worm (*Sabellaria alveolata*). While not listed as part of the River Barrow and Nore SAC, it is a species that is sensitive to changes in sediment regime and physical disruption (including storm damage). Most of the intertidal rock at the site was covered but the extent offshore would need additional survey.

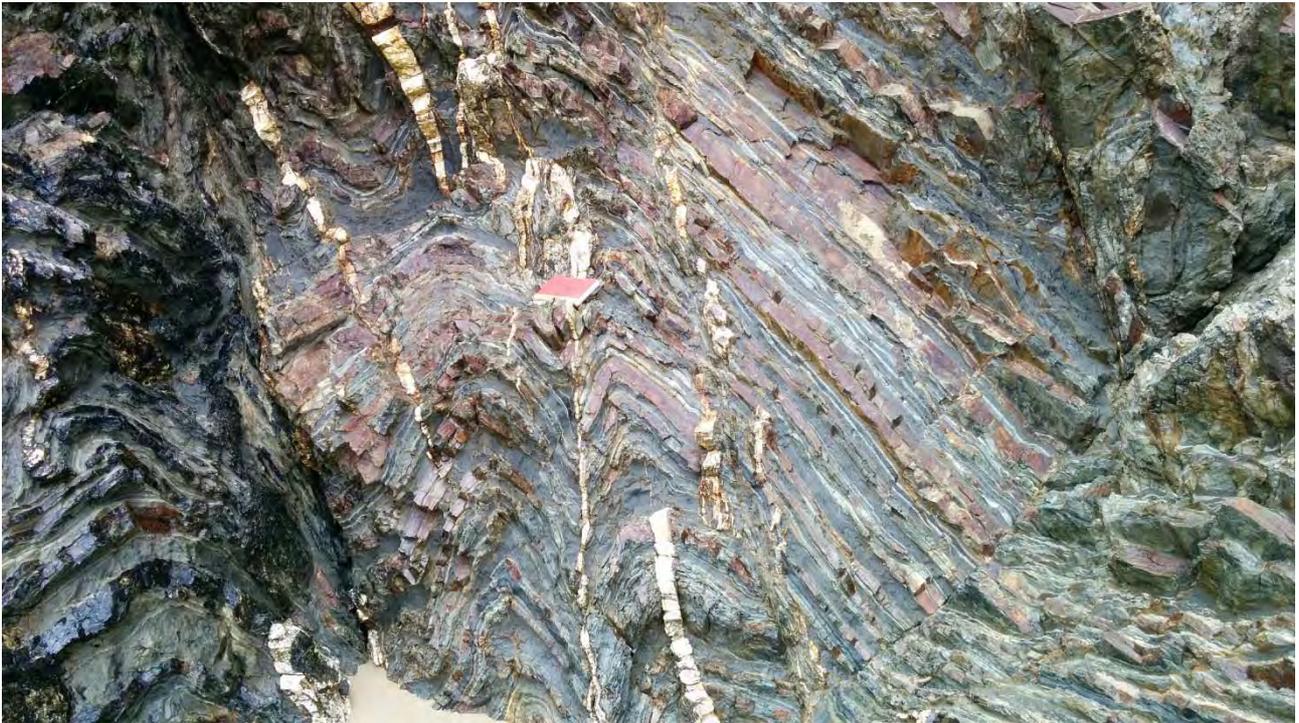
The southern side of the beach has a number of geological features which are likely to require protection. Photo 6 is an example of chevron folding in the metasediments.

Photo 6: Chevron folding in interlayered meta-sediments.

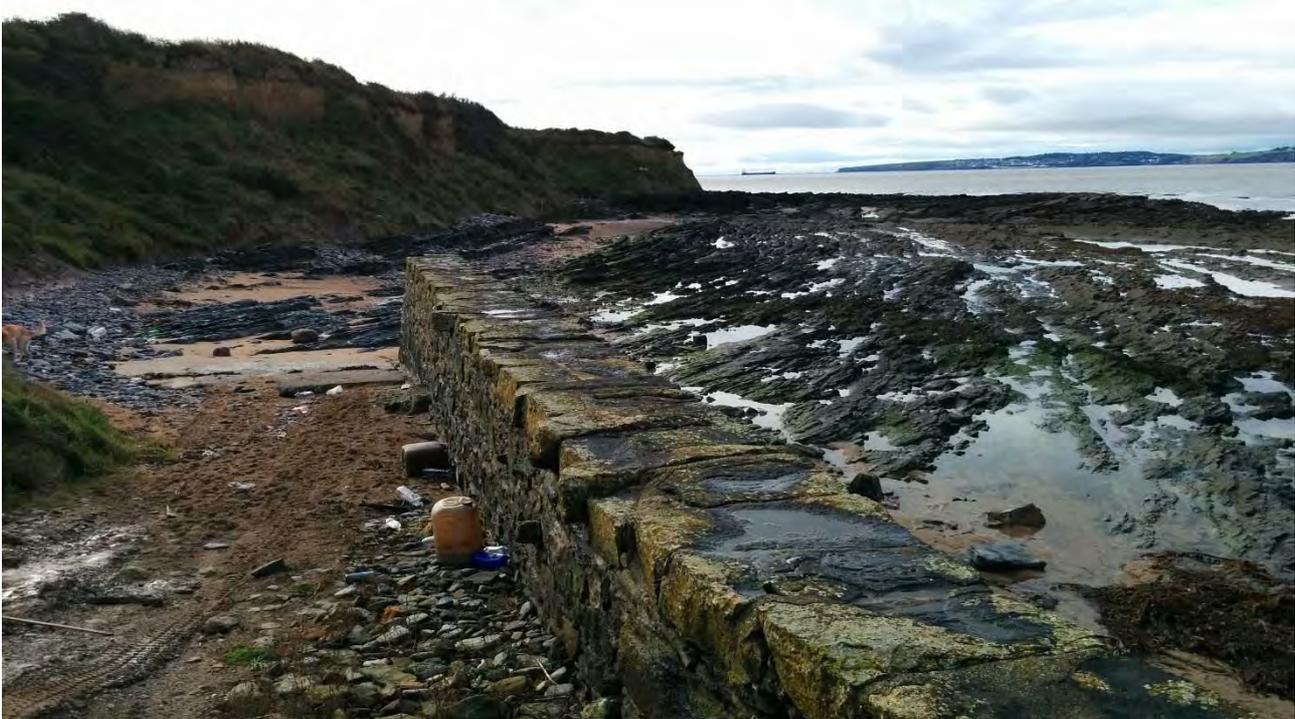
Limestone visibly outcrops along the southern end of the beach both at the base of the surrounding cliffs in this location and along the beach.

Photo 8: Access to Boyce's Bay with outcropping limestone

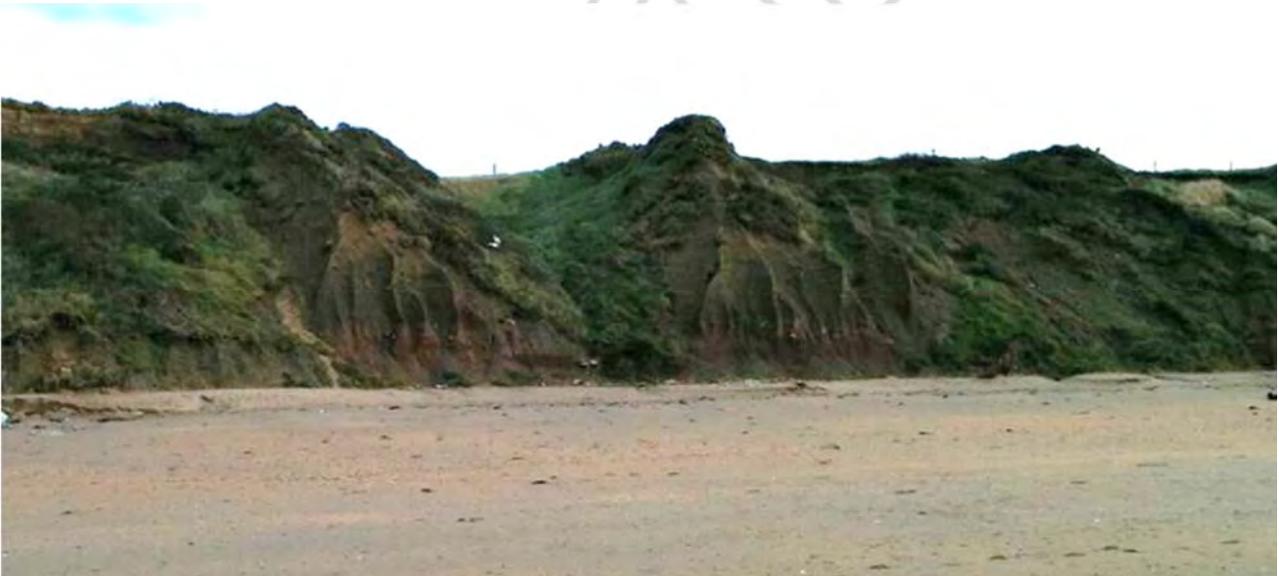
Photo 11: Slope failure along soil slopes.
