Monitoring Report

Archaeological monitoring of test pits on Greenlink Project, Hook Peninsula, Co. Wexford

Client: Greenlink Interconnector Ltd.

Project Type: Infrastructural Development

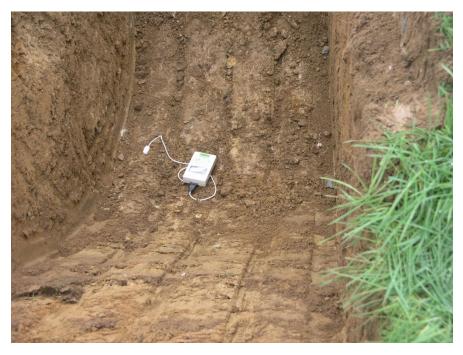
Figure 2: Geothermal meter in situ

These pits were excavated in greenfield sites on Greatisland, north and south of the Campile River and at Baginbun (Ramstown) on January 17th 2019. The pits were excavated to depths of 1.2-1.4m. Prior to excavation, the sites were archaeologically assessed and there were no surface indications of archaeological remains. The six pits were excavated using a mechanical excavator with a toothed 1m wide bucket.

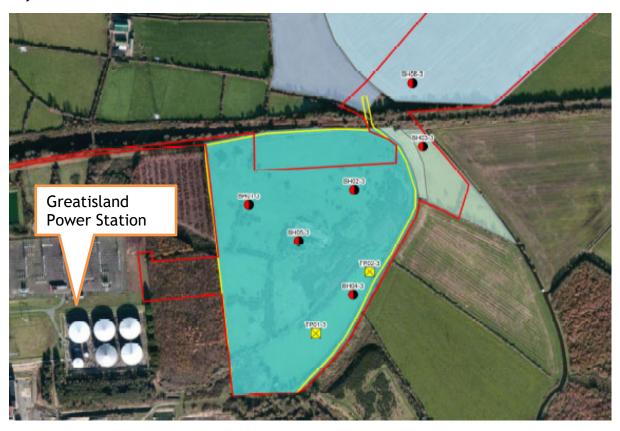
Figure 3: Test pit (TP01-3 and TP02-3) locations at Greatisland

Two locations on Greatisland were to the east of the Power Station (Fig 3). These were designated TP01-3 and TP02-3; TP01-3 was to the south of TP02-3. The soil profile was similar in both with an upper level of topsoil, 0.2-0.3m deep over boulder clay (Fig. 4 and

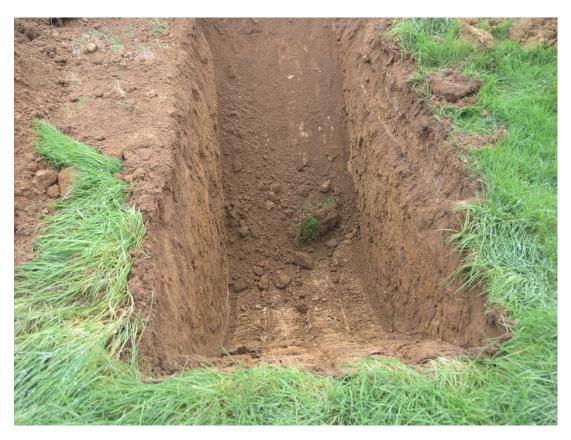
Figure 4: Greatisland Excavated Test Pit TP01-3

5). Shattered bedrock was uncovered at the base of the test pits and is identified as Rhyolite which forms the bedrock on Great Island.

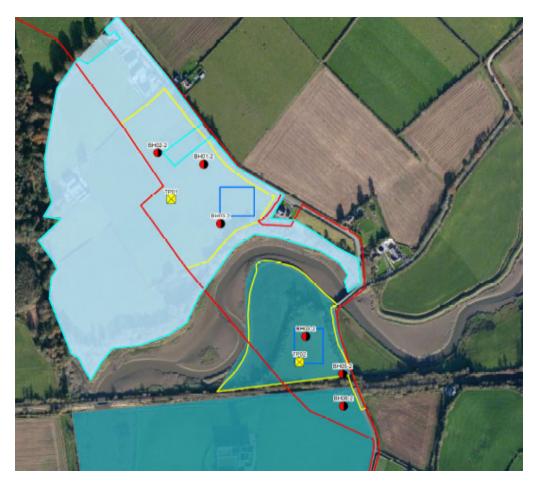
Figure 6: Test pit locations north and south of the Campile River

Test pit TP0-1 was to the north of the Campile River and TP0-2 to the south (Fig. 6). Both were in greenfield locations. The soil profile in TP0-1 was 0.2-0.3m of topsoil over boulder clay and shattered bedrock (Rhyolite) at a depth of 0.7m. TP0-2 had a similar profile with an upper topsoil layer of c. 0.2m (Fig. 7 and 8).

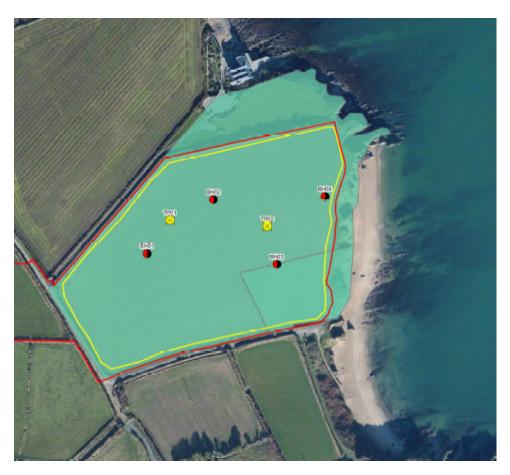
Figure 9: Test pit locations at Baginbun Head

The sub-strata at Baginbun comprise siltstone/mudstone on the east and sandstone on the west divided by a fault line. Both test pits (TP0-1 and TP0-2) were within the siltstone/mudstone area. The field had been tilled and the surface vegetation was the remnants of a cereal crop. Both test pits had an upper layer of 0.6m of topsoil over boulder clay.

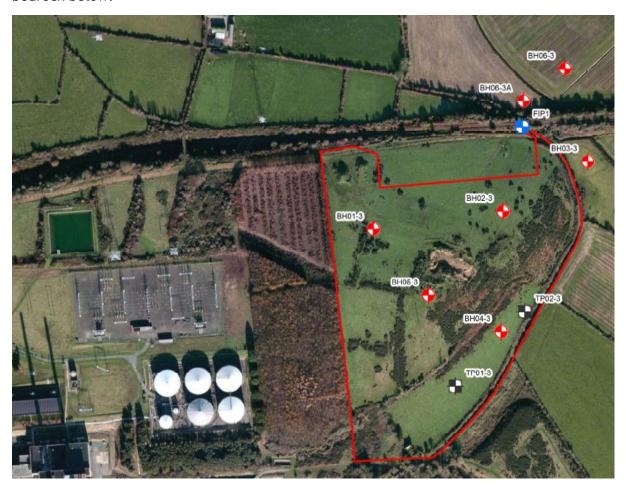
Figure 12: Greatisland Test pit locations

The test pits were on a south-facing slope on low-lying ground facing out towards the Waterford Estuary. TP01-3 was to the south and TP01-2 to the north (Fig. 12). Both had similar soil profiles of 0.2-0.3m of topsoil over boulder clay and shattered Rhyolite bedrock below.

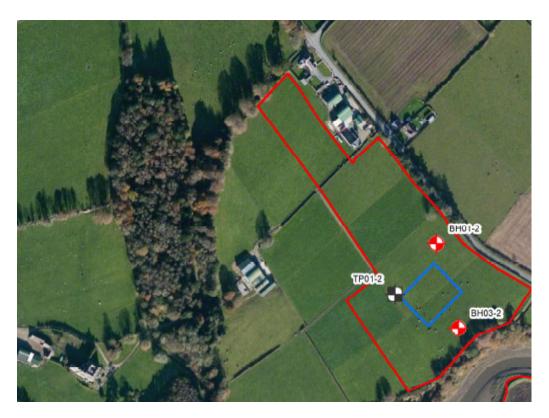
Figure 14: Test pit location North of Campile River

One test pit, TP01-2 was excavated north of the Campile River on a south facing slope overlooking the river valley (Fig. 14). The test pit had a similar soil profile to those on Greatisland with 0.2-0.3m of topsoil over boulder clay and shattered Rhyolite bedrock below (Fig. 15).

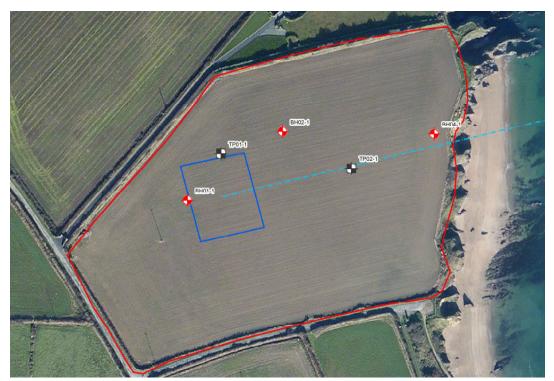
Figure 16: Test pits at Baginbun

Two test pits, TP01-1 and TP02-1 were excavated in a field where a cereal crop had previously been harvested at Baginbun Head (Fig 16). The stratigraphy was c. 0.6m of topsoil over boulder clay and shattered siltstone/mudstone bedrock beneath (Fig. 17).

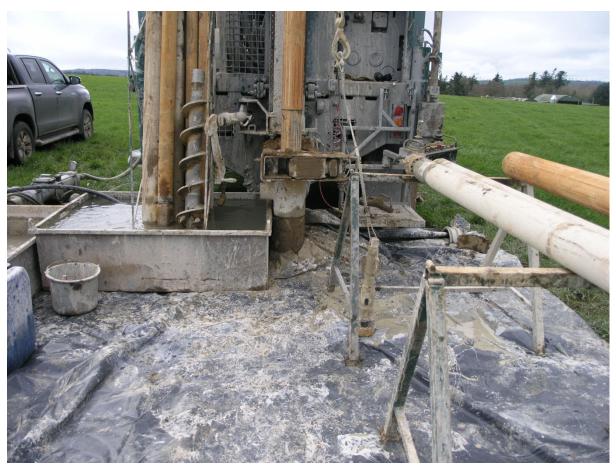
Figure 18: Bore-hole drilling north of the Campile River

A series of bore-holes were also made in greenfield locations to examine the geological sub-strata. The bore was c. 200mm wide and augured down (Fig. 18). The method is not conducive to observing strata or archaeological content.
