RE: Further Information Request.
Subject: Response to Further Information Request.
ABP. Ref: (Your Case Number:) ABP-321466-24

Further to your letter of 01 May 2025 regarding the Application for *“development under Section 37L of the Planning and Development Act 2001, as amended, for the ongoing use of the Waste Recycling & Transfer Facility at Sandyhill, St Margaret’s, Co. Dublin”*, please find below our response to same, alongside the requested additional information and/or clarifications in respect of reports previously submitted.

A. Waterman Moylan Drawing No. MAR-WMC-ZZ-GF-DR-C-P020-Drainage Layout

C. Waterman Moylan Drawing No. MAR-WMC-ZZ-GF-DR-C-P016 & 017- Entrance Sightlines (2.4m Setback) & Entrance Sightlines (3.0m Setback)

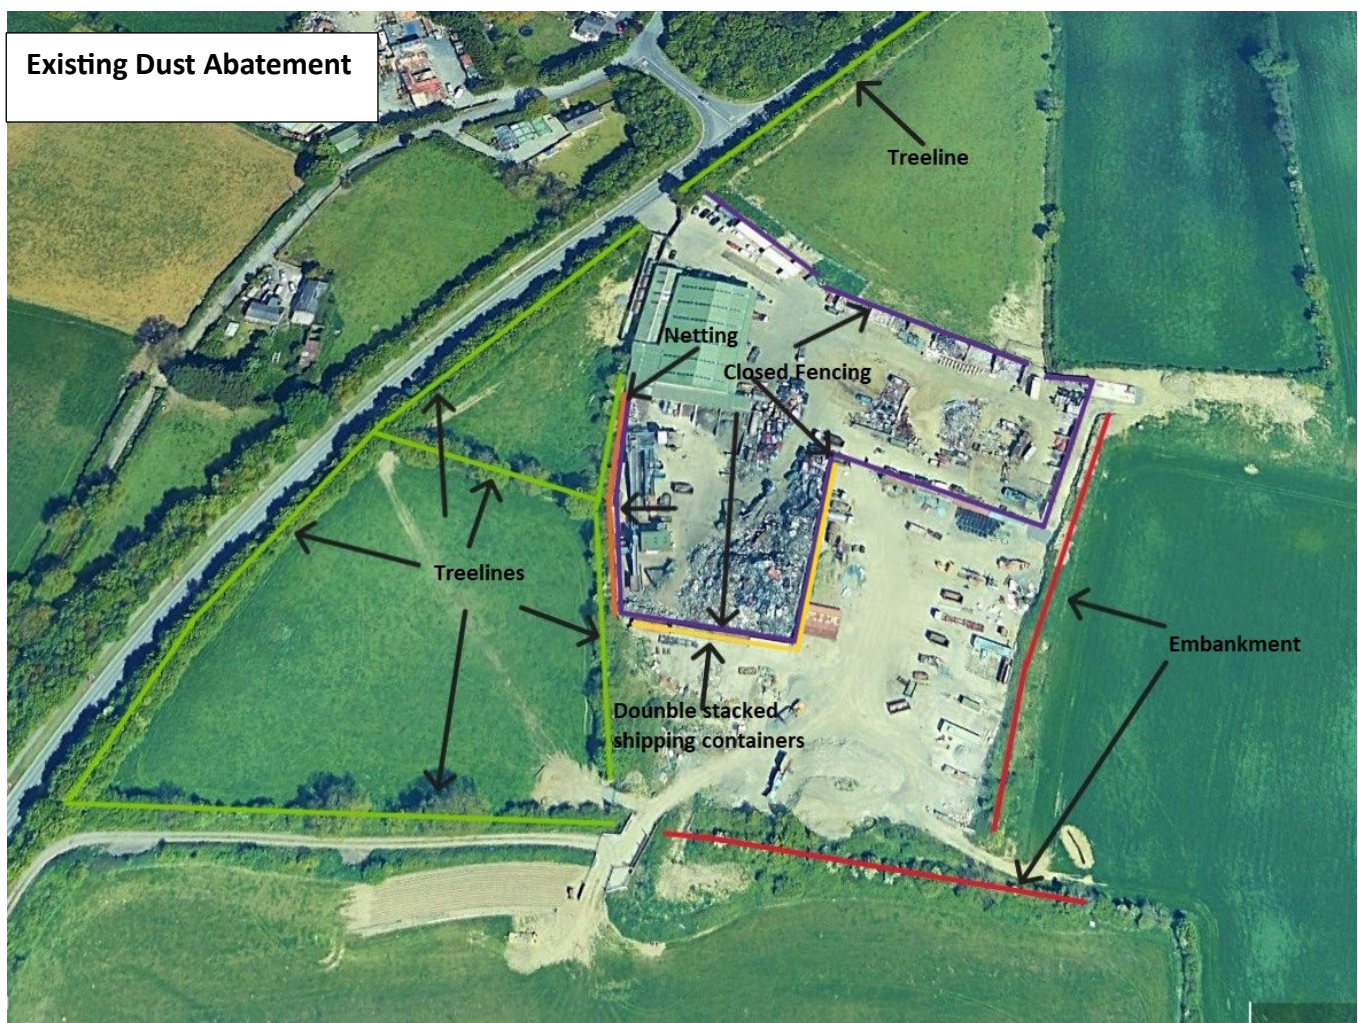
The closest residence is situated behind 3 treelines and upwind from the prevailing wind at the facility. The receptors are also protected by an existing dust netting above the western boundary fencing. The site is fully surfaced with concrete and its housekeeping is above the standard usually found at this type of facility. The site is cleaned by a road sweeper 3 times per week, and a forklift with a brush attachment is used regularly. The site is surrounded by enclosed boundary fencing, treelines and embankment. Double stacked shipping containers form an obstacle for the dust fall emissions to the south of the hammermill. When dust generation is likely (dry weather and/or high wind speed) the site is misted with water by a tractor with a water tank trailer.

Figure 2: Existing dust abatement

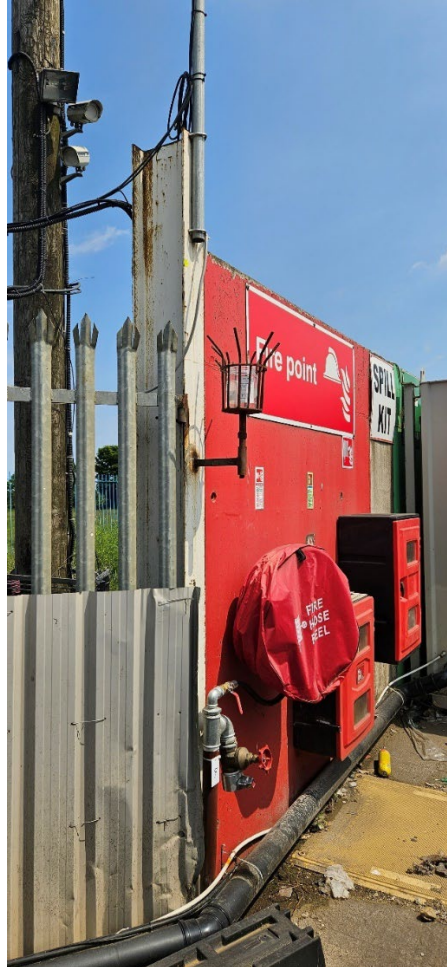
Photo 1: Photo of Dust monitor location D1 below the height of the boundary fencing

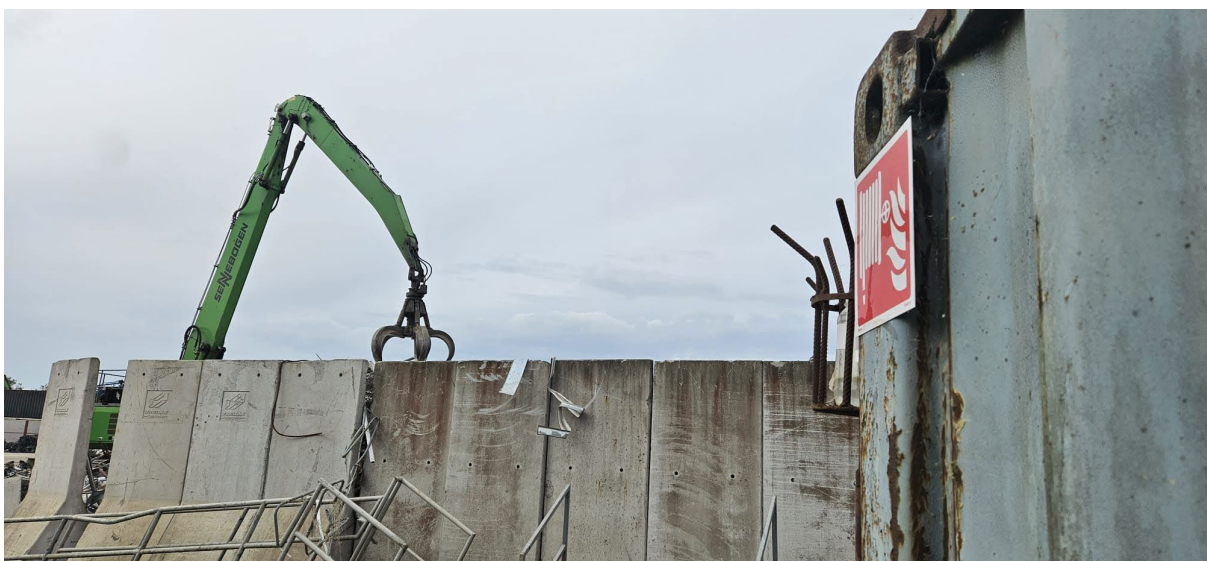
Photo 3: Photo of D2 location with close proximity to grab. Stockpile can be much higher than concrete dividers at this location

The source of dust in D2 and D3 can be correlated to the activity of loading of material. This is thought to be the main source of the exceedances. It needs to be noted that in multiple instances larger and relative heavy particles found in these dust jars and these could be classed as debris rather than windblown dust (Some examples of what was found in the dust jars can be viewed in chapter 8). That said the investigations, which are further described in the bi-monthly monitoring results reports, show that in prolonged periods of rain the likelihood of an exceedance decreases.

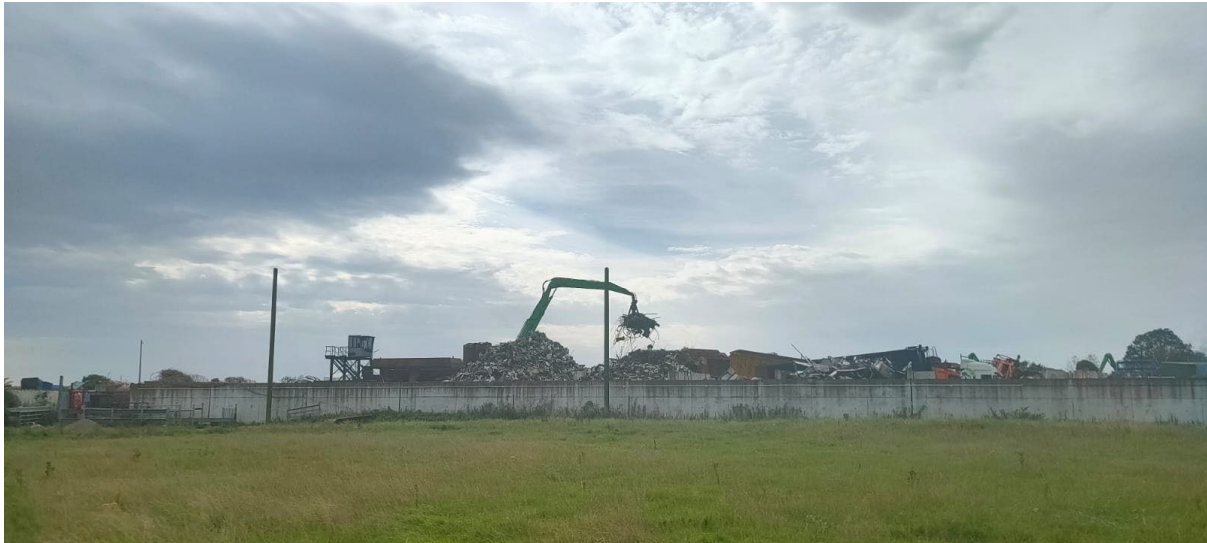
Photo 4: Photo showing the height at which the loading takes place.

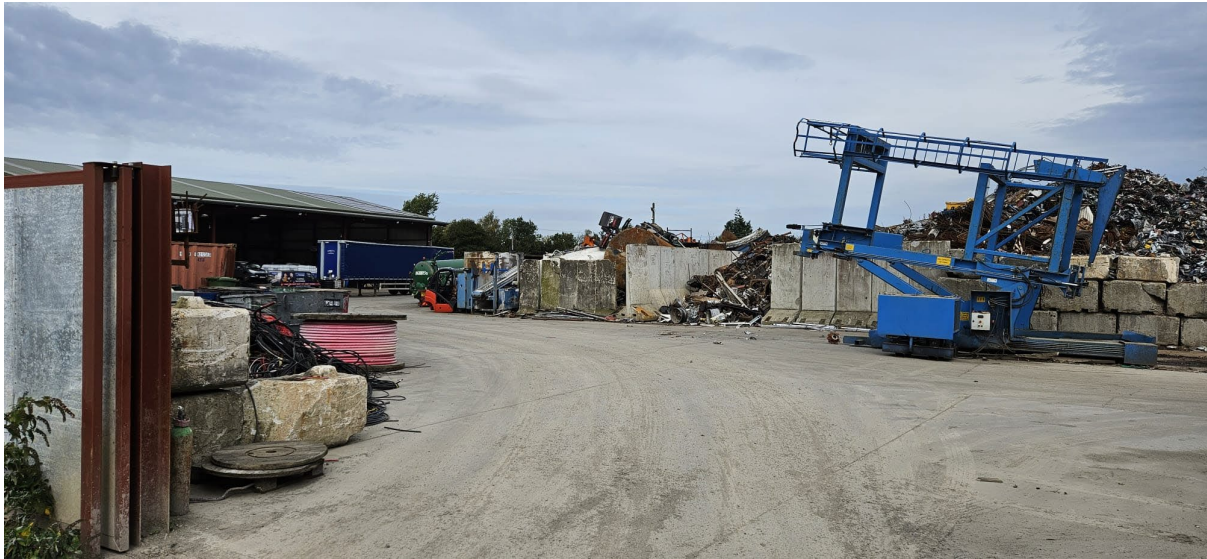
Photo 6: Photo of dust monitor location D3 near shipping container tipper, loading takes place up to 12m height

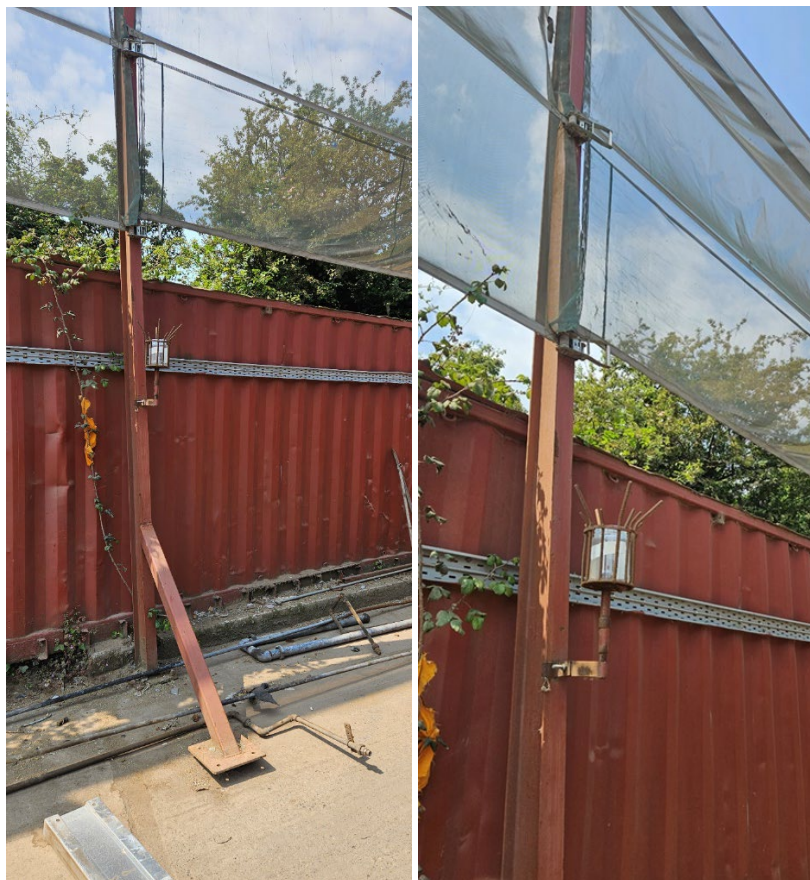
Photo 7 and 8: Location D4 clearly on the inside and under the dust abatement netting

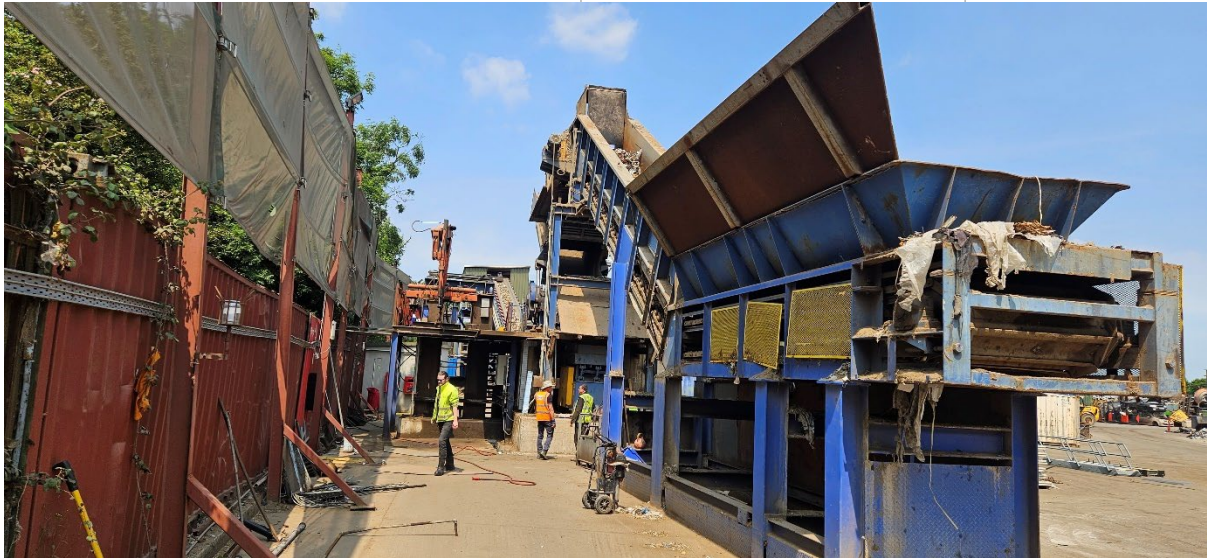
Photo 91: Higher plant enclosing dust location D4 and treeline interference visible

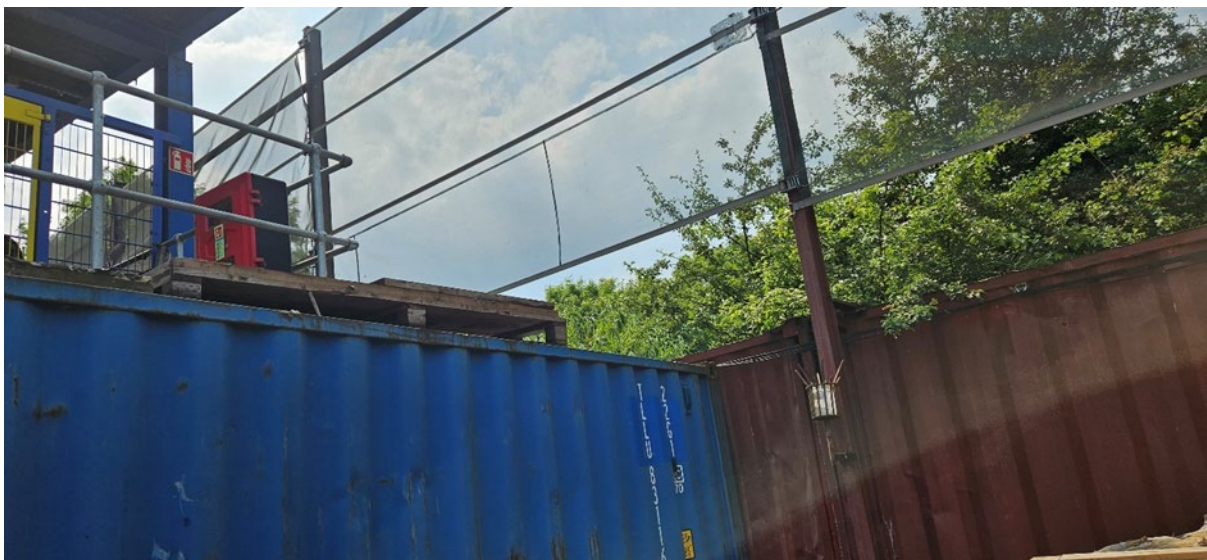
Photo 102: Dust location D5 clearly on the inside and under netting and treeline interference visible

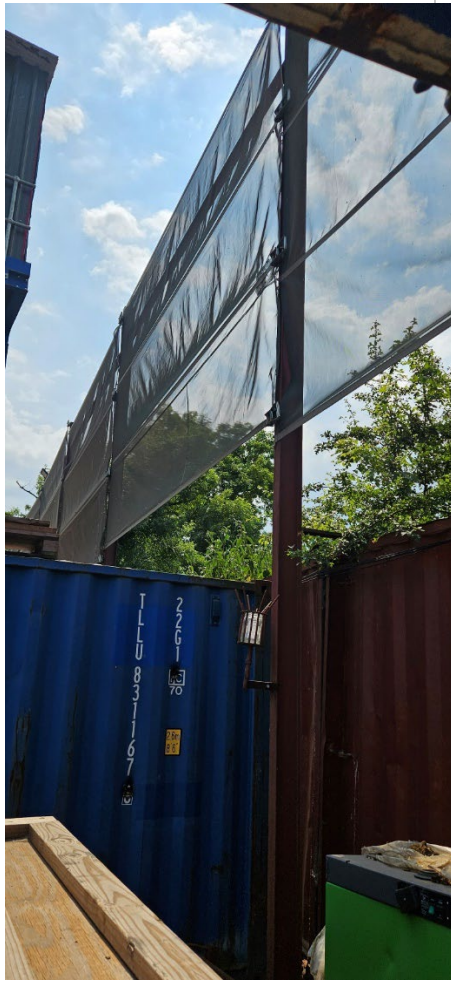
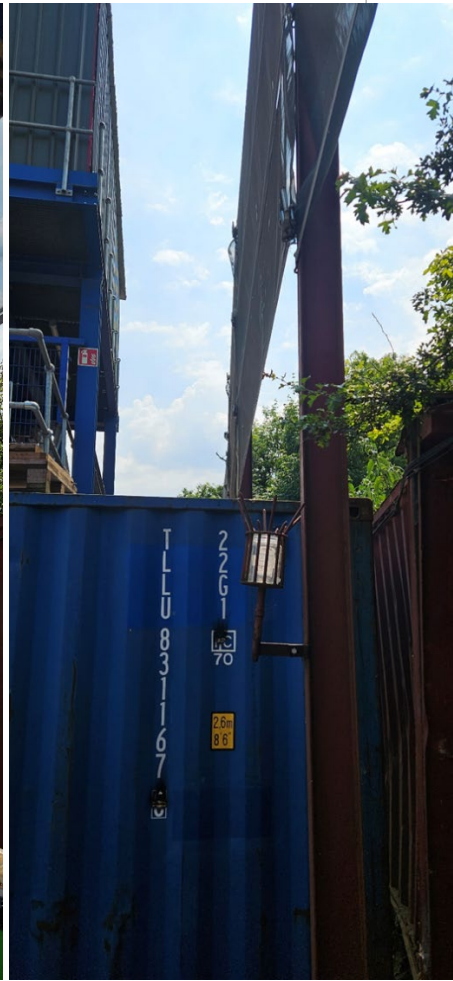
Photo 11 and 12 Dust location D5, container with higher flat surface directly next to collection point. Netting directly above collection point and at very close proximity the plant which is much higher than the collection jar. Allowing for debris to fall down into the jar

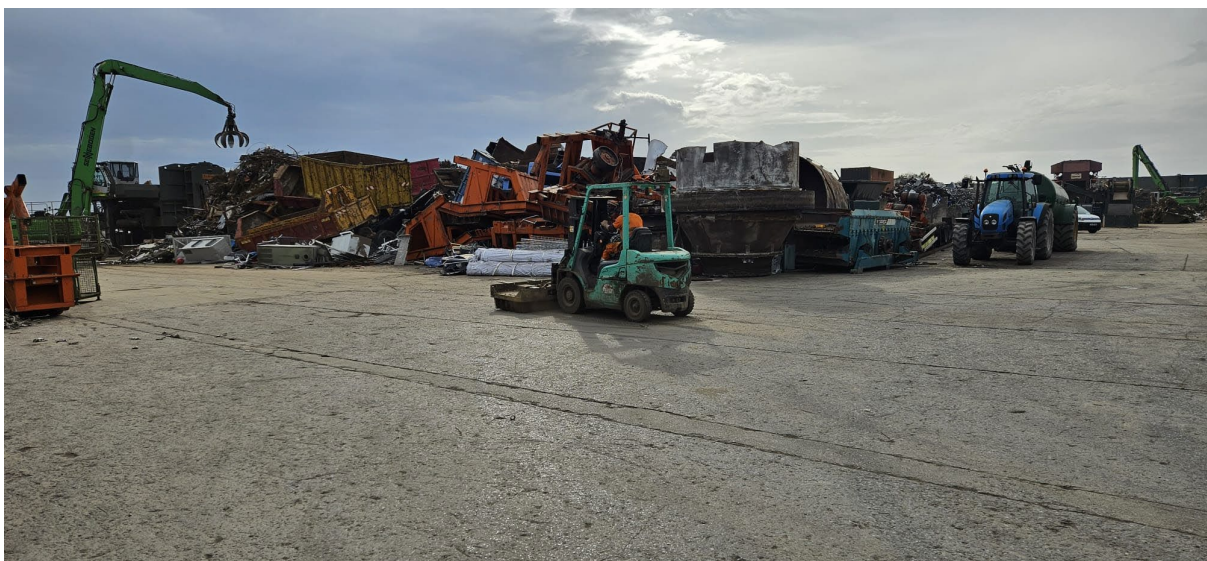
Photo 13: regular brushing to keep yard clean and avoid dust generation.

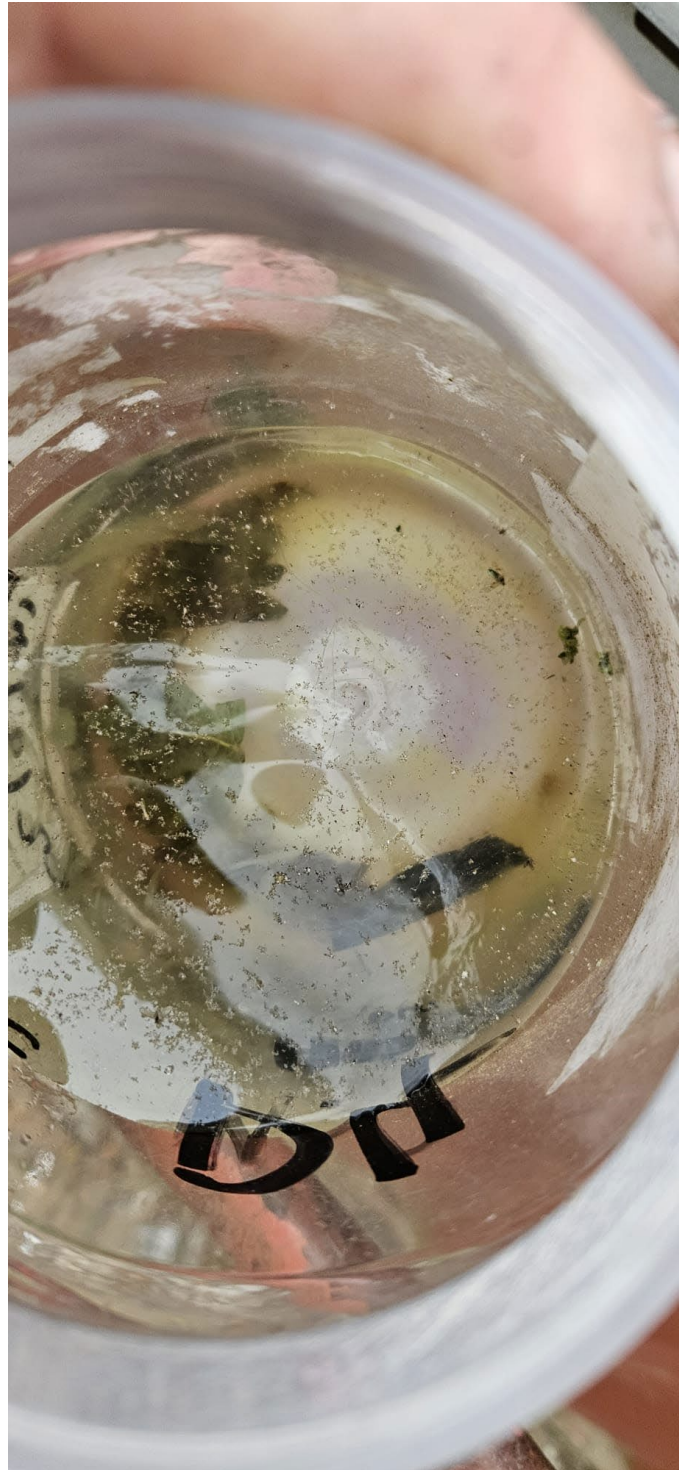
*Photo 14: example of organic matter falling in dust jar at location D4
(only large leaves are removed before analyses)*

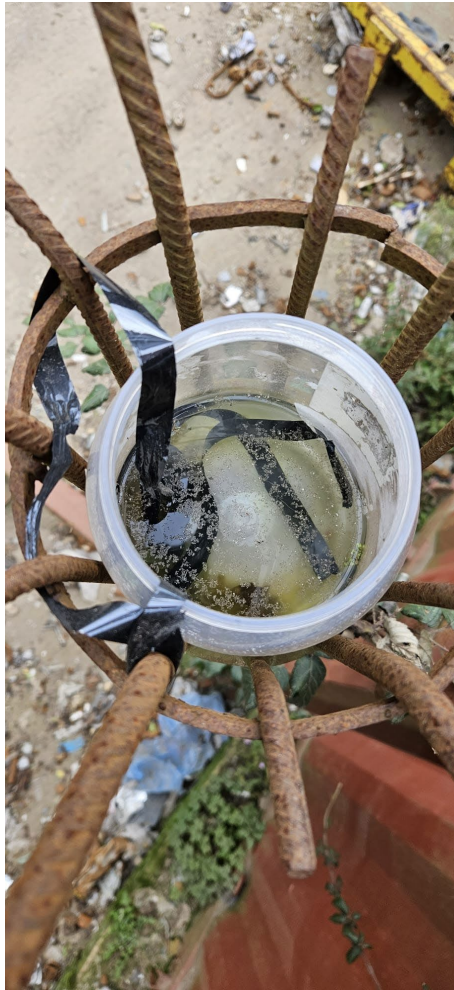
Photo 15: Another example of material fallen (tape and organic material) into a dust jar at D4

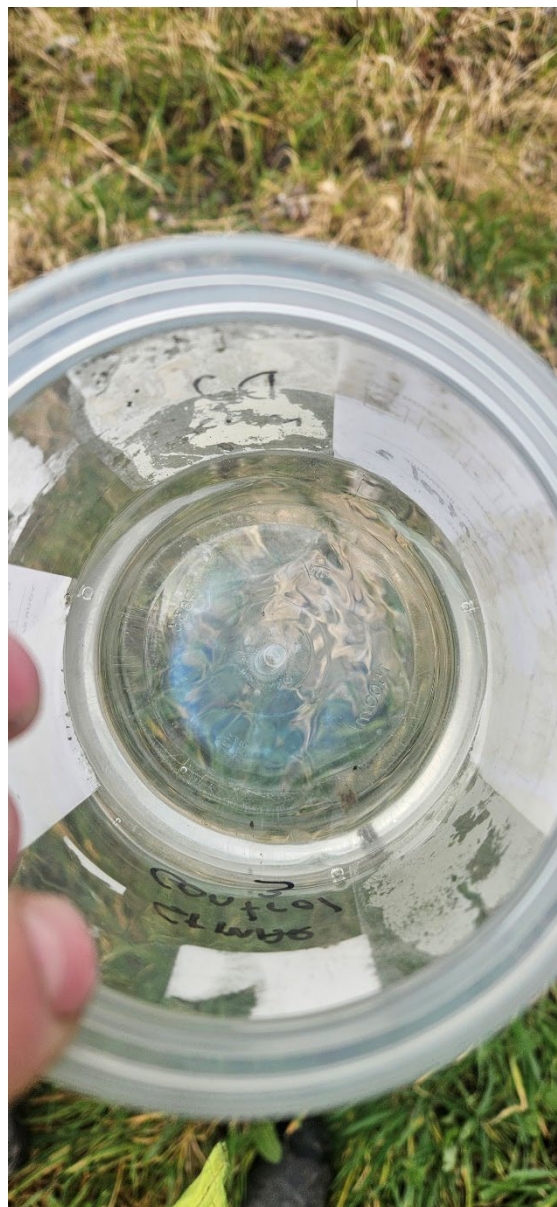
*Photo 16: examples of the dust jar after mitigation measures
(no debris and very little organic material) Control jar is placed
approx. 50m from netting and treeline at hammermill side.*

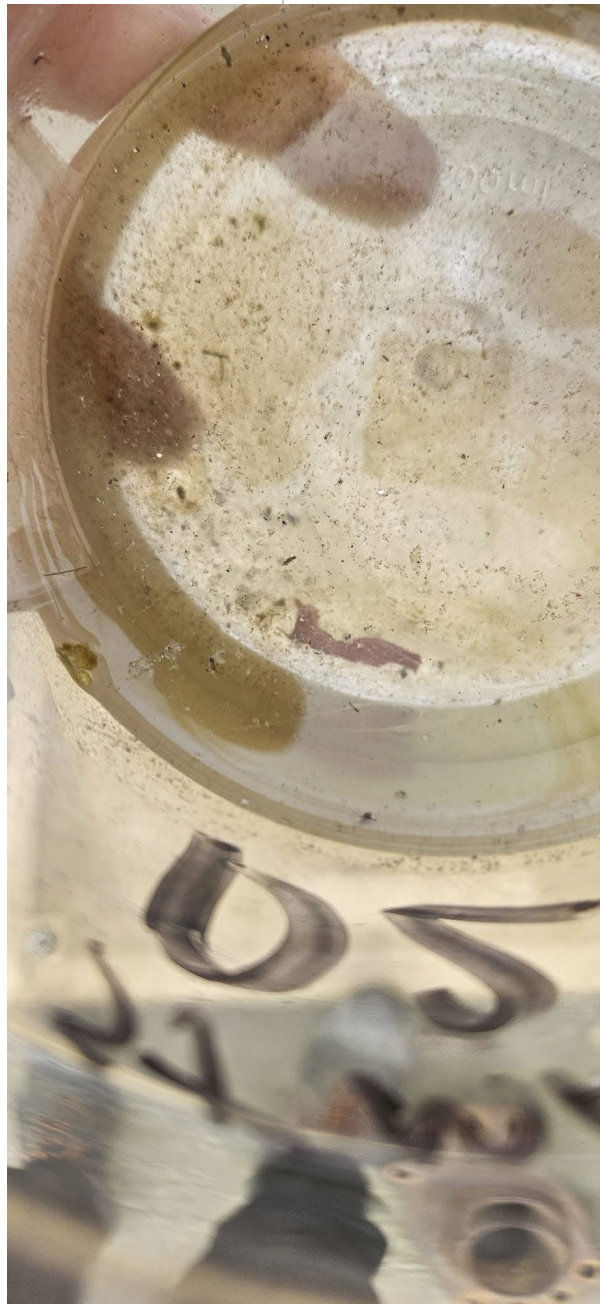
Photo 17: Example of large debris particles and even piece of metal at D2

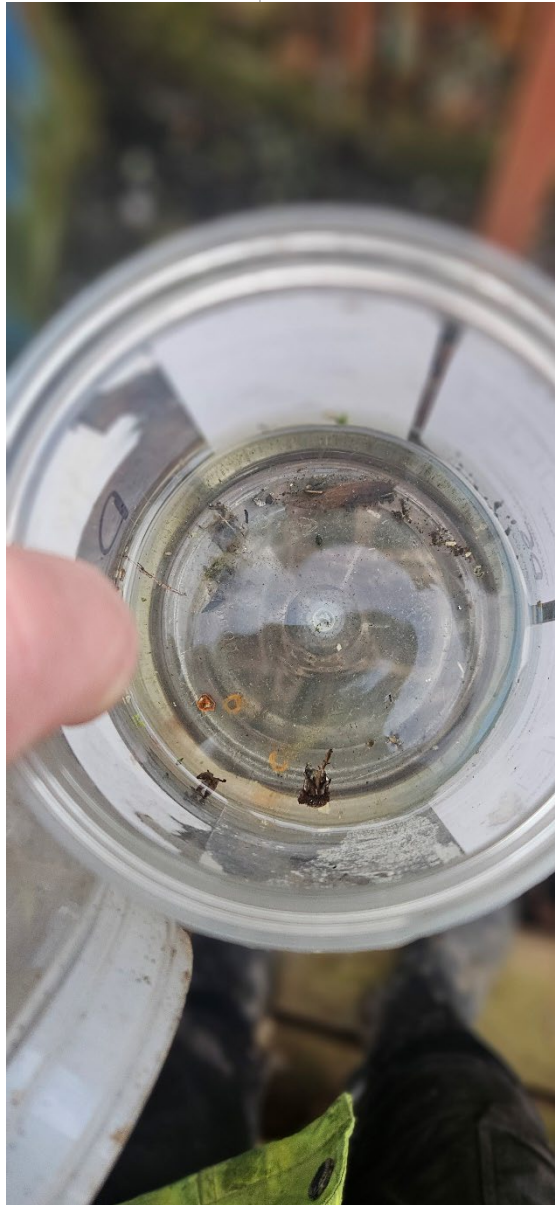
Photo 18: Example of large debris and organic material particles and even evidence of rust in D4

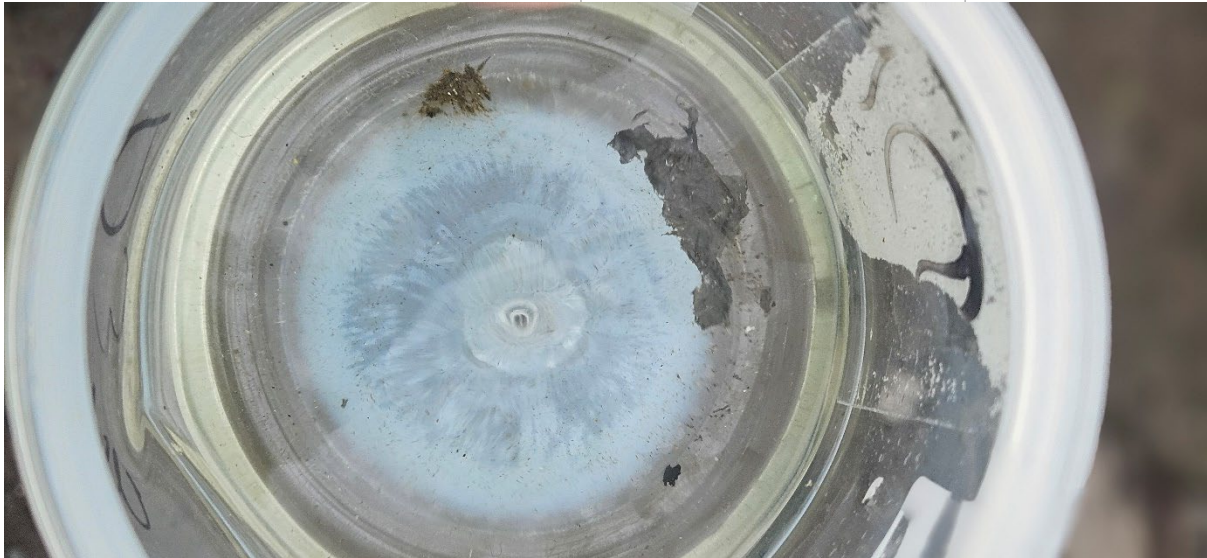
Photo 18: Example of large debris and particles in D3

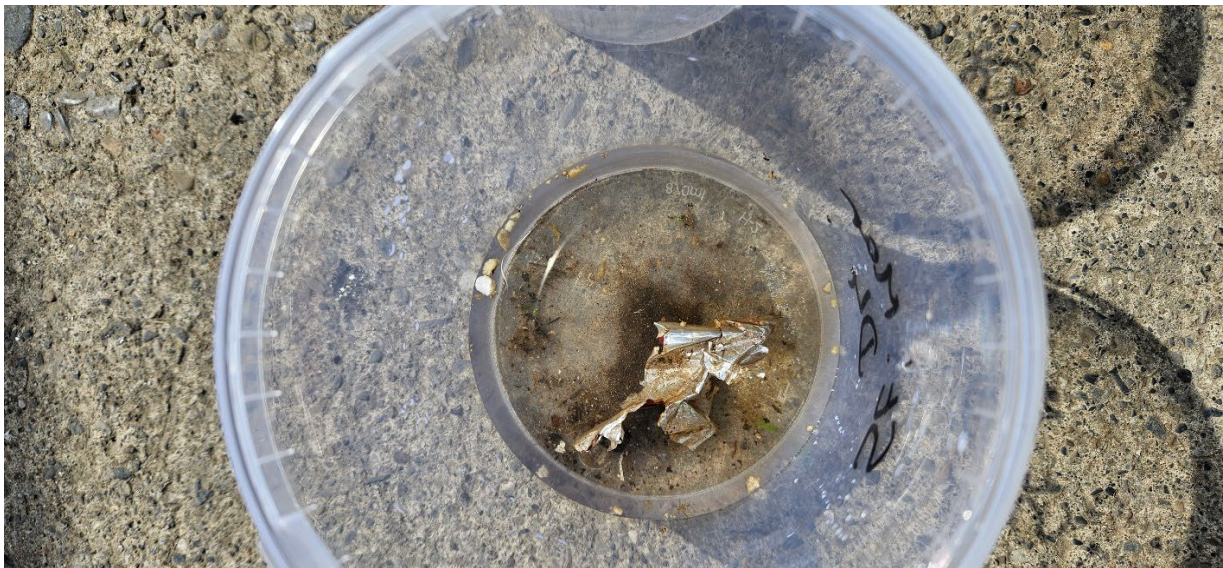
Photo 19: Example of sweet wrapper, large debris and particles in D4

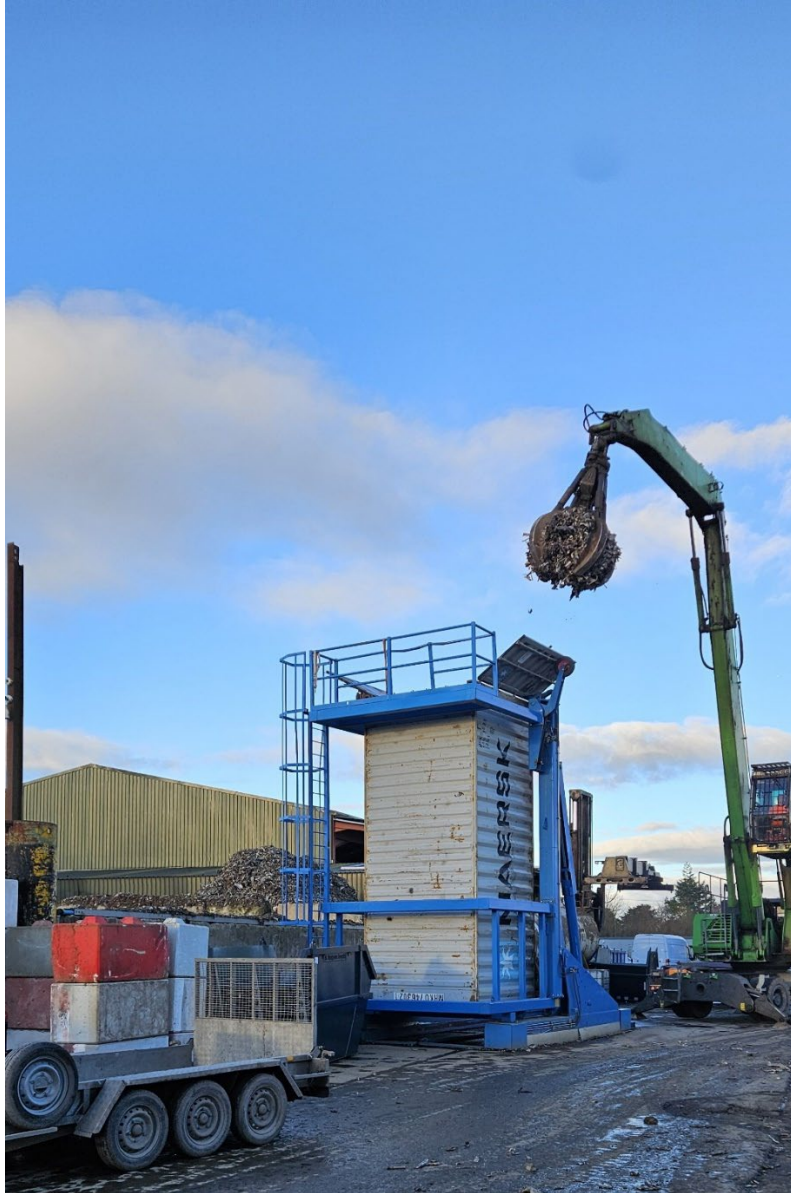
photo 21: Loading using the Tipper, loading at height.

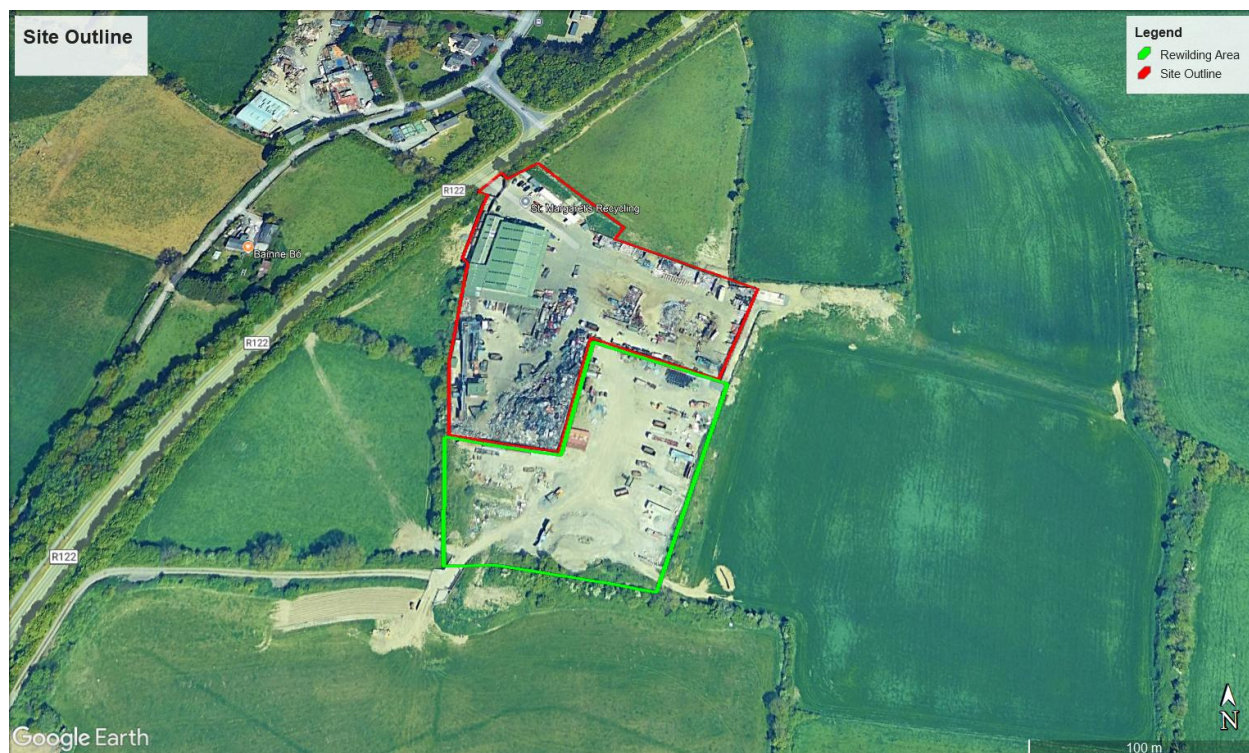
The outline of the proposed development is shown in Figure 1. The total site outline is in Red and the proposed rewilding area is outlined in Green.

Figure 1: Proposed Development Outline

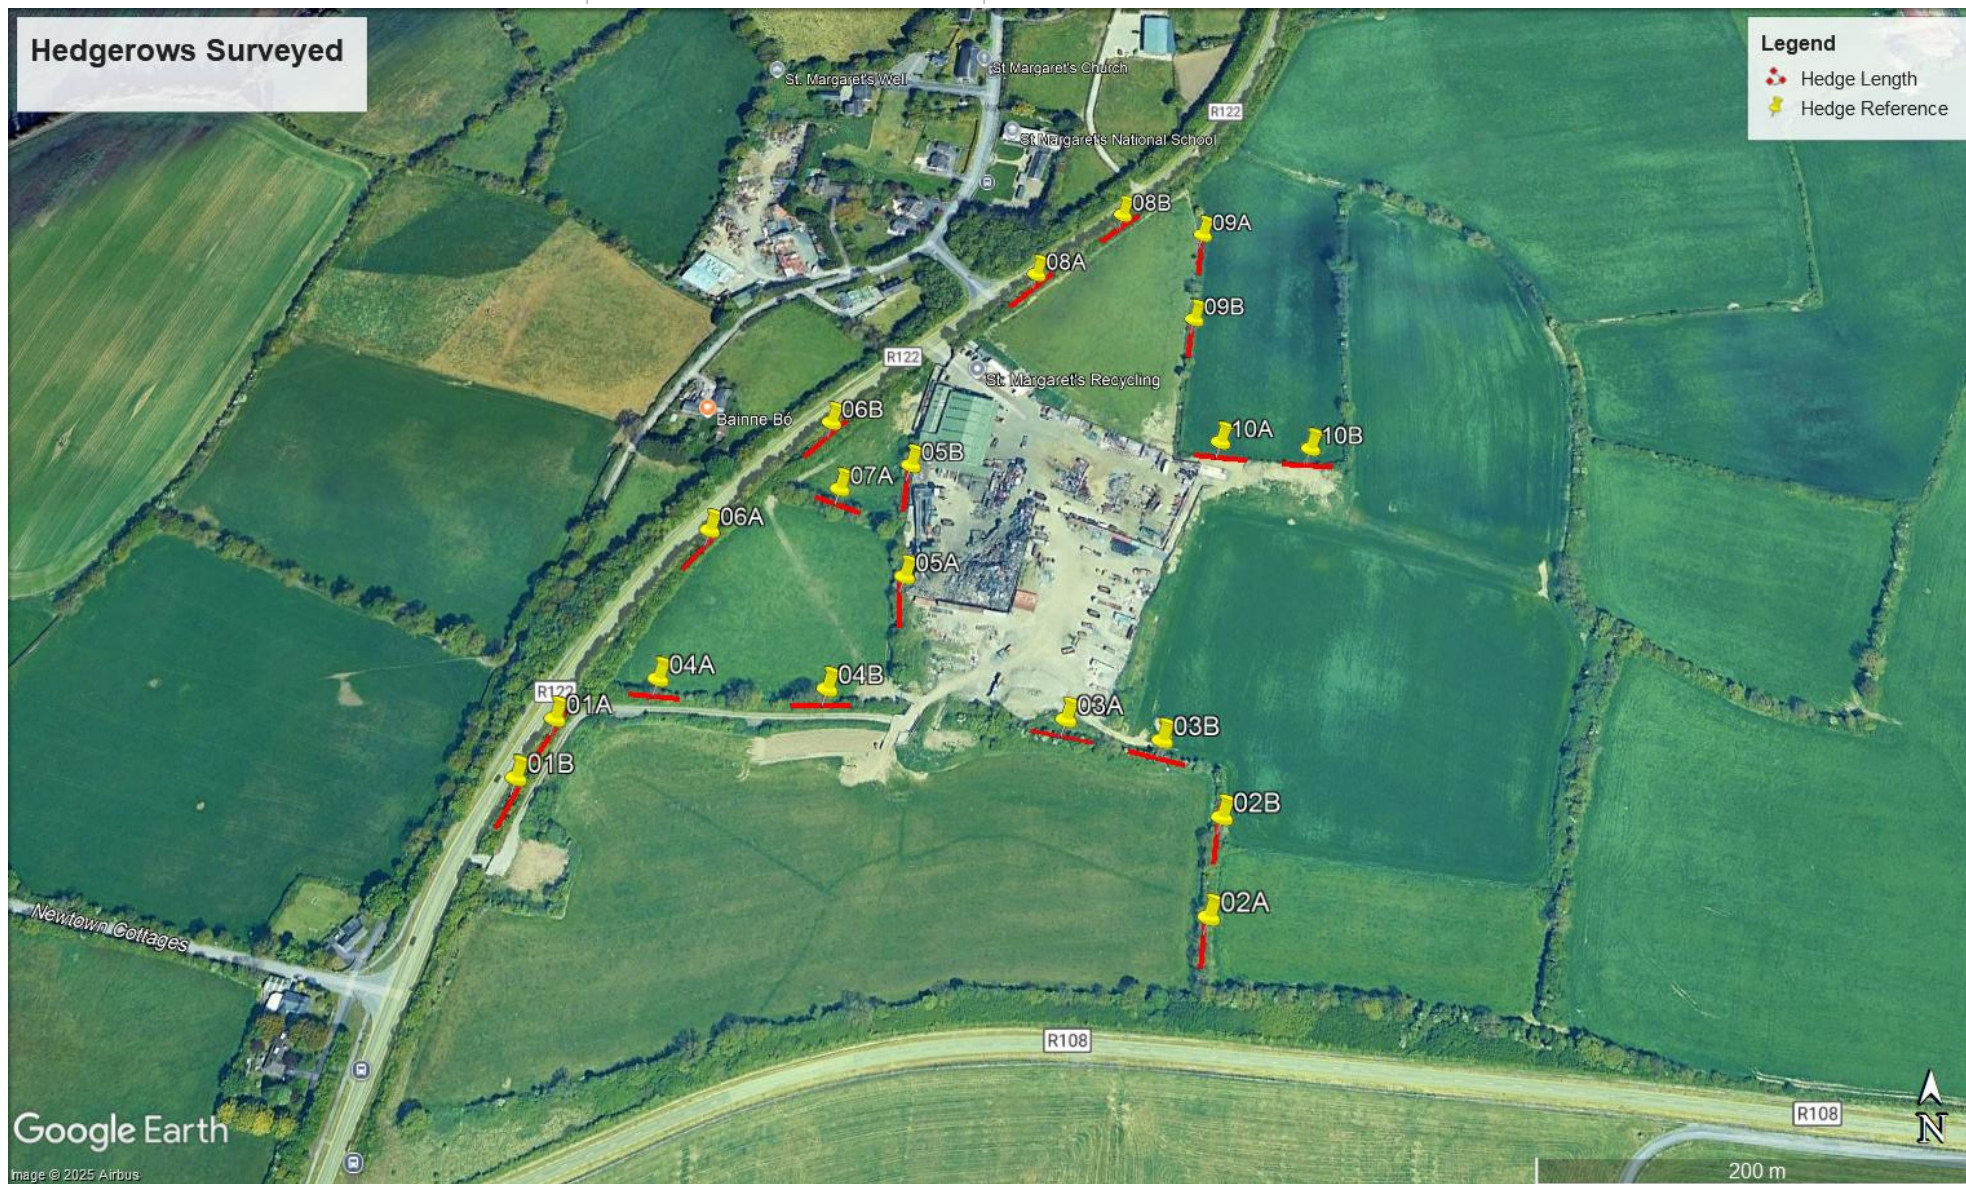
Figure 2: Hedgerows Surveyed
