**APPROPRIATE ASSESSMENT  
REMEDIAL NATURA IMPACT STATEMENT  
Application for Substitute Consent for proposed  
development on Tulla Road, Ennis, Co. Clare**

<b>Requested By:</b>	Valley Healthcare Fund - Infrastructure Investment Fund ICAV
<b>Prepared By:</b>	Brendan O Connor BSc Southern Scientific Services Ltd
<b>Date Reported:</b>	25/02/2022
<b>Our Reference:</b>	21P-264

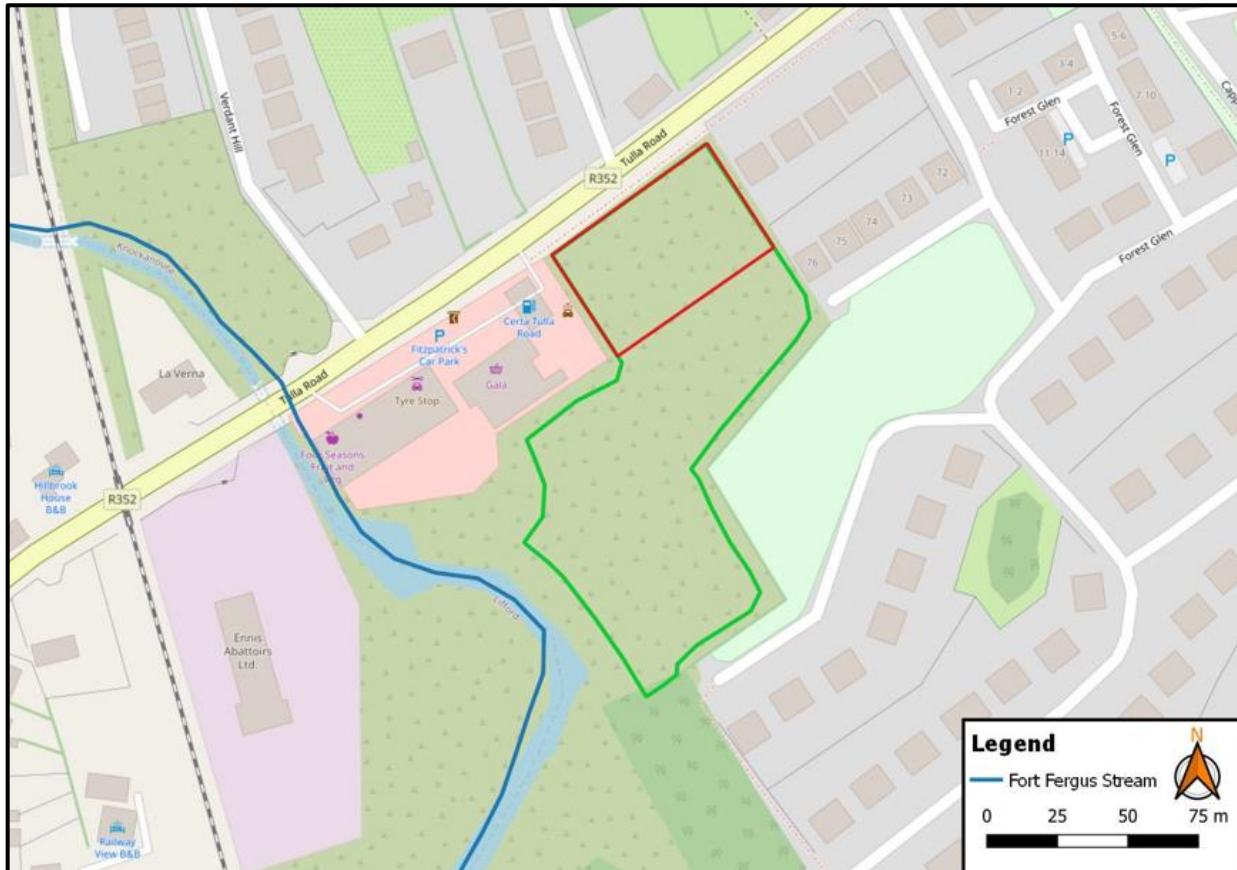
**Figure 3. Illustration showing the development site (in red) in relation to the larger area that was landfilled as part of the River Fergus Lower (Ennis) Certified Drainage Scheme (in green).**

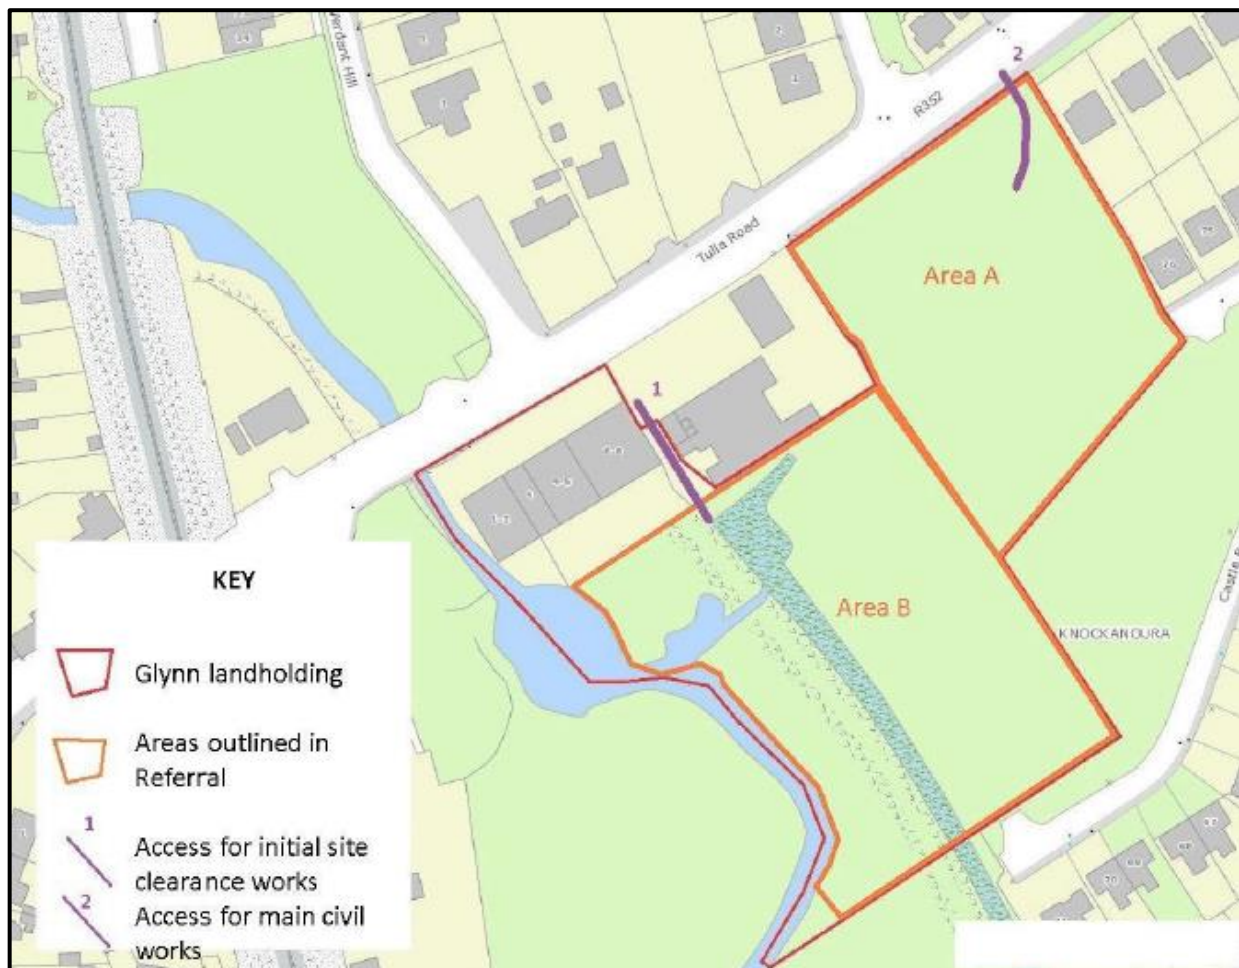
During these works between nearly the whole of the landholding (Area A and B combined) was filled with material imported onto the site (see Figure 4). The works which took place as part of the certified drainage scheme has led to the construction of a high berm forming a barrier between Fort Fergus Stream and the area infilled.

**Figure 4. Area B indicates location of drainage scheme works (extracted from Brendan Mc Grath & Associates letter dated 1st September 2017).**

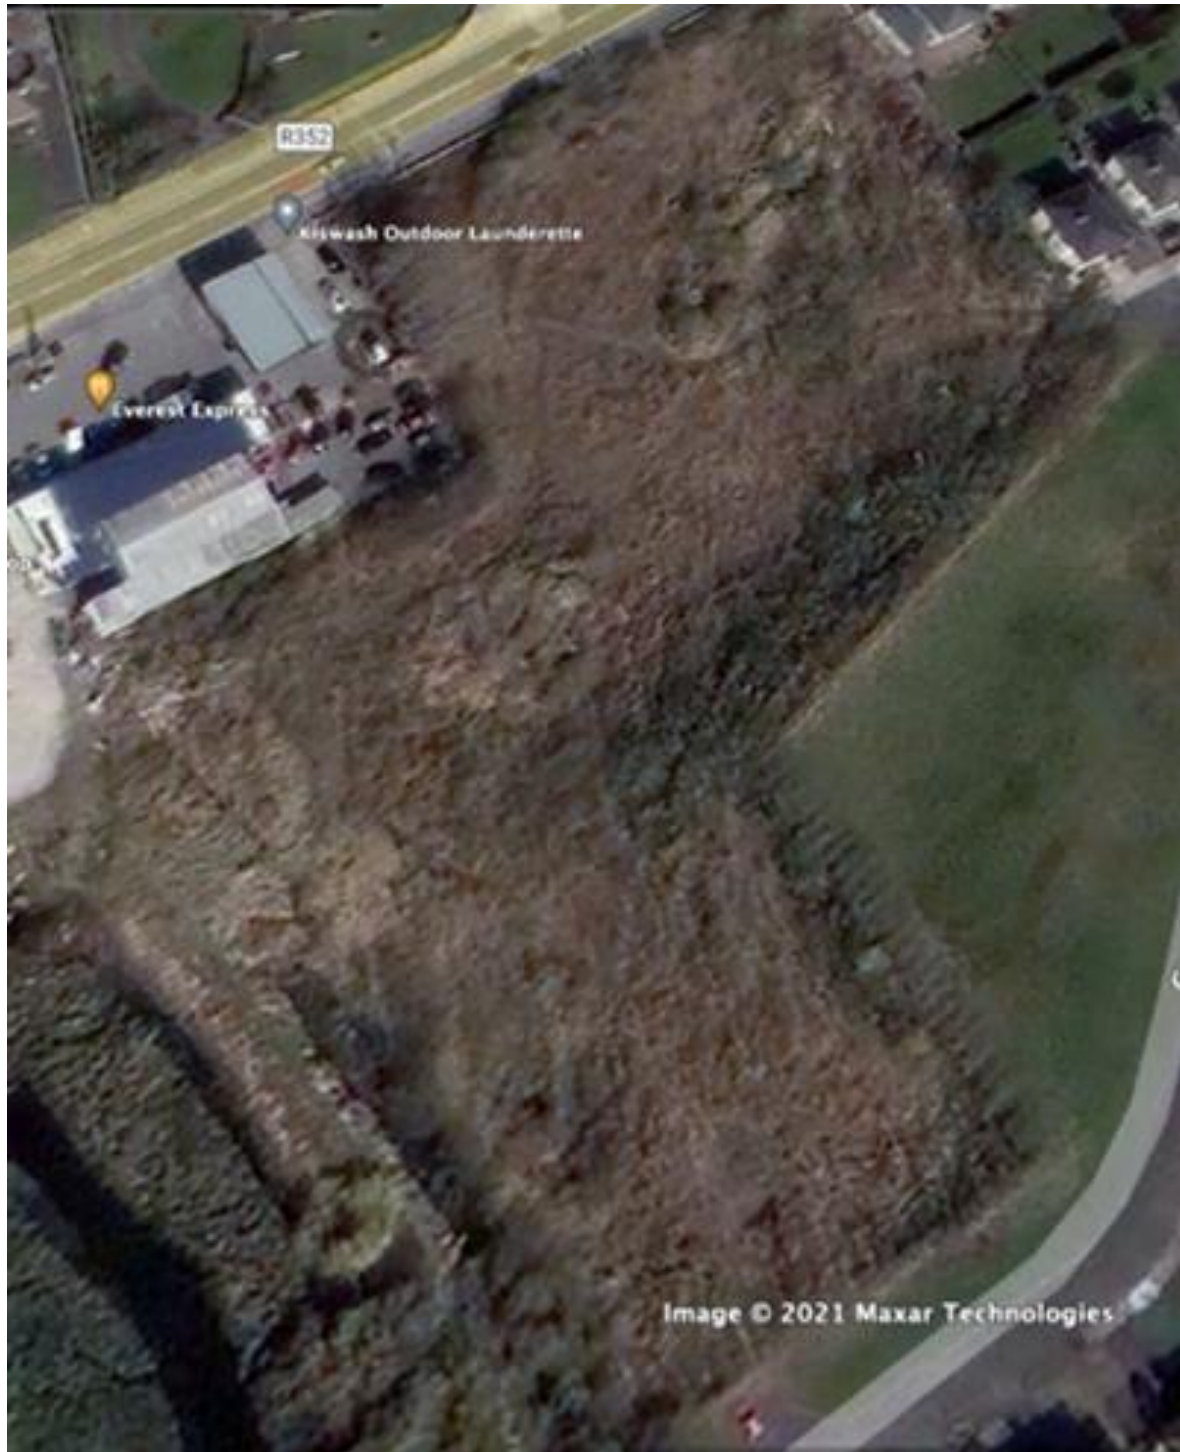
**Plate C: Satellite image (c.2011) of development site and area to the southwest, infilled as part of the drainage scheme.**

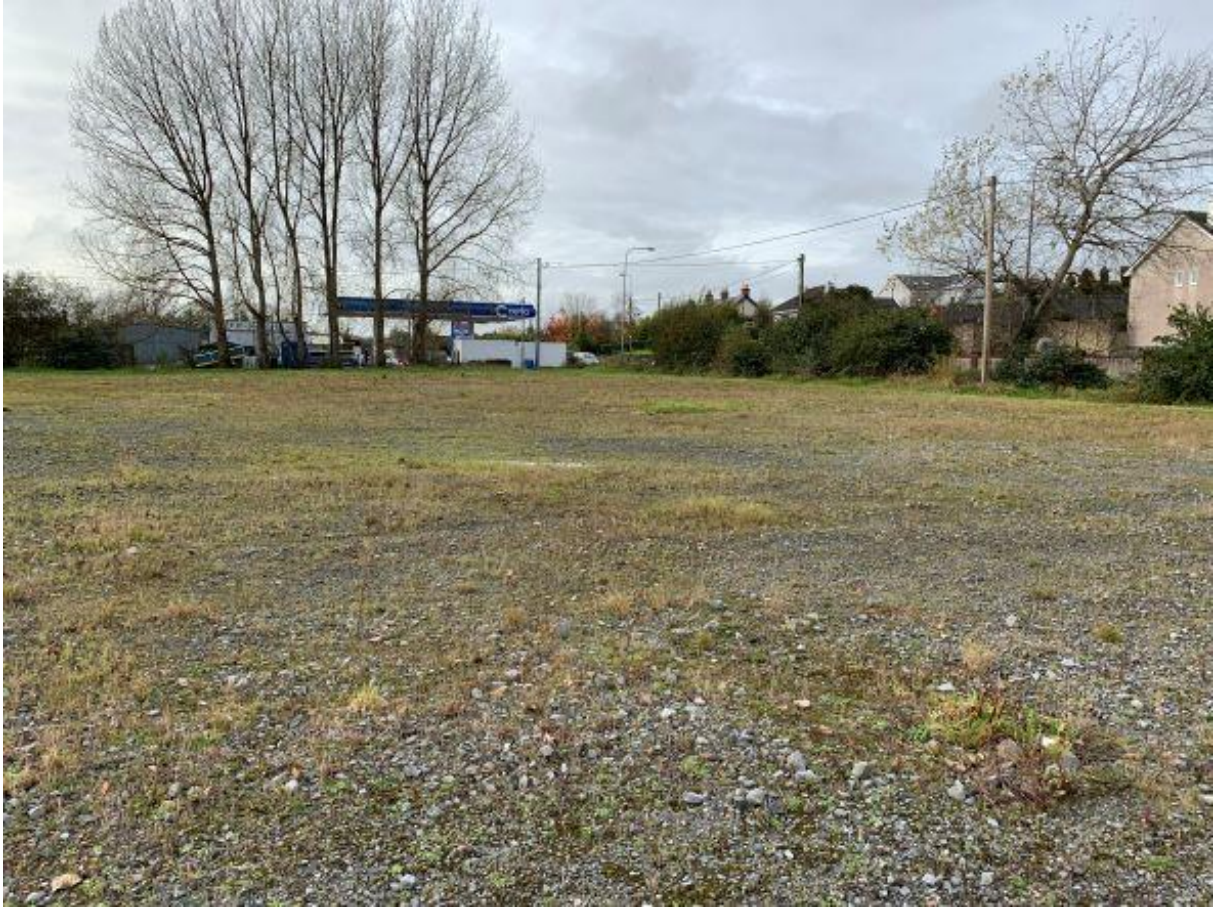
**Plate D: View of the development site (Facing southwest).**

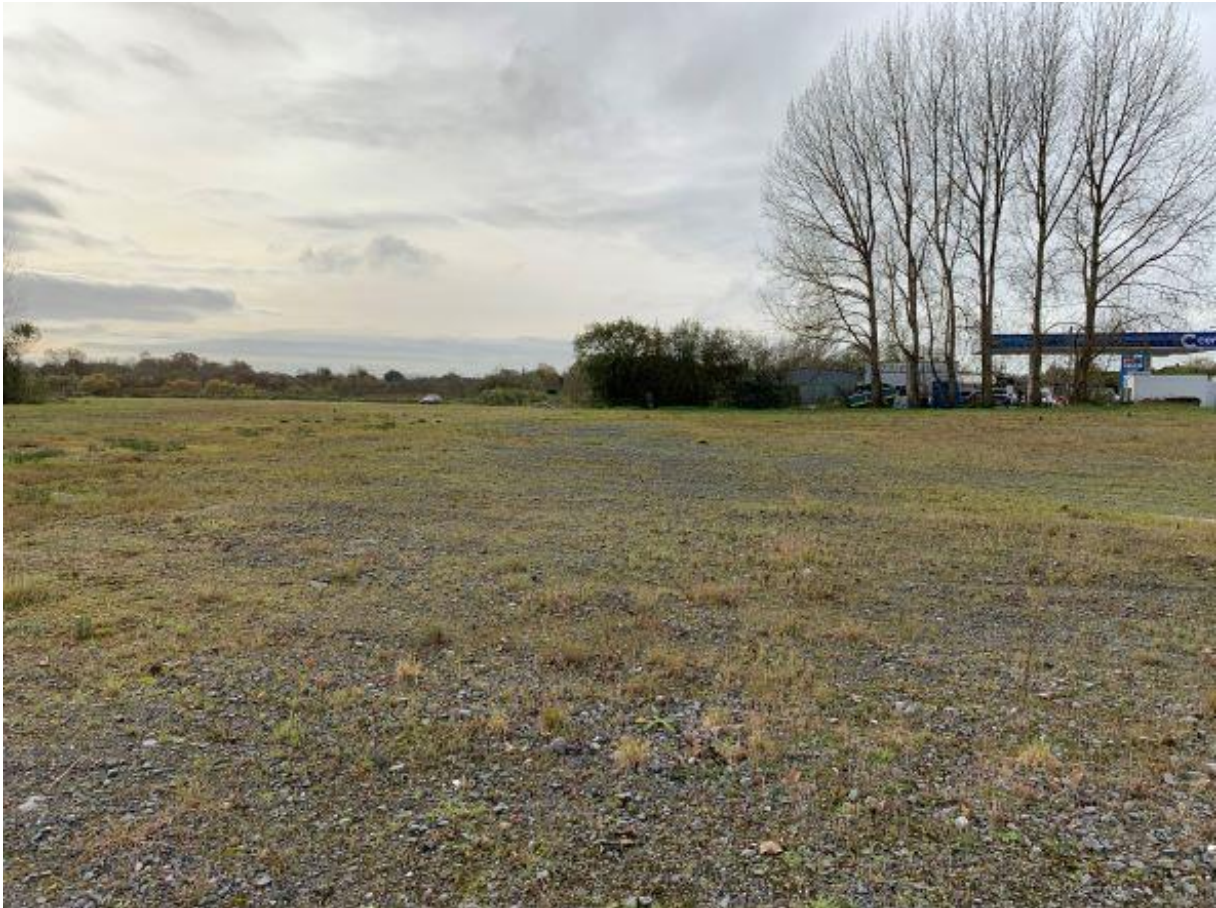
**Plate E: View of area to the south west of the development site infilled as part of the drainage scheme.**

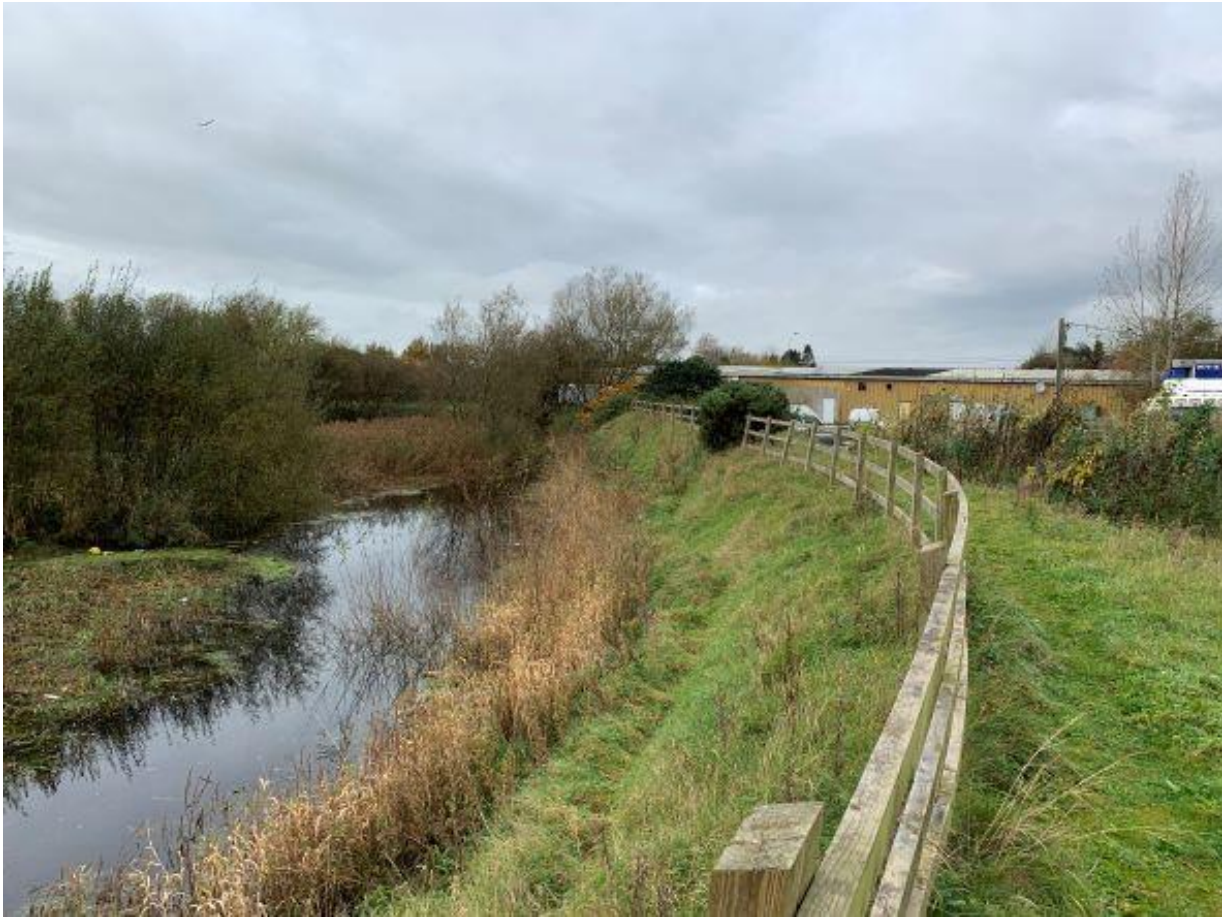
**Plate F: Flood defense berm constructed in 2013 on southern boundary of the area infilled as part of the drainage scheme adjacent to the Fort Fergus Stream.**

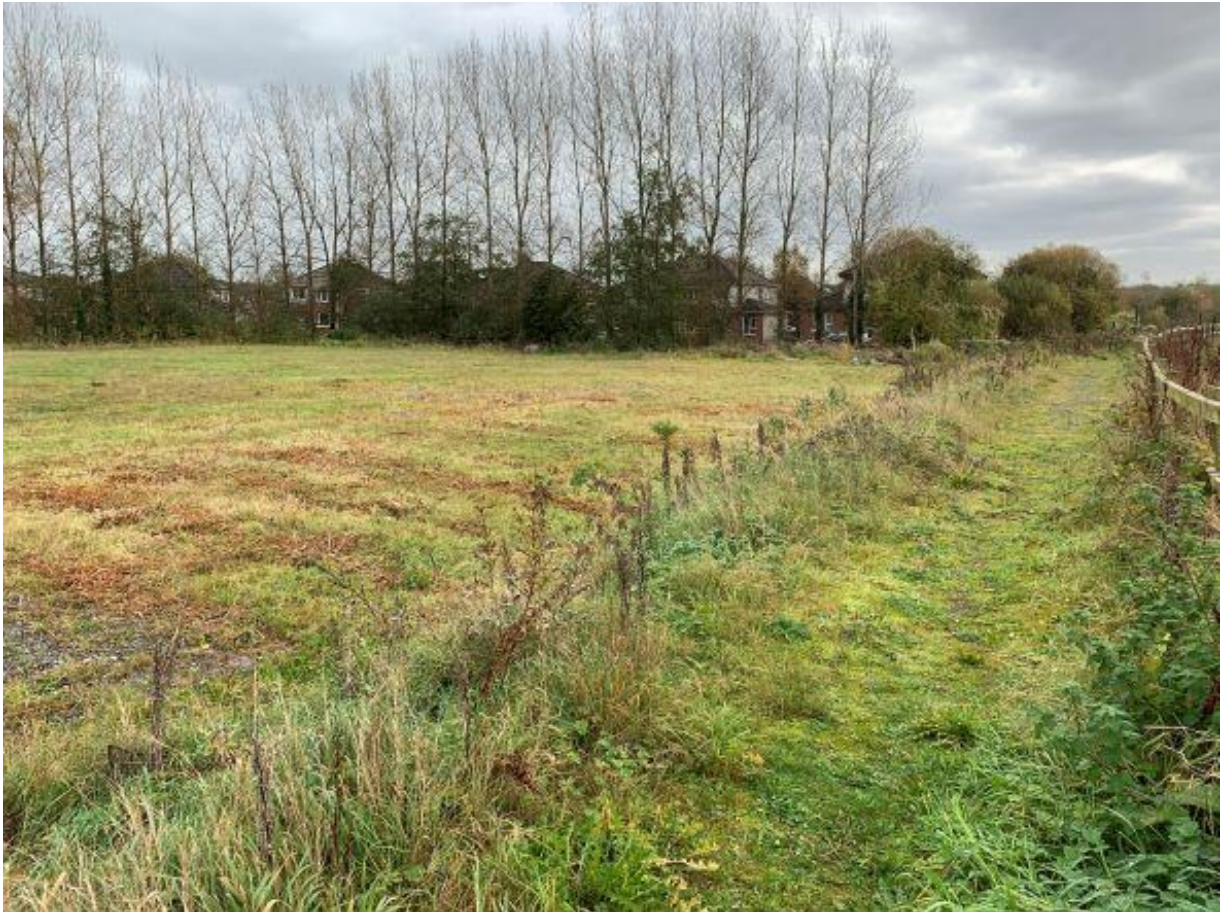
**Plate G: View of area infilled as part of the drainage scheme to the southwest of the development site adjacent to the flood defense berm.**

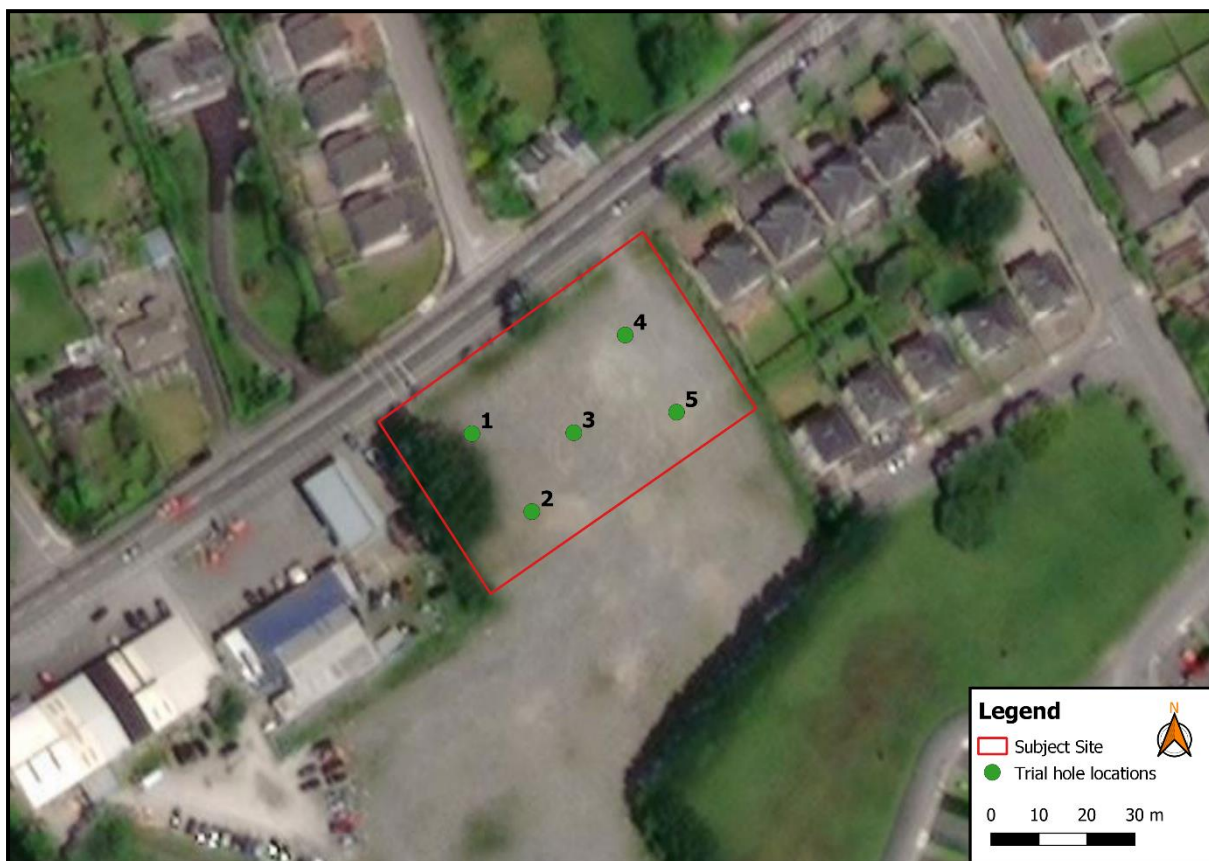
Five trial holes were excavated on-site on the 14<sup>th</sup> January 2022. The location of the trial holes on-site is presented in Figure 1 below. The trial hole locations were selected to best represent the size and shape of the site. Trial holes were excavated to approximately 6 metres, and approximately 2 m x 4 m in surface dimension. During each 1 metre of depth, the excavated material was set aside of the trial hole as a discrete sample pile. See Appendix I for site photographs and Appendix II for Trial Hole Logs. The material was examined visually for evidence of waste materials glass, ceramics, bricks, blocks, asbestos rope or insulation, plastic, metals, fabrics, cardboard, degradable waste, electrical devices, and any other extraneous objects or signs that could be construed as waste in the meaning of the term defined in regulations. A soil description was made using standard procedures, e.g soil structure, texture, colour, compaction, mottling, bedding planes, water ingress etc. All observations and measurements were entered in a trial hole log. The trial hole log is presented in appendix Y. At each 1 metre depth, a methane gas measurement was taken using a methane gas monitoring measuring down to 10ppm. Once the soil observations and characterisations were completed and recorded, the soil piles were mixed initially using the bucket of the excavator. Coning and quartering was used to reduce the size of the pile to a quantity that could be managed with a hand tool. Further coning and quartering was carried out until a 5kg sample was isolated. This sample was transferred to a plastic bag for transport to the laboratory. This procedure was repeated for each of the 5 trial holes. A total of 25 samples were collected at the site.

Figure 1. Location of 5 trial holes on site.

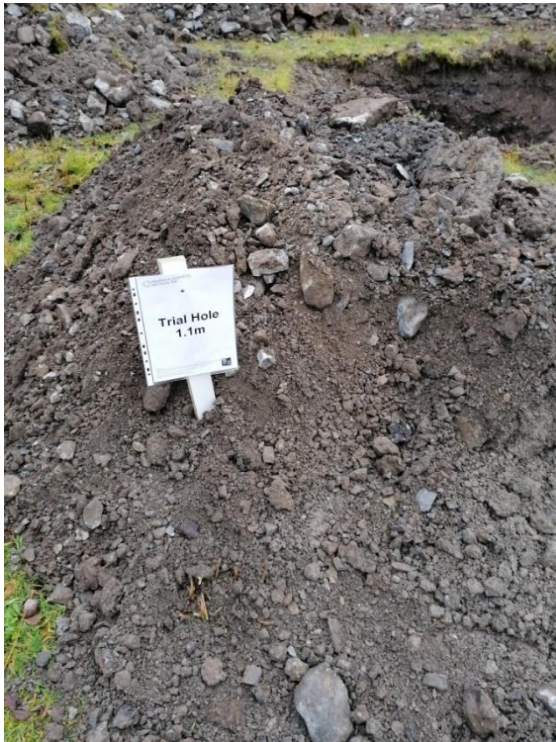
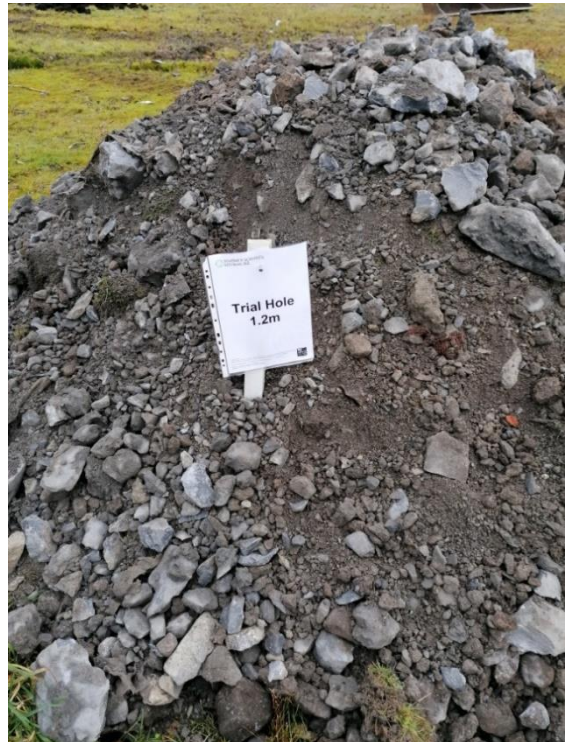
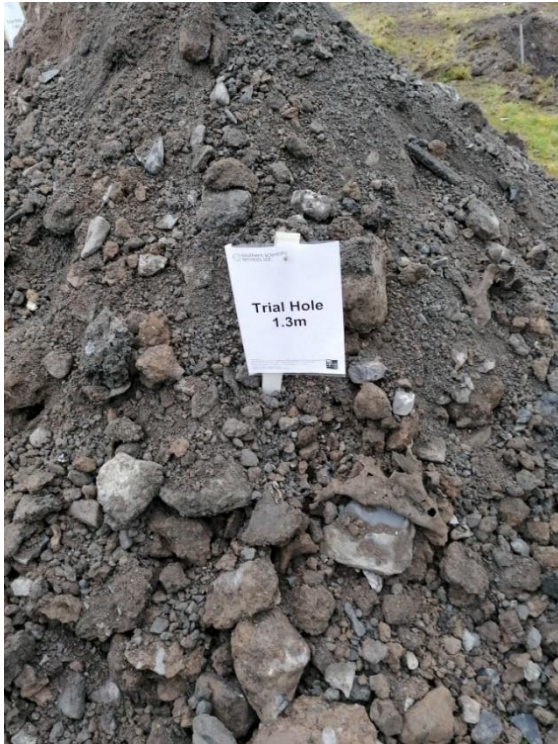
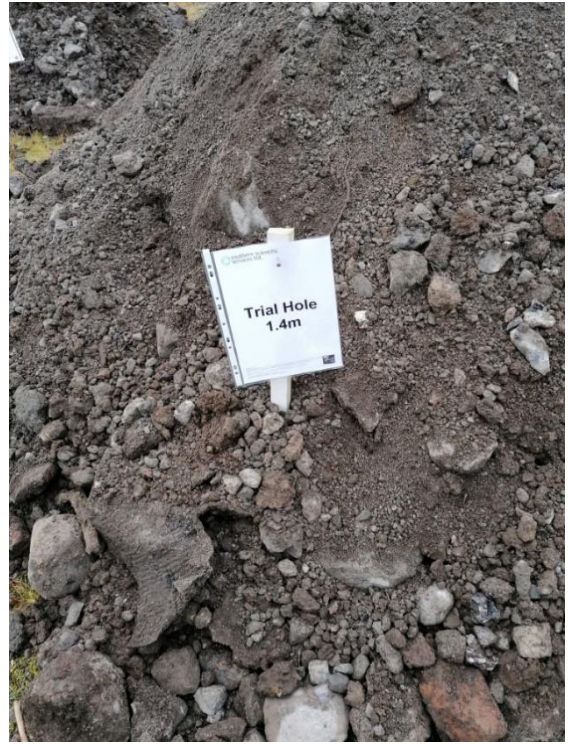
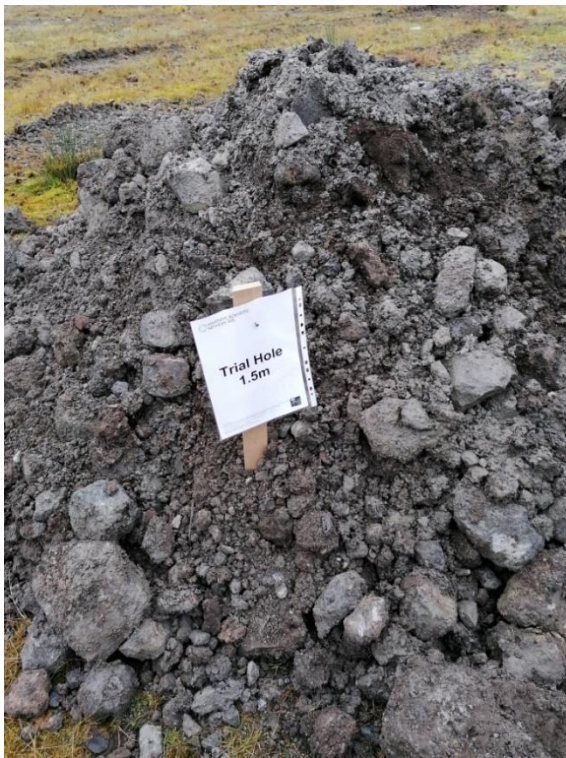
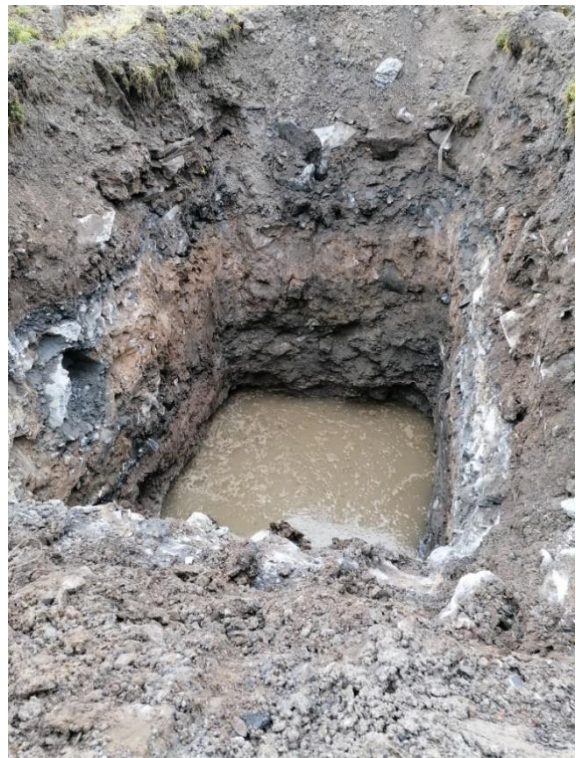
## Trial Hole No.1

Figure 6: Illustrates trial hole 1 & shows the different horizons within the trial hole.

3.4m BGL	
1-2m	1.2					Stone & gravel, predominately limestone (40-50%). Methane results recorded at this level = less than 10ppm <sup>1</sup> . No Waste		
2-3m	1.3					Stone & gravel (30-40%) Waste observed included extraneous quantities of plastic, wire, cloth <2% Methane results recorded at this level = less than 10ppm <sup>1</sup> .		
3-4m	1.4					Topsoil & subsoil. Stone 30%, gravel & limestone Methane results recorded at this level = less than 10ppm <sup>1</sup> . No waste observed		
4-5m	1.5					Stone 30%, gravel & limestone No waste observed Methane results recorded at this level = less than 10ppm <sup>1</sup> .

<b>General Remarks:</b> See Appendix I for relevant site photos (Figures 1-6) (1) Methane gas monitoring of trial hole: An RSGD38 Methane gas analyser was attached to a telescopic pole and used to monitor methane levels within the trial holes. The objective of the exercise was to detect methane ingress into the open trial arising from open horizontal channels within the profile. The Intake probe of the meter was positioned to the trial hole vertical wall and moved slowly in a horizontal plane around the vertical walls of the trial hole. This is exercise was repeated at each 1 metre level, starting at the top 1-2m level and working downwards. Methane Trigger value = 10,000ppm. The Lower Exposure Limit for Methane = 50,000ppm. Miscellaneous waste <1% and include some brick & plastic, also small quantities of timber in degraded state. No glass, electrical goods, Asbestos, or organic waste observed. Gravel content high in top 3m. No bedrock @ 6m Trial pit backfilled with arisings on completion.

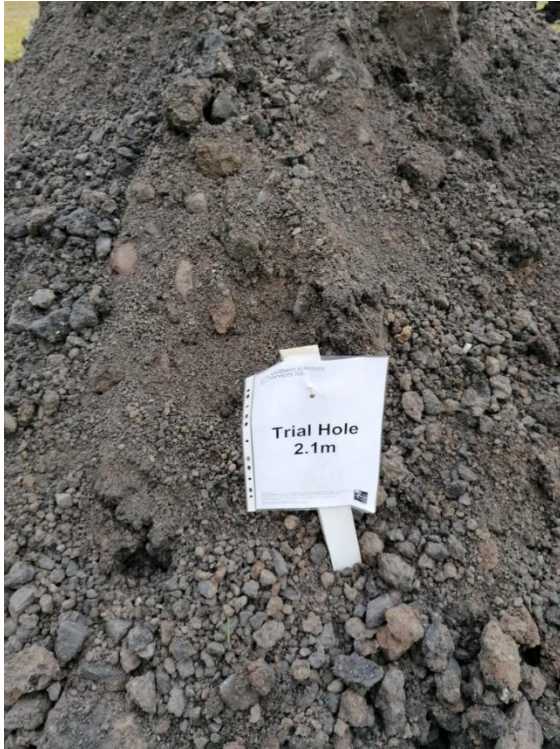
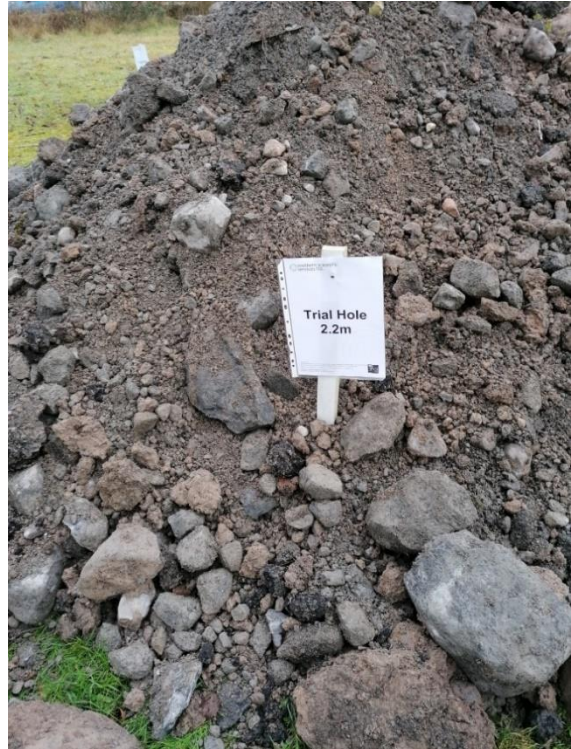
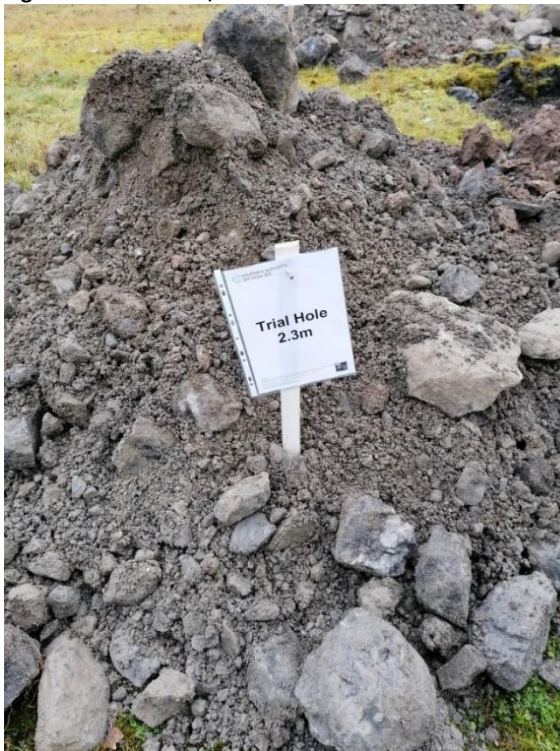
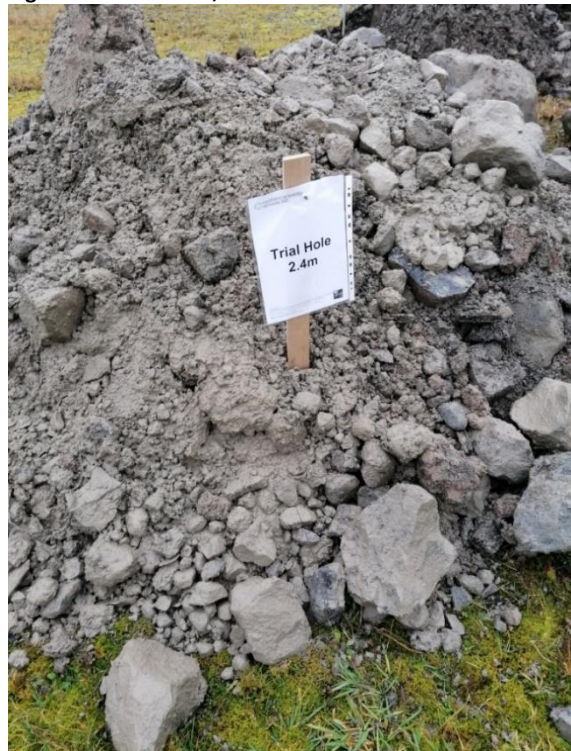
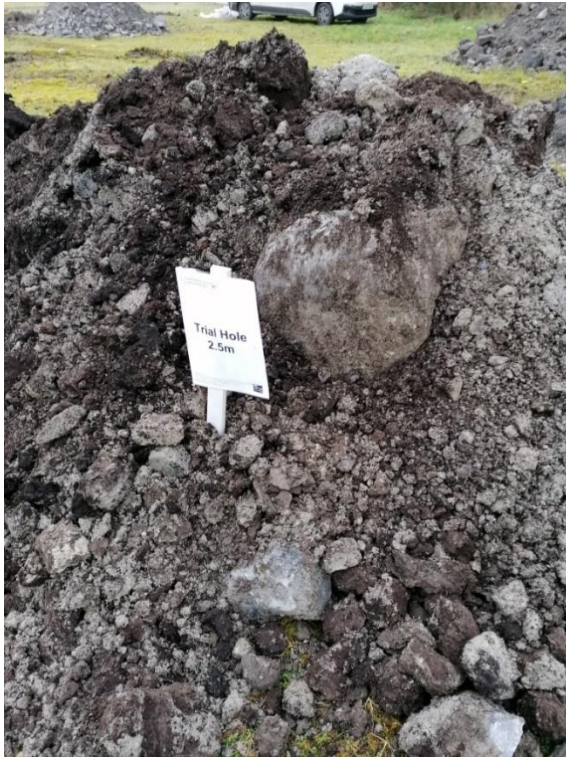
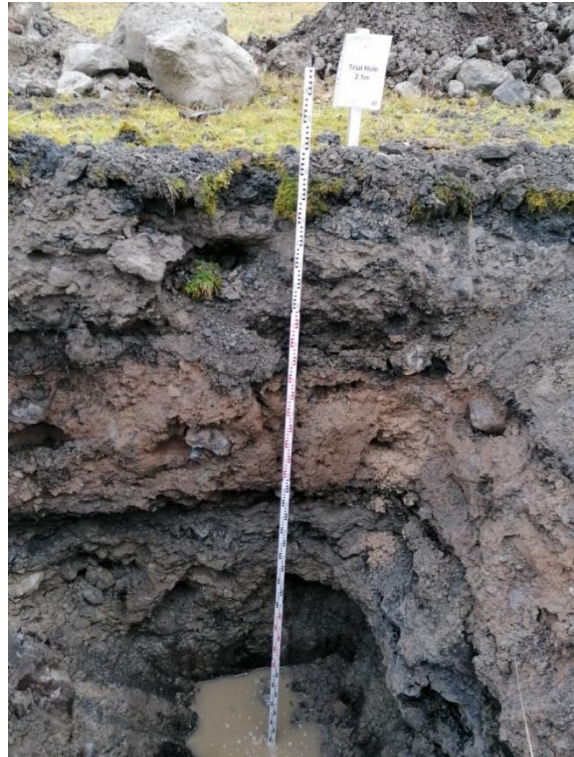
**Trial Hole No.2**

Figure 12: Illustrates trial hole 1 & shows the different horizons within the trial hole.

2.9m BGL	
1-2m	2.2					Stone & gravel (30%), predominately limestone Waste <1% (sewer pipe) Methane results recorded at this level = less than 10ppm <sup>1</sup> .		
2-3m	2.3					Stone & gravel (30-40%) Boulders (size 0.2m-0.3m) Grey in colour Waste: strip of dampcourse (<0.5kgs) Methane results recorded at this level = less than 10ppm <sup>1</sup> .		
3-4m	2.4					Wet stone (30-40%), gravel & soil Boulders (size 0.1m-0.4m) Predominantly limestone No waste observed Methane results recorded at this level = less than 10ppm <sup>1</sup> .		
4-5m	2.5					Soil observed in 3 layers Topsoil above subsoil, with peat observed below these soil layers Large boulder present No waste observed Methane results recorded at this level = less than 10ppm <sup>1</sup> .

<b>General Remarks:</b> See Appendix I for relevant site photos (Figures 7-12) Miscellaneous waste <1% and include some brick & plastic. No glass, Asbestos or organic waste observed. Trial pit backfilled with arisings on completion.
--	--

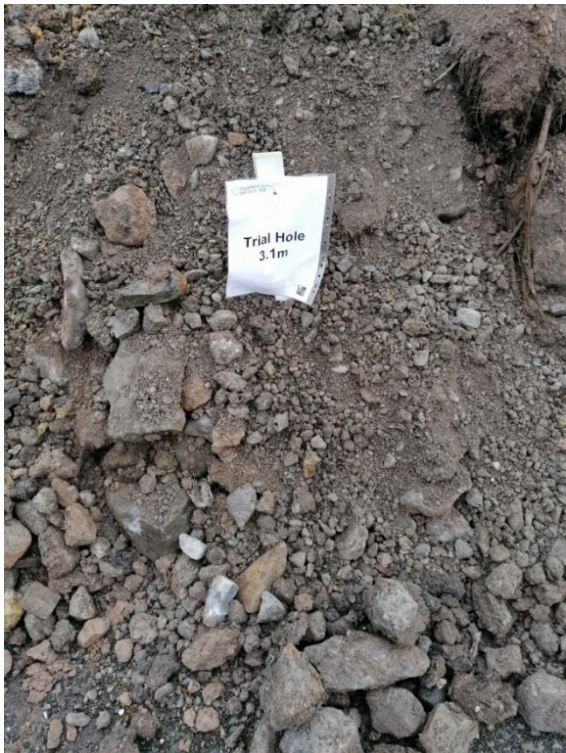
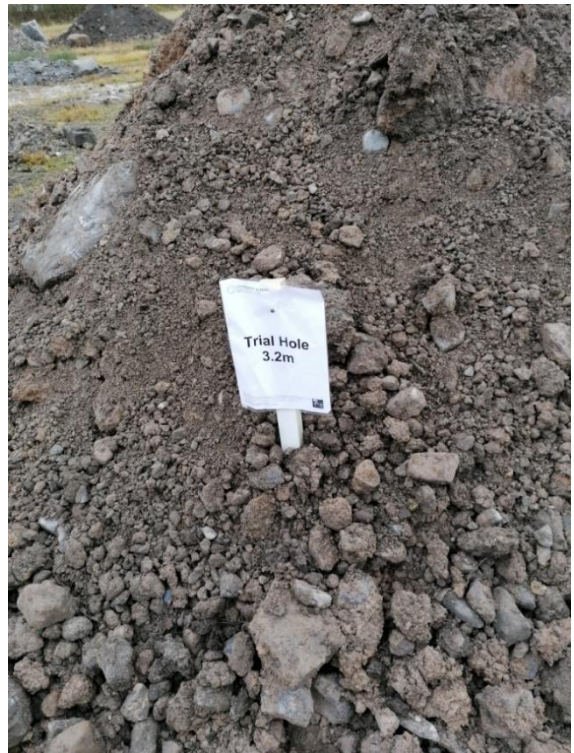
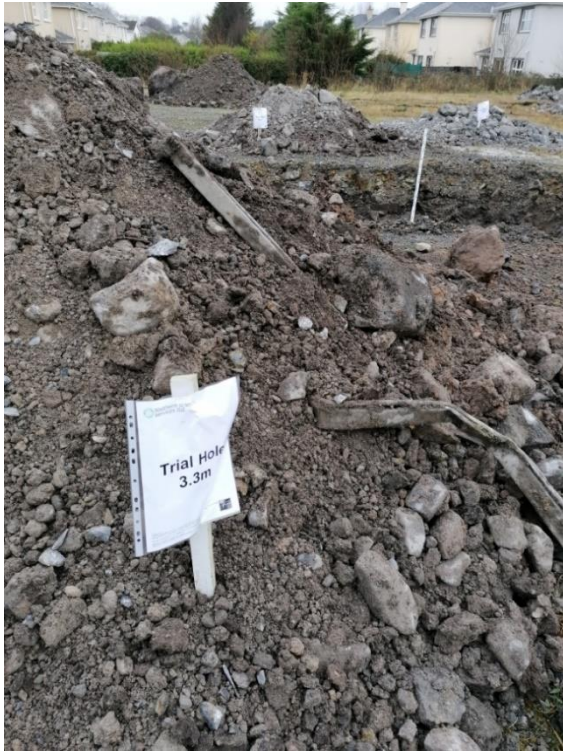
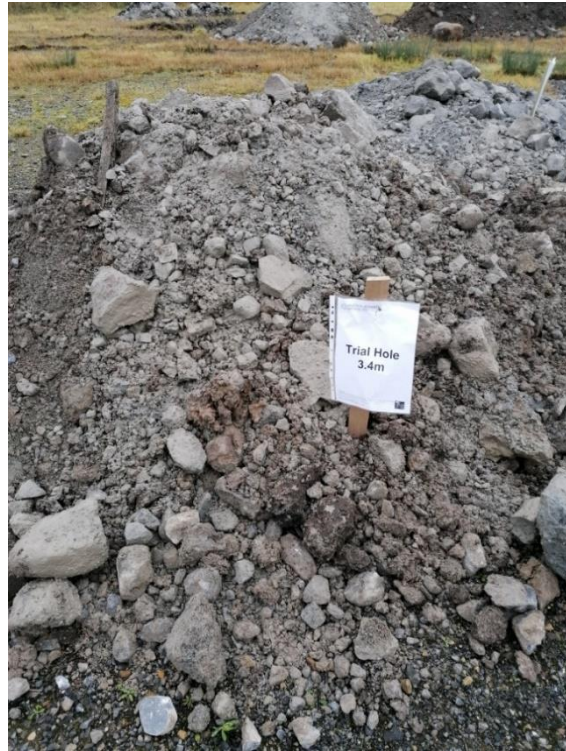
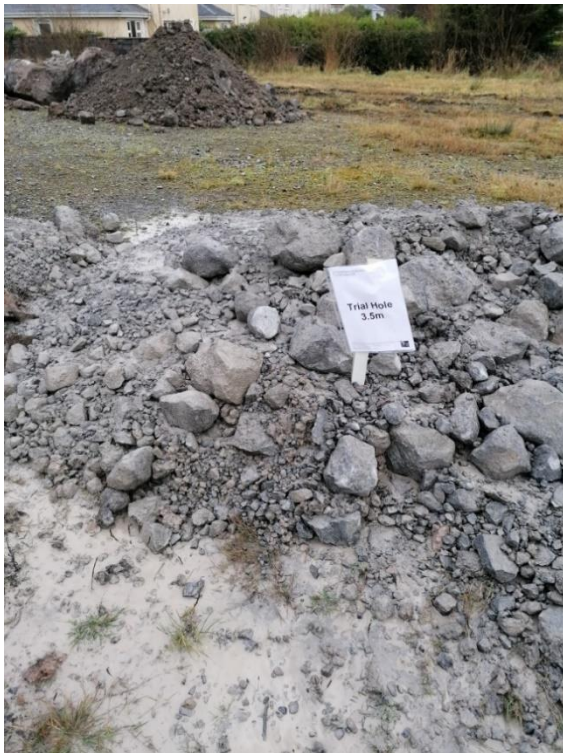
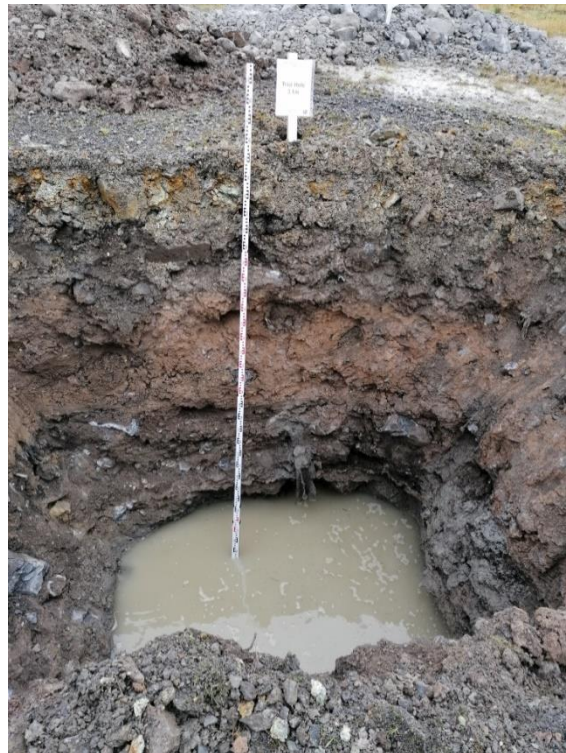
**Trial Hole No.3**

Figure 18: Illustrates trial hole 3 & shows the different horizons within the trial hole.

2-3m	3.3					Stone ,gravel (30-40%) & sand (30%) Boulders (size 0.2m-0.4m) Grey in colour Waste: rags, no other waste observed. Methane results recorded at this level = less than 10ppm <sup>1</sup>		
3-4m	3.4					Boulders, gravel & sand (30%), wet Boulders (size 0.15m-0.3m) No waste observed Grey in colour Methane results recorded at this level = less than 10ppm <sup>1</sup>		
4-5m	3.5					Boulders (30-40%), gravel & sand, wet Boulders (size 0.2m-0.4m) No waste of any kind observed Grey in colour Methane results recorded at this level = less than 10ppm <sup>1</sup>		
<b>Dimensions:</b>					<b>General Remarks:</b>			
Final Depth: 5m

See Appendix I for relevant site photos (Figures 13-18) Miscellaneous waste <1% and include some brick & plastic. No glass, domestic appliances, Asbestos or organic waste was observed. Some ingress of water @ 2.4m. No bedding plane. Trial pit backfilled with arisings on completion.

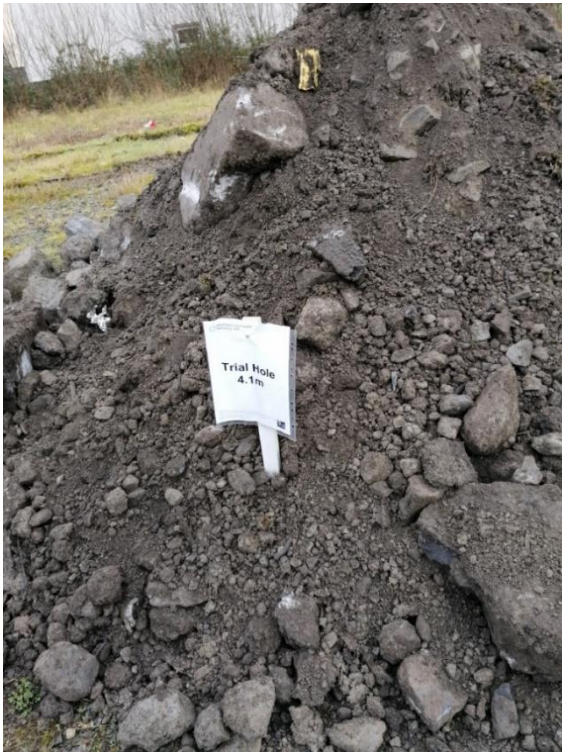
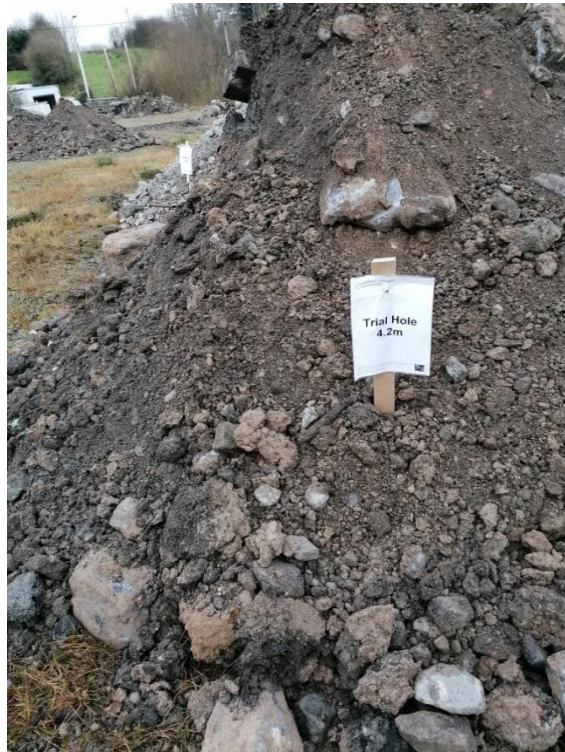
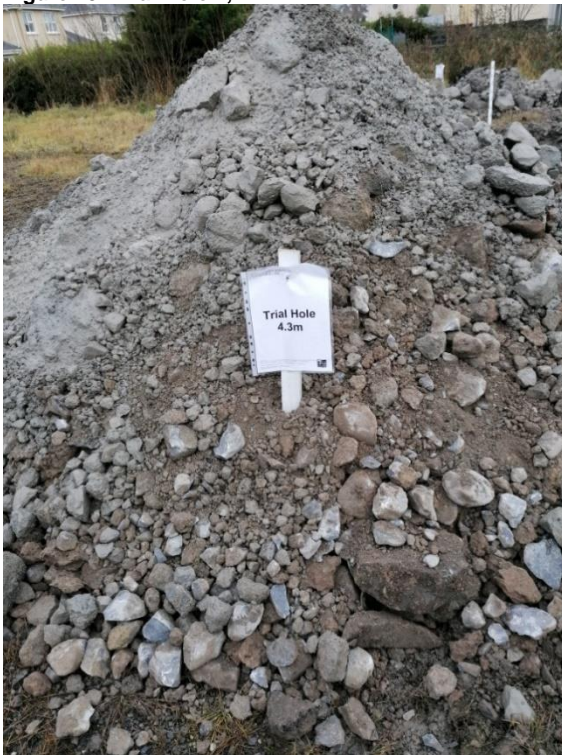
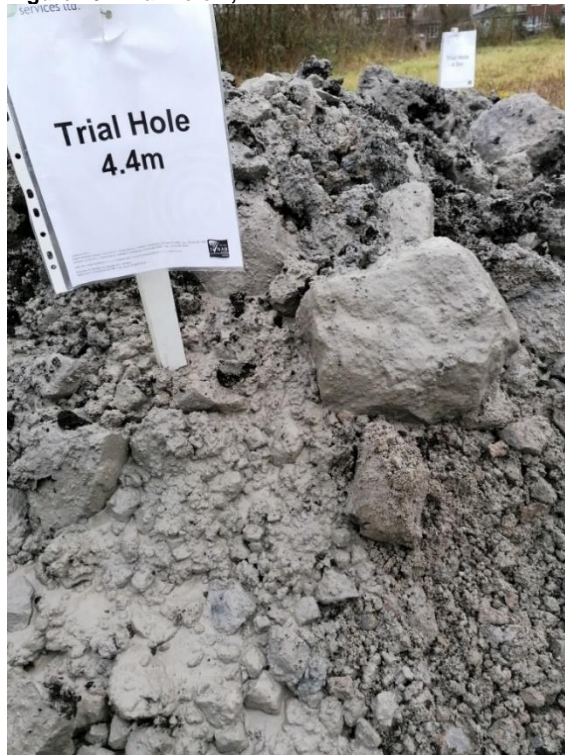
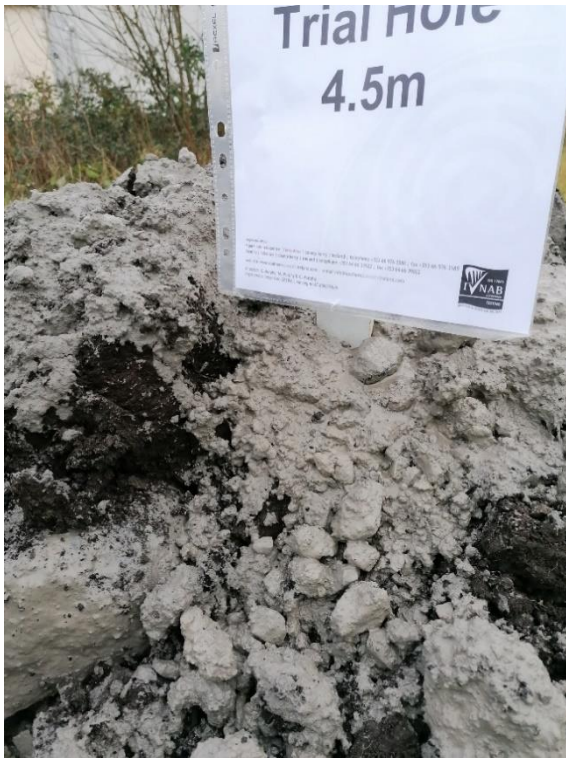
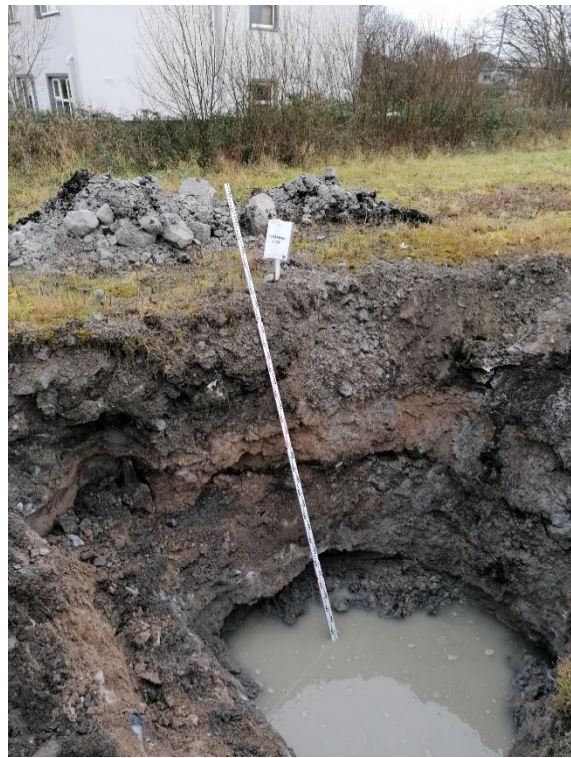
**Trial Hole No.4**

Figure 24: Illustrates trial hole 4 & shows the different horizons within the trial hole.

2.9m BGL	
2-3m	4.3					Gravel (75%), boulders, wet. Boulders (size 0.1m-0.3m) Grey in colour No waste observed. Methane results recorded at this level = less than 10ppm <sup>1</sup>		
3-4m	4.4					Boulders (30-40%), peat & gravel Boulders (size >0.75m) No waste observed Methane results recorded at this level = less than 10ppm <sup>1</sup>		
4-5m	4.5					Boulders (30-50%), gravel (30%) No waste observed Methane results recorded at this level = less than 10ppm <sup>1</sup>

<b>General Remarks:</b> See Appendix I for relevant site photos (Figures 19-24) Grey topsoil to 0.8m. 0.8-2.0m Grey brown soils with stone. 2.0-3.0 soil & stone, >30% boulders >30.0m virgin ground No glass, Asbestos or organic waste observed. Trial pit backfilled with arisings on completion.
--	---
