**APPROPRIATE ASSESSMENT  
REMEDIAL NATURA IMPACT STATEMENT  
Application for Substitute Consent for proposed  
development on Tulla Road, Ennis, Co. Clare**

<b>Requested By:</b>	Valley Healthcare Fund - Infrastructure Investment Fund ICAV
<b>Prepared By:</b>	Brendan O Connor BSc Southern Scientific Services Ltd
<b>Date Reported:</b>	25/02/2022
<b>Our Reference:</b>	21P-264

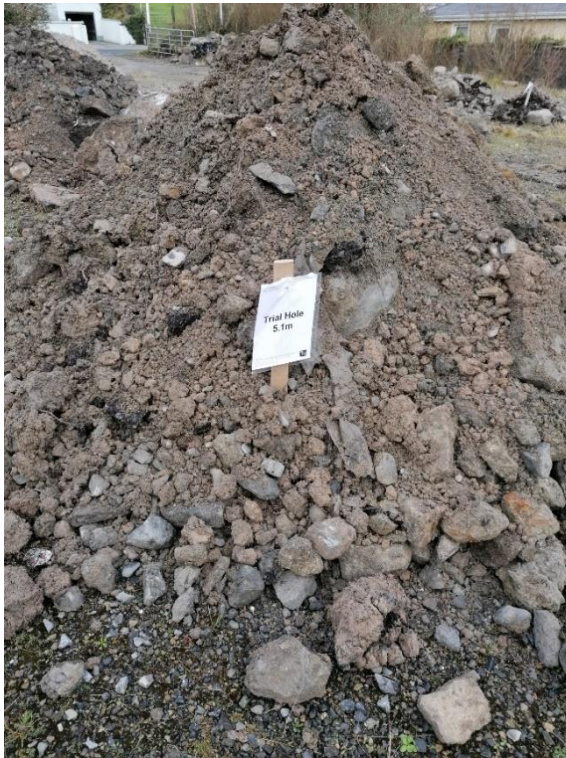
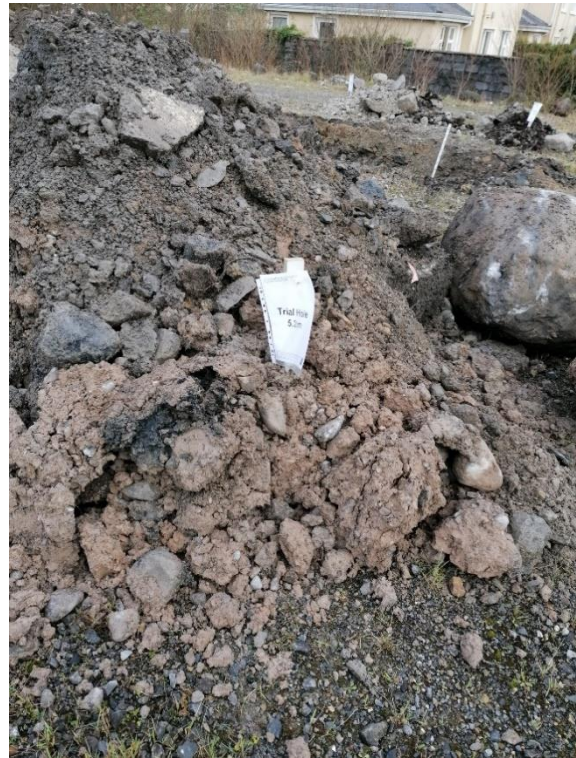
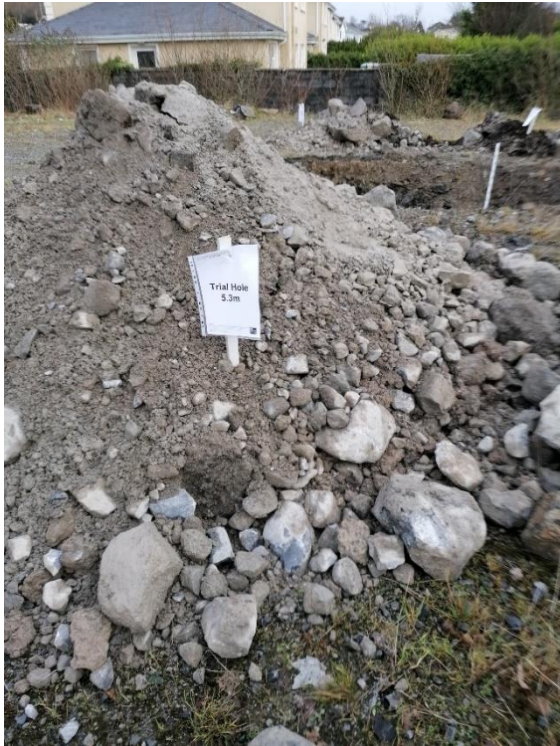
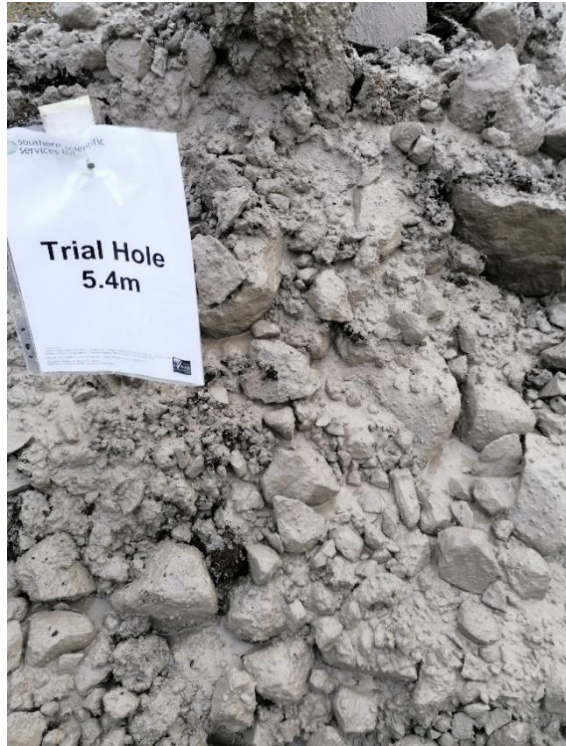
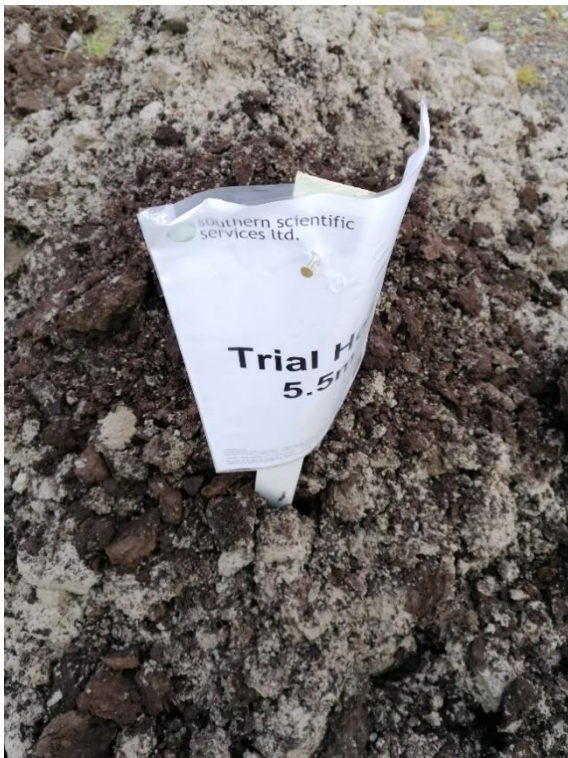
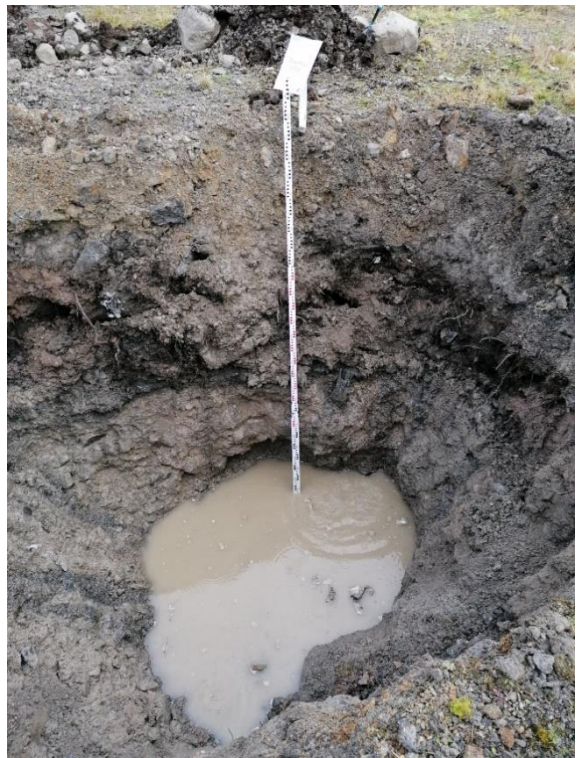
### Trial Hole No.5

Figure 30: Illustrates trial hole 5 & shows the different horizons within the trial hole.

2-3m	5.3					Stone (30-50%) & gravel No waste observed Grey in colour Methane results recorded at this level = less than 10ppm <sup>1</sup>		
3-4m	5.4					Stone (30-50%) & gravel No waste observed Grey in colour Methane results recorded at this level = less than 10ppm <sup>1</sup>		
4-5m	5.5					Peat & soil No waste observed Methane results recorded at this level = less than 10ppm <sup>1</sup>		
<b>Dimensions:</b>					<b>General Remarks:</b>			
<p>Final Depth: 5m</p>

<p>Length (m) 4 m</p> <p>Width (m) 2 m</p> <p>Orientation: °</p>					<p>See Appendix I for relevant site photos (Figures 25-30) Tree roots observed @ 1.2m No large waste, including domestic appliances, no rages, glass, Asbestos or metal observed. Trial pit backfilled with arisings on completion.</p>
