## REMEDIAL ENVIRONMENTAL IMPACT ASSESSMENT

### Ros an Mhíl Deep Water Quay

#### Chapter 16 Schedule of Mitigation

Department of Agriculture, Food and the Marine

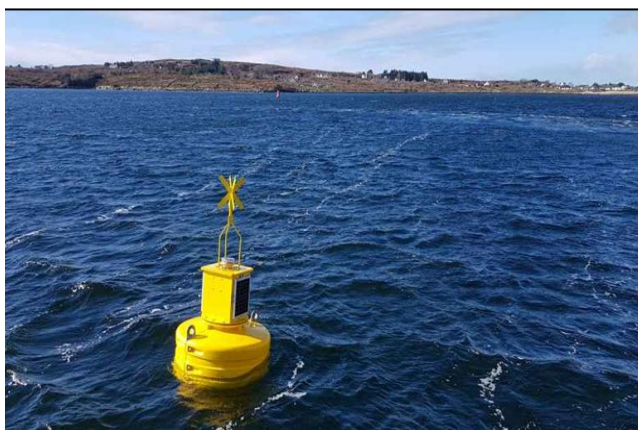
**Figure 16-1: Moored Buoy.**

- Stockpile areas for materials were bunded to prevent surface water runoff into the harbour waters;
- Monitoring buoys were deployed to measure turbidity and dissolved oxygen and relay information to the onshore station. These were fitted with alarms to notify the Contractor and Harbour Master should the limits be exceeded;

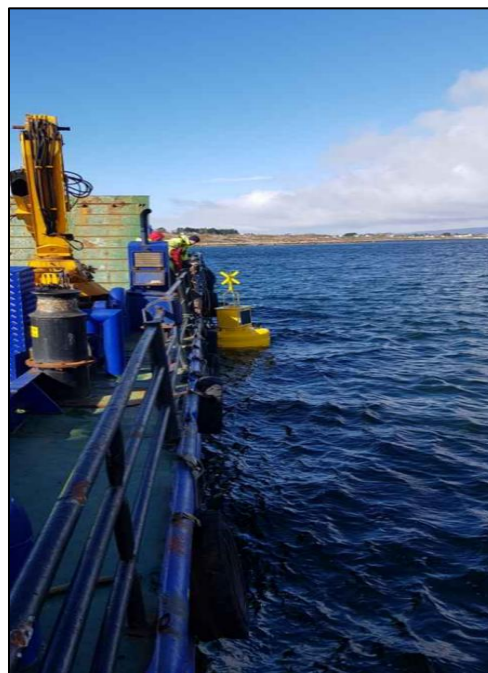
**Figure 16-2: Buoy being deployed.**

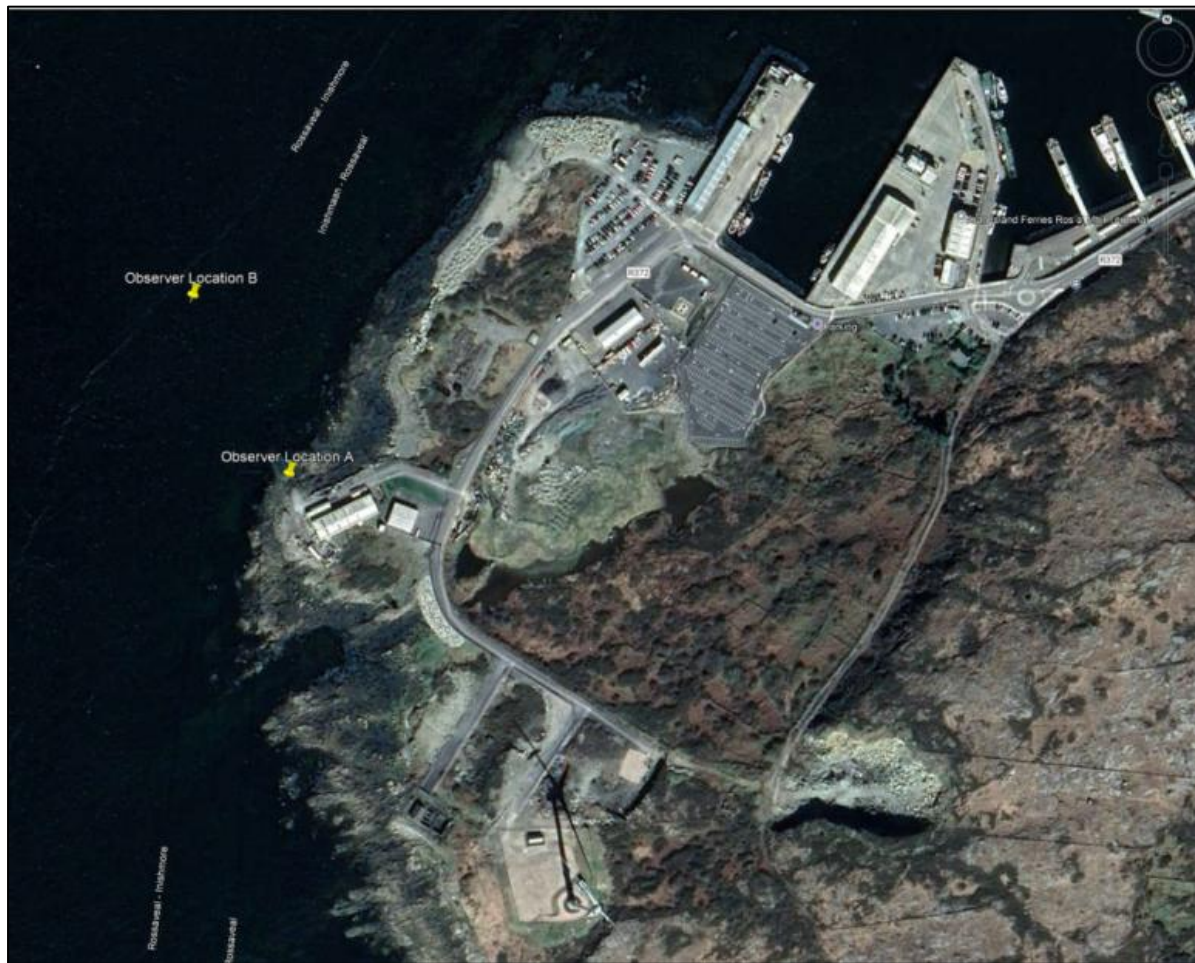
**Figure 16-4: Marine Mammal Observer locations.**

As part of the project requirements, marine mammal observation works for drilling, blasting and dredging operations were undertaken by the contractor between 26<sup>th</sup> June 2023 and 20<sup>th</sup> May 2024. A team of dedicated, experienced Marine Mammal Observers (MMOs) were engaged to conduct marine mammal mitigation activities during drilling, blasting and dredging operations for the project. One dedicated, JNCC-certified Marine Mammal Observer (MMO) was present for drilling, blasting and dredging operations, respectively. The MMO conducted 30-minute visual pre-work watches during daylight hours for marine mammals prior to the operations, and the MMO observations were conducted on site from land. The operations were conducted in accordance with the Department of Arts, Heritage and the Gaeltacht (DAHG) 'Guidance to Manage the Risk to Marine Mammals from Man-made Sound Sources in Irish Waters' (2014) which outlined industry best practice approach to mitigate against any possible disturbance to marine mammals. **Figure 16-4** shows the MMO locations.
