**REMEDIAL SCREENING FOR APPROPRIATE  
ASSESSMENT REPORT AND REMEDIAL  
NATURA IMPACT STATEMENT**

**Ros an Mhíl Deep Water Quay**

**Department of Agriculture, Food and the Marine**

**October 2025**

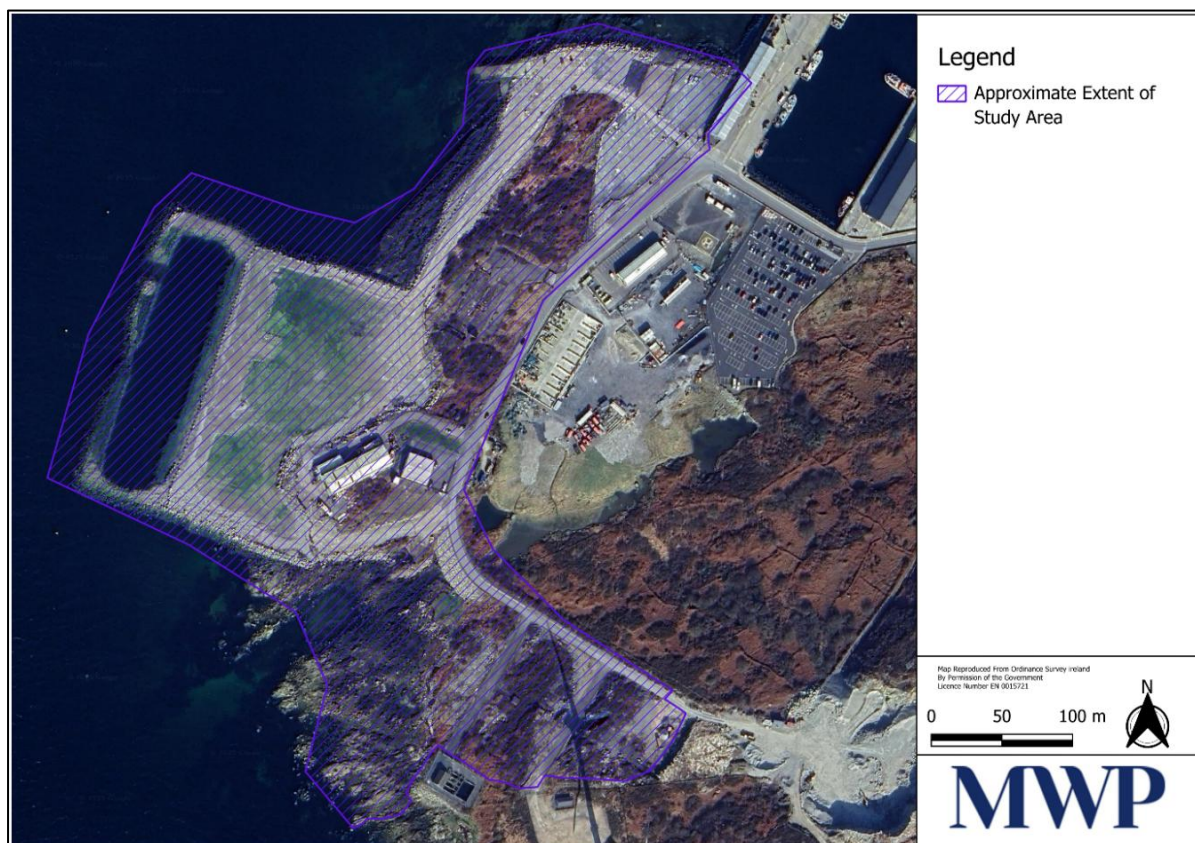
**Figure 1: Approximate extent of study area encompassing the development site and publicly accessible adjoining areas.**

The study area for the field surveys is shown in **Figure 1**, below and for this assessment was taken as the entire development site near Ros an Mhíl Harbour as well as the adjoining habitats (including part of Cashla<sup>10</sup> Bay).

The study area for the 2025 ecological surveys carried out by MWP was the entire development site near Ros an Mhíl Harbour and the publicly accessible surrounding lands as shown in **Figure 1**, above

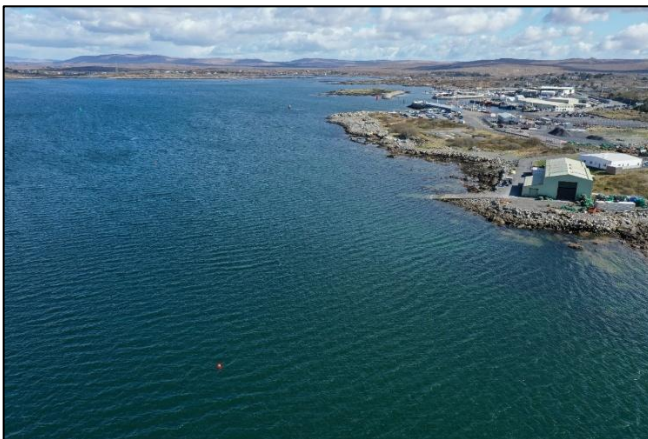
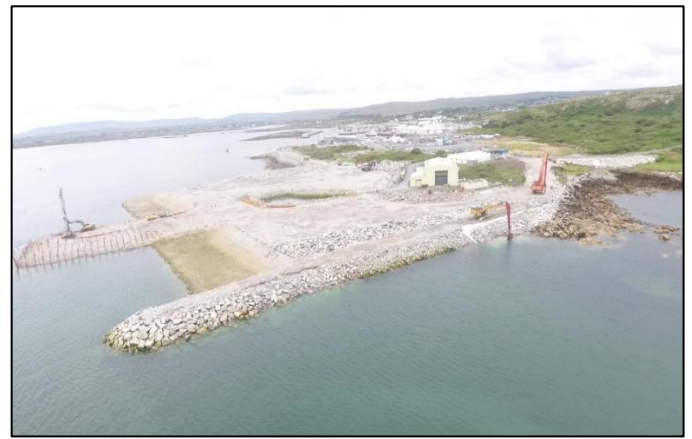
**Figure 3: Photographs of development site showing status pre commencement and status on 10th July 2023**

**Site Status Pre-Commencement**

**Site Status 10<sup>th</sup> July 2023**

On the basis of the foregoing, prior to the end of the appropriate period or “life” of the permission on 10<sup>th</sup> July 2023, significant works had been completed. Approximately 90% of the 2.4 hectares reclamation was complete and 15% of the rock blasting in the middle of the berthing pocket and quay wall trench was complete (see **Figure 3**).

The reclamation involved the use of imported engineering fill material transported from local quarries to the site, tipping from the lorries and use of excavators to place and level the material. The approximate quantity placed is 390,000 tonnes of stone.

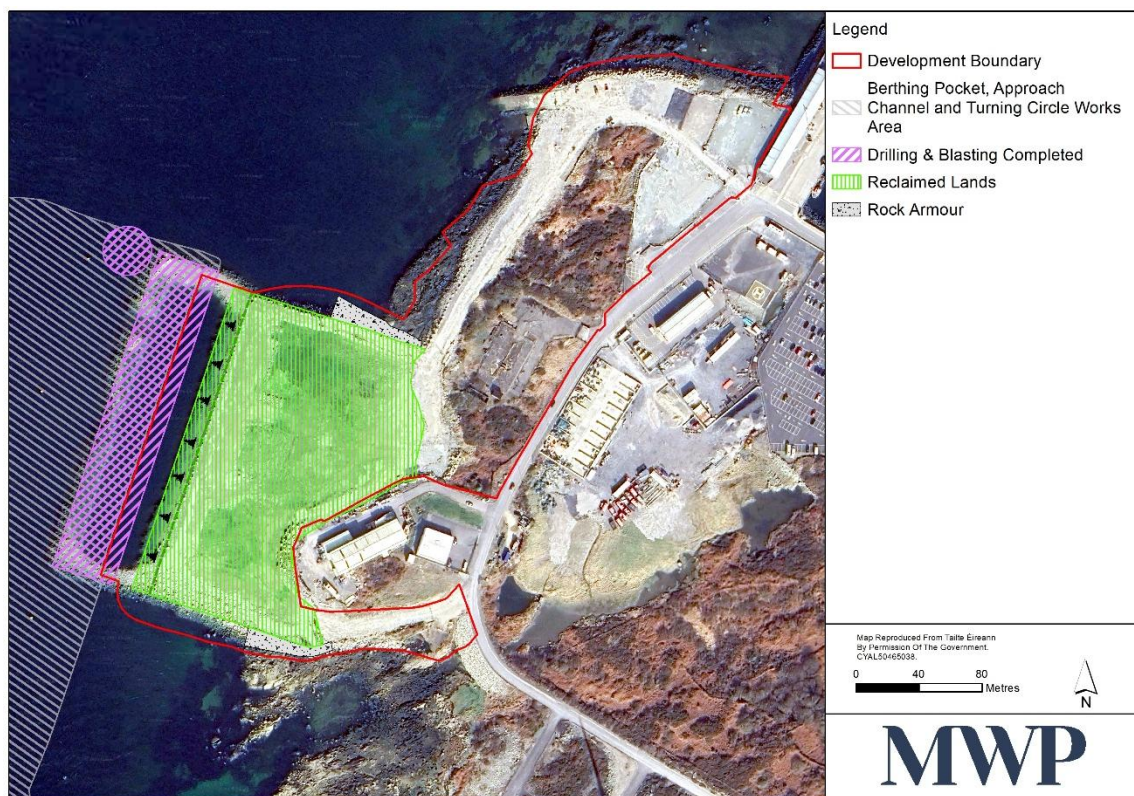
**Figure 4: Map indicating the development works area, including the reclamation area, the blasting and dredging areas, the berm construction areas and rock armour placed undertaken between Jan 2023 and May 2024**

The area of drilling and blasting for the quay wall and berthing area undertaken is indicated in purple in **Figure 4**. The relevant Planning Drawings of these works are 24984-XX-DR-MWP-CE-5010, 24984-XX-DR-MWP-CE-5011, 24984-XX-DR-MWP-CE-5012 and 24984-XX-DR-MWP-CE-5013.

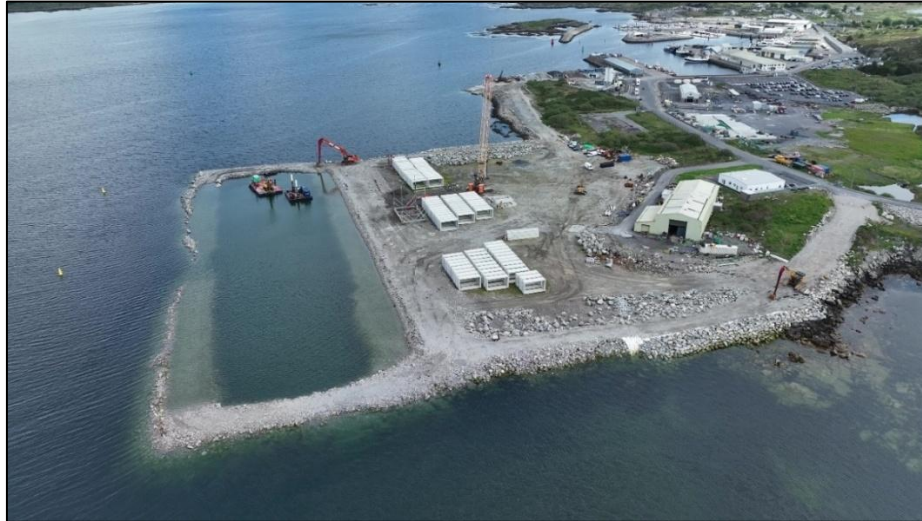
**Figure 5: Site Status on 20<sup>th</sup> May 2024 when the works ceased.**

When works were suspended in May 2024 (see **Figure 5**), all the contractor's equipment, facilities and materials were removed from site. The caissons and beams that had been delivered but not installed were returned to the manufacturer. This removal process took place between 20<sup>th</sup> May – 29<sup>th</sup> Oct 2024. A photograph of the final cleared site is provided in **Figure 6**.

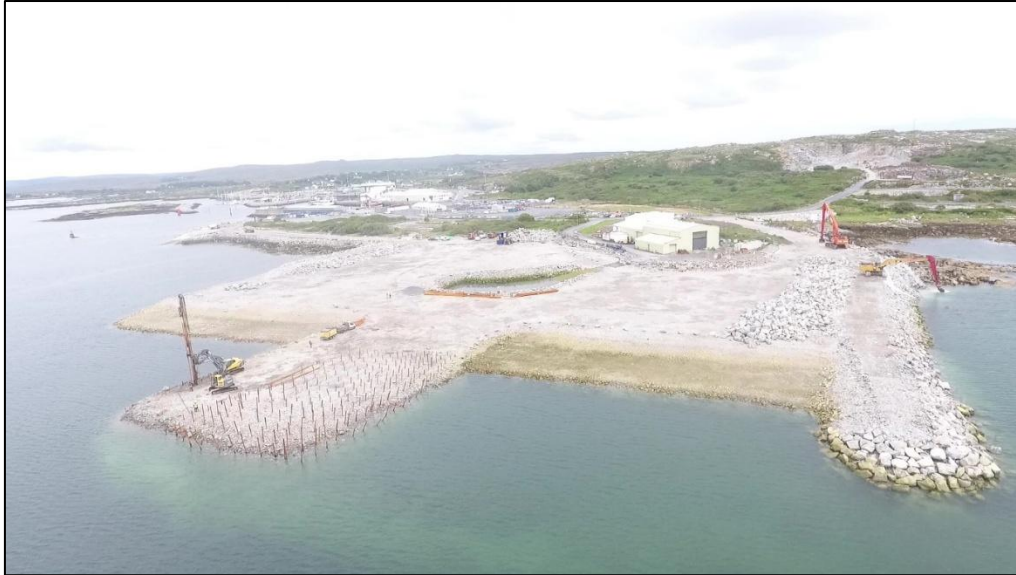
**Figure 7: Photograph of the development site on the 10th July 2023 indicating the reclaimed area when the 2017 planning permission expired.**

within the centre of the reclaimed lands). Also the first three temporary blasting platforms for the quay wall trench and berthing pocket had been constructed and the drilling and blasting was completed on two of the three platforms. The only additional reclamation works undertaken during the works period for which substitute consent is being sought was the filling of the remaining hole in the centre of the reclamation area shown in **Figure 7**.

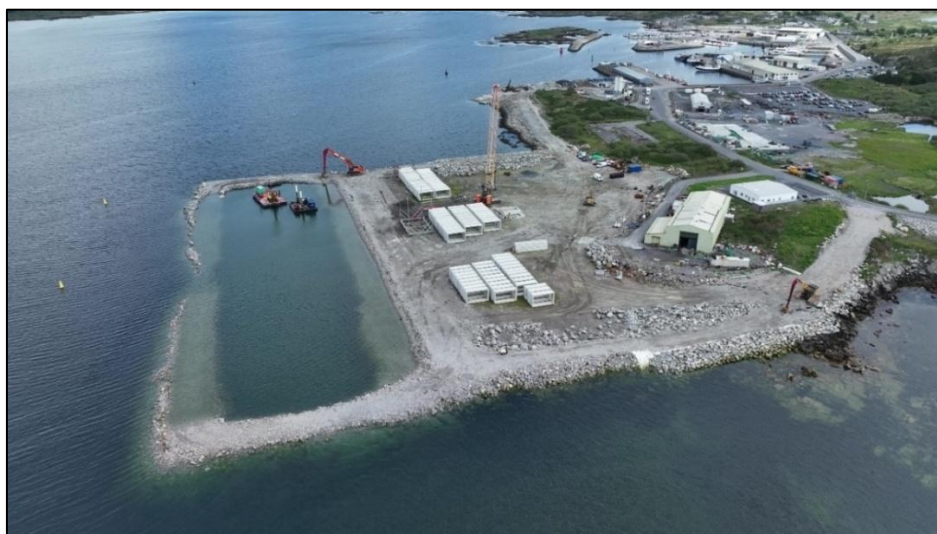
**Figure 8: Site Status on 14 May 2024 when the presumed lawful works ceased.**

In order to create a safe working environment for the construction of the quay wall, a temporary protective rock berm north, south and west of the proposed quay wall was constructed. **Figure 8** provides a photograph of this temporary protective berm around the quay wall trench. The quay wall trench is located in the middle of the lagoon within the berm. The berm structure is needed temporarily to facilitate the construction of the quay wall. Imported rock from local quarries was used to construct the northern and southern berms and dredged rock from the blasting areas was used to construct the remainder (west side) of the protective berm.

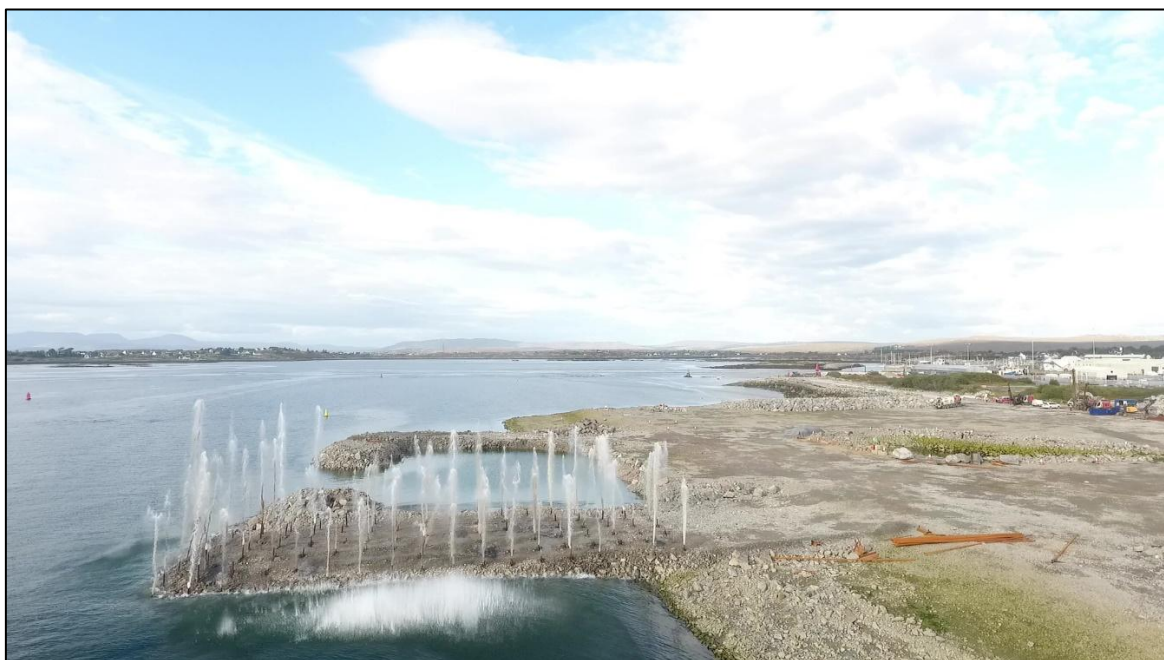
Figure 10: Photograph of a platform blasting event.

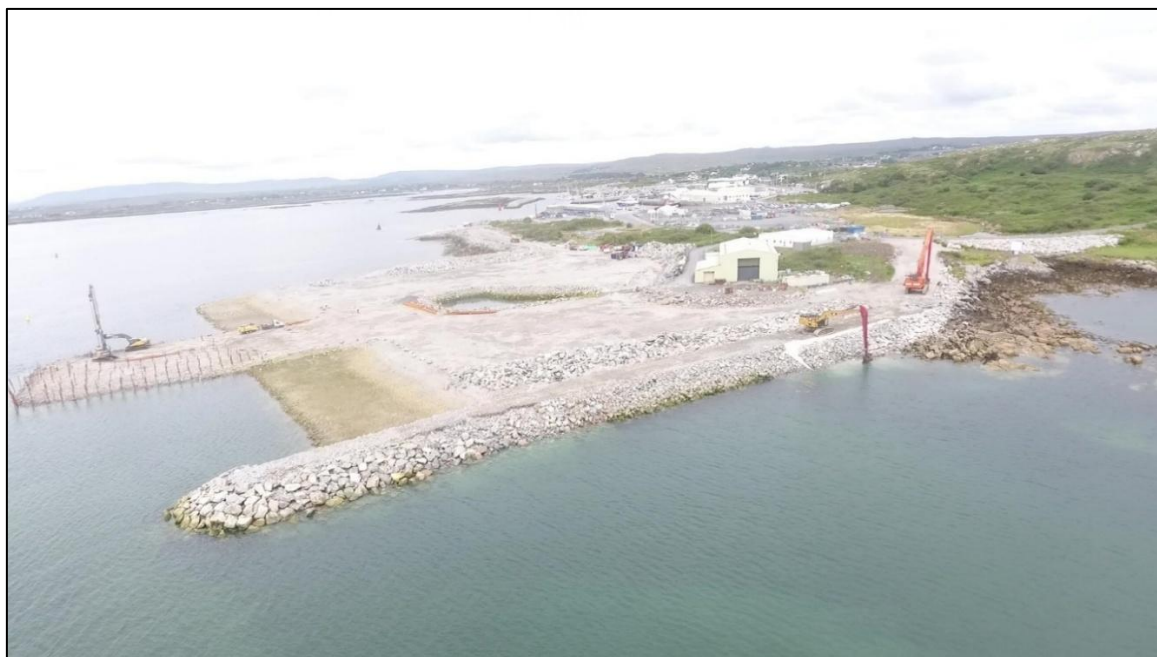
**Figure 11: Southern protective berm with initial 3 blasting platforms in the middle of the quay wall trench on 12 July 2023.**

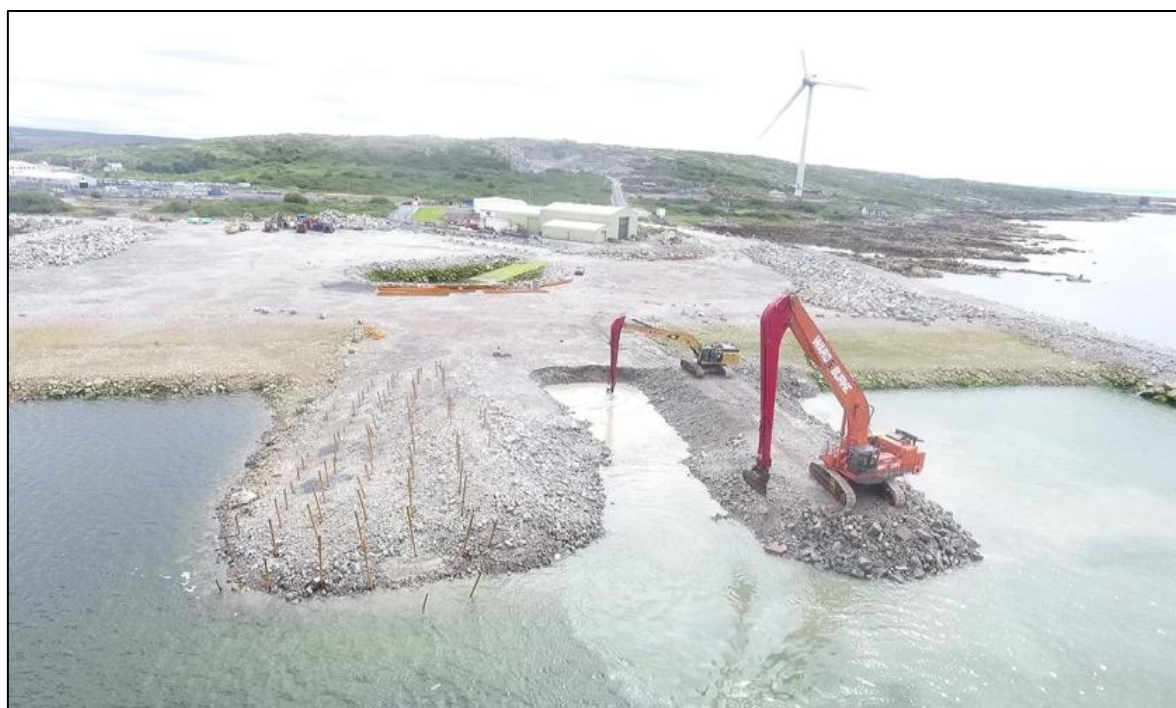
**Figure 12: Construction of blasting platform 5 on 18th July 2023.**

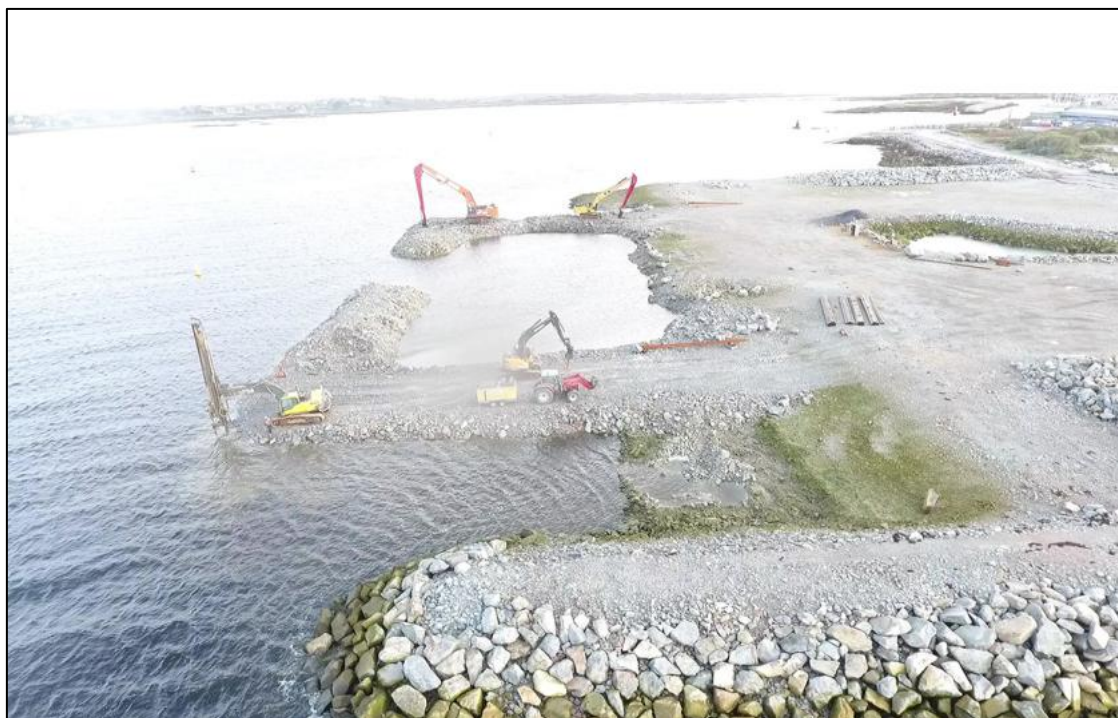
**Figure 13: Construction of two blasting platforms on 26th Sept 2023.**

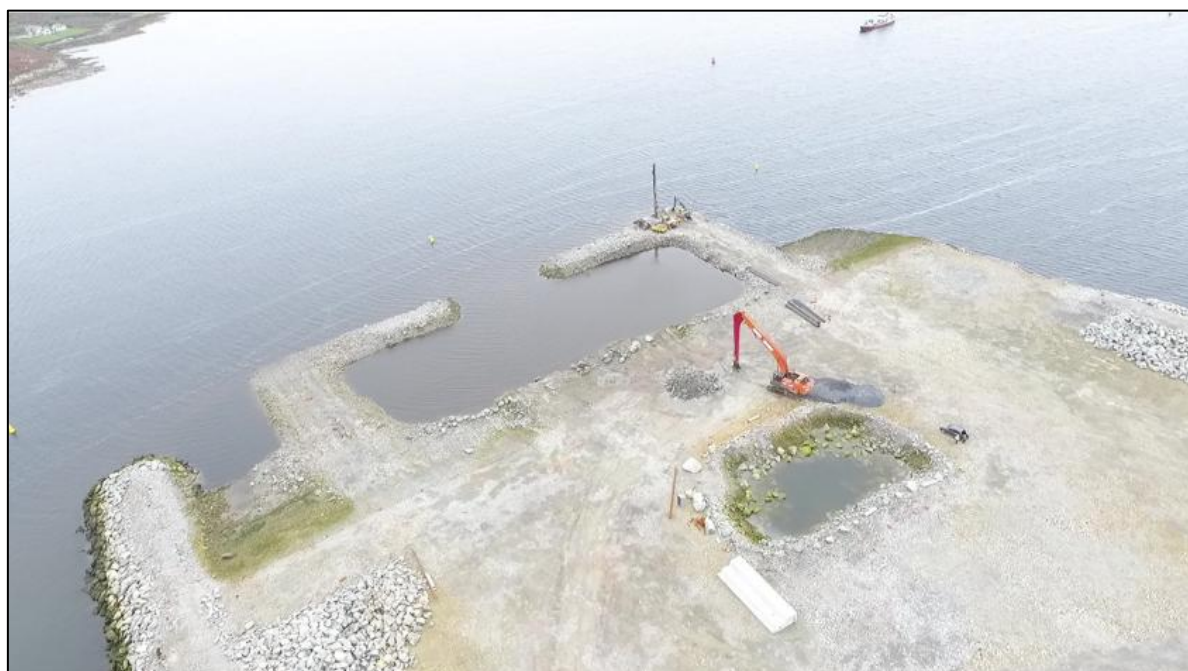
**Figure 14: Progress with blasting platforms on 11 Oct 2023.**

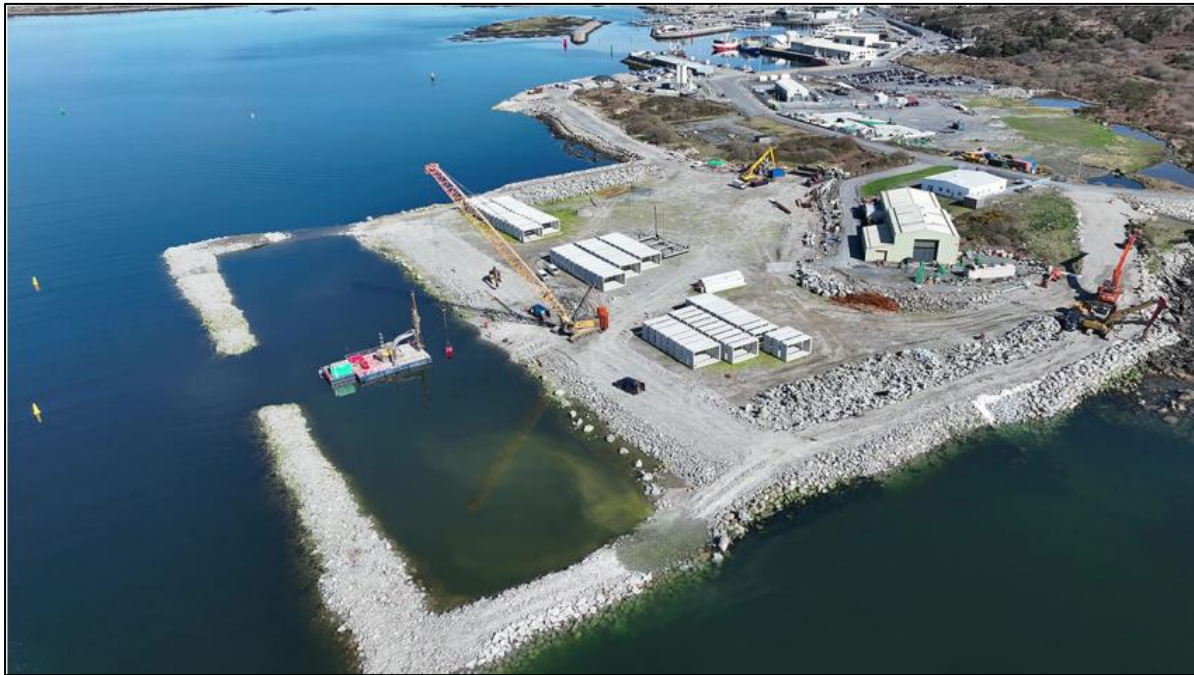
Figure 15: Quay wall trench and protective berm on 20th March 2024.

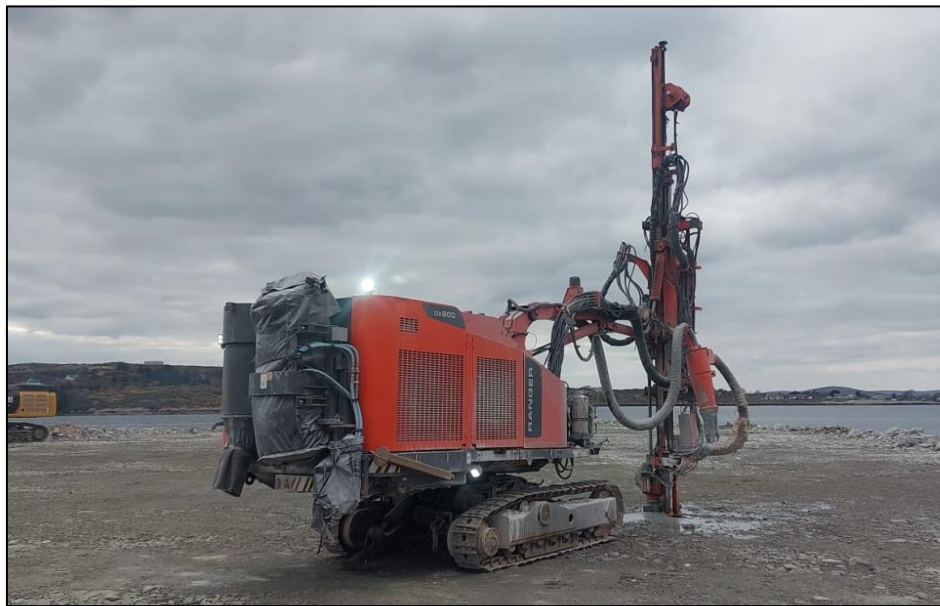
Figure 16: Drilling Rig used to drill the blasting holes.

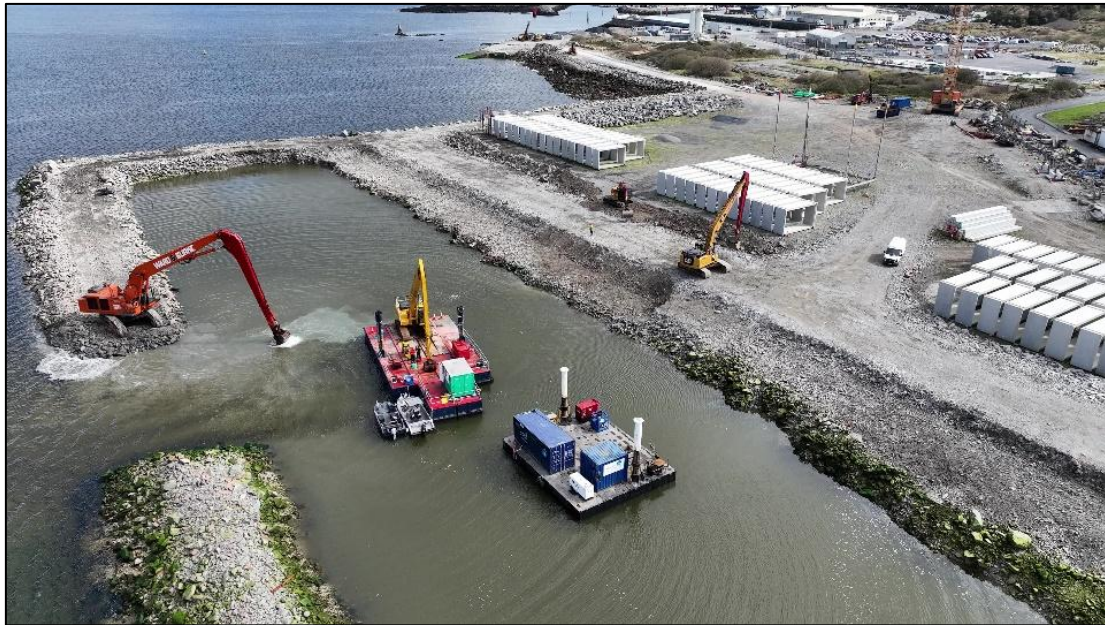
**Figure 17: Photograph showing use of excavators on the protective berm and on floating pontoons in the constructed lagoon.**

The dredging of the blasted rock began just after the 11th July 2023 using excavators on the platform and/or on floating pontoons. The dredged rock was used to create each new blasting platform and the protective temporary berm on the sea (west) side of the quay wall trench (see **Figure 17**). All the dredged material was rock rather than sand or silt. These works are subject of the substitute consent application.

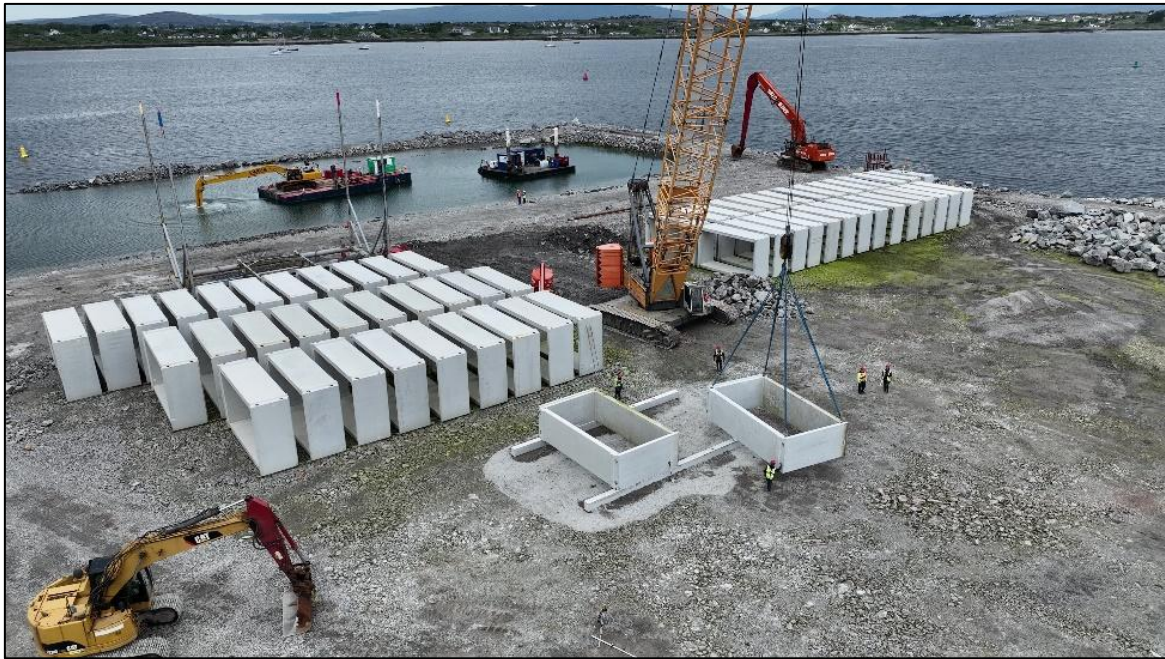
Figure 18: Photograph showing the (7m x 4m x 2m) concrete caisson boxes being positioned on precast concrete foundation beams positioned on the ground during a field trial on land.

These foundations consisted of precast reinforced concrete ground beams (12m long x 0.35m wide x 0.5m high) placed along front and rear lines of the previously permitted quay wall. The pre-cast concrete beams for the quay wall had been constructed off-site and were delivered.

**Figure 18** illustrates how caissons are placed on top of the foundation beams. The foundation beams are lowered into the quay wall trench using land-based cranes and a levelling frame designed specially to lower the beams into position. **Figure 19** shows this lowering frame with two beams attached before it was lowered into the quay wall trench. This frame has four adjustable hydraulic legs, which, once lowered into the trench and sitting on the bed, are adjusted to level the beams and frame to the correct level for the foundations of the Quay wall. The top of the foundation beams need to be at a level of minus 10m Chart Datum on the 200m long front wall of quay and at minus 4.74mcd on the return walls of the quay. Once correctly positioned, divers' direct liquid concrete delivered via a Tremie Pipe (see **Figure 20**) to surround the concrete beams to hold them in position and ensure their stability and proper bearing. Once concreted into position, and after allowing sufficient time for the concrete to cure, the frame operator releases the beams, and proceeds with the installation of the next set of beams.

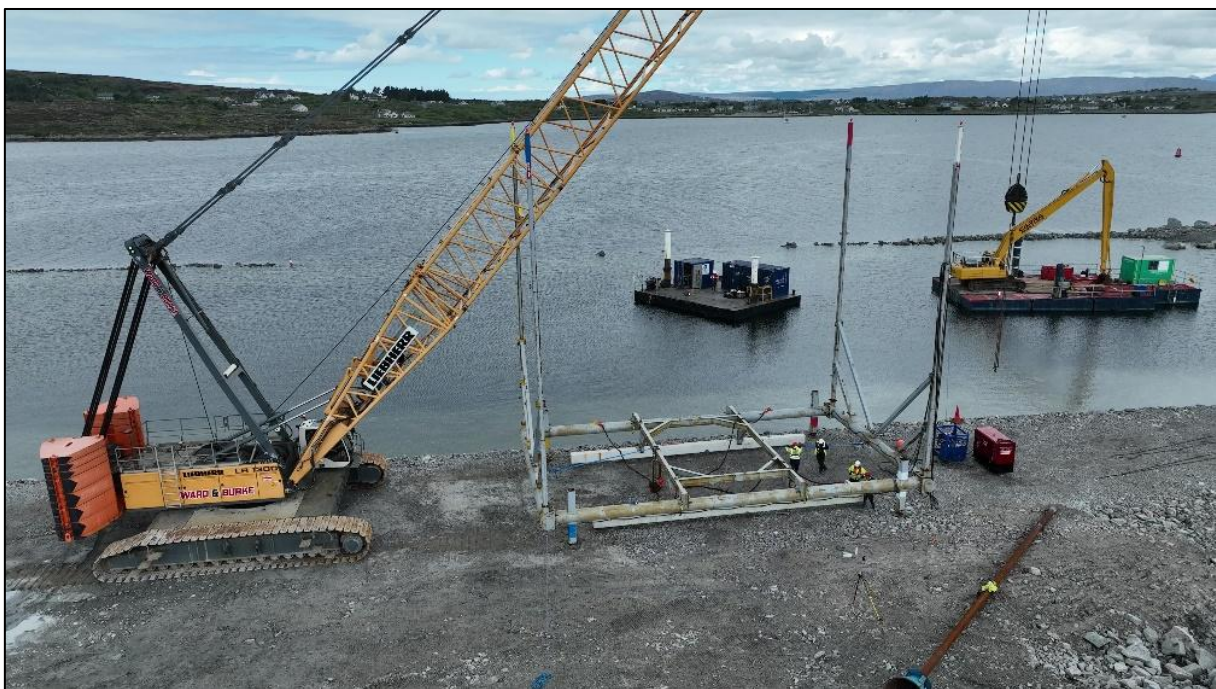
Figure 19: Bespoke frame used to accurately lower and position the foundation beams for the quay wall in the trench.

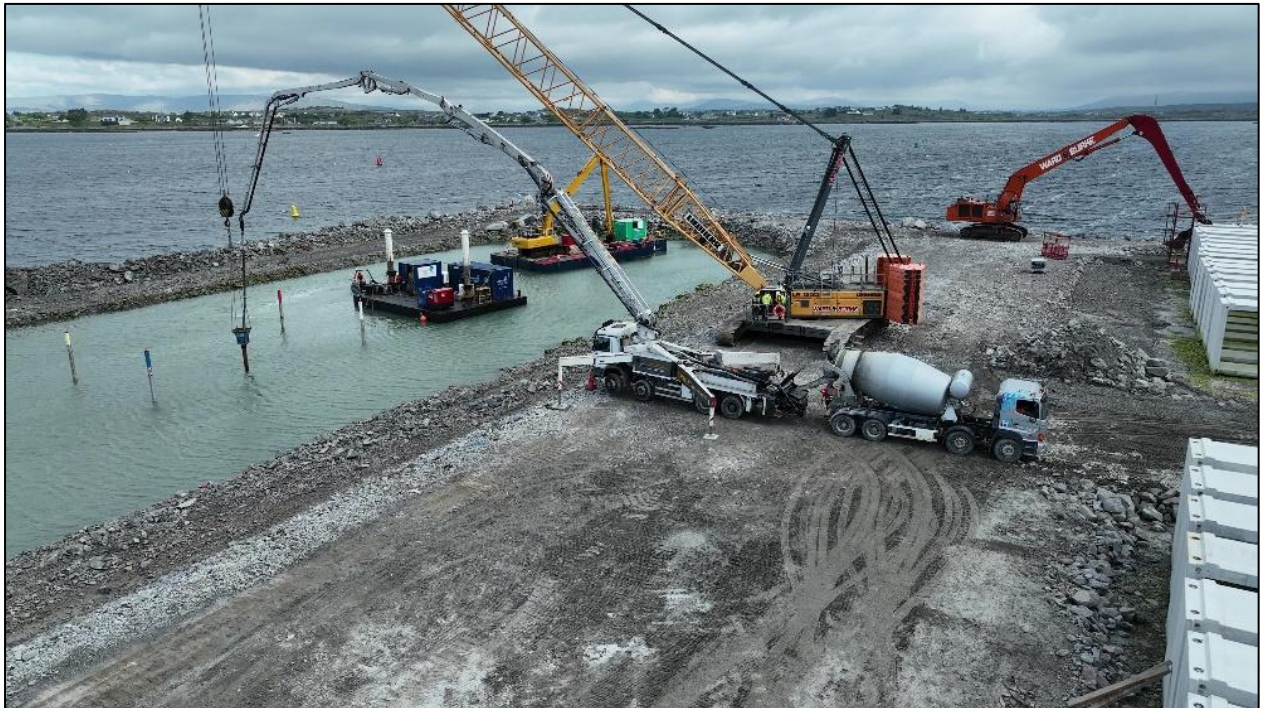
**Figure 20: Liquid concrete being delivered via Tremie Pipe and directed by underwater divers to surround and hold the foundation beams in place.**

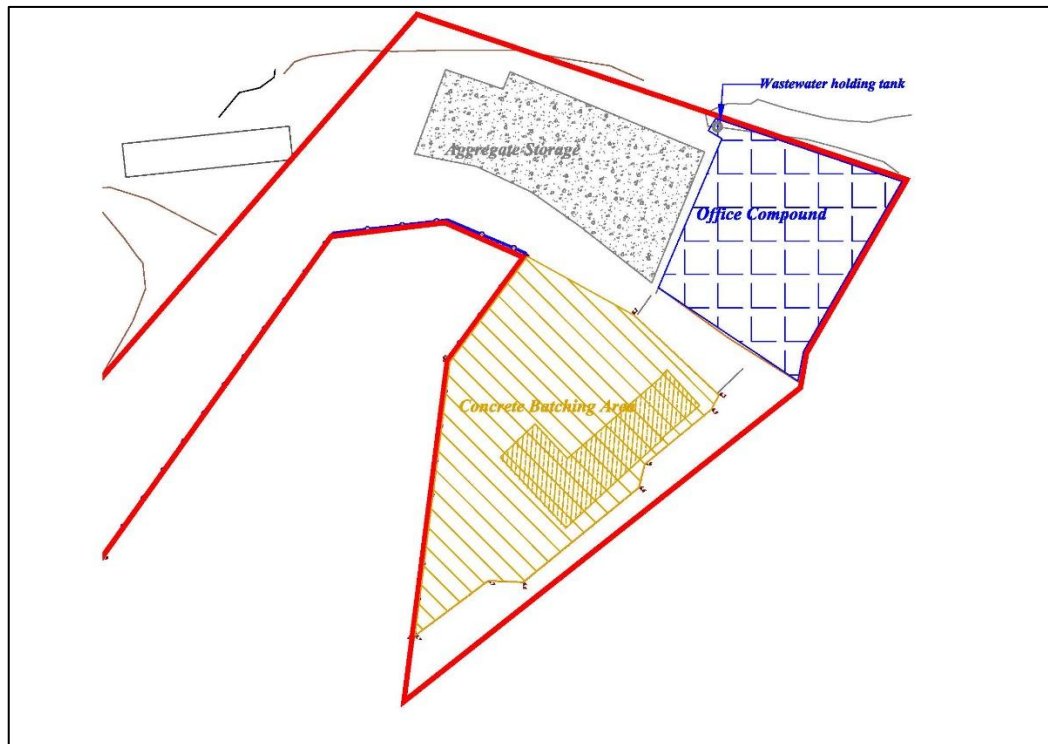
Figure 21: Layout for the Construction Compound Facilities at the northern end of the proposed development site.

The compound was put in place prior to the expiration of the appropriate period of Planning Ref. 17/967 and remained in place and operational during the period 11th July 2023 and 20th May 2024 and therefore falls within the scope of the substitute consent application.

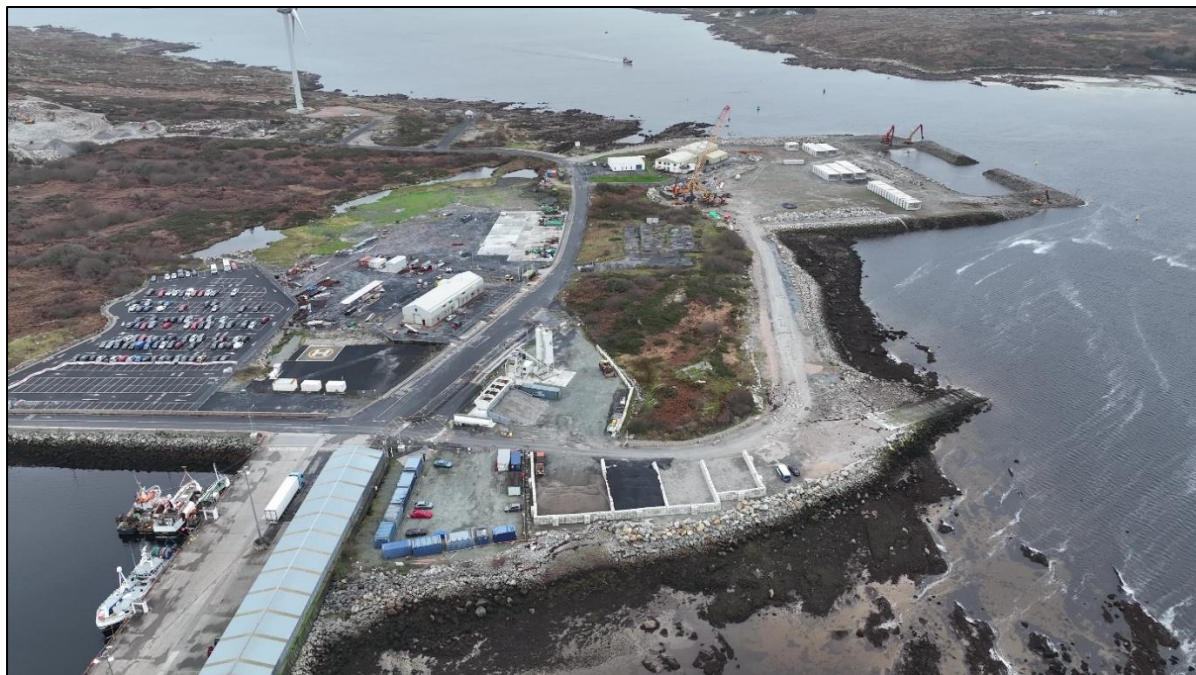
Figure 22: Photograph on the 14th Dec 2023 View of Compound, Concrete Batching Plant, Aggregate Storage Areas in foreground with works area in background.

A temporary contractor's compound was located in the northern corner of the project site adjacent to the existing Ros an Mhíl harbour facilities in a surfaced area previously used for parking (see **Figures 21 to 23**). This site included temporary site offices (Portacabins), staff welfare facilities and car parking, and equipment lay down areas.

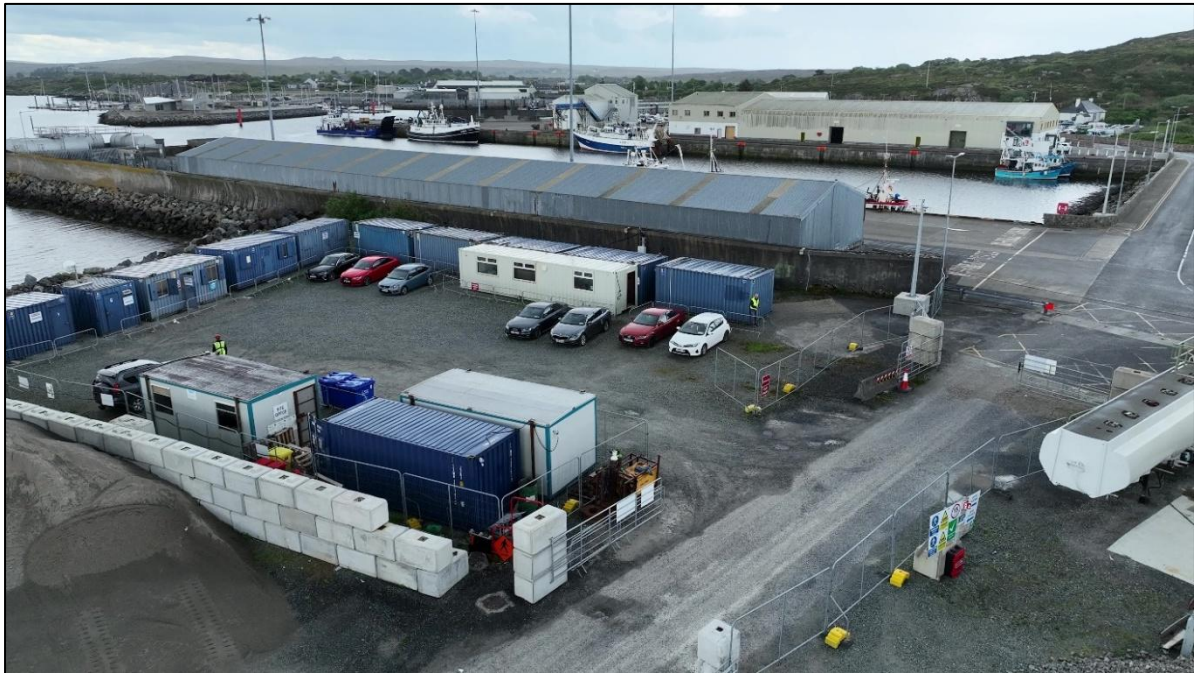
Figure 23: Photograph of the Construction compound with offices, storage and parking areas.

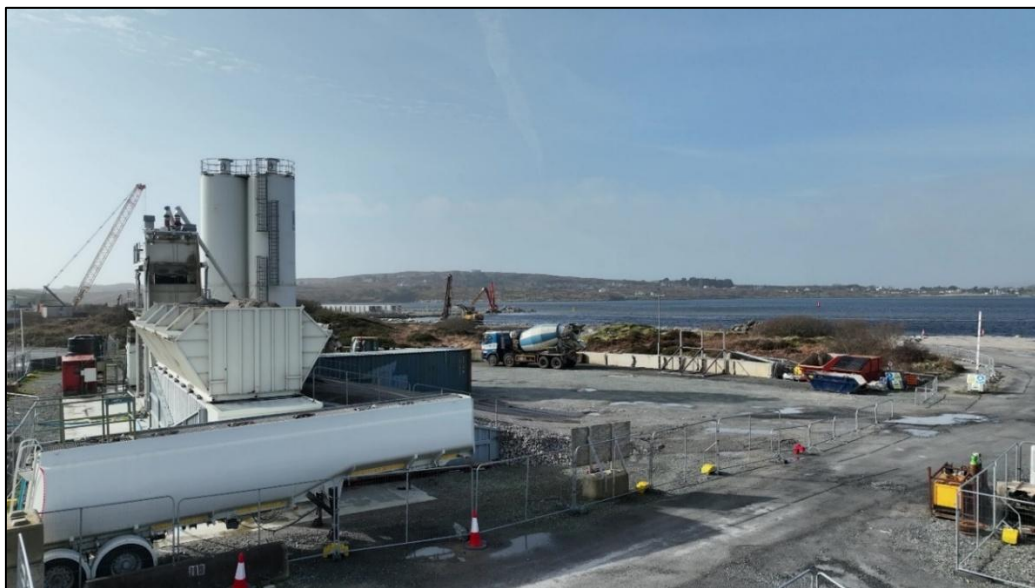
Figure 24: Photograph of the mobile Concrete Batching Plant and water storage tank.

A project specific ready-mix concrete batching plant also formed part of the construction facilities provided on site (see **Figure 24**) during the substitute consent period 11th July 2023 and 20th May 2024. A concrete base for the plant was constructed in September 2023 and the batching plant was installed in October 2023. This plant was used to provide concrete for the construction of the quay wall foundations. When the construction works ceased in May 2024, the batching plant was removed from site.

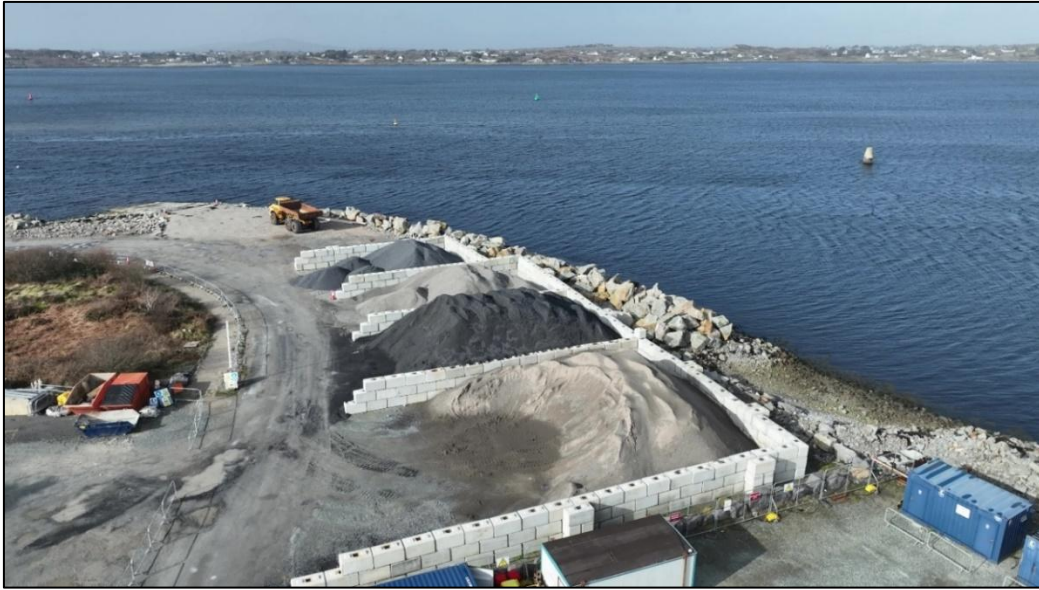
**Figure 25: Storage areas for the construction materials and supplies for the concrete production plant adjacent to the construction compound.**

Storage areas for the construction materials and supplies for the concrete production plant were located adjacent to the construction compound (see **Figure 25**).

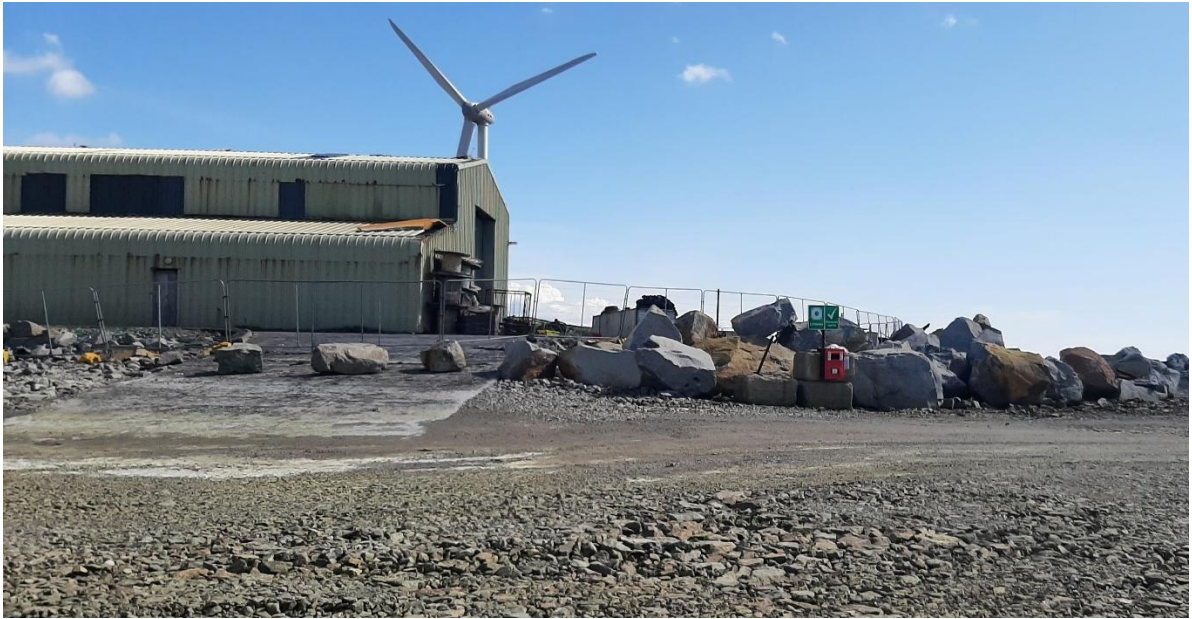
**Plate 1. Westernmost Údarás na Gaeltachta building and reclaimed land, both classified as Building and Artificial Surfaces (BL3), with Stone Walls and Other Stonework (BL1) to the right of the middleground.**

**Buildings and artificial surfaces (BL3)** is the predominant terrestrial habitat type within the development boundary. It encompasses the reclaimed land and approach causeway, both Pier 1 and Pier 2, the Údarás na Gaeltachta buildings, Cashla Bay Lighthouse, the R372 and other local roads, and all existing structures and car parks with artificial surfaces (refer to **Figure 26**, above, for building locations). The reclaimed land was created predominantly by importation of engineering fill material, and to a lesser extent reusing blasted and dredged seabed substratum. Small areas of **Stone walls and other stonework (BL1)** consisting of large rocks and boulders occur on reclaimed land to the west and north of the Údarás na Gaeltachta buildings.

Both these artificial habitat types are devoid, or almost devoid, of any vegetation. Refer to **Plate 1**, below (see also **Plate 2** and **Plate 3**, below).

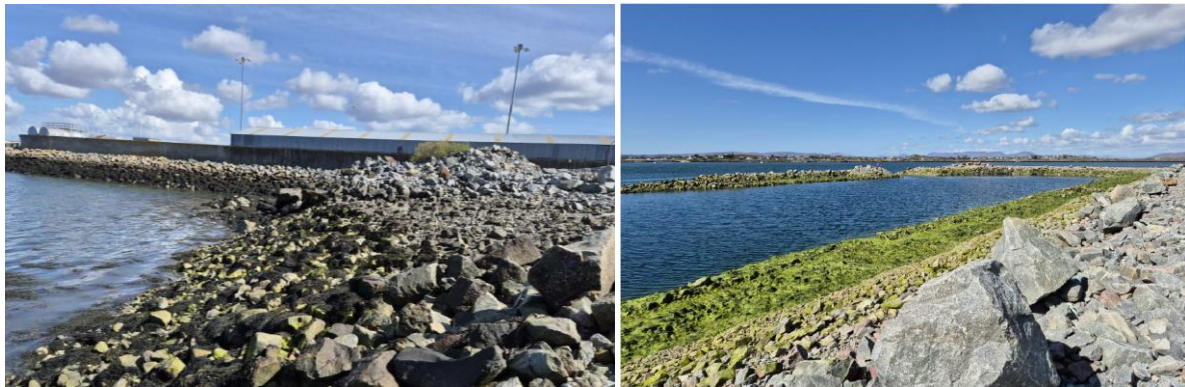
**Plate 2. Sea Walls, Piers and Jetties (CC1) and Open Marine Water (MW1) – (left) at northeast corner with Pier 1 in background, and (right) rectangular rock berm with green seaweed (*Enteromorpha* spp.) layer.**

On the seaward sides of the development area, there are **Sea walls, piers and jetties (CC1)** consisting mainly of protective rows of large rocks and boulders that are partially or totally inundated by sea water during tidal movements. The rocks and boulders of the upper shore that are subject to wave splash and sea spray display patches of the black lichen (*Verrucaria maura*). At the lower shore, where the rocks and boulders are periodically completely inundated, fucoids and kelps occur. Refer to **Plate 2**, below.

Also categorised as this habitat type is the rectangular configuration of protective rocks constructed at the western side of the site at the proposed deep water quay location. Measuring approximately 215 metres long and 60 metres wide, this rectangle of rocks is covered in layers of ephemeral green seaweed (*Enteromorpha* spp.) during the summer months - see **Plate 2**, below.

Extending away from the site to the west, north and south into the bay is **Open marine water (MW1)**. This also describes the marine habitat found within the protective rectangular berm - see **Plate 2**, below.

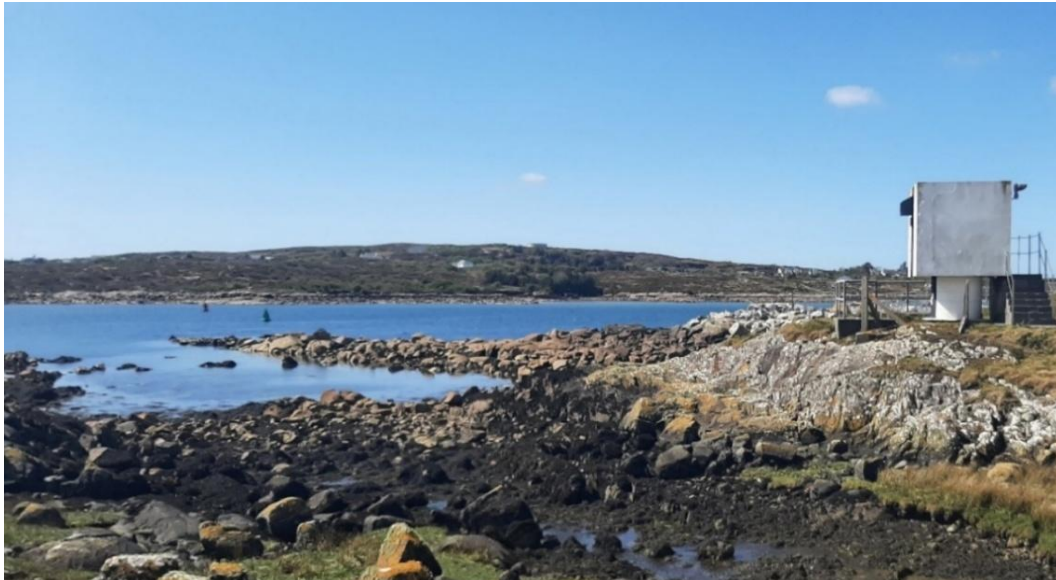
**Plate 3. West-facing view across Cashla Bay - Open Marine Water (MW1) and Exposed Rocky Shores (LR1) (with visible lichen zone) transitioning to Moderately Exposed Rocky Shores (LR2). Cashla Bay Lighthouse, categorised as Buildings and Artificial Surfaces (BL3), is located on the right.**

The small section of shoreline south of Cashla Bay Lighthouse is classified as **Moderately exposed rocky shore (LR2)** and is comprised of boulders and rock and a smaller lichen zone than more exposed rocky shorelines. Black lichen and fucoids occur on the lower shore while at upper sections there are some patchy occurrences of terrestrial vascular plants like scurvygrass (*Cochlearia* spp.) and thrift (*Armeria maritima*) – see **Plate 3**, below.

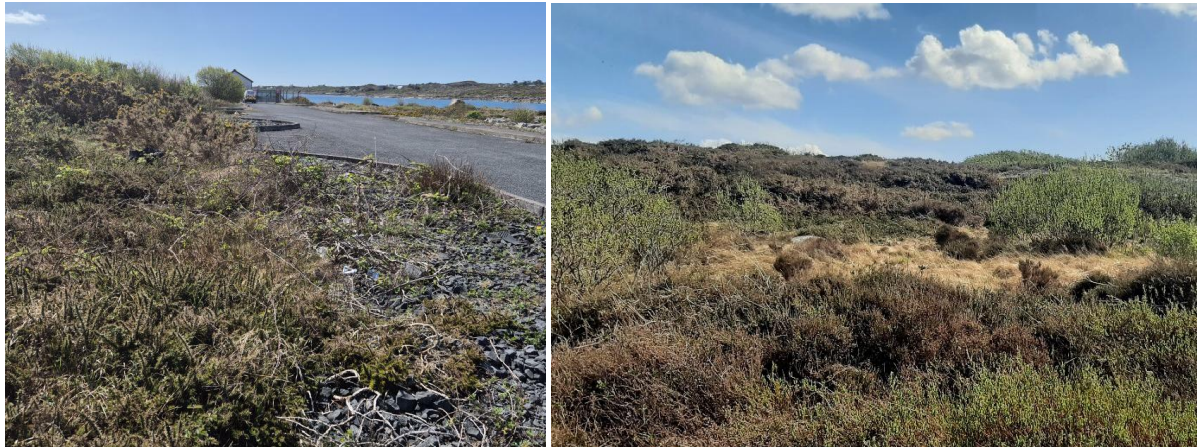
**Plate 4. Area of Scrub (WS1) / Recolonising Bare Ground (ED3) adjacent to the R372 road classified as Buildings and Artificial Surfaces (BL3) (left), and Scrub (WS1) at northeast corner of study area near Pier 1.**

Two areas comprised of a **Scrub (WS1) / Recolonising Bare Ground (ED3)** mosaic are located to the southeast of the redline boundary adjacent to the Lir Environmental Research wind turbine and the R372. Vegetation within these areas is varied but dominated by gorse (*Ulex europaeus*), bramble (*Rubus fruticosus* agg.), and willow (*Salix* spp.) and typical ruderal species including dandelion (*Taraxacum* spp.) and ragworts (*Senecio* spp.) – refer to **Plate 4**, below.

An area of **Scrub (WS1)** in the northwestern region of the study area is dominated by dense gorse, bramble, heather, and bracken (*Pteridium aquilinum*) with patches of purple moor-grass (*Molinia caerulea*) and scattered willow trees also present - refer to **Plate 4**, below.

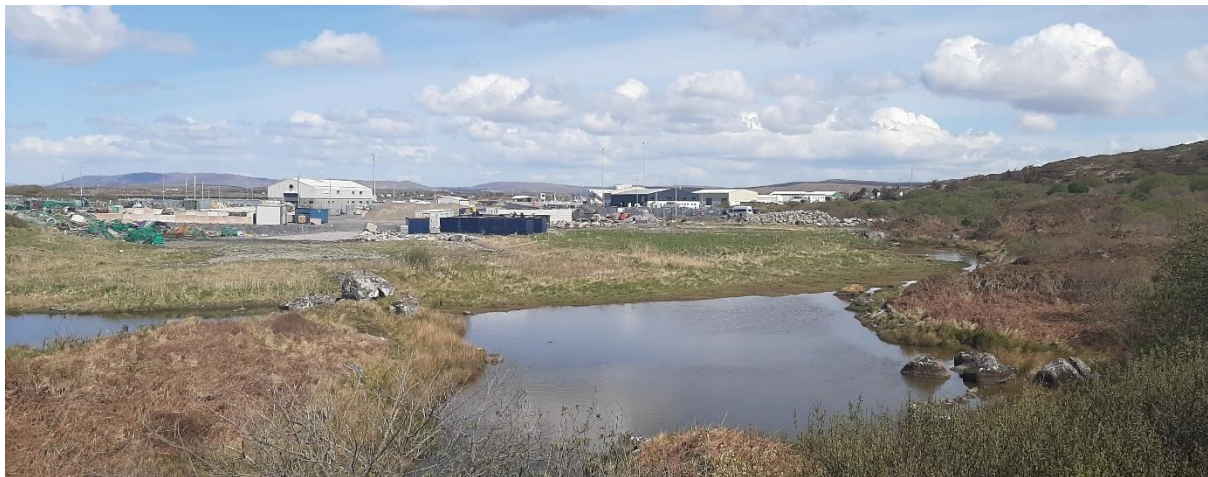
**Plate 5. Northeast-facing view of Lagoons and Saline Lakes (CW1) fringed by Upper Salt Marsh (CM2) (in middleground) and large tract of Scrub (WS1) / Dry Siliceous Heath (HH1) extending away to the right.**

The eastern side of the study area consists of a large tract of **Scrub (WS1) / Dry siliceous heath (HH1)** mosaic stretching from close to the Harbour Offices on Pier 1 southwards to where the R372 terminates near the Lir Environmental Research wind turbine. Dominant floral species at this habitat includes gorse of varying heights, dense bracken, willow, ivy, and ling (*Calluna vulgaris*) with the occasional occurrence of single, young stands of holly (*Ilex aquifolium*) and rowan (*Sorbus aucuparia*). Ground flora at the edge of this habitat supports species including dandelion, primrose (*Primula vulgaris*), coltsfoot (*Tussilago farfara*), and silverweed. See **Plate 5**, below
