**Remedial Stage 1: Appropriate
Assessment - Screening and Stage
2: Natura Impact Statement**

**Substitute Consent Application
at
Ardcahan Quarry, Dunmanway, Co.
Cork**

**On behalf of
Murray Brothers Tarmacadam Ltd.**

Job Number: E2049

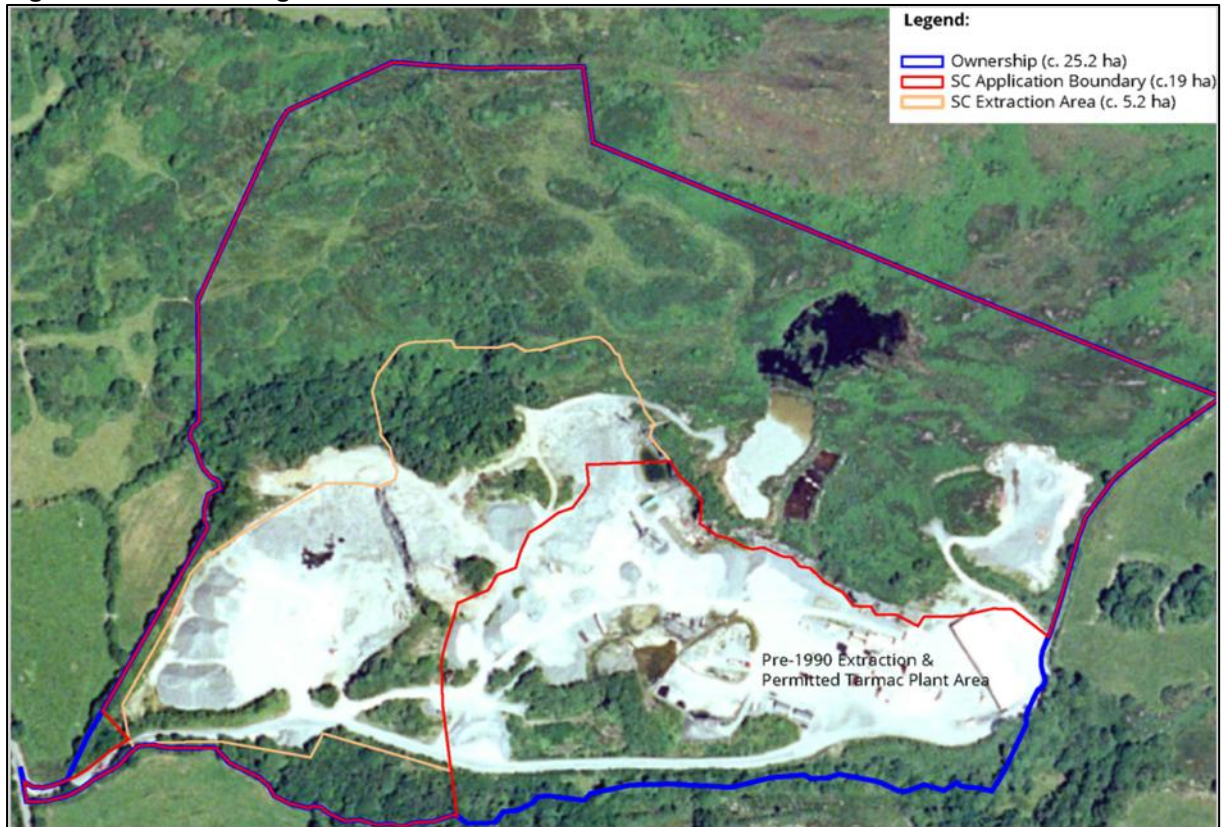
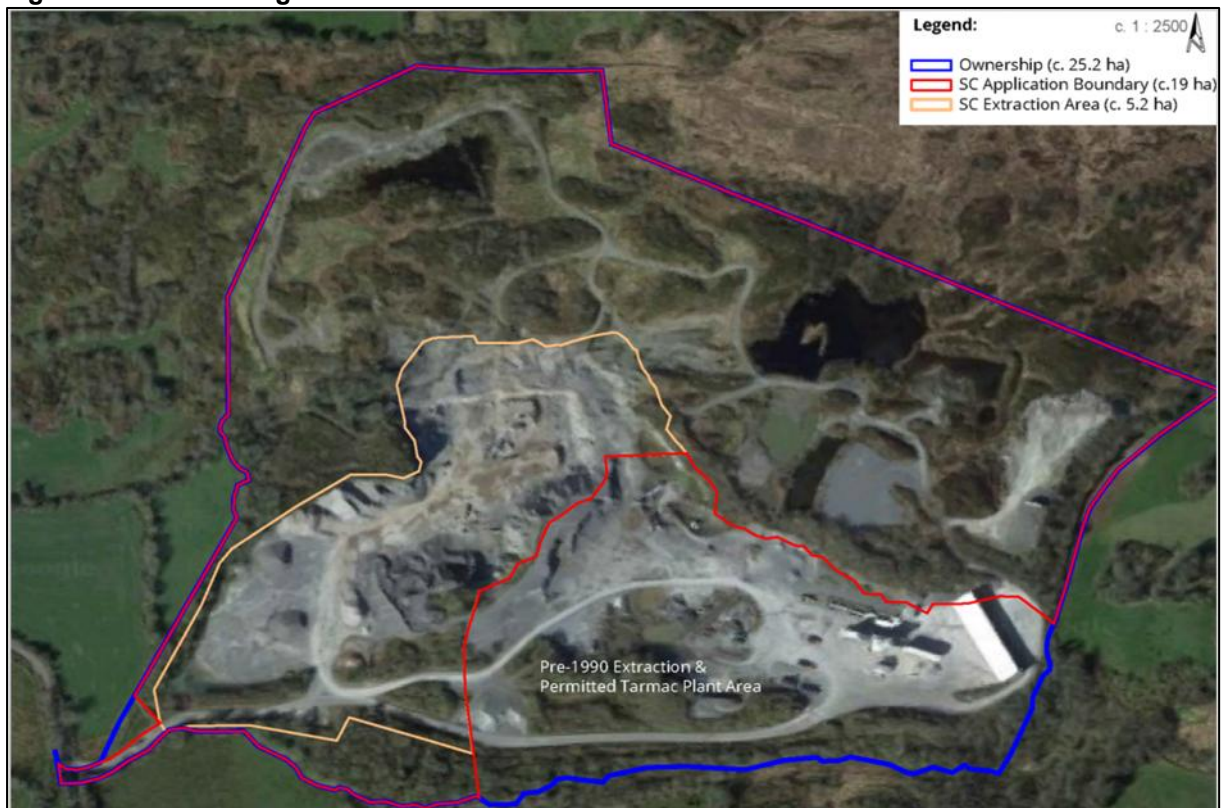
It is highlighted that some areas within the site, which may appear as worked-out areas in the aerial photography, were actually used for ancillary purposes such as stockpiling topsoil and quarried material (e.g. to the north of the tarmacadam plant). These areas are not included in the 'extraction area' figures presented in Table 3-1 but do form part of the 'quarry development' area for which Substitute Consent is being sought. Conversely, the former extraction area includes small pockets of vegetation which appear unquarried in more recent aerial imagery due to natural recolonisation.

Aerial Imagery from 1995, 1996, 2001, 2006 and 2013 provides evidence of changes within the Site. Through a desktop study of these images, the baseline habitats considered likely to be present during each year were identified and analysed. No aerial imagery is available prior to 1995. Refer to Figures 3-1 to 3-4 for historic aerial imagery of the Site.

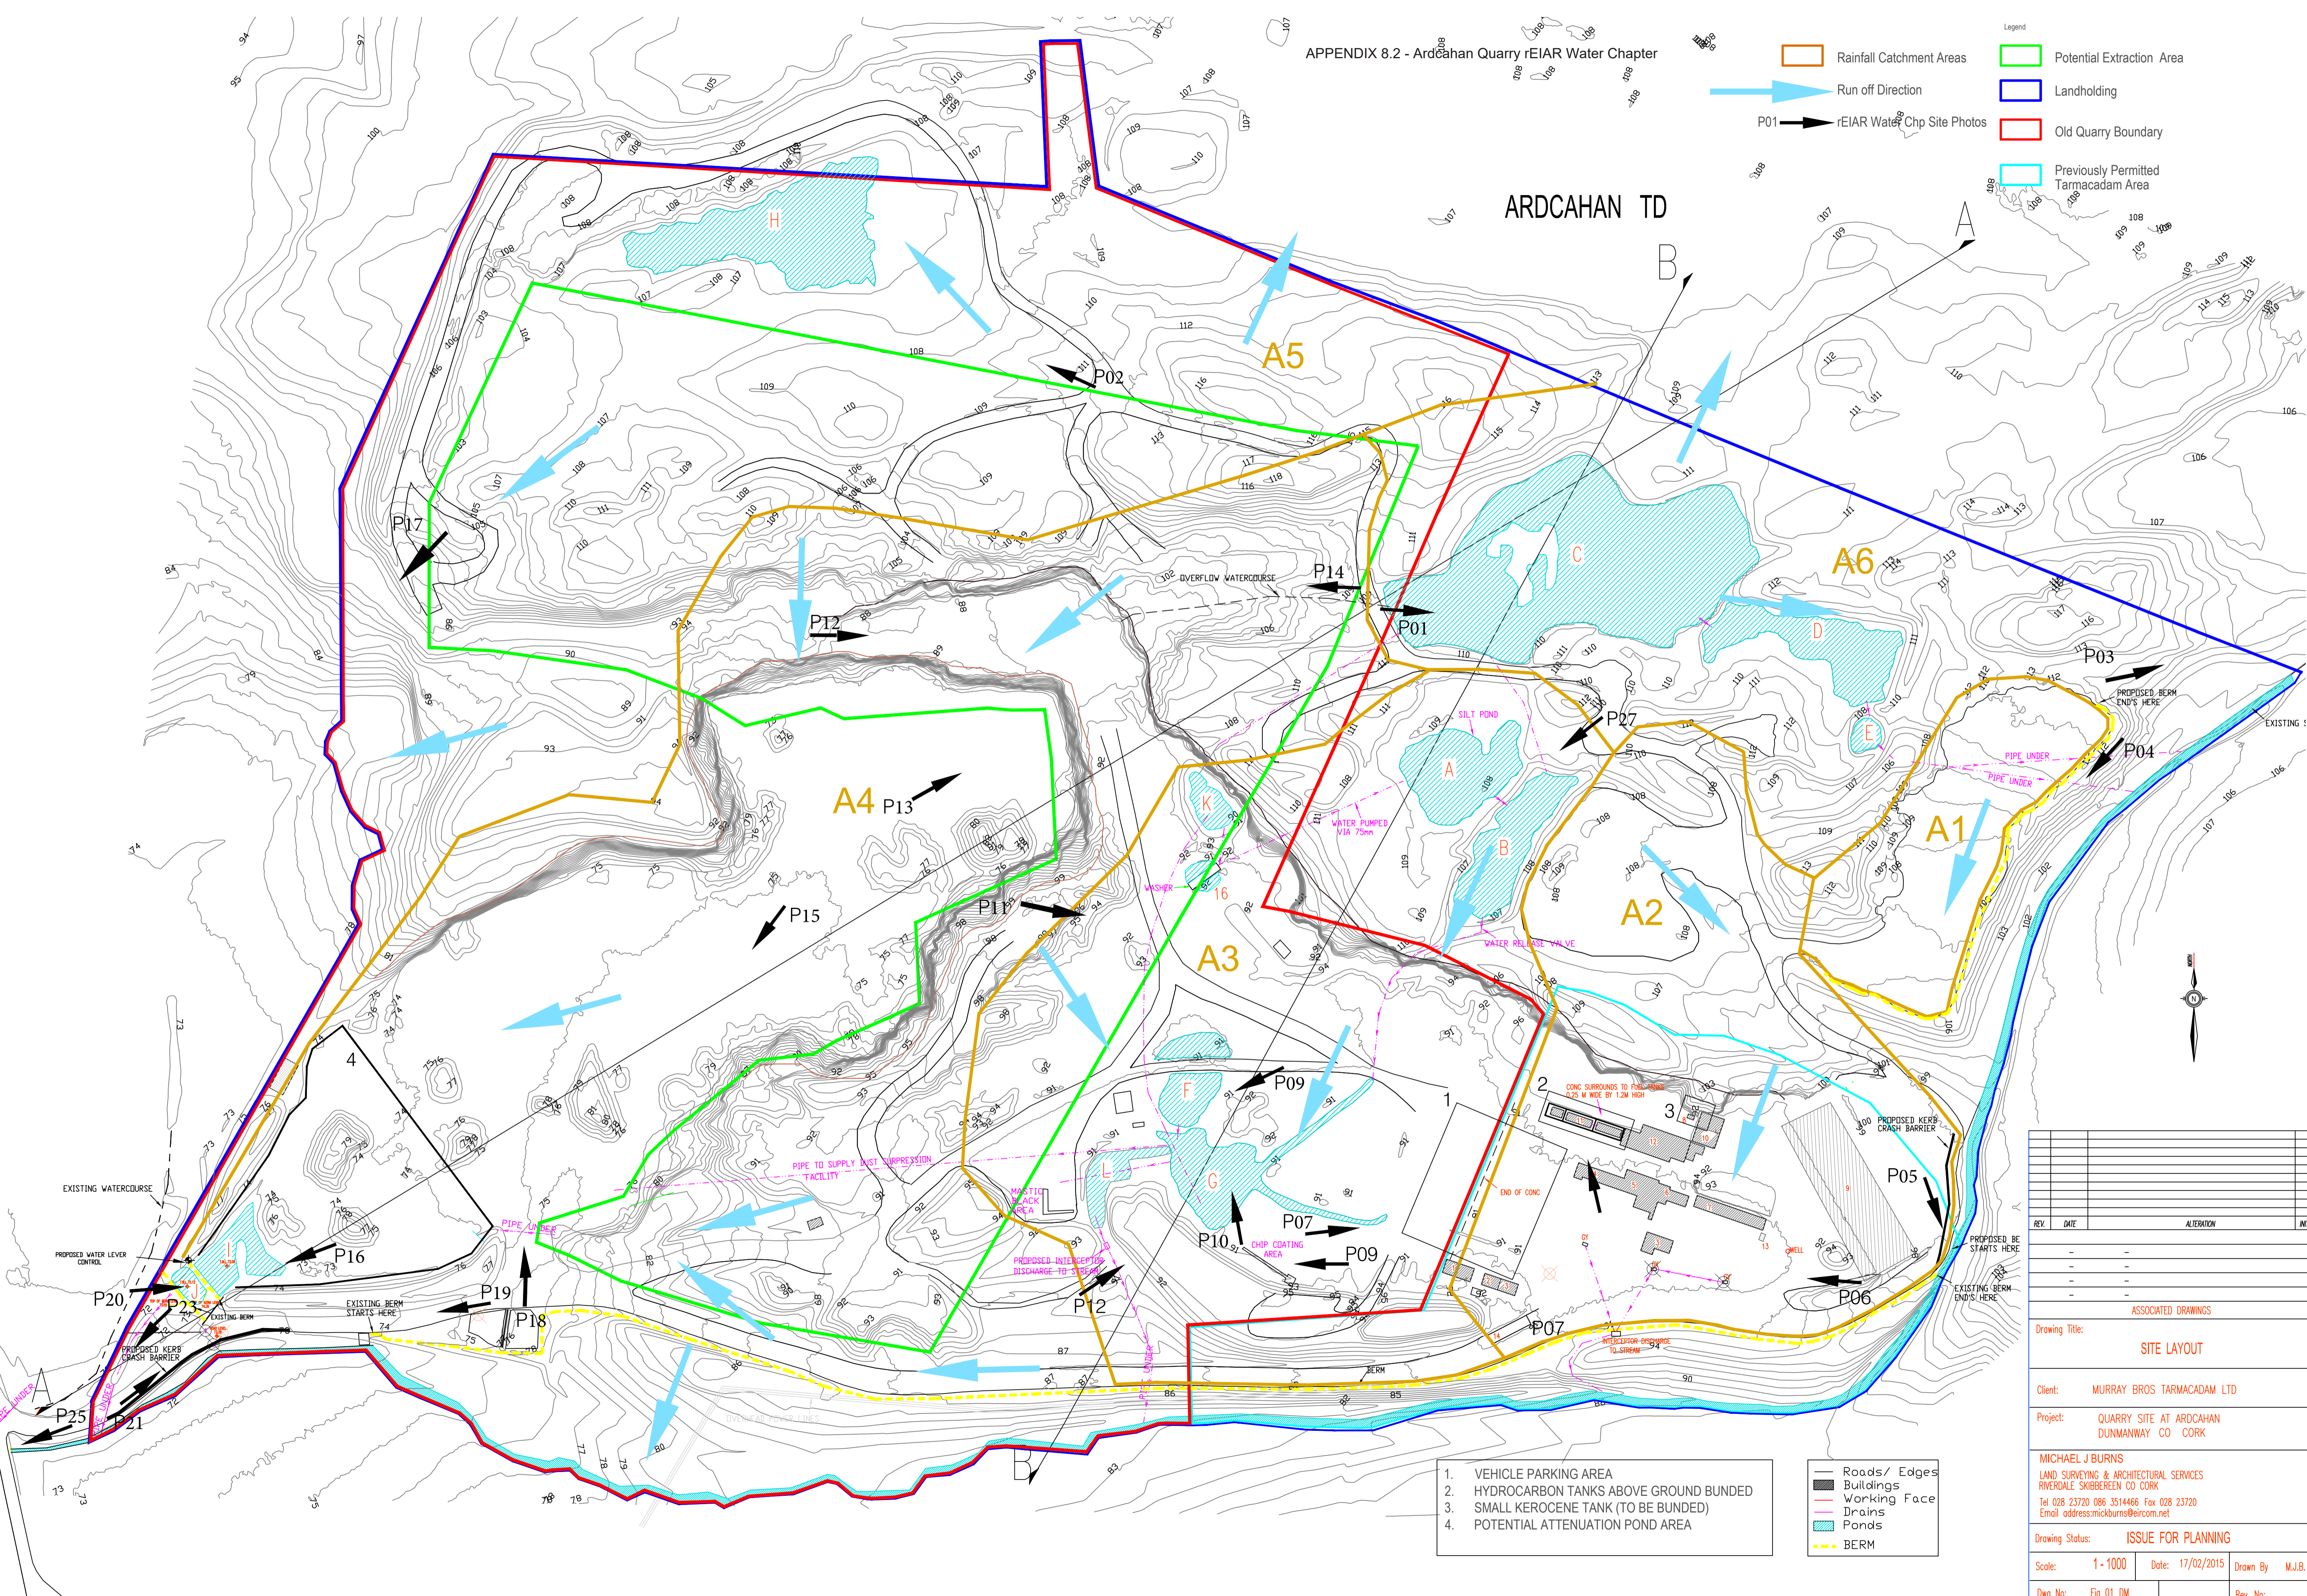
- Rainfall Catchment Areas
- Potential Extraction Area
- Landholding
- Old Quarry Boundary
- Previously Permitted Tarmacadam Area
- ▶ Run off Direction
- ▶ rEiAR Water Chp Site Photos

1. VEHICLE PARKING AREA
2. HYDROCARBON TANKS ABOVE GROUND BUNDED
3. SMALL KEROCENE TANK (TO BE BUNDED)
4. POTENTIAL ATTENUATION POND AREA

- Roads/ Edges
- Buildings
- Working Face
- Drains
- Ponds
- BERM

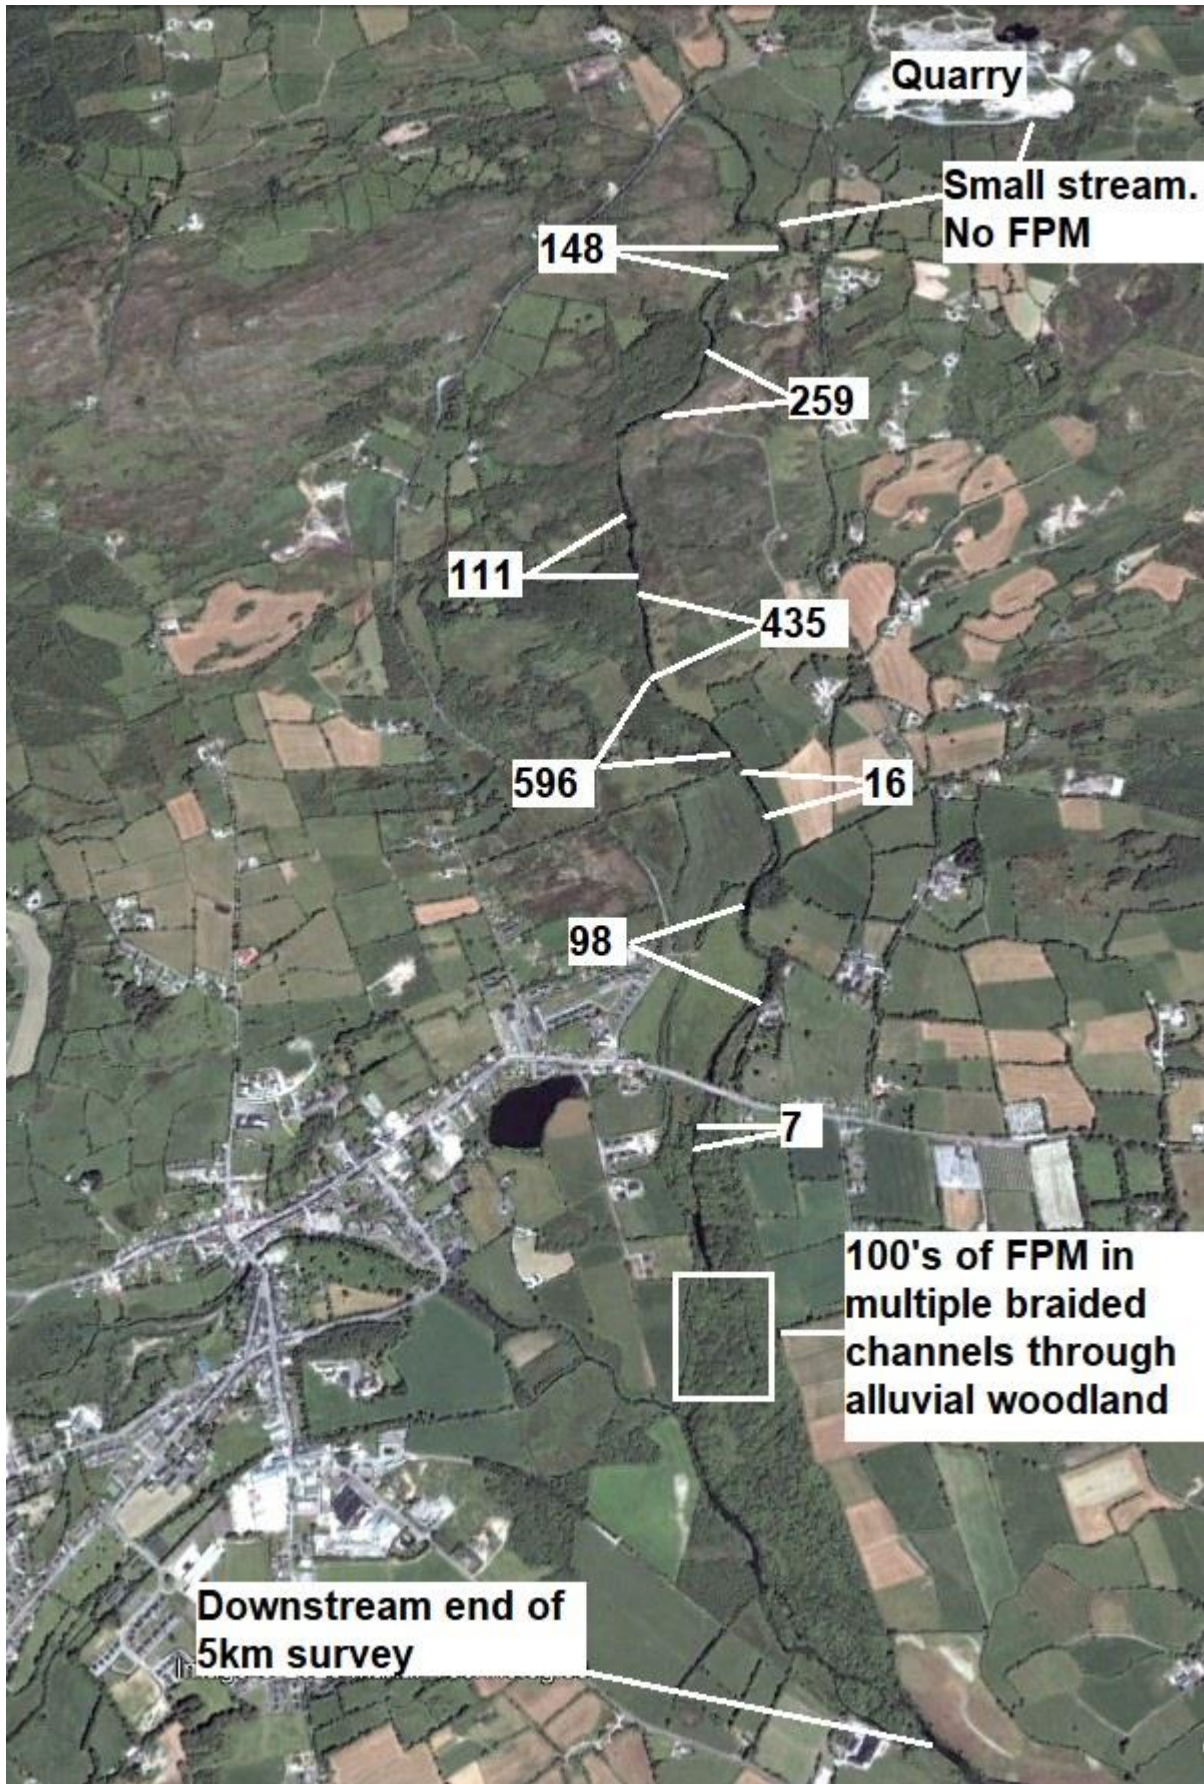
Figure 2. Freshwater Pearl Mussel Locations and Numbers June 2023

The distance from the confluence of the stream from the quarry with the River Bandon (ITM 524406 555396) to the first Freshwater Pearl Mussel (FPM) downstream was c. 80m. From this point, at ITM 524438 655304 to ITM 524423 655268, 148 FPM were counted. (Figure 2). As the proposed development at the quarry site was delayed, Sweeney Consultancy was commissioned to re-survey this part of the River Bandon FPM population nearest the quarry.

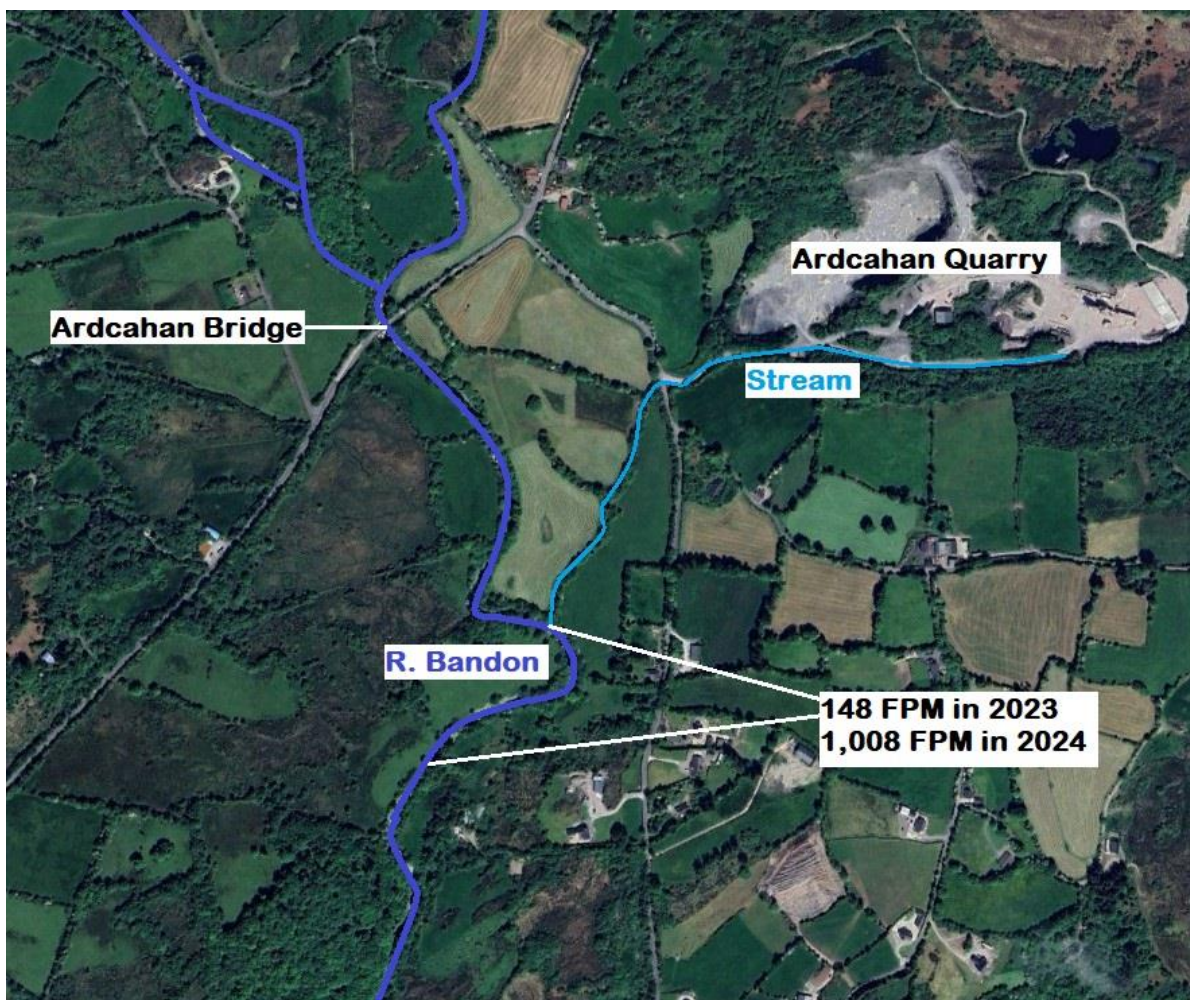
Figure 3. Freshwater Pearl Mussels close to Ardcahan Quarry

1,008 live FPM were found in the section of the River Bandon surveyed (Figure 3). This included some very close to the confluence of the small stream from the quarry.
