**Remedial Appropriate Assessment Screening & Remedial Natura Impact Statement –  
Information for a Stage 1 (AA Screening) and Stage 2 (Natura Impact Statement) for  
Substitute Consent in Respect to a Development at Tara Hall, Balscadden Road,  
Howth, Co. Dublin.**

**19<sup>th</sup> May 2025**

**Prepared by:** Bryan Deegan (MCIEEM) of Altemar Ltd.  
**On behalf of:** Mr. John Roe.

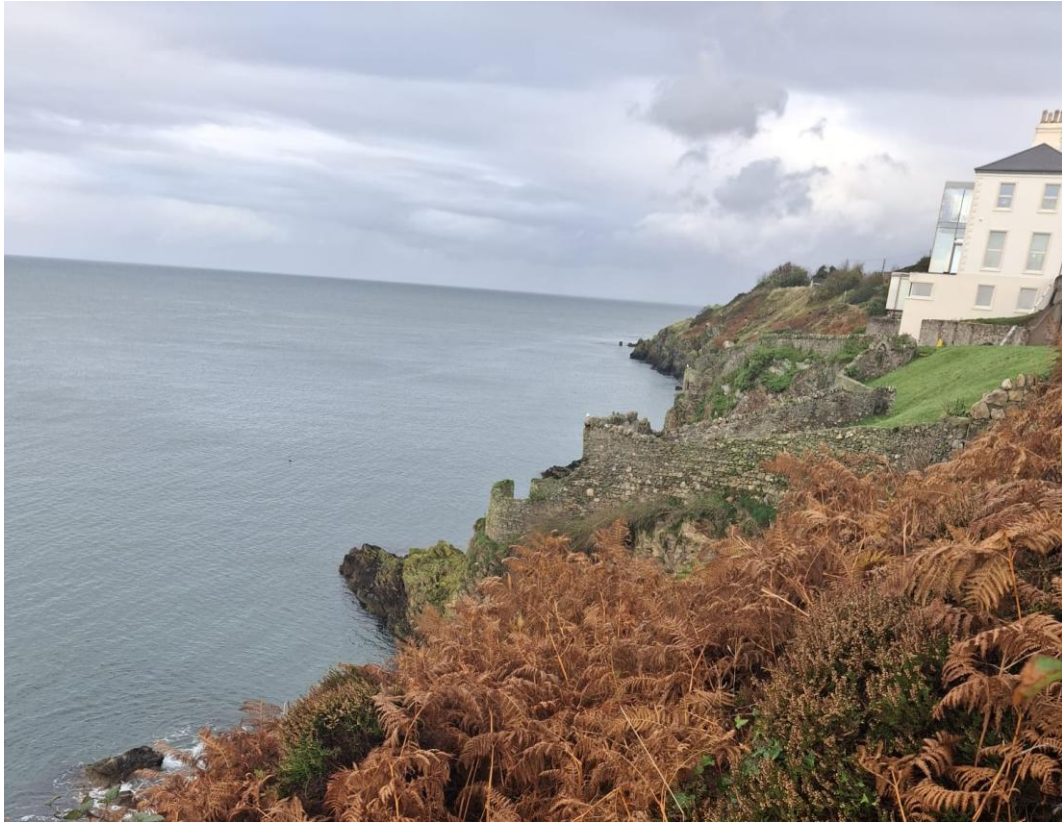
**Figure 3.** View of site looking west-east (Howth Head SAC QI Species Vegetated sea cliffs of the Atlantic and Baltic coasts and European dry heath visible outside site boundary, but not within the site.)

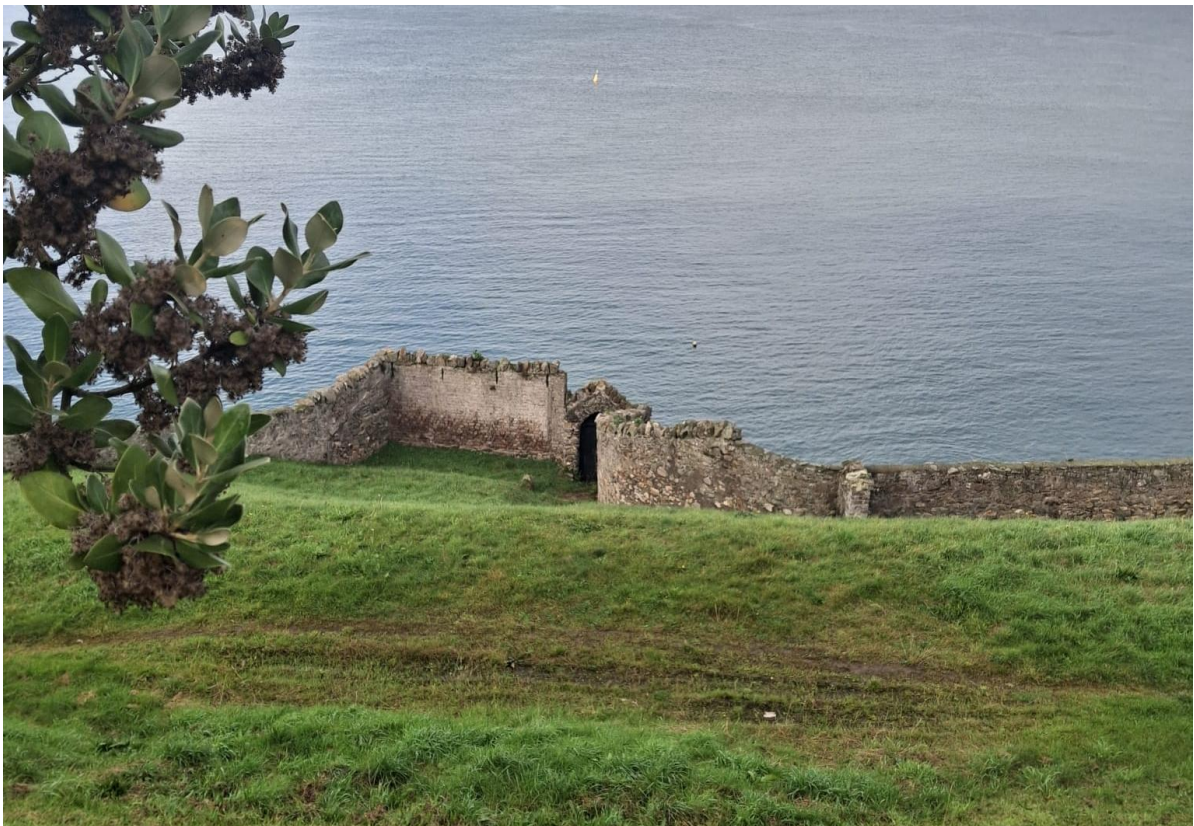
**Figure 4.** View looking north over area within the site outline to the east of the dwelling. (Note amenity grassland is the primary habitat on site.)

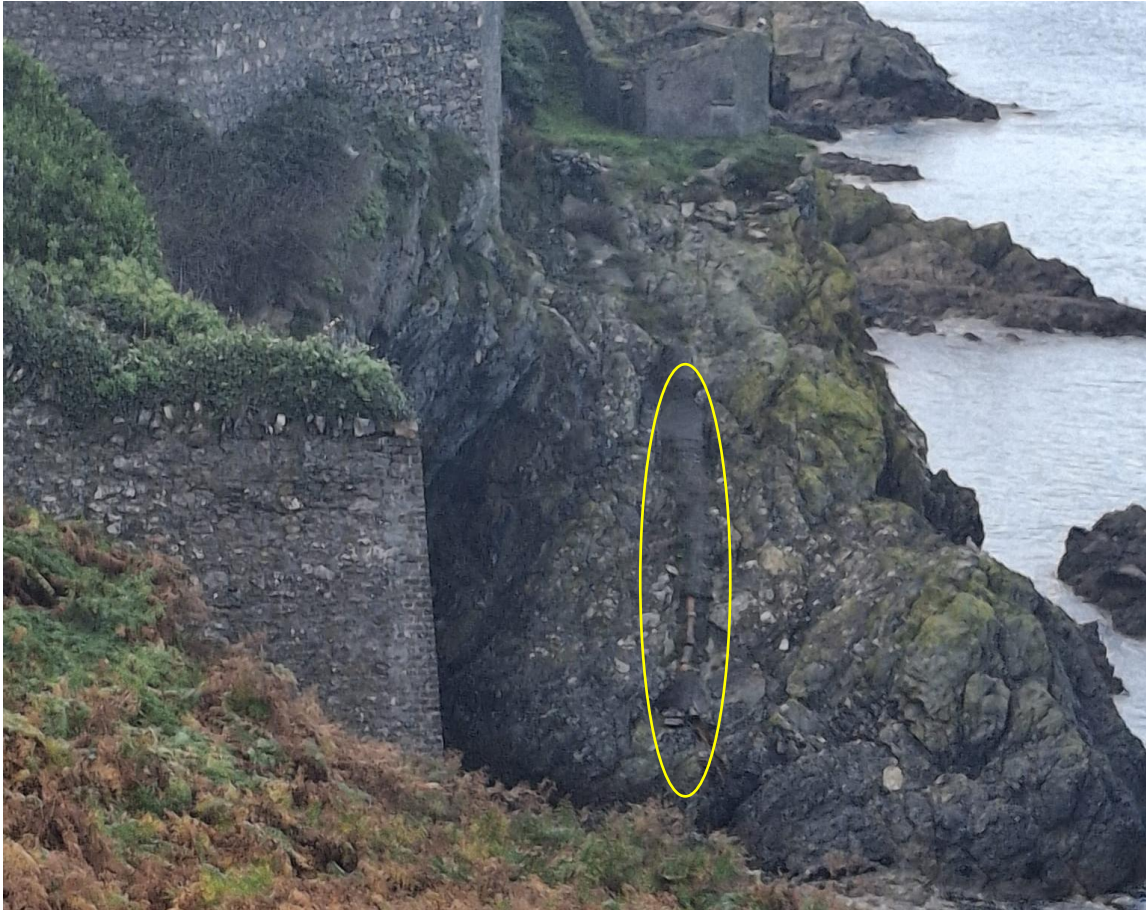
**Figure 5.** Cliff face outfall (Clay pipes within yellow outline)

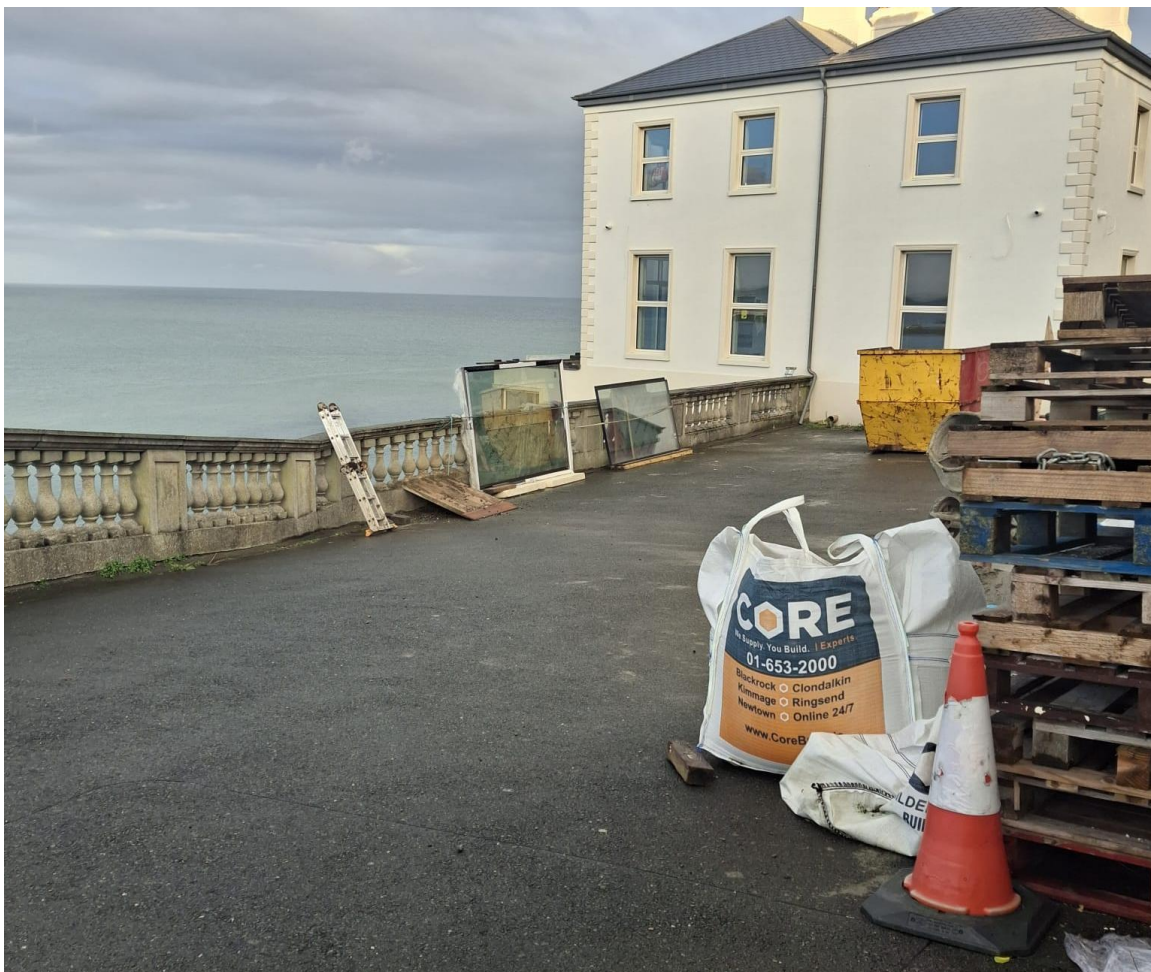
- All demolition and removal was carried out by hand. The nature of the ground didn't allow for access with any machinery.
- All of the walls were built in stone and therefore most of the demolition rubble was used on site to make up ground for the percolation area (approx. 1m high over an area of 150sqm).
- Some stone was also salvaged and used to clad the walls around the septic tanks. The remaining rubble was disposed of into skips.
- A distance of 1m was kept from the boundary wall at all times during the works as shown in the photographs below.
- All materials were stored in the paved area to the west.

**Figure 6.** Storage of materials within paved area of garden during construction

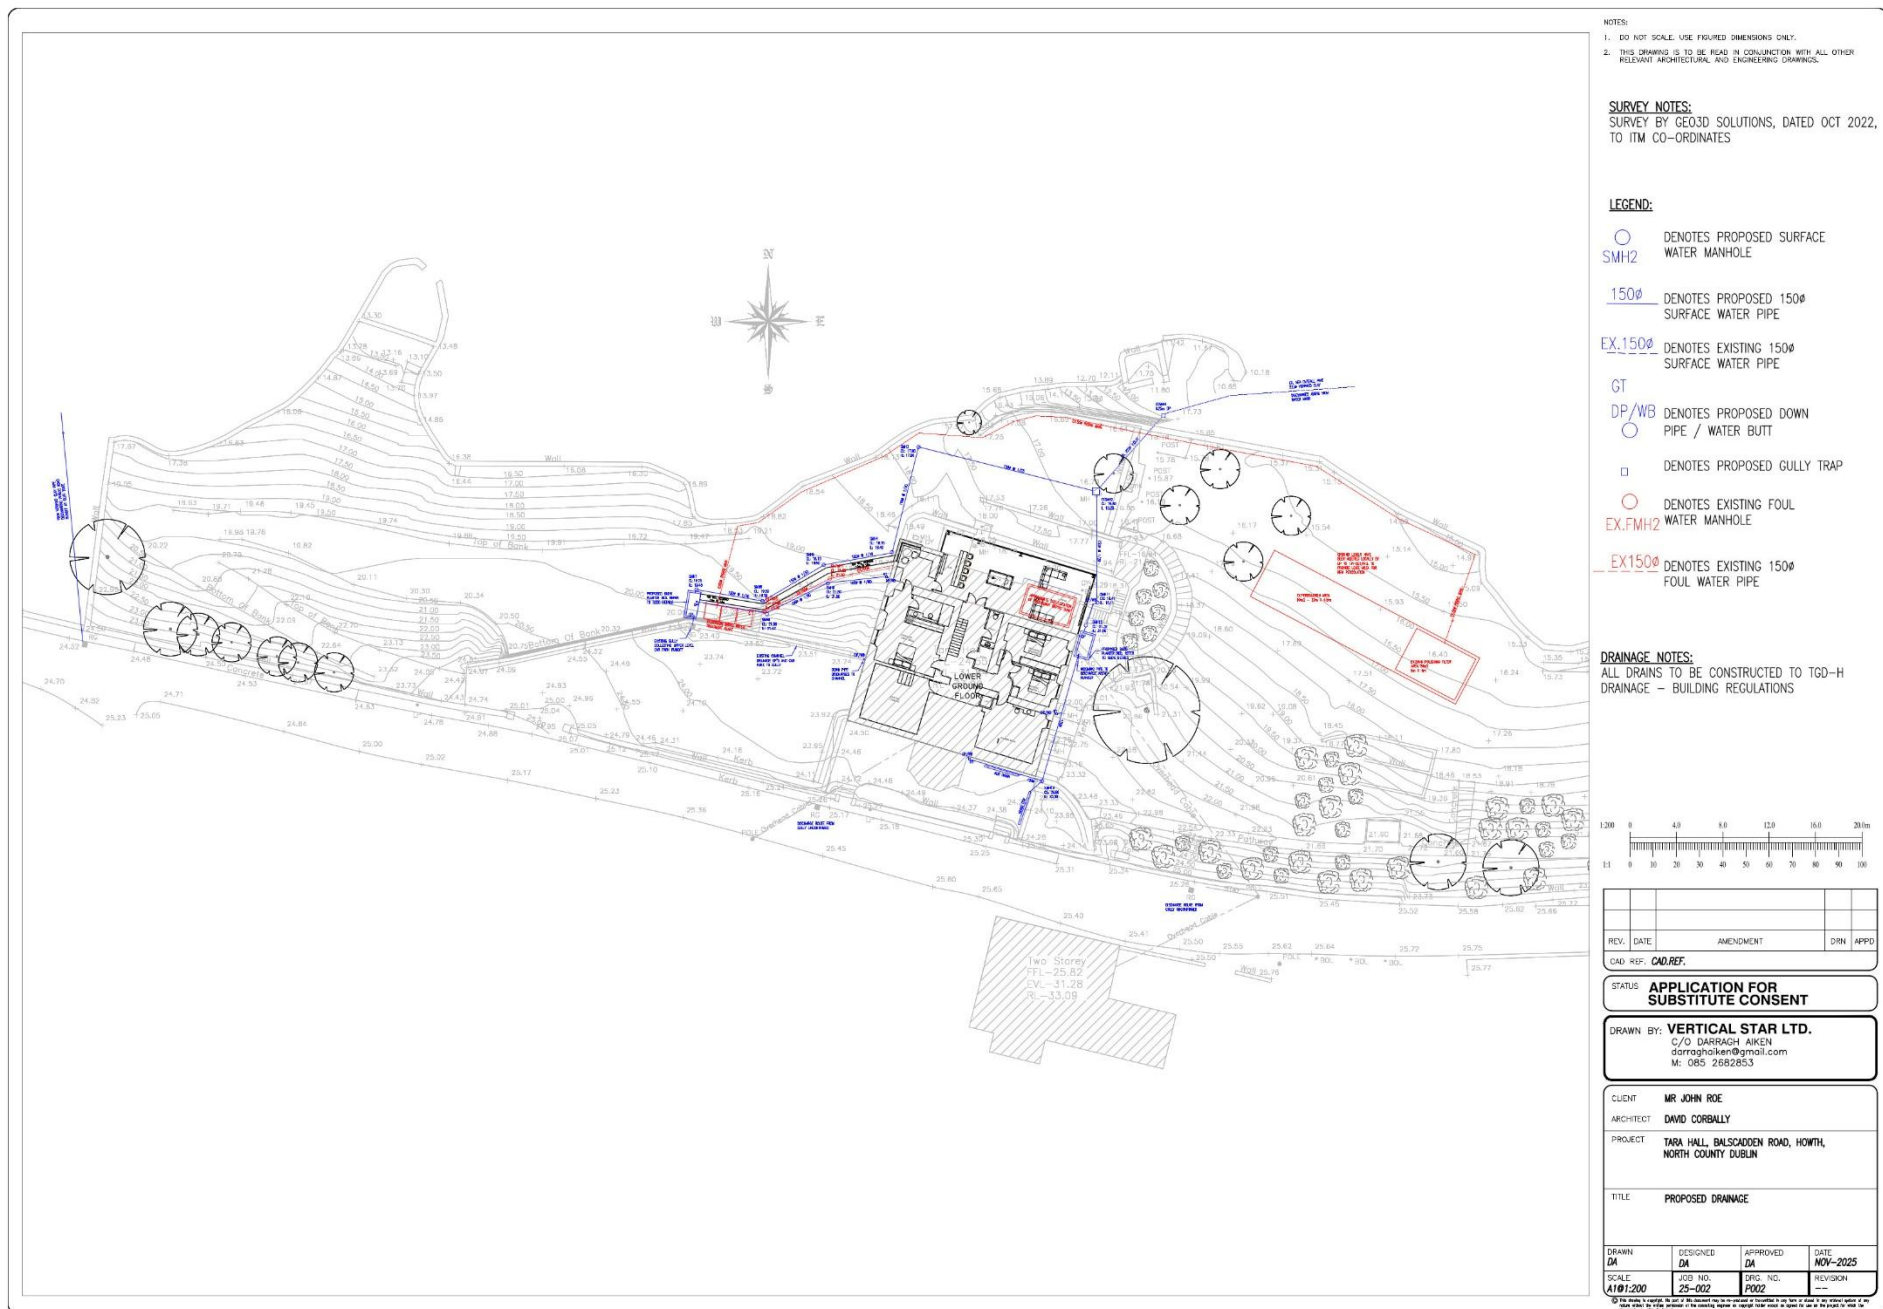
Figure 10. Drainage Layout

*No surface water is permitted to enter the foul water system and all building drainage works, constructed in 100 / 150 mm uPVC pipework are to be constructed to Technical Guidance Document H – Drainage, of the Building Regulations.'*

The surface and foul water layout is demonstrated in Figure 10.
