Wind farms and blanket peat

a report on the Derrybrien bog slide

**The Bog Slide of 16th October 2003
at Derrybrien, Co. Galway, Ireland**

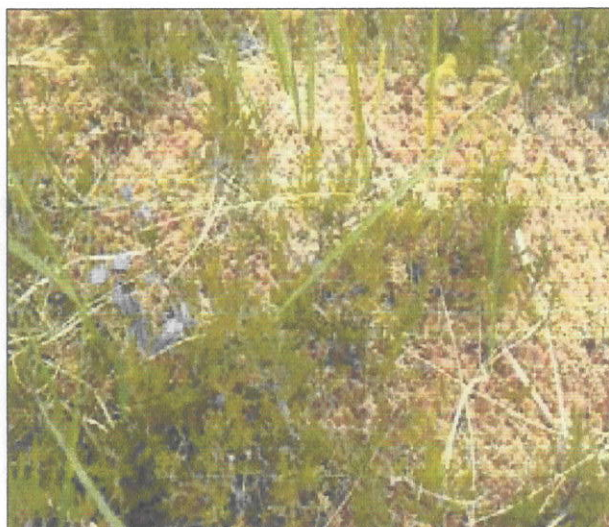
Plate 2.1: Typical Derrybrien bog vegetation, with heath milkwort (*Polygala serpyllifolia*) and purple moor grass (*Molinia caerulea*) as characteristic oceanic species within a bog moss (*Sphagnum capillifolium*) hummock [nanotope] capped by heather (*Calluna vulgaris*).

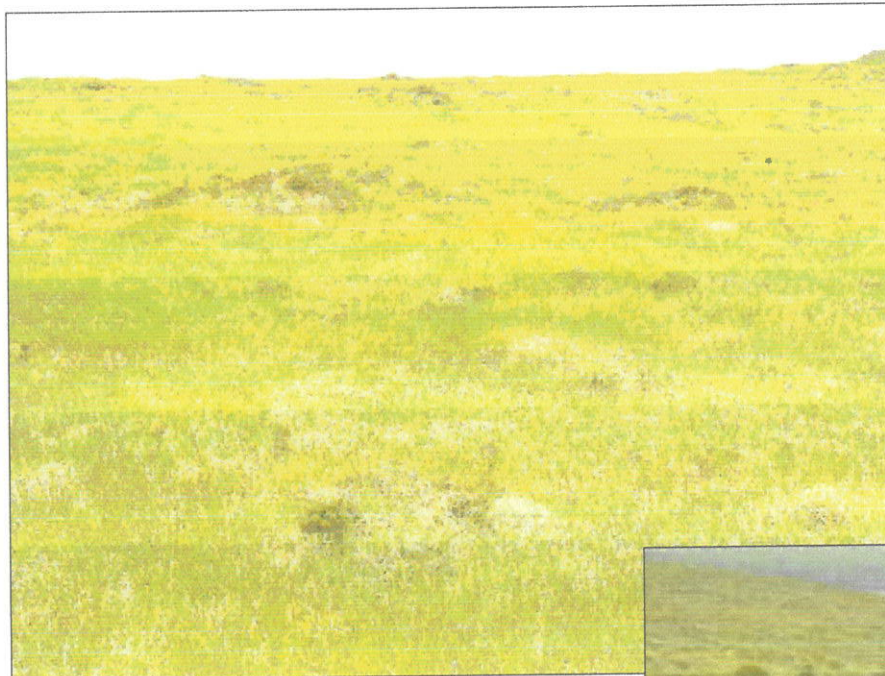
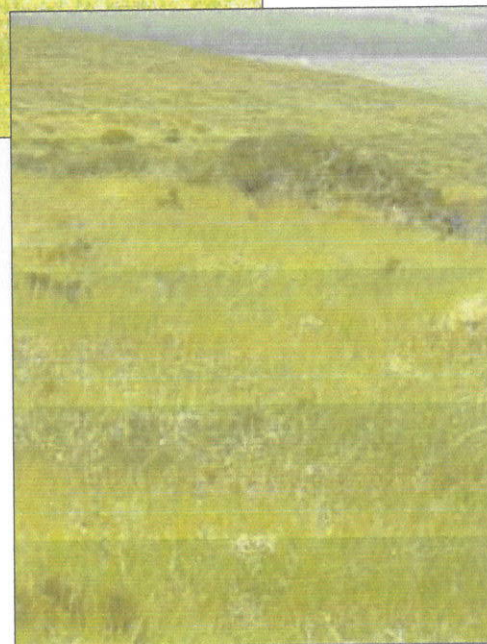
Plates 2.2: Typical view across the northern slopes of the watershed blanket mire (mesotope) that dominates the summit of Cashlaundrumlahan. In the upper photograph a series of hummocks (nanotopes) can be seen as a repeated structural motif (microtope) scattered across the slope but, in this case, there are no pools, only terrestrial elements forming the microtope pattern.

In the case of Cashlaundrumlahan, the blanket mire complex (macrotope) represents the whole assemblage of peatland units that interlink to form the continuous peat landscape centred around, and dominating, the Cashlaundrumlahan massif. These individual peat systems are now quite difficult to see because extensive forestry has obscured much of the blanket mire structure. Nevertheless, a small portion of characteristic watershed mire can be seen on the summit ridge, where an area of bog pools has not been ploughed for forestry. Here, the bog surface shows a repeated pattern (microtope) of pools and intervening ridges on which there are both high and low hummocks. Some of the blanket mire features still to be found are illustrated in plates 2.1 to 2.3.

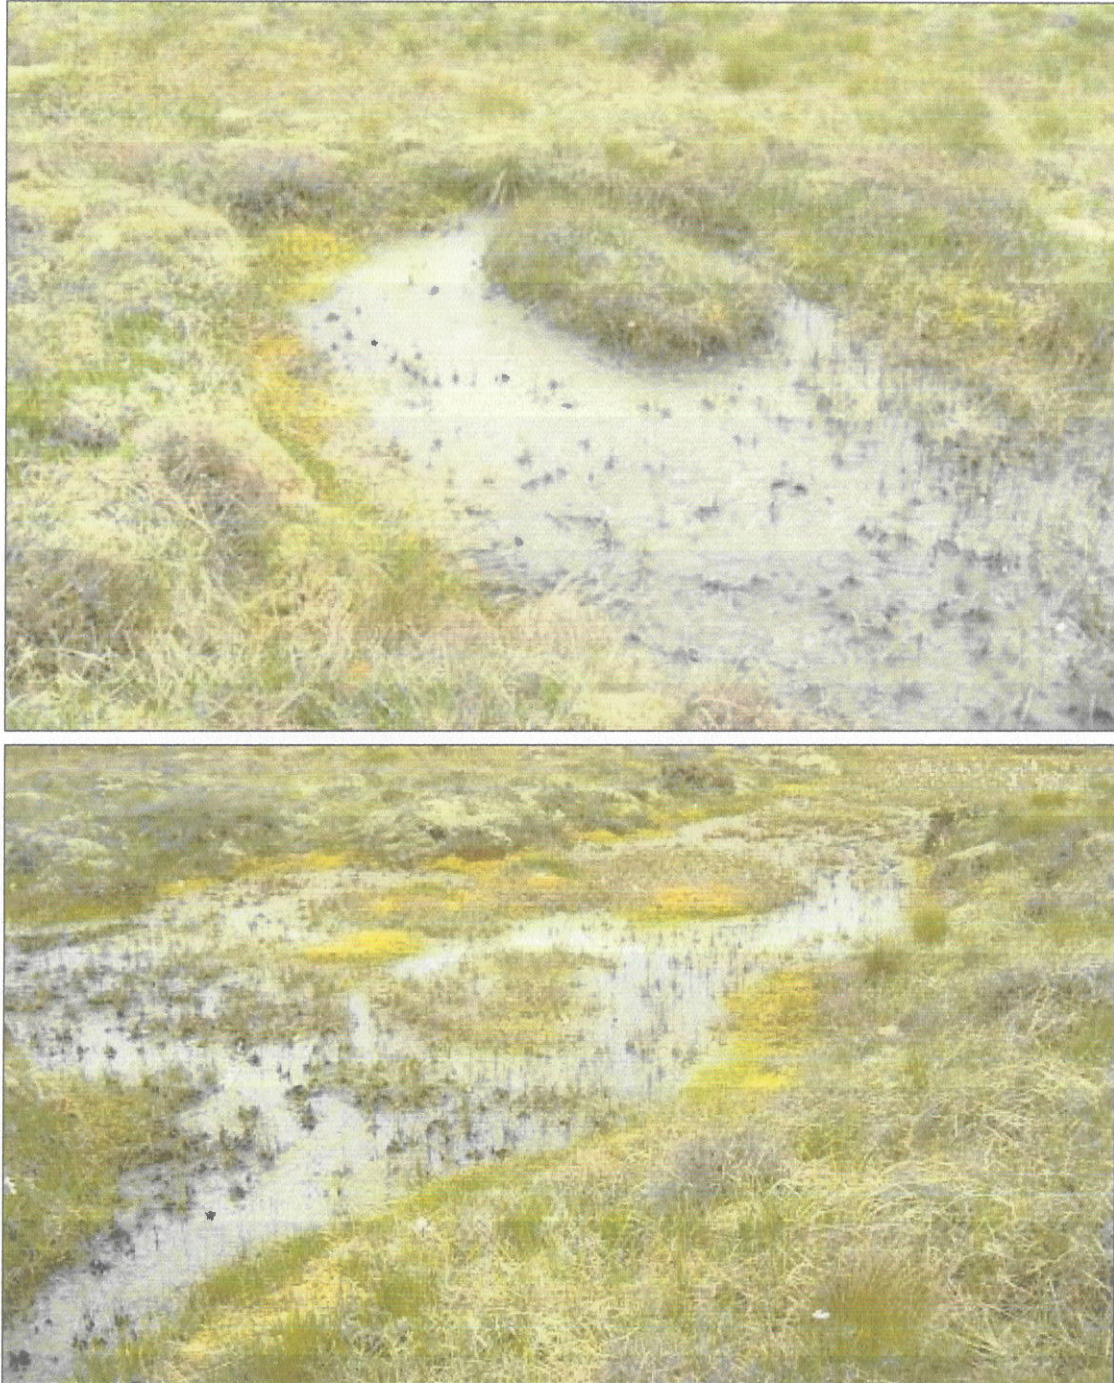
Plate 2.3: Example of the only bog pool complex surviving on Cashlaundrumlahan. As might be expected, this indicates an area of deep peat on the summit ridge and represents a watershed mire mesotope with a typical microtopo pattern of pools.

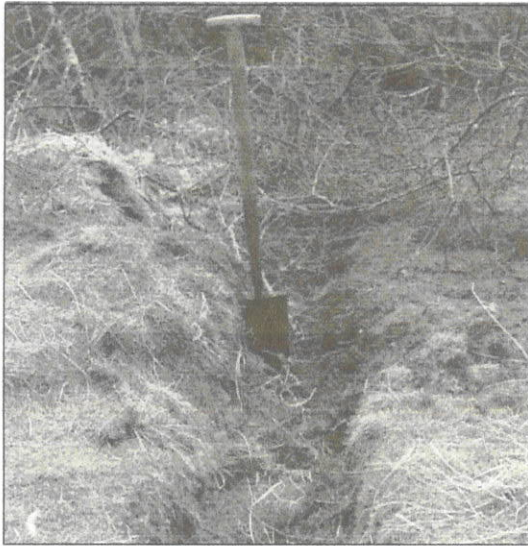
Plate 3.1: Longitudinal crack in a plough furrow under mature forestry on deep peat in the north of Scotland, after removal of the litter layer.

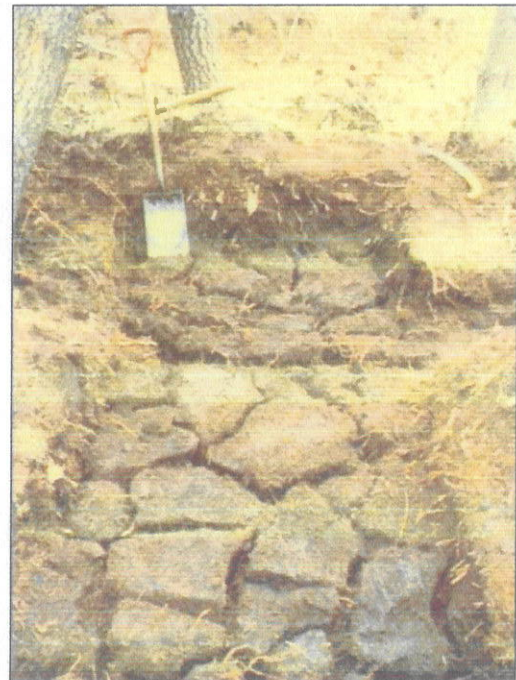
Plate 3.2: Reticulate cracking in a plough ridge under mature forestry on deep peat in the north of Scotland, revealed by removing the surface fibrous layer.

Some years later, reticulate networks of cracks develop on the plough ridges directly beneath the trees. These develop fully within 20 years of planting on shallow and moderately deep peats and can penetrate to the substratum if the peat layer is less than one metre thick. These cracks are confined to the catotelm peat which has by now lost a great deal of water and is fairly dense. They do not open on the surface because the acrotelm is reinforced by strong structural tree roots but are invariably found when the surface 30 cm fibrous layer is removed (plate 3.2). However, the ditch and furrow cracks now become visible because they have grown so wide that the root and litter mat tears (fig 3.1).

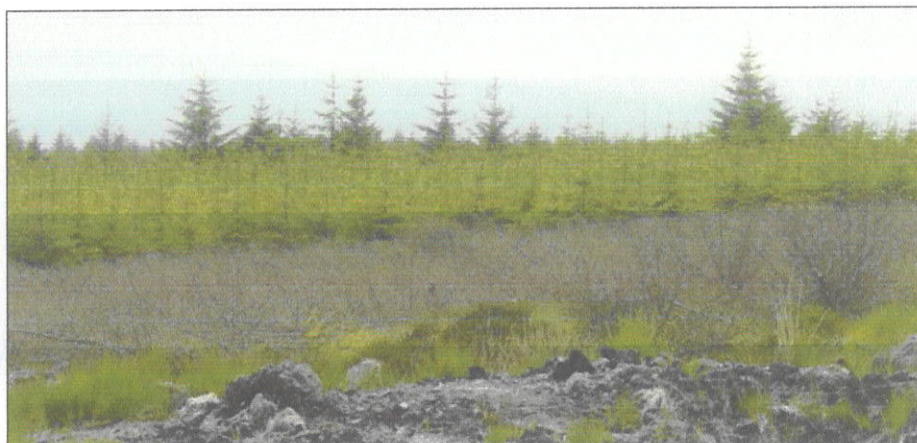
Plate 3.3: Spruce planted after the south-west part of the forest was destroyed by fire about 10 years ago. The ground here has thus been drained and planted twice: part of this area was involved in the October 2003 bog slide.

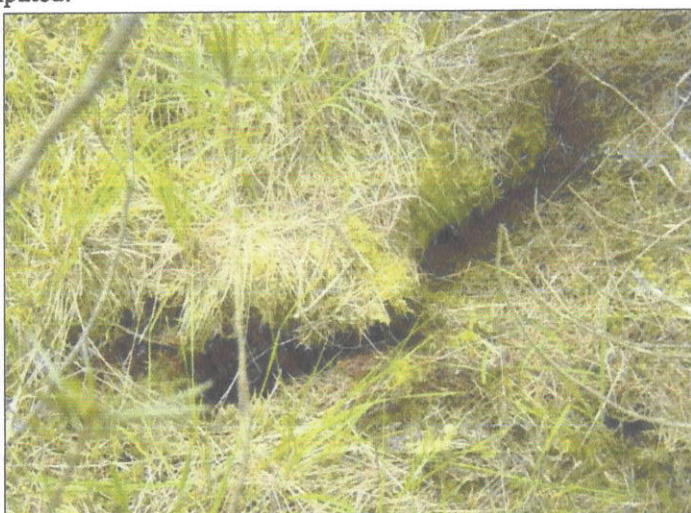
Plate 3.4: A crack in the peat surface beneath forestry which is just visible despite the thick litter layer.

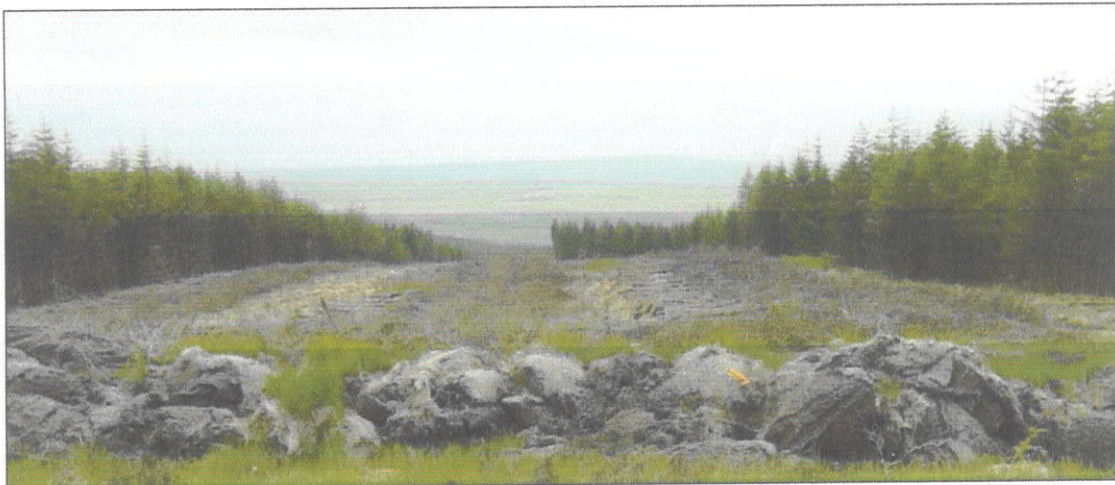
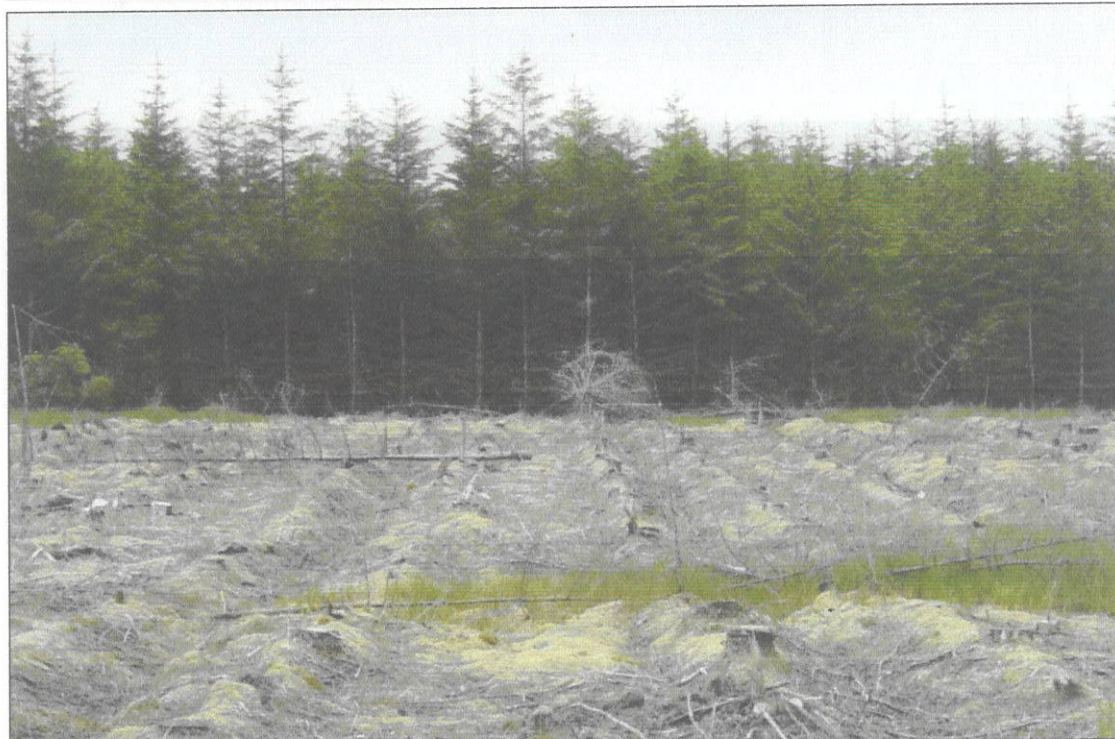
Plates 3.5: Areas on Cashlaundrumlahan where forestry has been felled to make way for construction work.

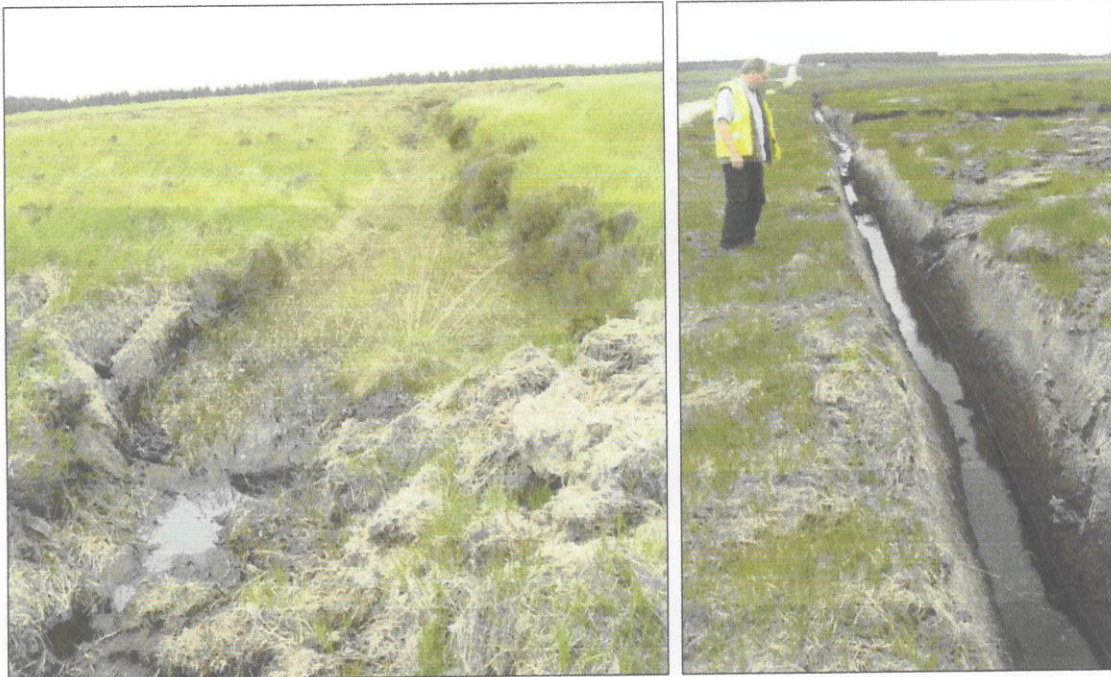
Plate 3.6: Turbary fields on the summit of the site showing (above) an old peat bank and (right) the downslope catchwater drainage system, re-excavated after peat slide in 2003).

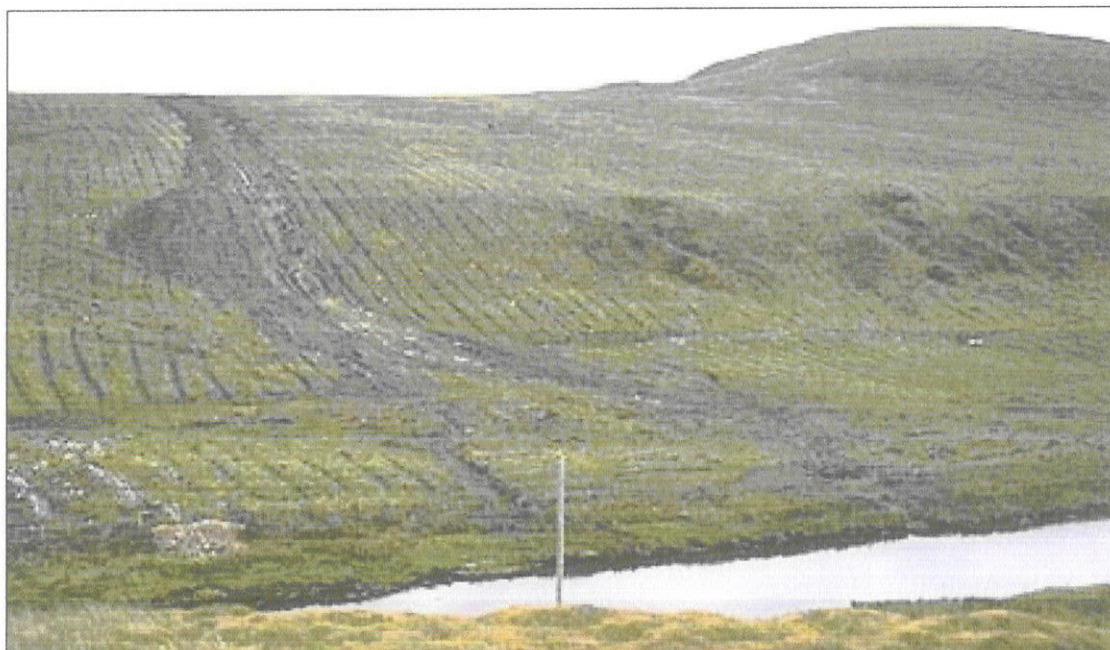
Plate 4.1: A bog burst in pre-drained forestry area in Co. Mayo blanket bog. Liquefied peat was discharged into the Owenmore River. Late 1980s.

- Byrne (undated) includes in her account of Irish bog bursts a photograph of failure of peat by the Owenmore River in County Mayo that had been pre-drained for forestry (plate 4.1).

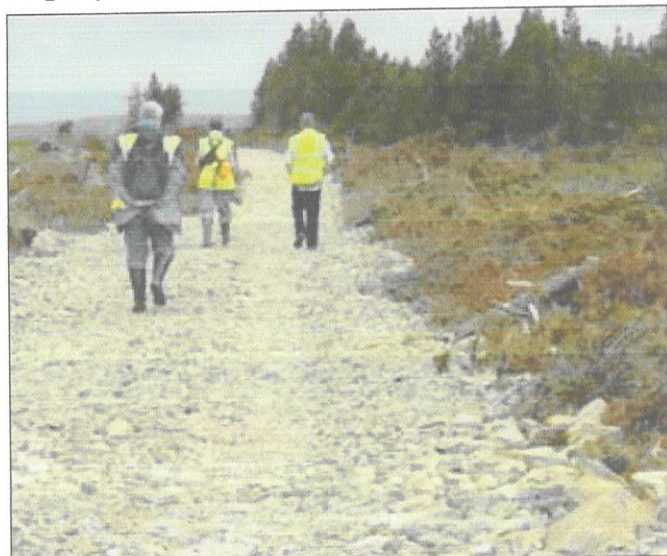
Plate 5.1: Floating road at Derrybrien Wind Farm.

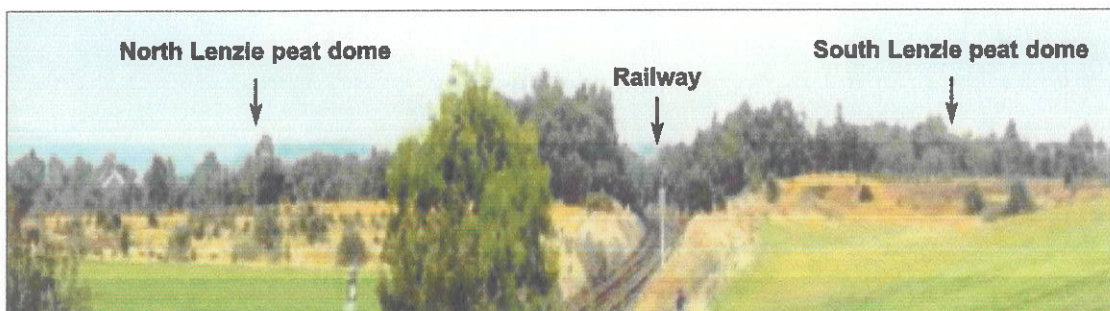
Plate 5.2: Railway line ‘floated’ across Lenzie Moss during the 19th Century. The track has now sunk by about three metres and the bog is clearly divided into two sections. Note also the lines of taller trees flanking the track, reflecting the associated drainage.

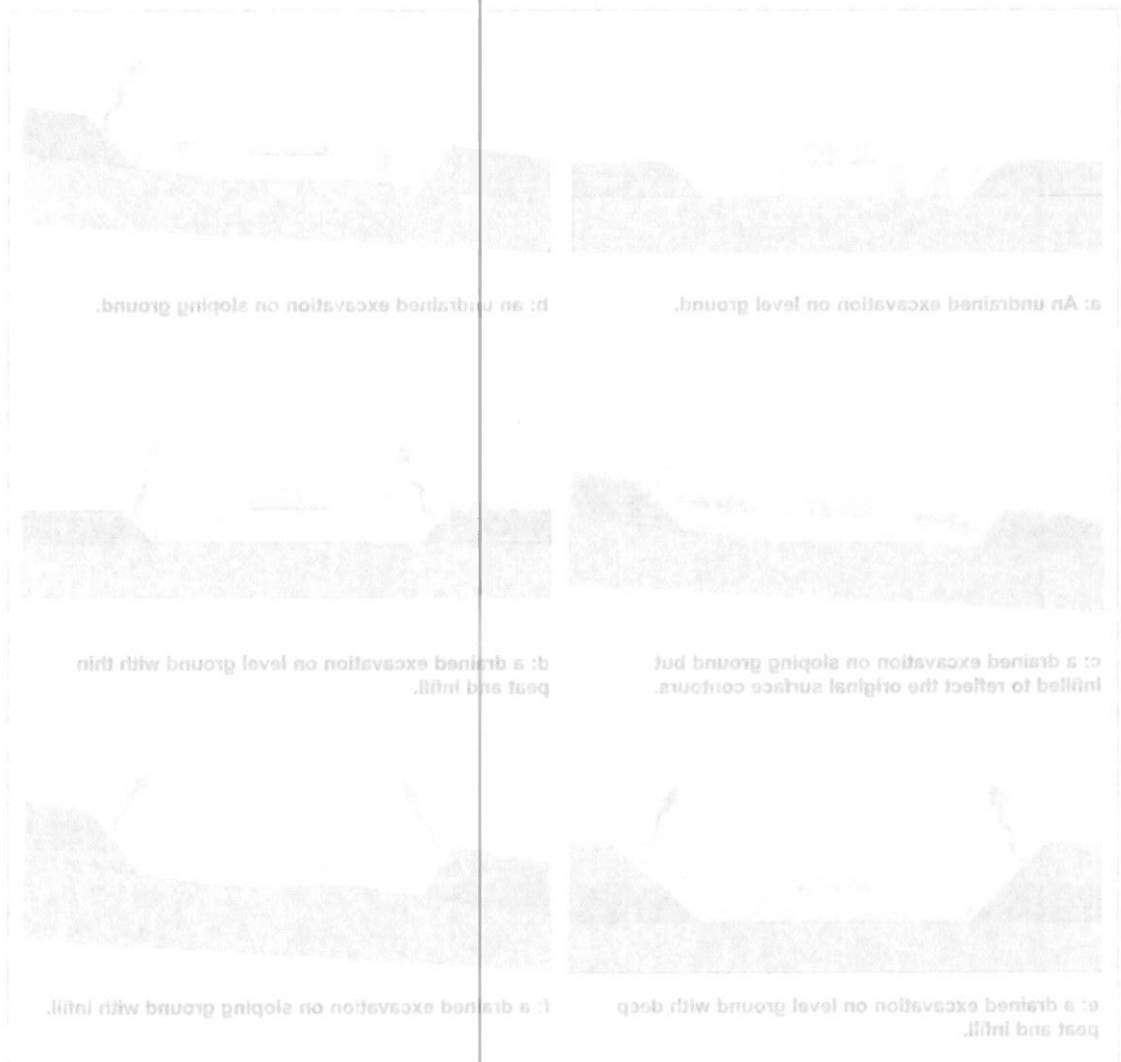
Figure 8.3: Turbine-base construction. The illustrations represent a cross-section of an excavation and construction for a wind-turbine tower. The bedrock is dark grey, the peat thickness is green, water is blue and rock infill is red spots. The yellow is the concrete base for the turbine, the turbine is the turbine base 'can' and the light grey is the turbine tower. The red wavy arrows represent loss of CO₂ and water from the peat, the blue arrows represent water movement.

Another consequence of submersion is that the foundation pad is subjected to hydrostatic pressure. Even though care is taken to ensure that the concrete is dense, homogeneous and free of cracks so that it has low permeability, water can seep through it under pressure. This is dangerous because concrete contains calcium hydroxide which can be leached out in seepage water, reducing the strength of the concrete, especially if the water contains carbon dioxide. Acid waters with a pH of less than 6.5 are known slowly to degrade concrete while humic acids (the main acids in peat) cause much more rapid degradation.¹

between the base and the water table. If the base is installed below the water table and is thus submerged in use, its effective mass will be reduced by a buoyancy effect. This will tend to reduce the effective downward anchoring force, adding a potential instability into the construction. This explains in part why developers normally ensure that there is adequate drainage around turbine bases.
