Summary of Chapter 5

WINDFARMS AND BLANKET PEAT

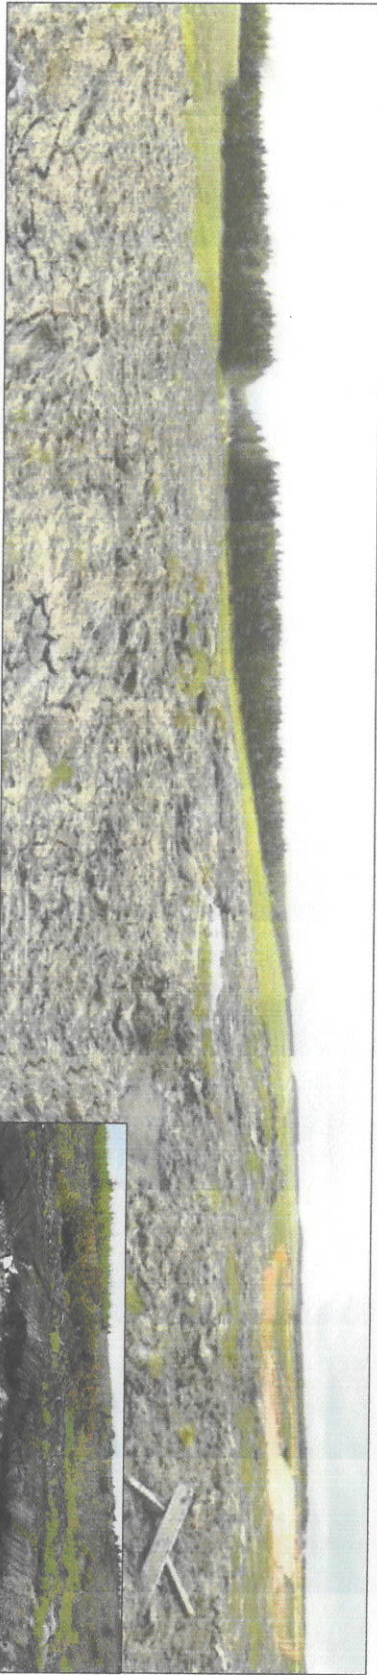
Plate 7.1. Top: T67, showing the base-can, the overburden burying its plinth and the exposed peat faces on the excavation sides. The area of peat removal is clearly much greater than the 15 metres x 15 metres claimed. Cracks in the catotelm peat are highlighted by arrows.

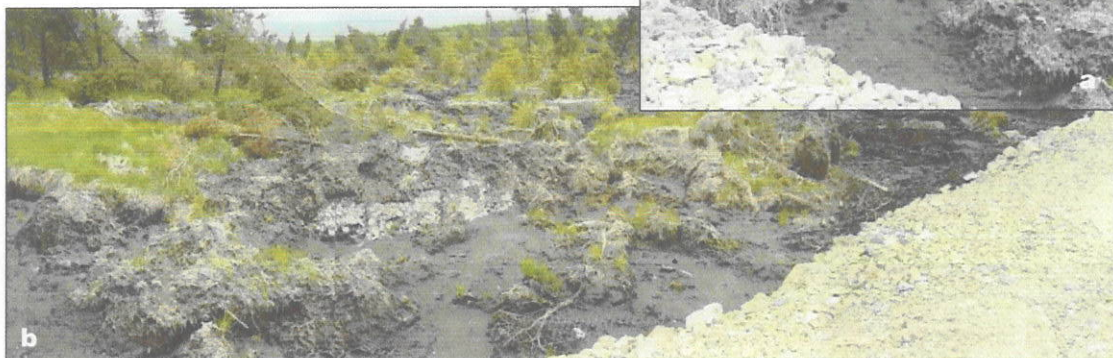
within days of the slide indicate that the southern wall of the excavation remained in place, supporting a precariously perched excavator. The road had bowed southwards by 10-20 metres (plates 8.2b, c and d). Plate 8.3, taken in June 2004, gives two views looking southwards from the reconstructed road at T68. The pattern of detachment of rafts of vegetation along plough lines was still evident in mature lodgepole pine plantation at the eastern side of the scar. South of T70, a small exposure of bedrock was found at this time (plate 8.4c) but appeared to be the result of water erosion subsequent to the landslide. The trees in this area were smaller than those upslope and included some Sitka spruce understood to have been planted to repair fire damage (plate 8.4a). A crack in apparently intact surface was found at the eastern edge

Plate 8.1a & b: The view to the south of T70, 8 June 2004.

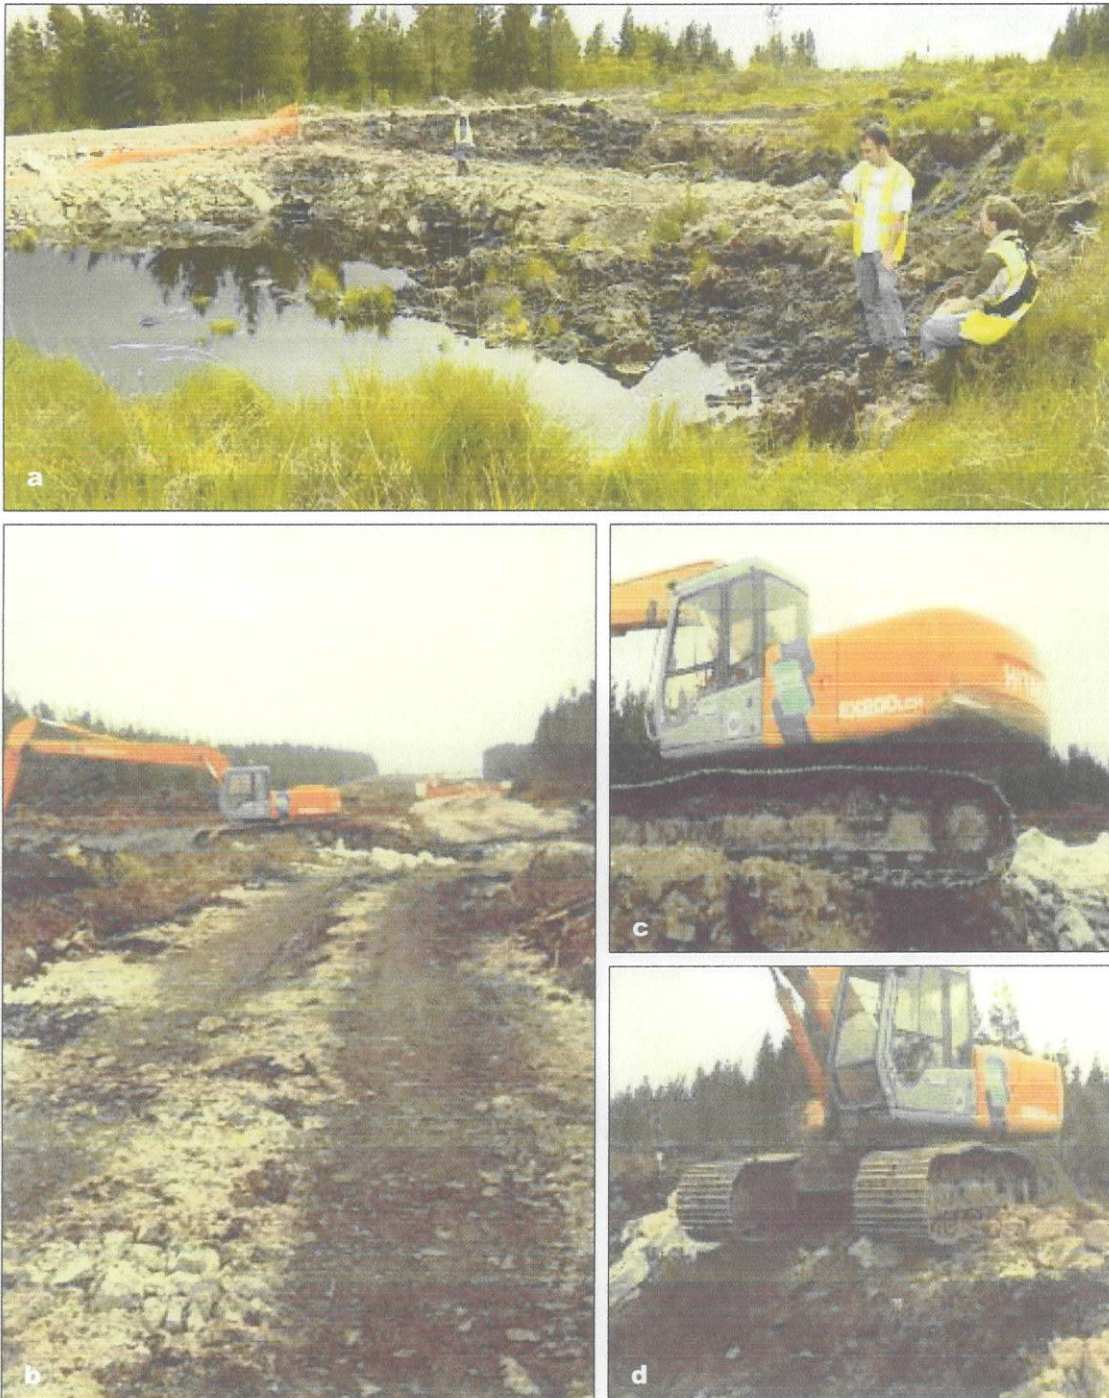
Plate 8.2: The head of the peat slide at T68. a: turbine base excavation in June 2004; b: deformation of floating road October 2003; c, d: an excavator after the bog slide.

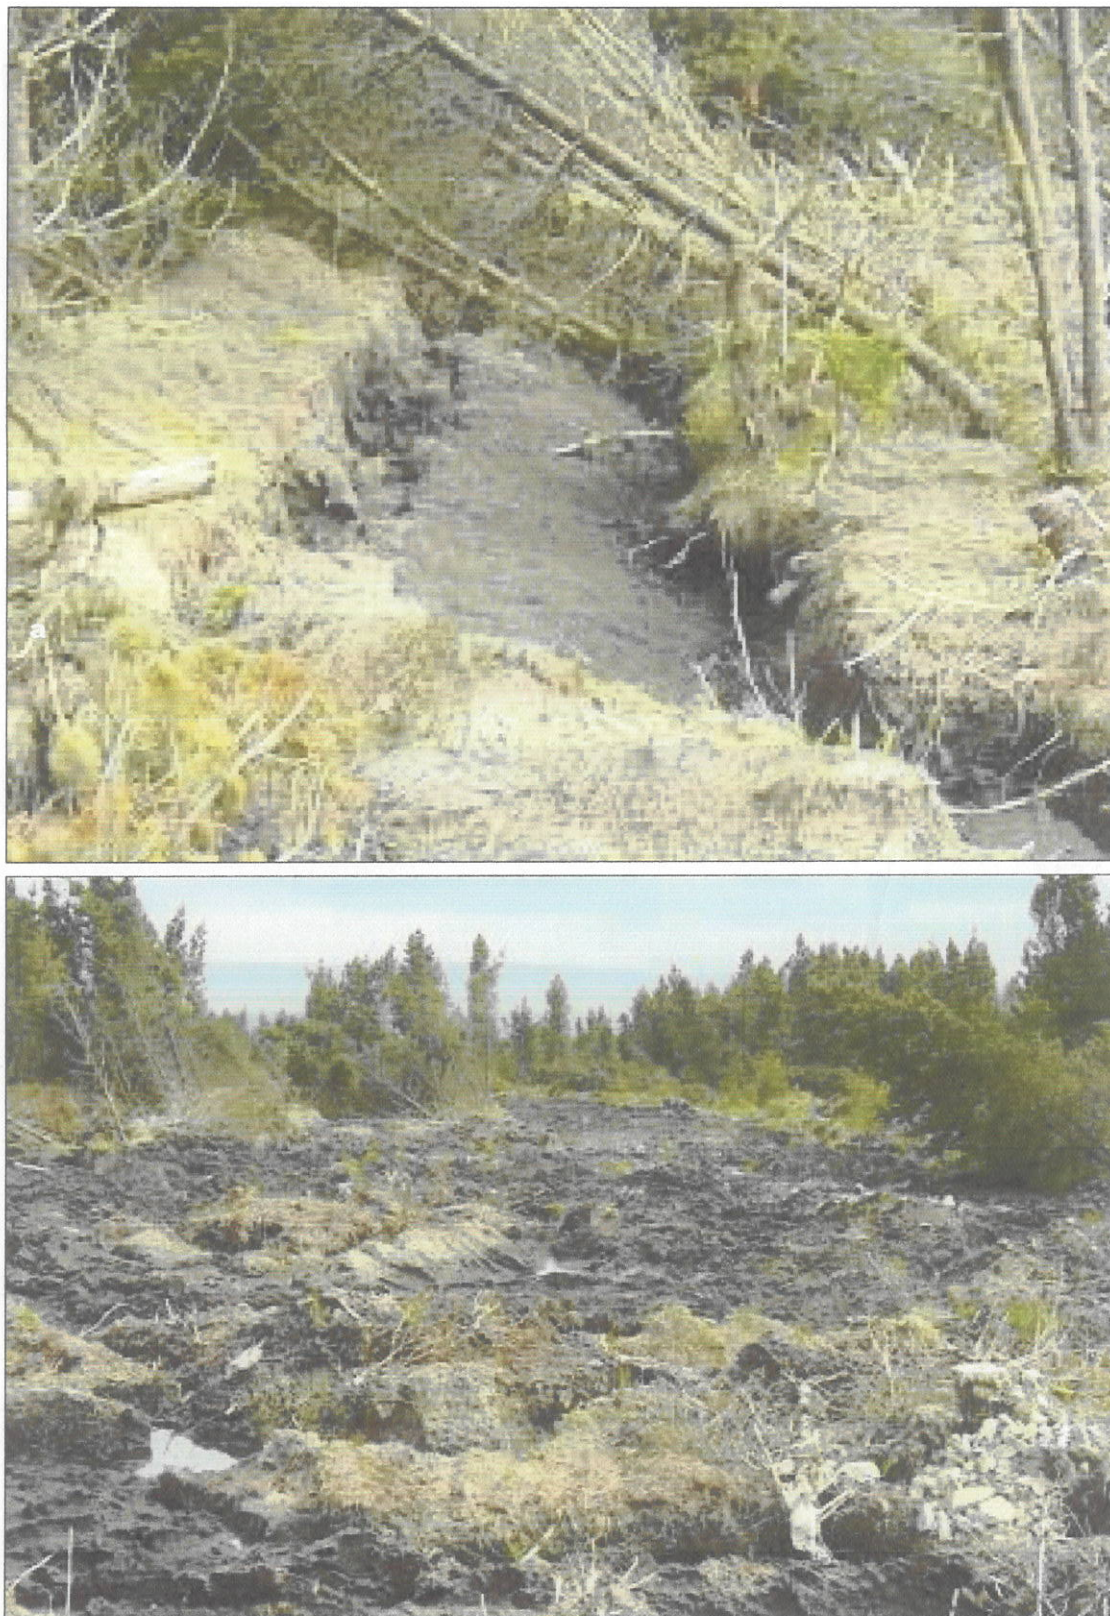
Plate 8.3: The bog slide just below T68, 8 June 2004. Top, the pattern of detachment of rafts of surface vegetation along forestry plough lines at the west side of slide and, bottom, the centre of the slide, looking south.

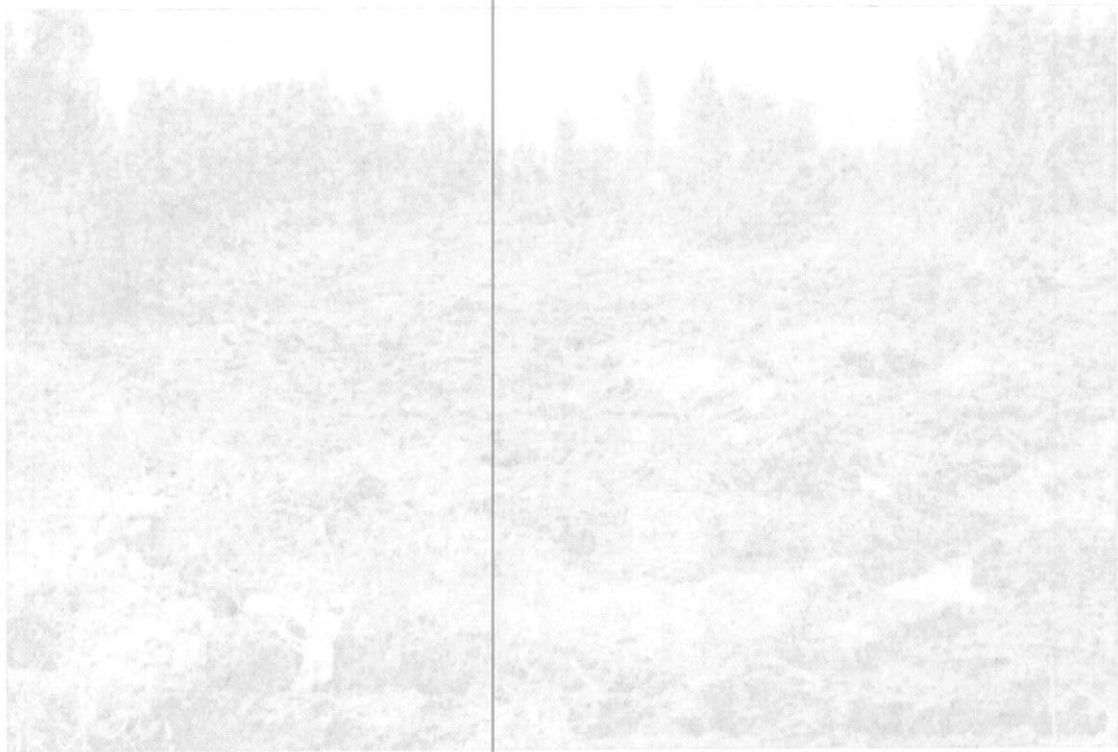
Plate 8.3: The bog slide just below T69, 8 June 2004. Top, the pattern of detachment of rafts of surface vegetation along forestry plough lines at the west side of slide and, bottom, the centre of the slide, looking south.

within days of the slide indicate that the southern wall of the excavation remained in place, supporting a precariously perched excavator. The road had bowed southwards by 10–20 metres (plates 8.3b, c and d). Plate 8.3, taken in June 2004, gives two views looking southwards from the reconstructed road at T68. The pattern of detachment of rafts of vegetation along plough lines was still evident in mature lodgepole pine plantation at the eastern side of the scar. South of T70, a small exposure of bedrock was found at this time (plate 8.4c) but appeared to be the result of water erosion subsequent to the landslide. The trees in this area were smaller than those upslope and included some Sitka spruce understood to have been planted to repair fire damage (plate 8.4a). A crack in apparently intact surface was found at the eastern edge

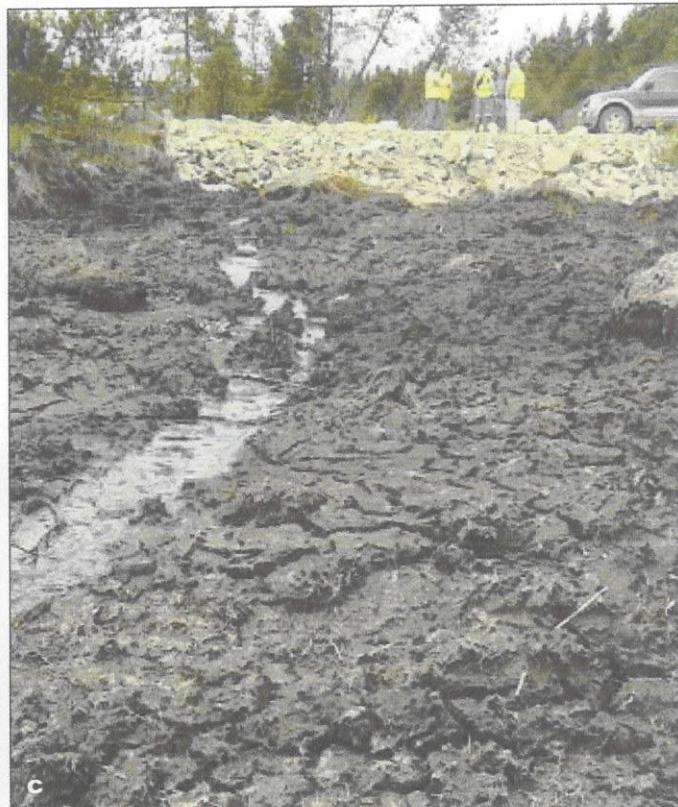
Plate 8.4. Site T70 on 8 June 2004.
a: looking upslope from road towards T68;
b: looking upslope towards T70;
c: exposure of the bedrock.

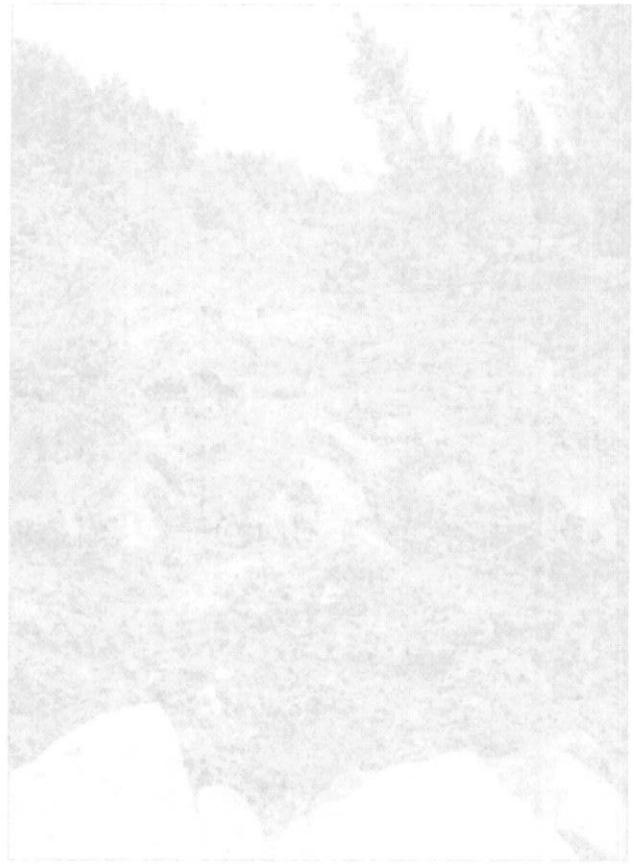
Plate 5.4. Site T70 on 8 June 2004.
a: looking upslope from road towards T68;
b: looking upslope towards T70;
c: exposure of the bedrock.

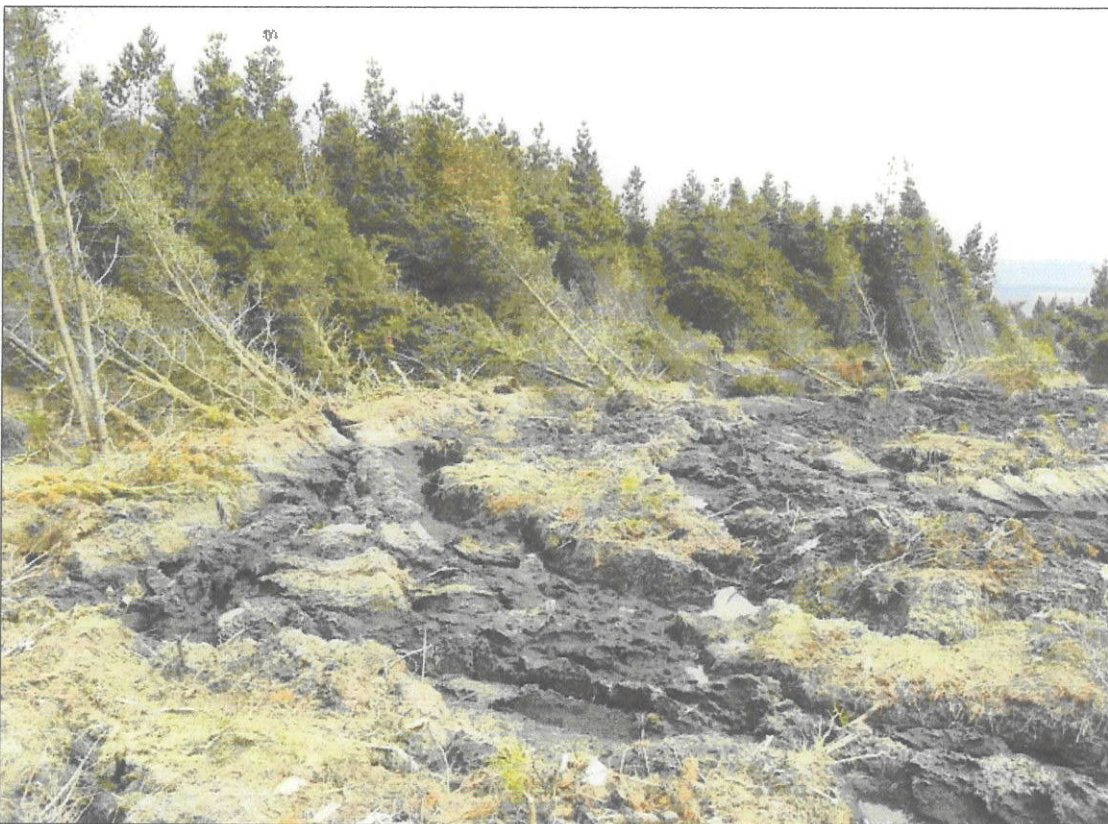
Plate 8.5: Looking southwards from T68 on 8 June 2004, the peat appeared to have separated from the plantation along plough furrows to form long ribbons that were progressively drawn into the slide.

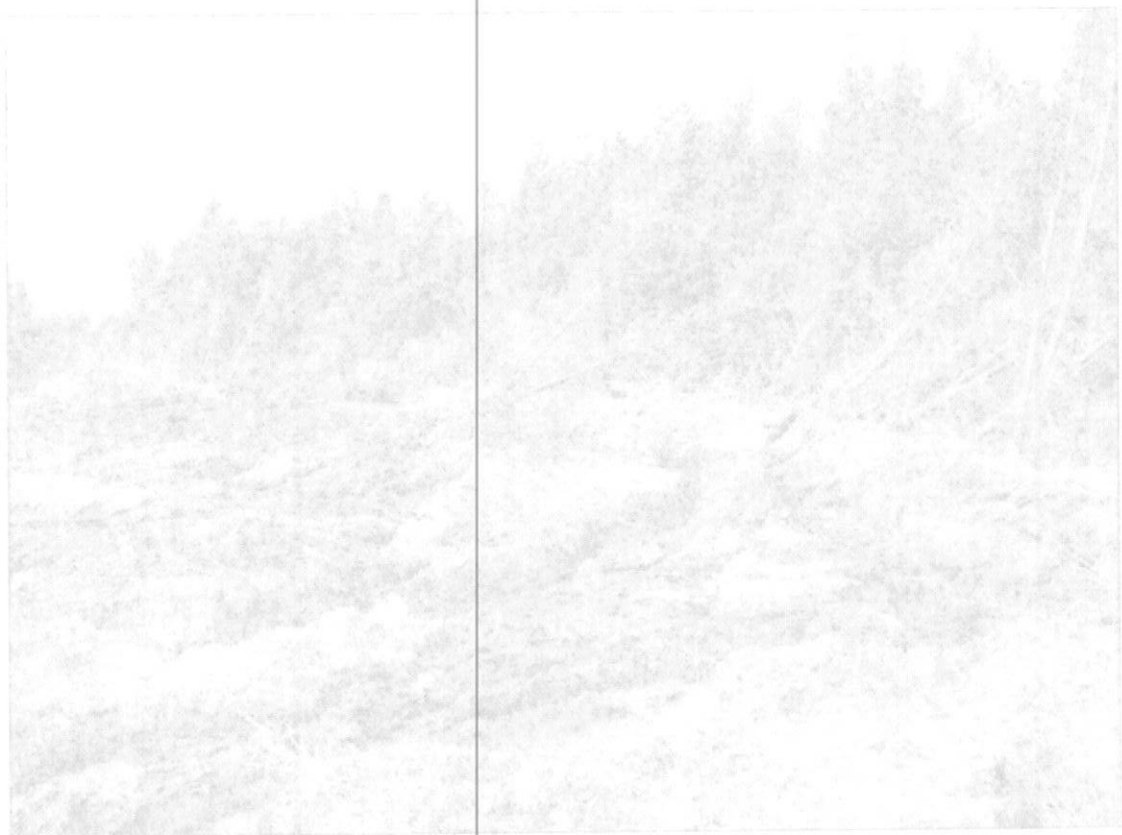
Plate 8.2: Looking southwards from T68 on 8 June 2004, the peat appeared to have separated from the plantation along plough furrows to form long ribbons that were progressively drawn into the slide.

Evidence that water does tend to pond in this location is provided by the fact that the T68 excavation was water-filled in June 2004 (plates 8.2 and 8.11). Such ponding would certainly render excavation more difficult and thus the presence of a pump at this location might not be unexpected. What is not clear, however, is whether this pump was in operation on the day of the peat failure. The T70 site was located to the north of a floating access road 300 metres downslope of T70. It is not clear whether or not the excavation for T70 had been completed at the time of the slide. All of the other sites planned for the southernmost row of turbines had been excavated except the one (T71) immediately to the east of T70, which had been partially excavated. The AGECE mapping sheet states that the T70 'base was not constructed'. Therefore it seems likely that T70 had been excavated but possible that it had not. If the former was the case, the excavation was certainly full of water (see below).

Evidence that water does tend to pond in this location is provided by the fact that the T68 excavation was water-filled in June 2004 (plates 8.2 and 8.11). Such ponding would certainly render excavation more difficult and thus the presence of a pump at this location might not be unexpected. What is not clear, however, is whether this pump was in operation on the day of the peat failure. The T70 site was located to the north of a floating access road 300 metres downslope of T70. It is not clear whether or not the excavation for T70 had been completed at the time of the slide. All of the other sites planned for the southernmost row of turbines had been excavated except the one (T71) immediately to the east of T70, which had been partially excavated. The AGEC mapping sheet states that the T70 'phase was not constructed'. Therefore it seems likely that T70 had been excavated but possible that it had not. If the former was the case, the excavation was certainly full of water (see below).

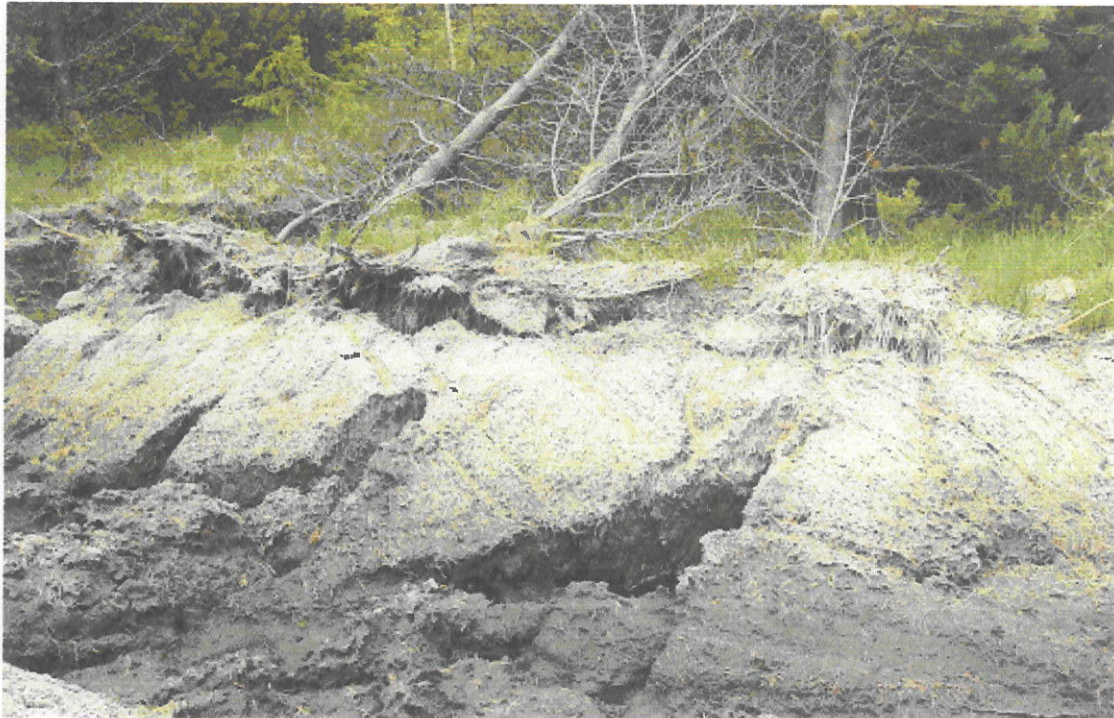
Plate 8.6: Face of delaminated ribbon of peat. Note the depth of delamination and the tendency of tree roots to run along the line of the ribbon with few roots extending laterally at right angles to the ribbon. This suggests that there is relatively limited root growth across lines of the cracks that form under plantation conditions.

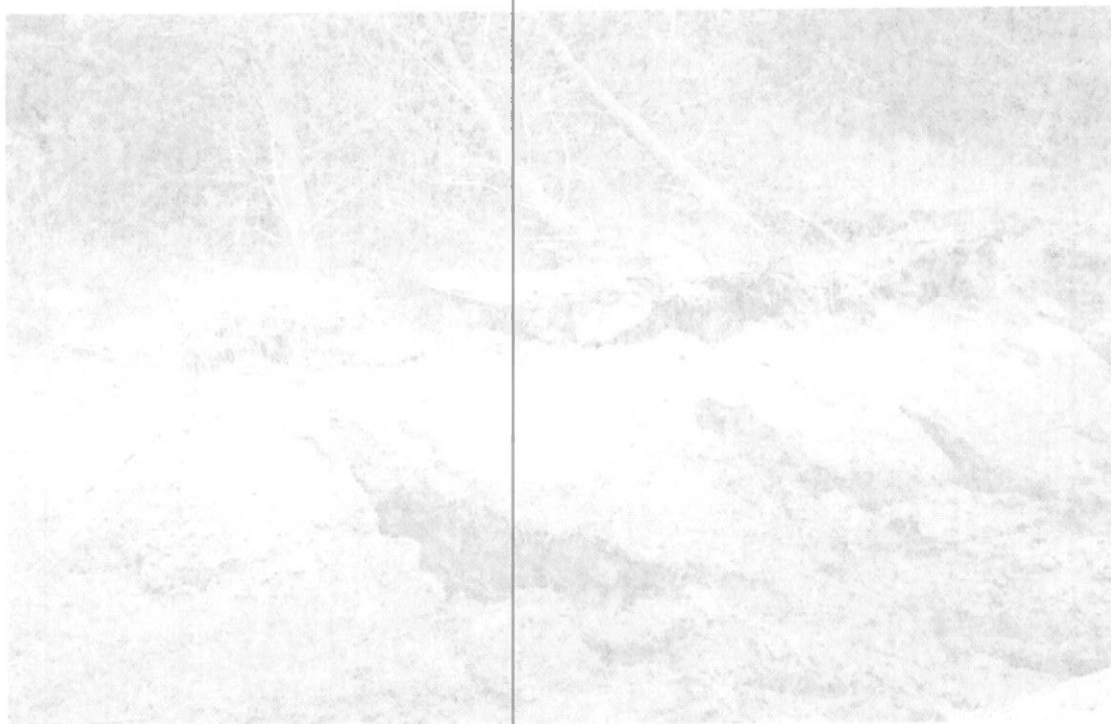
Plate 8.6: Face of delaminated ribbon of peat. Note the depth of delamination and the tendency of tree roots to run along the line of the ribbon with few roots extending laterally at right angles to the ribbon. This suggests that there is relatively limited root growth across lines of the stacks that form under plantation conditions.

This separation into ribbons would be enhanced by the cracking along drain and plough lines. Since the plantation between T68 and T70 is around 30 years old and obviously mature, whilst that below T70 results from two plantings separated by a fire over the same period, we might well expect to find cracking in the vicinity of the slide. Plate 8.8 shows a peat ribbon just beginning to separate along what appears to be a plough-furrow crack just above the eastern side of the area that was most severely disturbed by the slide.

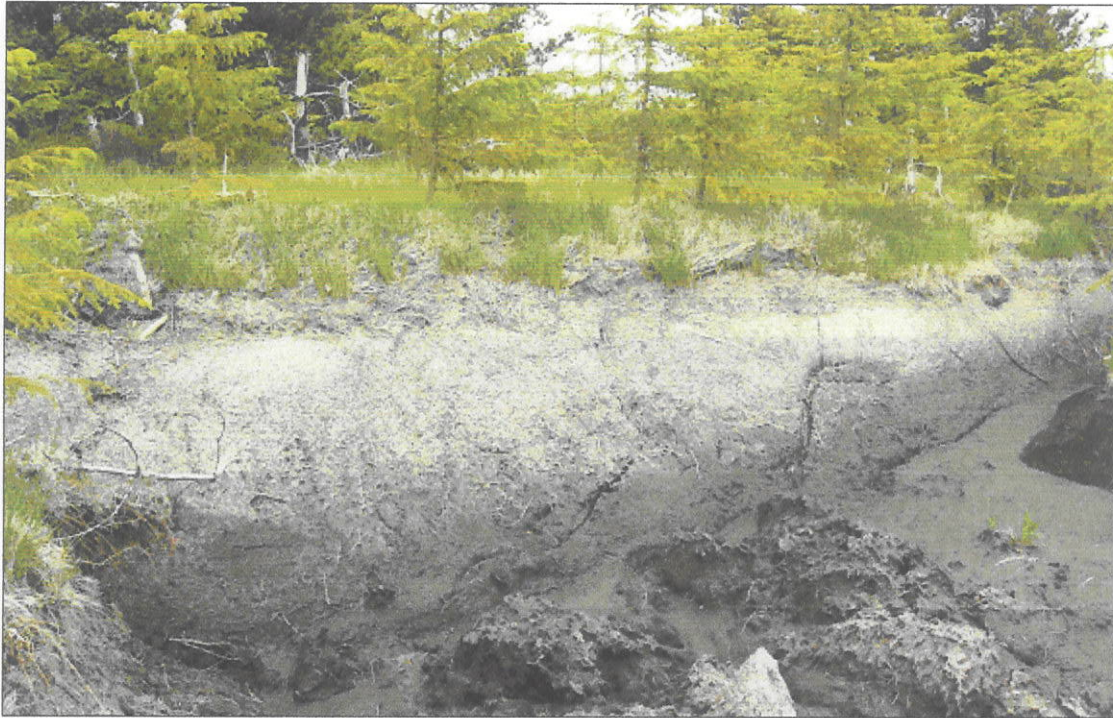
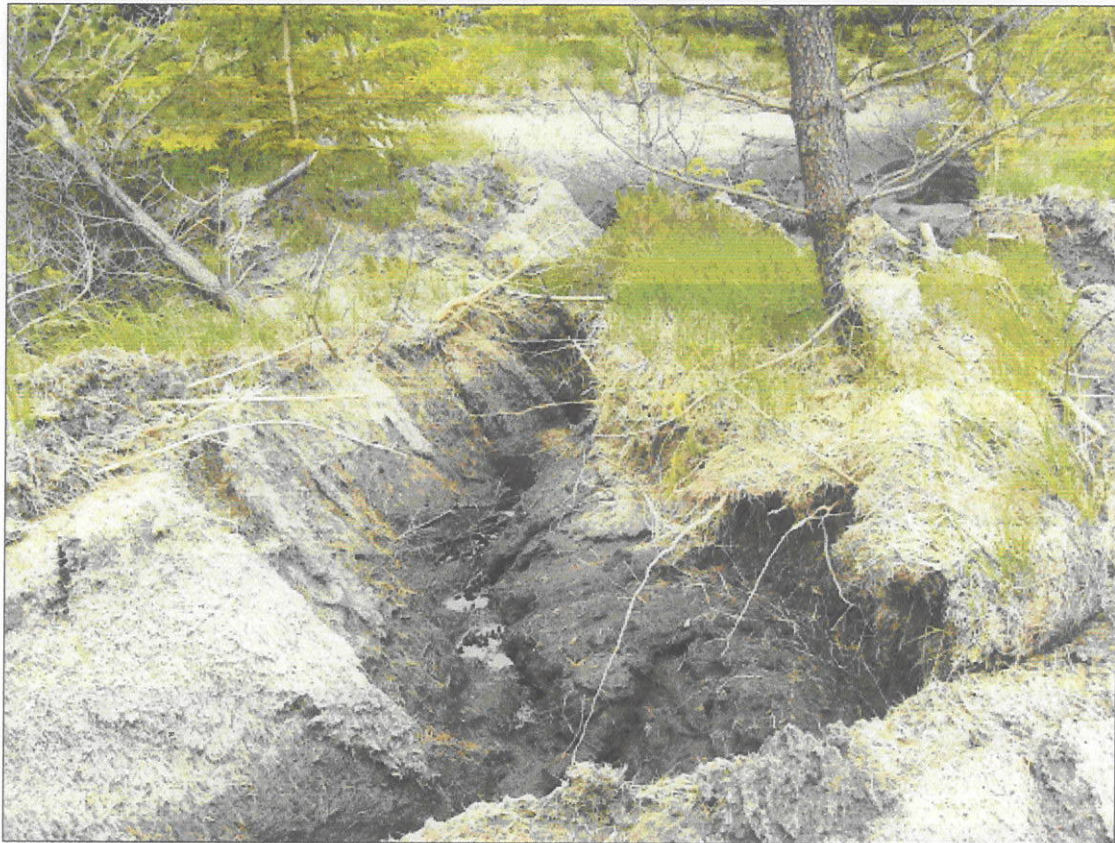
Plate 8.7: Delaminated ribbons of peat at the edge of the failed area near T70. The two-layered structure of the peat profile is obvious on the faces of the ribbons but there are few protruding tree roots. Some cracking of catotelm peat is evident in the upper picture.

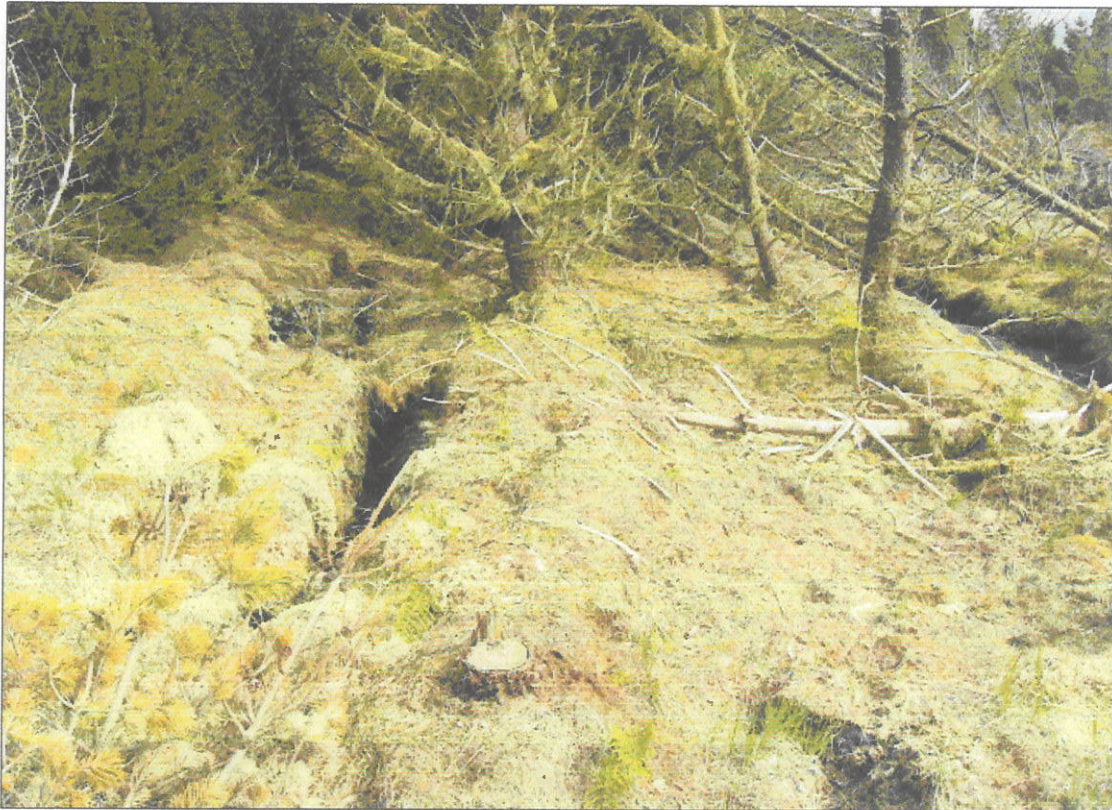
Plate 8.8: A peat ribbon just beginning to separate along what appears to be a plough-furrow crack adjacent to the failed area.

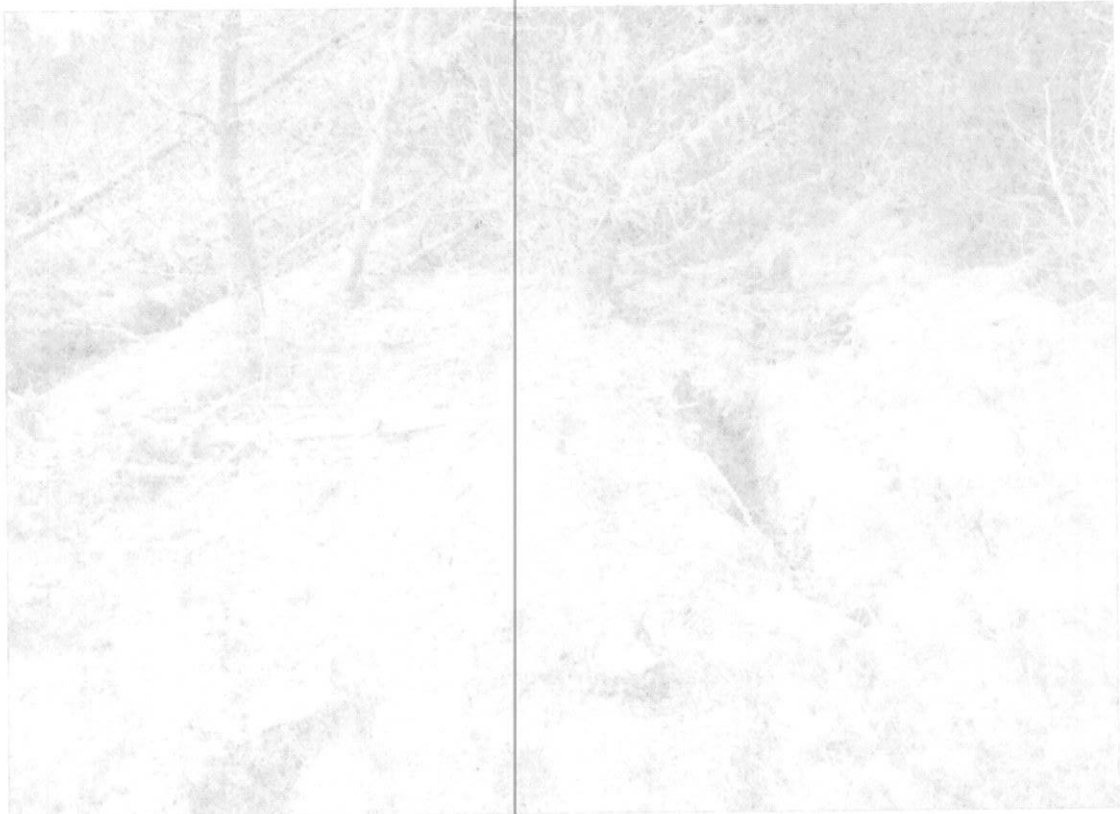
Plate 8.8: A peat ribbon just beginning to separate along what appears to be a plough-furrow crack adjacent to the failed area.

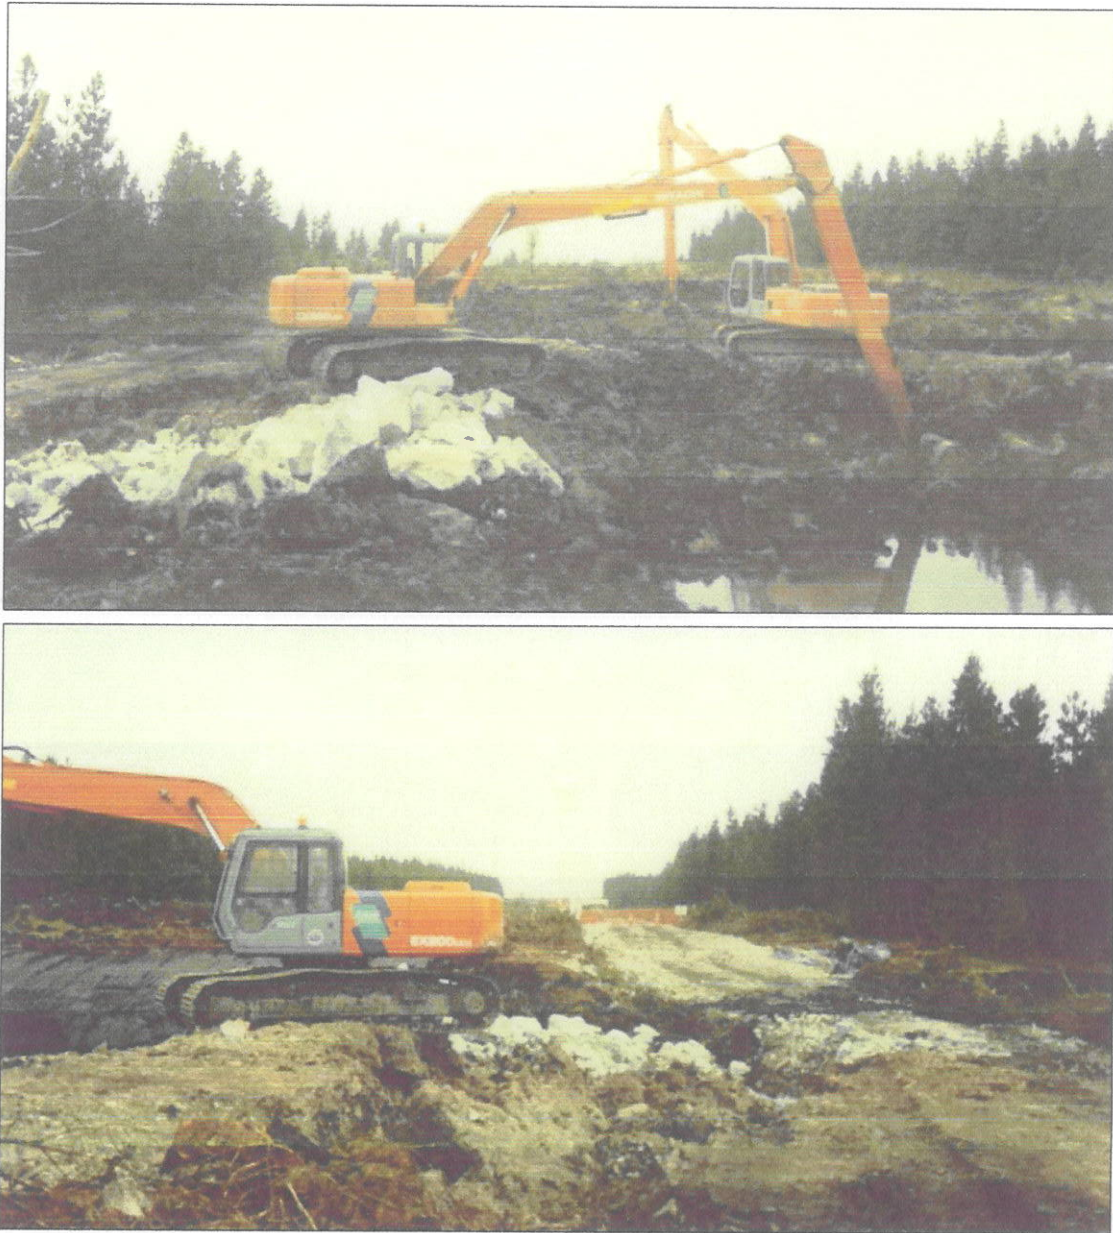
Plate 8.9: T68 shortly after the bog slide. The head of the failure was marked by a tension crack which can be seen beneath the perched excavator and the access road bowed downslope (to the right of the lower picture, which was taken from the west side of the slide).

According to the AGECE (2004) account, the excavation had reached mineral soil and had 'several drains feeding into it and appeared to have been water-filled . . . site representatives (have) indicated that they (were) unaware of any over-pumping at this location'. Photographs taken within days (plates 8.8 and 8.9) show the positions of the excavators. At that time there was a small quantity of water in the base of the excavation.

According to the AGEC (2004) account, the excavation had reached mineral soil and had 'several drains feeding into it and appeared to have been water-filled'. . . site representatives (have) indicated that they (were) unaware of any over-pumping at this location. Photographs taken within days (plates 8.8 and 8.9) show the positions of the excavators. At that time there was a small quantity of water in the base of the excavation.

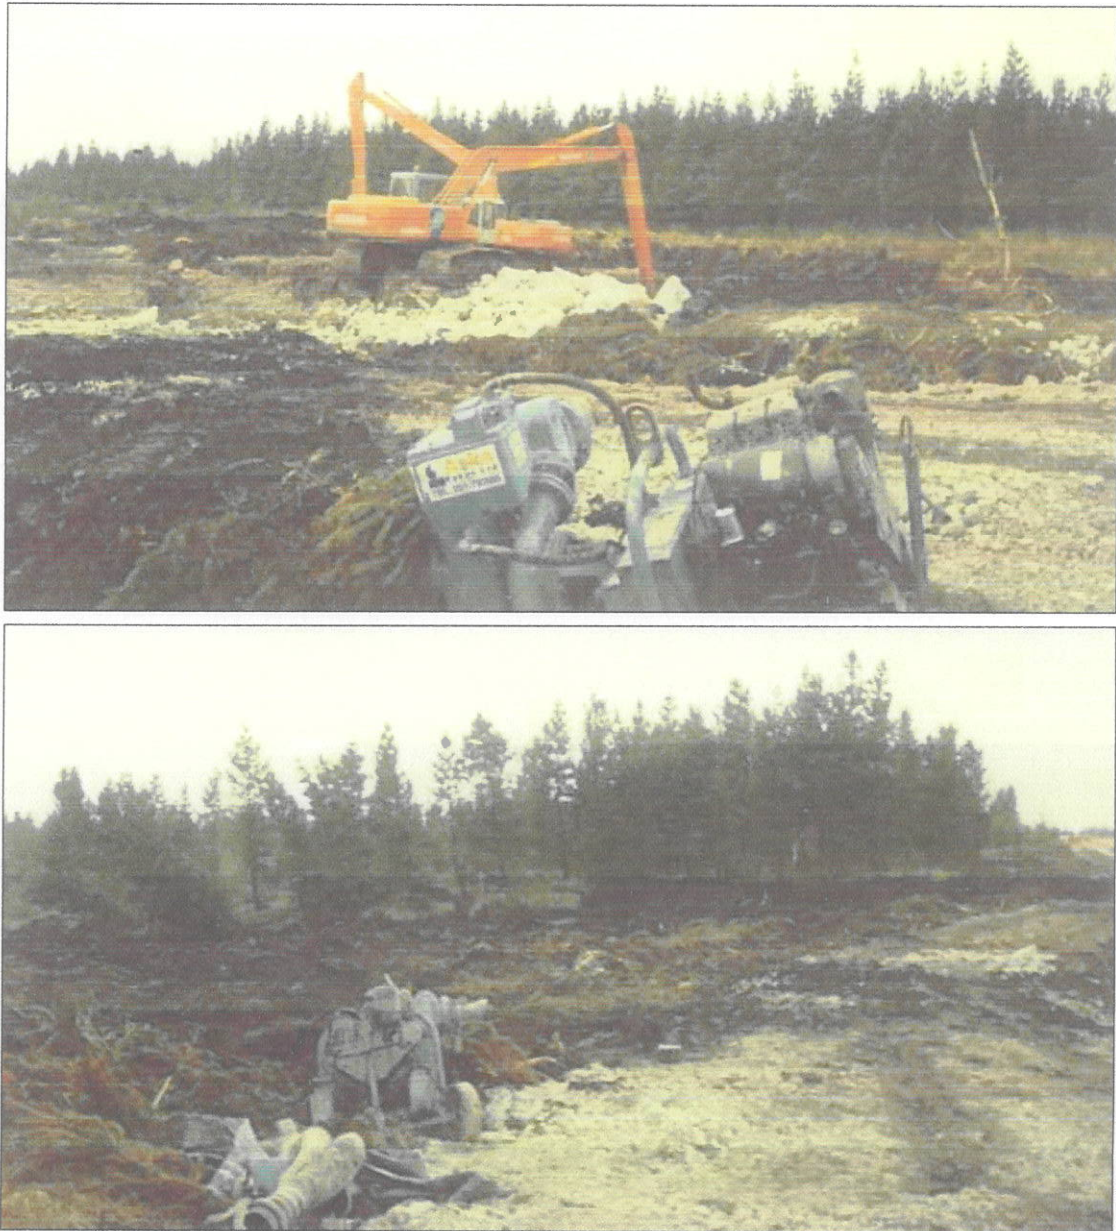
Plate 8.10: Photographs taken at T68 shortly after the bog slide. A disconnected water pump features prominently in these frames, which were taken from south and east of the slide.

There was also a disconnected water pump at the southern edge of the road. It has not been possible to clarify whether this was being used on the day of the slide, or whether it had been brought in later. However, its position suggests that it could have been used at some time to pump water from the excavation to a point close to the centre of the failed area. The fact that it appears to have slid or been pushed off the edge of the surfaced part of the road onto the timber rafting may be consistent with its having been present when the road moved downslope.

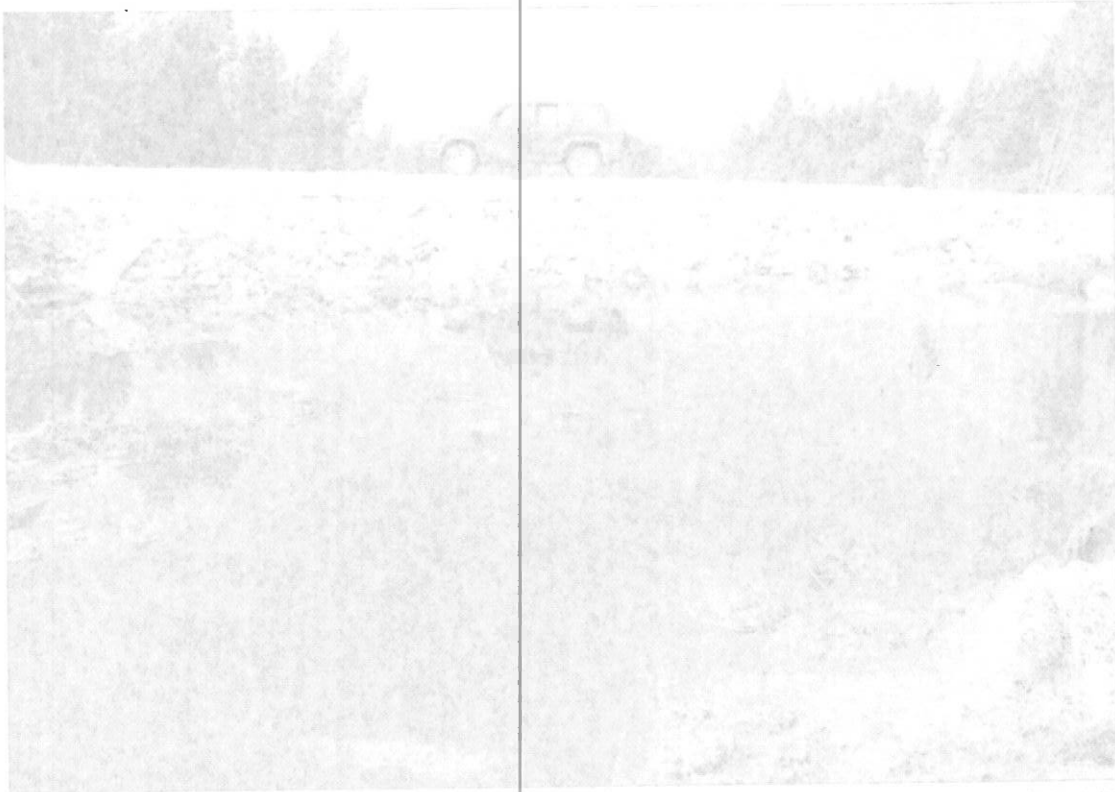
Plate 8.11: A damaged floating road just by T68. By June 2003, when this photograph was taken, it had been top-loaded with some decimetres of rock and aggregate, presumably rendering it rather less permeable to water than previously. A considerable depth of water had accumulated uplope, as the picture shows.
