Remedial Natura Impact Statement

Substitute Consent for
Deviations at Meenbog
Windfarm, Co. Donegal

Project Number: **220623**

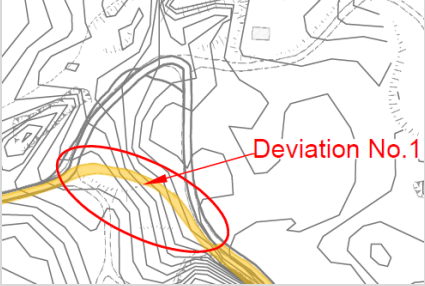
No.	Deviation Description	Location of Deviation	Reason for Deviation
1	Entrance road off N15 (the hairpin bend)

<p>The existing hairpin bend was unsafe as it did not provide adequate line of sight for vehicles using the road. This was a safety concern that only came to light prior to construction and after it was established that the as-built route was feasible from a geotechnical perspective with the benefit of site investigations.</p> <p>The as-built alignment would have required a reduced construction footprint compared to the permitted.</p>
2	Peat cell southeast of substation

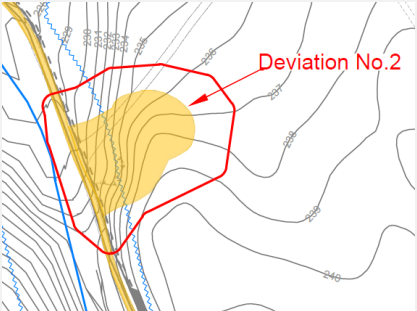
<p>Peat cells were created as part of the engineering plans for excess peat that was generated during the course of construction and required management, greater than the volumes estimated pre-construction.</p>
3	T10 access road:

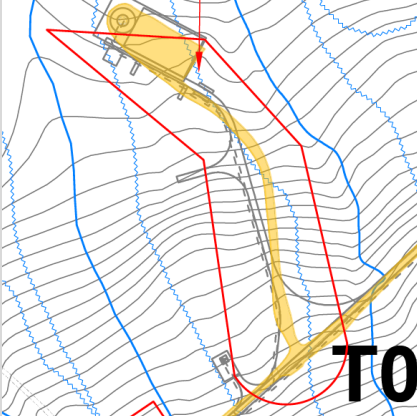
<p>Realigned road was adjusted to follow more favourable ground conditions and topography.</p>

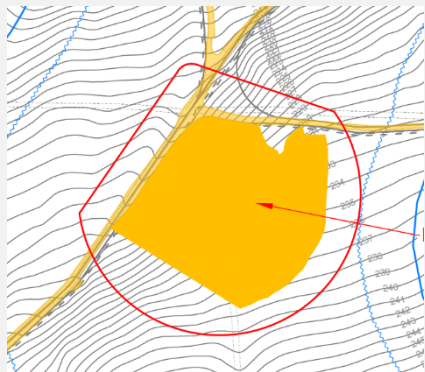
<p>4</p>	<p>Borrow Pit southwest of T12</p>

<p>Existing forestry borrow pit was expanded to win stone on-site ahead of gaining access to the wind farm borrow pits. Excavation of the existing forestry borrow pit continued in lieu of excavation at the permitted BP1 borrow pit.</p>
<p>5</p>	<p>T12 access road</p>

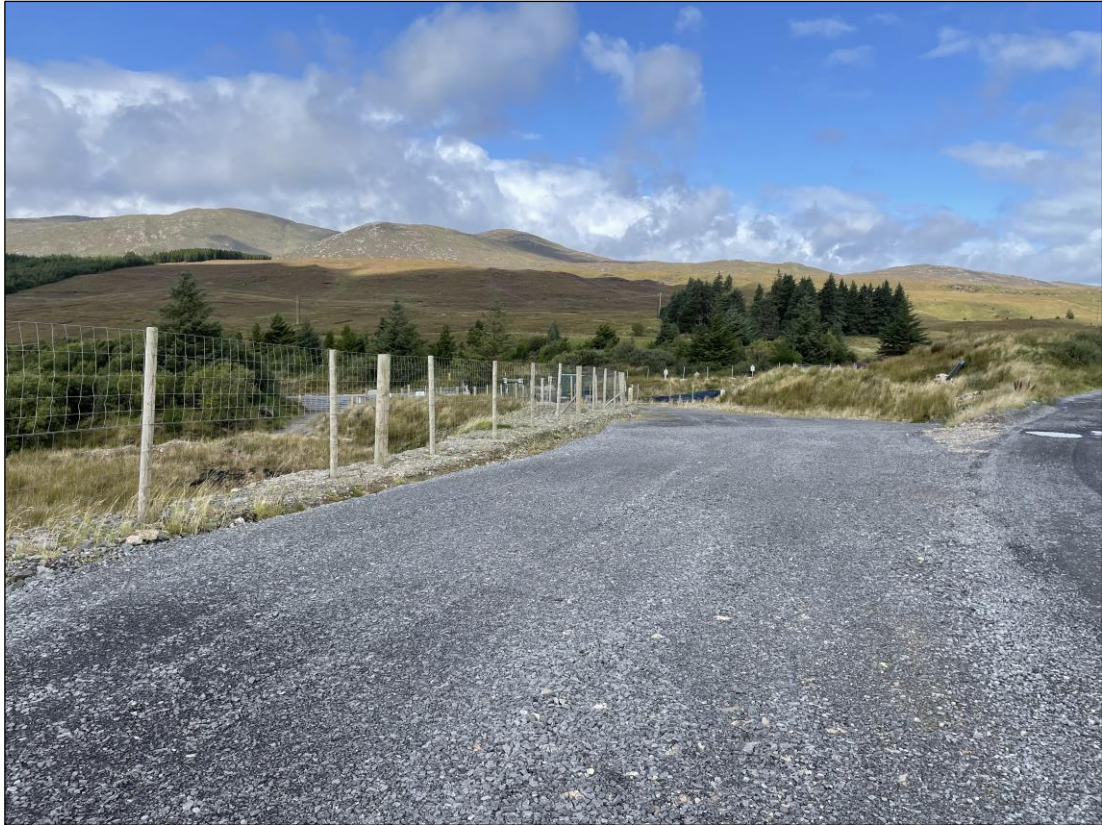
Plate 4--1 Deviated section of access road as viewed from the southeast – facing northwest towards the N15 (August 2023).

The site of the deviation was the subject of a comprehensive ecological walkover survey on the 23rd August 2023. The current habitats at the site of Deviation 1 include Spoil and Bare Ground (ED2), Recolonising Bare Ground (ED3) associated with the ongoing operation of the quarry and the new access road (Plate 4-1), willow (*Salix cinerea*) and bramble (*Rubus fruticosus*) Scrub (WS1) and Active Quarries and Mines (ED4) in the wider area. In addition, the relocated settlement pond was observed and classified as Artificial Lakes and Ponds (FL8), this was lined with plastic and was of low ecological value (Plate 4-2). The overflow system was observed and was in use at the time of the visit (after several days of heavy rain), with the pond discharging to an existing culvert beneath the new road and an existing quarry road and into a drain that forms part of the original quarry drainage network. No significant habitat for any of the Key Ecological Receptors (KERs) or Key Ornithological Receptors (KORs) or KORs that were identified in the Submitted EIAR or the NIS which was lodged with the application for the Permitted Development (“the Submitted NIS”) were recorded at the site of Deviations 1 and no additional significant faunal habitat was recorded. The site of Deviation 1 was assessed by AFRY Engineers (2023) as stable. The AFRY site technical note is available in Appendix 4-1..

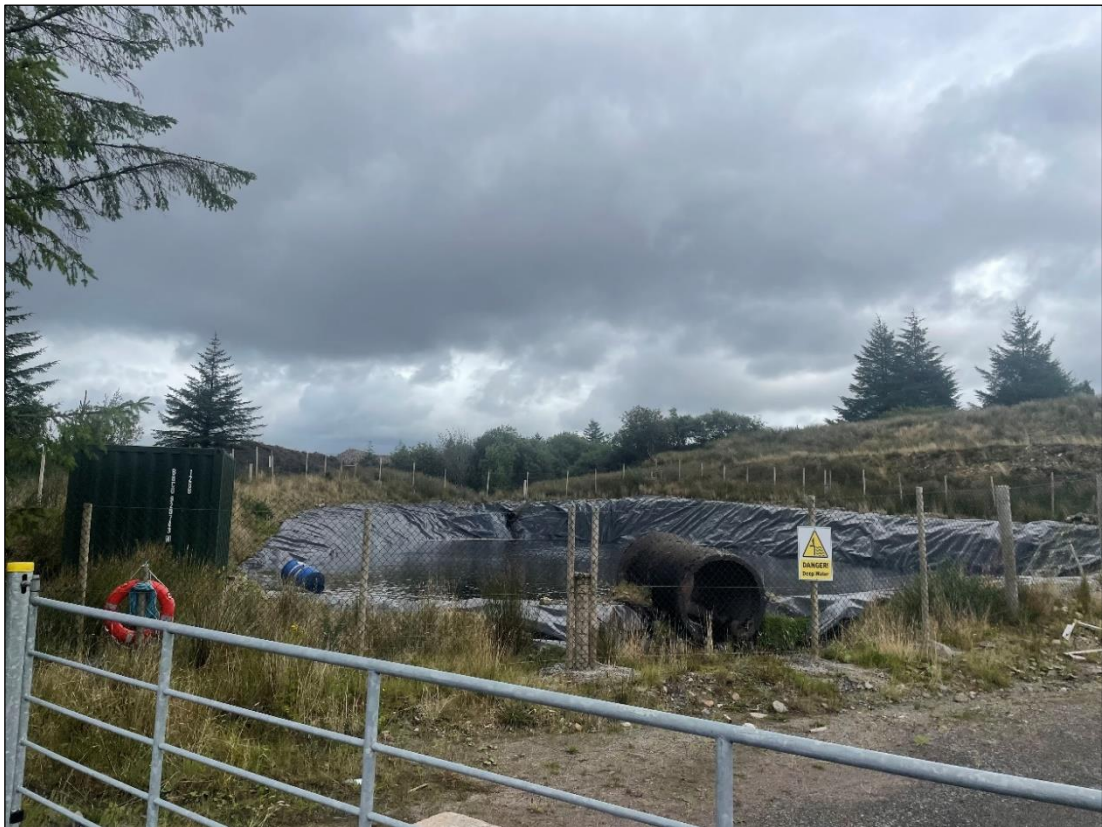
Plate 4--2 Relocated and plastic lined settlement pond showing overflow pipe (August 2023).

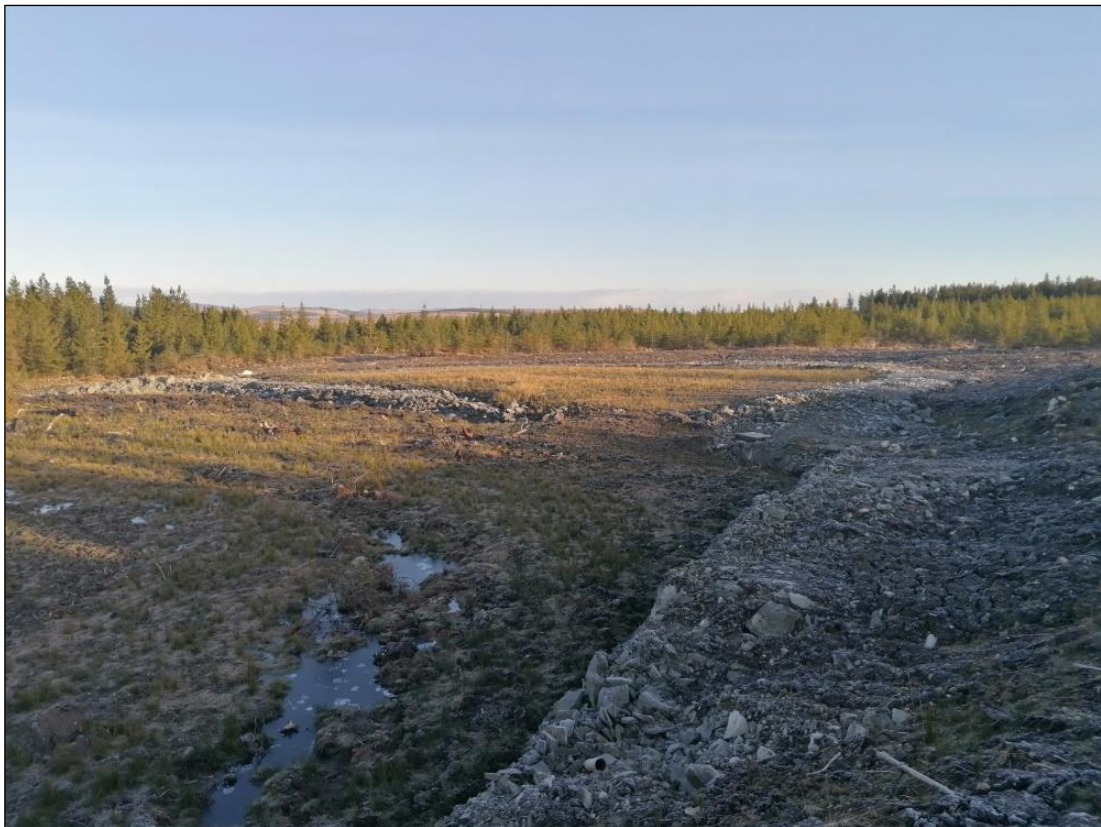
Plate 4-3 Peat Surface after Peat Deposition (2021)

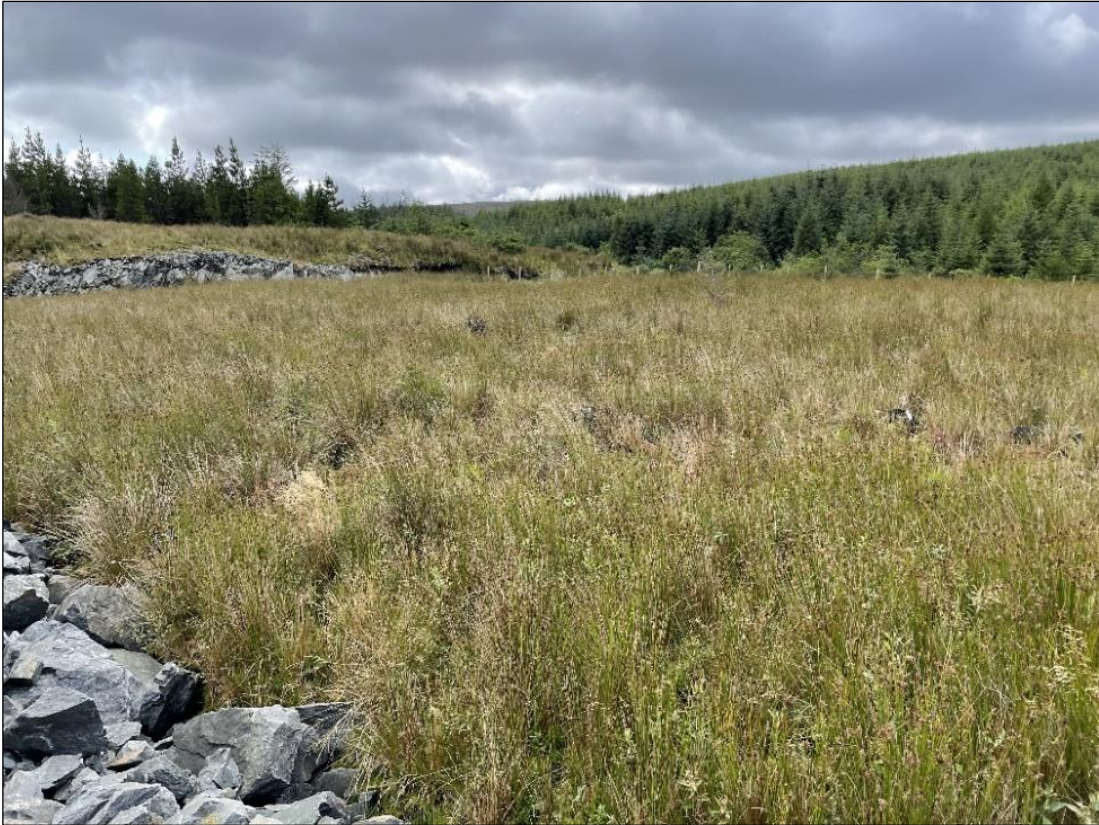
The site of the Deviation 2 was the subject of a comprehensive ecological walkover survey on the 23rd August 2023. The current conditions on the site are described below. Peat arisings were deposited in the peat cells up until July 2020. Since that time the surface of the deposited peat has revegetated with species including soft rush (*Juncus effusus*), ling (*Calluna vulgaris*), and tormentil (*Potentilla erecta*). Some grey willow (*Salix cinerea*) and *Sphagnum* species were starting to recolonise also. It was best classified as wet heath (HH3). A stone bank formed the western boundary of the peat cell. Plates 4-3 and 4-4 below show the progression of site revegetation from 2021 to present. Conifer plantation (WD4) surrounded the site to the north, east and south. No evidence of any overtopping or run off from the peat storage area was recorded during the site visit and the peat was firm underfoot with wet pools present throughout. No watercourses or running drains were recorded on the site of Deviation 2. There were dry drains associated with the road and a small watercourse located on the opposite side of the road from the deviation and removed from it by approximately 25metres. No significant habitat for any of the KERs or KORs that were identified in the Submitted EIAR or the Submitted NIS were recorded at the site of Deviation 2 and no additional significant faunal habitat was recorded. A sitewide geotechnical stability assessment was carried out in October 2023 by AFRY. The assessment found that the peat cells are stable works are complete at this deviation.

Plate 4--4 Revegetated Peat Surface (2023)

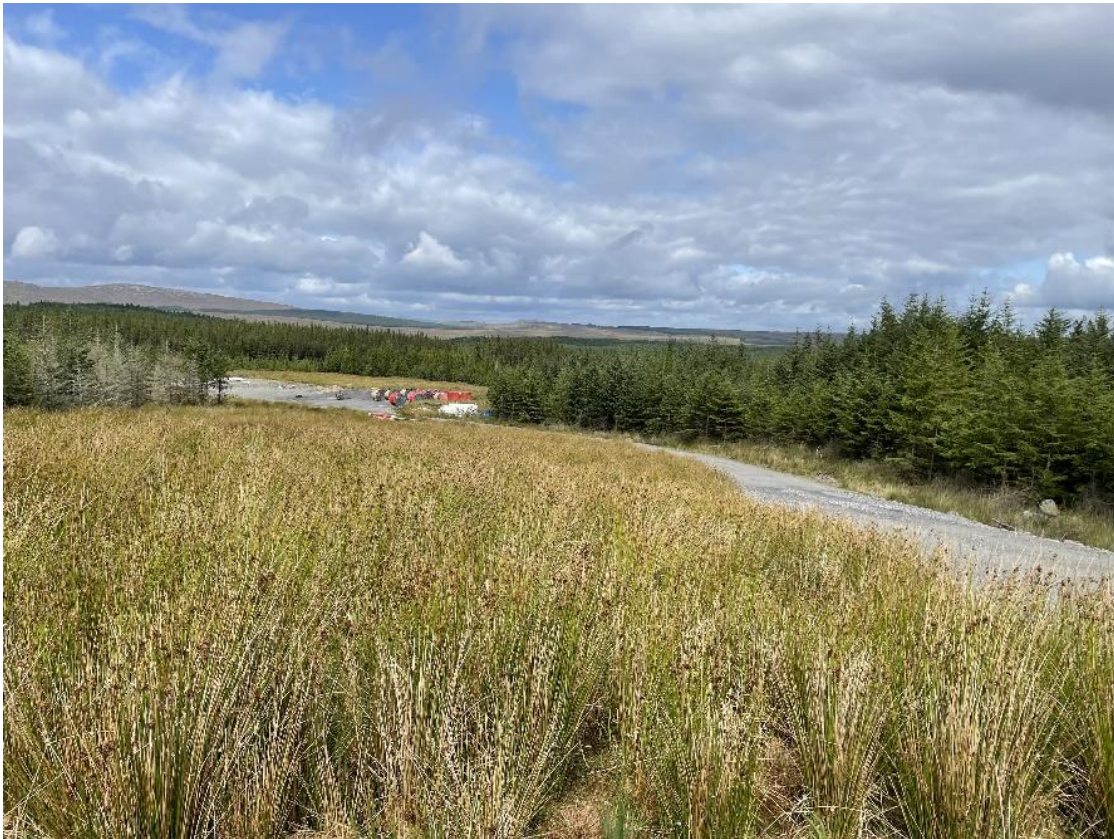
The site of the Deviation 3 was the subject of a comprehensive ecological walkover survey on the 23rd August 2023. The current conditions at the site of Deviation 3 are described below. The deviation involved a slight realignment of the access road to T10. This may have resulted in additional loss of trees however the habitats at the site of the deviation include a new access road in a slightly altered position that is classified as Buildings and Artificial Surfaces (BL3) and an area that has been cleared of Conifer Forestry and is now recolonising with vegetation that is dominated by soft rush (*Juncus effuses*) and bulbous rush (*Juncus bulbosus*). There are also numerous grey willow (*Salix cinerea*) seedlings in this area and it is likely that it will ultimately succeed to willow scrub (WS1) and woodland habitat. The site of Deviation 3 is completely surrounded by Conifer Plantation (WD4). There is a tributary of the Bunadaowen located approximately 35m to the west of Deviation 3. No significant habitat for any of the KERs or KORs that were identified in the Submitted EIAR or the Submitted NIS were recorded at this site and no additional significant faunal habitat was recorded. The recolonising habitats will likely provide good broadleaved woodland and scrub habitat. The existing site conditions is shown in Plate 4-5.

Plate 4--5 Rushy vegetation dominating the habitat at Deviation 4.

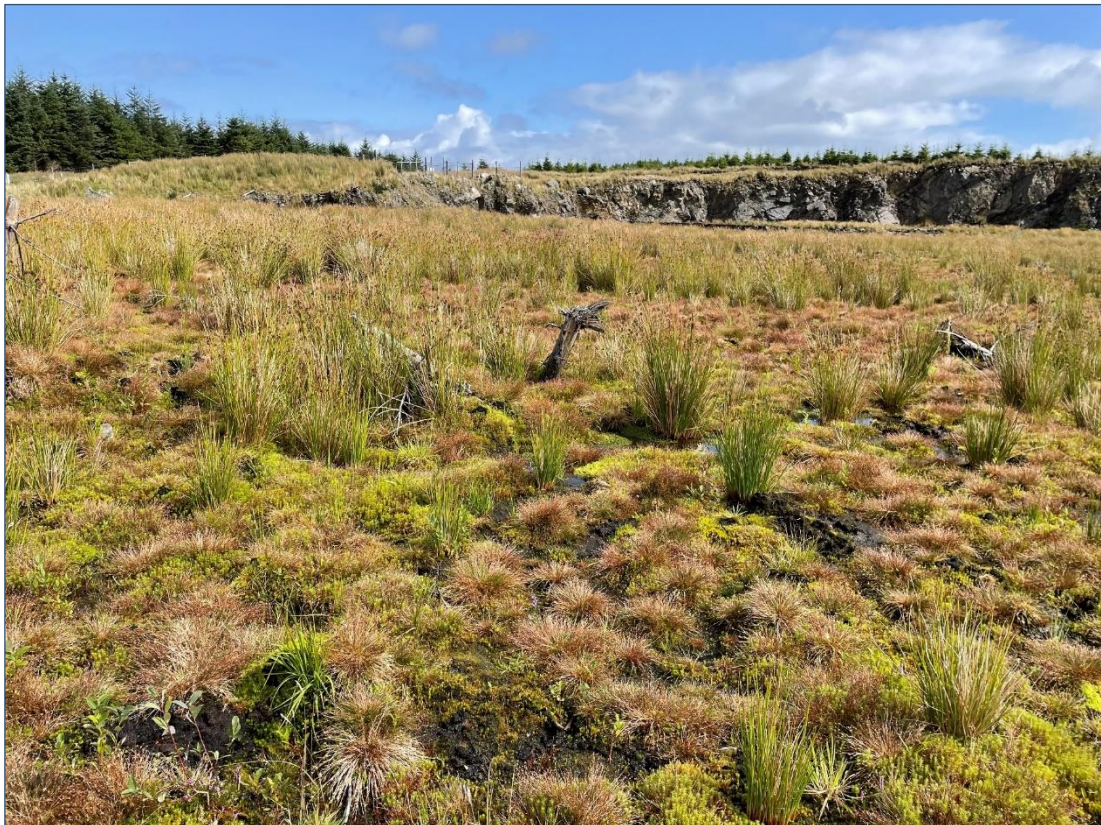
The site of Deviation 4 was the subject of a comprehensive ecological walkover survey on the 23rd August 2023. The current conditions on the site of Deviation 4 are described below. Since the cessation of peat deposition in the cell, the surface of the deposited peat has revegetated with species including soft rush (*Juncus effusus*), bulbous rush (*Juncus bulbosus*), Yorkshire fog (*Holcus lanatus*) and tormentil (*Potentilla erecta*). Some ling (*Calluna vulgaris*), *Polytrichum* and *Sphagnum* species were starting to recolonise also. It was best classified as wet heath (HH3) (Plates 4-6 and 4-7). A constructed stone bank formed the north western boundary of the peat cell and sections of the borrow pit that have not been fully reinstated with peat support bare rock habitat (ED4) (Plate 4-8). The surrounding areas include the main wind farm spine road to the north west, another wind farm/forestry road (BL3) to the north and young Conifer Plantation (WD4) on shallow peats to the south and east. Heath vegetation was evident beneath the conifer trees. No evidence of any overtopping or run off from the peat storage area was recorded during the site visit and the peat was firm underfoot with wet pools present throughout. No watercourses or running drains were recorded on the site of Deviation 4. No significant habitat for any of the KERs or KORs that were identified in the Submitted EIAR or the Submitted NIS were recorded at this site and no additional significant faunal habitat was recorded. The revegetating cells provided good habitat for reptiles and amphibians. A sitewide geotechnical stability assessment was carried out in October 2023. The assessment found that the peat cells are stable (AFRY, 2023).

Plate 4--6 Revegetating surface of peat cell

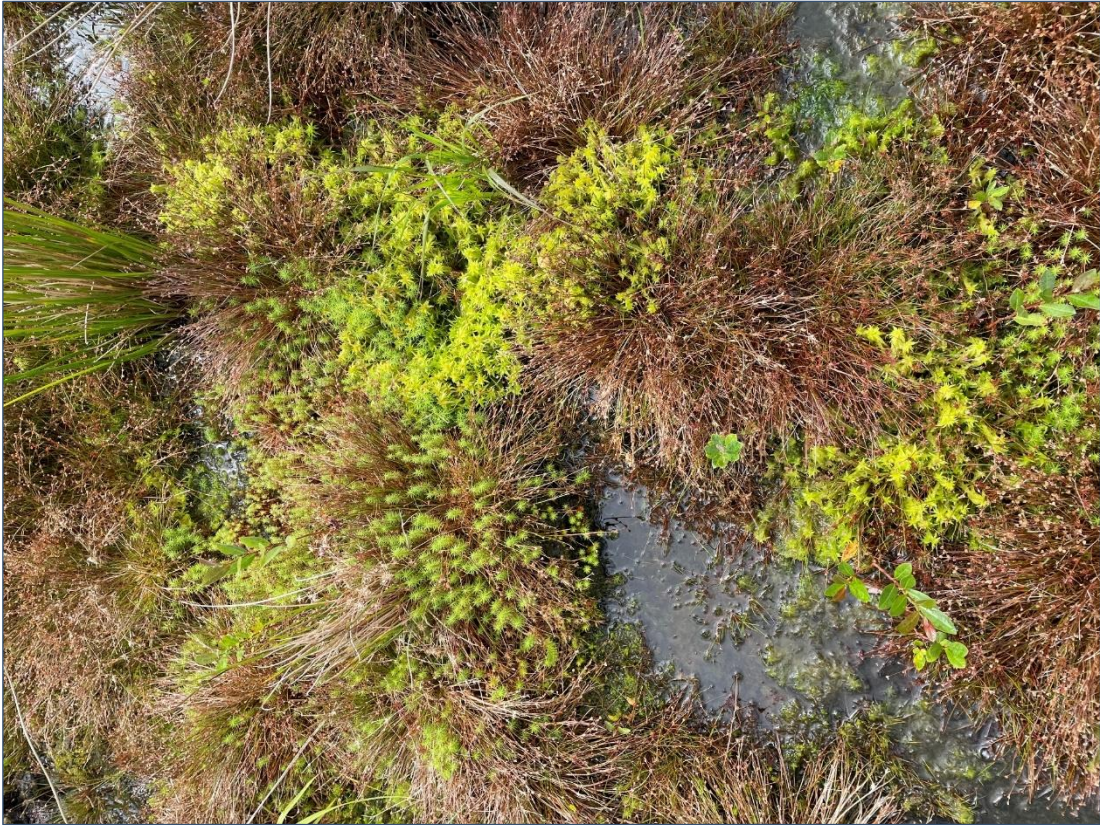
Plate 4--7 Close up of revegetating surface of peat cell

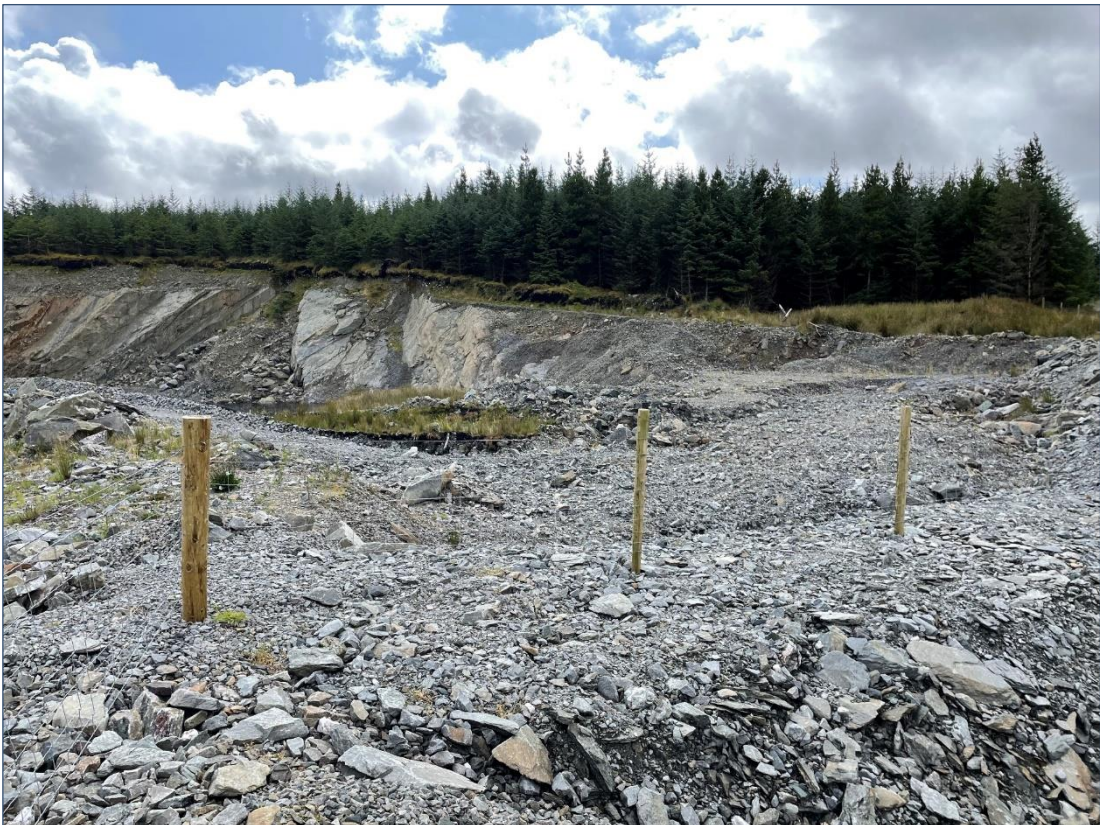
Plate 4--8 Unfilled section of peat cell and conifer plantation on shallow peats in the surrounding area.

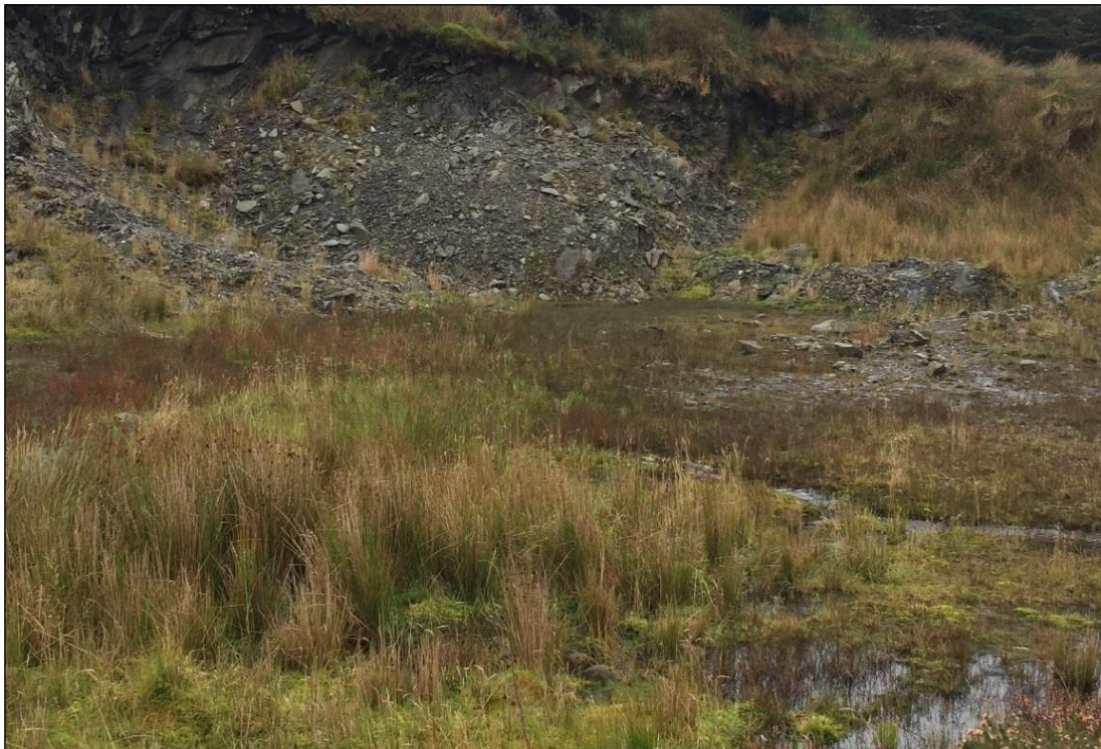
The receiving environment on the site of s Deviation 4 is located entirely within the Submitted EIA study area and is fully described in the Submitted EIA. There was an existing borrow pit surrounded by a conifer plantation with a small artificial pond within the pit as shown in Plate 4-9 and described in Section 6.3.2.1 of the Submitted EIA. The artificial pond was artificially created and was part of forestry infrastructure. It was not assigned as a KER. The Habitat Map (reproduced in Figure 4-1) shows the area as conifer plantation (WD4). The existing borrow pit was considered to be insignificant in the context of the overall conifer plantation in the area and the use of this existing borrow pit was assessed and permitted. This deviation from the Permitted Development was within the forestry plantation that surrounded the existing forestry borrow pit. The subsoils in this area were made up of blanket peat at a depth of 0.1-1.5m (Ionic 2021 Report).

Plate 4-9 Pre – existing borrow pit at the location of Deviation 5.

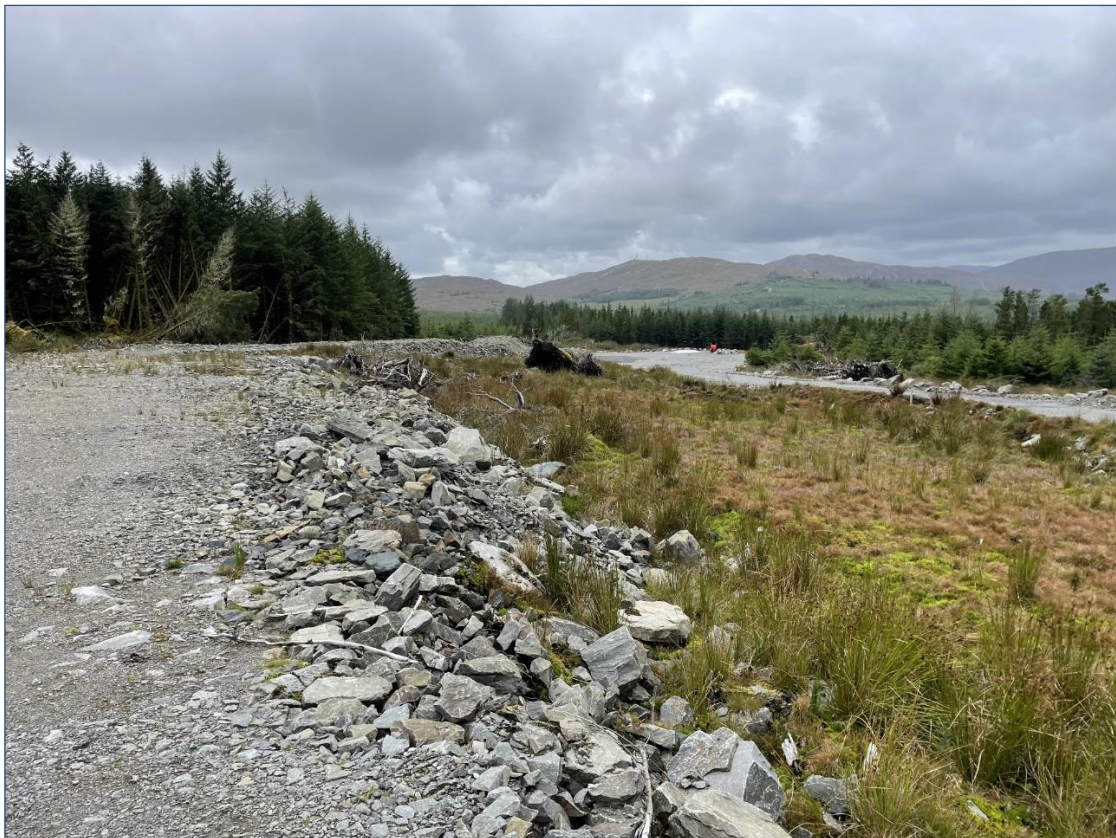
The site of the Deviation 7 was the subject of a comprehensive ecological walkover survey on the 23rd August 2023. The current conditions on the site of Deviation 7 are described below. The deviation involved a slight realignment of the access road to T08 following the construction of a containment berm in the area. The road was constructed closer to the berm than originally proposed and avoided additional loss of trees. The habitats at the site of the deviation include a new access road in a slightly altered position that is classified as Buildings and Artificial Surfaces (BL3) and an area on both sides of the access road that has been cleared of Conifer Forestry and is now recolonising with vegetation that is dominated by bryophytes with soft rush (*Juncus effuses*) and bulbous rush (*Juncus bulbosus*). Ling (*Calluna vulgaris*) and foxglove (*Digitalis purpurea*) were among the species that were recolonising close to the retained forestry plantation. It is likely that it will ultimately succeed to willow scrub (WS1) and woodland habitat. The site of Deviation 7 is completely surrounded by Conifer Plantation (WD4) There is a tributary of the Bunadaowen located approximately 190m to the north west of the deviation. No significant habitat for any of the KERs or KORs that were identified in the Submitted EIAR or the Submitted NIS were recorded at the site of Deviation 7 and no additional significant faunal habitat was recorded. The recolonising habitats will provide likely provide good broadleaved woodland and scrub habitat. The existing site conditions are shown in Plates 4-10. and 4-11.

Plate 4--10 Containment berm on left of plate, with amended road to the right. Recolonising habitats visible where conifer forestry has been felled

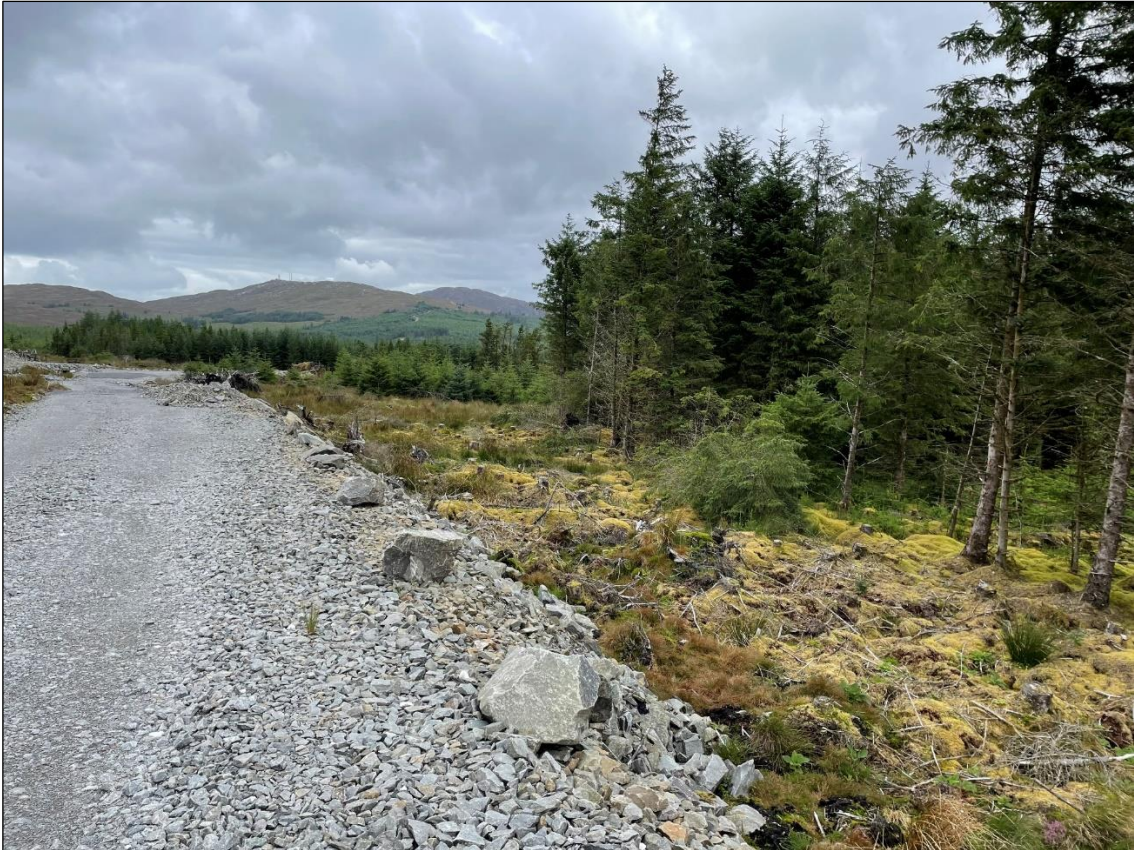
Plate 4--11 Amended Road. Recolonising habitats visible where conifer forestry has been felled

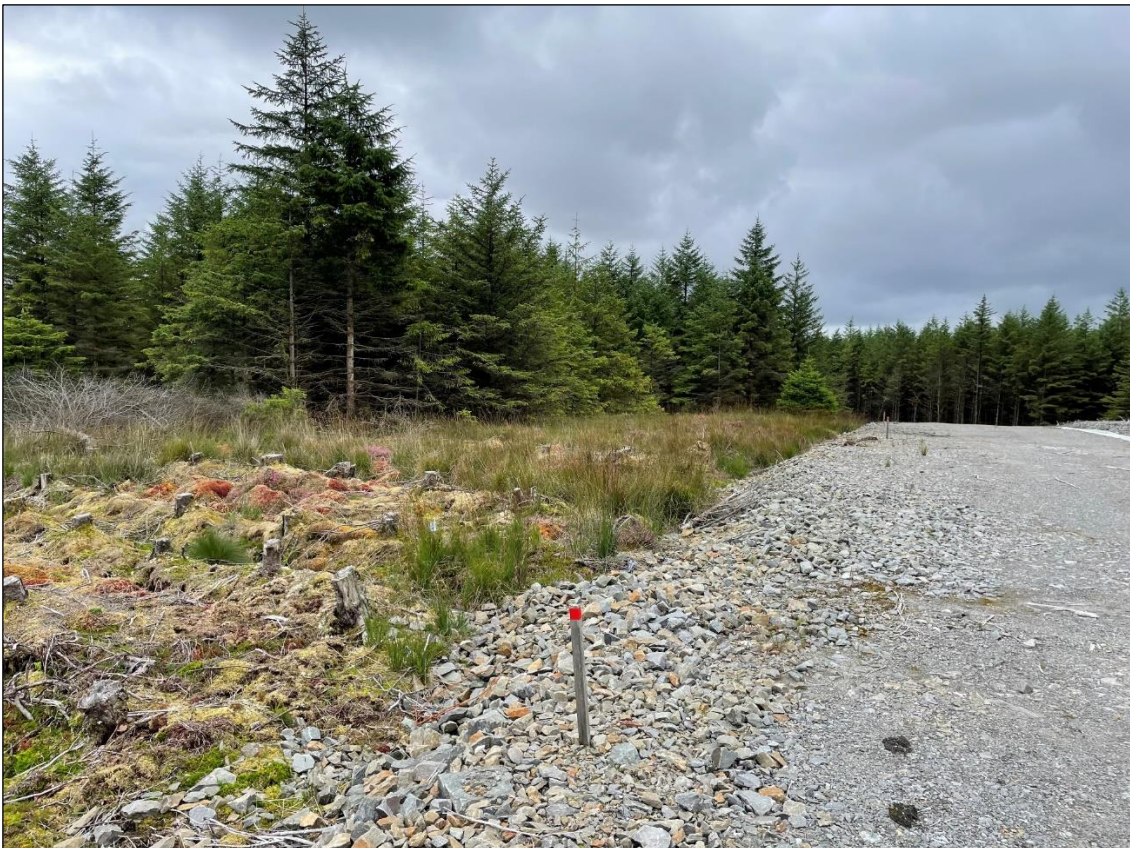
The site of Deviation 10 was the subject of a comprehensive ecological walkover survey on the 23rd August 2023. The current conditions on the site of Deviation 10 are described below. The deviation involved a slight realignment of the access road to T04. This resulted in a minor additional loss of trees, however the habitats at the site of the deviation include a new access road in a slightly altered position that is classified as Buildings and Artificial Surfaces (BL3) and an area that has been cleared of Conifer Forestry and is now recolonising with vegetation that is dominated by soft rush (*Juncus effuses*) but also includes heath vegetation including Sphagnum mosses, and Ling (*Calluna vulgaris*). It is likely that heath vegetation will dominate in this area. The site of Deviation 10 is completely surrounded by Conifer Plantation (WD4) and clear felled forestry. There is a tributary of the Glendergan River located approximately 400m to the west of the deviation, though indirect connectivity to this may be provided through forestry drains in the area. No significant habitat for any of the KERs or KORs that were identified in the Submitted EIAR or the Submitted NIS were recorded at the site of Deviation 10 and no additional significant faunal habitat was recorded. The recolonising habitats will provide likely provide wet heath habitat in the future. The existing site conditions are shown in Plate 4-12.

Plate 4-12 Slight amendment to location of access road, showing heath habitats recolonising where the conifer forestry has been felled

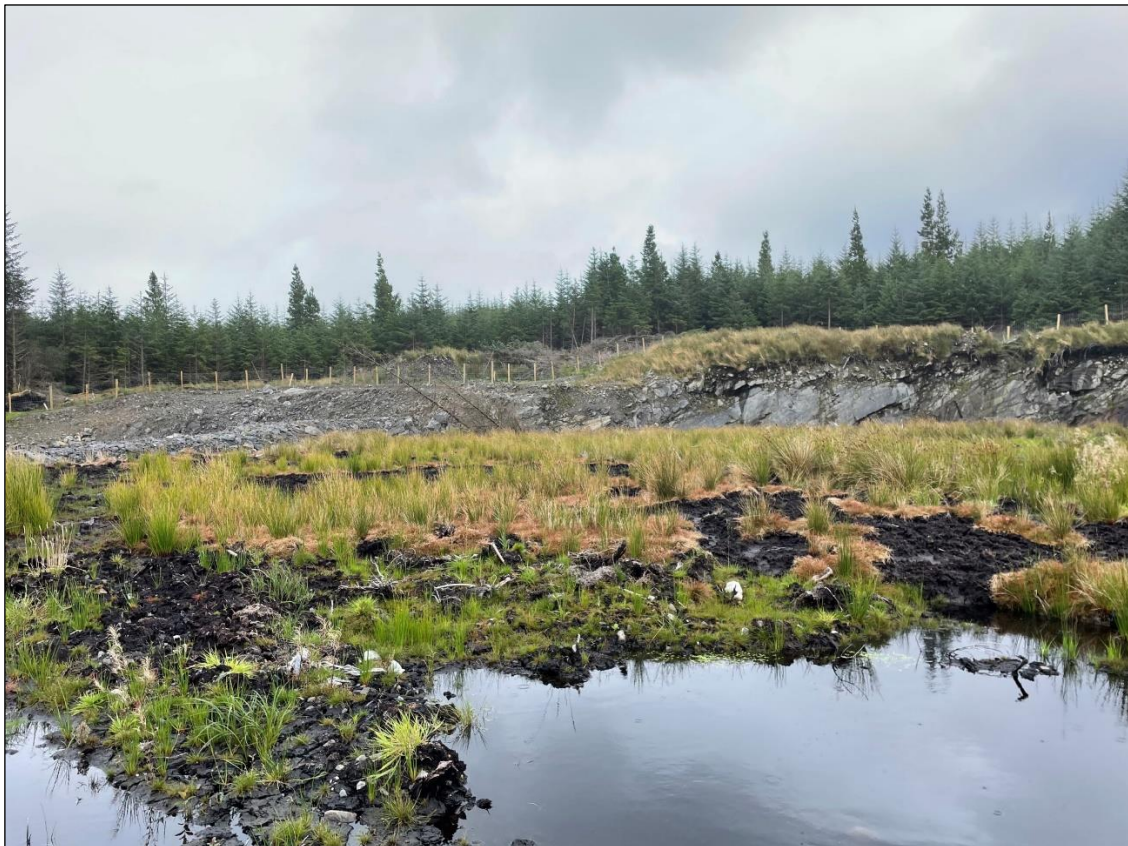
The site of the Deviation 11 was the subject of a comprehensive ecological walkover survey on the 23rd August 2023. The current conditions on the site of Deviation 11 are described below. Since the cessation of peat deposition in the cell, the surface of the deposited peat has begun to revegetate with species including soft rush (*Juncus effusus*), Yorkshire fog (*Holcus lanatus*), creeping bent grass (*Agrostis stolonifera*) and tormentil (*Potentilla erecta*). It was best classified as recolonising bare ground but is likely to succeed to Wet Grassland (GS4) and wet heath (HH3). No sphagnum development was recorded on the site of Deviation 10. The bund walls consisted primarily of bare rock with some revegetation. They were best classified as Recolonising Bare Ground (ED3). Whilst there are forestry drains in the area, there were no obvious flowing drains recorded and no signs of overtopping or pollution. There is a tributary of the Bunadaowen located approximately 60m to the west of the deviation. An unfilled section of the pit exists in the north eastern section of the site. This supports bare rock and a pool that is classified as Artificial Lakes and Ponds (FL8). No significant habitat for any of the KERs or KORs that were identified in the Submitted EIAR were recorded at this site and no additional significant faunal habitat was recorded. The revegetating cells will provide good habitat for reptiles and amphibians in the future. The existing site conditions are shown in Plates 4-13 and 4-14. A sitewide geotechnical stability assessment was carried out in October 2023 by AFRY and attached in Appendix 4-1. The assessment found that the peat cells are stable.

Plate 4--13 Recolonising Bare Ground inside peat cell

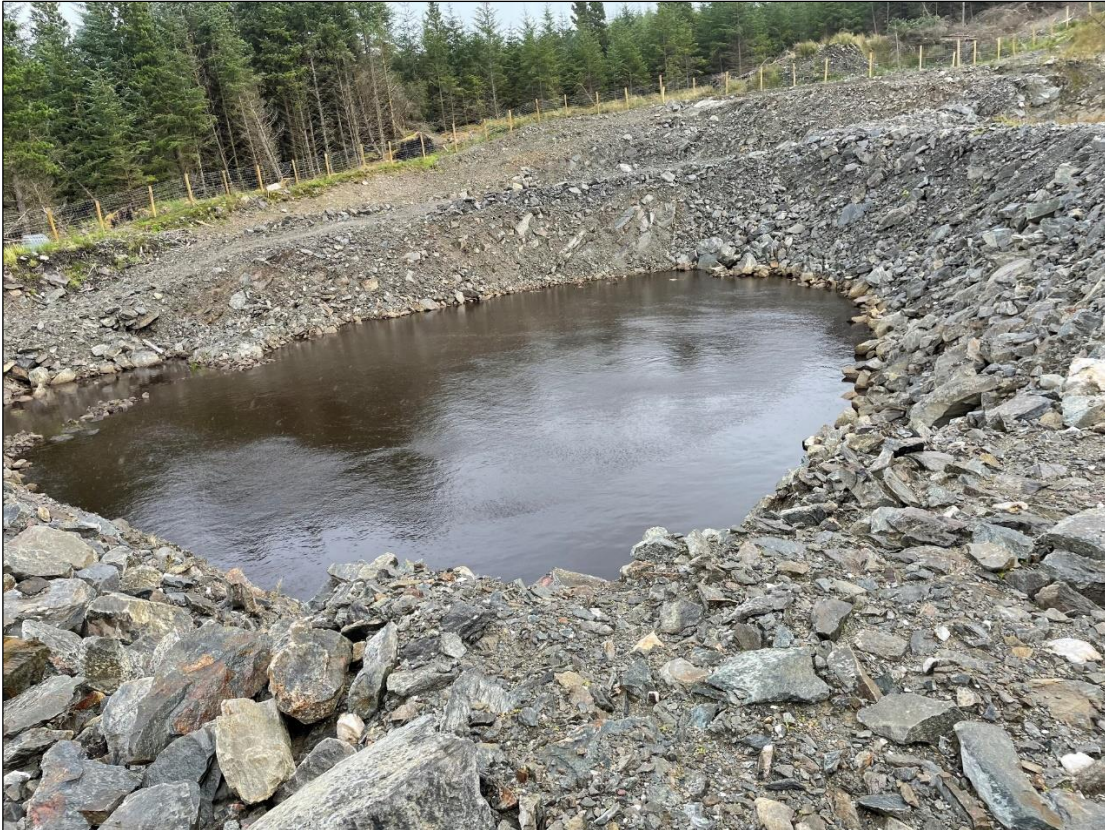
Plate 4--14 Unfilled section of peat cell with artificial pond

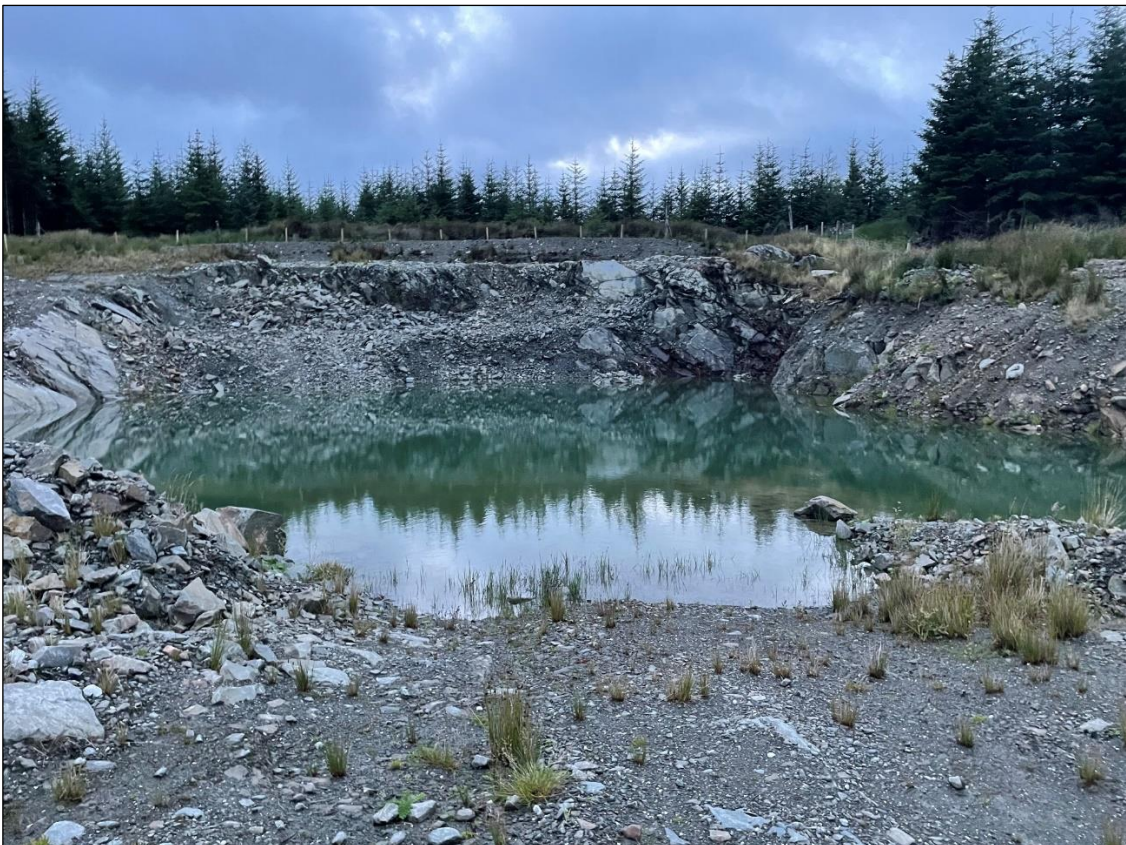
The site of the Deviation 15 was the subject of a comprehensive ecological walkover survey on the 23rd August 2023. The current habitats at the site of Deviation 15 include clear felled conifer plantation (WD4). It was felled as part of consent for bat mitigation around T18 and thus included in planning consent for the Permitted Development. The rock has been excavated from this peat cell, but the deposition of peat has not commenced. The resultant pit has filled with water with no sign of overtopping, and the adjacent turbine base is also flooded. The cell is classified as Spoil and Bare Ground (ED2) Artificial Pond (FL8). An existing forestry track is located to the south of the deviation and there are forestry drains associated with it. No signs of pollution or run-off into the drains were recorded during the site visit. The surrounding habitats include Conifer Plantation to the north, east and west, with the infrastructure associated with T18 located to the south. The Bunadaowen River is located, at closest, 80 meters from this deviation and there is an indirect link with it via forestry drains. No significant habitat for any of the KERs or KORs that were identified in the Submitted EIAR were recorded at this site and no additional significant faunal habitat was recorded. The revegetating cells provided good habitat for reptiles and amphibians. Plate 4-15 shows the nature of Deviation 15. A sitewide geotechnical stability assessment was carried out in October 2023 and found the site to be stable.

Plate 4-15 excavated peat cell at Deviation 15

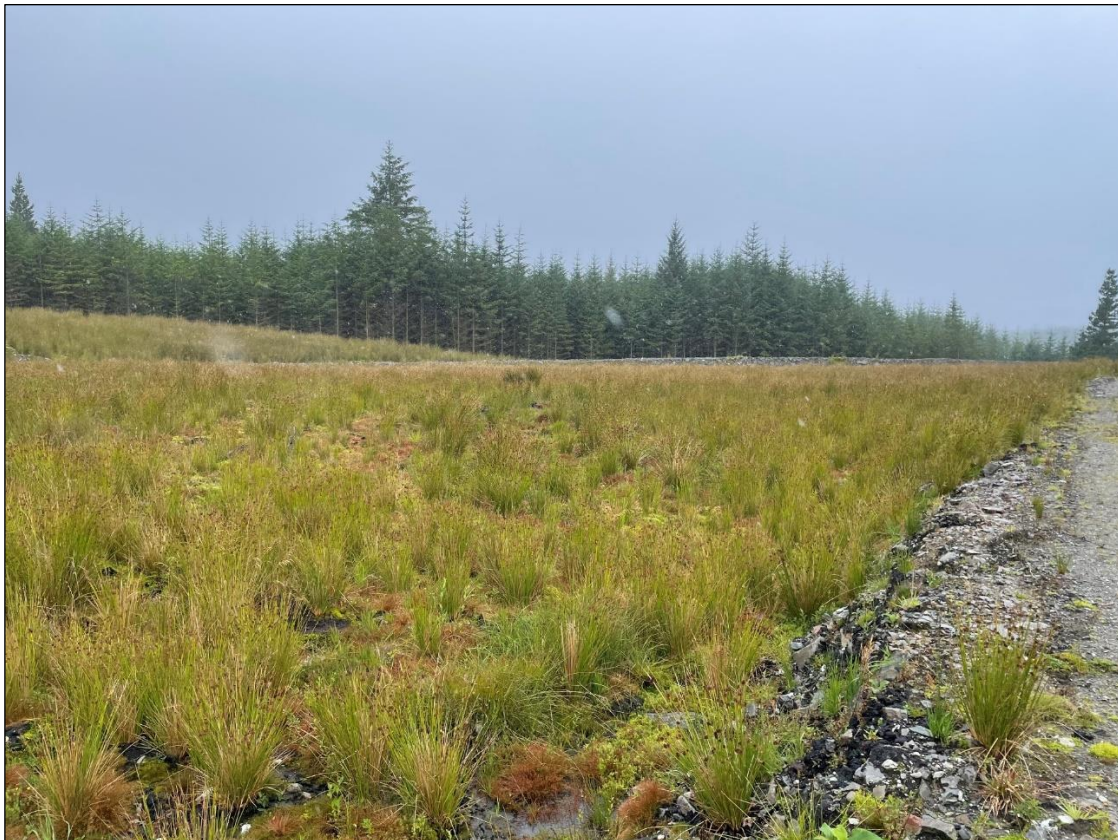
The site of Deviation 17 was the subject of a comprehensive ecological walkover survey on the 23rd August 2023. The current conditions on the site of Deviation 17 are described below. Since the cessation of peat deposition in the cell, the surface of the deposited peat has revegetated with species including soft rush (*Juncus effusus*) and bulbous rush (*Juncus bulbosus*), which are dominant in the drier areas, particularly in the southern sections of the site of this deviation. In other areas, there is a wetter and more varied flora including Yorkshire fog (*Holcus lanatus*), tormentil (*Potentilla erecta*), ling (*Calluna vulgaris*), *Polytrichum* and *Sphagnum* species. There were pools developing on the surface with species such as bog pondweed (*Potamogeton polygonifolius*) It was best classified as Wet Grassland (GS4) in the drier areas and wet heath (HH3)/Blanket Bog(PB2) in the wetter areas. Three forestry drains were recorded flowing north west out of the site of Deviation 17 and ultimately into a tributary of the Bunadaowen River after a surface water distance of approximately 180m. Whilst no signs of significant pollution were recorded, there was some silt at the base of the cell bunds. The bund walls consisted of earth and rock and were best classified as Recolonising Bare Ground (ED3). No significant habitat for any of the KERs or KORs that were identified in the Submitted EIAR were recorded at this site and no additional significant faunal habitat was recorded. The revegetating cells provided good habitat for reptiles and amphibians. The existing site conditions are shown in Plates 4-16, 4-17, and 4-18. There were some signs of cracking within the bund walls. However, a sitewide geotechnical stability assessment was carried out in October 2023. The assessment found that the peat cells are stable.

Plate 4--16 Drier, rush dominated sections of the site

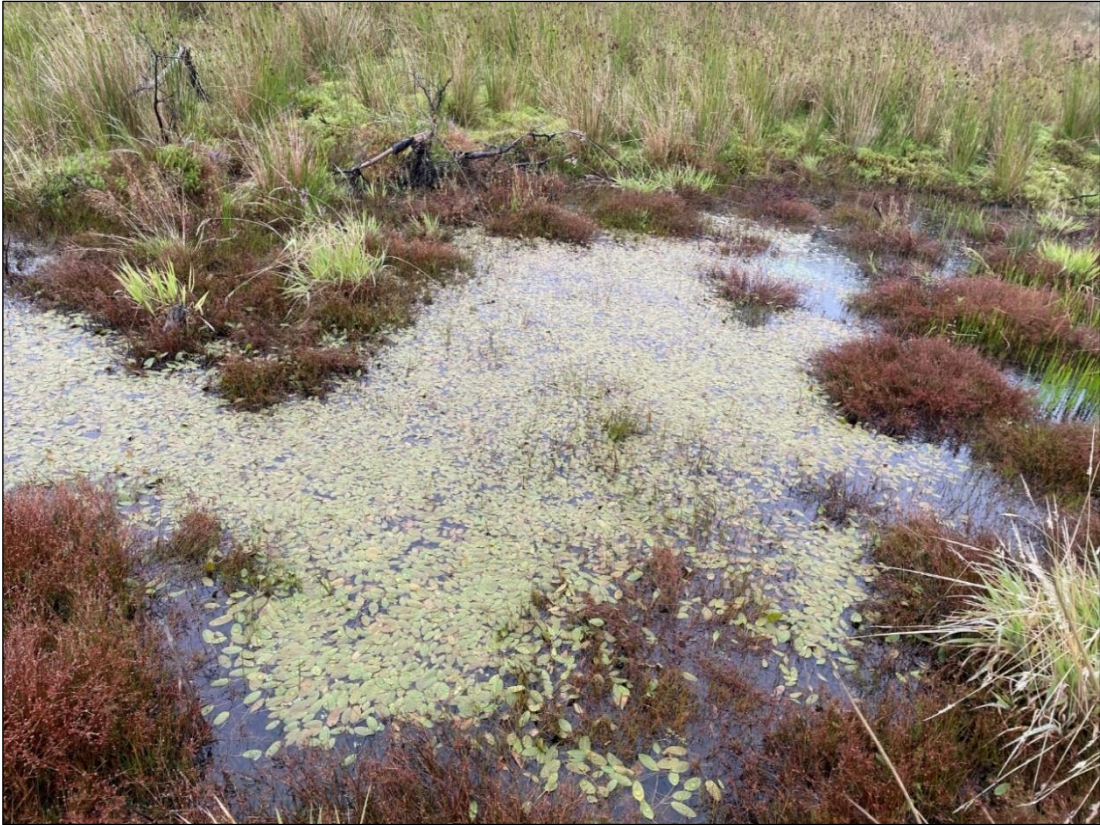
Plate 4-17 Wet pool developing on top of peat cell

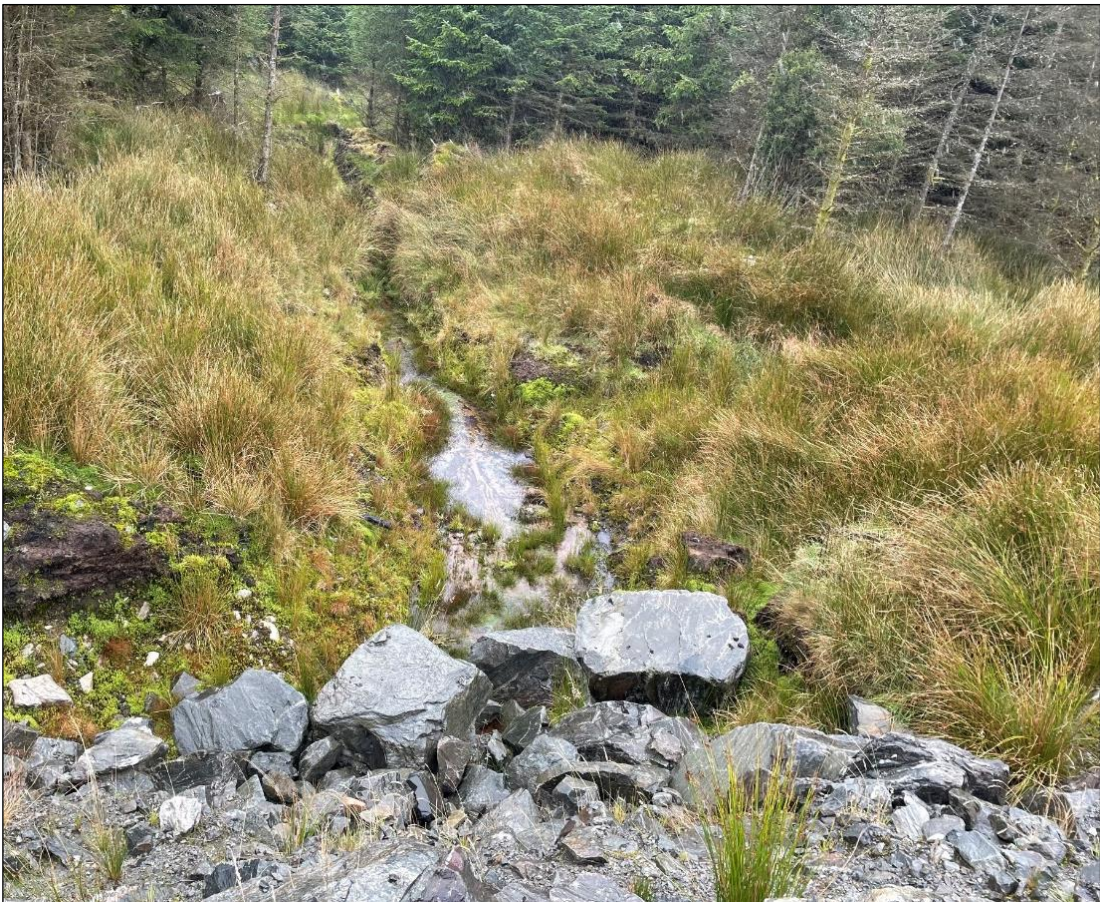
Plate 4-18 Forestry Drain running out of site. Small accumulation of silt at base of bund – no signs of any effects thereafter
