Remedial Natura Impact Statement

Substitute Consent for
Deviations at Meenbog
Windfarm, Co. Donegal

Project Number: **220623**

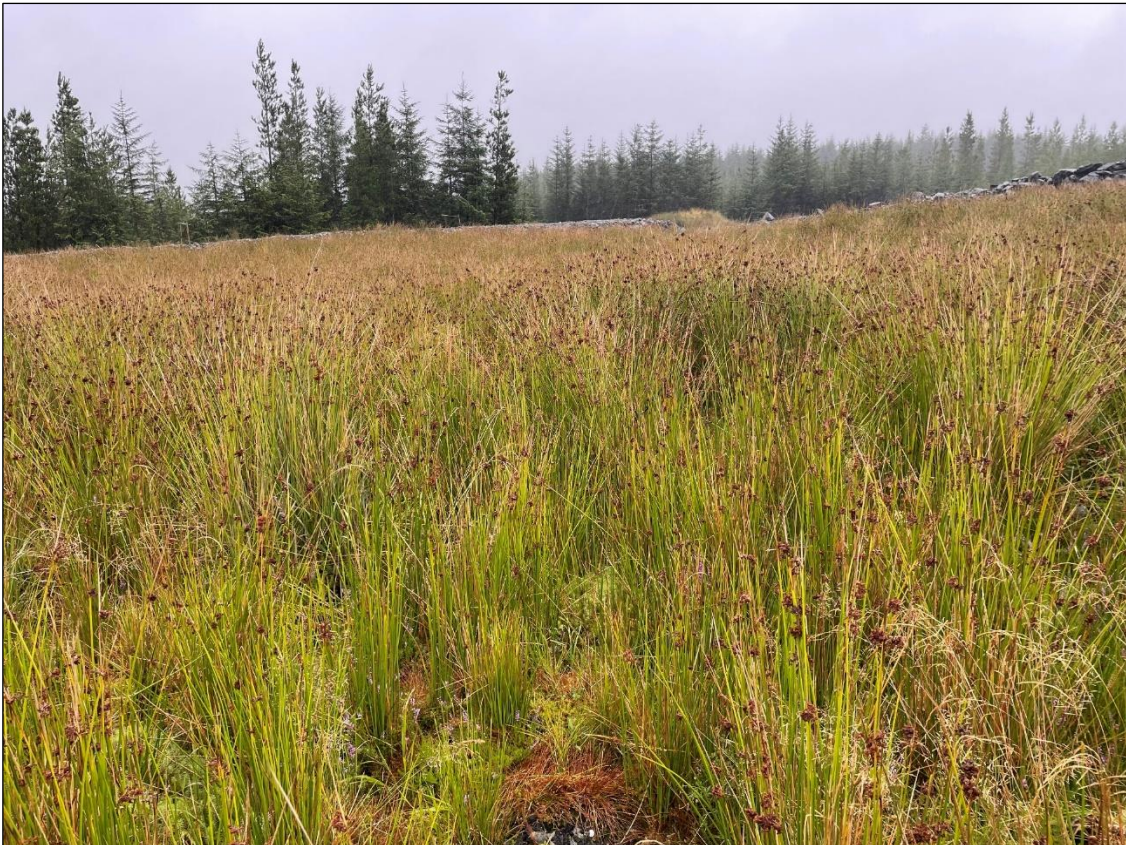
The site of Deviation 18 was the subject of a comprehensive ecological walkover survey on the 23rd August 2023. The current conditions on the site of Deviation 18 are described below. Since the cessation of peat deposition in the cell, the surface of the deposited peat has revegetated with species including soft rush (*Juncus effusus*) and bulbous rush (*Juncus bulbosus*), which are dominant throughout. Other species including Yorkshire fog (*Holcus lanatus*), creeping bent grass (*Agrostis stolonifera*), tormentil (*Potentilla erecta*), ling (*Calluna vulgaris*), *Polytrichum* and *Sphagnum* species. It was best classified as Wet Grassland (GS4) and wet heath (HH3). There were pools developing on the surface of the cell, which supported abundant growth of *Sphagnum* species. The bund walls consisted primarily of bare rock with some revegetation. They were best classified as Recolonising Bare Ground (ED3). Whilst there are forestry drains in the area, there were no obvious flowing drains recorded and no signs of overtopping or pollution. No significant habitat for any of the KERs or KORs that were identified in the Submitted EIAR were recorded at this site and no additional significant faunal habitat was recorded. The revegetating cells provided good habitat for reptiles and amphibians. The existing site conditions are shown in Plates 4-19 and 4-20. There were some signs of cracking within the bund walls. However, a sitewide geotechnical stability assessment was carried out in October 2023. The assessment found that the peat cells are stable.

Plate 4--19 Rush dominated section of the revegetated peat cell

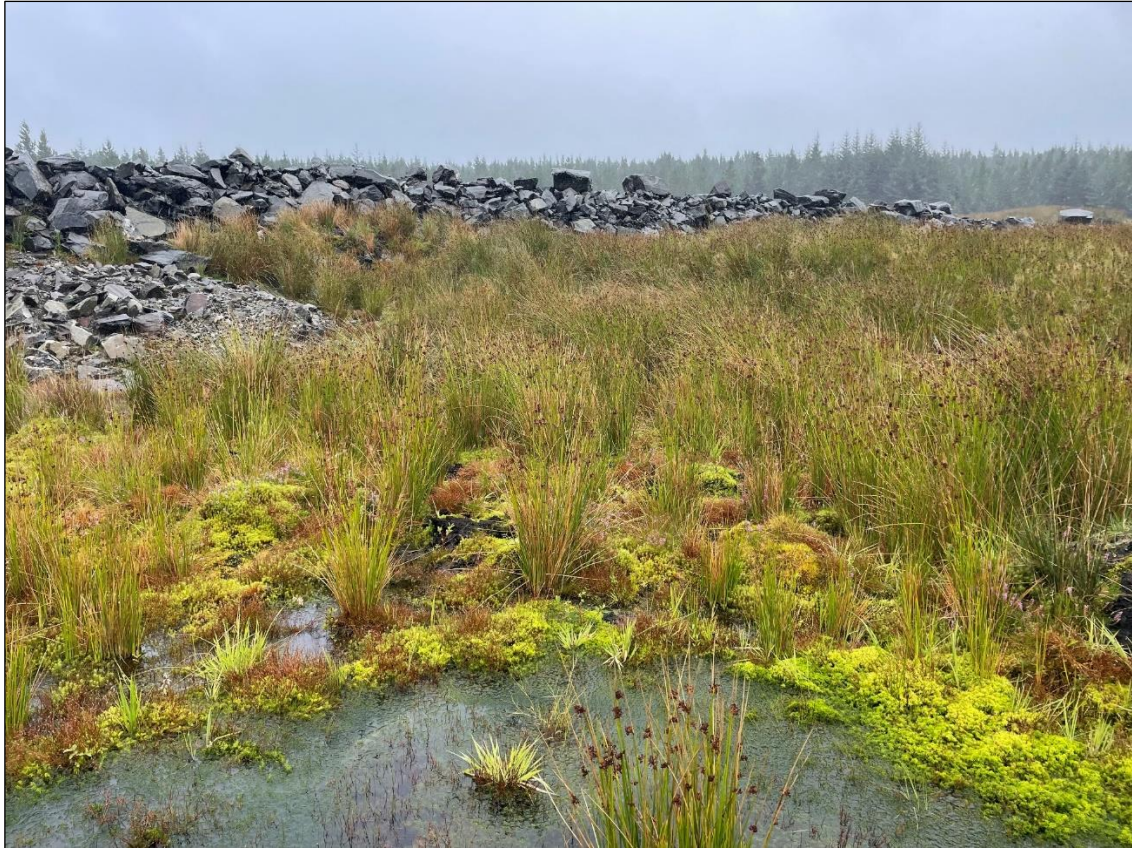
Plate 4--20 Sphagnum dominated pool within the revegetated peat cell

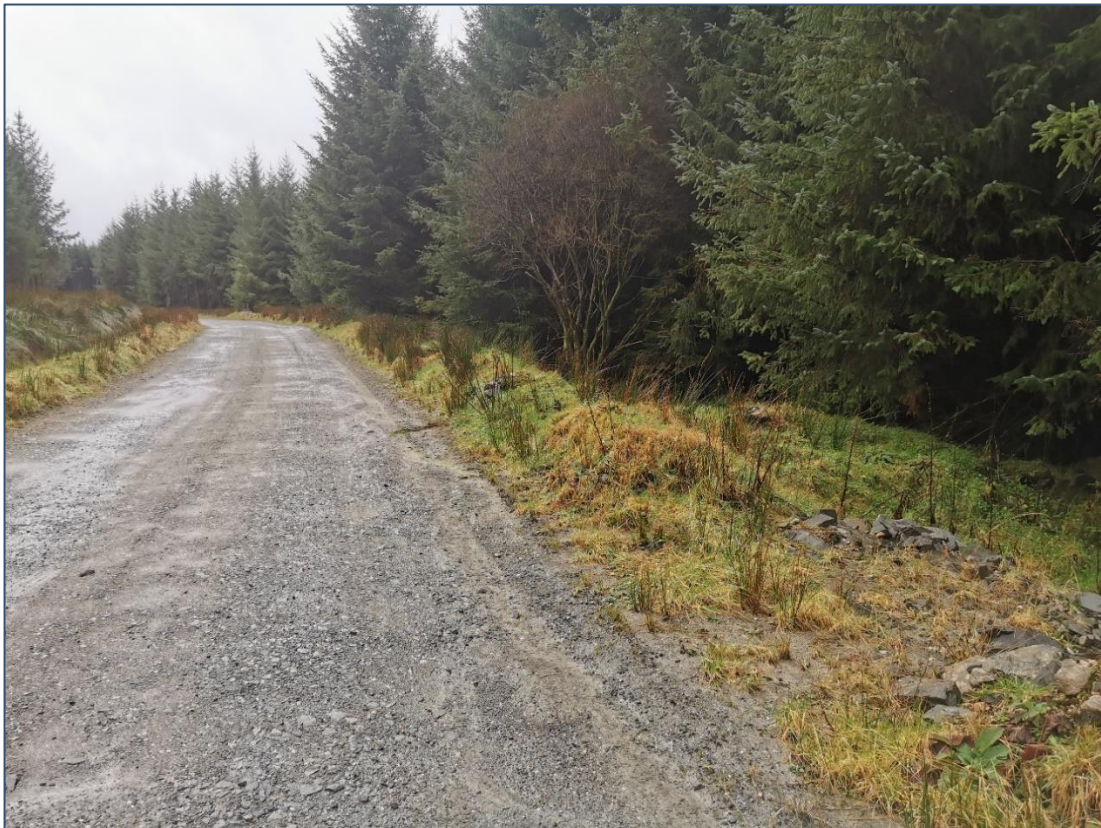
The site of Deviation 24 was the subject of a comprehensive ecological walkover survey on the 23rd August 2023. The current conditions on the site of Deviation 24 are described below. This deviation involved the inclusion of water protection measures alongside the permitted infrastructure but outside the permitted footprint. This may have resulted in additional loss of coniferous trees. However the habitats at the site of this deviation include low roadside berms that are recolonising with that is dominated by soft rush (*Juncus effuses*) and bulbous rush (*Juncus bulbosus*). There are also numerous grey willow (*Salix cinerea*) seedlings on these berms and it is likely that it will ultimately succeed to willow scrub (WS1) and woodland habitat. The settlement ponds and aquatic features are best classified as drainage ditches a(FW4) and small Artificial Ponds (FL8). The elements of this deviation almost all surrounded by Conifer Plantation (WD4) but are strongly associated and contiguous with the permitted infrastructure. They are located in the Bunadaowen catchment. No significant habitat for any of the KERs or KORs that were identified in the Submitted EIAR were recorded at this site and no additional significant faunal habitat was recorded. The recolonising habitats will provide likely provide scrub and wetlands that will provide good habitat for amphibians and reptiles. Plate 4-21 below shows the roadsie berms in December 2023.

Plate 4--21 Revegetated roadside berm, December 2023.

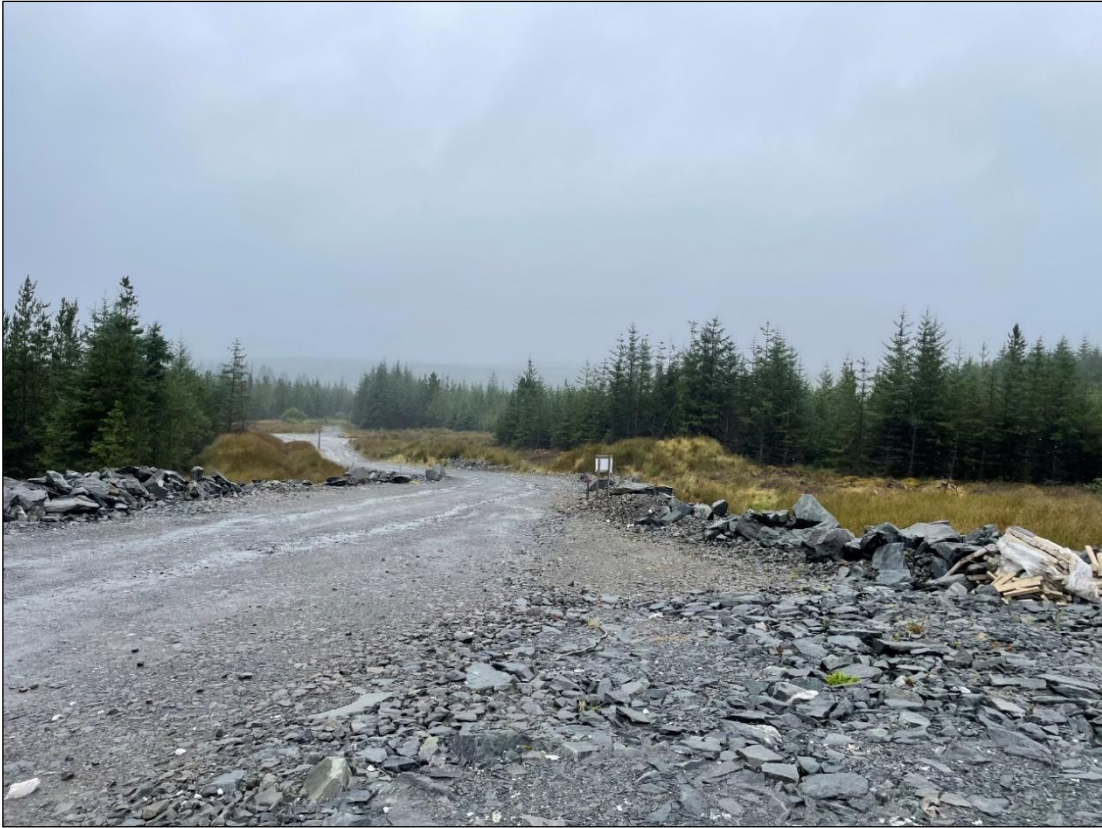
The sites of these deviations were the subject of a comprehensive ecological walkover survey on the 23rd and 24th August 2023. The current conditions on the sites of these deviations are described below. The deviations all involved a slight realignment of the permitted infrastructure. This may have resulted in additional loss of trees in some places, though in the majority, it involved the same or less than was assessed in the Submitted EIAR but in a slightly altered (but adjacent) location. The habitats at the sites of these deviations include new infrastructure in a slightly altered position that is generally classified as Buildings and Artificial Surfaces (BL3) and a surrounding area that has been cleared of Conifer Forestry and is now recolonising with vegetation that is dominated by soft rush (*Juncus effuses*), bulbous rush (*Juncus bulbosus*) and bryophytes with saplings of grey willow (*Salix cinreea*). In many cases it also includes heath vegetation including Sphagnum mosses, and Ling (*Calluna vulgaris*). It is likely that in many areas the surrounding vegetation will succeed to willow scrub and woodland. The sites of these deviations are all surrounded by Conifer Plantation (WD4), clear felled forestry and permitted forestry and wind farm infrastructure. The sites of these deviations are located within two three separate sub-catchments. Deviations 5,12,13,14,16,20, 21 and 24 are located in the Bunadaowen sub catchment of the Mourne Beg River. Deviations 22 and 23 are located in the Shruhargarve sub catchment of the Mourne Beg River. Deviations 8 and 9 are located in the catchment of the Glendergan River. None of the works associated with any of these deviations involved any works within any natural watercourses, though indirect connectivity to these watercourses may be provided through forestry drains in the area. No significant habitat for any of the KERs or KORs that were identified in the Submitted EIAR were recorded at these sites and no additional significant faunal habitat was recorded. The recolonising habitats will likely provide scrub and wet woodland habitat in the future. An example of the typical existing site conditions at these deviations are shown in Plates 4-22. and 4.23.

Plate 4--22 Site of minor deviation at Deviation 13 – road constructed on route of existing road instead of making new (adjacent road)

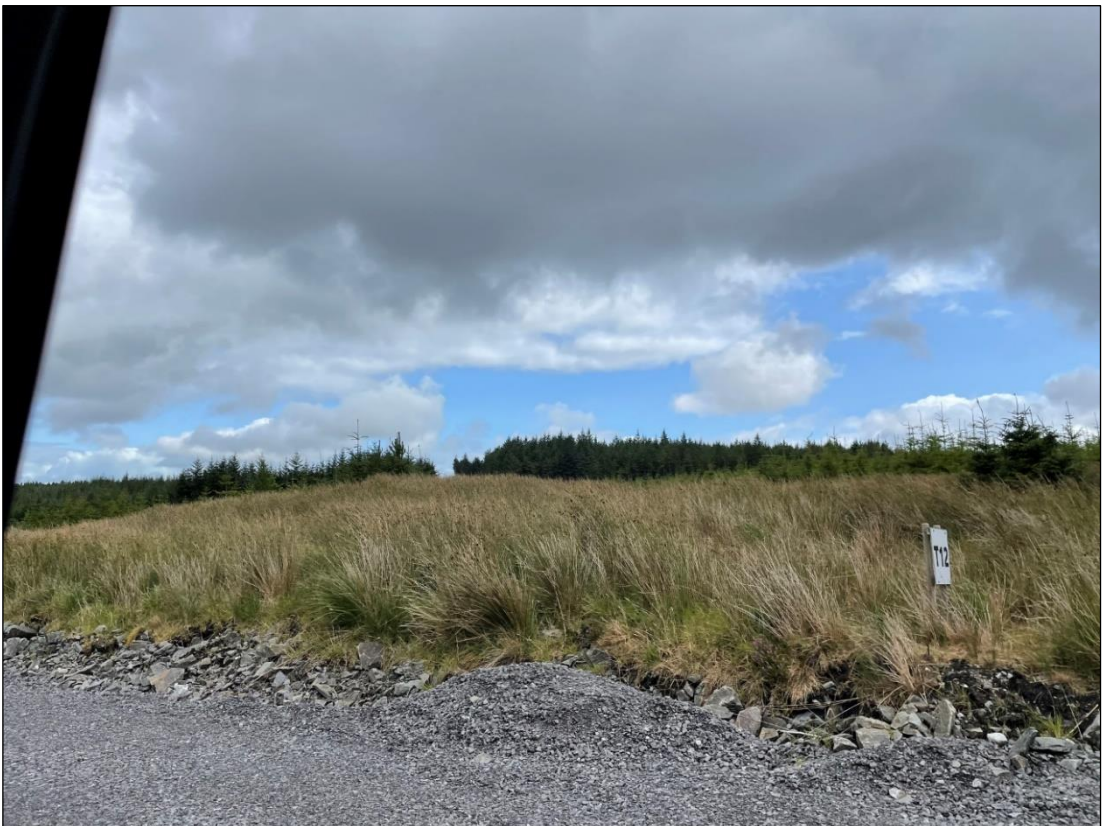
Plate 4--23 Site of minor deviation at Deviation 6 – road constructed approximately 30m downslope of the permitted to avoid excessive cut
