**2020 PRELIMINARY  
WATERCOURSE, OTTER AND  
MACRO INVERTEBRATE  
ASSESSMENT**

Environs of the Meenbog Wind  
Farm, Shruhingarve Stream  
and Mourne Beg River, Co.  
Donegal

Project Title: **Meenbog Wind Farm**

Document Title: **Preliminary Watercourse, Otter and Macro-Invertebrate Survey**

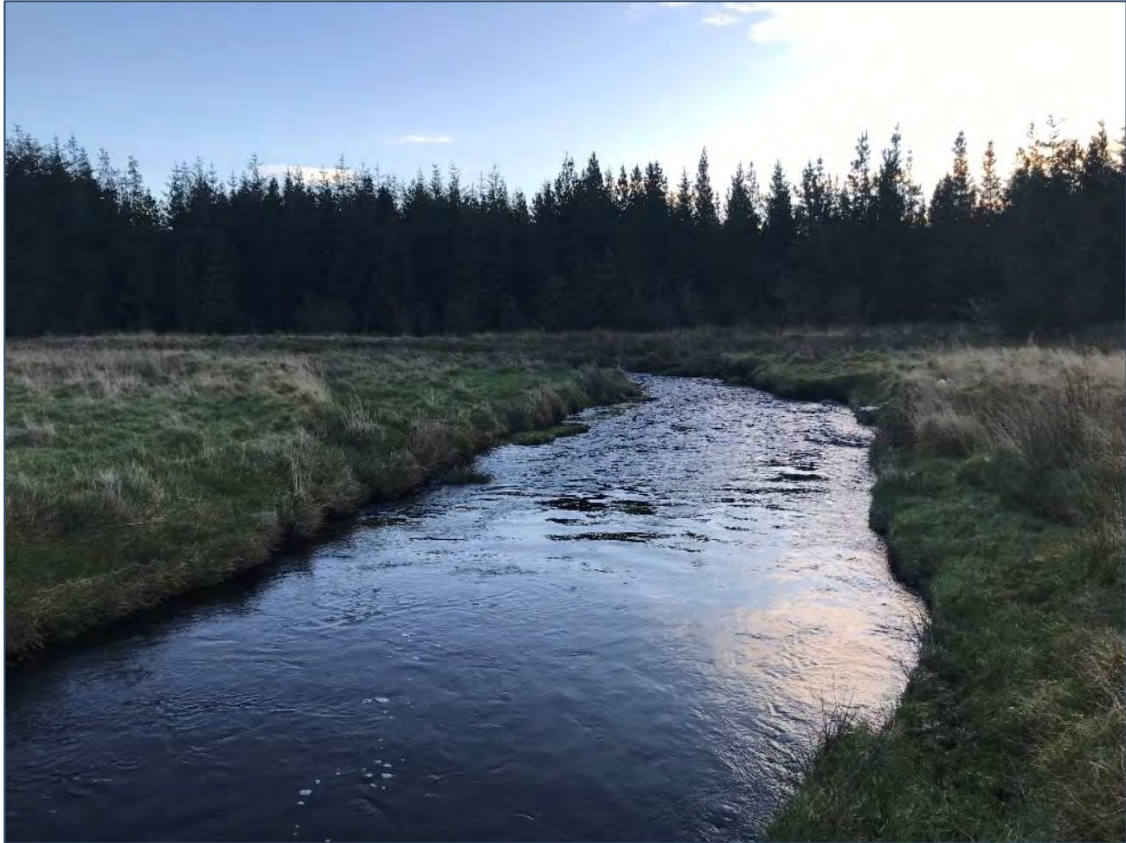
*Plate 3-1. Mourne Beg River immediately upstream of the confluence with the Bunadownen River. Glide and Riffle with surrounding rank grassland and forestry.*

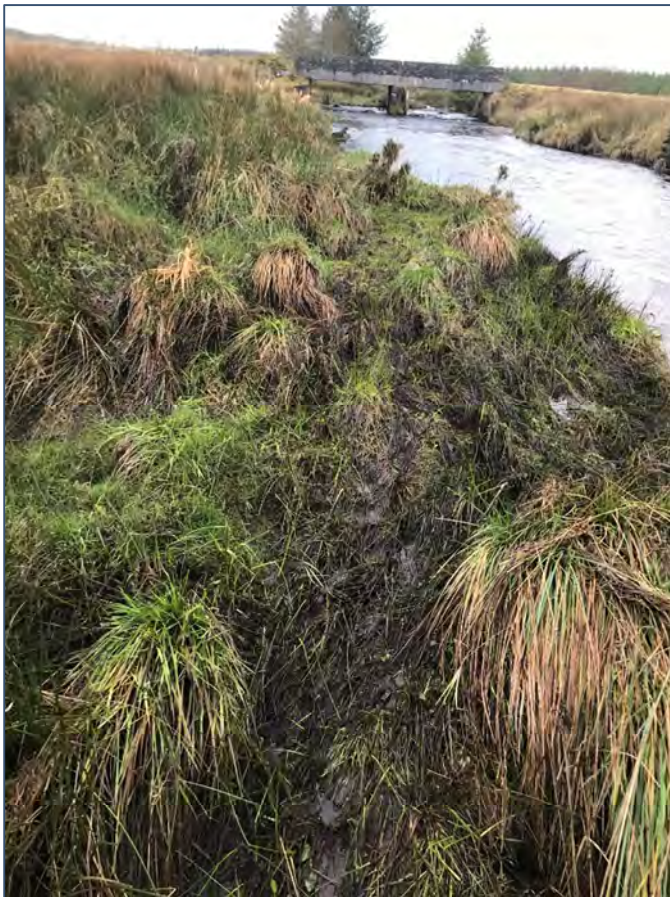
*Plate 3-2. Bankside upstream of the Shruhingarve and unaffected by the peat slide.*

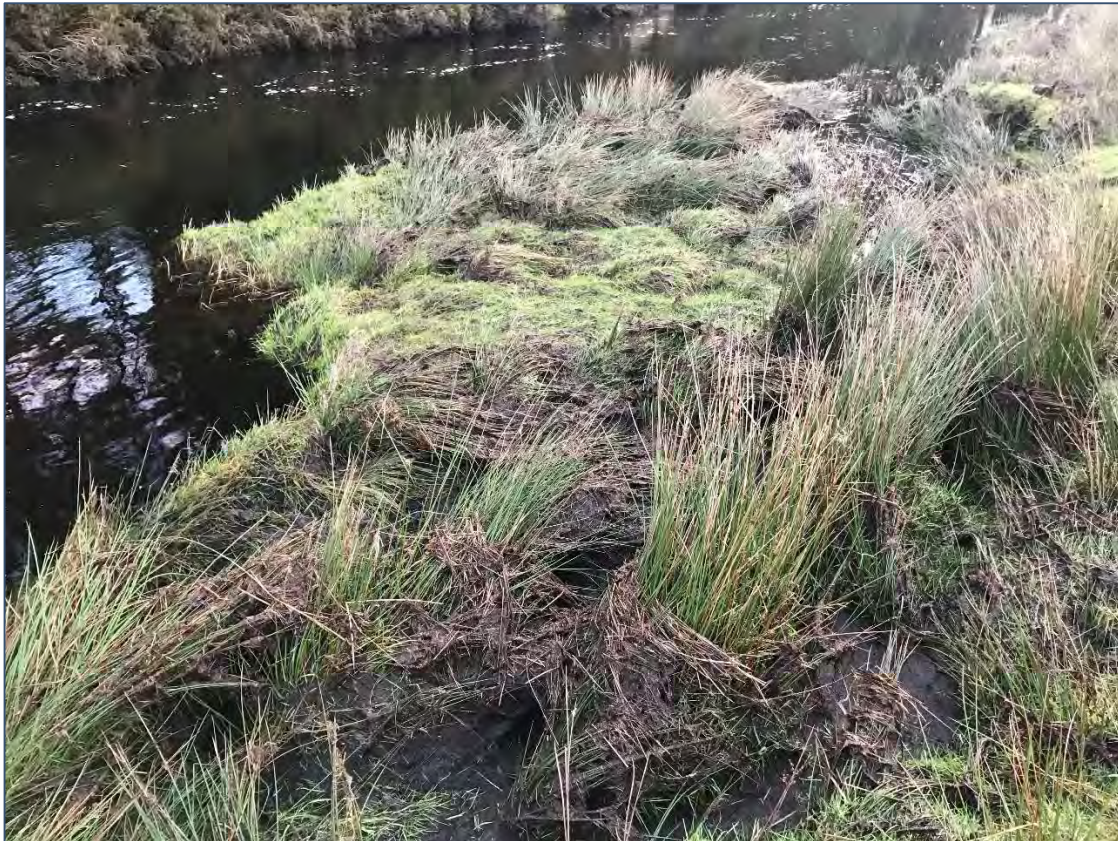
Plate 3-3. Bankside at the confluence between the Shruhingarve and the Mourne Beg Rivers

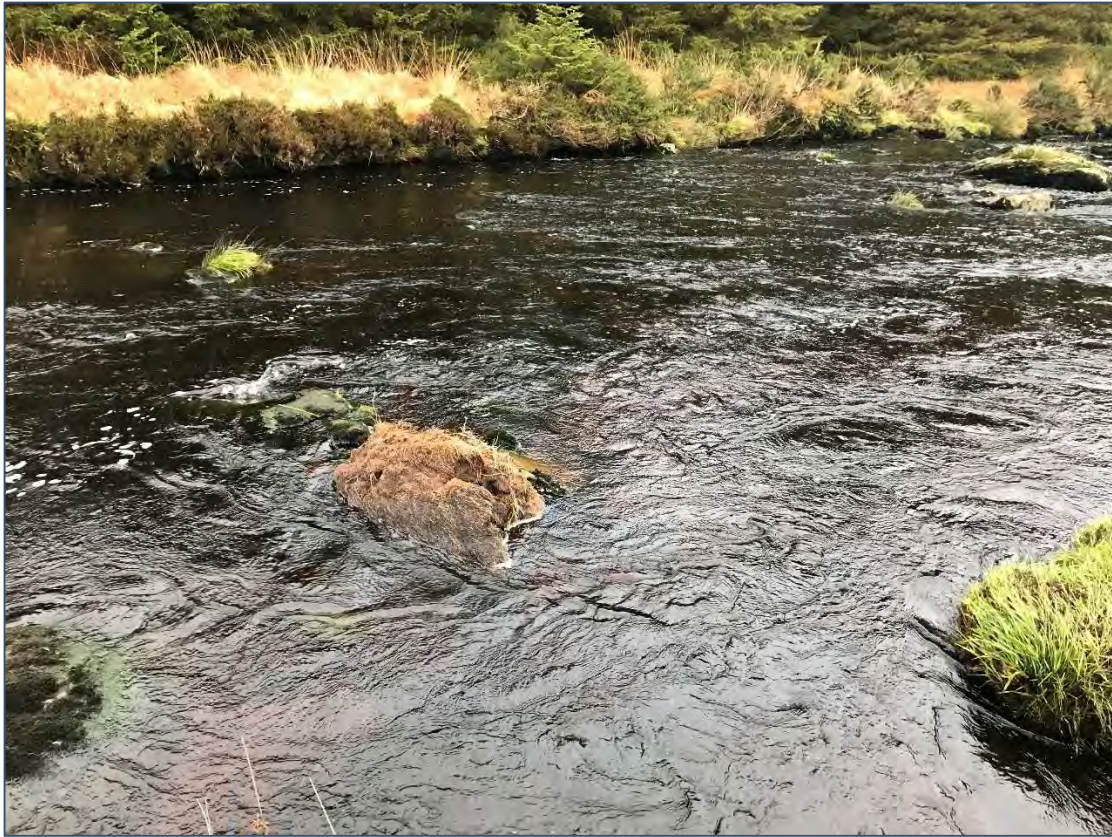
*Plate 3-4. Section of bog/bankside habitat that was washed into the stream upstream of the Shruhanganve and not associated with the peat slide.*

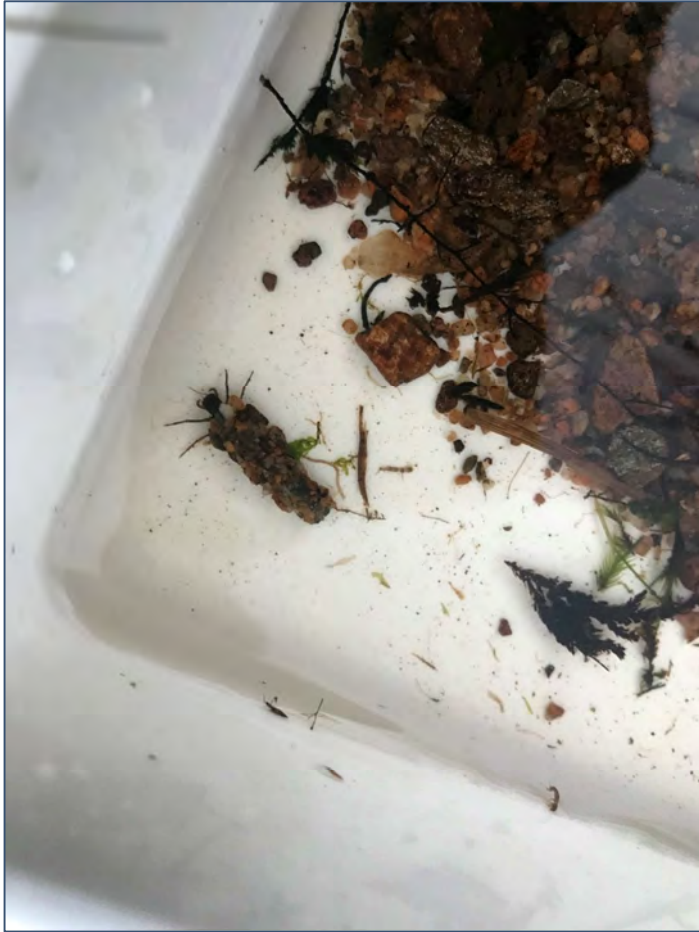
2. Samples taken upstream of the Shruhanganve and in tributaries downstream did not contain the elevated levels recorded in the Mourne Beg downstream of the Shruhanganve.

*Plate 3-5. Kick sample located upstream of the Shruhingarve showing clean gravels with little fibrous peaty material.*

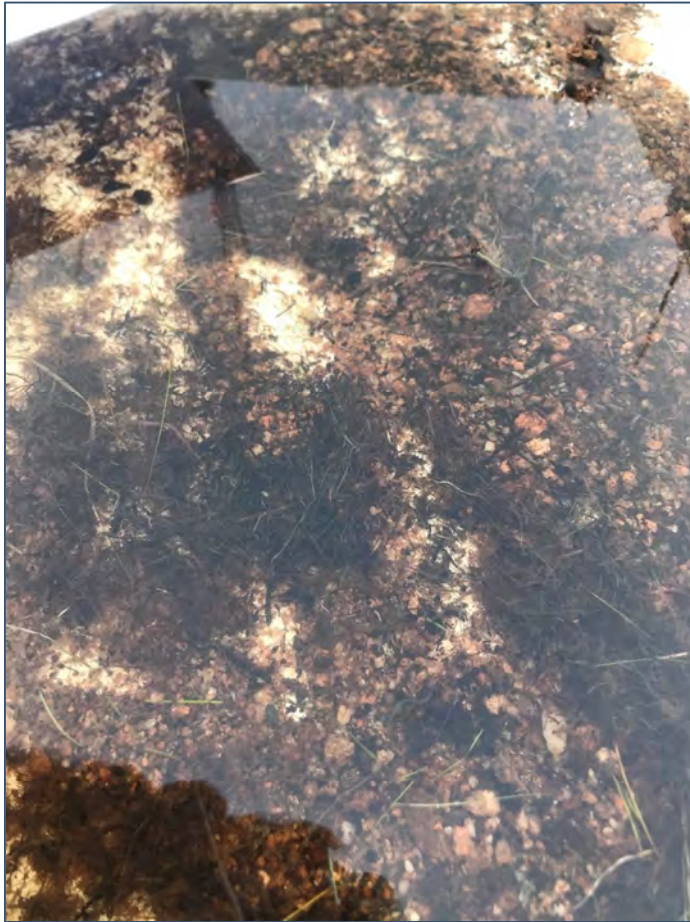
1. Levels of fibrous material generally decreased the further downstream of the Shruhingarve that the sample was taken.

*Plate 3-6. Kick sample located downstream of the Shruhingarve showing high levels of fibrous peaty material.*

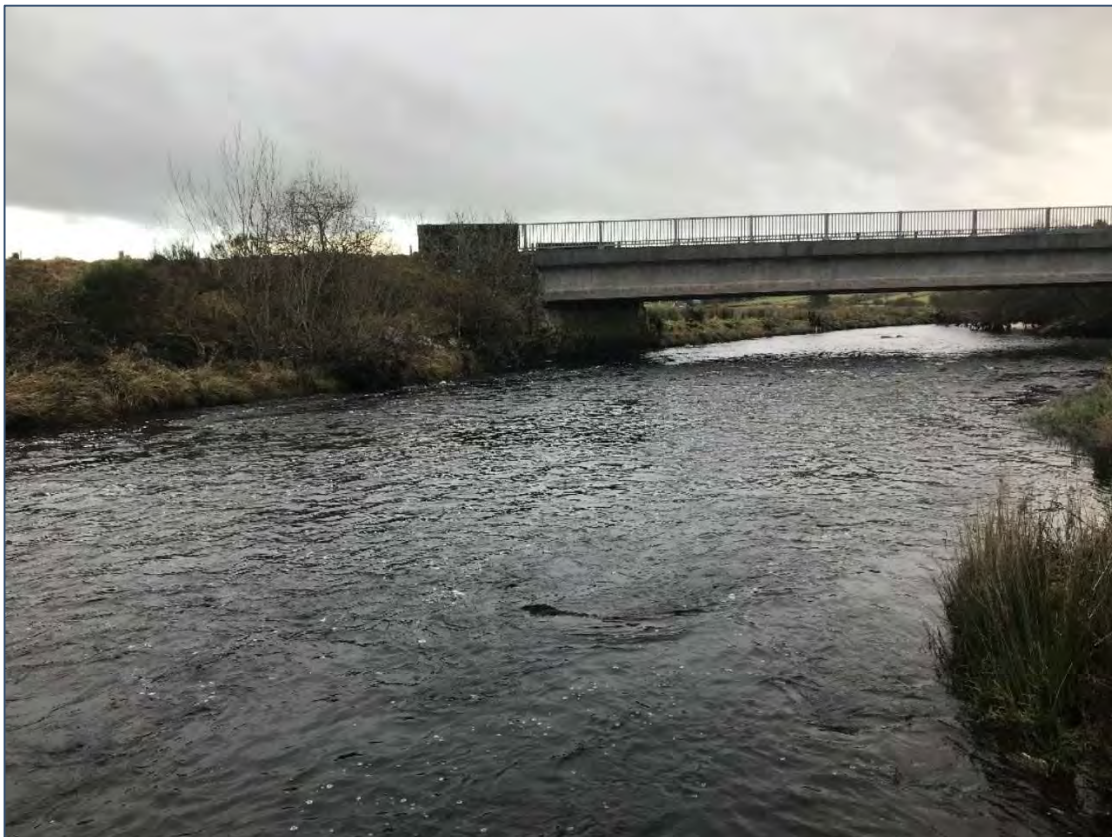
The habitats alongside the river at this location were dominated by wet grasslands that included species such as soft rush (*Juncus effuses*) and creeping bent (*Agrostis stolonifera*). There were sporadic bankside trees including ash (*Fraxinus excelsior*) and grey willow (*Salix cinerea oleifolia*). There were signs of recent high water including the deposition of vegetation and sediments. However, these were consistent with similar features recorded upstream of the Shruhingarve and no impacts of the peat slide on the bankside habitats were evident during the walkover survey. This section is shown in Plate 3-7.

Plate 3-7. Mourne Beg River at Survey Section Three

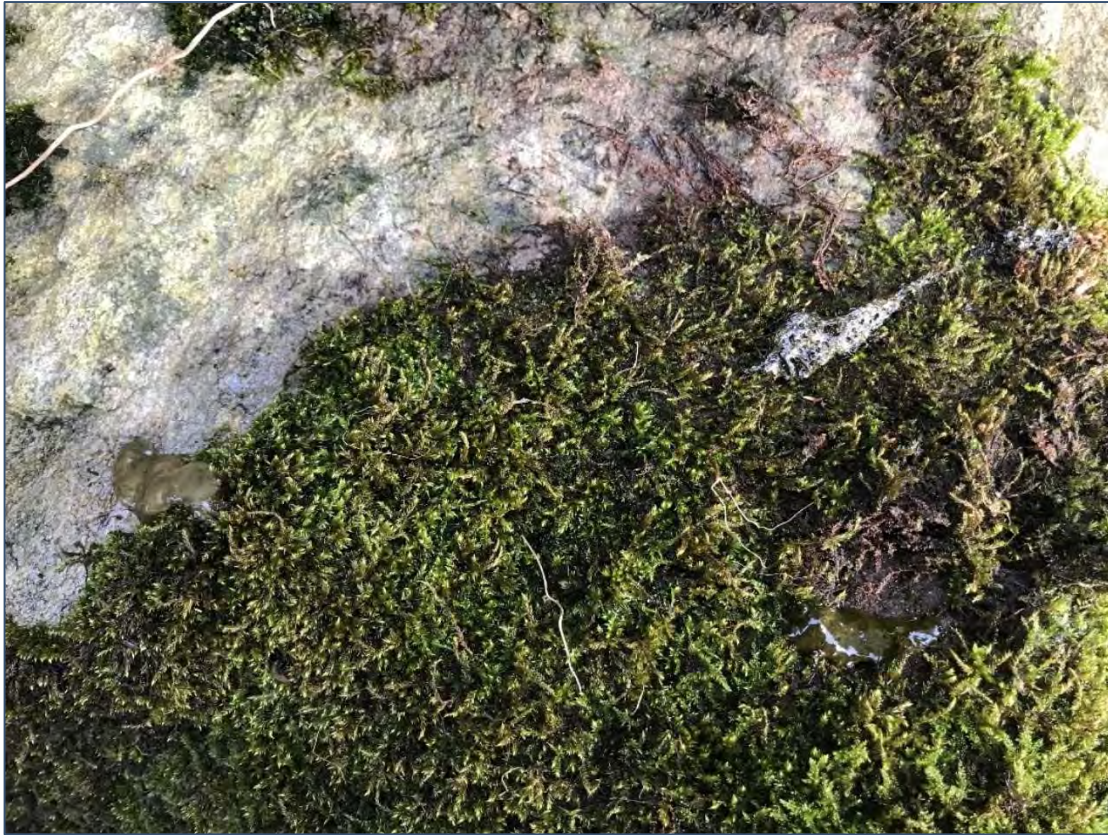
A number of fresh otter spraints and oily secretions were recorded under the bridge on the left (northern) bank of the river (See Plate 3-8). No other signs of this species were recorded at this location.

*Plate 3-8. Otter signs under bridge at Survey Section 3*

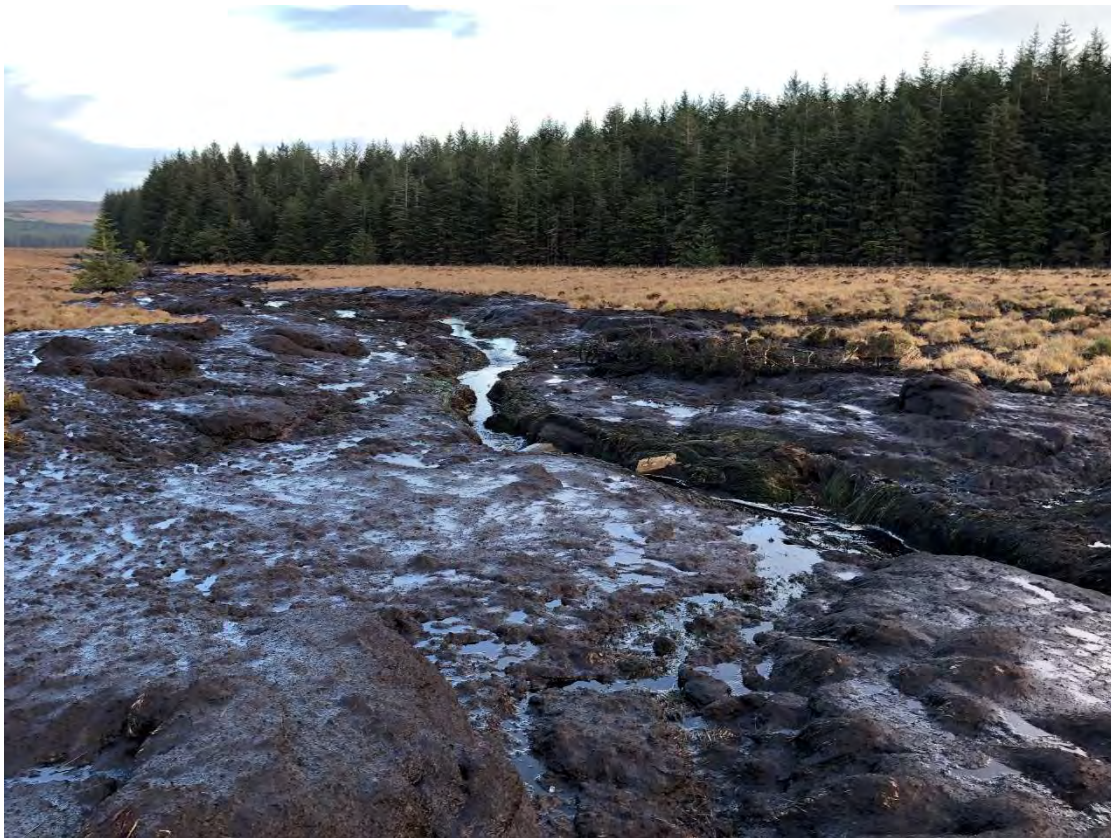
The habitats alongside the bank of the Shruhengarve Stream consisted of forestry plantation in the southern sections of the survey section. Proceeding to the north/downstream, the stream is surrounded by blanket bog habitats. Large deposits of peat were recorded on either side of this stream. These deposits consisted both very soft and wet peat along with large sections of more solid peat with surface vegetation attached. These had been deposited both within the stream channel and on both banks. In places, the deposition spread up to a maximum of approximately 15 metres from the stream, though over much of the section it was less than 5 metres. In some areas, there were deep accumulations of peat on the banks with up to 0.5 metres of wet peat deposited. In other areas, the rushes which surround the stream were visible through the peat. Typical images of the Shruhengarve Stream are shown on Figures 3-9 and 3-10.

Plate 3-9. Shruhengarve Stream and peat deposited on its bank as viewed from upstream of the public road, facing downstream

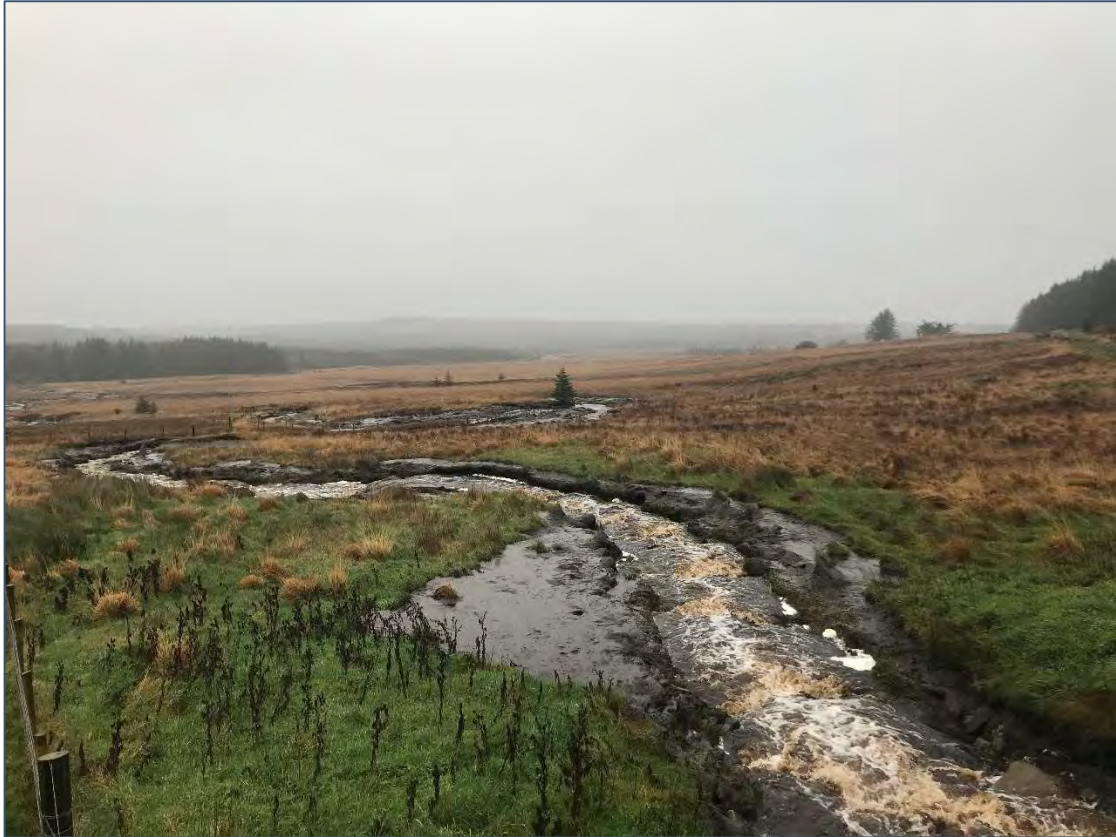
Plate 3-10. Shruhingarve Stream as viewed from the public road

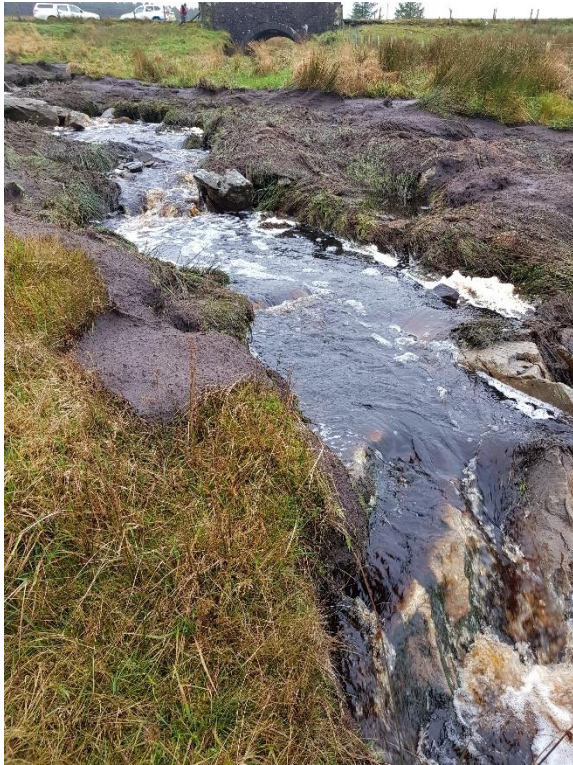
**Photo 1.** Shruhanagarve stream RS01S260830

General Description	Water chemistry
<p>Fast flowing high gradient stream approximately 2m wide with a substrate of boulder, cobble, gravel and excessive peat accumulations observed both instream and along the bank. High water colour observed due to peat in the water. Due to the large size of the substrate and the pH of the stream the habitat here is poor for macroinvertebrates</p>	<p><b>Dissolved oxygen</b> DO %-100.3% 12.13mg/l  <b>Temperature</b> 7°C  <b>Conductivity</b> 36.2 µs/cm  <b>pH</b> 4.51</p>

The Shruhanagarve tributary (RS01S260830) joins the Mourne Beg approximately 1.2km downstream from this site. No historical records were available for the Shruhanagarve stream. No Macroinvertebrates were found in the bankside sort or when the sample was returned to the laboratory and therefore the site (RS01S260830) was classified at Q1\* (Bad ecological condition). This suggests that the landslide may have affected the macroinvertebrate community in this stream as some macroinvertebrates would be expected in a stream of this size and nature. Large accumulation of peat within and on the banks of the stream are concerning especially if winter high flows re-mobilise the material.

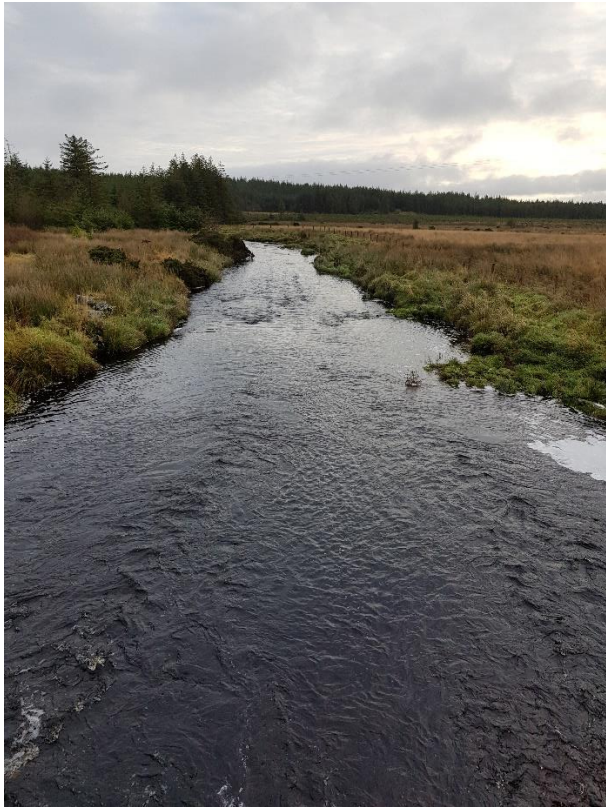
**Photo 2.** Upstream Mourne Beg RS01M010200

General Description	Water chemistry
<p>Moderate flow in the river, approximately 8m wide with a substrate dominated by cobble and gravel with no accumulations of peat observed. Slight water colour observed due to humic nature of the catchment. Excellent habitat observed for both macroinvertebrate and salmonids</p>	<p><b>Dissolved oxygen</b> DO %-97.5% 11.91mg/l  <b>Temperature</b> 6.7°C  <b>Conductivity</b> 34.3 µs/cm  <b>pH</b> 6.07</p>

The upstream site on Mourne Beg (RS01M010200) was at Q4 indicating good ecological conditions. This is consistent with the historical data for this site in 2019 when the site was also classified as Q4. Five Group A taxa were found at this site which is consistent with good water quality. This group are sensitive to pollution and require fast flowing, highly oxygenated clean substrate and are usually only found in rivers with good water quality however it should be noted there were no mayflies present which would suggest some acidification impacts.

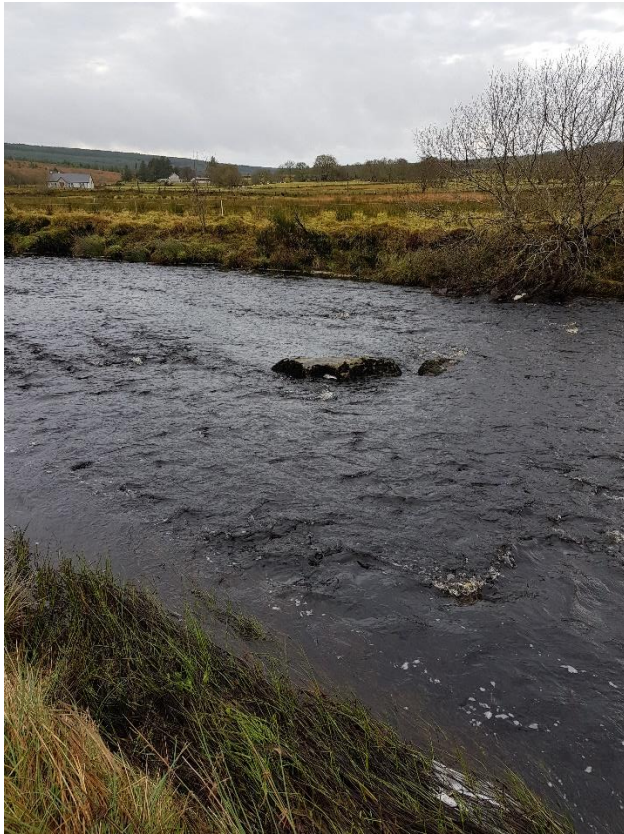
**Photo 3.** Downstream Mourne Beg RS01M010420

General Description	Water chemistry
<p>Moderately fast flowing stretch of river, approximately 10m wide with a substrate dominated by gravel and some cobble with some accumulations of peat observed on the bankside. Slight water colour observed due to peat in the catchment. Good salmonid spawning habitat observed (although noted this may not be usable habitat due to increase fines)</p>	<p><b>Dissolved oxygen</b> DO %-100.1% 12.21mg/l  <b>Temperature</b> 6.8°C  <b>Conductivity</b> 35 µs/cm  <b>pH</b> 5.72</p>

The macroinvertebrate fauna at the downstream site (RS01M010420) (3.2km downstream from the Shruhanagarve confluence) on the Mourne Beg was indicative of Q3-4\* (\* denotes impact by siltation) indicating moderate ecological condition. There was a noticeable difference in the biological community upstream and downstream of the Shruhanagarve confluence. Similar Group A taxa were recorded at the downstream site, but they occurred in low numbers (either as singletons or few). More group C taxa were recorded here which include taxa that are more tolerant to water

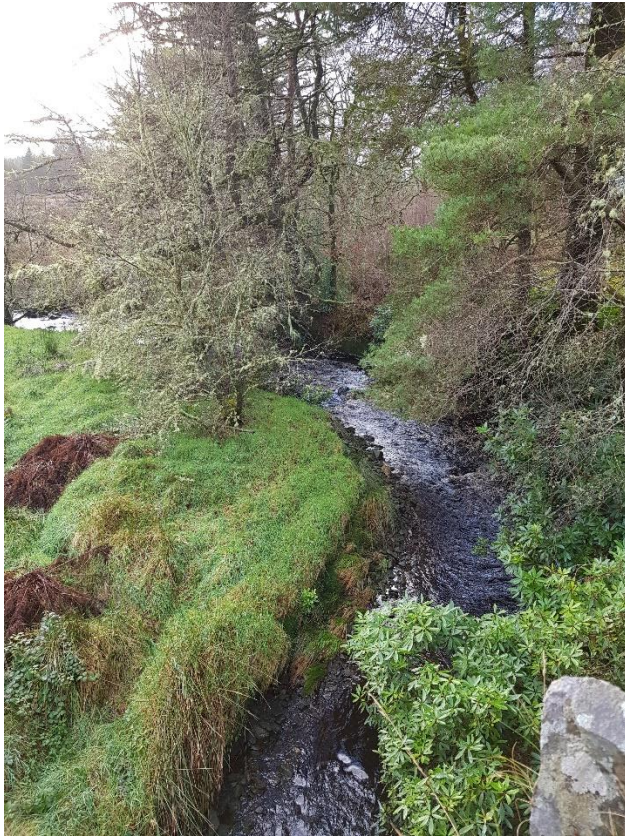
**Photo 4.** Bunadaowen RS01B010100

General Description	Water chemistry
<p>Fast flowing stream, approximately 6m wide with a substrate dominated by cobble and some gravel. High water colour observed on the day which was not typical for this site. Quite a shaded stretch of stream and pH fluxes, this site is currently included in the EPA acid sensitive river monitoring programme.</p>	<p><b>Dissolved oxygen</b> DO %-100.3% 12.06mg/l  <b>Temperature</b> 7.1°C  <b>Conductivity</b> 33.6 µs/cm  <b>pH</b> 5.9</p>

The Bunadaowen (RS01B010100) (an upstream tributary of the Mourne Beg) was also sampled and found to be at Q4\* (\* denotes impact by siltation) good ecological condition however it was affected by increased fines. There was a noticeable discolouration in the water on the day of sampling. This fine sediment had not settled on the stream bed at the time of sampling. The absence of heptageniidae and baetidae in the Bunadaowen suggest that acidification may be affecting the macroinvertebrate community. These sites (Bunadaowen is already part of the acid sensitive monitoring programme AWIC) will be included in the acid sensitive monitoring programme in spring 2021.

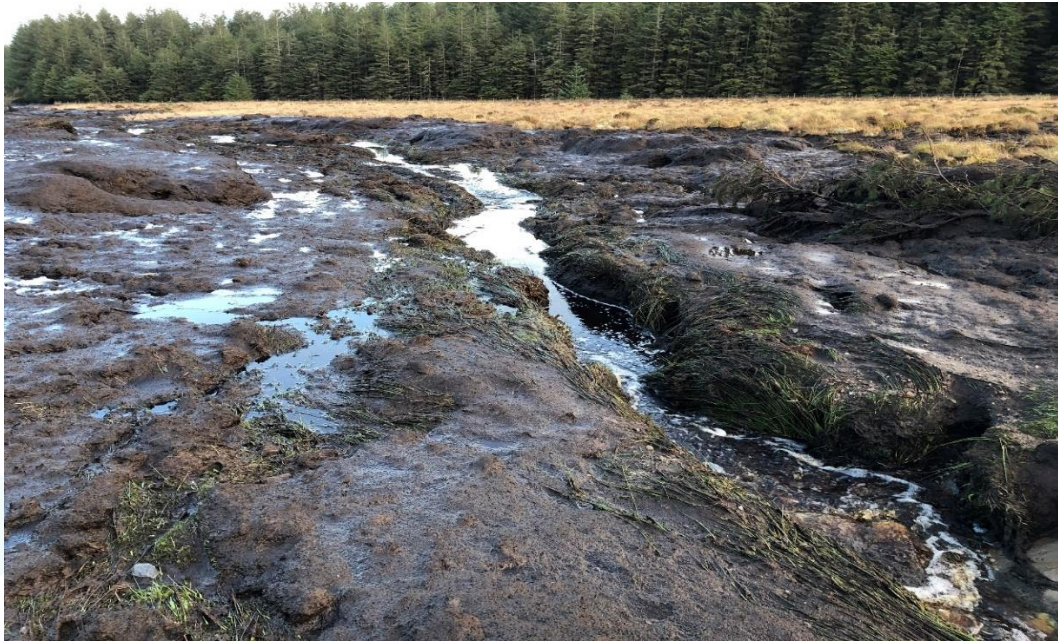
The Shruhingarve stream downstream of Wall 1 continues to flow within the original natural stream channel, but larger flows during and after large rainfall events have caused some secondary mobilisation of the peat that would have been originally deposited on the stream banks. While the majority of the streambank peat deposits appear relatively stable, overland flows from the adjacent bog habitat towards the stream have caused some further mobilisation of the deposited peat in particular locations. It is not considered justifiable to leave the peat deposits in place without mitigation, as to do so would result in further secondary mobilisation of the deposited peat into the adjacent stream.

*Plate 1. Peat deposited on stream bank downstream of Wall 1, with intact vegetation partially visible and larger deposits of peat further back from stream edge*

Work on the implementation of Recommendation 3 was started in December 2020 but has been paused pending approval from Donegal County Council. A short section of coir fibre matting was installed downstream of Wall 1 with the aim of stabilising shallow deposits of peat on the streambanks in that location.

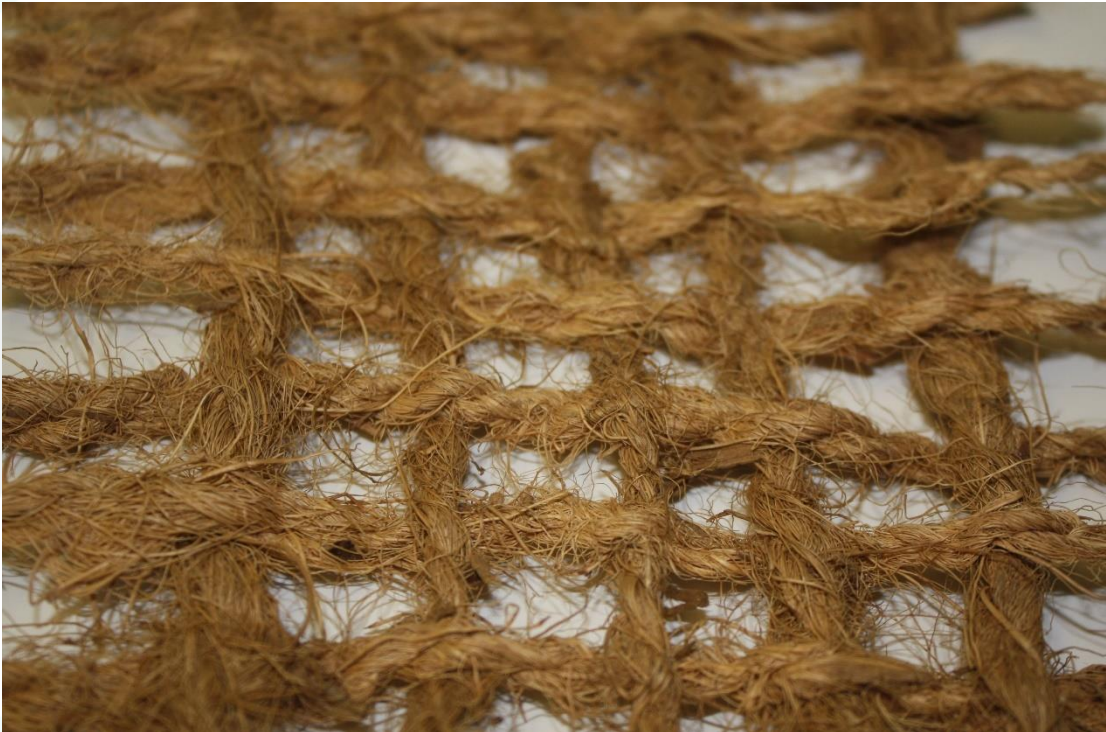
*Plate 2 CoriMesh biodegradable woven coconut fibre used on bare surfaces to prevent erosion and promote revegetation*

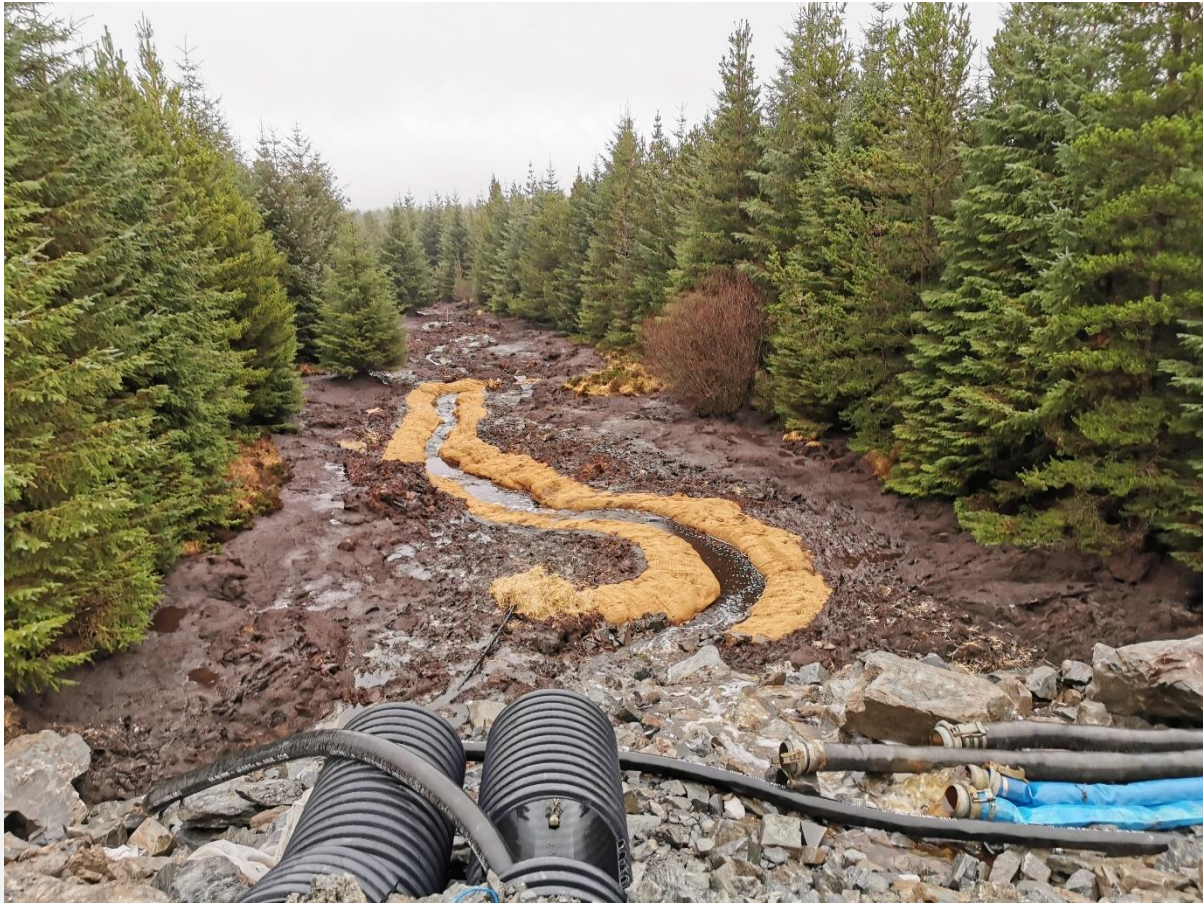
*Plate 3 Coir matting installed on the Shruhanganrve downstream of Wall 1.*

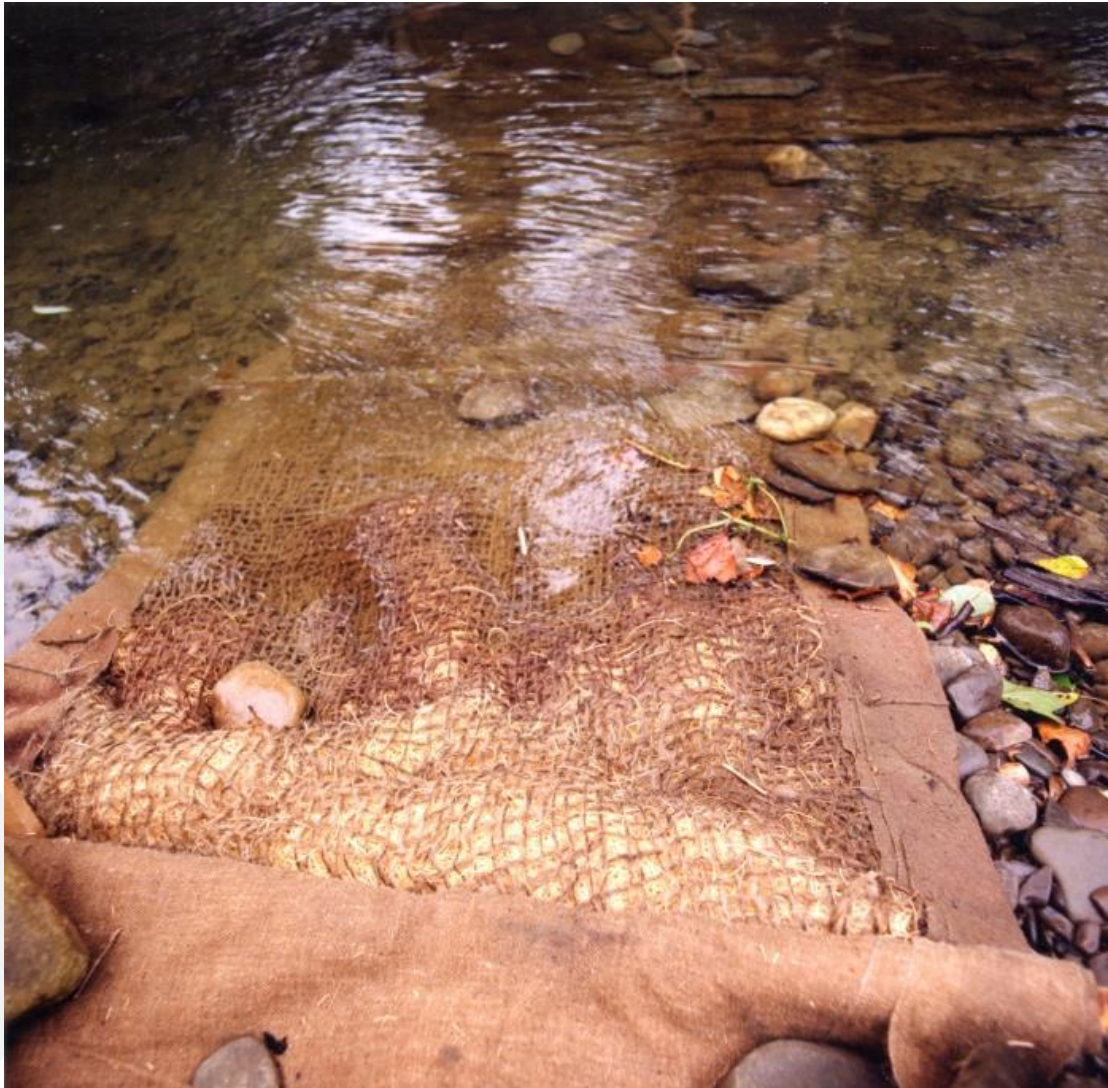
*Plate 4 Sedimat installed on stream bed to trap suspended sediment through upper layer of jute mesh and lower layers of wood wool.*

The effectiveness of the proposed Sedimats cannot be guaranteed, and therefore this recommendation is being made on a trial basis, with the trial to be extended and repeated if proven to be effective.

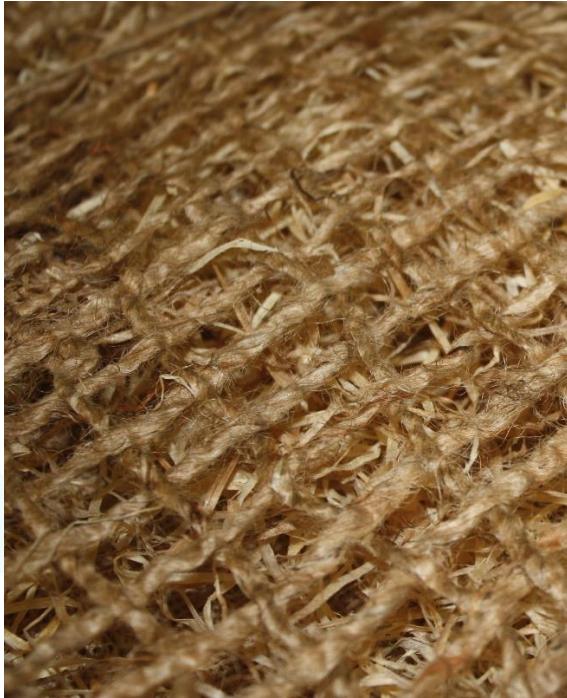
*Plate 5 Narrow view of Sedimat with layered jute mesh and wood wool*

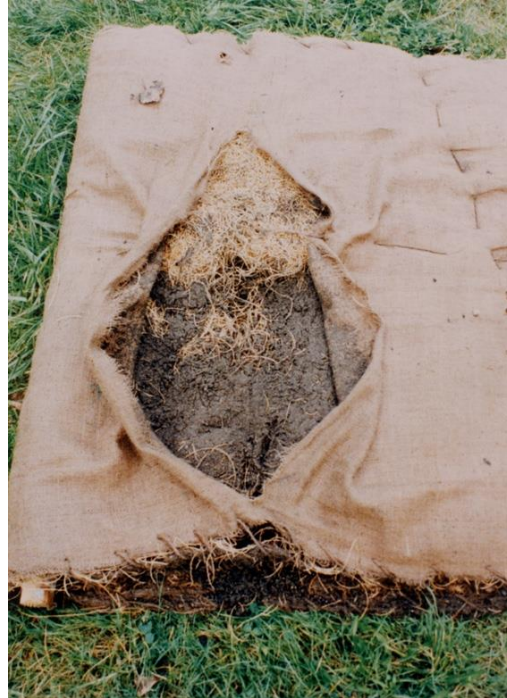
*Plate 6 "Full" Sedimat after having been removed from stream bed*

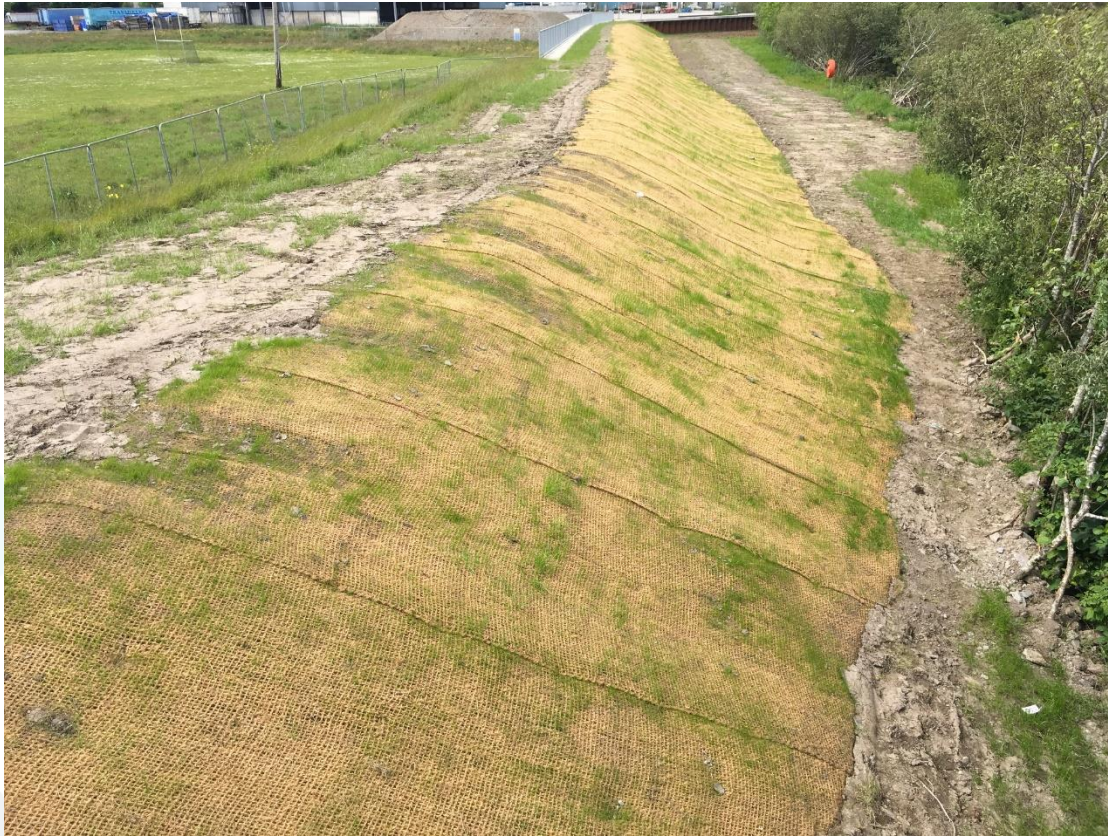
*Plate 7 Large-scale use of CoriMesh to stabilise exposed ground, as likely required upstream of Wall 1 once large peat deposits are removed*

7. *More detailed recommendations for the removal of the peat and stabilisation of the unvegetated surfaces that remain will be developed in future iterations of the Action Plan.*
