Section 5 of the Planning and development Act, 2000 (as amended).

Your Case Number: ABP-308844-20
Planning Authority Reference Number: 10/5
Planning Grant Reference: 08/943
Kilmainham, Mountmellick, County Laois

Whether ongoing quarrying activities (specifically extraction below the water table, backfilling, boundary removal, haul road building, making-up ground, demolition and crushing of construction materials, and other developments) on lands at Kilmainham, Mountmellick, County Laois at or are not development and are or are not exempt development.

Operator/s:	Wisely/Nutgrove
Development Address:	Kilmainham, Mountmellick, Co. Laois.
Quarry Register Ref.	QY05/36 & that granted under 08/943
Fee:	€ 80.00

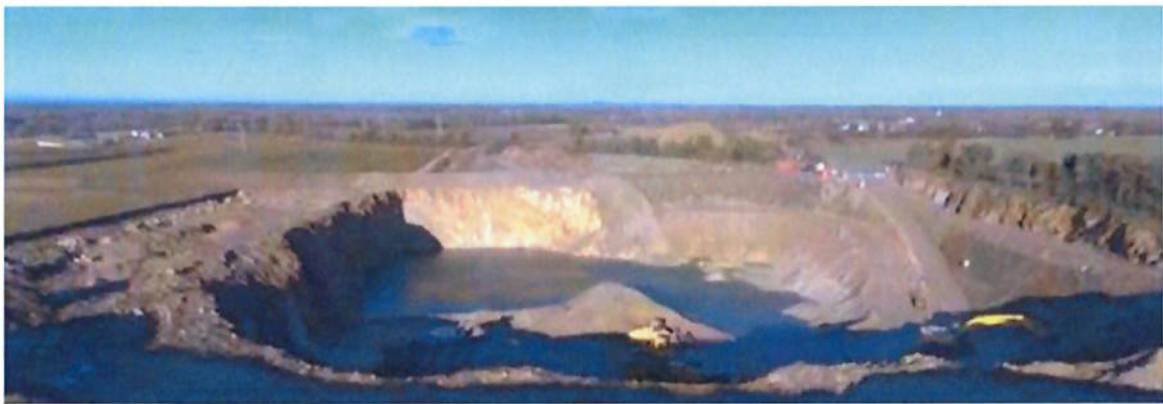
Photo 1. 2021 – image shows the western face [to the west] – this is where the most recent blasting occurred i.e., along the western and south-western faces. Note the construction of a further embankment or another haul road perhaps in front of the canteen, toilet area.

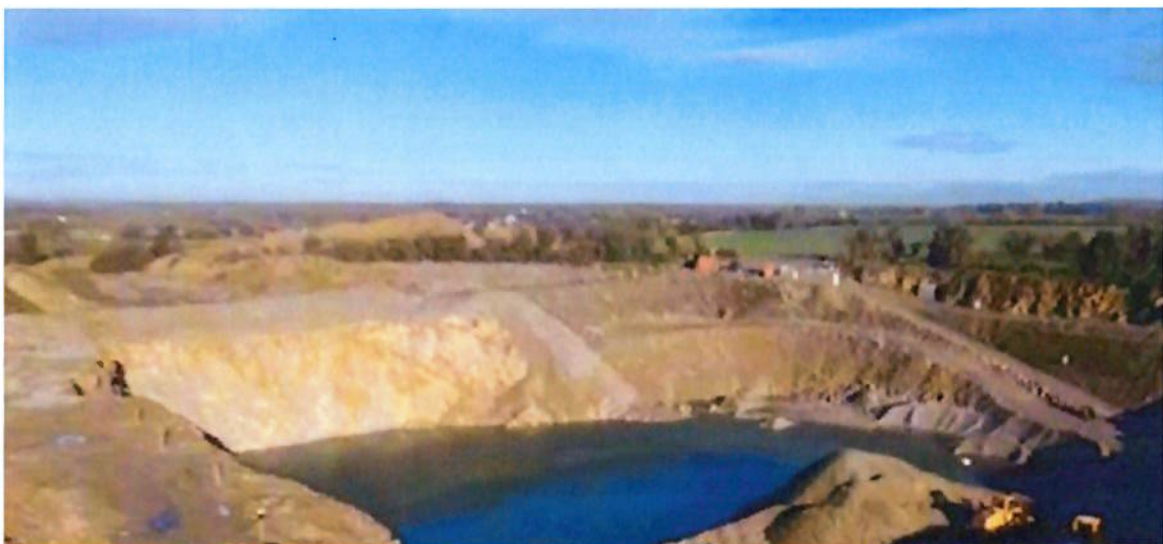
Photo 2. 2021 – the quarry floor continues to be removed some of the most recently blasted areas are currently resting under water.

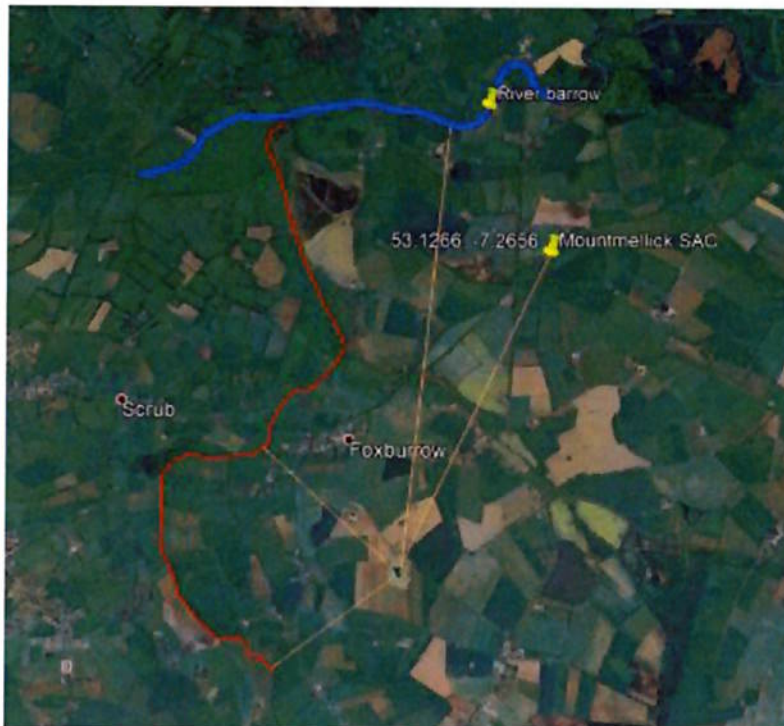
Development in the context of other notable features in the area

Blue River Barrow

Red River Triogue c. 1km

Orange lines Distances from the development

Yellow tags 2 * EU NATURA SAC sites

Mountmellick SAC Site Code: 002141 c. 2km

Barrow Nore SAC Site Code: 002162 c. 3km

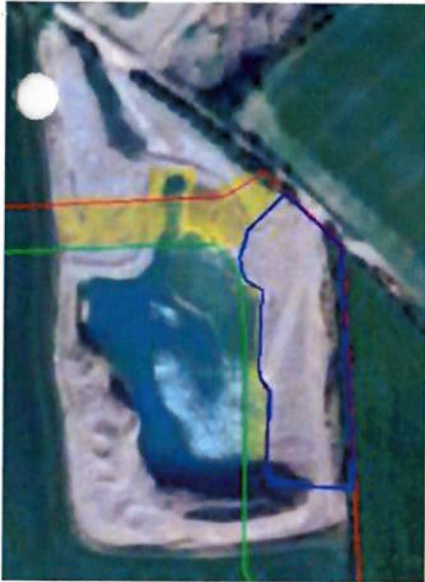
2016 – Approximate overlay – red Folio LS2488F, green approx outline from JSPE site plan (indicating the area to be extracted) and blue is the area that we believe was excavated and removed (several metres deep) backfilled to provide a new entrance and haul roads. The yellow highlighted areas are other areas that have been either partially or wholly backfilled.

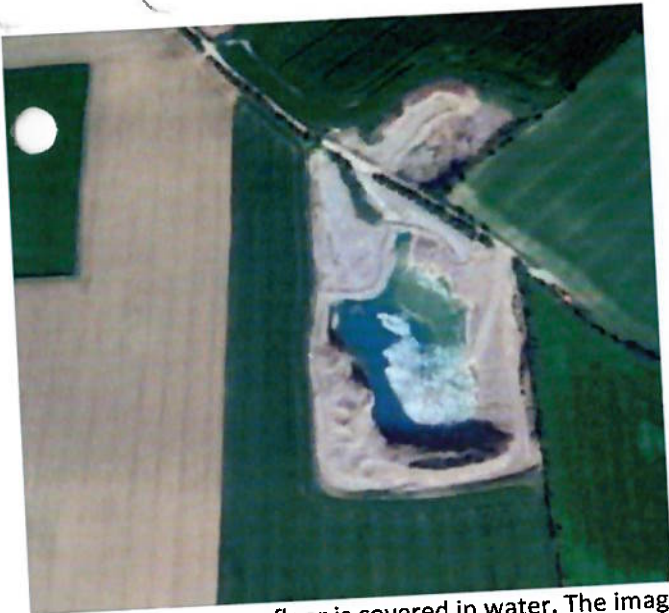
2016 – entire quarry floor is covered in water. The image shows the entire area after the creation of a new entrance backfilling. Haul roads are to the eastern side. The image also shows the overburden to the north after it has been partially removed.

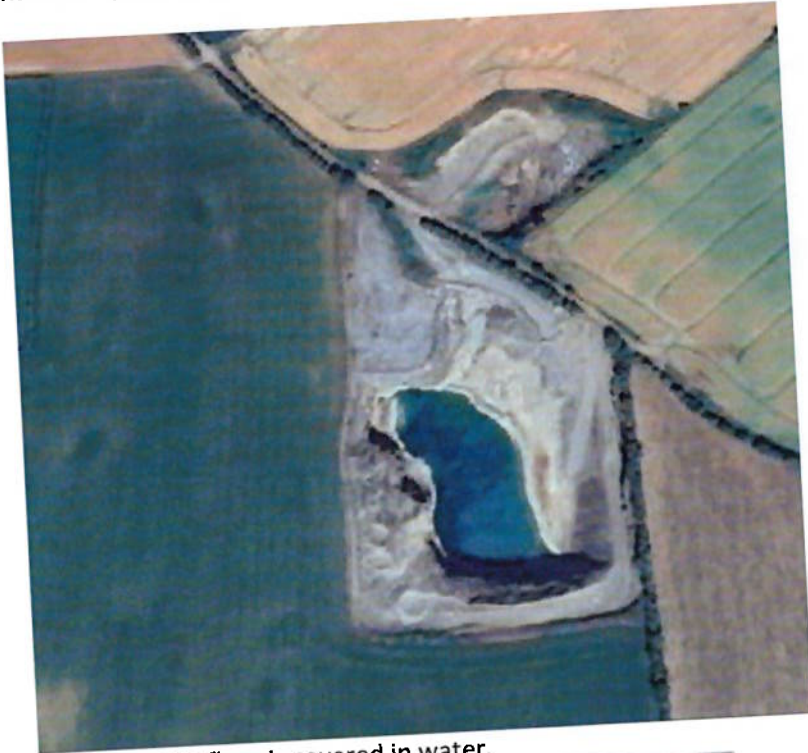
2018 – quarry floor is covered in water.

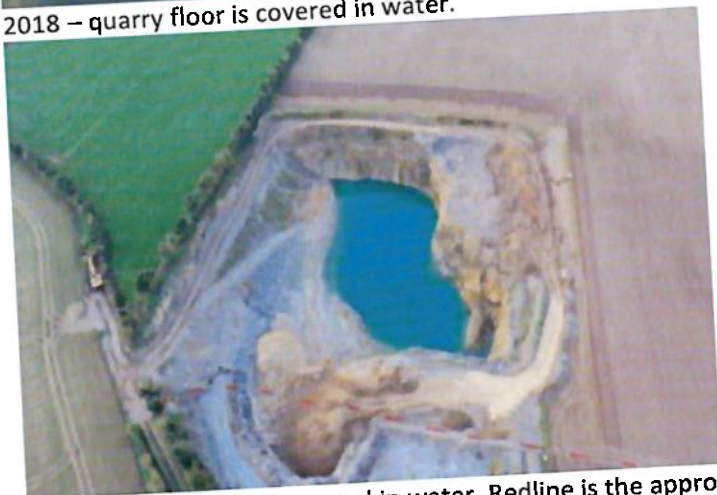
2019 – quarry floor is covered in water. Redline is the approximate location of extents of Folio LS2488F, see the backfilling to the south of the image. Note the presence of digger resting in neighbouring land.

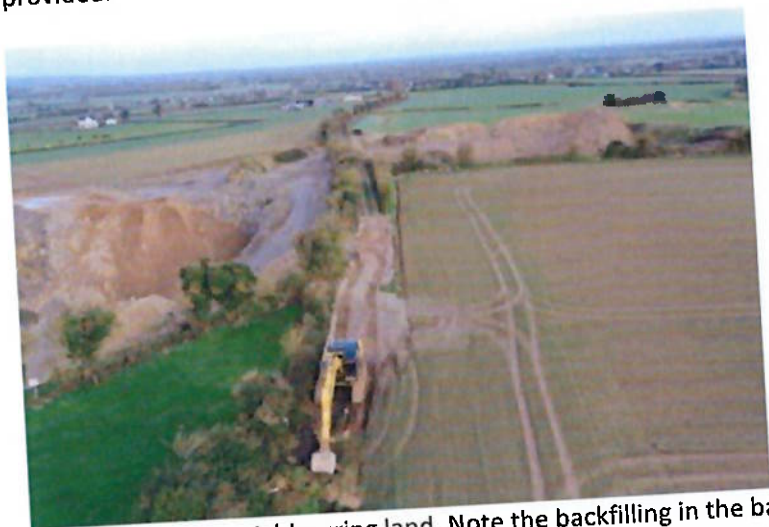
As we understand it the machinery has been stored continuously and extending over many years from 2014-2020 inclusive. See the presence of machinery resting on the neighbouring lands during this period in the images provided.

2019 – Digger in neighbouring land. Note the backfilling in the background and the partially removed stockpile of overburden – it was hauled from to backfill and create the new entrance and haul roads.

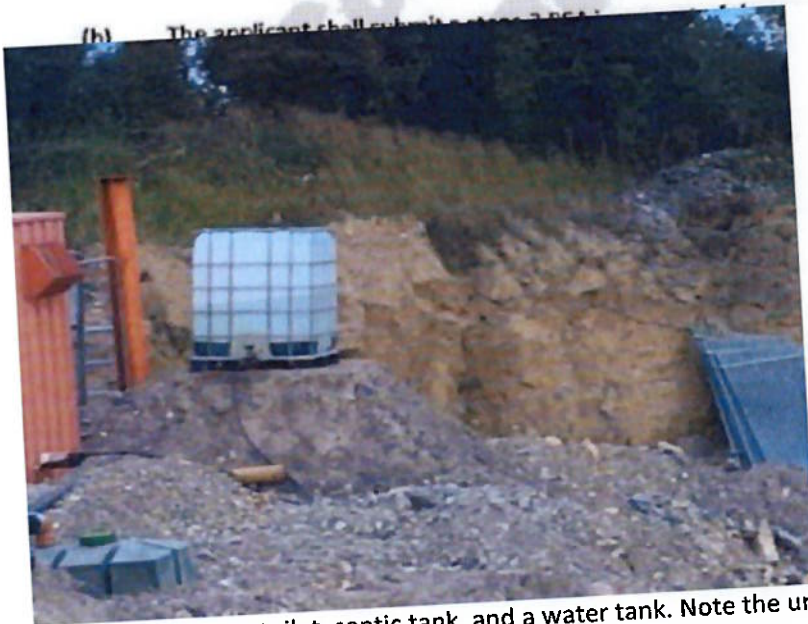
The ground is all made-up, and subsidence is apparent (refer to 2014 images showing that entire of the eastern and northern section i.e. the current entrance and haul roads were excavated, removed, and appear to have been made-up since).

The image shows a toilet, septic tank, and a water tank. Note the unfenced and exposed rock face that is directly abutting the neighbouring land where livestock is frequently kept.

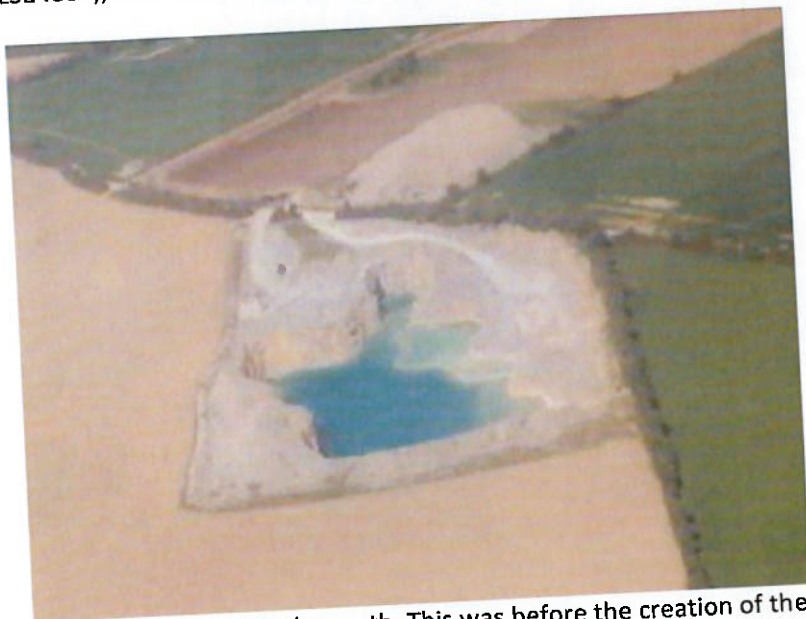
2014 Intact mound to the north. This was before the creation of the new entrance and backfilling that occurred within Folio LS2488F.

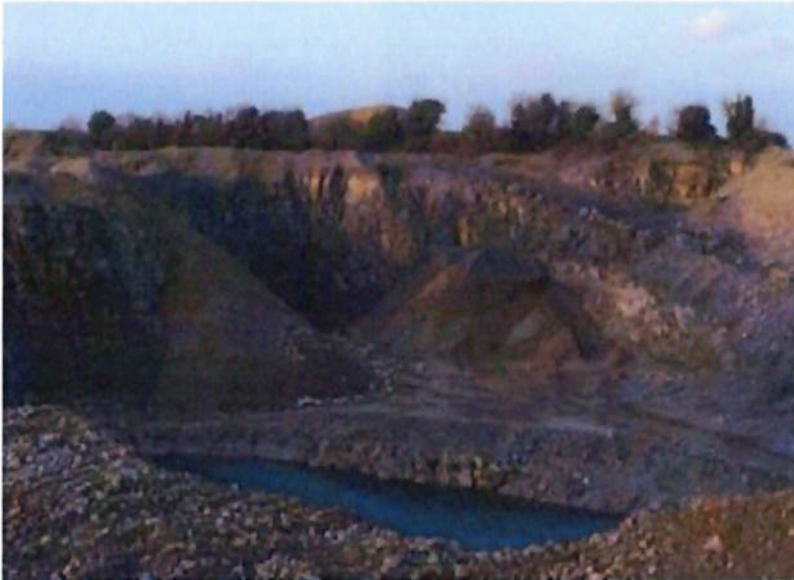
Commencing the backfilling at "G" note the overall depth of the area that was excavated. The backfilling extends right to the entrance (which you can see is being backfilled too in the upper east section of the image)

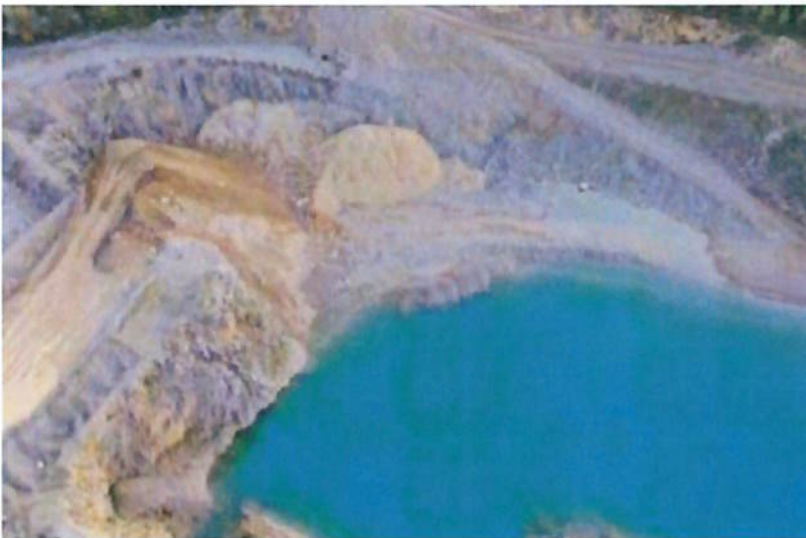
Backfilling at "G", which now extends right the way across to the entrance. Note quarry floor is covered in water
