Case number: ABP-318827-24
Planning authority ref: EX83/2023

25th January 2024

Violet Hill House, Herbert Road, Bray, Co. Wicklow

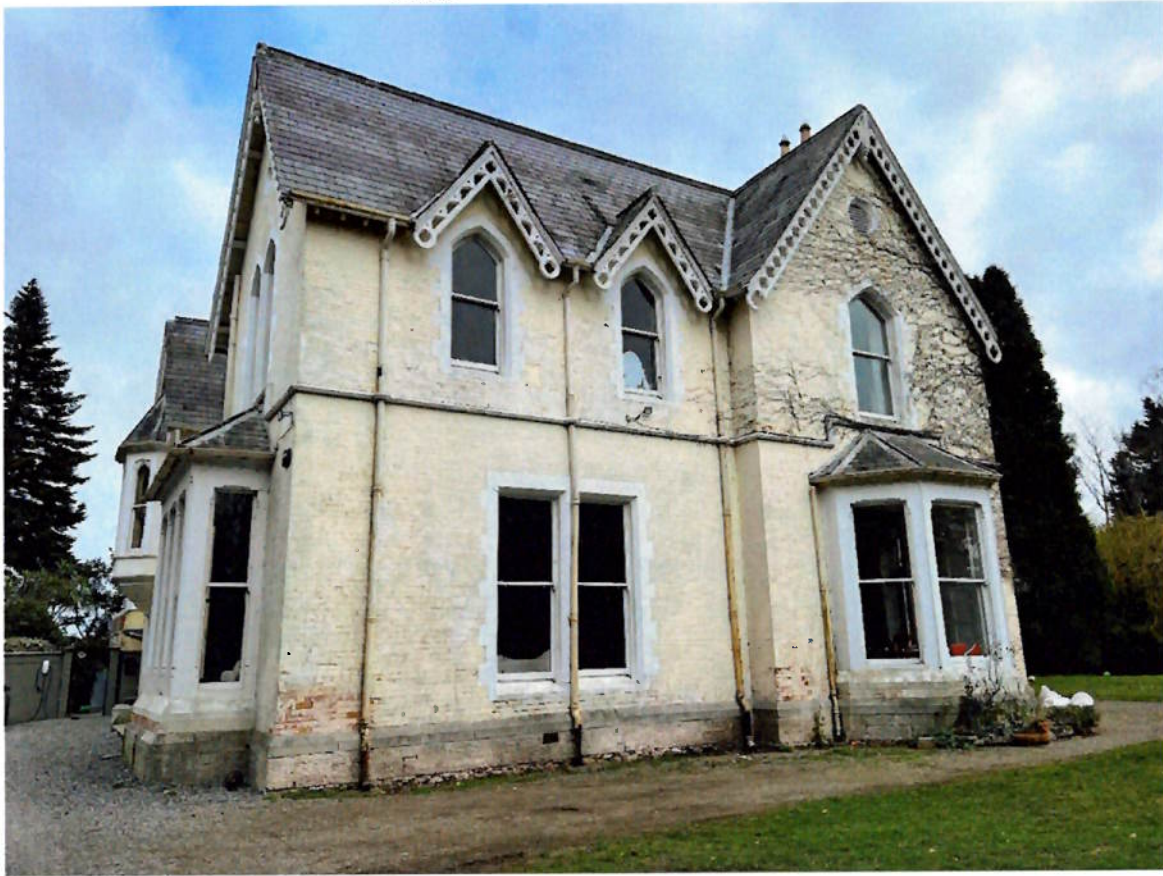
Before Paint removal – note the damp and deterioration

The limewash and paint were in a state of disrepair, please see attached photographs. The removal of the paint can only benefit the fabric of the building in that the building can breath as per its original design.

As can be seen by the photographs, the limewash was in a state of disrepair, the paint had deteriorated also as the under layer of limewash deteriorated over time. The brickwork has been saved from freeze thaw action from water lodging in behind the limewash and causing further damage. As can be seen from the photographs, the brick work came out in exceptional condition.

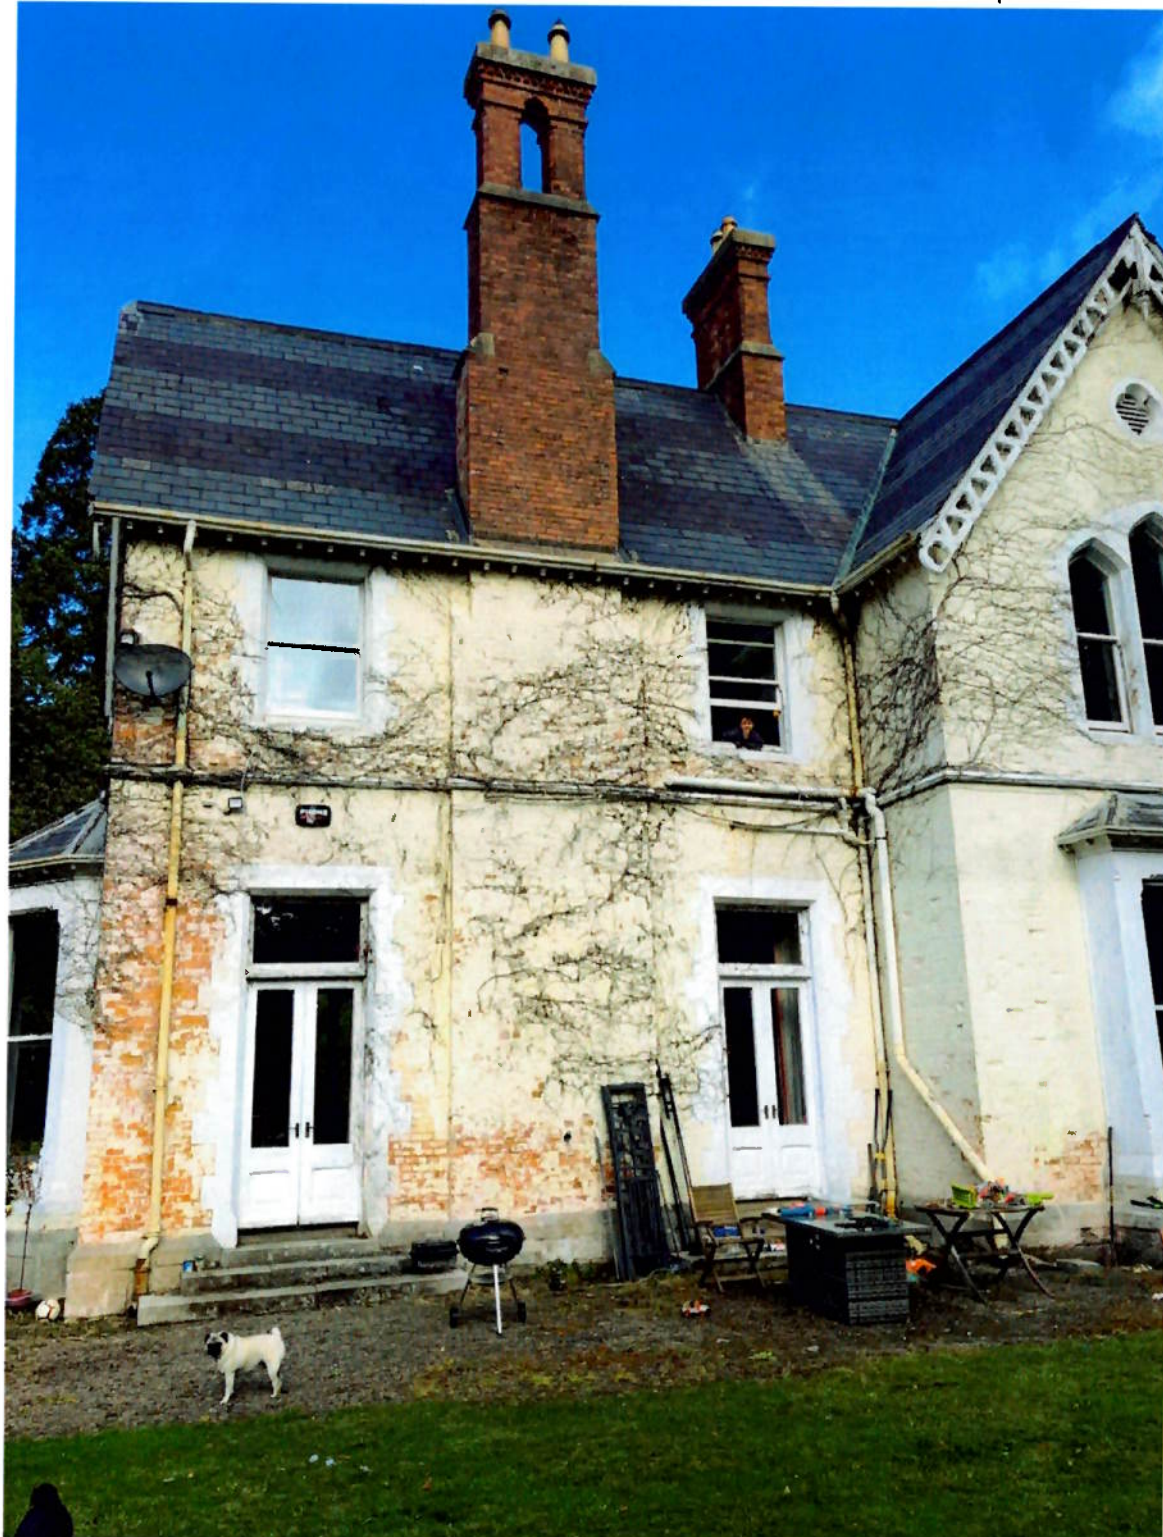
Note the original redbrick chimney stacks and deterioration of the Limewash and paint

The painted and lime washed exterior walls were already inconsistent with the character of the building by virtue of the fact that all chimneys which were built of redbrick similar to that of the external walls were never painted and being that the chimneys are such a prominent feature of

the exterior fabric, the painted exterior was clearly clashing with them, and Violet Hill House was never intended to be painted by the architect William Fogarty almost two hundred years ago.

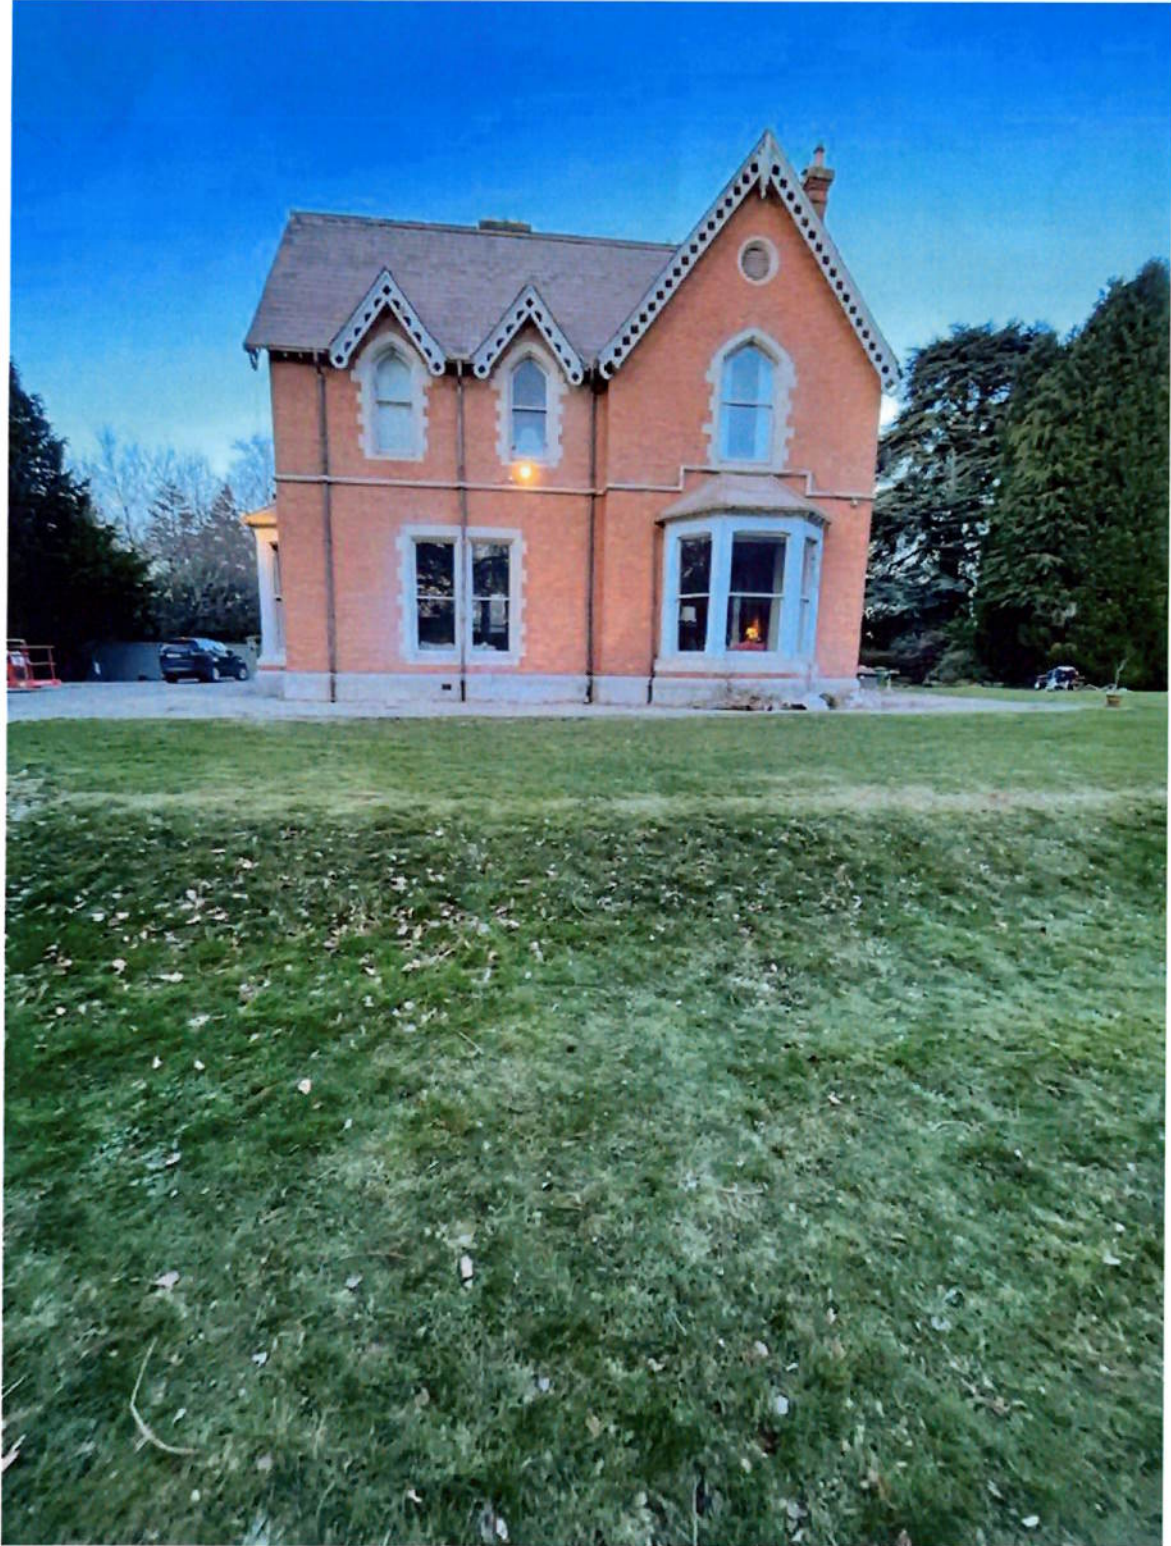
After the removal of the limewash and paint.

Limewash and Paint removal was completed with a very soft glass bead under low pressure. The reason is that the limewash required abrasive removal with an abrasive that would not damage the underlying brick, and this has been successful achieved, as evidenced in the pictures.

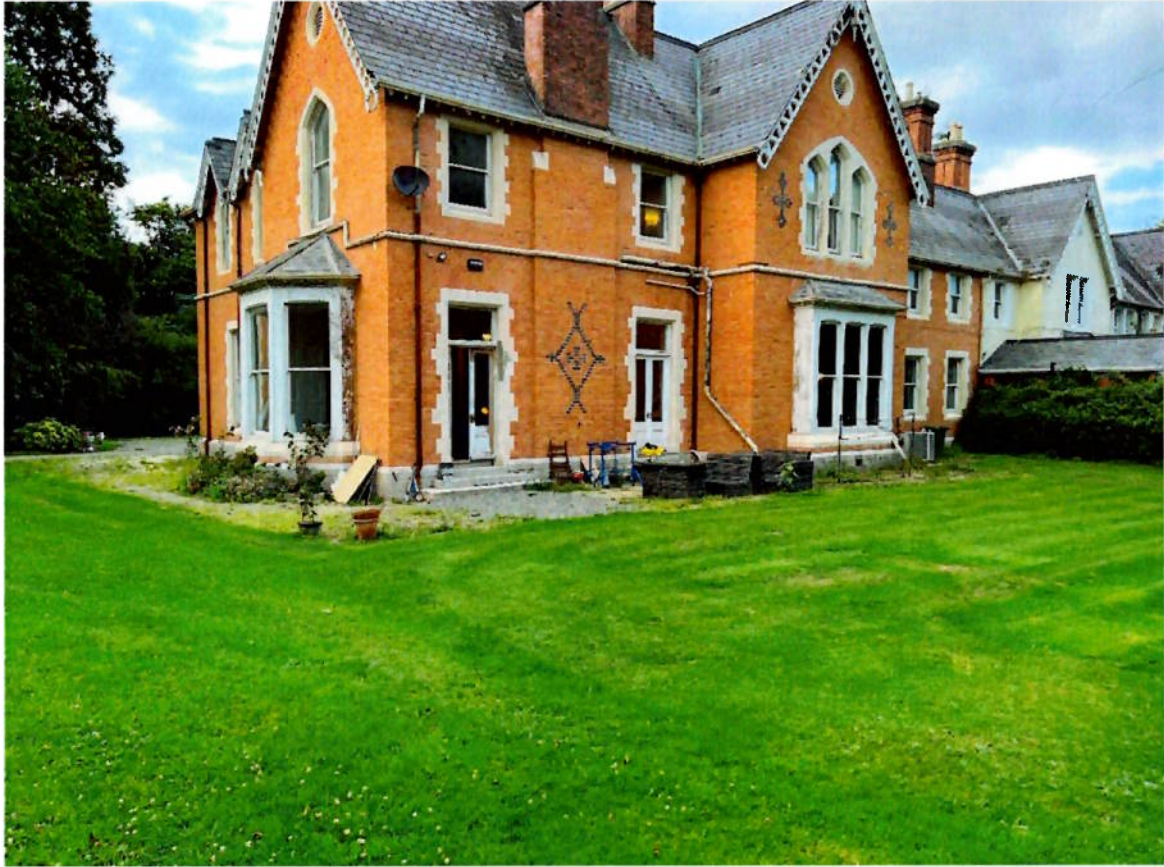
Polychromatic elements of the design.

Violet Hill house was designed by William Fogarty in red brick, incorporating polychrome brickwork, which has now been revealed for the first time since the building was erroneously painted on an unknown date in the 1970's (nobody can say if this was before or after the building was afforded its protected status). It is clear to see that this is the most magnificent and beautiful brickwork, which was shamefully limewashed and then painted.

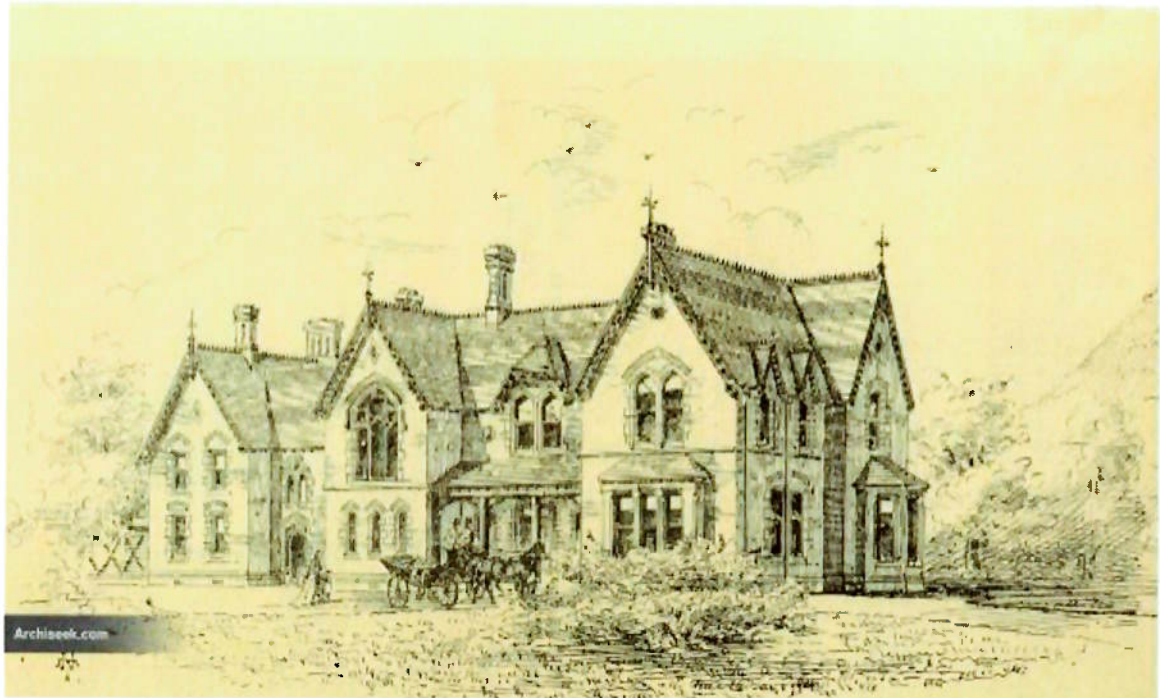
Original Main House Constructed in 1868 – Note The Galley is not yet constructed.

Amber and the Gallery apartments were added to the building at a later date and do not form part of the original main house. <https://www.archiseek.com/2014/1868-violet-hill-bray-co-wicklow/> The Original House can be seen here without the extension of Amber and the Gallery.

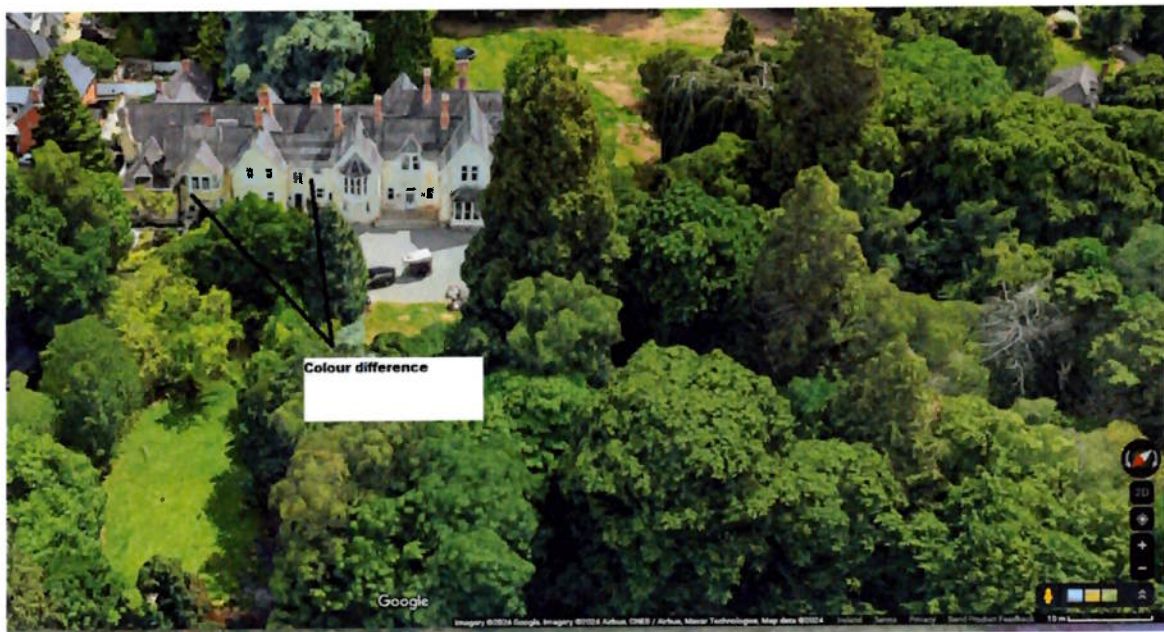
Difference in paint colours as between the units – Gallery is much a darker cream not in keeping with the remainder of the units.

Further, as can be seen from Google Maps, The Gallery is painted a deeper cream colour than the Original Main House, and as such is a patchwork in itself. It is not a consistent colour to the Original Main House before the limewash and paint were removed.

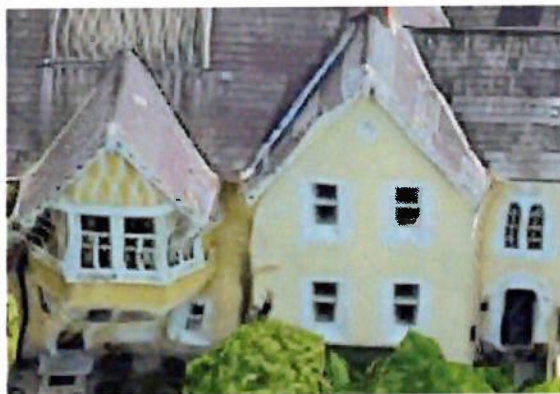
Clear colour difference between the Gallery and the Main Original House – Courtesy of Google maps

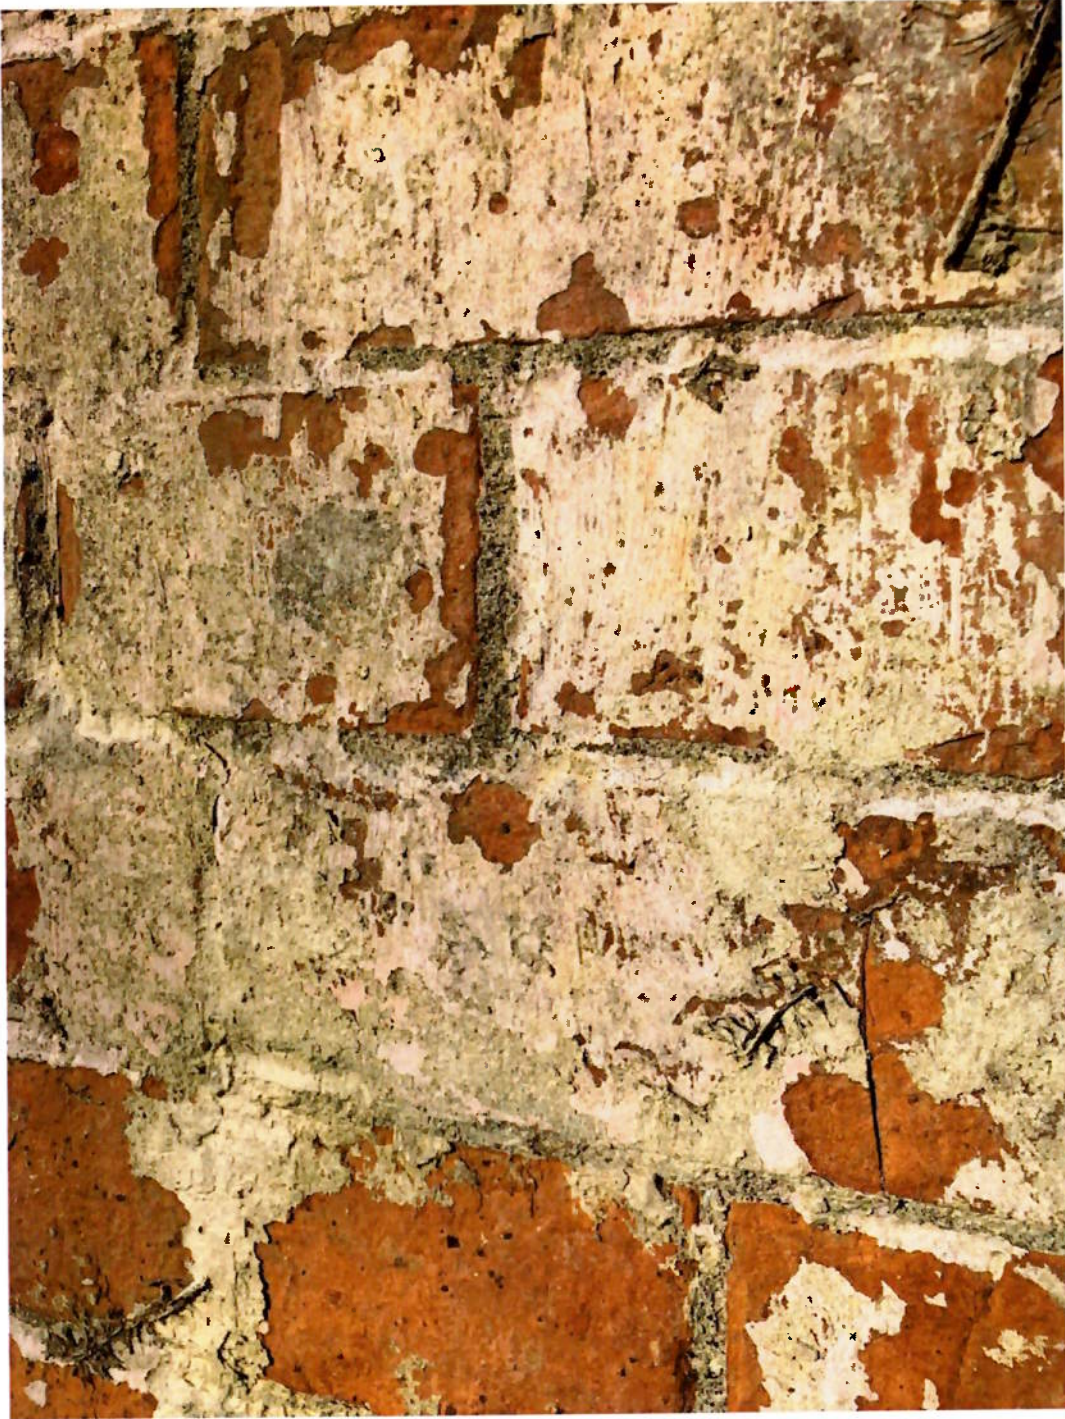
The bad state of the deteriorated Limewash and flaking pain

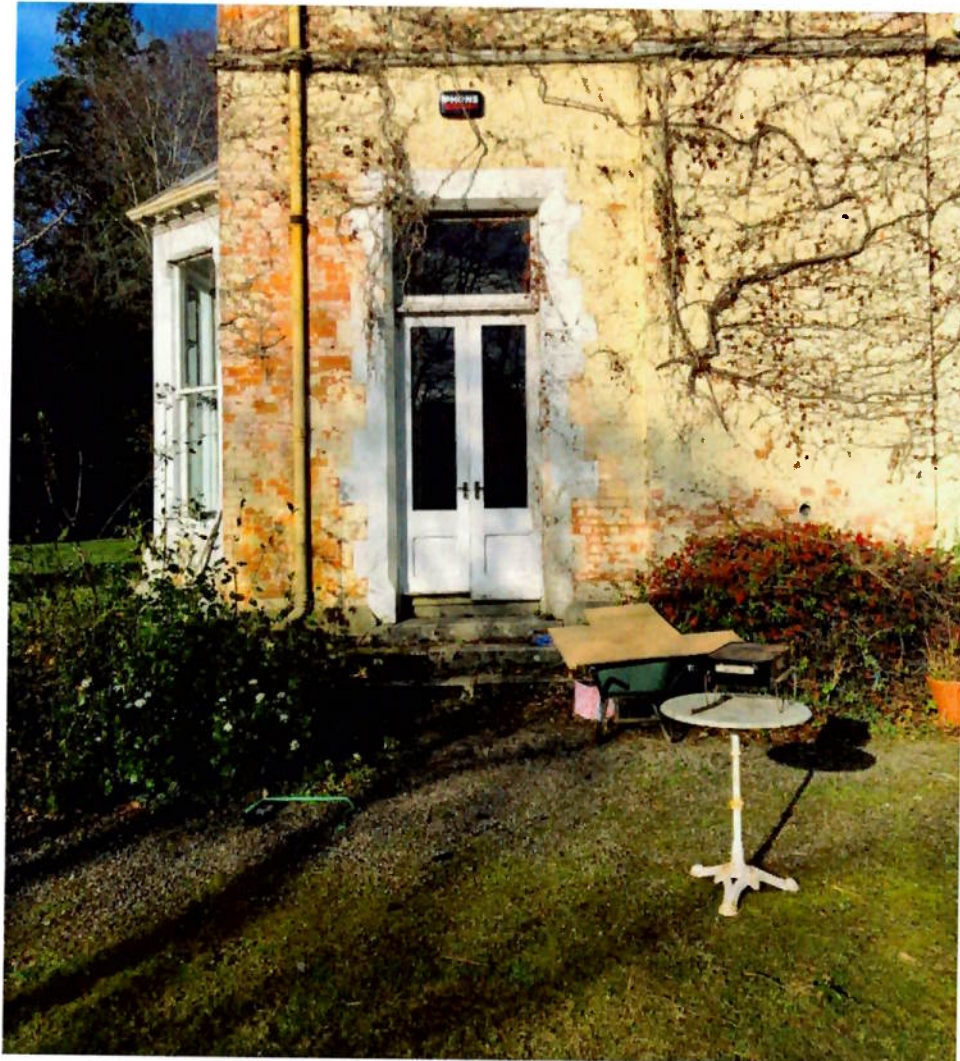
The bad state of the deteriorated Limewash and flaking paint.

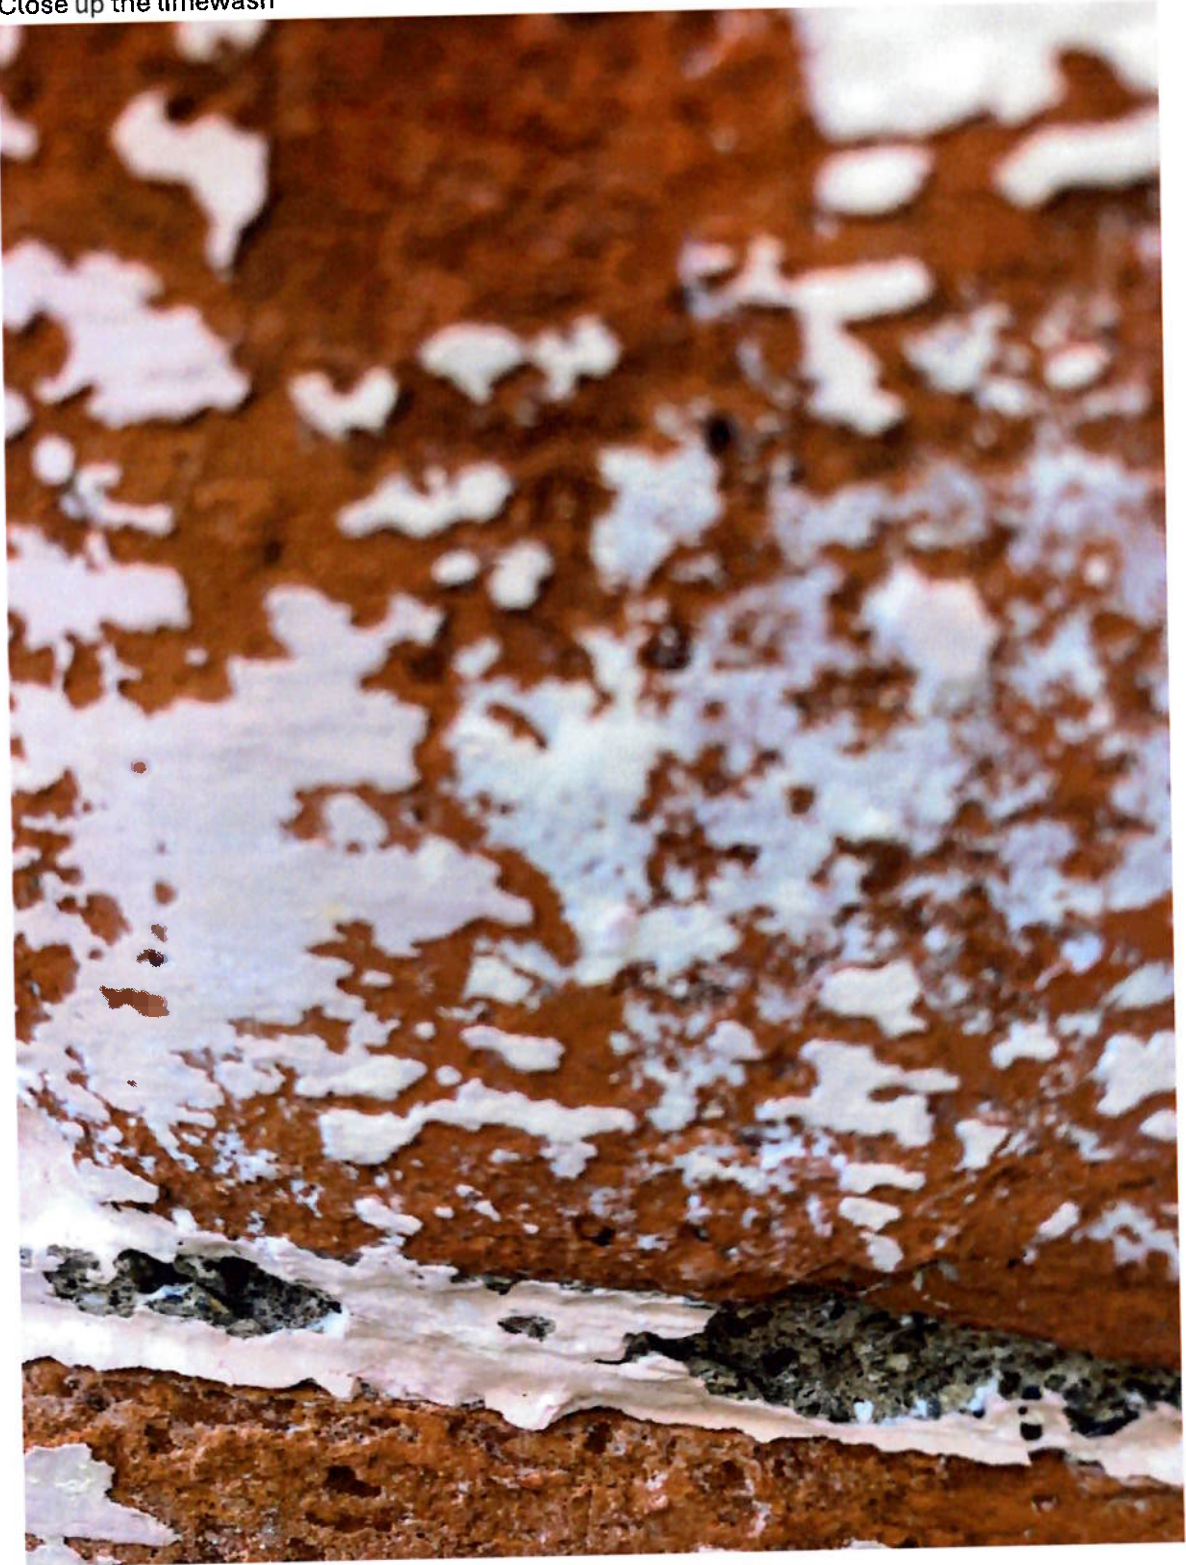
Close up the limewash

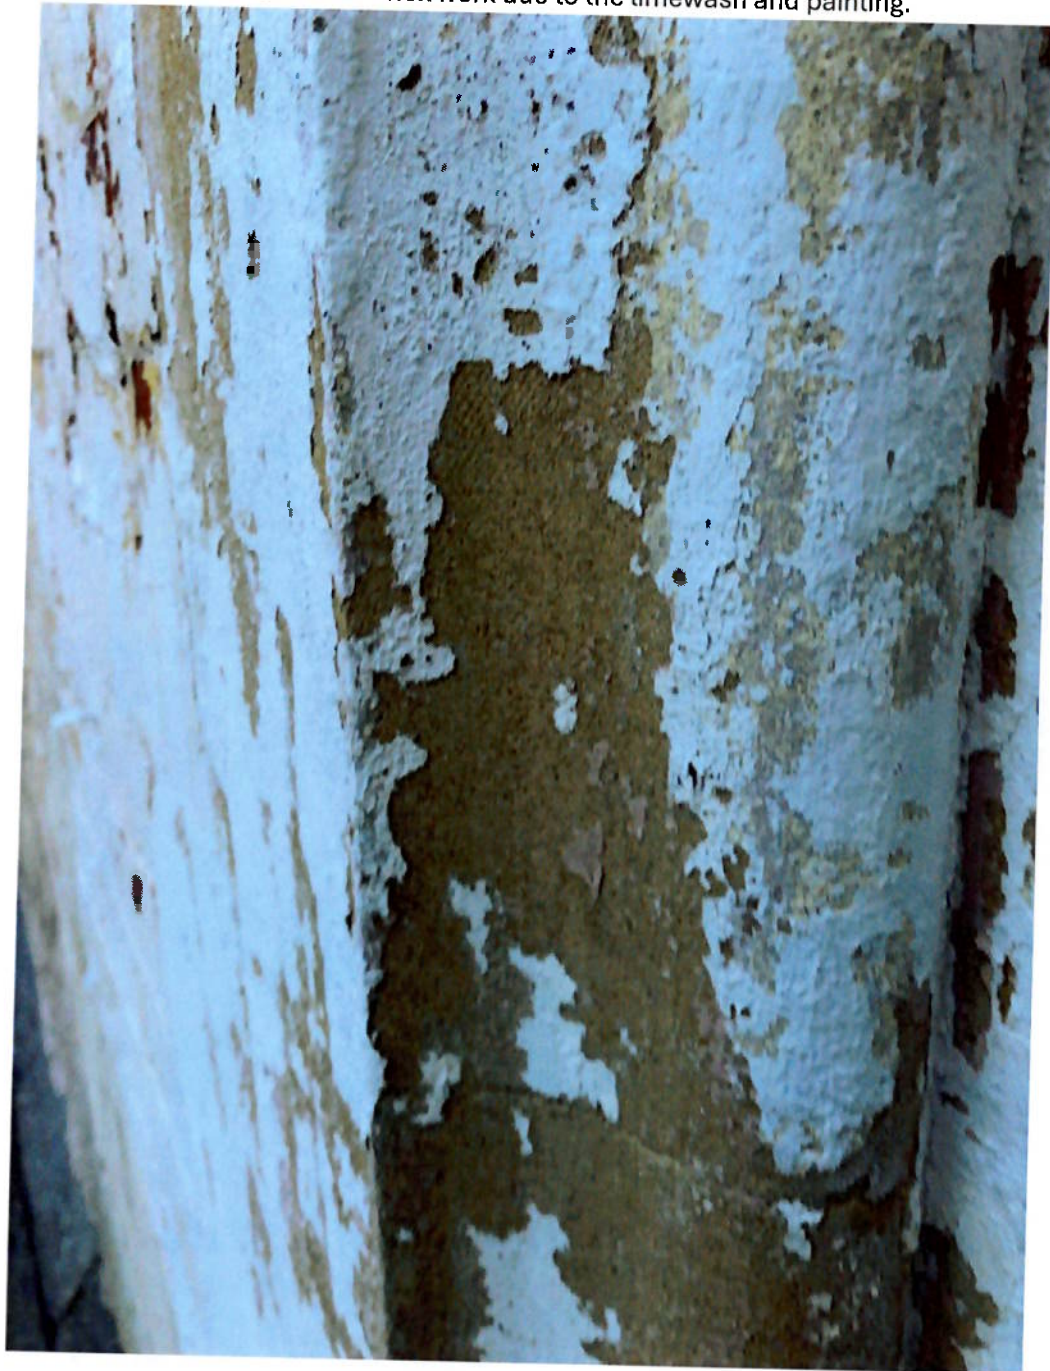
Further deterioration of the brick work due to the limewash and painting.

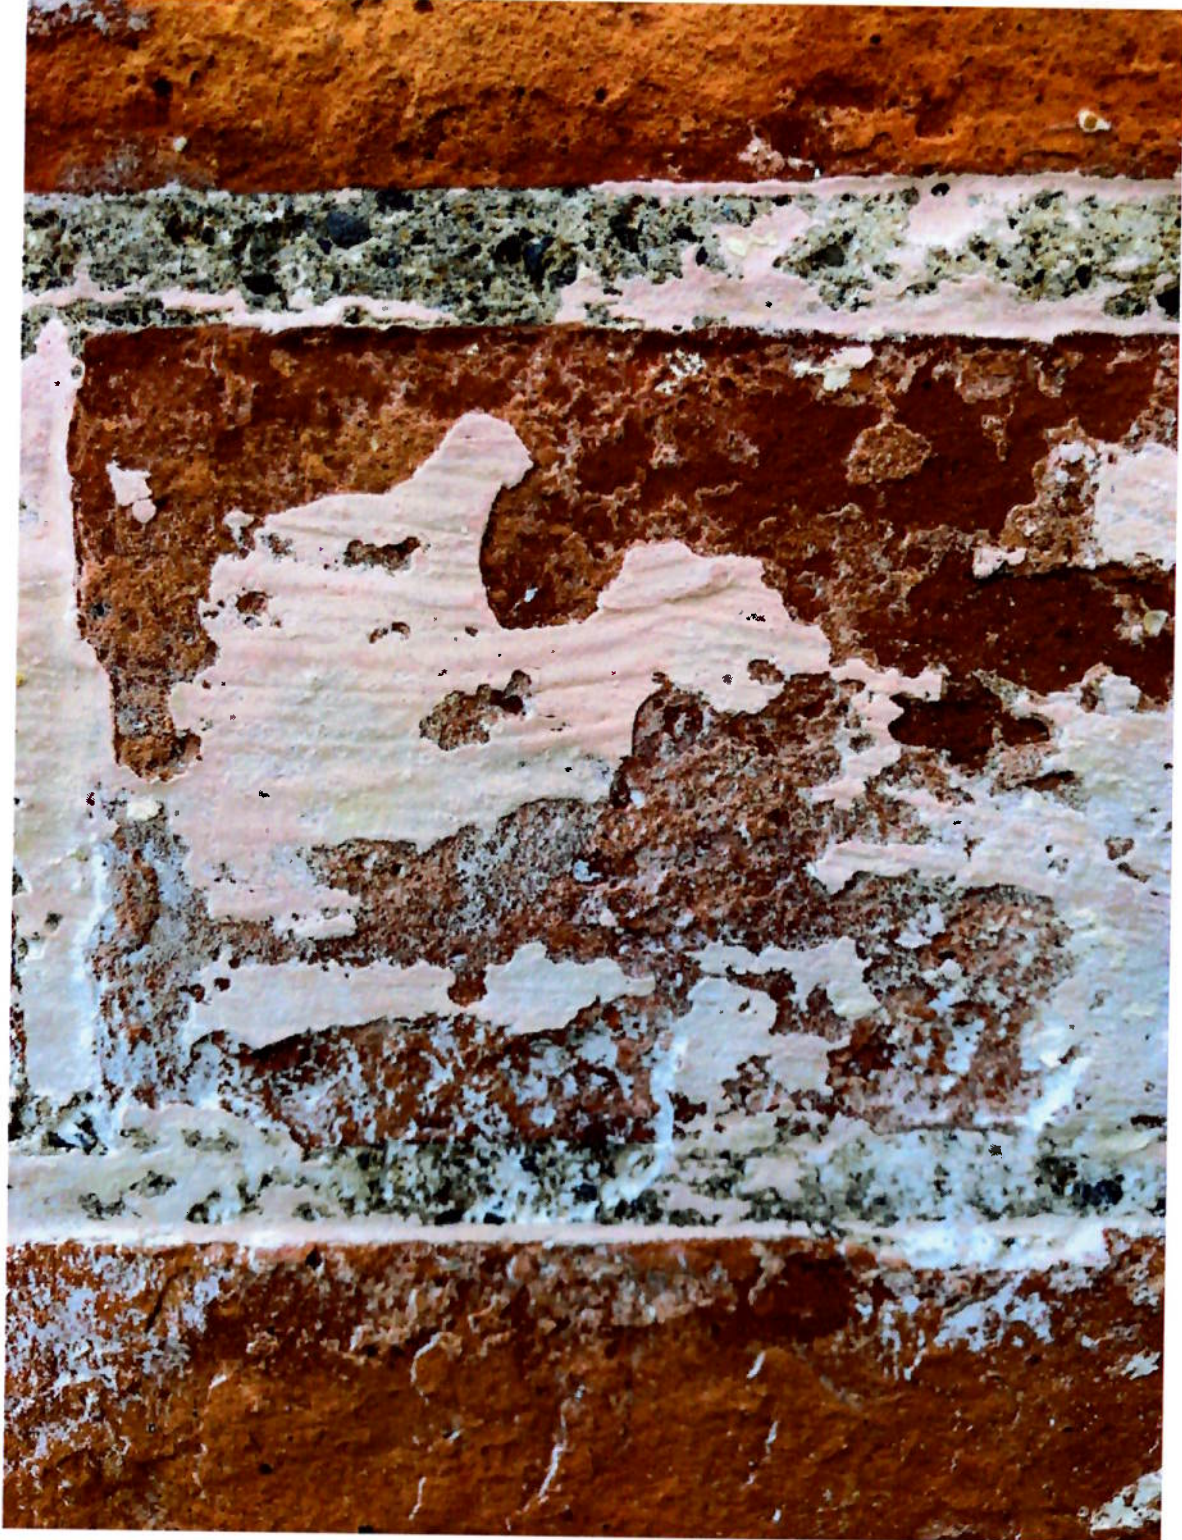
Close up the Limewash that had to be delicately removed.

Due to the fact that the limewash was applied, it had to be removed in a manner that would gently remove it. If it was just paint, then it would have been a much easier task. The applicant is not aware that the building is limewashed and fails to mention this in their report.

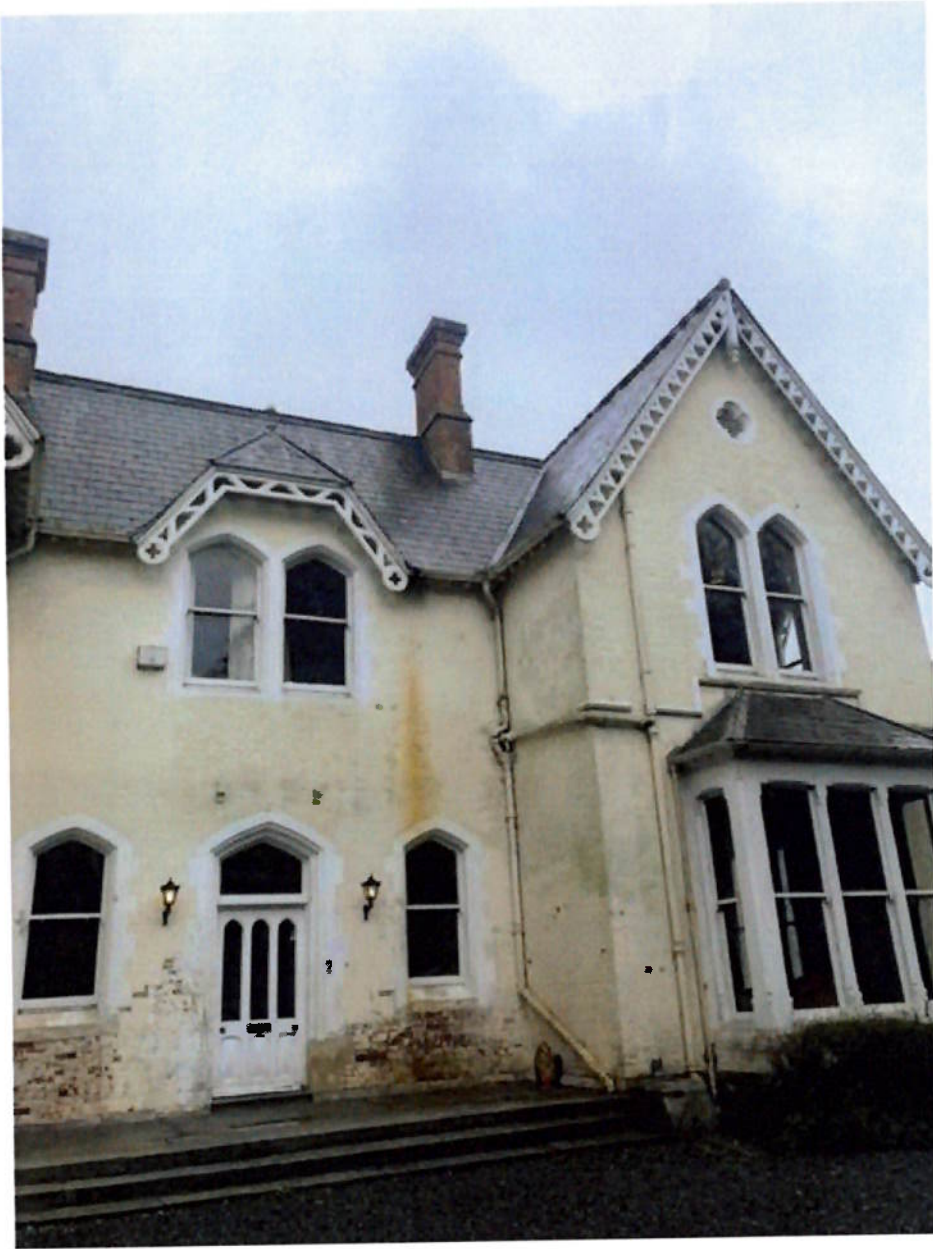
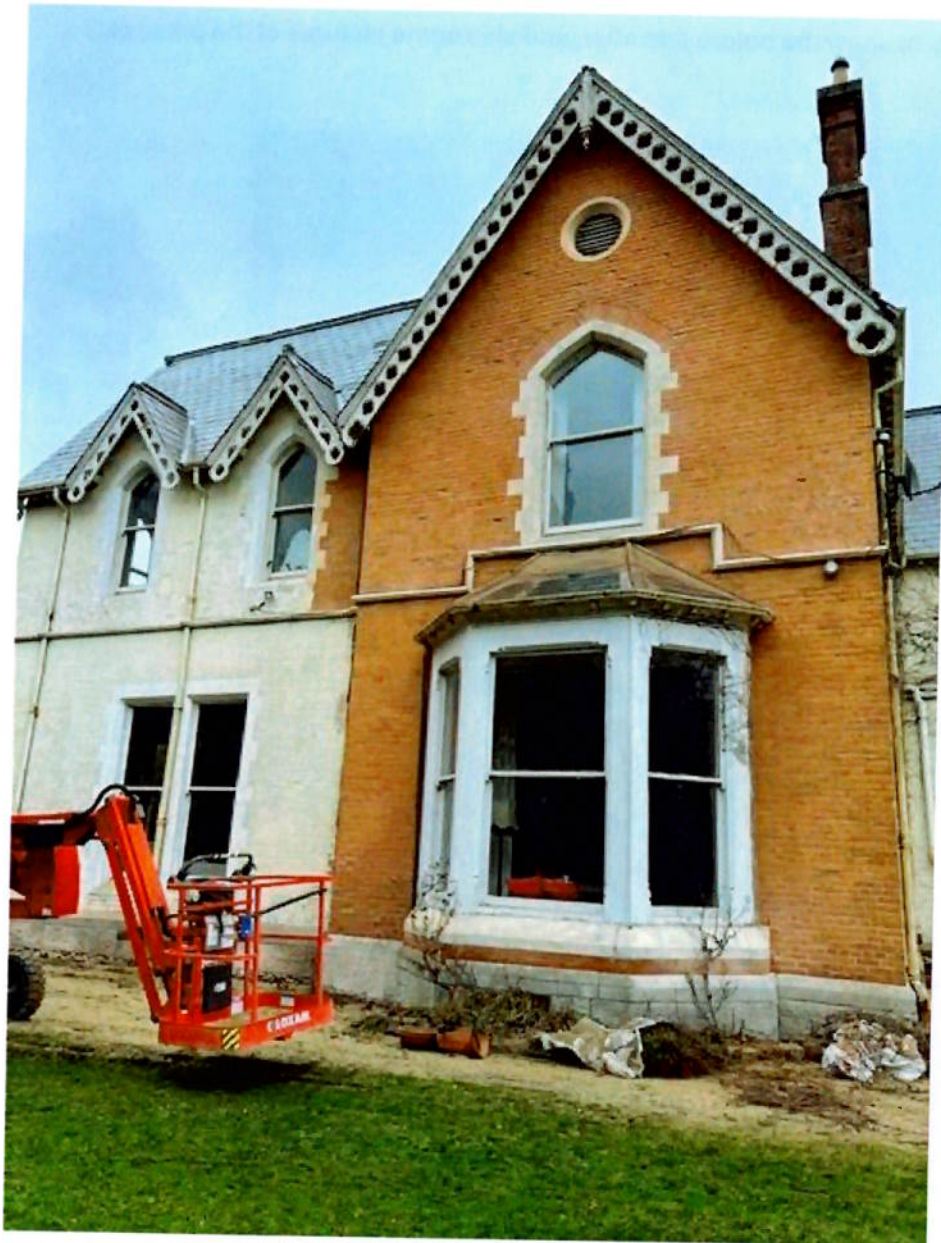
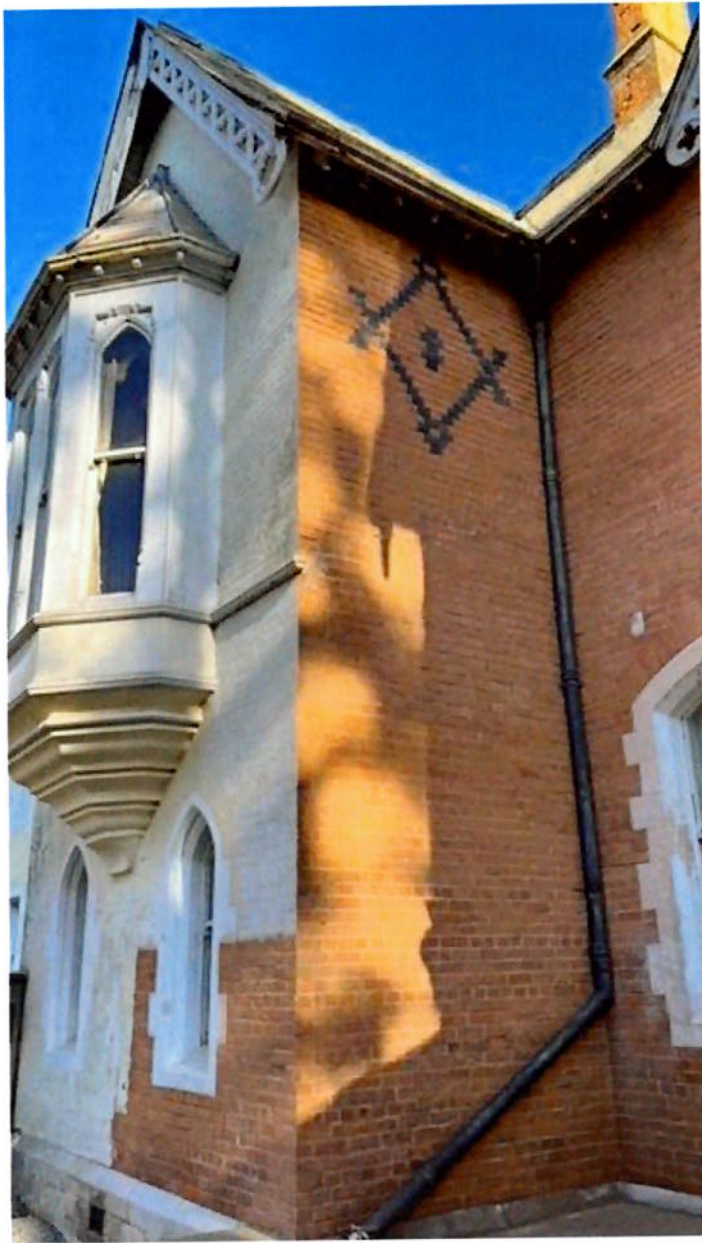
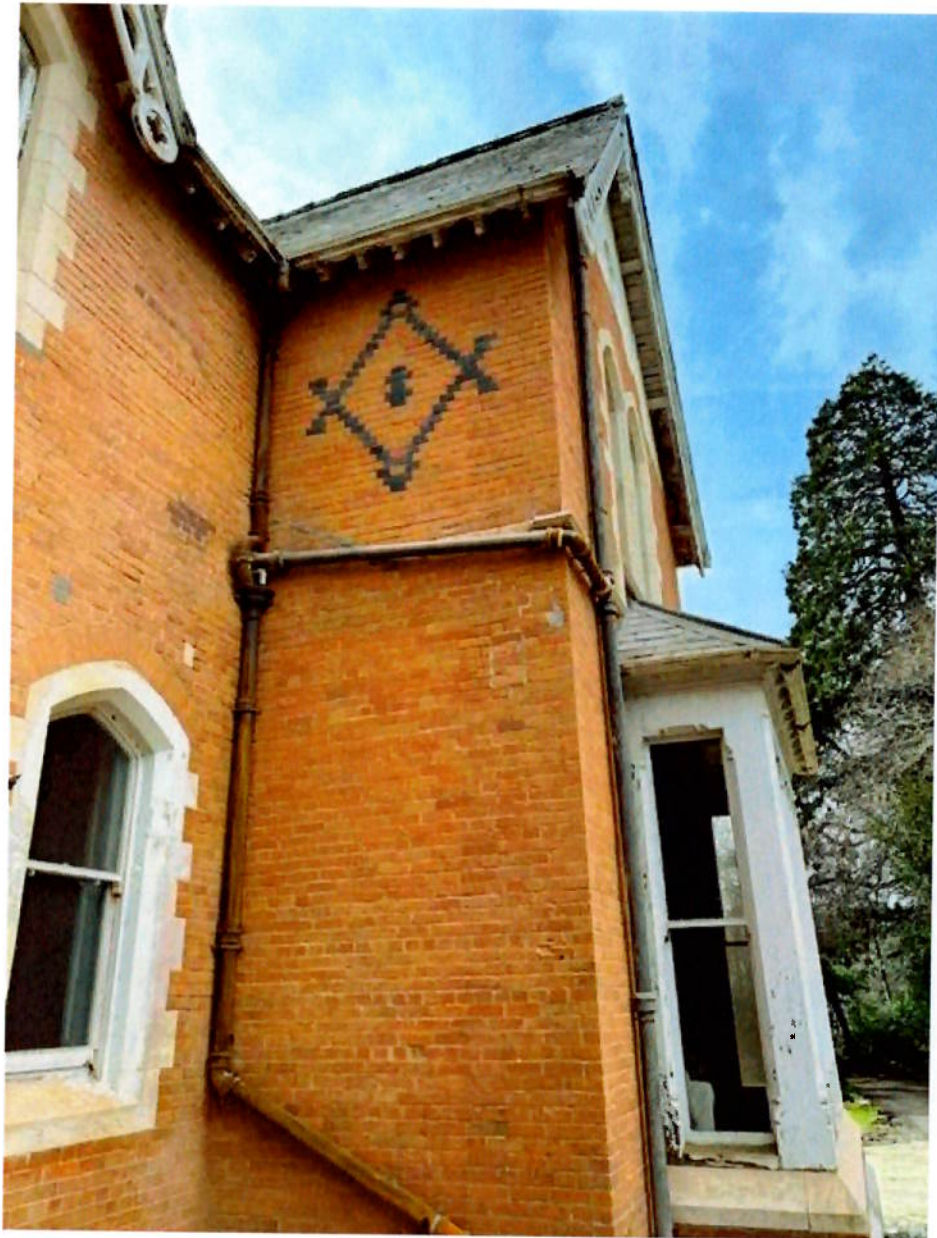
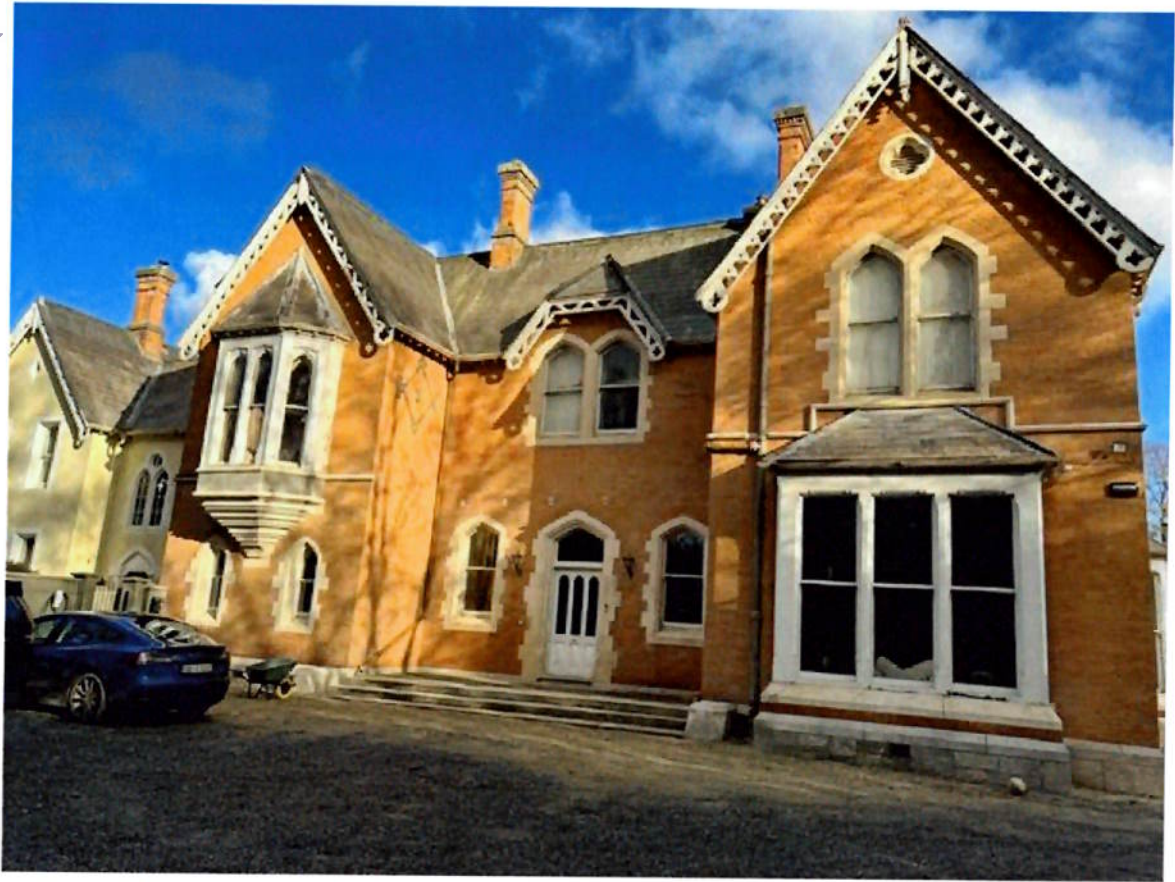
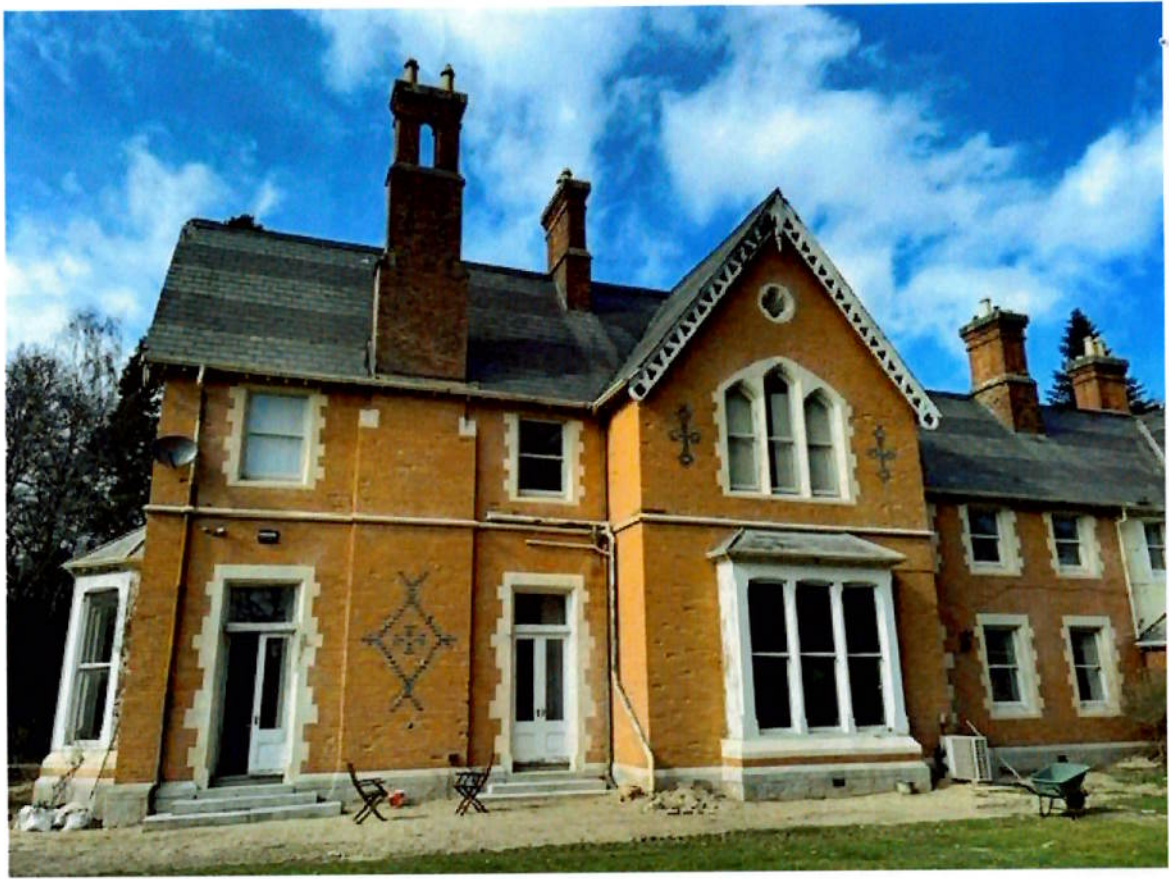
Further photographs to show the before and after, and also some pictures of the process.
