Re: Section 5 Declaration: Whether the peat extraction on a bog and associated works is or is not development and is or is not exempted development at Annaghmore, Lough Fen, Co. Offaly

**Offaly County Council Re: DEC23-24 / UD22-029 –The peat extraction at Annaghmore.
Lough Fen, Co. Offaly**

ANNAGHMORE LOUGH FEN PNHA
ECOLOGICAL SURVEY

Annaghmore Lough Fen 16 July 2023.

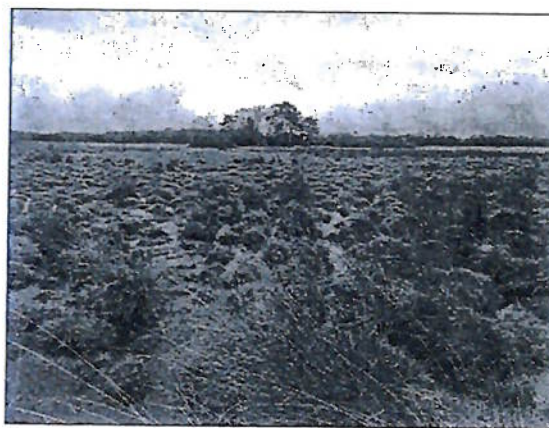
View of bog woodland over Annaghmore Lough Fen

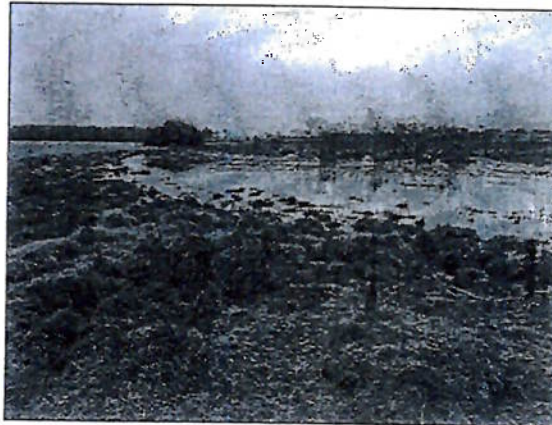
Annaghmore Lough and adjacent fen

The lake is very shallow, perhaps c. 1 m deep at the time of survey. The presence of a plant debris forming a strand line shows that the water levels fluctuate during wet and dry seasons. Local residents report that cattle often wade into the centre of the lake in summer, and so summer water levels must be quite shallow. The Site Synopsis (Appendix A) claims that it is only a "couple of centimetres" deep, but this is likely to be an exaggeration.

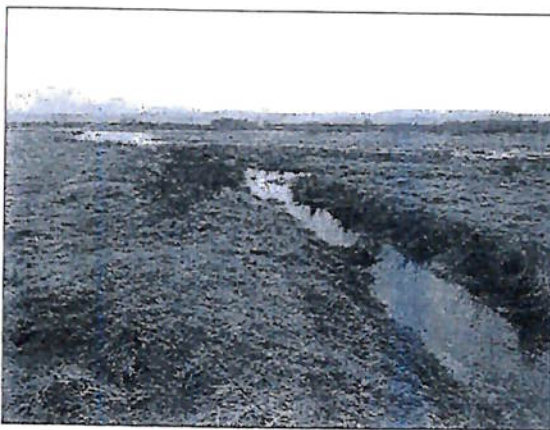
Channelised stream feeding Annaghmore Lough with semi-improved grassland to left

The lake is fed by a **lowland / depositing river (FW2)** flowing in from the northwest. Near its entry, the stream is approximately 2 m wide and 0.5 m deep. It has a gravel substrate and supports marginal stands of fool's water-cress and water starwort. The stream has been dredged in the past, as shown by its straight course, depth and grassed-over mounds of spoil on the northeast bank. Further to the west, the inflowing stream is bounded by a **treeline (WL2)** of alder with some rusty sally, hawthorn and gorse.

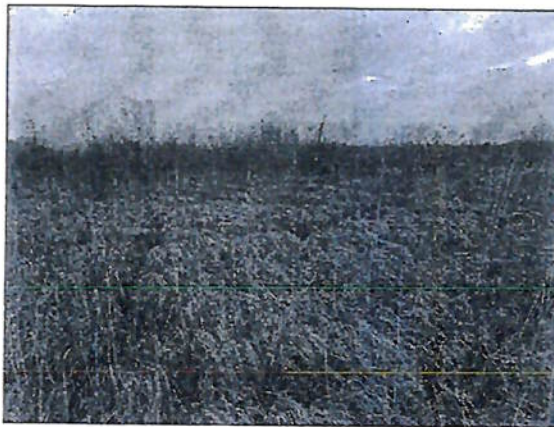
Surrounding the lake was **rich fen and flush (PFI)** habitat, which corresponds to the EU Habitats Directive type '*alkaline fen (7230)*' (European Commission, 2013). The main part of the fen lay southwest of the lake and stream. It was dominated by a low sward of sedges and a relatively high cover of mosses. Sedges recorded included glaucous sedge and yellow sedge, but the time of year was not suitable for identifying sedges, and so no efforts were made to compile a comprehensive list. In 1993, Douglas and O'Donovan recorded six sedges, including glaucous sedge, long-stalked yellow sedge, common sedge, carnation sedge, bottle sedge, and what they suspected was tawny sedge. The dominant moss was *Calliergonella cuspidata*, a common wetland species, but several characteristic fen mosses were present, including *Scorpidium cossonii*, *Bryum pseudotriquetrum*, *Campylium stellatum* and *Calliergon cordifolium*.

Alkaline fen on west side of the lake

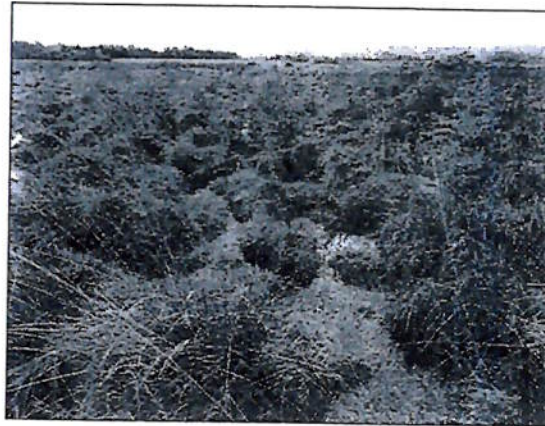
Further east where the fen would have been transitional to raised bog, great fen-sedge was frequent. Some of this fen appeared to occupy cutover bog. The eastern fen was divided by a fence running east-west. The northern part of the fen was observed from a distance, and it was noted that much of the great fen-sedge and associated fen vegetation north of the fence had been recently mown or cleared.

Alkaline fen on east side of lake

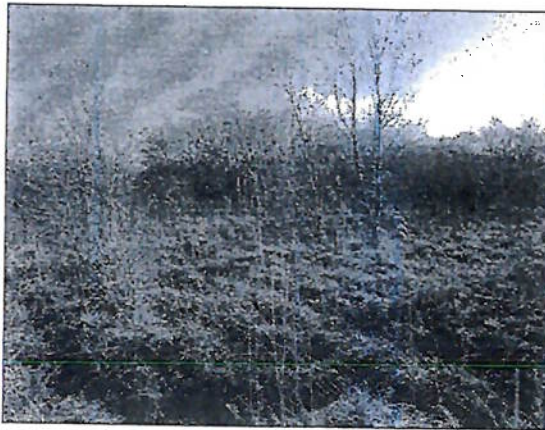
Wet woodland edge with transition to open alkaline fen in foreground

Adjacent to the fen was a young stand of birch and rusty sally forming a closed canopy (c. 90% cover) woodland. The understorey was dense and occupied by birch and willow saplings with frequent guelder-rose and occasional young holly. The field layer was sedgy with abundant bottle sedge, patches of ivy and bramble and frequent meadowsweet. *Calliergonella cuspidata* and *Pseudoscleropodium purum* were abundant and *Rhytidiadelphus squarrosus* was frequent. Water

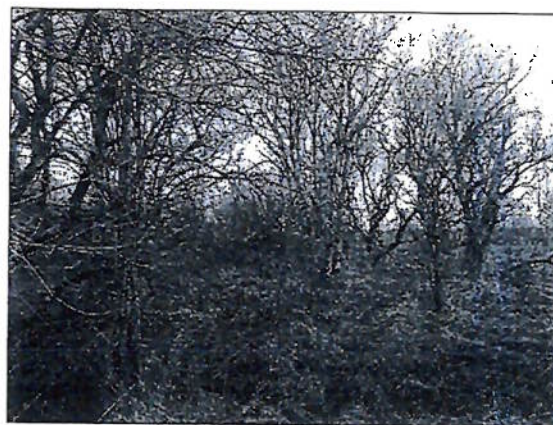
South-eastern section of wet woodland: more mature and open woodland structure with grassy field layer

The south-eastern end of this woodland band was more mature and open and appeared to be less wet. Birch and rusty sally were the dominant trees, and a single ash tree was also present. The understorey was sparse, and the field layer was grassy and dominated by creeping bent and common sedge. Also frequent were the grasses red fescue and Yorkshire fog, meadowsweet and bramble. This section is also best classified as **wet willow-alder-ash woodland (WN6)** and **BM5 birch-purple moorgrass woodland, grey willow-marsh bedstraw subtype**. There are some similarities with another subtype **BM3 birch-purple moorgrass woodland, Yorkshire fog-bent grass subtype** which also characteristically grassy, but tends to occur on more acidic sites. The stand showed no signs of grazing, but the grassy field layer and lack of an understorey suggests it may have been grazed in the past.

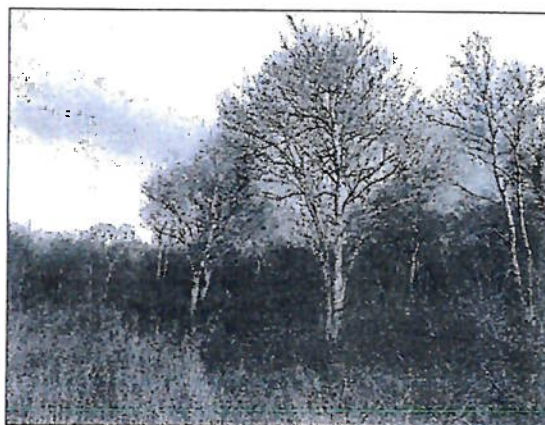
The transition from the wet woodland described above to a generally more open and acidic **bog woodland (WN7)** was relatively abrupt and quite noticeable in the field. Birch was again the most abundant canopy tree species, but rusty sally was only occasional, and Scots pine was frequent. Canopy cover averaged only about 40%. The understorey layer was patchy and mainly occupied with birch and Scots pine saplings. Purple moor-grass dominated the field layer, while bog-myrtle, bramble,

Bog woodland edge and poor fen with abundant bog-myrtle in foreground

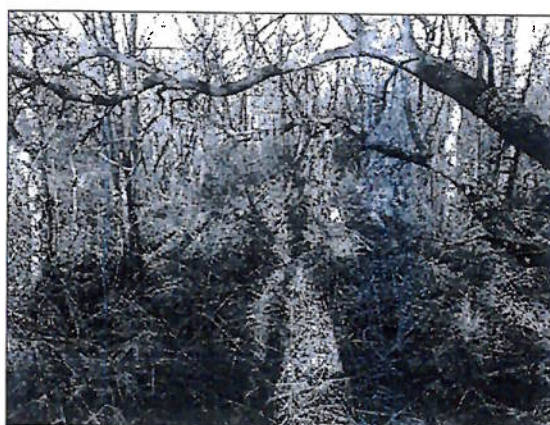
Closed canopy bog woodland corresponding to Annex I habitat type

In the centre of the woodland, at the transition to more base-rich wet woodland, patches of the woodland have affinities to the Habitats Directive Annex I type 'bog woodland (91D0)'. Here, the birch canopy was more full (c. 75%) with rusty sally and Scots pine both occasional. The field layer was characterised by abundant bottle sedge with some bramble, but was distinctly more mossy. *Aulacomnium palustre* and *Hylocomium splendens* were most abundant, but *Sphagnum* species characteristic of

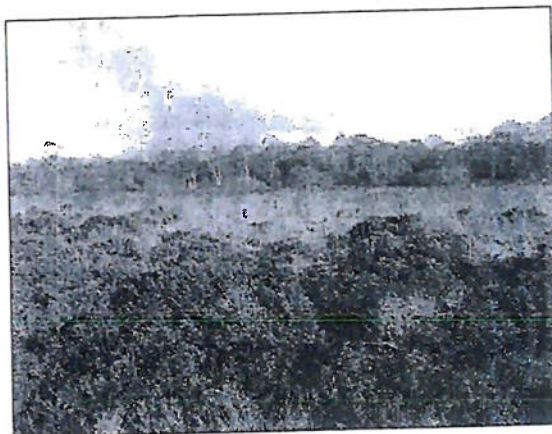
The bog woodland petered out into a zone of purple moorgrass dominated **poor fen (PF2)**. The purple moorgrass was quite dense and tussocky and afforded very little habitat for bryophytes, such as *Hypnum jutlandicum* and *Sphagnum capillifolium* ssp. *rubellum*. Vascular plants scattered amongst the purple moorgrass included bog-myrtle, ling heather and cross-leaved heath. Also present closer to the woodland margin were more open patches where great fen-sedge was locally abundant, and purple moorgrass was less so, and other species, such as devil's-bit scabious and *Pseudoscleropodium purum* could gain a foothold. The transition to **raised bog (PBI)** to the southwest was rather sharp.

Purple moor-grass dominated poor fen in middle ground with raised bog margin in foreground and bog woodland in back

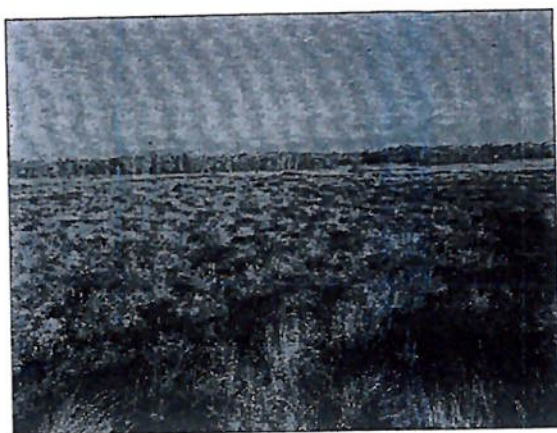
The northern section of uncut raised bog was dry and degraded, firm underfoot, and with less than 5% cover of *Sphagnum* (mainly *Sphagnum capillifolium* ssp. *rubellum*). The habitat corresponded with the *marginal* raised bog ecotope, as defined and used in NPWS raised bog monitoring projects (Kelly et al., 1995, Fernandez Valverde et al., 2005, Fernandez Valverde et al., 2012, Fernandez Valverde et al., in press). Ling heather, hare's tail cottongrass

Uncut but drying and degraded raised bog

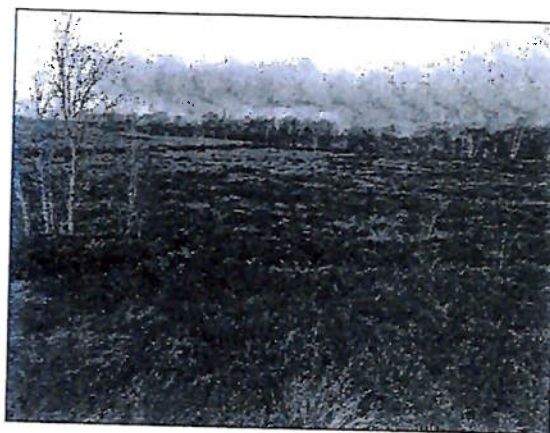
Most of the remnant bog was surrounded by cutover bog of varying ages. The most recent and actively cutover areas were mapped simply as **cutover bog (PB4)** (Figures 3-4). There were also areas of old cutover bog that have probably been cut by hand in the past. These have regenerated vigorous stands of ling heather with some hare's-tail cottongrass, and so have been mapped as **dry heath (HH1)**, according to habitat mapping guidance (Fossitt, 2000, Smith et al., 2011).

Dry heath vegetation on old cutover bog

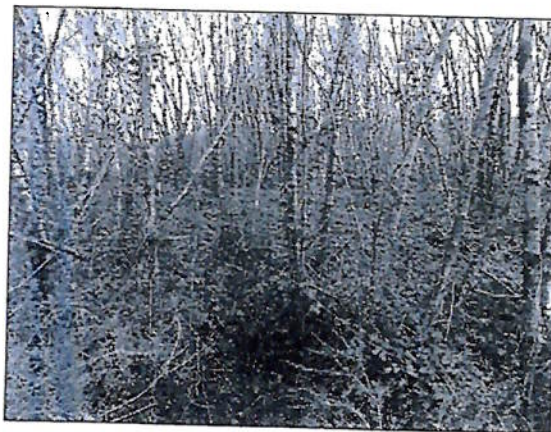
The majority of this part of the site was occupied by **bog woodland (WN7)** that has developed on the cutover. The woodland was a heterogeneous mixture of ages and species composition, depending on age and management. Birch was the main canopy species throughout, however, with bramble and bracken usually abundant in the field layer. Holly, rusty sally, ivy, broad buckler fern, *Kindbergia praelonga*, *Hypnum* species and *Polytrichum formosum* were also common. Different parts were

Bog woodland on cutover in north-east part of site

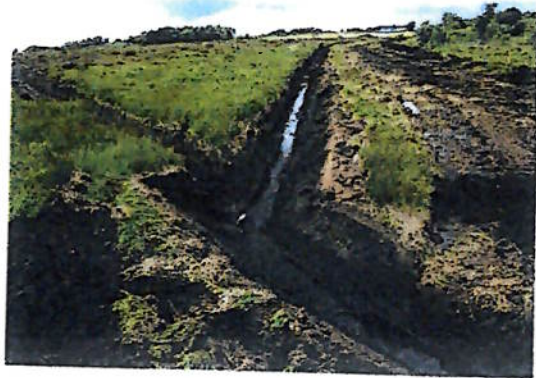
Picture 1

The drain through the lagg facing north with fen to the right and raised bog to the left. Other drains that run west to east across the peat harvesting area feed into this north flowing drain.

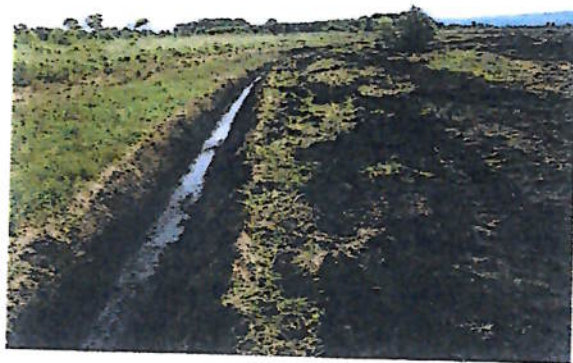
Picture 2

Facing south to the Laois Offaly border from roughly the same place the fen is now on left with the raised bog to the right. The Slieve Blooms are in the background.

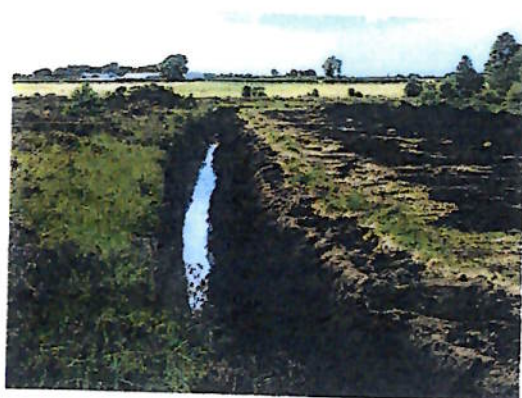
Picture 3

Looking north along the newly dug drain through the lagg with the fen on the right and the raised bog on the left. This area was totally undisturbed prior to recent drainage work. The drain turns left (west) when it meets the boundary with the field.

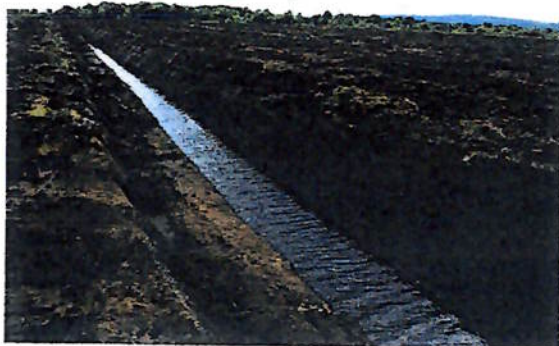
Picture 4

One of the new trenches that connects with the outer head drain and flows north through the lagg. Peat from this drain has been spread across the bog surface.

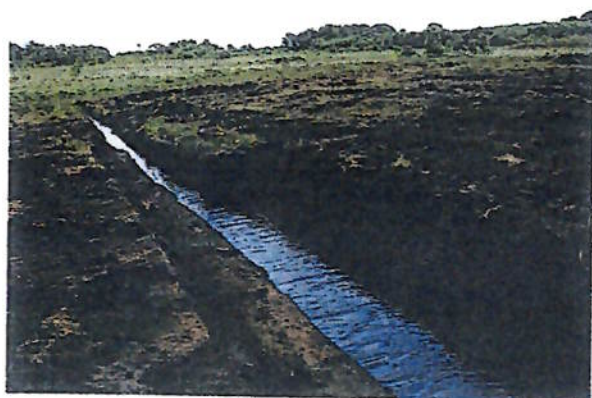
Picture 5

This trench from which peat blocks have been extracted connects with the drain through the lagg which is not visible here. The fen is in the background. At top left is woodland in the fen.

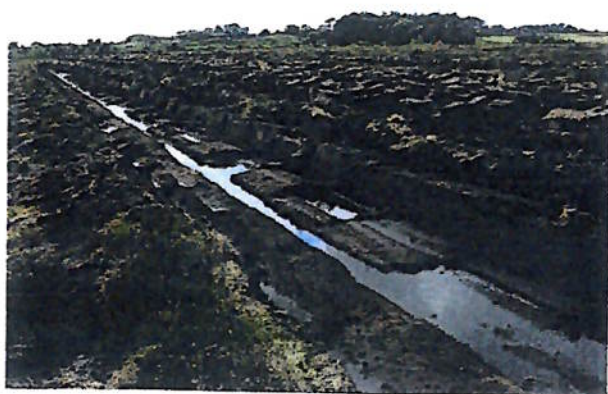
Picture 6

One of the trenches with stacked peat blocks. The view is to the west towards the quarry area.
