Re: Referral of Application for a Declaration of Exempt Development
Under section of Planning and Development Act 2000(as Amended) for
Development at Grangebeg , Dunlavin, Co Kildare, as contained within
Kildare Co Council Exempt Development File Reg Ref No ED 1130 .
Applicant: Mr Tom Moore . Grangebeg Dunlavin Co Kildare

**Application for Declaration of Exempt Development under Section 5,
of the Planning and Development Act 2000 as amended. Development at
Grangebeg , Dunlavin, Co Kildare W91AHC9. Applicant: Thomas Moore**

REPORT AND RECOMMENDATIONS IN RELATION TO RECENT FLOODING ON LANDS AT GRANGEBEG, DUNLAVIN, CO. KILDARE FOR TOM MOORE

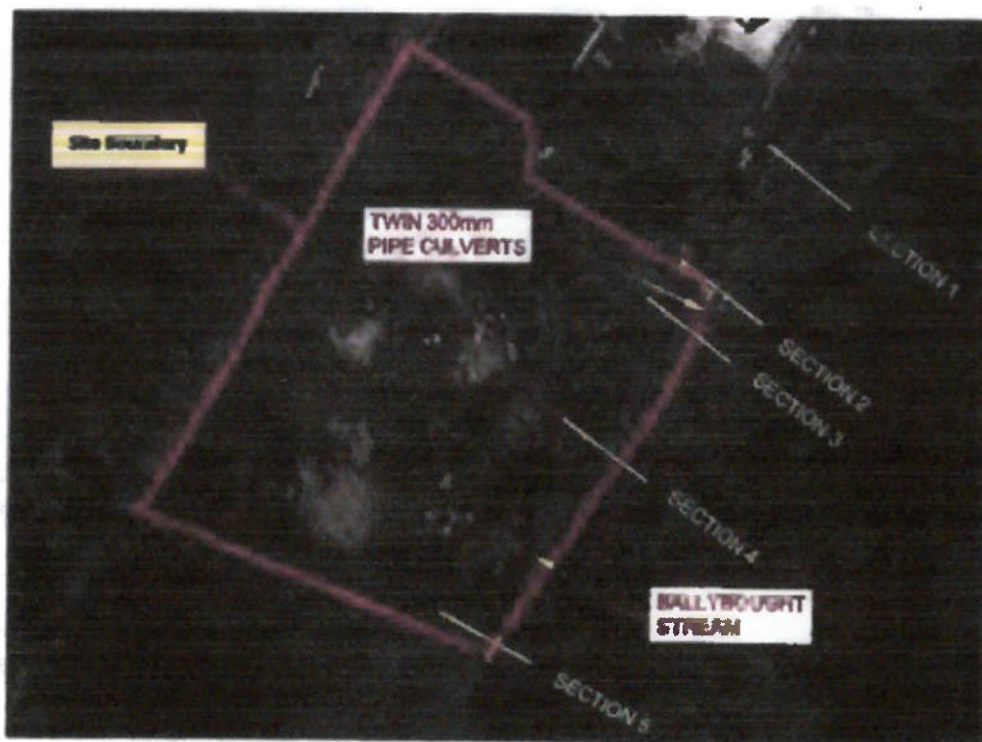
Figure 13 – Ballybought Stream

As illustrated in Figure 13 below, the Ballybought Stream flows as open channel watercourses adjacent to the eastern boundary of the proposed development site. The Ballybought Stream is conveyed via twin 300mm pipe culverts at the north-eastern corner of the site. A survey of the stream and culvert was undertaken on the 19th of July 2016. The watercourse channel was surveyed at the cross-sectional locations shown in Figure 13 below. The stream channel was observed to be free flowing and relatively free from any significant vegetation.

A total channel length of approximately 77m between Sections 1 and Section 5 along the stream watercourse channel was modelled as shown in Figure 13 above. The cross-sections surveyed were georeferenced and incorporated into the model together with the twin 300mm pipe culverts as shown in Figure 17 below. These pipe culverts were recently installed by Kildare County Council at this location.

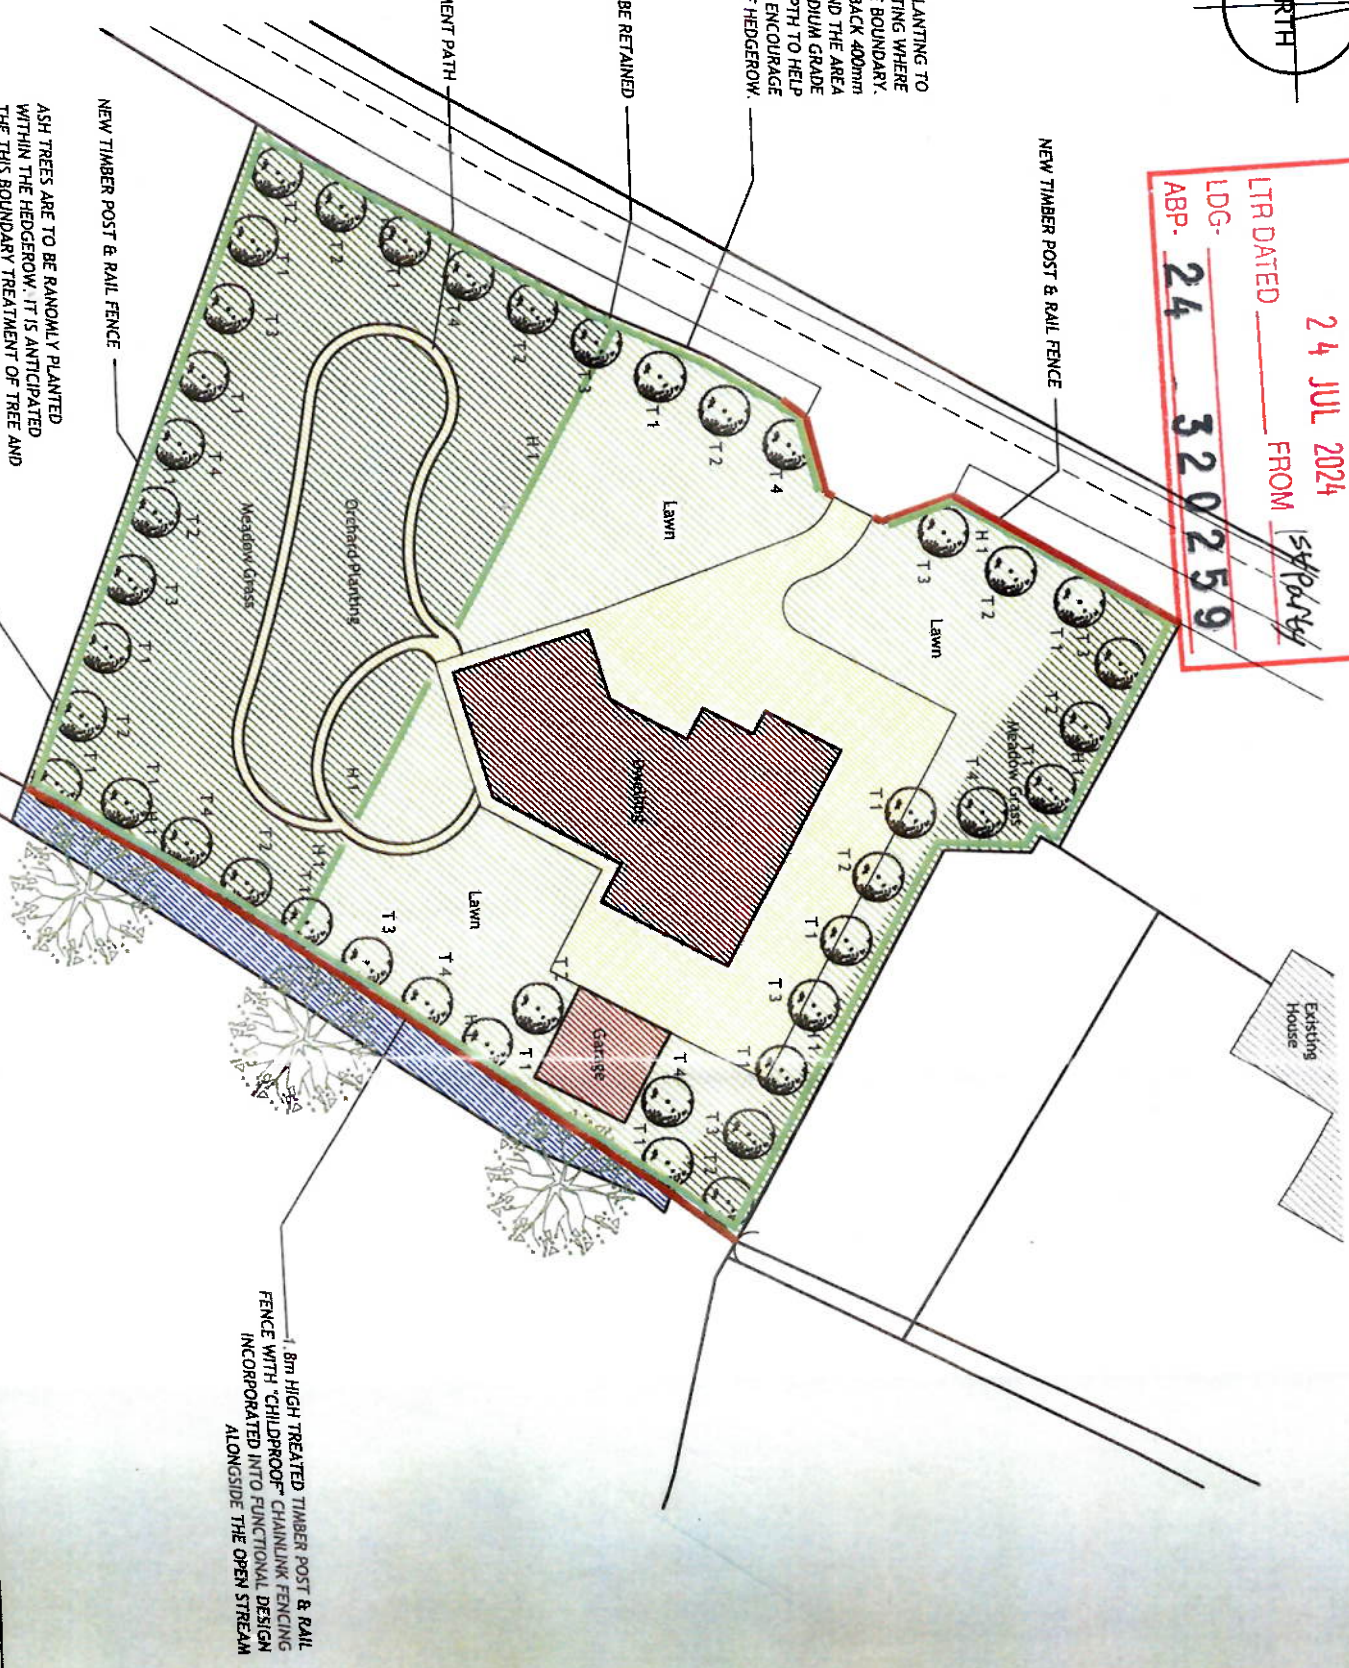
ASH TREES ARE TO BE RANDOMLY PLANTED WITHIN THE HEDGEROW. IT IS ANTICIPATED THE THIS BOUNDARY TREATMENT OF TREE AND HEDGEROW PLANTING REFLECTS THE FIELD BOUNDARIES IN THE SURROUNDING LANDSCAPE.

Furthermore, Condition No 4& 5 required landscaping details to be submitted to the planning department, for their approval, prior to commencement of development. The applicant lodged the Landscaping Plan. The Landscape Drawing, Ref Dr-178, received by the LA in compliance correspondence on 31 July 2017, is enclosed herewith and marked Map No 4, indicates 'the open stream', it is not just shown, but specifically referred to in the notes on that drawing ..Quote:
