Re: Declaration of Structural Design Failure
Site Ref: CK103 Wellington Rd. Exchange

NCI-Compliance Report

Site Name:	Wellington Road	Site ID:	TCK5225	Date:	13/03/2024
Issue Number	001

Our Ref: GH/Rp/P24116+ attachments (*.pdf)

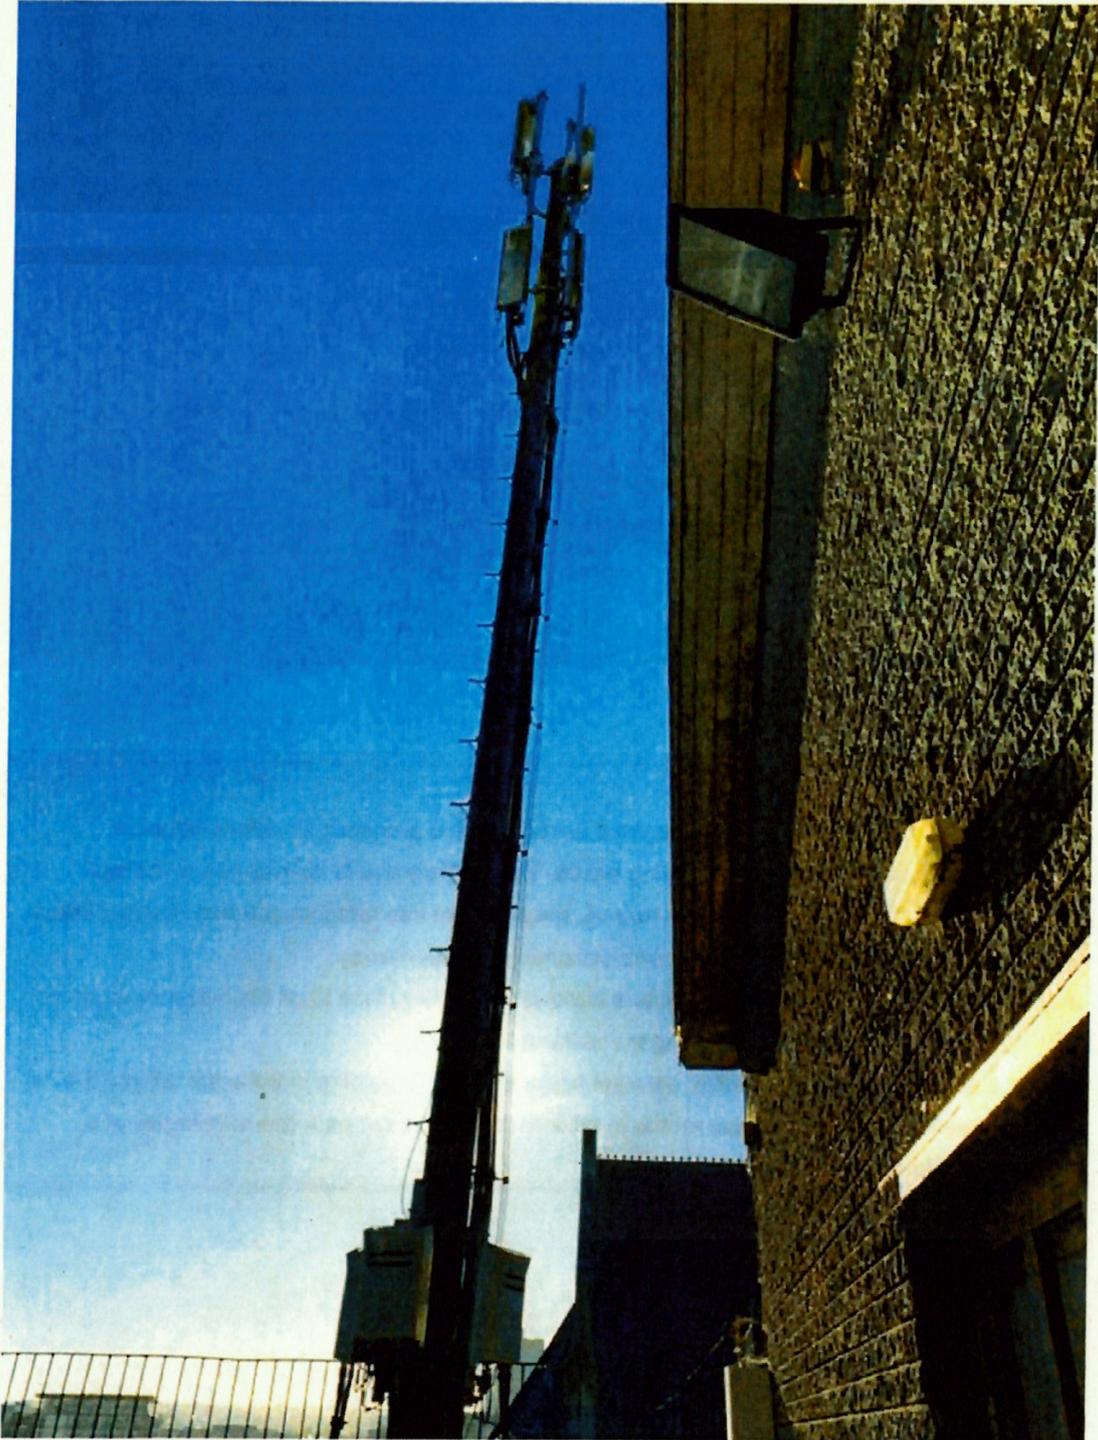
Tilt of structure towards the exchange building clearly visible. Wall of exchange building and the church tower in the background are used as references for what is level.

An in person structural survey has been carried out prior to the proposed Vodafone upgrade. The existing timer pole is no longer standing plumb. This is likely due to subsidence of the soil around the base of the structure. For this reason, the structure has failed and cannot accommodate any further equipment and should be decommissioned and taken away. Due to the precarious location of the structure base which is very close to an old masonry retaining wall no delay should be taken in removing the existing structure. A fall of the structure will likely result in damage to the exchange building or potential fall into the car park area/street. This will also cause rubble to fall into the church car park due to collapse of a section of the retaining wall.

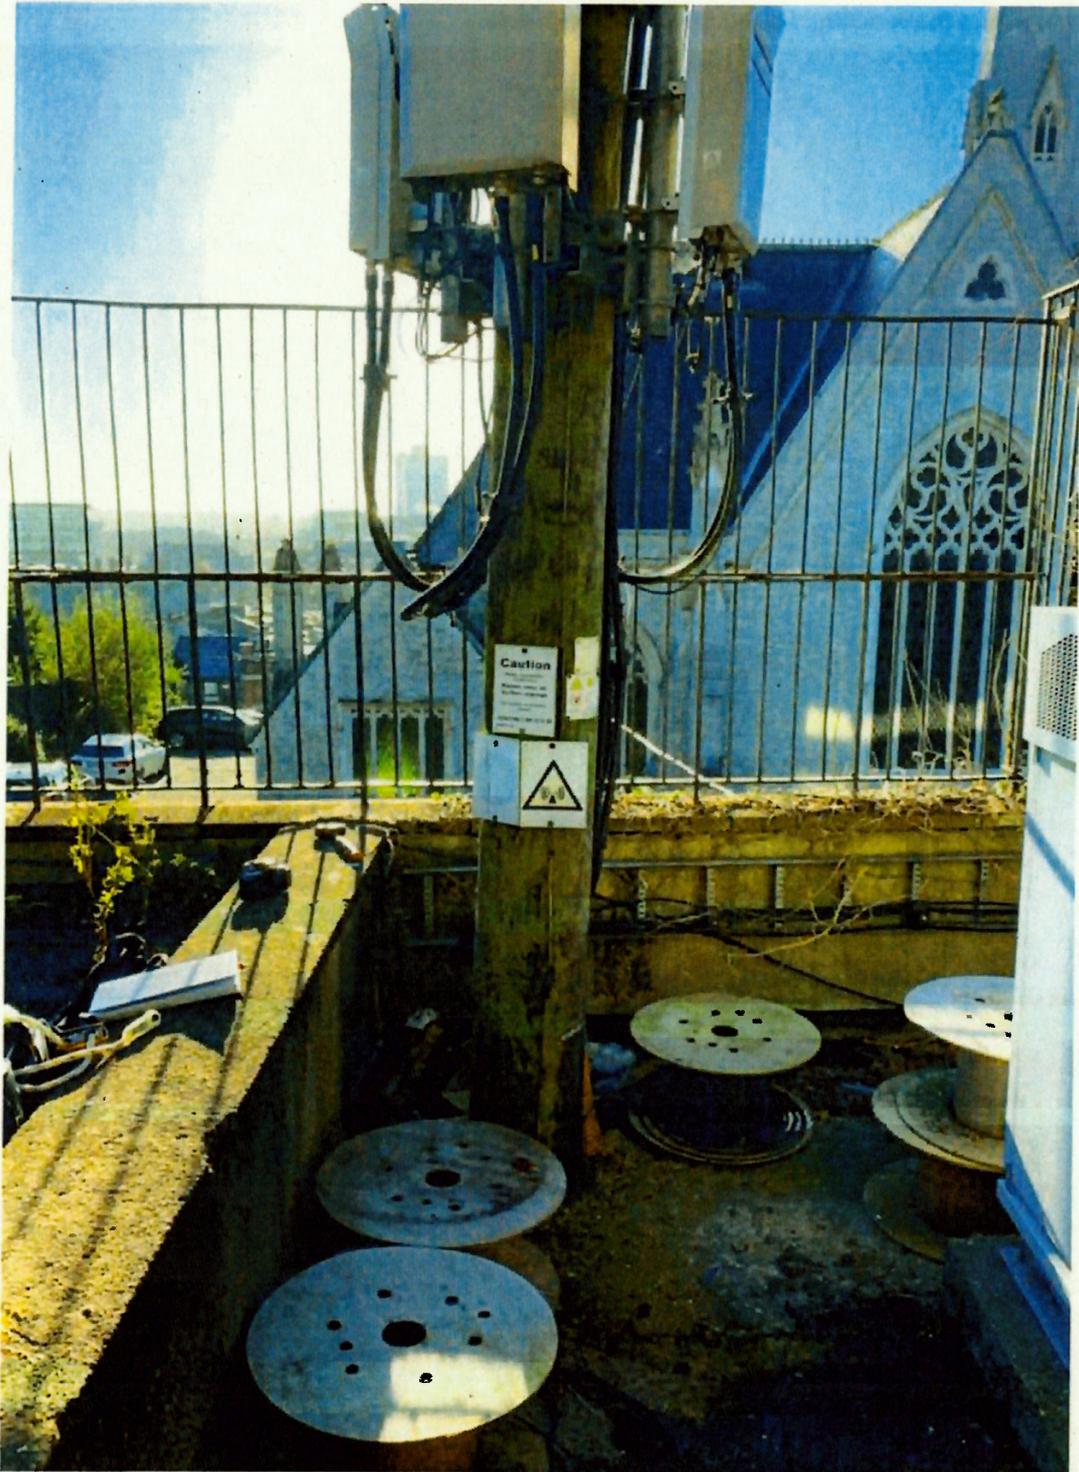
Area of retaining wall likely to fail and cause rubble to fall if structure fails and falls in the expected direction.

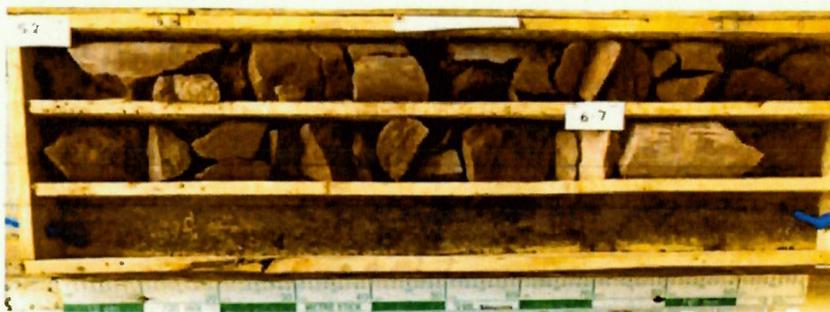
RC01, 5.2m

The Sandstone rockmass characterization has been established using the Rock Quality Designation, (RQD, Deere, 1964), Rock Mass Rating (RMR) using the Geo-mechanics System (Bieniawski, 1989). A review of the rock properties, strength (I_{s50} MPa), fracture spacing (60mm - 140mm) and condition (moderately weathered, rough surfaces, close-medium spaced), Rock Quality Designation (RQD10%) and groundwater (assumed 'dry'); was undertaken. The rockmass rating, RMR 41 - 46 indicating Class III fair, medium strong LIMESTONE rockmass.

Location	Rock mass rating, RMR	Class	Friction, ϕ^0	Cohesion, kPa	Point load index, MPa
RC01	41 - 46	III	25-28	200 - 230	4.3

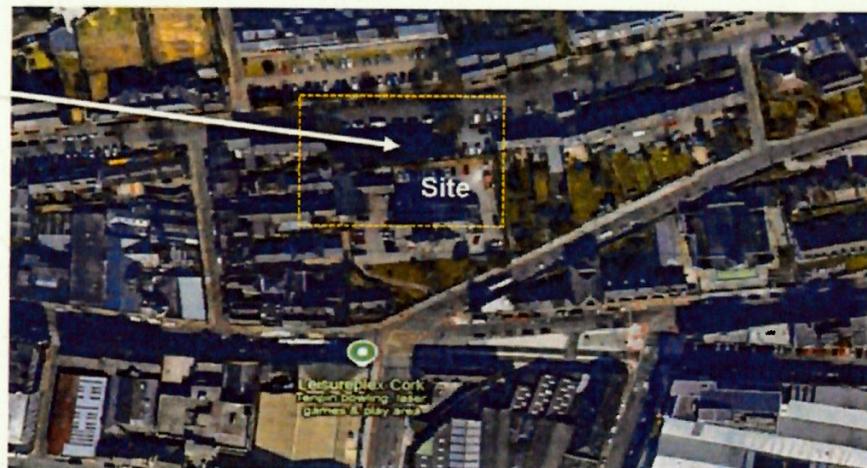
A site map and details of monitoring locations and instrumentation are included in Appendix 1 of this report. The below image is an overview of the site location and the general position of the instrumentation.

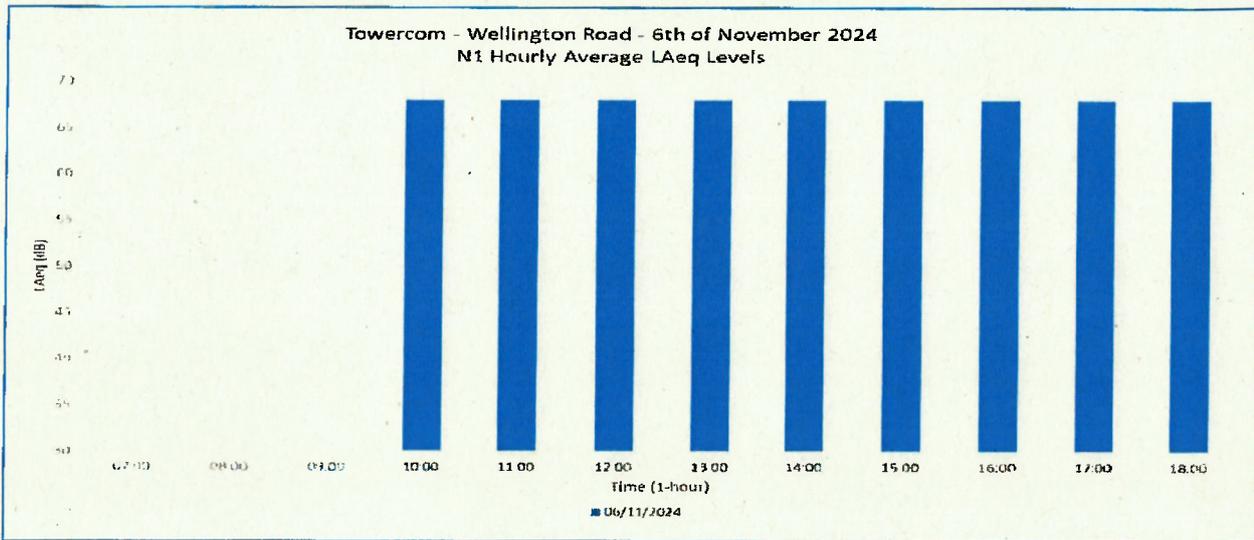
N1 – EIR Exchange, Wellington Road, Cork												
Hourly Average LAeq Levels dB (A)												
Date	07:00	08:00	09:00	10:00	11:00	12:00	13:00	14:00	15:00	16:00	17:00	18:00
06/11/2024				68	68	68	68	68	68	68	68	68
07/11/2024	63	63	63
