NOVEMBER 2020 PEATSLIDE ENVIRONMENTAL REPORT

Environmental Report

November 2020 Peat Slide at Meenbog Wind Farm, Co. Donegal and subsequent Restoration and Remediation Works

Client:	**Planree Limited**
Project Title:	**November 2020 Peat Slide at Meenbog Wind Farm, Co. Donegal and subsequent Restoration and Remediation Works**
Project Number:	**220623**
Document Title:	**Environmental Report**
Document File Name:	**220623_Environmental_Report F - 2024.03.29**
Prepared By:	**MKO** **Tuam Road** **Galway** **Ireland** **H91 VW84**

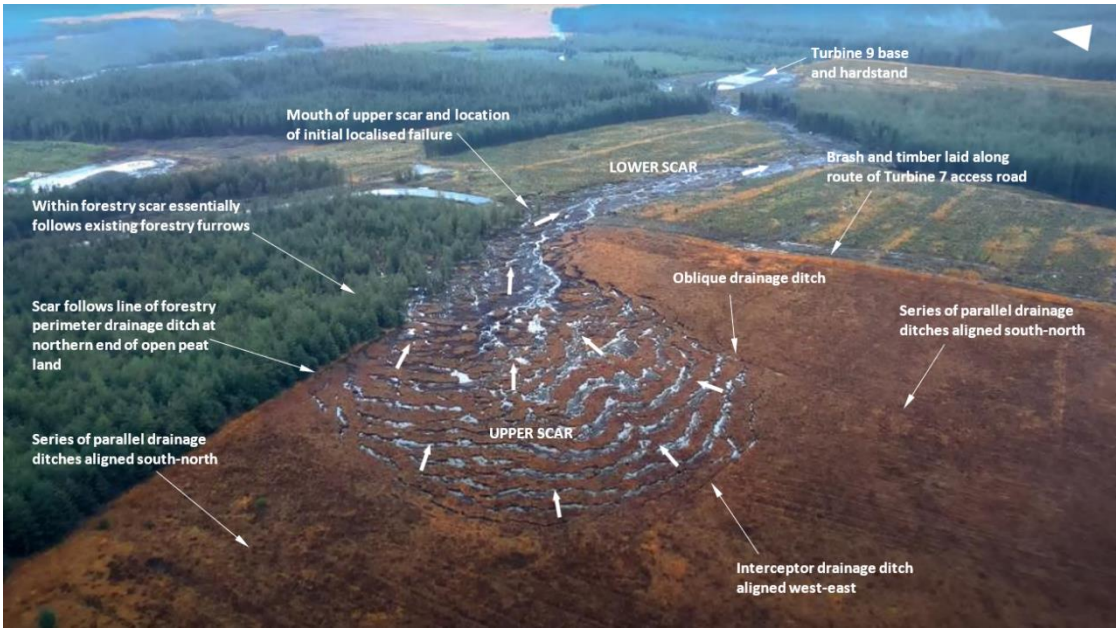
Figure 1 Extent of peat failure of 12 November 2020

The three distinct parts of the peat failure are shown in Figure 3.1, which should be viewed when reading the description below.

1. *Upper scar. This comprised the primary source area of the failed material. The upper scar was about 260m long by up to about 120m wide. The head of the failure scar was within open peat land. The southern part of the scar was also within open peat land. The northern part of the scar was within forestry plantation.*

The pattern of displaced peat within the upper scar forms a series of concentric rafts that have moved laterally and downslope towards the mouth of the scar (Figure 3.2). The concentric rafts have to varying degrees partly detached and moved downslope but would have had insufficient inertia to exit the upper scar. These concentric rafts provide a buttressing effect to the peat behind, and effectively support the side-wall of the upper scar. Typically 1 to 1.5m of vertical exposed peat face is observed. The upper scar forms a saucer shape with the width of the downslope mouth (bottleneck) much narrower (about 43m) than the maximum scar width (120m). This gives a ratio of mouth to maximum width of about 0.17.

2. *Lower scar. This comprised a secondary source area of the failed material. The lower scar is rectilinear and essentially follows the slope gradient (Figure 3.2. The lower scar was about 260m long by about 43m wide. The head of the lower scar is taken at the downslope mouth of the upper scar and essentially coincides with the upslope boundary of a recently felled forestry plantation. The lateral perimeter of the scar essentially follows the existing forestry furrows. The estimated total area of the lower scar is about 1.18ha.*

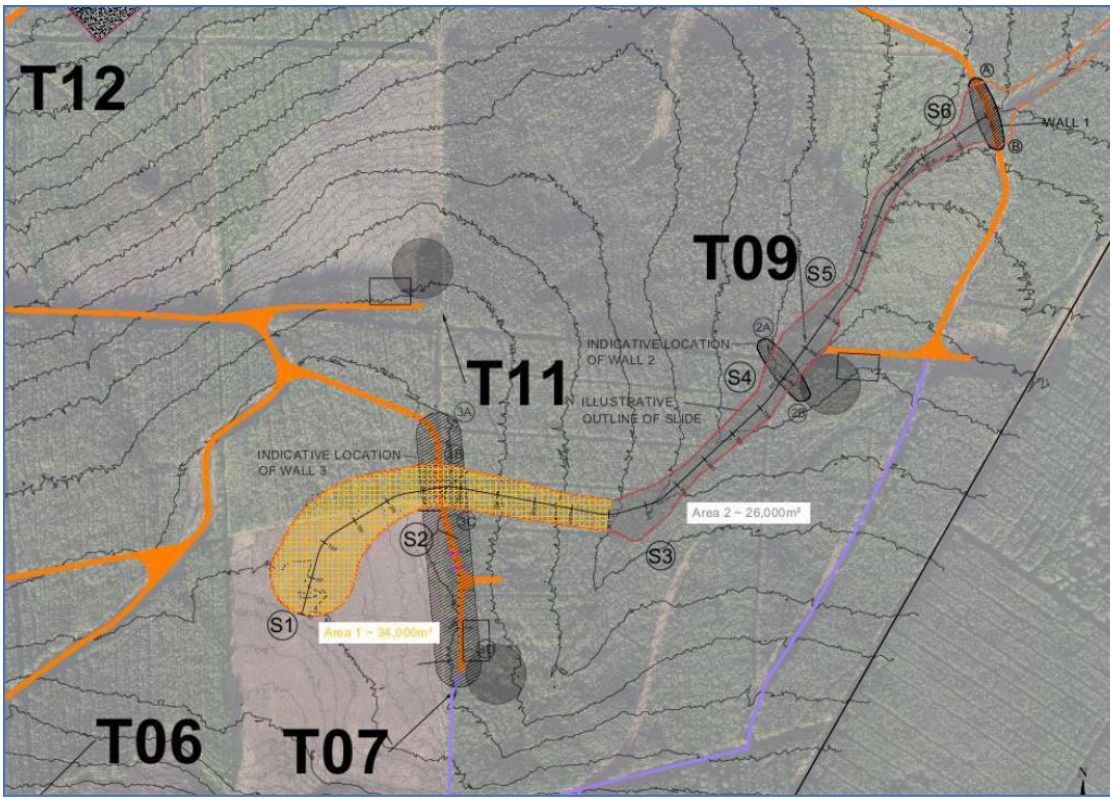
Figure 3 Emergency works area overview map

The first stage was the immediate response within the first 24-72 hours which consisted of emergency measures to prevent further material from entering local watercourses.

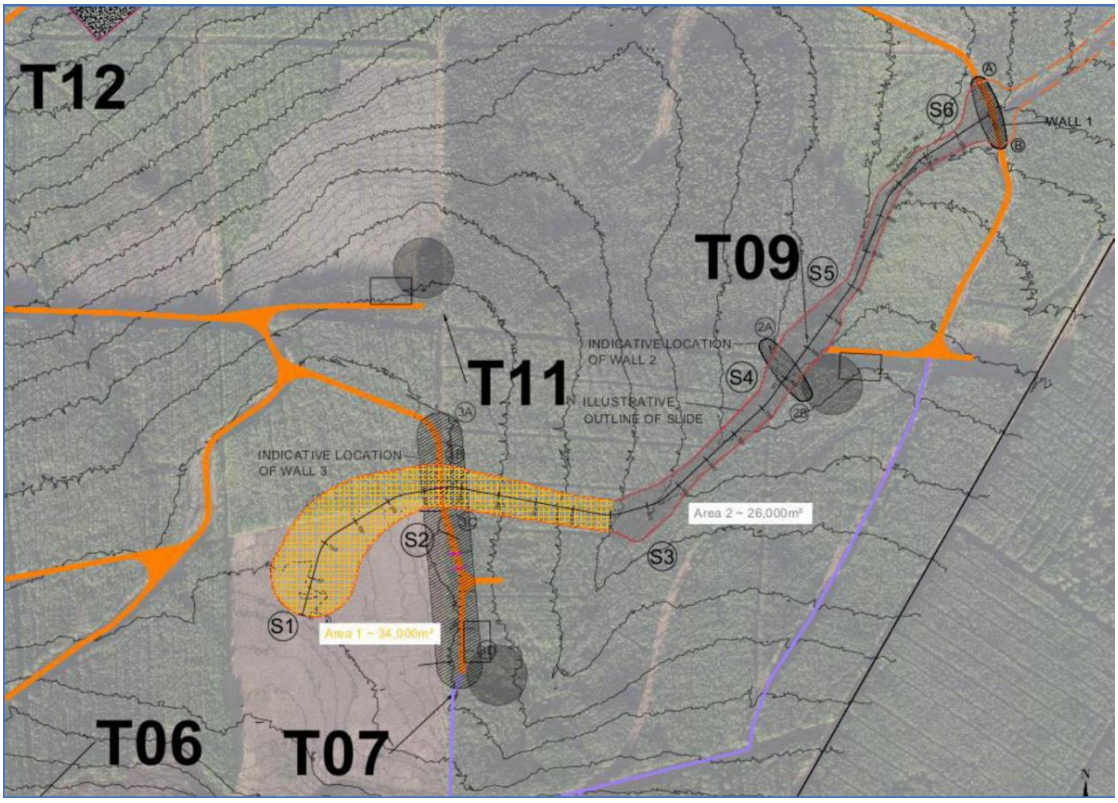
Figure 2.1 Overview map of works area

As set out in the notice and in line with section 6.1.5 of the project Construction and Environmental Management Plan ("CEMP"), we can confirm that following the peat slide on 12th Nov 2020, all construction works were ceased on the wind farm site as soon as notice of the incident was provided to site management. The only activities undertaken were those works required to ensure construction areas were left in a safe condition. Once all personnel on site had been safely accounted for, available resources were then immediately re-directed towards mitigating against further discharges to watercourses. The response to the peat slide can be split into stages which are set out below.

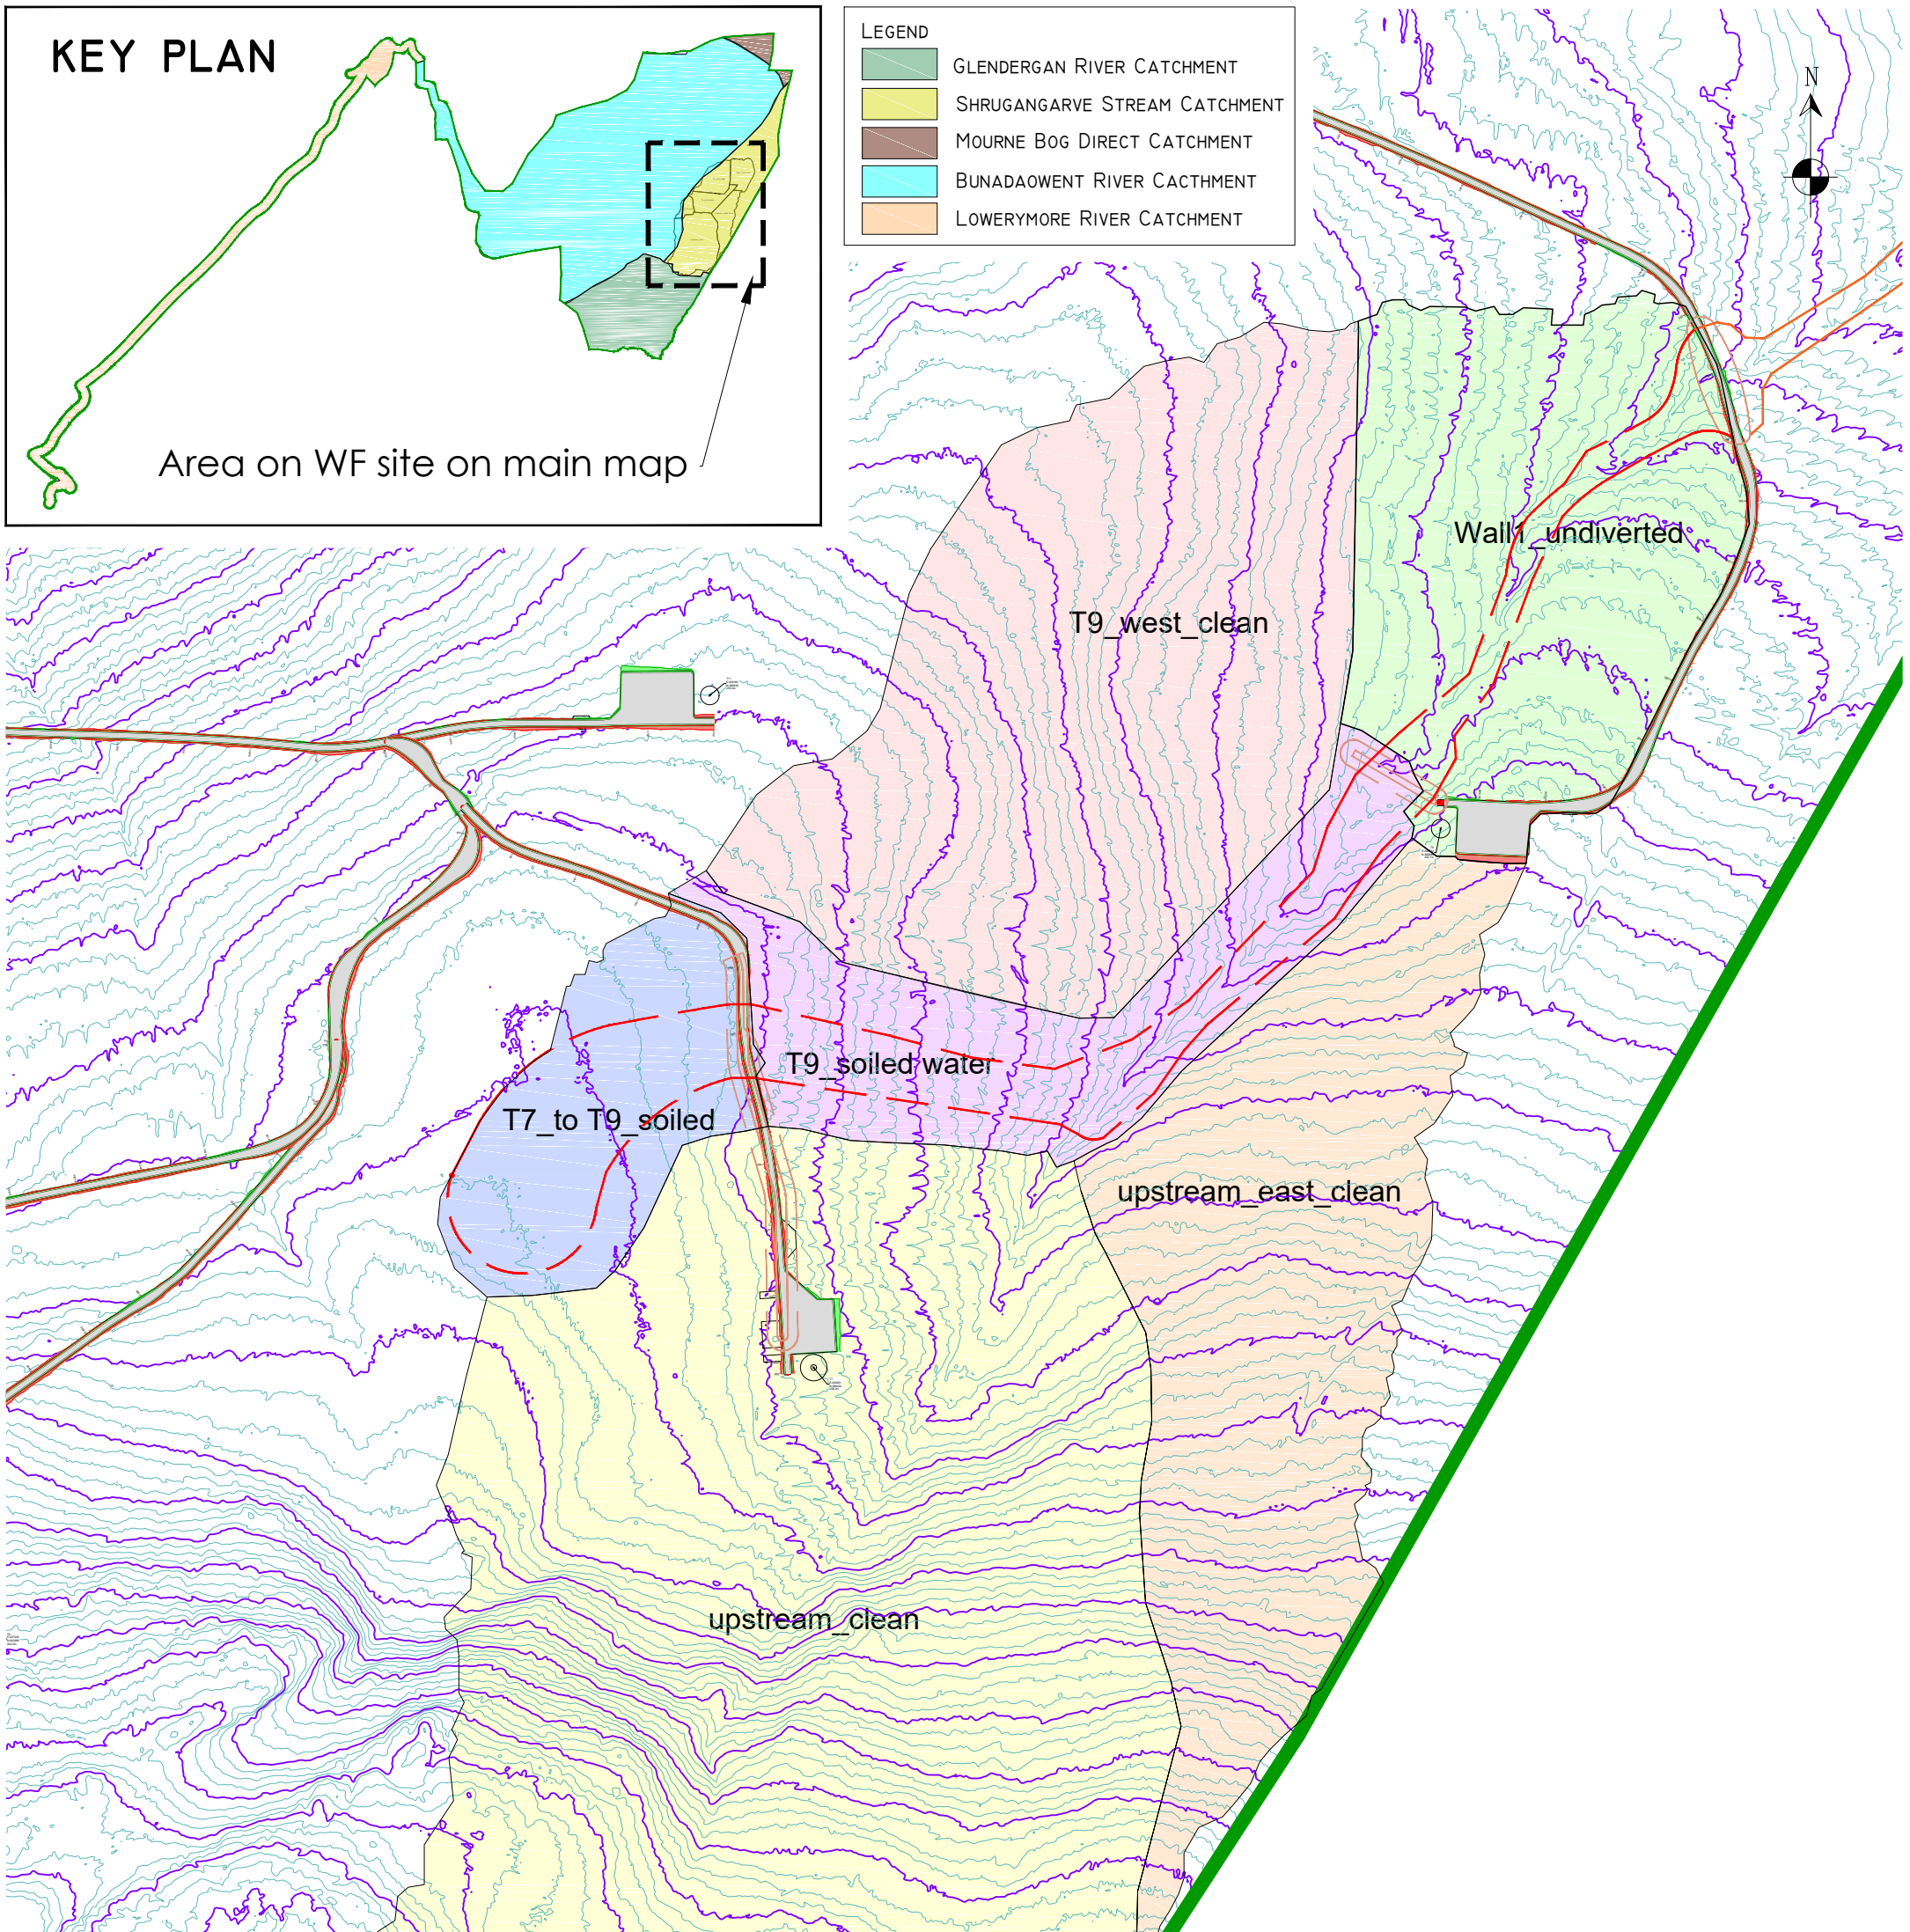
Figure No: P1249-5_D101

Note on Drawing Status:
This drawing represents the approximate catchment areas based on site inspections completed during week beginning 30th November 2020.

Wall1 Total catchment area			0.851	km²	100%		85.1	Ha
Potential clean areas								
upstream_clean	0.375	km²		44%			37.5	Ha
upstream_east_clean	0.123	km²		14%			12.3	Ha
T9_west_clean	0.155	km²		18%			15.6	Ha
			0.654	km²	77%			
Soiled Areas								
T9_soiled	0.058	km²		7%			5.8	Ha
T7toT9_soiled	0.043	km²		5%			4.3	Ha
Wall1_undiverted	0.155	km²		12%			9.9	Ha
			0.200	km²	23%

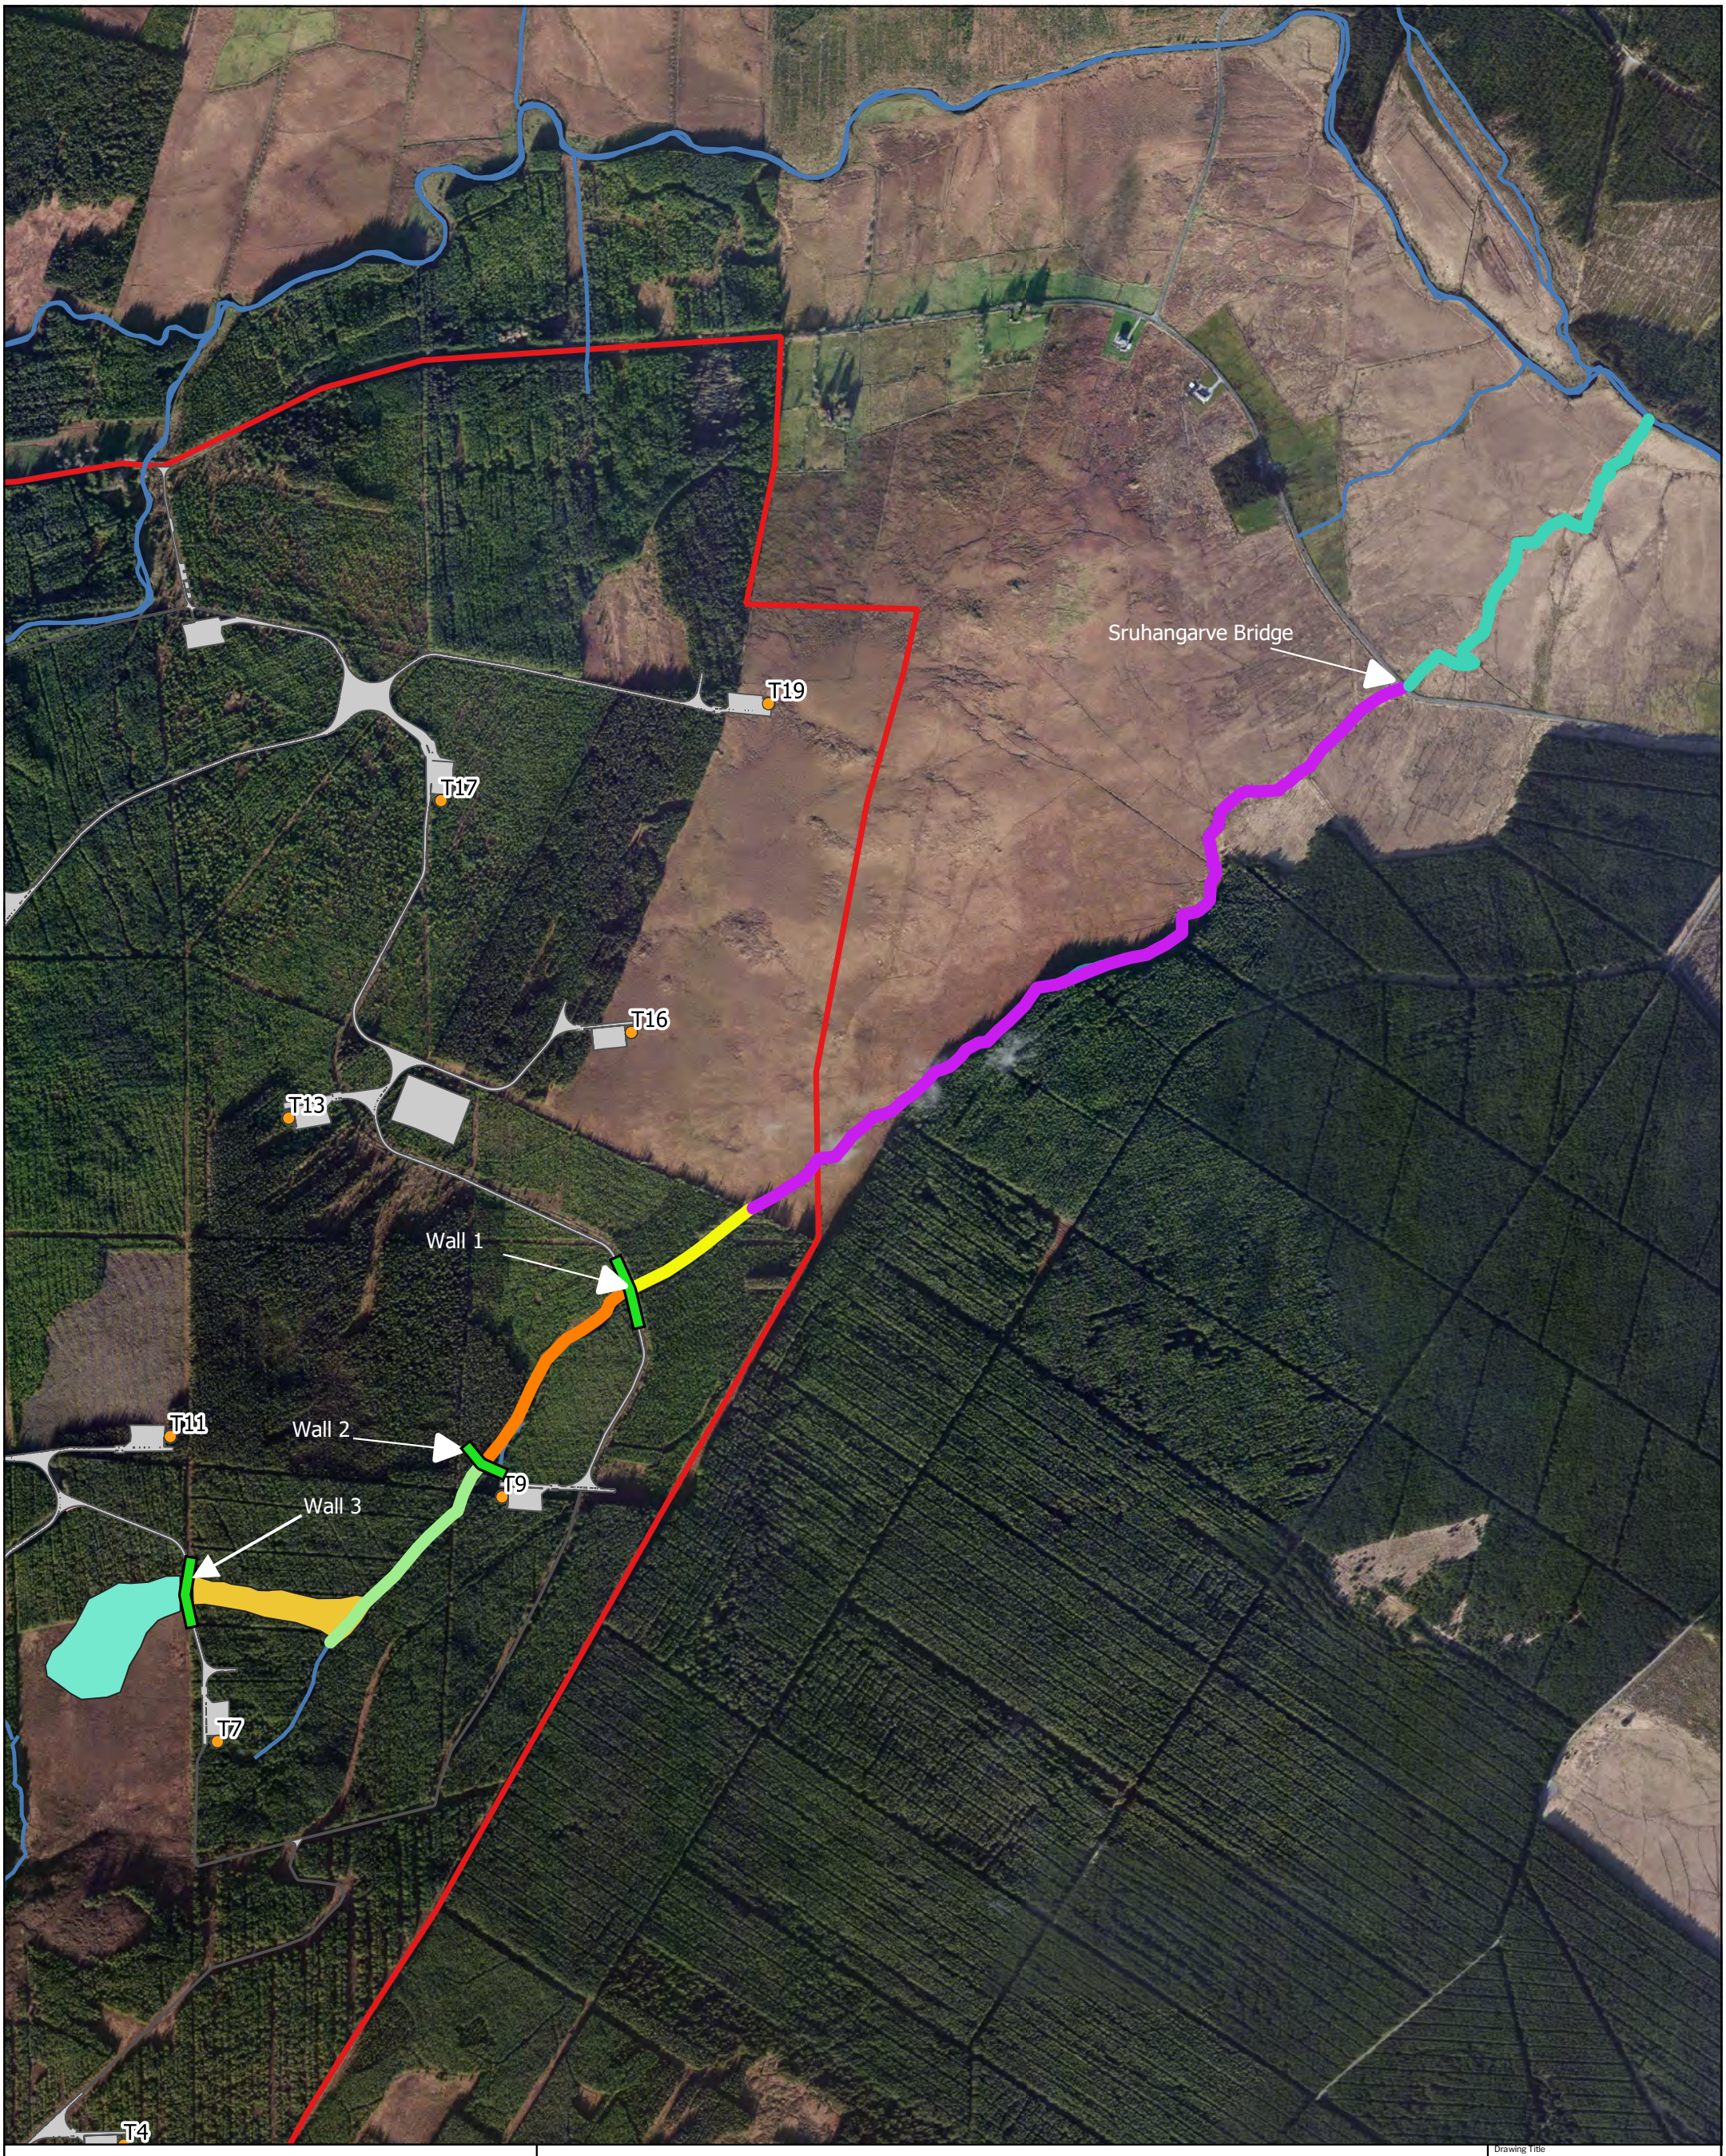
Drawn By	Checked By
TJB	BK
Project No.	**Drawing No.**
201174	Figure 5.1
Scale	**Date**
1:10000	18/11/2020

For the purposes of describing the recommended water quality protection measures, Figure 5.1 has been prepared which divides the Shruhangarve stream into five sections or reaches, and these reaches will be referred to further below.

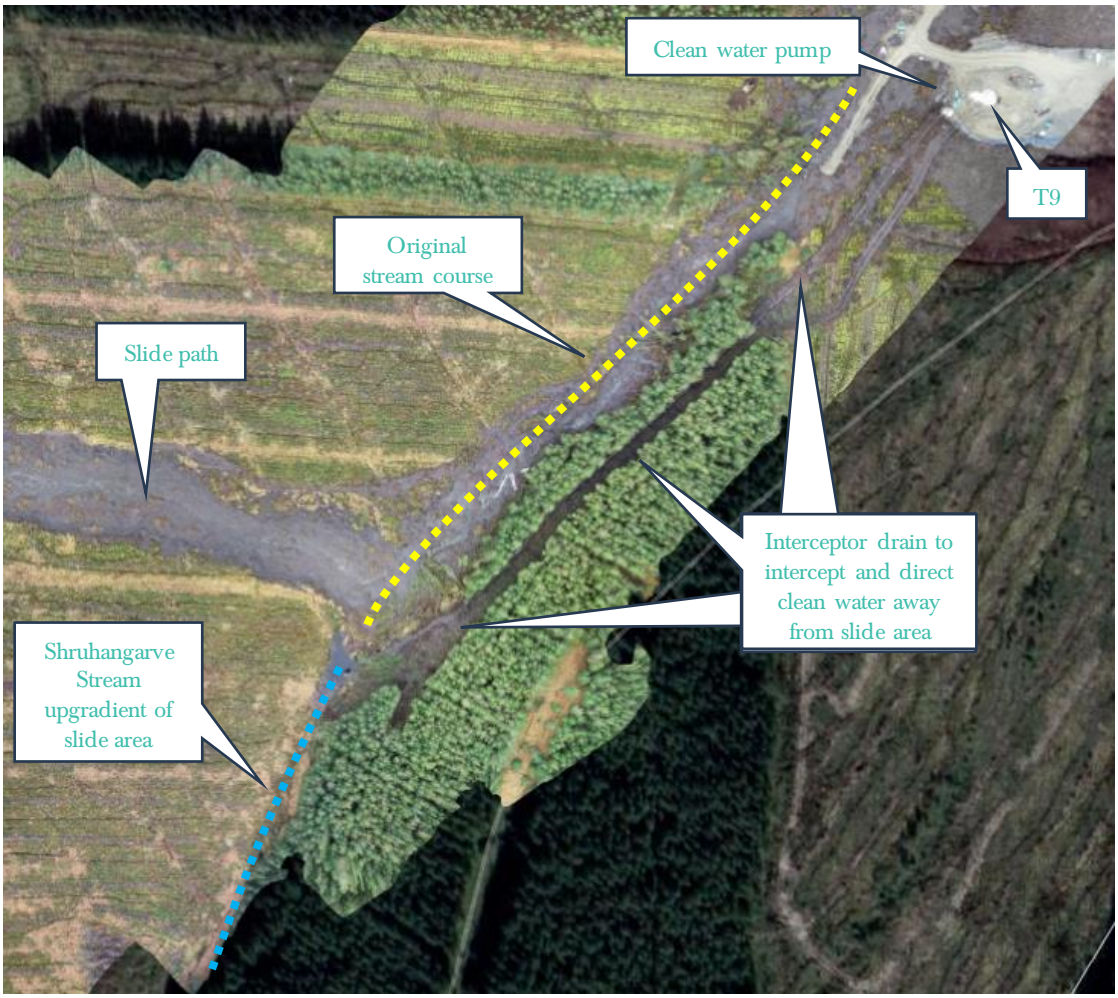
Figure 5.4 Aerial view of Stream Reach 1, showing interceptor drains collecting clear water for pumping around peat slide area

Large volumes of clean water are already being successfully intercepted upstream of the peat slide area on the Shruhangarve stream as a result of the emergency works now substantially completed on site, and are being prevented from reaching the peat slide area and becoming entrained with sediment, see Figure 5.4 below. Further volumes of clean water are being intercepted as overland flow, and prevented from reaching the peat slide area and becoming entrained with sediment. The more "clean" water that can be intercepted upstream or upgradient of the peat slide area, the less water will become soiled. Intercepting as much clean water as possible and diverting or pumping it to the downstream side of Wall 1 keeps that clean water clean and prevents that water mobilising further sediment or deposited peat sludge it might otherwise encounter.

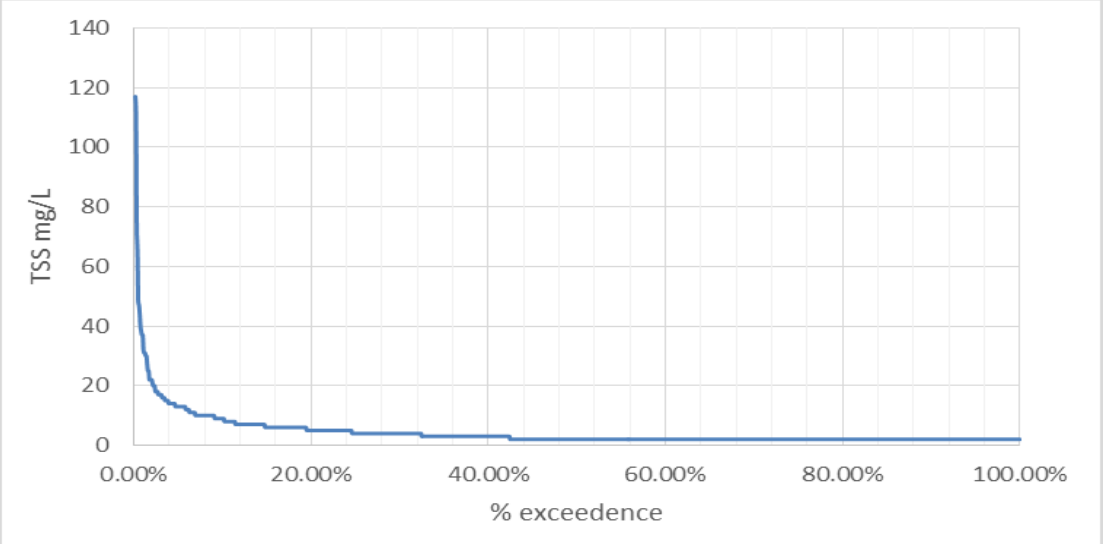
Figure 5.15. TSS treatment data using Siltbuster systems (with 3 stage chemical dosing).

1. Lamella plate clarifier system such as Siltbusters work very well in peatland environments when used in combination with 3-stage chemical treatment
2. Monitoring data indicate no carry-over of treatment chemicals in the post treatment discharge.

An example of treatment capability of Siltbuster systems from Corrib is provided in Figure 5.15. This is a duration curve of downstream water quality data post Siltbuster treatment. The system was setup so that any water not meeting discharge criteria was recycled back to the settlement ponds. The graph shows all data, and only 24 treated water (discharge water) data points out of 1194 records were above 20 mg/L (i.e. recycling occurred at these times).

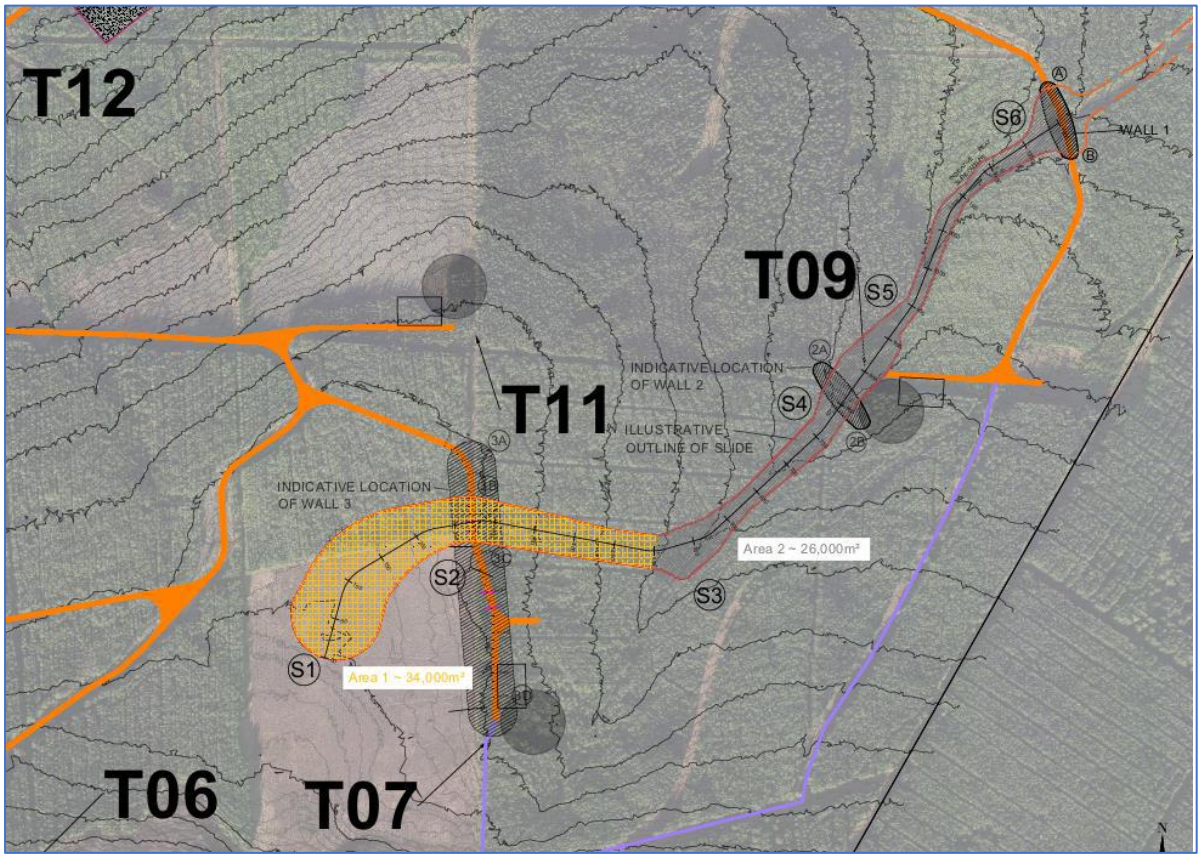
Figure 1 – Overview map of works area

It was evident that majority of the material that slid was deposited between points S3 and S6 shown on Figure 1 above, largely because of the shallower gradient and also by the existing roadway leading to turbine no. 9 (T9). This unstable, water-laden material presented the most immediate risk in terms of pollution of watercourses with the concern that the roadway could be overtopped by material being retained to the South. This risk was exacerbated by the fact that the slide material had entered the local stream (at approximately point 'S3' in Figure 1) and water from the surrounding catchment entering the stream would be retained behind the roadway (identified as 'Wall 1' in Figure 1). A secondary risk in terms of immediate further pollution of watercourses was the risk of additional movement of material from the area upslope of the slide initiation point (to the South and west of point 'S1' in Figure 1.

Works commenced at the roadway to T9 (referred to as Wall 1 in Figure 1 above) on the afternoon of the 12th November 2020 as soon as an inspection had been conducted to ensure it was safe for personnel to work in the area. It was not possible to produce a detailed design in this timeframe given the need for immediate action however the proposed works were reviewed and progressed in consultation with the Designer Ionic Consulting. The initial aim was to raise the berm by 1.5m-2m for a length of approximately 100m along the area retaining the slide, this was further raised over the following days by up to 3.8m from the original design level.

The detailed geotechnical assessment undertaken in step 2 identified the risk of further peat movement upslope of the slide initiation point in the peatland area (refer to point S1 in Figure 1) was still significant. Two other points for further check barrages were identified, denoted as 'Wall 2' and 'Wall 3' in Figure 1 to mitigate against this potential risk. Access for construction of Wall 2 would be from the hardstanding at T9 and access for Wall 3 would be from the last section of road constructed to solid formation on the approach to the turbine 7 (T7) location. Wall 3 was prioritised for the following reasons:

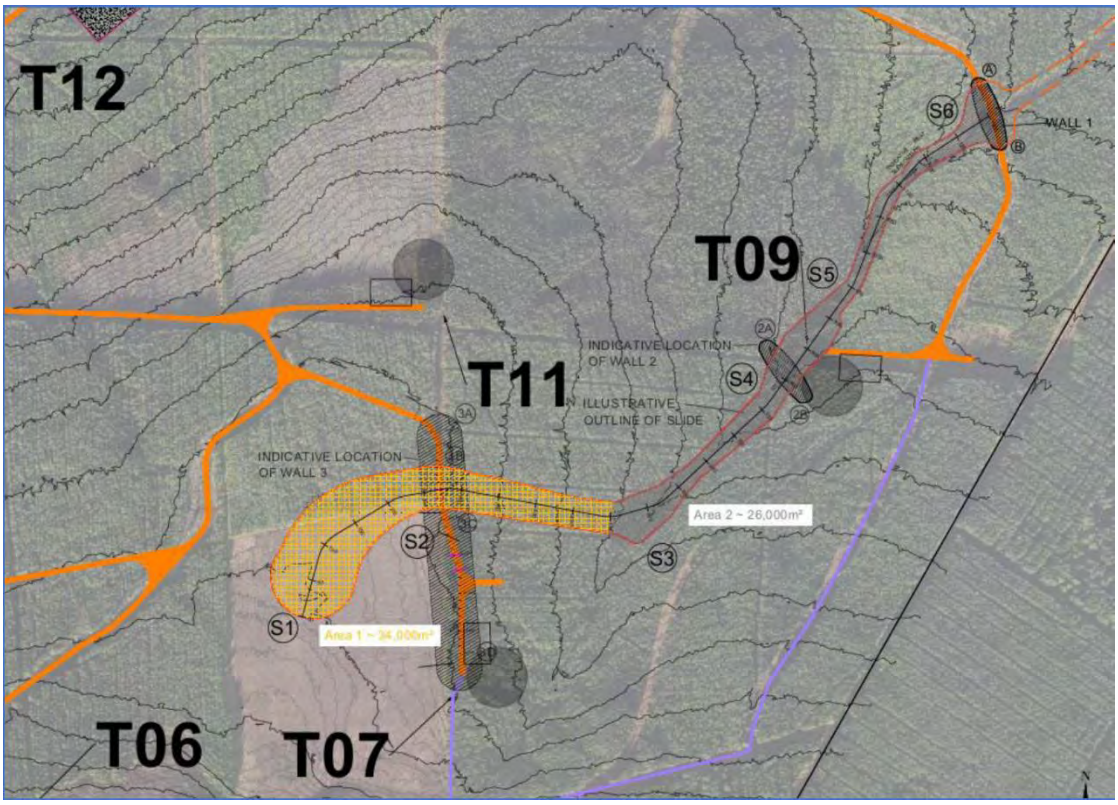
Figure 2.1 Overview map of works area

As set out in the notice and in line with section 6.1.5 of the project Construction and Environmental Management Plan ("CEMP"), we can confirm that following the peat slide on 12th Nov 2020, all construction works were ceased on the wind farm site as soon as notice of the incident was provided to site management. The only activities undertaken were those works required to ensure construction areas were left in a safe condition. Once all personnel on site had been safely accounted for, available resources were then immediately re-directed towards mitigating against further discharges to watercourses. The response to the peat slide can be split into stages which are set out below.

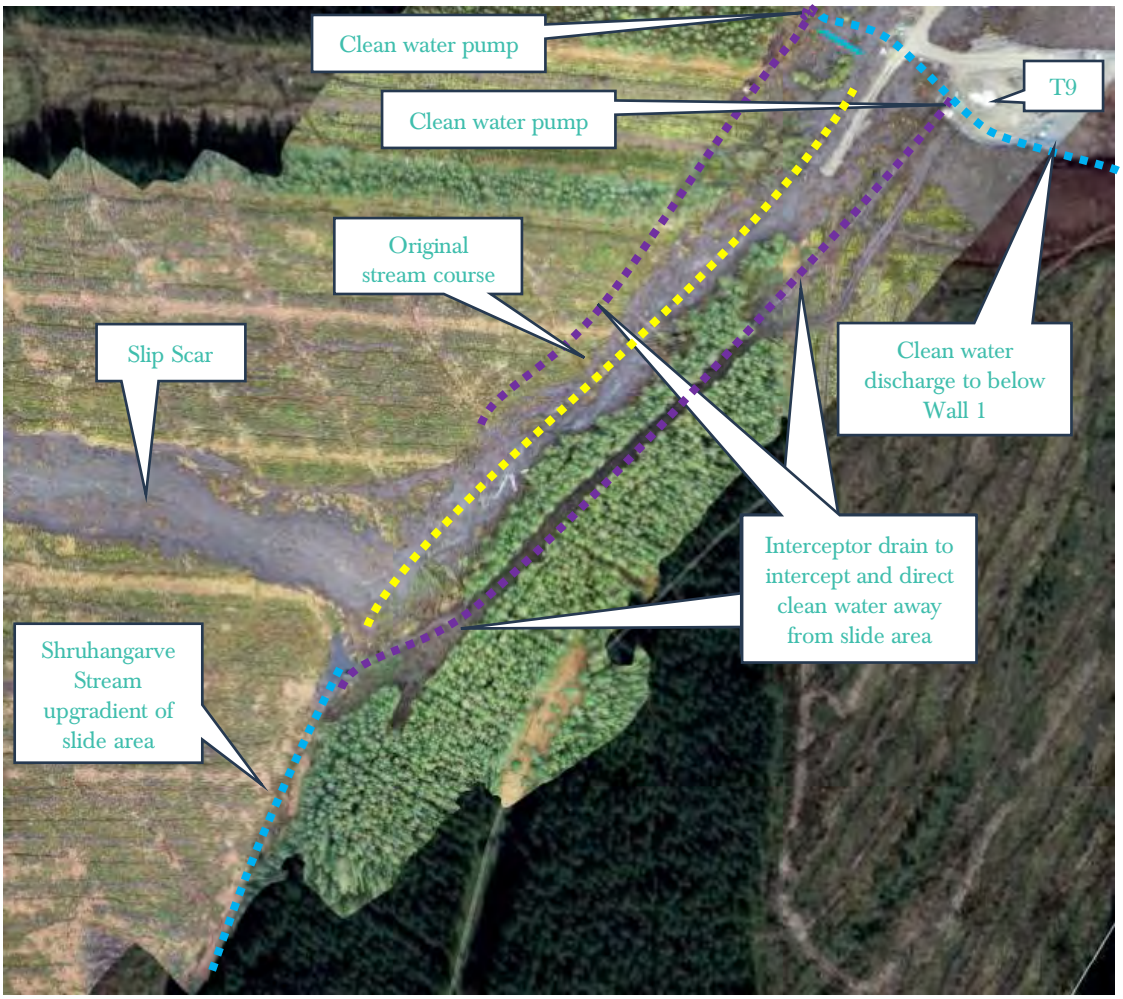
Figure 2.3 Aerial view of Stream Reach 1, showing interceptor drains collecting clear water for pumping around peat slide area

Large volumes of clean water are already being successfully intercepted upstream of the peat slide area on the Shruhangarve stream as a result of the emergency works now completed on site, and are being prevented from reaching the peat slide area and becoming entrained with sediment, see Figure 2.3 below. Further volumes of clean water are being intercepted as overland flow, and prevented from reaching the peat slide area and becoming entrained with sediment. The more "clean" water that can be intercepted upstream or upgradient of the peat slide area, the less water will become soiled. Intercepting as much clean water as possible and diverting or pumping it to the downstream side of Wall 1 keeps that clean water clean and prevents that water mobilising further sediment or deposited peat sludge it might otherwise encounter.

Analysis of the Shruhangarve catchment topography upstream of Wall 1 undertaken since the peat slide has divided it into "clean" and "soiled" sub-catchment areas, as detailed on HES Figure No. P1249-5_D101 included above. Clean water is being intercepted from the sub-catchment areas labelled as "upstream_clean", "T9_west_clean", and "upstream_east_clean" on HES Figure No. P1249-5_D101. Further efforts are considered likely to yield diminishing returns and may not be justifiable given the extent of further works required. Objectives of recommendations

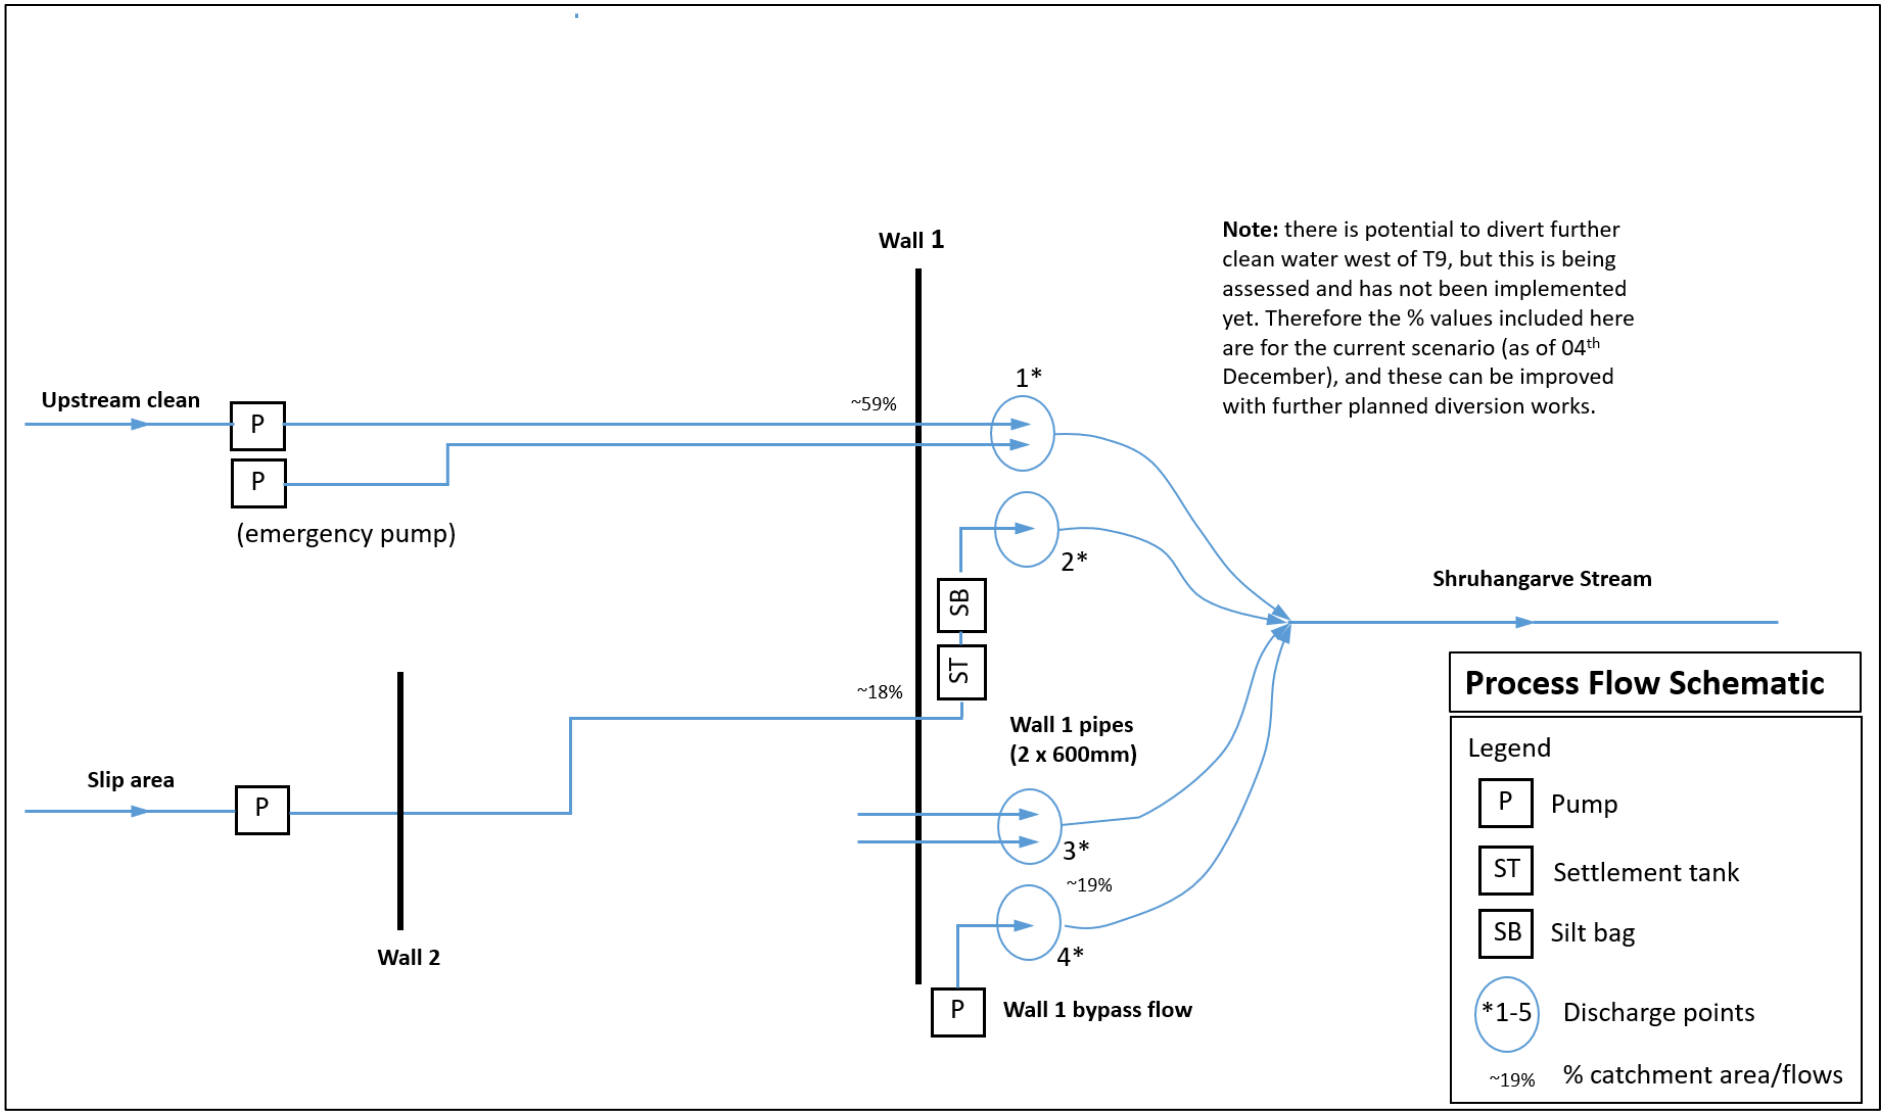
Figure 3.1 Flow diagram of current water flows and pumping arrangements on-site

At Wall 1, there are two further discharges. The first is overflow from the pond behind Wall 1, and this overflow occurs through 2 no. 600mm pipes (Discharge 2). As outlined above much of the runoff water from the catchment is being diverted around the pond upstream of Wall 1. The second discharge at Wall 1 is seepage flow through the southern (lower) end of Wall 1. This flow is captured in a sump downstream of Wall 1 and pumped laterally into the main channel of the Shruhangarve (Discharge 3). The purpose here is to prevent flows down through the forestry which could destabilise the peat there, and also remobilise some of the loose peat/sludge that coats the ground following the peat slide.
