NOVEMBER 2020 PEATSLIDE ENVIRONMENTAL REPORT

Environmental Report

November 2020 Peat Slide at Meenbog Wind Farm, Co. Donegal and subsequent Restoration and Remediation Works

Client:	**Planree Limited**
Project Title:	**November 2020 Peat Slide at Meenbog Wind Farm, Co. Donegal and subsequent Restoration and Remediation Works**
Project Number:	**220623**
Document Title:	**Environmental Report**
Document File Name:	**220623_Environmental_Report F - 2024.03.29**
Prepared By:	**MKO** **Tuam Road** **Galway** **Ireland** **H91 VW84**

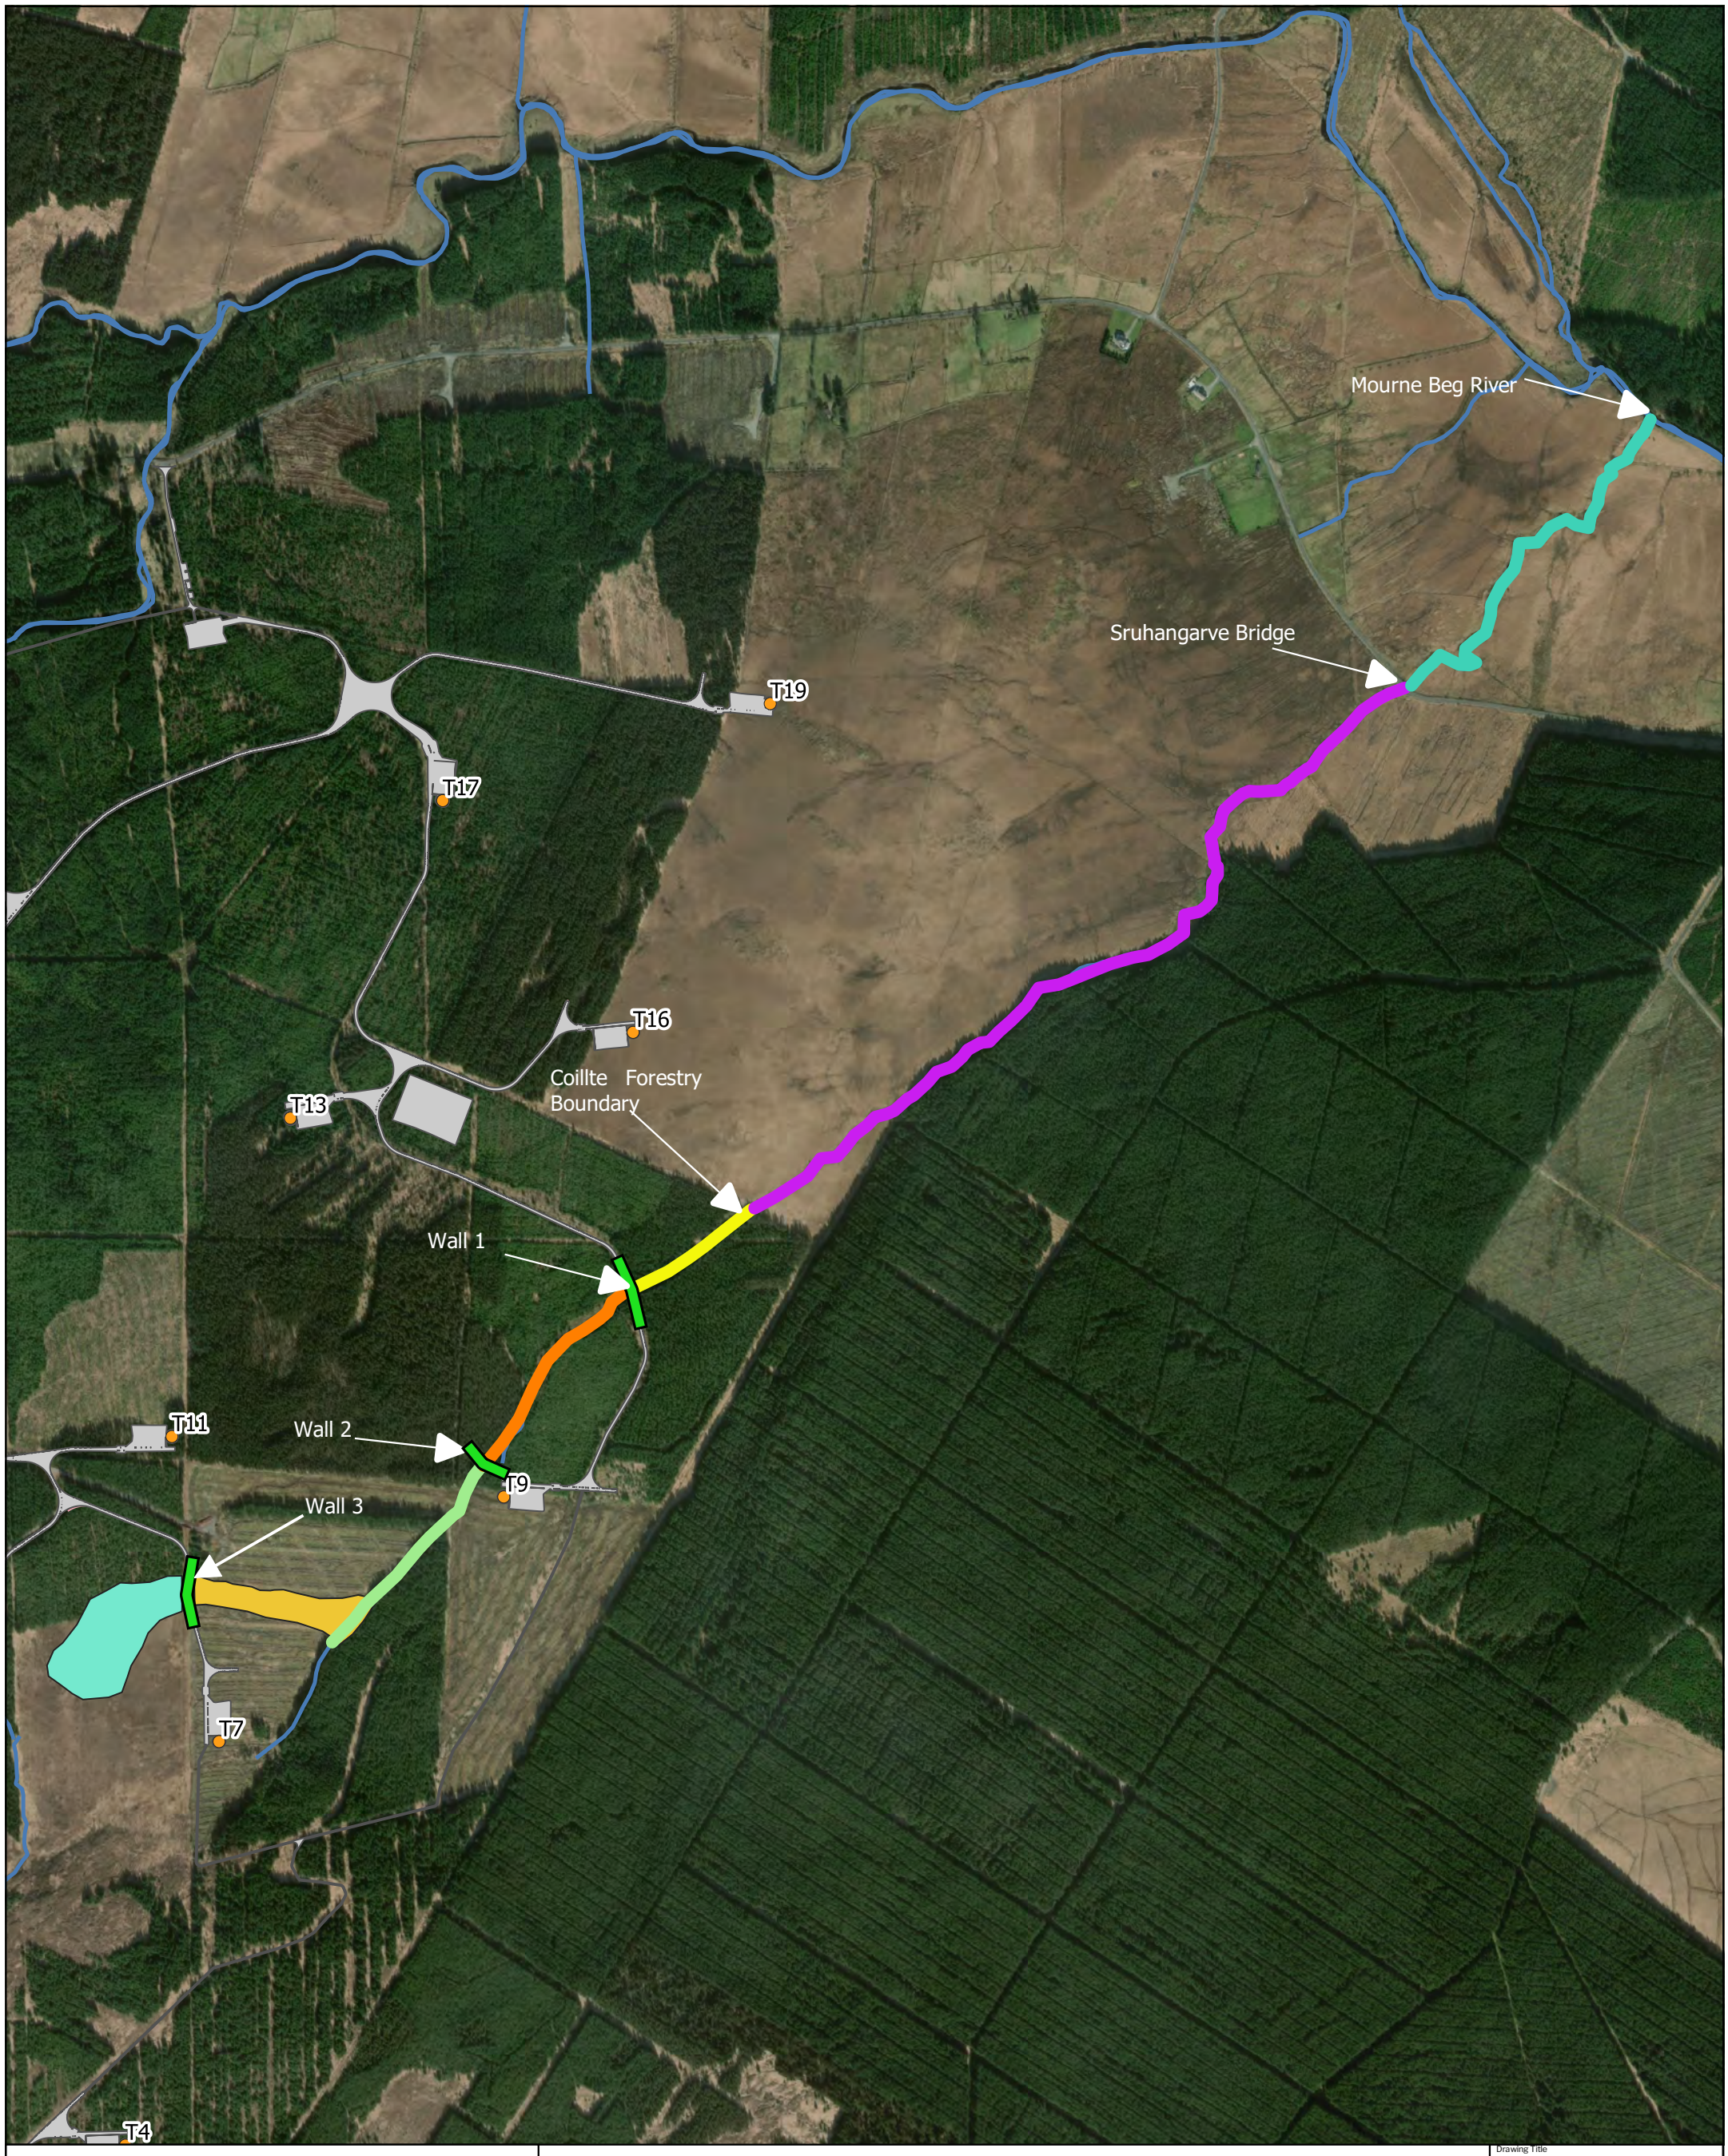
Drawn By	Checked By
TJB	BK
Project No.	Drawing No.
201174	Figure 5.1
Scale	Date
1:10000	12/03/2021

The peat slide resulted in the formation of a wide slip scar (as shown on Figure 5.1) downstream of Wall 3 and significant impacts on the Shruhangarve stream channel between the base of the slip scar and Wall 2. Whilst further works are required in following phases to restore the Shruhangarve stream channel, Phase 1A includes works that will assist in the stabilisation of the slip scar and the banks of the upstream of Wall 2.

For the purposes of describing the recommended water quality protection measures, Figure 5.1 has been prepared which divides the Shruhangarve stream into five sections or reaches, and these reaches will be referred to further below. The proposed water quality protection measures have been divided into two phases of work to allow for the implementation of some works while necessary studies and assessments are conducted for the future phases.

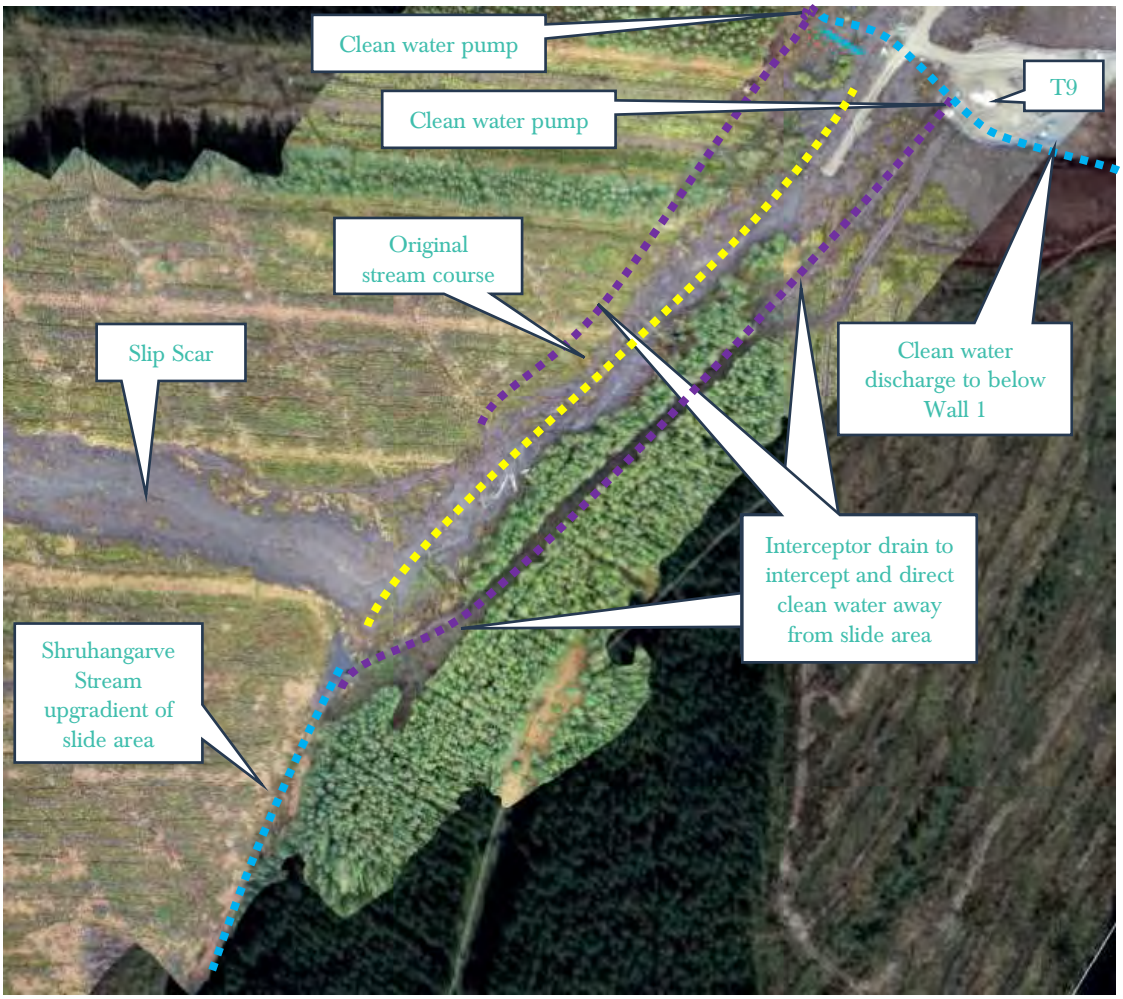
Figure 2.4 Aerial view of Stream Reach 1, showing interceptor drains collecting clear water for pumping around peat slide area

Large volumes of clean water are already being successfully intercepted upstream of the peat slide area on the Shruhangarve stream as a result of the emergency works now completed on site, and are being prevented from reaching the peat slide area and becoming entrained with sediment, see Figure 2.4 below. Further volumes of clean water are being intercepted as overland flow, and prevented from reaching the peat slide area and becoming entrained with sediment. The more "clean" water that can be intercepted upstream or upgradient of the peat slide area, the less water will become soiled. Intercepting as much clean water as possible and diverting or pumping it to the downstream side of Wall 1 keeps that clean water clean and prevents that water mobilising further sediment or deposited peat sludge it might otherwise encounter.

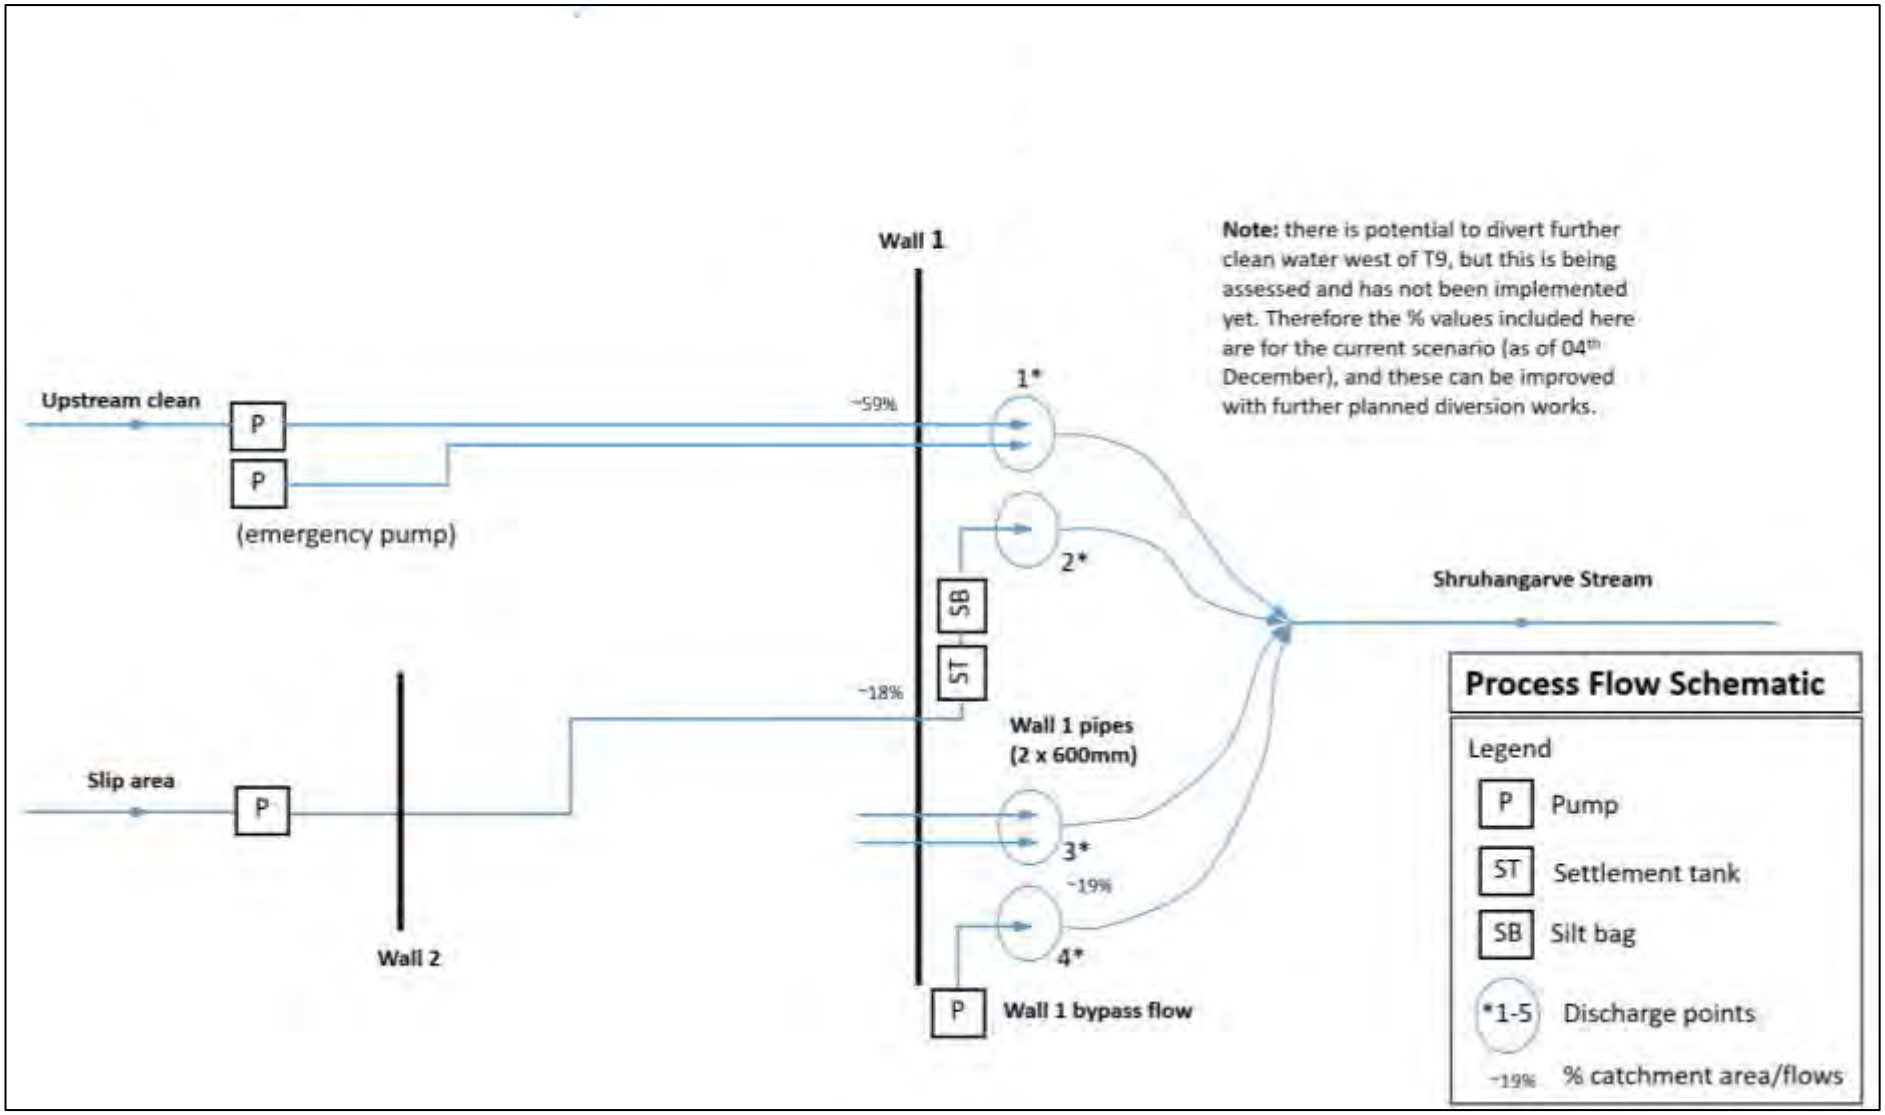
Figure 3.1 Flow diagram of current water flows and pumping arrangements on-site

At Wall 1, there are two further discharges. The first is overflow from the pond behind Wall 1, and this overflow occurs through 2 no. 600mm pipes (Discharge 2). As outlined above much of the runoff water from the catchment is being diverted around the pond upstream of Wall 1. The second discharge at Wall 1 is seepage flow through the southern (lower) end of Wall 1. This flow is captured in a sump downstream of Wall 1 and pumped laterally into the main channel of the Shruhangarve (Discharge 3). The purpose here is to prevent flows down through the forestry which could destabilise the peat there, and also remobilise some of the loose peat/sludge that coats the ground following the peat slide.

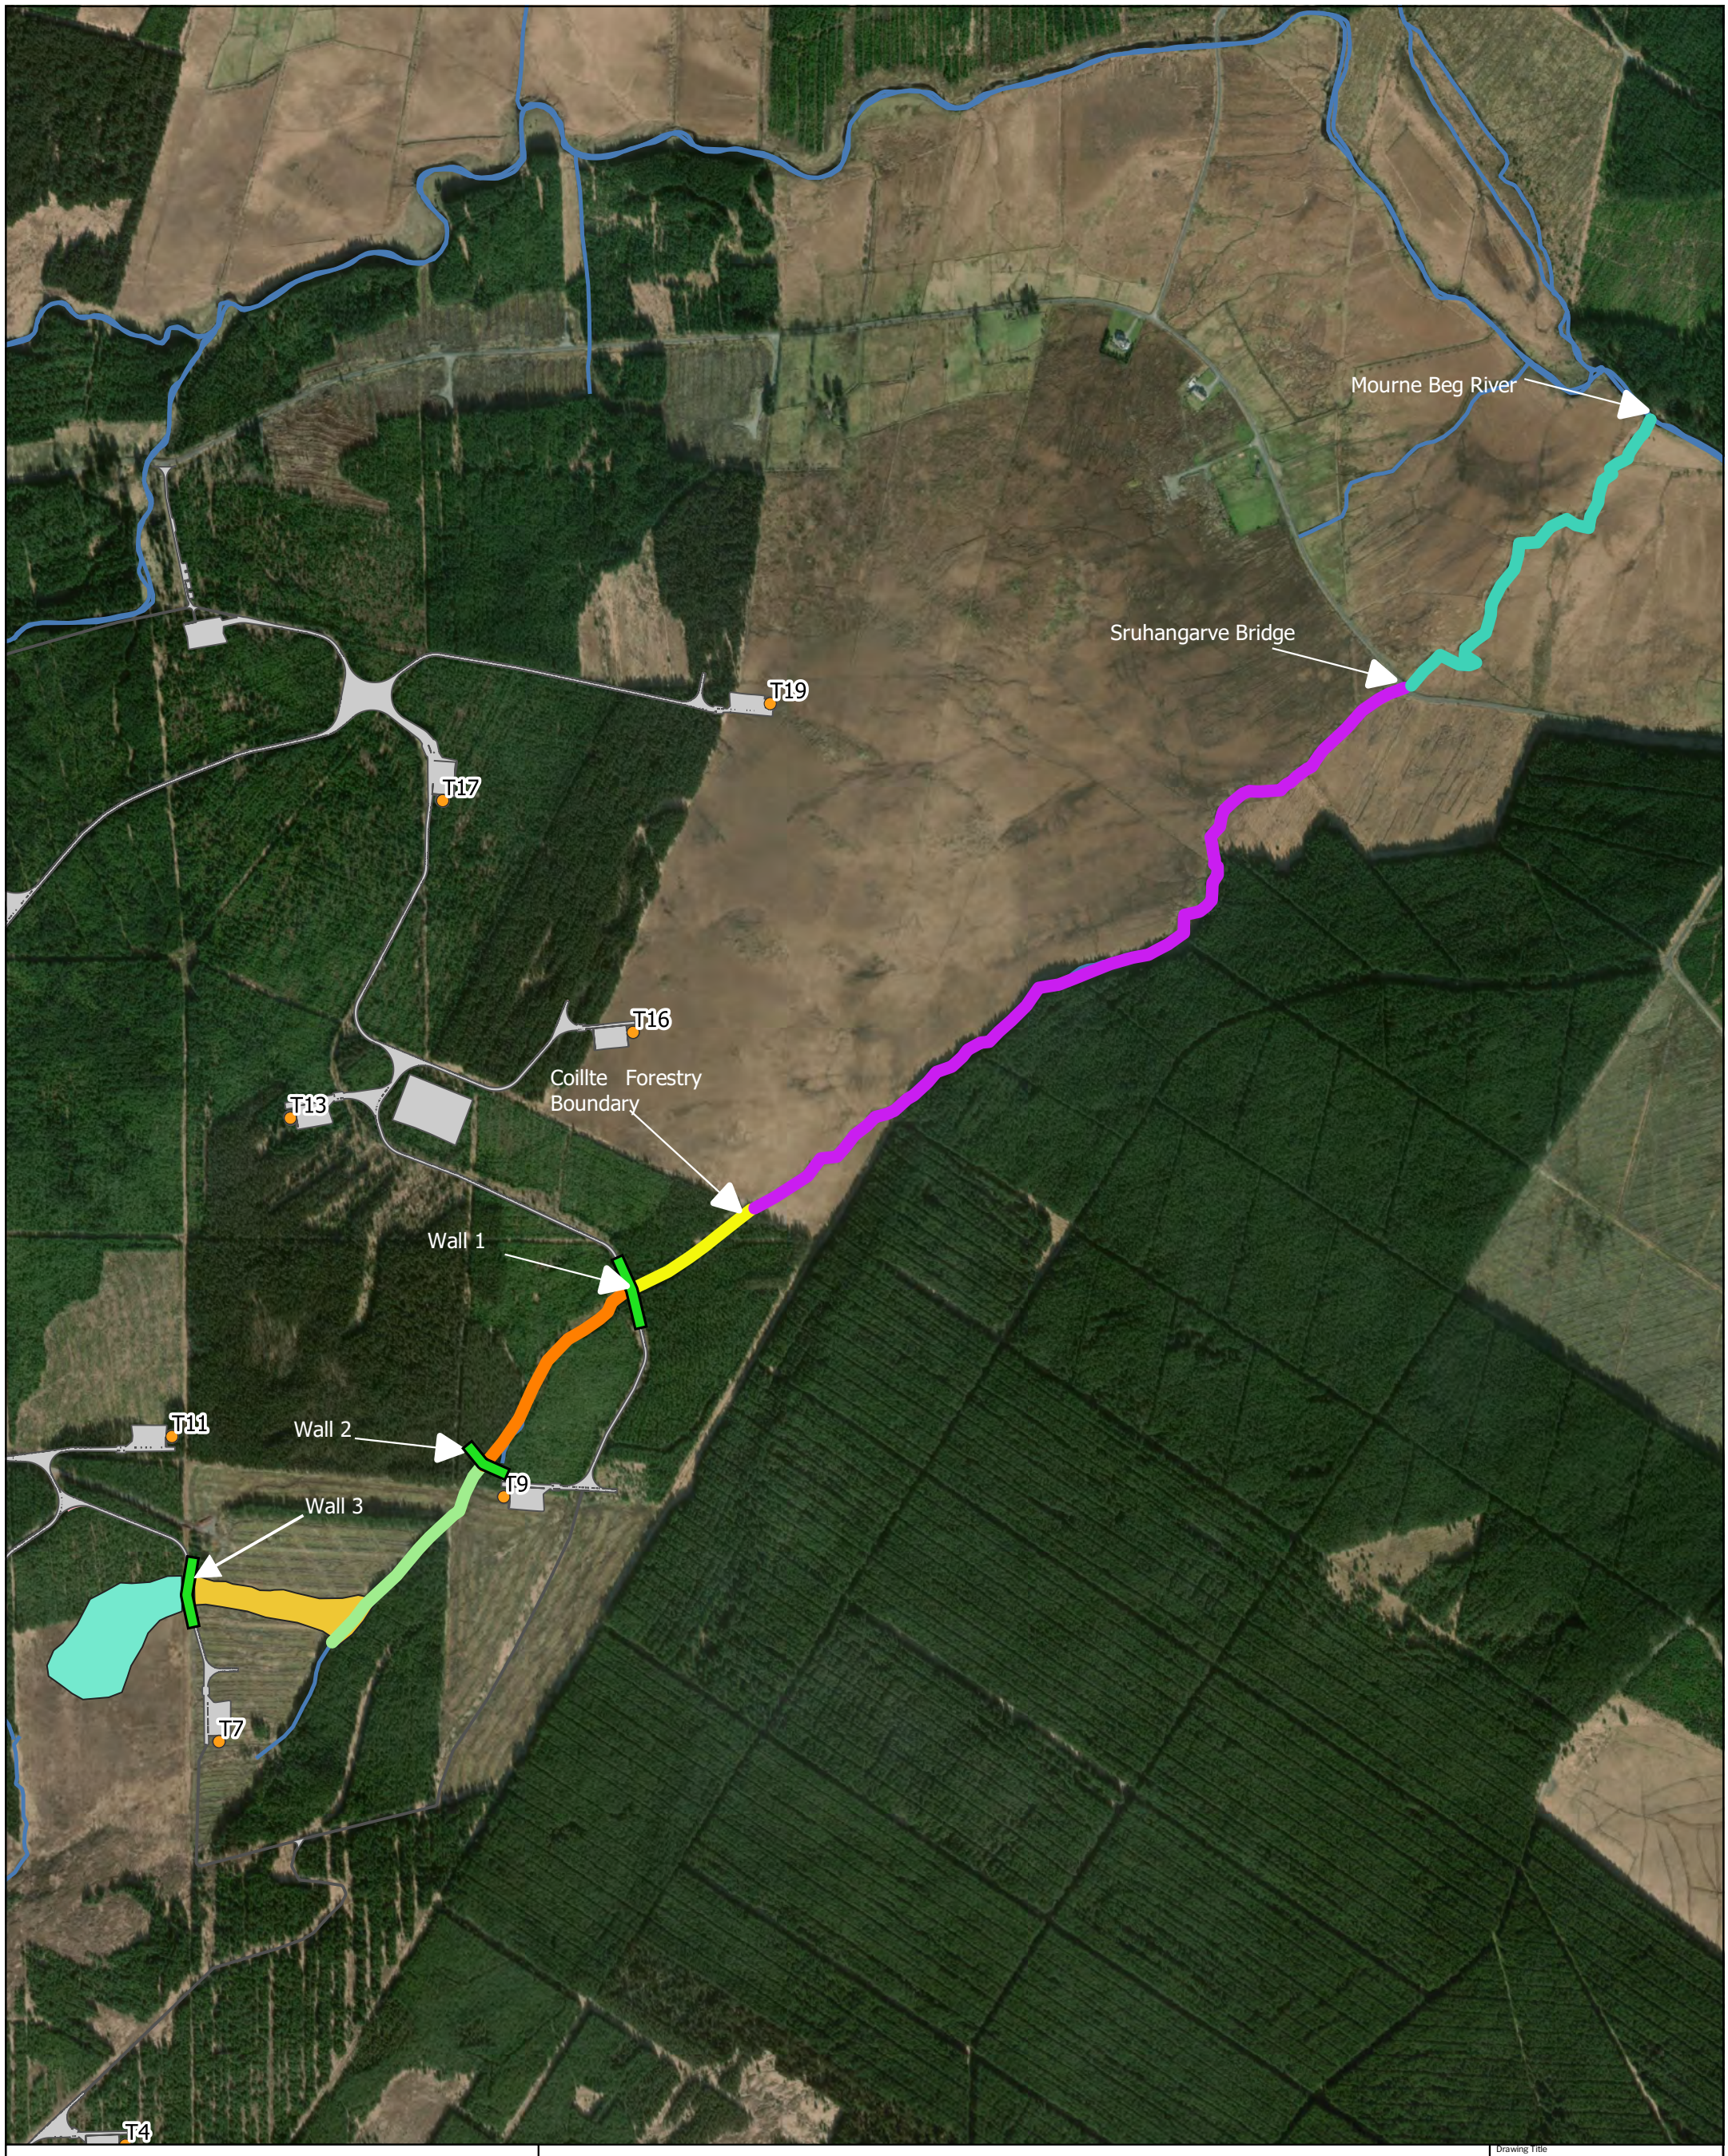
Drawn By	Checked By
TJB	BK
Project No.	**Drawing No.**
201174	Figure 5.1
Scale	**Date**
1:10000	12/03/2021

The peat slide resulted in the formation of a wide slip scar (as shown on Figure 5.1) downstream of Wall 3 and significant impacts on the Shruhangarve stream channel between the base of the slip scar and Wall 2. Whilst further works are required in following phases to restore the Shruhangarve stream channel, Phase 1A includes works that will assist in the stabilisation of the slip scar and the banks of the upstream of Wall 2.

For the purposes of describing the recommended water quality protection measures, Figure 5.1 has been prepared which divides the Shruhangarve stream into five sections or reaches, and these reaches will be referred to further below. The proposed water quality protection measures have been divided into two phases of work to allow for the implementation of some works while necessary studies and assessments are conducted for the future phases.

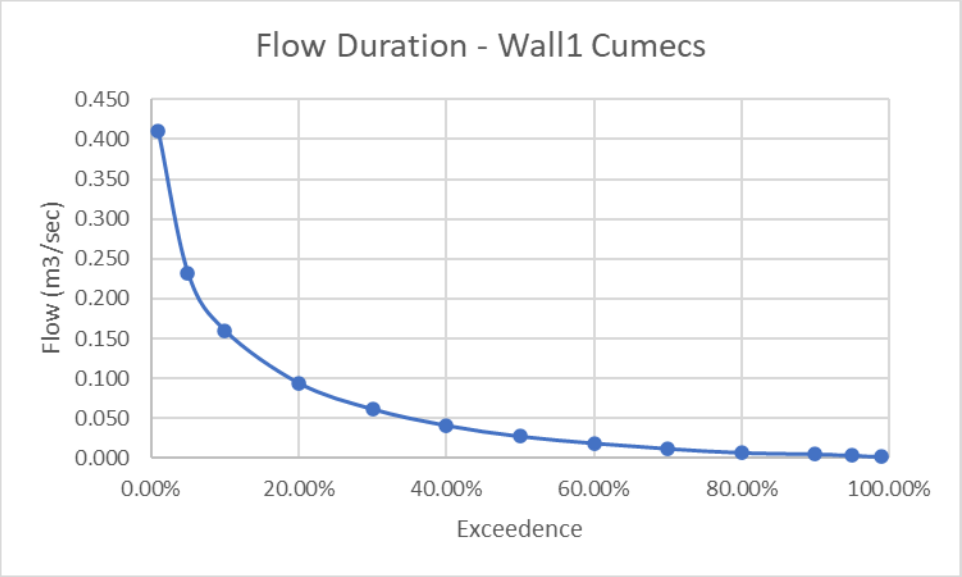
On site flow measurements have also been recorded, and to date total flows in the order of 30 to 300 L/s (~100 to 1,000 m^3/hr) have been recorded at Wall1. Flows vary depending on preceding rainfall on the catchment.

Flow ratios at the Shruhangarve bridge downstream of the site indicate that Wall1 flows are approximately 30% of the recorded flow at the bridge (on 25th November), and similarly Wall1 flows are <2% of the recorded flow (25th November) at Croagh Bridge on the Mourne Beg River (downstream of Shruhangarve confluence).

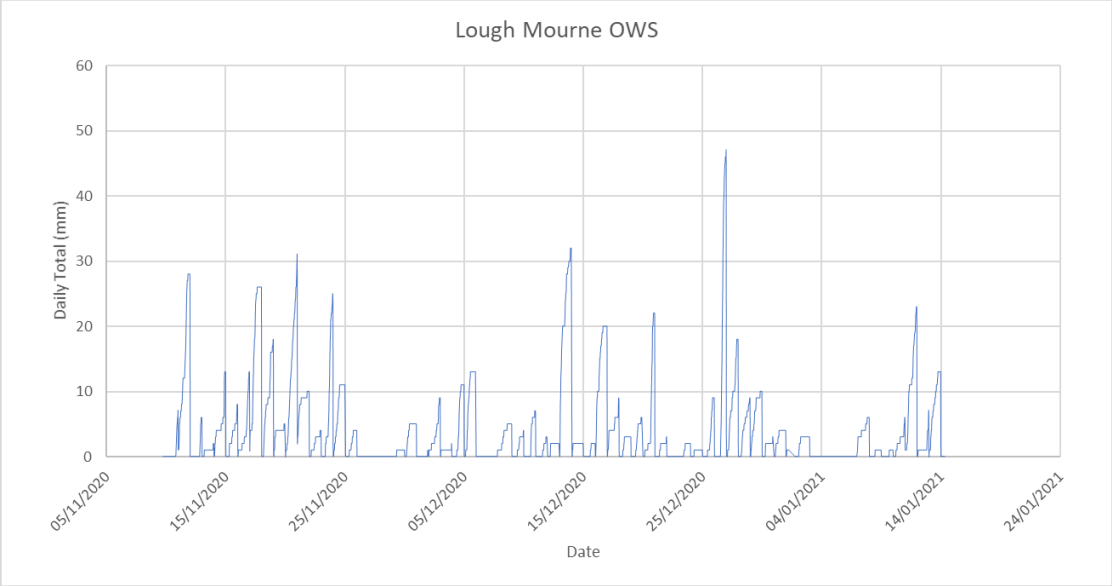
Figure 2-2.Lough Mourne ACS – Daily Rainfall Data (cumulative plot)

Continuous rainfall monitoring is undertaken at Lough Mourne ACS (Automatic Climate Station). Data since 10th November are plotted below (Figure 2-2). Highest daily total since 10th November was recorded on 26th December at 48mm. Data from Lough Mourne ACS indicates there was 28mm of rainfall on the 11th November, the day before the peat slide occurred.

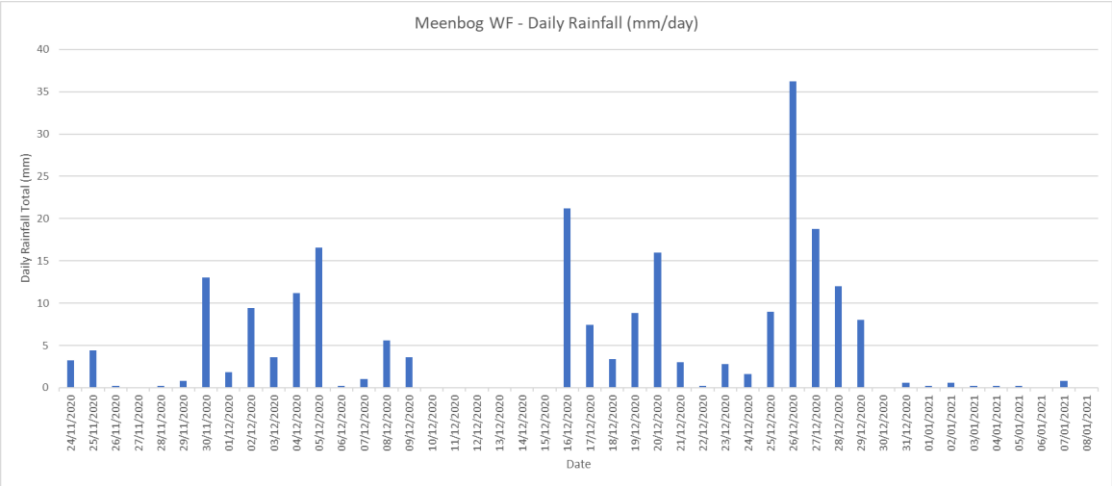
Figure 2-3. Meenbog wind farm – Daily Rainfall Data (daily total plot)

Rainfall monitoring has been installed at the wind farm site and has been ongoing since 24th November 2020. Collated data is presented here as Figure 2-3. The highest daily total on site since monitoring began was recorded on 26th December 2020 (36.2mm).

(Please note we have no data included on Figure 2.3 for Dec 11th to Dec 15th, as data downloaded were automated from 15th onwards). Data does exist for those dates, but it has not been downloaded yet). Daily rainfall totals for the site are provided in tabular form as Appendix 1.

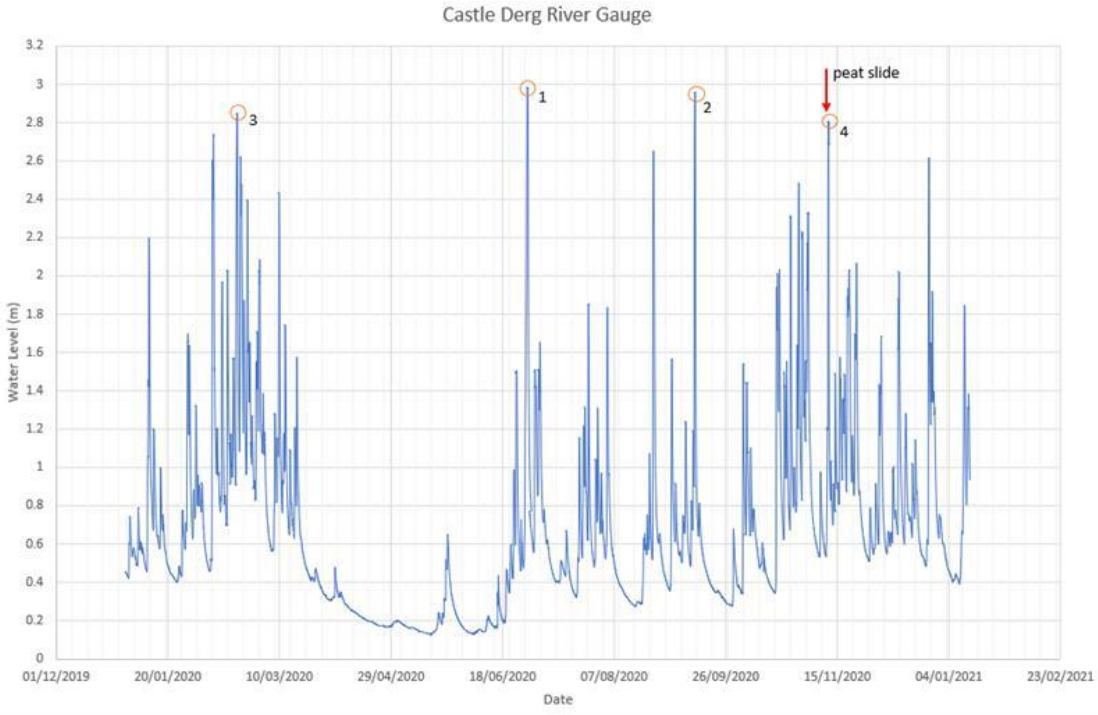
Figure 2-4. Castlederg river level data – Jan 2020 to Jan 2021 (on the Derg River at Castlederg)

Automated surface water level monitoring data for Derg River (15min interval data) is available for a gauging station located at Castlederg town (~17km downstream of the Meenbog wind farm site). All available data from January 2020 to January 2021 are plotted on Figure 2-4.

The water level plot shows high flow levels in the Derg River on the 12th of November 2020. The peak water level depth recorded at Castlederg was ~2.8m. The water level was generated by preceding heavy rainfall (28mm recorded at Lough Mourne ACS on 11th November 2020) which fell on the catchment on 10th and 11th November. The water level recorded in the Derg River on the 12th November 2020 was the fourth highest flood event of 2020. This hydrograph shows the natural variability in river flows over an annual cycle. This variability likely results in variations in turbidity across the same cycle.

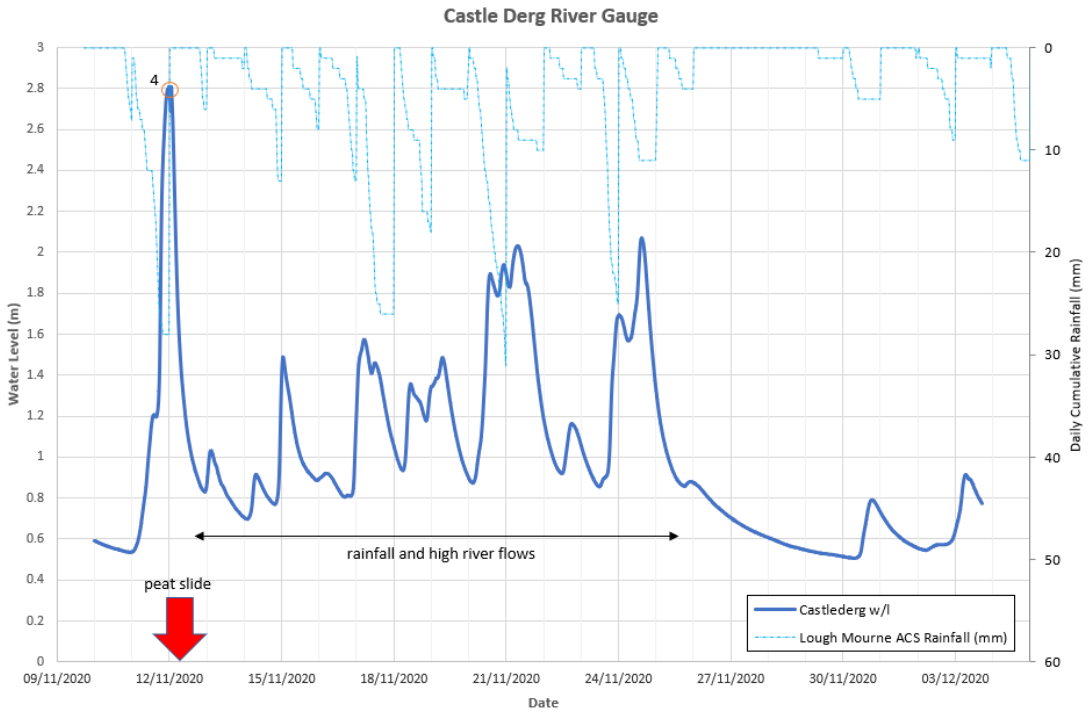
Figure 2-5. Castlederg river level data – Nov 2020 to Dec 2020 (on the Derg River at Castlederg)

There were a number of heavy rainfall events in the days following the peat slide, and these are illustrated by the river water level response recorded on Figure 2-5.

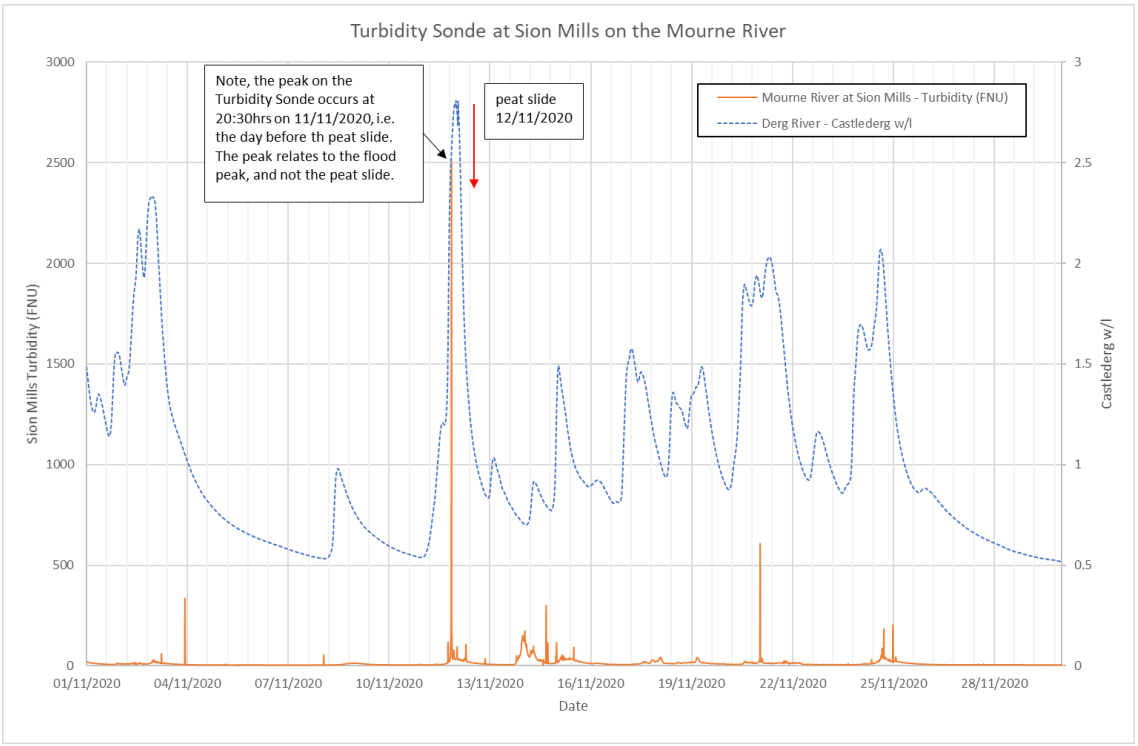
Figure 2-6. Sion Mills Turbidity Monitoring for month of November 2020 (on the Mourne River)

Continuous turbidity monitoring is completed by the Loughs Agency at Sion Mills, ~41kms downstream of the Shruhangarve/Mourne Bed River confluence. Data from this monitoring device for the month of November is plotted on Figure 2-6. There is a significant recorded peak in turbidity at Sion Mills at 20:30hrs on the 11th November 2020. This peak corresponds with the recorded flood peak in the Derg/Mourne Rivers as illustrated by the water level hydrograph data from Castlederg (on the Derg River, hydrograph data included on Figure 2-4). There are additional smaller spikes in turbidity recorded at Sion Mills for the remainder of November, and these spikes also correspond with higher water levels (i.e. higher river flows in the Derg River being transferred downstream to the Mourne River) recorded at Castlederg.

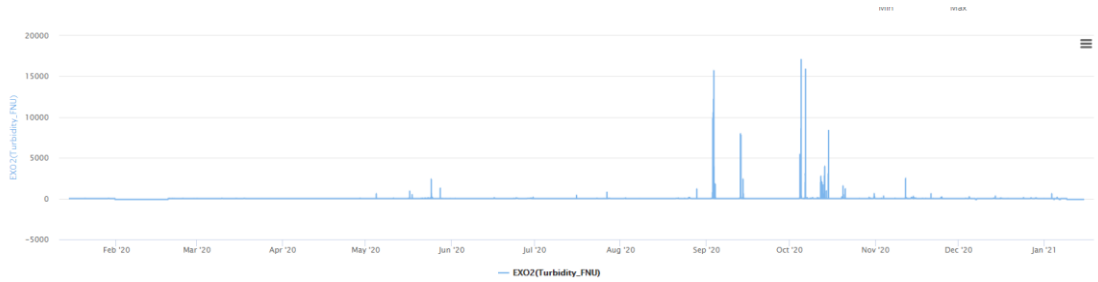
Figure 2-7. Sion Mills Turbidity Monitoring for Jan 2020 to Jan 2021 (on the Mourne River)

A screen capture of the full turbidity dataset at Sion Mills from January 2020 to January 2021 is included as Figure 2-7. The plot shows recorded spikes in turbidity preceding the peat slide event at Meenbog wind farm. Spikes are recorded in May/June and September/October.

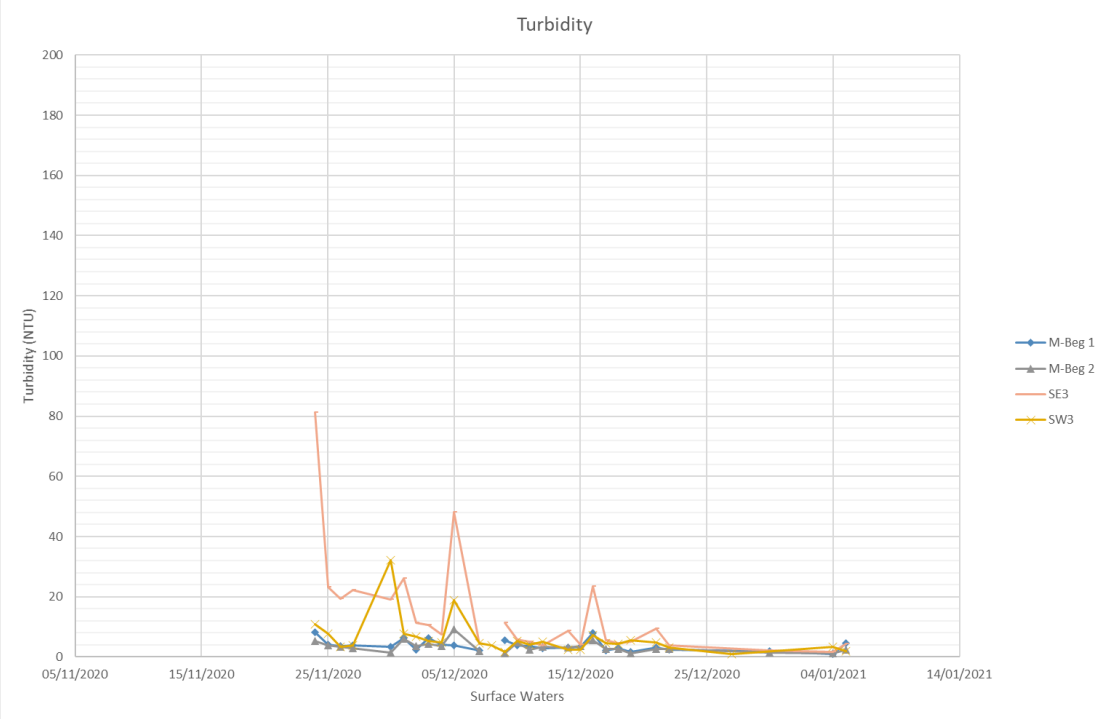
Figure 3-2. Daily field turbidity monitoring data plot

The collected field turbidity data gives a daily indication of variability in water quality (turbidity being a proxy for Total Suspended Solids (TSS)) downstream of the peat slide event. Data for SE3, SW3, MBeg1, and MBeg2 are plotted on Figure 3-2, and a summary of that data is provided in Table 3-4.

Monitoring Location	Data Range (NTU)	Observed trends
SE3	81.2 to 1.75	Spikes in data during emergency works period, but decreasing trend from 24th November onwards
SW3	32.1 to 0.93	Background data in the Bunadowen, this location is upstream of the peat slide
MBeg1	8.3 to 0.97	Relatively stable, with minor variability as a result of rainfall and variations in flows
MBeg2	9.25 to 1.15	Relatively stable, with minor variability as a result of rainfall and variations in flows

The turbidity data show a very clear trend of decreasing turbidity on the Shruhangarve and a return to close to normal levels by mid-December. Short-term increases in turbidity can be seen as a result of rainfall events. Daily field turbidity monitoring data are provided in tabular form as Appendix 2

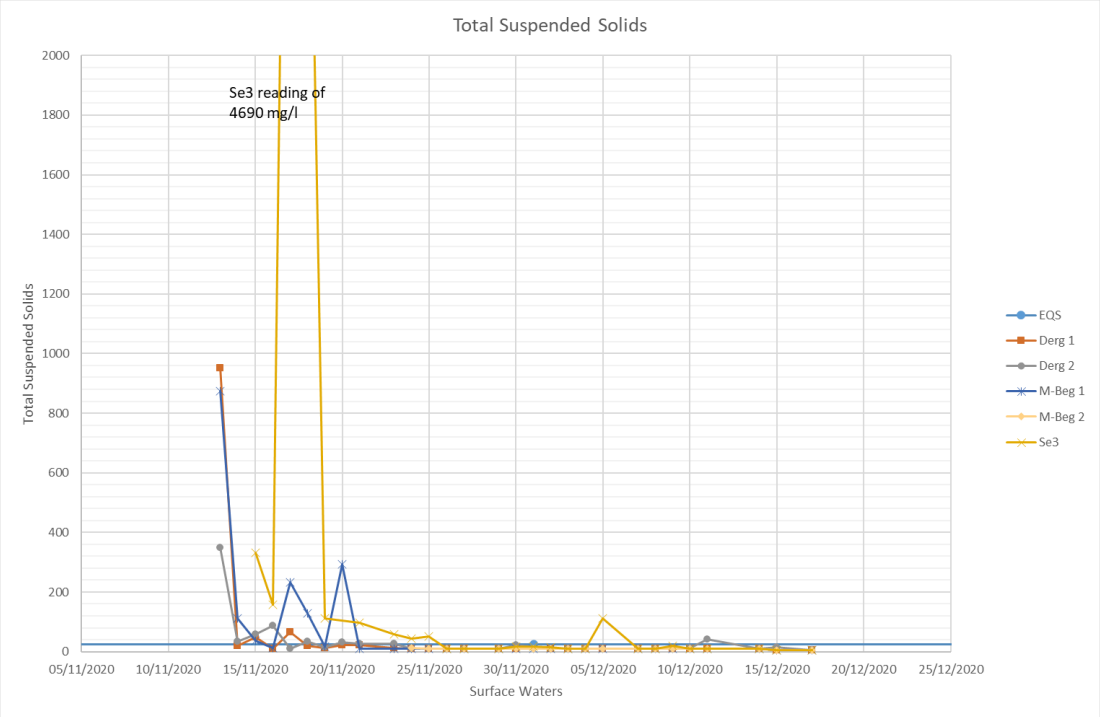
Figure 3-3. TSS (lab) data plot

TSS data (lab data) for SE3, MBeg1, MBeg2, Derg 1 and Derg2 are plotted on Figure 3-3, and a summary of that data is provided in Table 3-5.

Monitoring Location	TSS Data Range (mg/L)	Observed trends
SE3	4,690 to 6	Initial TSS load was high after the peat slide and during the emergency works period, with a settling down of recorded variations after the 25th November 2020. Only 1 exceedance of 25mg/L EQS occurred between 26th November and 17th December 2020.
MBeg1	875 to 4	Initial TSS load was high after the peat slide, with some further variation during the emergency works period, with a settling down of recorded variations after the 21st November 2020. No exceedance of 25mg/L EQS from 21st November onwards.
MBeg2	<10	(upstream of Shruhangarve confluence) All recorded data below salmonid EQS (25 mg/L).
Derg1	951 to 4	Initial TSS load was evident at Derg 1 after the peat slide, with some further variation up to 17th November 2020. No exceedance of 25mg/L EQS from 17th November onwards, with only 3 recorded exceedances on 13th, 15th, and 17th November.

Derg2	349 to 4	Initial TSS load was evident at Derg 2 after the peat slide, with some further variation up to 23rd November 2020. Only 1 exceedance of 25mg/L EQS from 23rd November onwards, but the recorded data suggests other catchment influences as Derg2 TSS data is higher than the upstream Derg1 data on 11 occasions.

The TSS data show a very clear trend of decreasing solids in the Shruhangarve, Mourne Beg and Derg Rivers following the peat slide event. There are indications from Derg2 data that other anthropogenic activities may be impacting on water quality in the Derg River downstream of Castlederg.

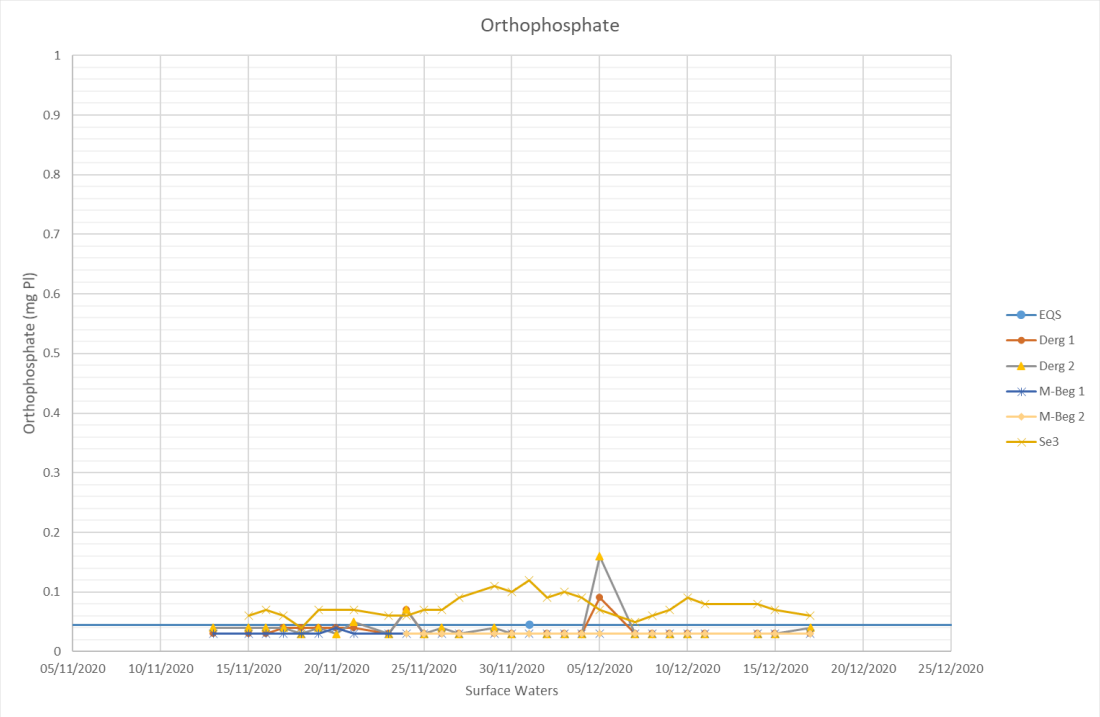
Figure 3-4. Ortho-P (lab) data plot

Ortho-P data (lab data) for SE3, MBeg1, MBeg2, Derg 1 and Derg2 are plotted on Figure 3-4, and a summary of that data is provided in Table 3-6.

Monitoring Location	Ortho-P Data Range (mg/L)	Observed trends
SE3	0.12 to 0.04 (n = 26, μ = 0.075)	Elevated ortho-P has been recorded since the peat slide and during the emergency works period, but importantly this does not appear to be impacting on downstream water quality at MBeg1 as significant dilution is available after the confluence of the Shruhangarve and the Mourne Beg River.
MBeg1	0.04 to 0.03 (n = 29, μ = 0.03)	Low ortho-P data results, with Good Status (mean of 0.03 mg/L) indication using mean of recorded data.
MBeg2	0.03 (n = 19, μ = 0.03)	Low ortho-P data results, with Good Status (mean of 0.03 mg/L) indication using mean of recorded data.
Derg1	0.09 to 0.03 (n = 27, μ = 0.035)	Low ortho-P data results, with Good Status (mean of 0.03 mg/L) indication achieved using mean of recorded data.
Derg2	0.16 to 0.03 (n = 28, μ = 0.04)	Generally low ortho-P data results, but recorded data suggests other catchment

Monitoring Location	Ortho-P Data Range (mg/L)	Observed trends
		influences as Derg2 data for ortho-P is higher than the upstream Derg1 data on 8 occasions.

The recorded ortho-P data shows elevated trends in the Shruhangarve Stream, but this is not having an impact on water quality in the Mourne Beg River, as data from MBeg1 is consistently meeting the Good Status EQS. There are indications from Derg2 ortho-P data that other anthropogenic activities may be impacting on water quality in the Derg River downstream of Castlederg.

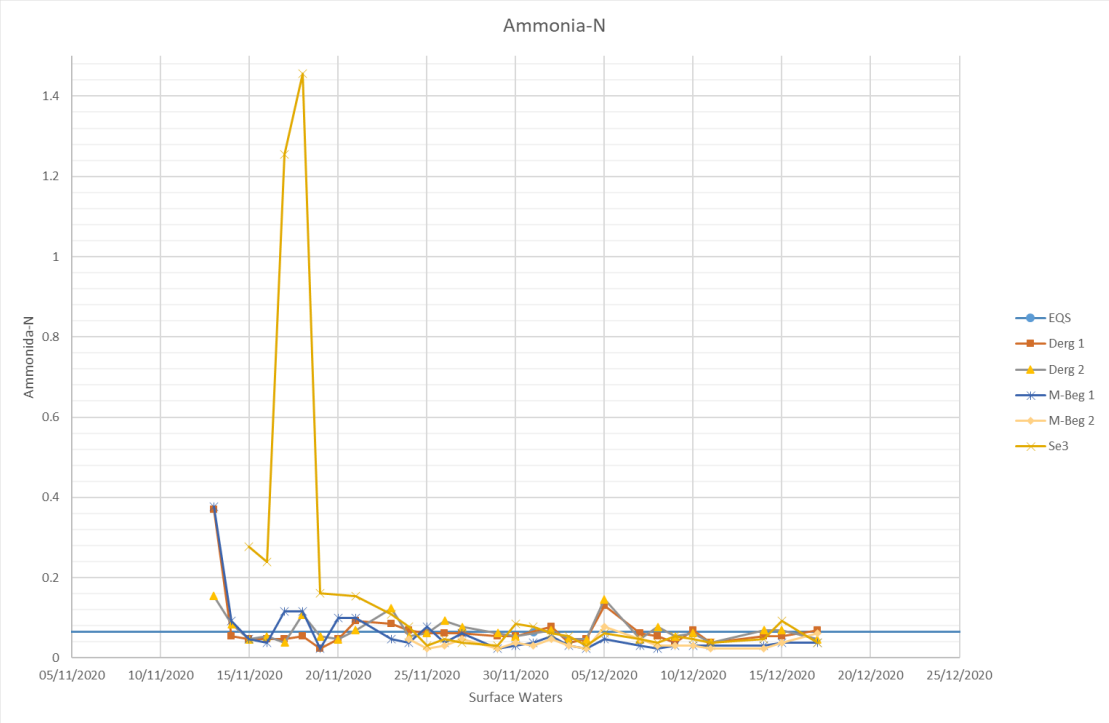
Figure 3-5. Ammonia (lab) data plot

Ammonia data (lab data, converted to Ammonia-N to compare to EQS) for SE3, MBeg1, MBeg2, Derg 1 and Derg2 are plotted on Figure 3-5, and a summary of that data is provided in Table 3-7.

Monitoring Location	Ammonia-N Data Range (mg/L)	Observed trends
SE3	0.03 to 1.46 (n = 28, μ = 0.07)	Elevated Ammonia-N was recorded up to 24th November 2020 following the peat slide, with only small temporal variations since then.
MBeg1	0.02 -to 0.38 (n = 29, μ = 0.06)	Elevated Ammonia-N was recorded up to 25th November 2020 following the peat slide, with only small temporal variations since then.
MBeg2	0.02 to 0.08 (n = 19, μ = 0.04)	Low background ammonia-N recorded.

Monitoring Location	Ammonia-N Data Range (mg/L)	Observed trends
Derg1	0.02 to 0.37 (n = 28, μ = 0.07)	Elevated ammonia-N recorded on 13th November 2020, with only small temporal variations since then.
Derg2	0.04 to 0.15 (n = 28, μ = 0.04)	Elevated ammonia-N recorded on 13th November 2020, with only small temporal variations since then. Again, recorded data suggests other catchment influences as Derg2 data for Ammonia-N is higher than the upstream Derg1 data on 12 occasions.

The recorded ortho-P data shows elevated trends in the Shruhangarve Stream, but this is only having a minor effect on downstream water quality in the Mourne Beg River. There are indications from Derg2 ammonia-N data that other anthropogenic activities may be impacting on water quality in the Derg River downstream of Castlederg.
