NOVEMBER 2020 PEATSLIDE ENVIRONMENTAL REPORT

Environmental Report

November 2020 Peat Slide at Meenbog Wind Farm, Co. Donegal and subsequent Restoration and Remediation Works

Client:	**Planree Limited**
Project Title:	**November 2020 Peat Slide at Meenbog Wind Farm, Co. Donegal and subsequent Restoration and Remediation Works**
Project Number:	**220623**
Document Title:	**Environmental Report**
Document File Name:	**220623_Environmental_Report F - 2024.03.29**
Prepared By:	**MKO** **Tuam Road** **Galway** **Ireland** **H91 VW84**

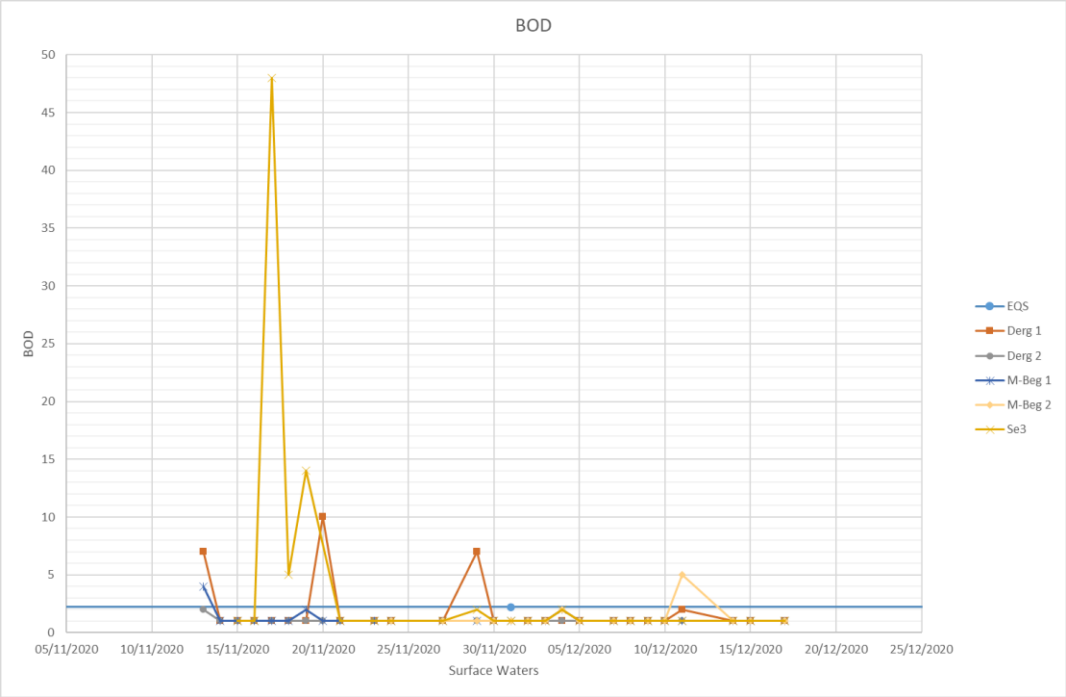
Figure 3-6. BOD (lab) data plot

BOD data (lab data) for SE3, MBeg1, MBeg2, Derg 1 and Derg2 are plotted on Figure 3-6, and a summary of that data is provided in Table 3-8.

Monitoring Location	BOD Data Range (mg/L)	Observed trends
SE3	48 to 1 (n = 28, μ = 1.8)	Elevated BOD was recorded up to 19th November 2020 following the peat slide, with only small temporal variations since then.
MBeg1	4-to 1 (n = 29, μ = 1.18)	Elevated BOD was recorded on 13th November 2020 following the peat slide, with only small temporal variations since then.
MBeg2	5 to 1 (n = 19, μ = 1.29)	Low background BOD, with one spike on 11th December 2020 (5mg/L).
Derg1	10 to 1 (n = 28, μ = 1.8)	Elevated BOD was recorded on 13th November 2020 and 20th November following the peat slide, with only small temporal variations since then.
Derg2	2 to 1 (n = 28, μ = 1.03)	In general, low BOD recorded.

The recorded BOD data shows elevated trends in the Shruhangarve Stream, but this has not caused any significant ongoing effect on downstream water quality in the Mourne Beg River.
