PEAT STABILITY ASSESSMENT FOR MEENBOG WIND FARM SITE (FT, 2021)

Meenbog Wind Farm

Peat Stability Assessment of Meenbog Wind Farm Site

Abstract: This assessment addresses the stability of the site of the Meenbog Wind Farm, County Donegal following a peat failure at the site on 12 November 2020.

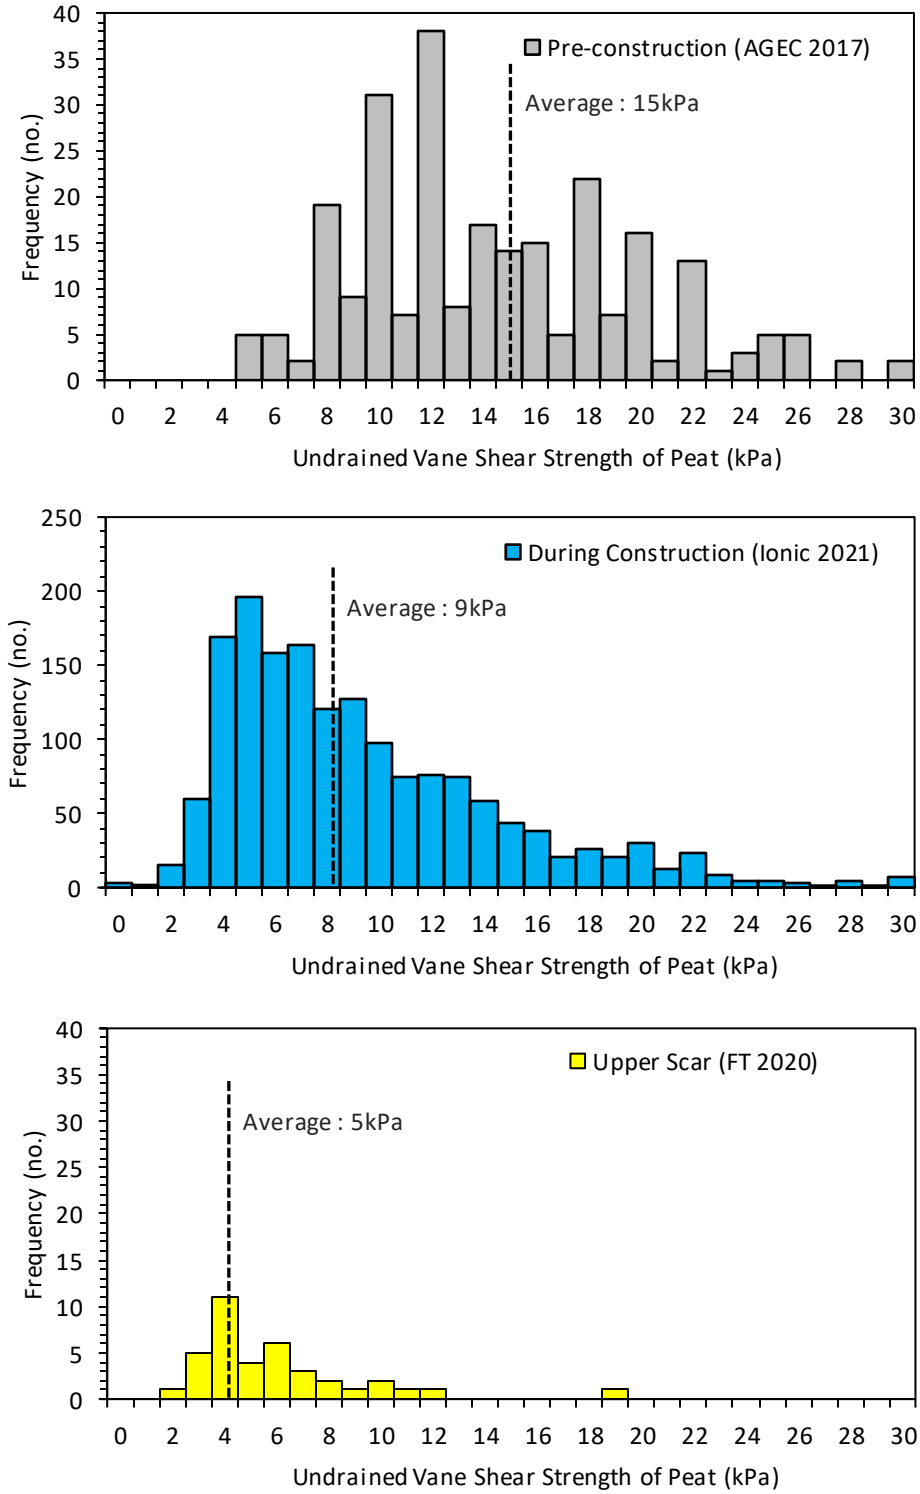
Figure 3: Range of undrained peat strength

(3) Body of very weak peat immediately upslope. Essentially immediately upslope of the floating road was a flat plateau area that was partly formed of essentially a large body of notably saturated and very weak peat. This body of saturated and very weak peat relied for lateral stability on the peat slope upon which the floating road was being constructed. Hand vane results by FT post-failure showed undrained shear strengths in the range 2 to 9kPa, with an average value of slightly less than about 5kPa. These low recorded peat strengths are significantly lower than the site-wide results and would represent a body of very weak peat (**Figure 3**).

(d) Insitu hand vane test results in the body of saturated and very weak peat showed undrained shear strengths in the range 2 to 9kPa, which are significantly lower than the site-wide results (**Figure 3**).

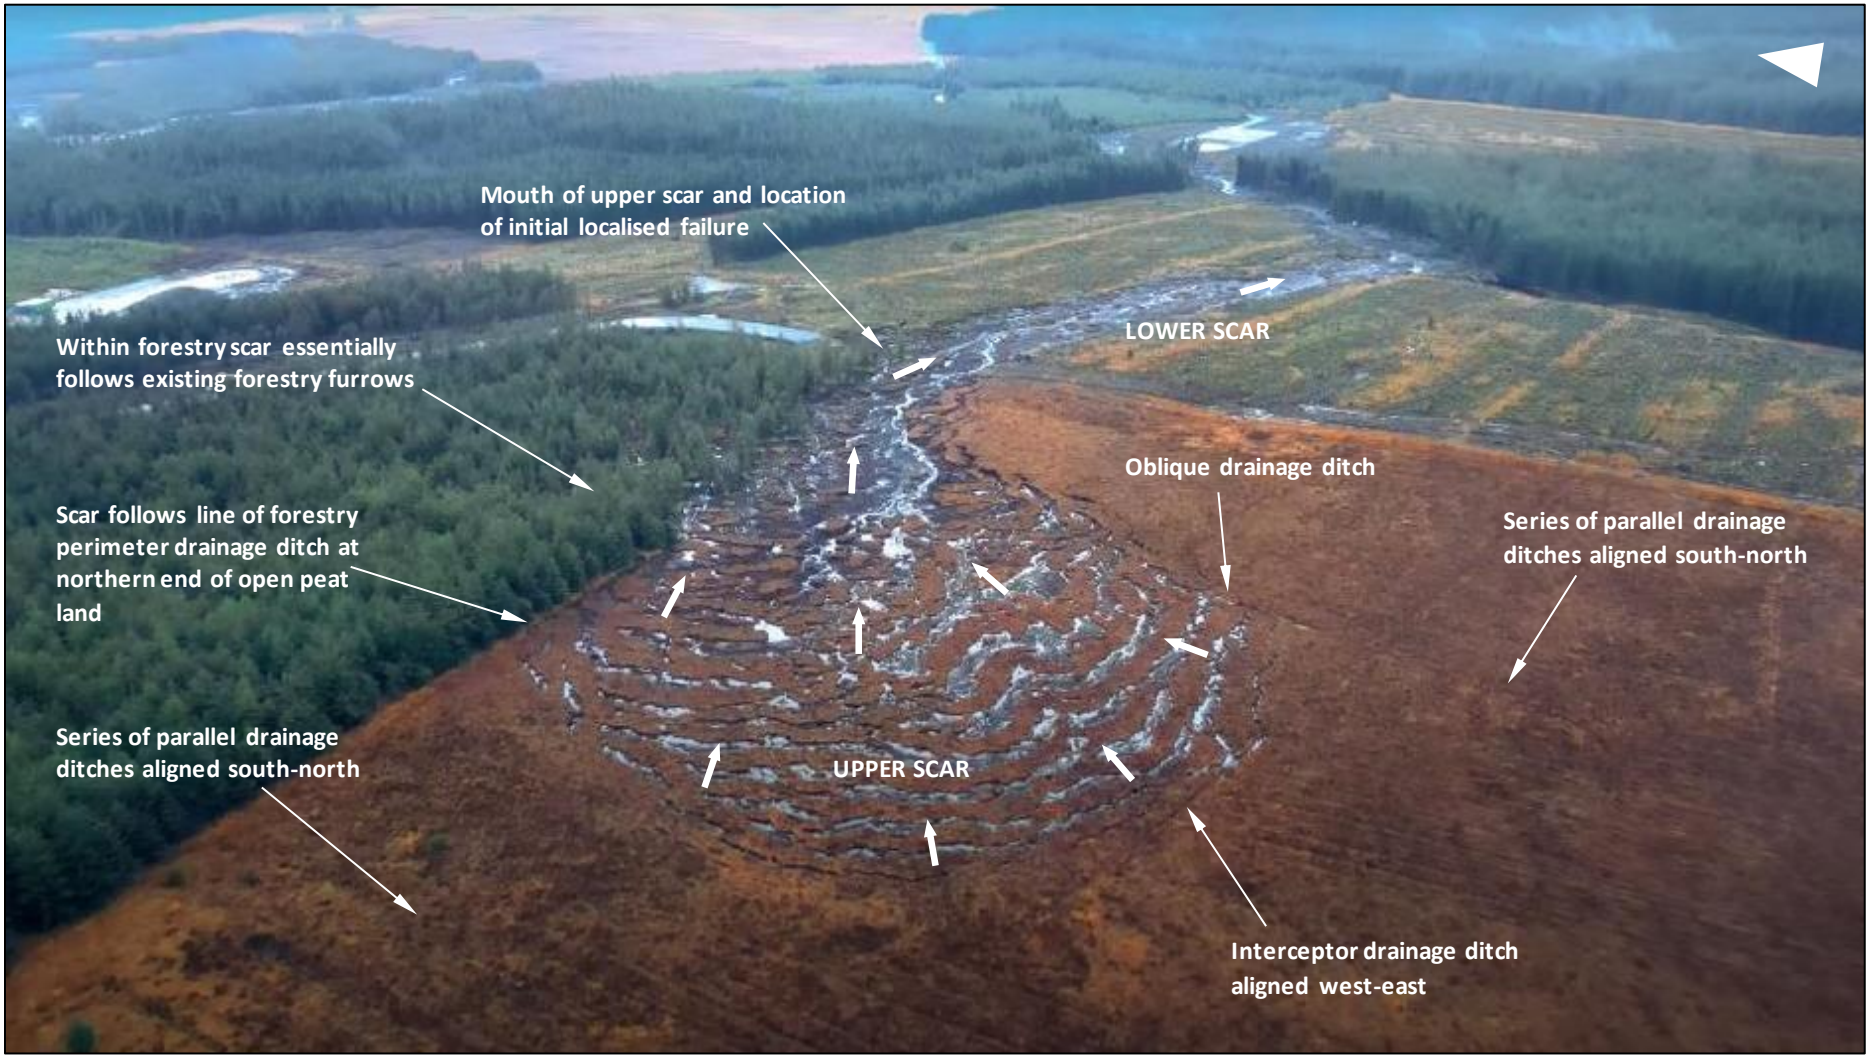
Figure 10: Aerial image of upper and lower scars

Whilst most of the area of the upper scar is within open peat land that has no drainage, the perimeter extent of the upper scar was significantly controlled by existing drainage ditches and forestry furrows in the area (**Figure 10**). To the south there is a series of parallel drainage ditches (less than about 1m deep) that feed water northwards towards the failure scar. These parallel drainage ditches feed into an interceptor drainage ditch aligned west-east. This interceptor has essentially controlled the southern limit of the scar. To the east the scar is controlled by an oblique drainage ditch. To the north the scar follows the line of the forestry perimeter drainage ditch before extending further northwards into the forestry plantation where the scar essentially is controlled by the forestry furrows.

(2) Lower scar. This comprised a secondary source area of the failed material. The lower scar is rectilinear and essentially follows the slope gradient (**Figure 10**). The lower scar was about 260m long by about 43m wide. The head of the lower scar is taken at the downslope mouth of the upper scar and essentially coincides with the upslope boundary of a recently felled forestry plantation. The lateral perimeter of the scar essentially follows the existing forestry furrows. The estimated total area of the lower scar is about 1.18ha.

Where there were drains passing below the floating road, such as the forestry perimeter drainage ditch at the northern end of the open peat land (**Figure 10**), then this would have severed the acrotelm layer (upper fibrous layer) of the peat where most of the intrinsic (tensile) strength of the peat lies.

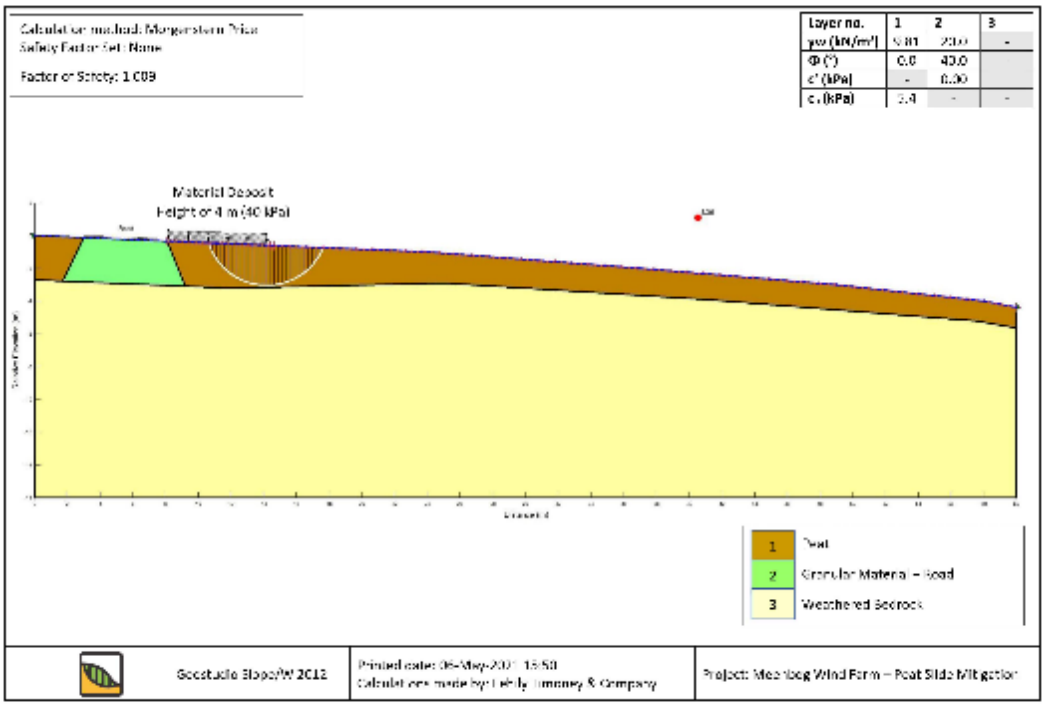
Figure 14: Further investigation - results of back-analysis of peat failure near T5

The results of the back-analysis together with an example of stability output are shown in **Figure 14**. The main findings of the back-analysis are as follows:

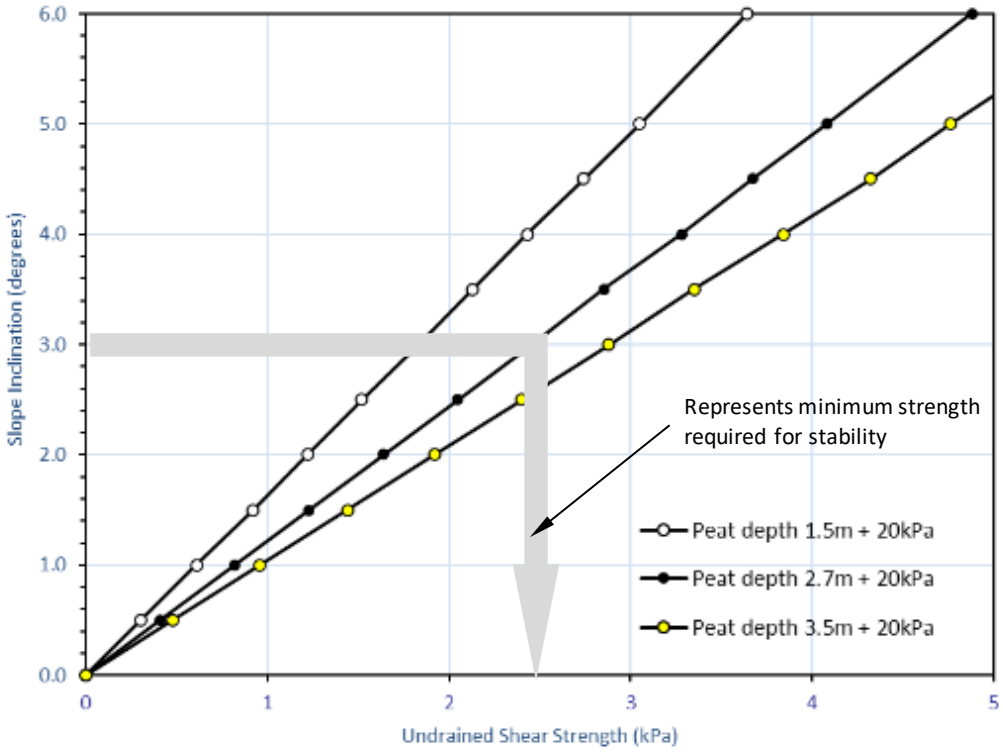
Figure 15: Further investigation - results of sensitivity analysis of peat failure of 12 November 2020

(a) Sliding analysis - plot lines represent onset of stablity for various peat depths at floating road to T7

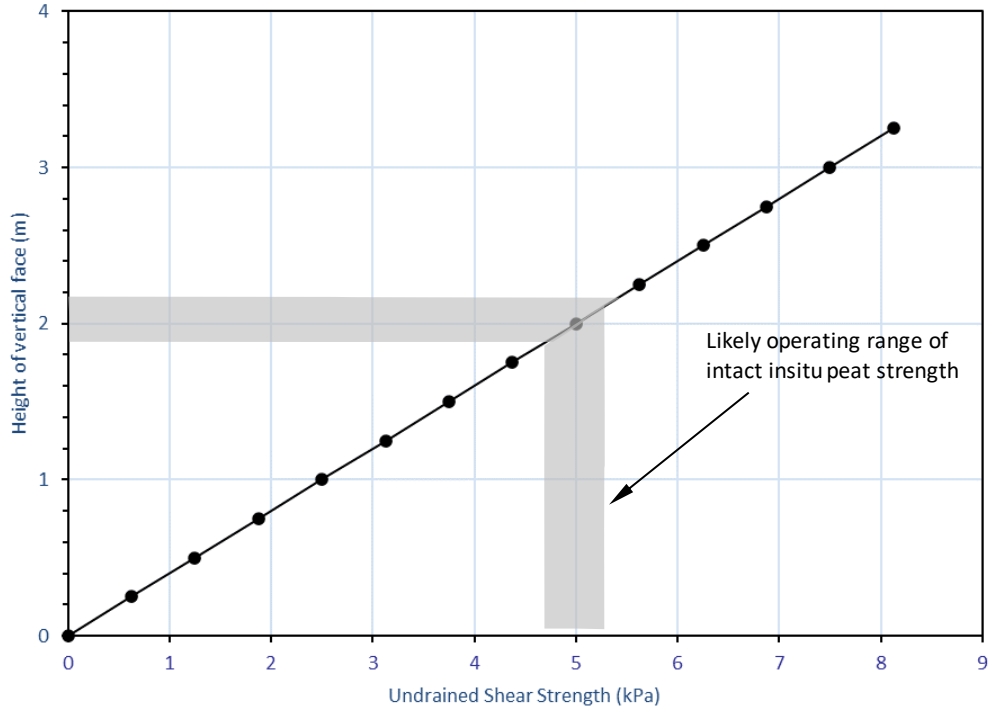
(b) Stable vertical height of peat in upper scar

(2) A sensitivity analyses was also carried out to determine the range of stable vertical height of scar side-walls, see **Figure 15 (b)**. This shows the following:

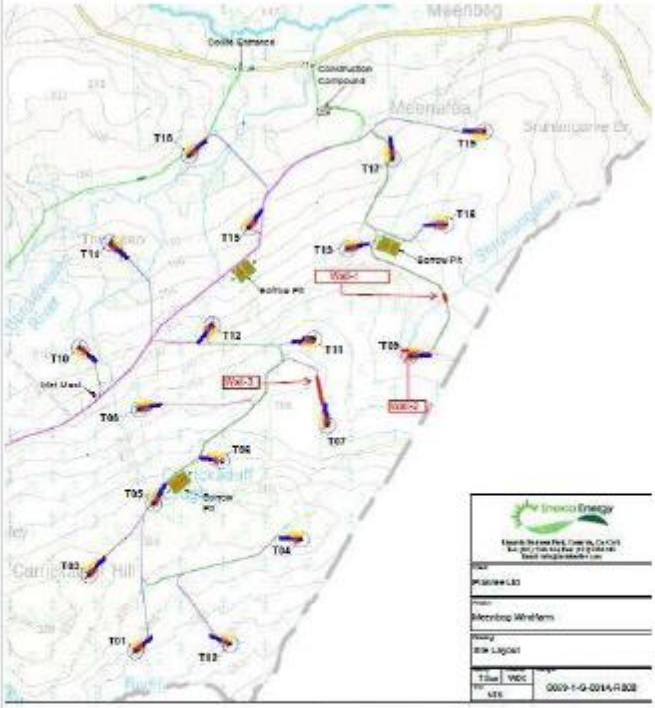
Figure 2: Schematic received by email from Donegal County Council on the 17th November 2020 showing proposal from operator to construct 3 walls to mitigate against further damage and peat instability (note: Wall 1 constructed on the 12th/13th November 2020, Wall 2 and Wall 3 proposed).

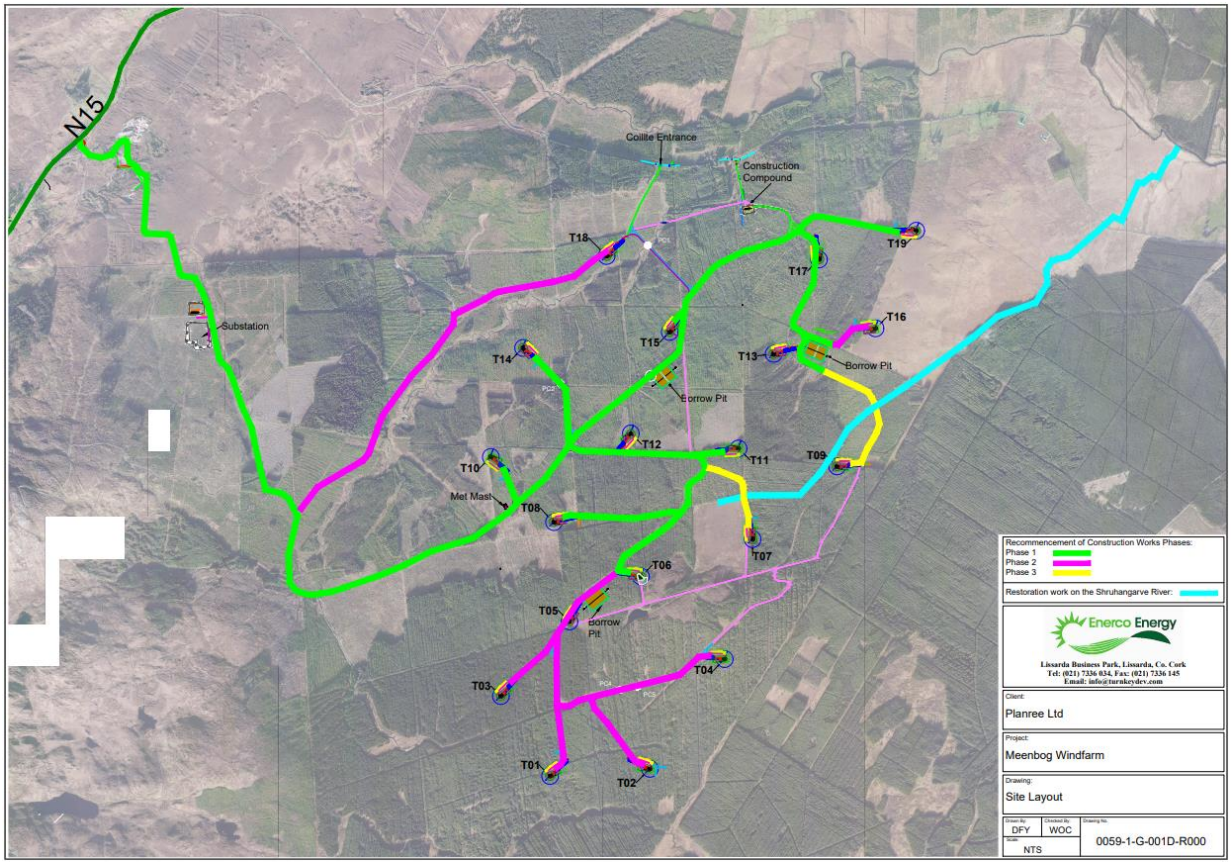
Figure 1 Map of Zones 1, 2, 3

For the purposes of this report the site has been divided into 3 zones referred to as Zone 1, Zone 2 and Zone 3.

Zone 1 consists of the already constructed solid roads, hardstandings and turbine foundations, as shown in green, and includes the Main Spine Road, T5 (north), T6, T8 - T15, T17, T19.

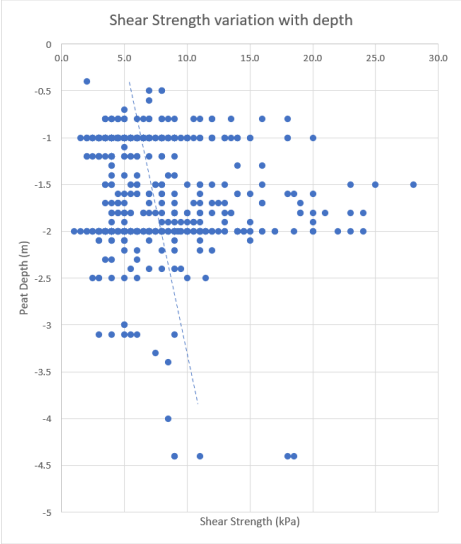
Figure 2 Shear Strength variation with depth

The pattern of results below (based on 1100 paired results, i.e. two test results at one location) presents a slight trend of increasing strength with depth between 1 and 2m as shown below, and the smaller sample of deep peat readings between 3.0 and 4.4m also indicates a slight pattern of shear vane strengths increasing with depth. However, this data set includes testing from a range of peats depths across the entire site and therefore a more targeted analysis was also completed using a refined testing data set in deeper peat locations, refer to Section 7, which also shows a similar trend of slightly increasing strength with depth.

Note that significantly higher readings can often be obtained within the fibrous acrotelm (upper layer of peat) however these are not included within the analysis (other than areas with very shallow peat). Also, relatively higher readings can also be obtained within the catotelm layer due to, for example, more intact organic matter or penetration of the test equipment into the underlying mineral soil. These were also not included in the analysis.

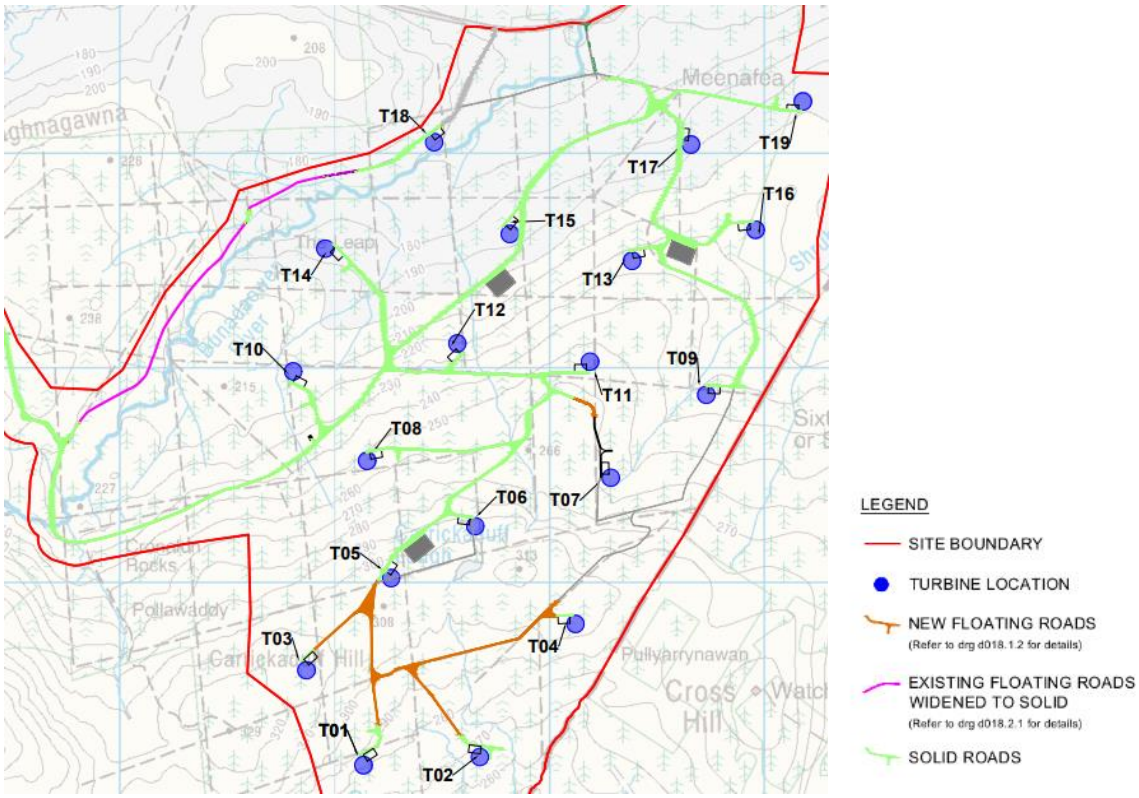
Figure 3 Overall Road Type Layout Map

The overall layout for road types is shown below. The floating roads proposed were at spur roads to T1, T2, T3, T4 and T7, in accordance with the planning documentation and CEMP, as these were the only sections of road with average peat depths generally in excess of 1.5m.

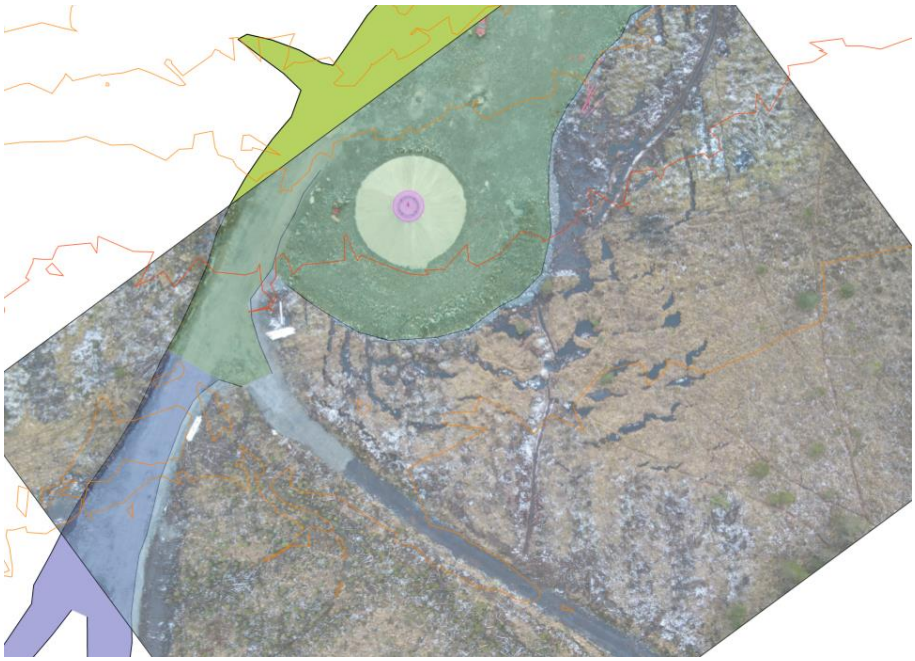
Figure 9 T5 as-built and aerial image

Aerial image and as-built at T5, illustrating cracking around the peat retaining berm:

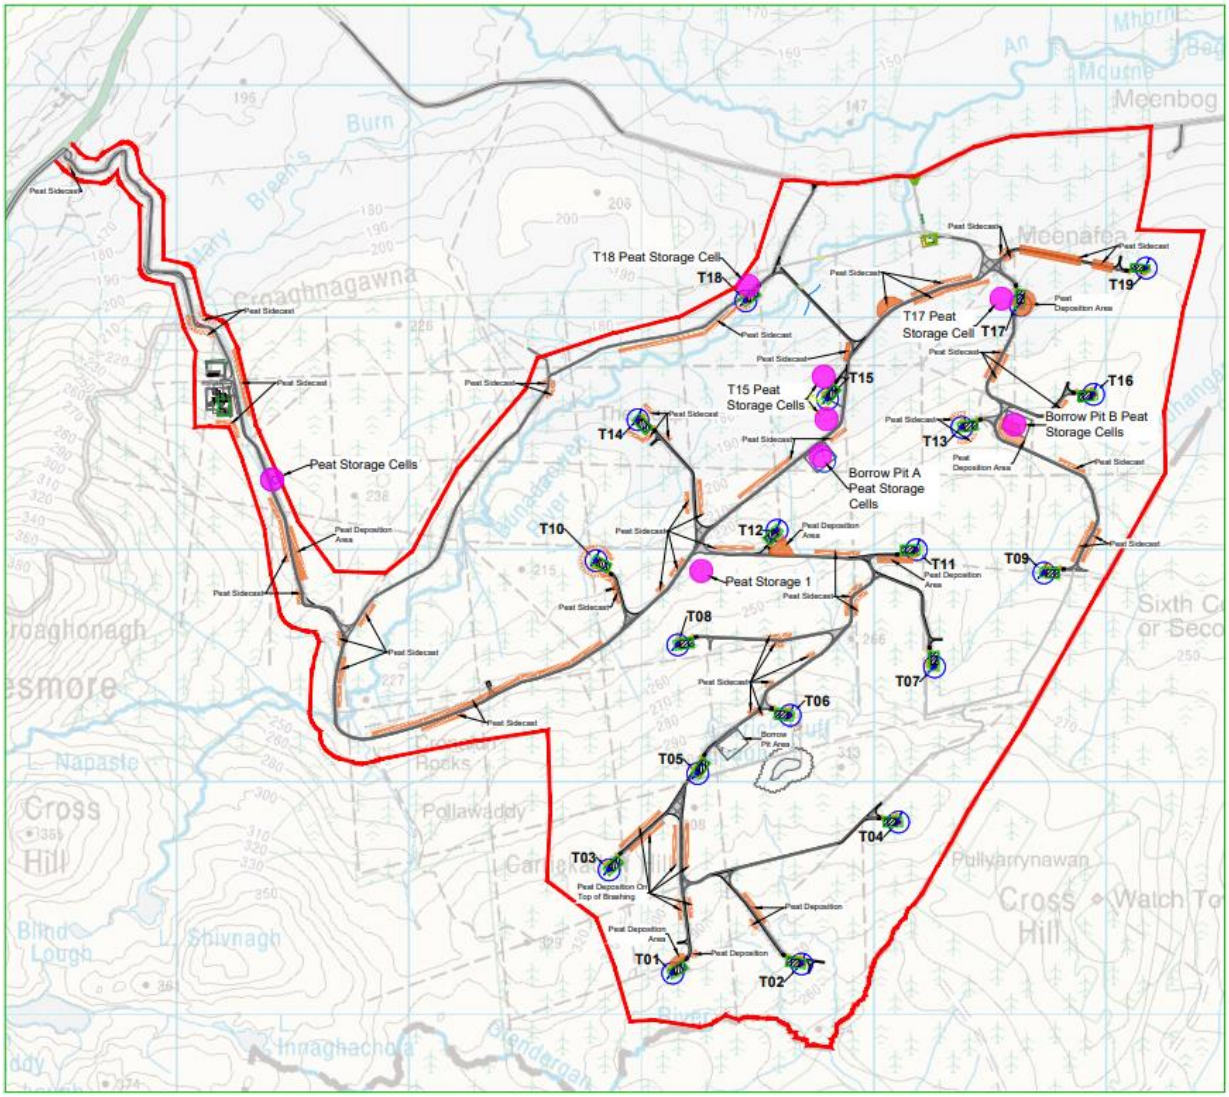
Figure 11 Peat Storage and Deposition Areas

As part of earlier construction practice on site, arisings (dominantly peat) from excavations were deposited onto the existing peat surface at a number of locations. A visual inspection of the condition of the placed arisings was carried out by FT (see FT report Appendix A4). No evidence of instability of the placed arisings was identified that would be considered to represent a risk of large-scale peat failure. These observations would concur with the expected behaviour of the insitu peat, that is the placed arisings would result in consolidation of the underlying insitu peat with a subsequent gain in strength over time. As such, the stability of the insitu peat below the placed arisings will increase over time. Typically, the critical period for instability of the insitu peat is immediately following application of the load.

The peat storage cells are generally excavated below existing ground level to solid sub-formation and designed with stone/rock berms on the low side retaining the emplaced peat. The relevant sub-sections of the report that include peat storage cells include design calculations for the retaining berms at each location to demonstrate stability.

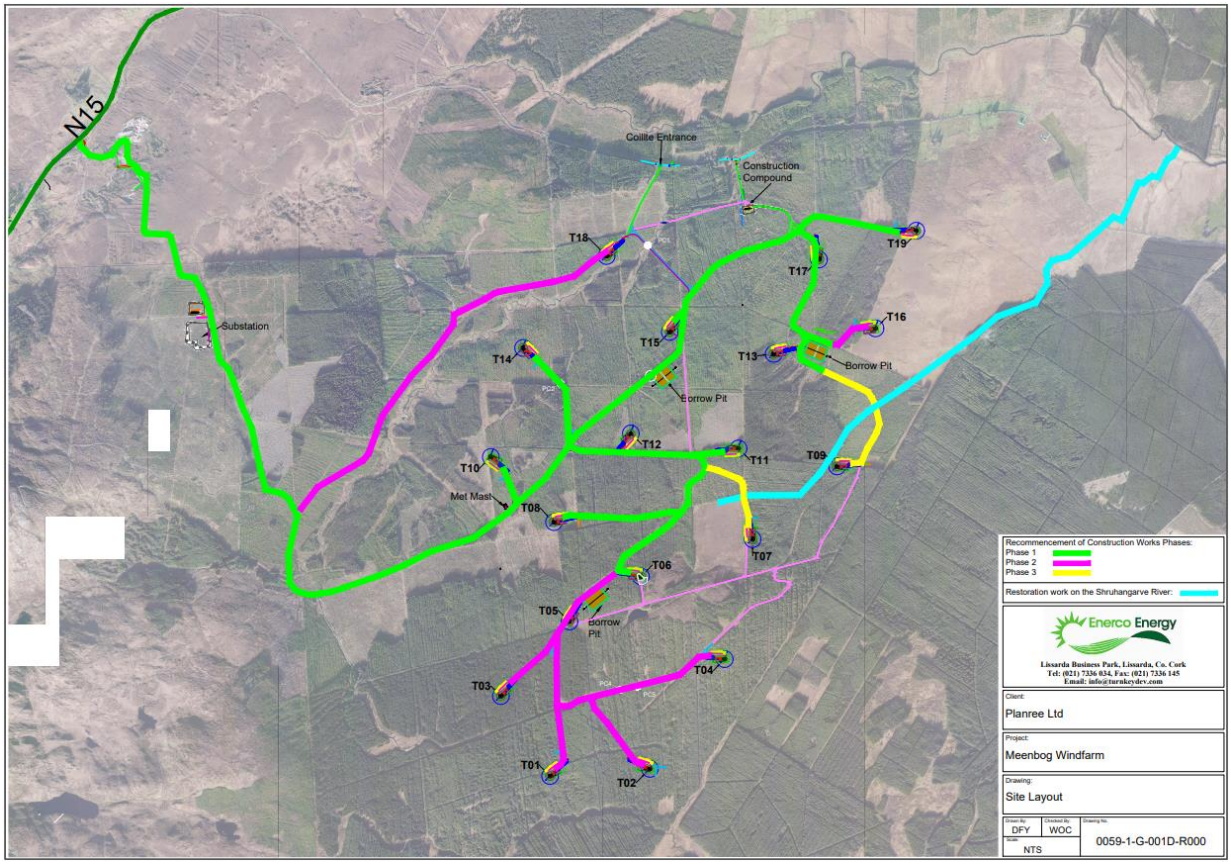
Figure 12 Zone 1 indicated in green

This section of the report relates to the existing solid roads across the site, along with related infrastructure in these areas including hardstandings, turbine foundations, peat storage cells, borrow pits, as well as peat deposition areas. Zone 1 in this report relates to the green areas outlined in the following map. All of these infrastructure elements are constructed on solid ground, primarily on bedrock but also locally on stiff subsoil.

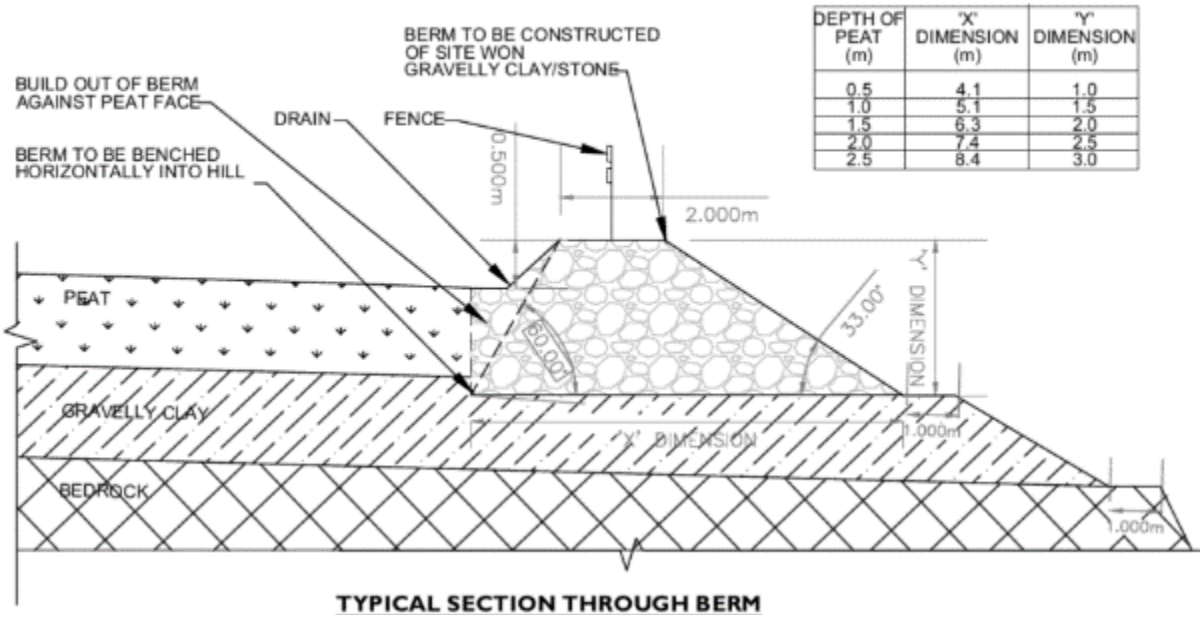
Figure 16 Substation berm section details

Berms are provided around the excavated perimeter of the compound to ensure the stability of the undisturbed upslope peat. Design calculations and details were provided to provide the required factor of safety against sliding. The berms were inspected by Ionic Consulting following construction and confirmed as suitable.

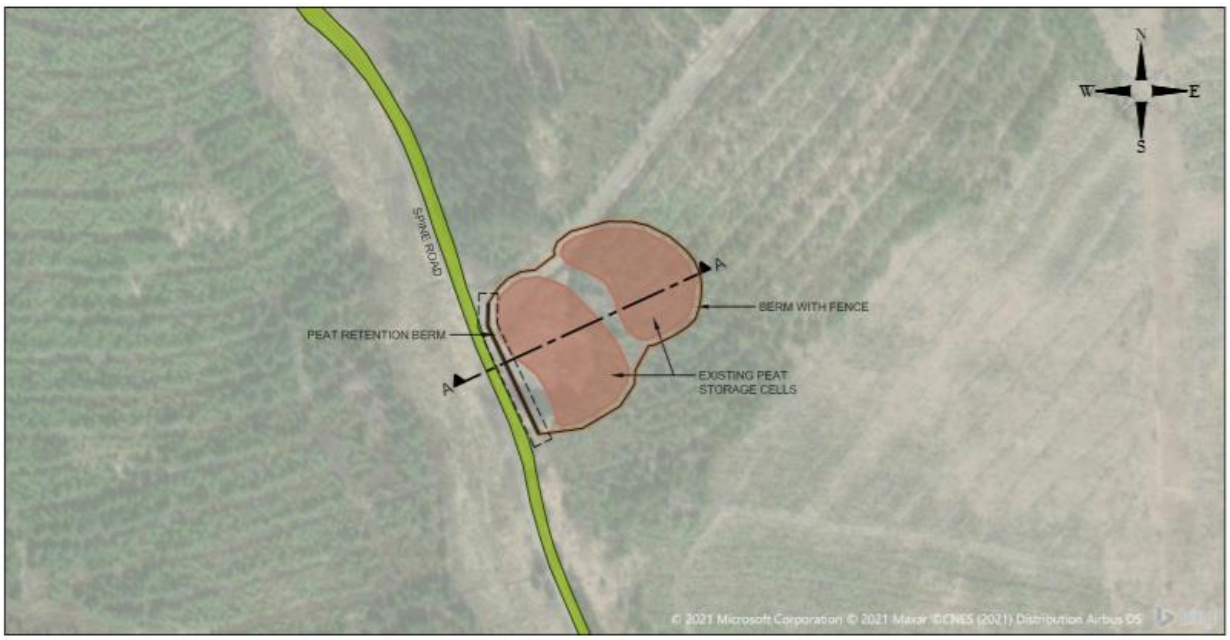
Figure 17 Peat Storage Cells South of Substation plan details

Peat Storage Cells are located south of the substation and adjacent to the site spine road. They are located at the site of an existing borrow pit which was expanded. This excavated area was subsequently used to create two cells to store peat, by constructing berms along the open (south-west) sides of the cell areas. A berm calculation has been included below to demonstrate the stability of the cell. Note that the overdesign factor for sliding is 1.63 for the most onerous case which is the Eurocode 7 uplift limit state under fully buoyant conditions. Details of this peat cell are included on drawing MNBG d021.4.1.

This area is bounded on the south-west side by the site spine road which is constructed to solid formation. The stability assessment of the peat indicates an adequate safety margin in this area.

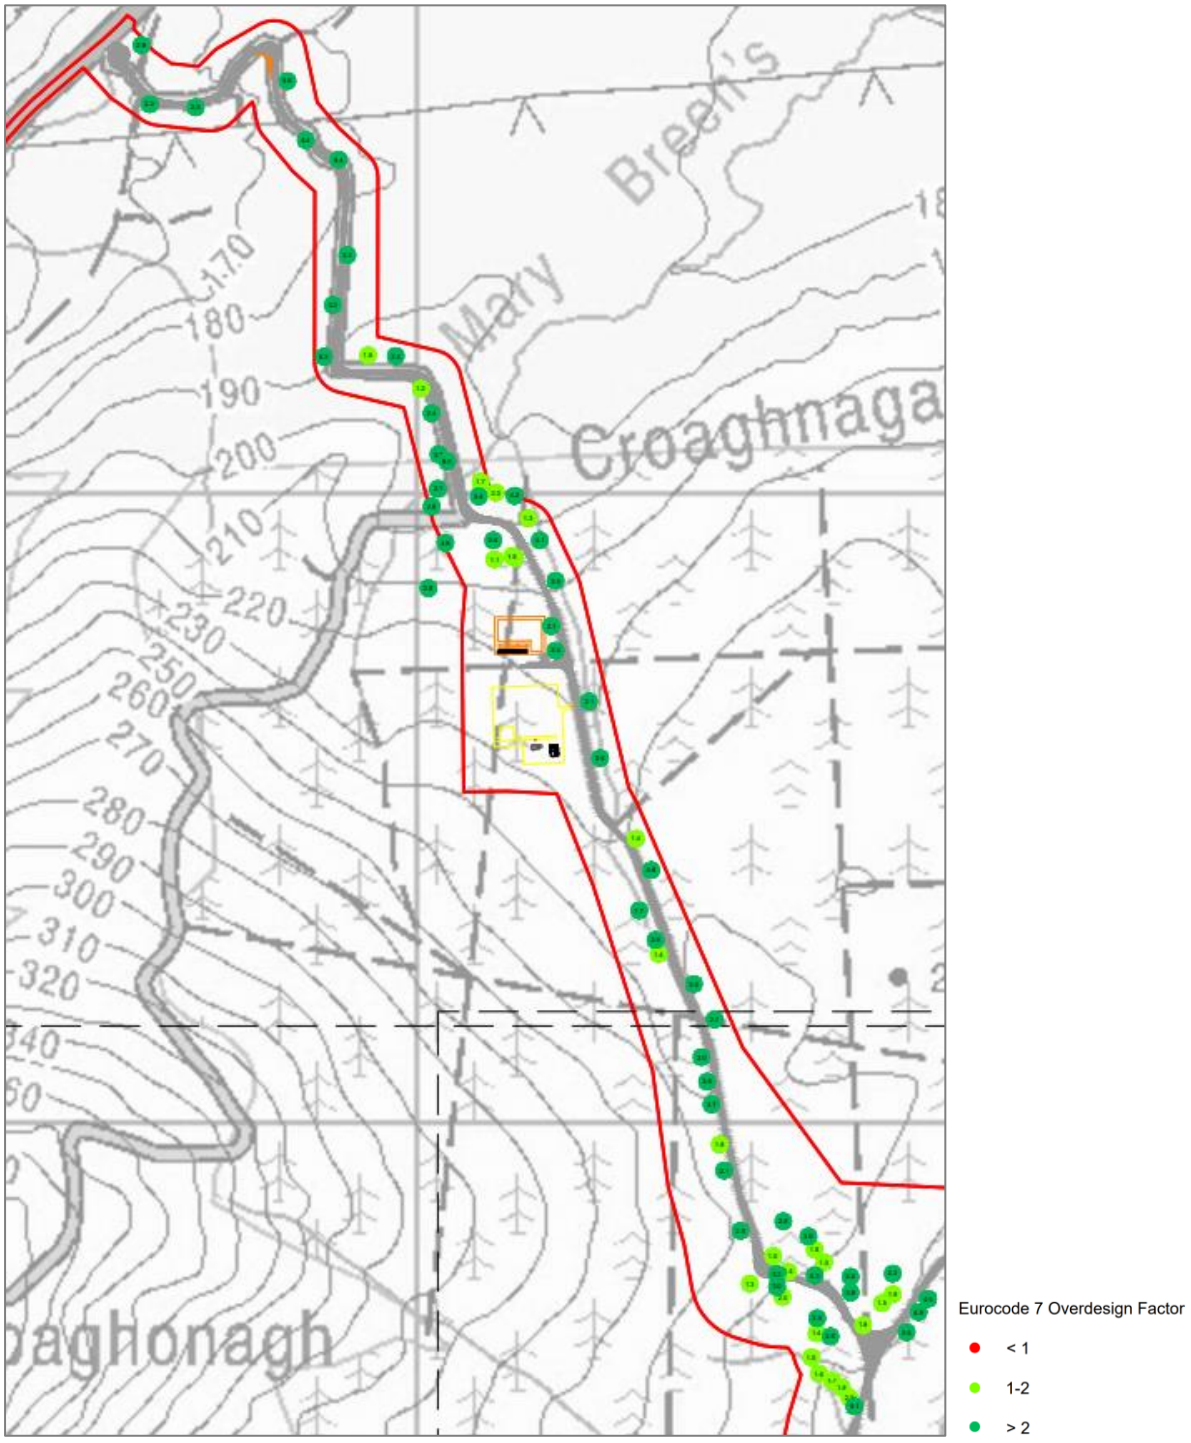
Figure 19 ODF results in this assessment section

The assessment along this section of road was based on 69 assessment points which were selected from a wider set of data points. The most onerous locations are selected based upon the lowest shear strengths or the deepest peat measured, with reference also to the gradients at different locations.

It should be noted that this road was constructed along an existing forest track which has been in place for decades. The road was widened by up to 2m but largely follows the original alignment. The upgraded wind farm road has been constructed to solid sub-formation.

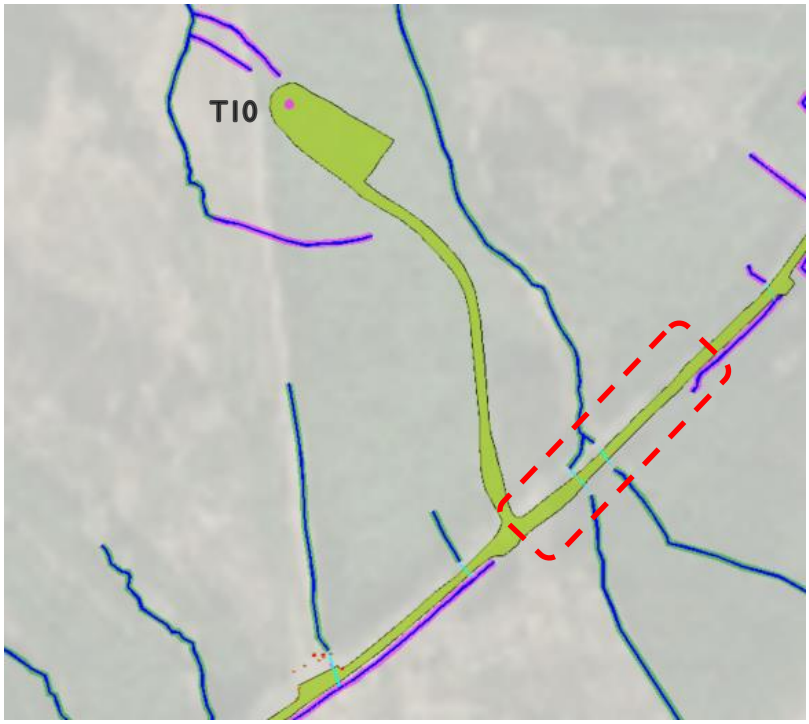
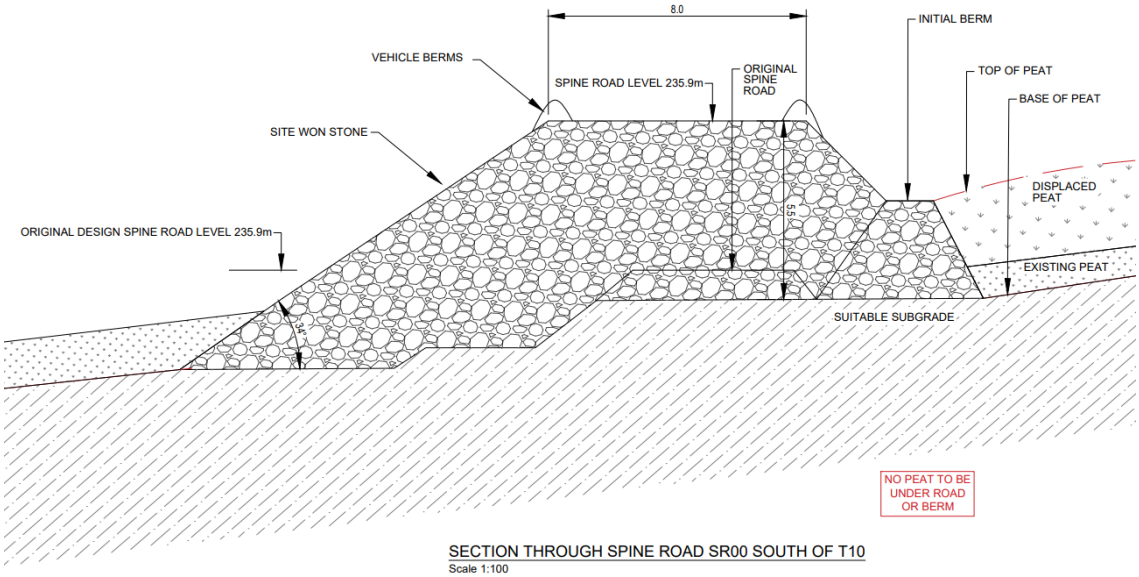
Figure 27 Spine Road south of T10 Peat Stabilisation Berm plan

This section of the spine road SR00 is located on the uphill side of turbine T10 spur road, hardstand and foundation. The road was raised as a result of the peat movement from T5/T6, which progressed beyond the T8 area and ended at the spine road at this location. The road was raised to ensure safe access through the end section of the peat movement and to mitigate against further peat movement if it were to occur.

The raised road was designed to ensure it could act to retain the peat if further movement was to occur. The design is included below along with a summary of the overdesign factors against sliding and overturning failure. Note that these calculations are carried out to Eurocode 7 IS EN 1997-1 with partial safety factors for loads and materials also applied.

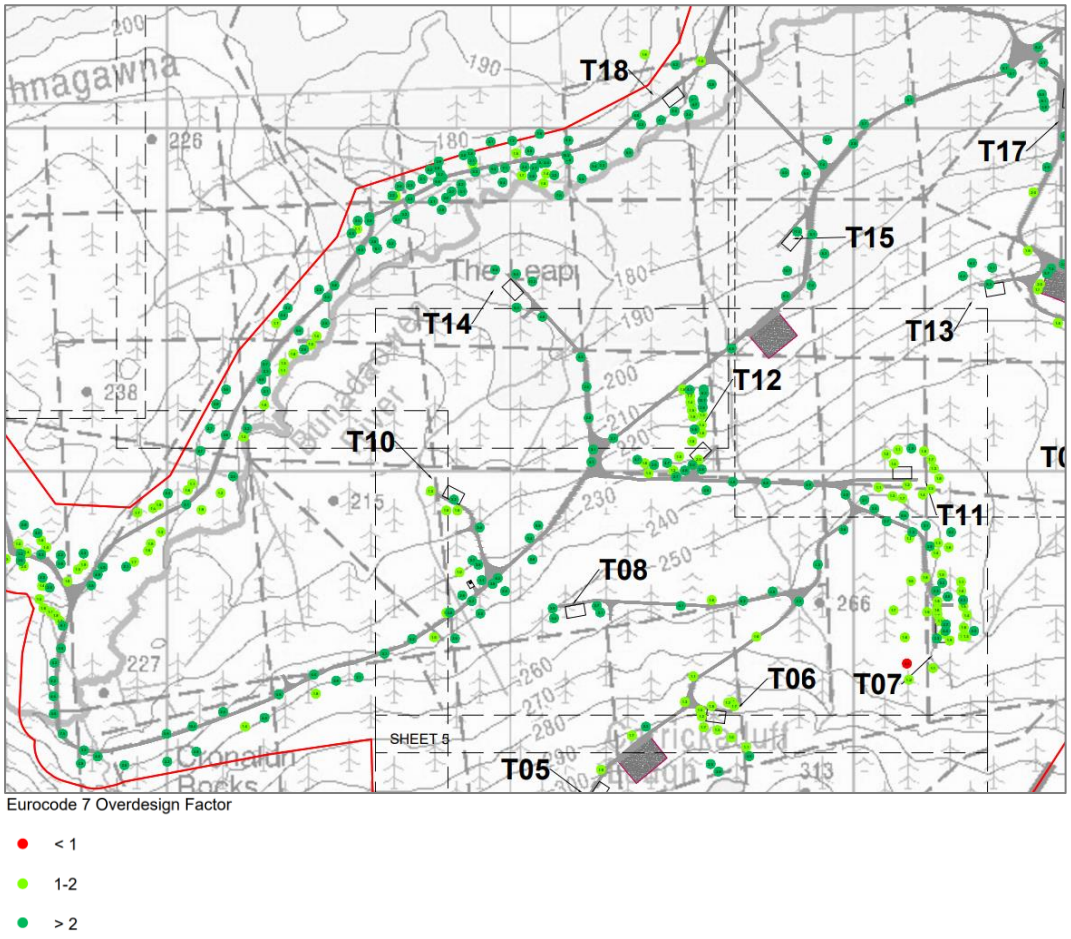
Figure 33 ODF results in this assessment section

The assessment indicates that this section of the site is stable and was based on 51 peat assessment points along the road, as well as stability assessments at Peat Storage Area 1, Borrow Pit A, Met Mast and bridge works.

The road was constructed along an existing forest track which has been in place for decades. It was widened by up to 2m but follows the original alignment. The upgraded wind farm road has been constructed to solid sub-formation. All peat containment berms are built on solid sub-formation and sized to provide the required safety margin in accordance with Eurocode 7

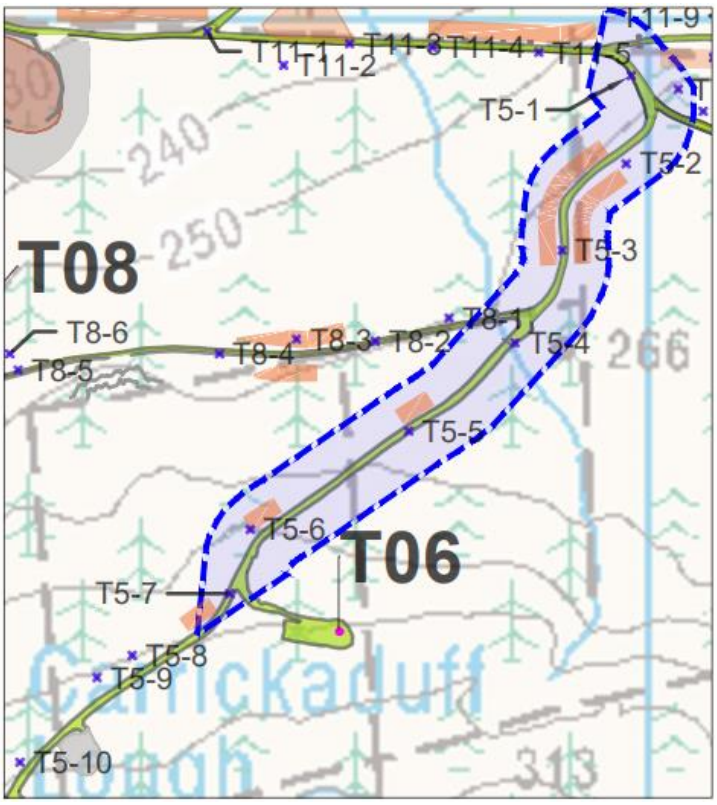
Figure 35 Section of T5 Road assessment area

The assessment indicates that this section of the site is stable, and that the safety margin is in excess of 1.0, as required to comply with Eurocode 7. The average overdesign factor is 2.4 along this section of road, values range from 1.09 to 4.3.

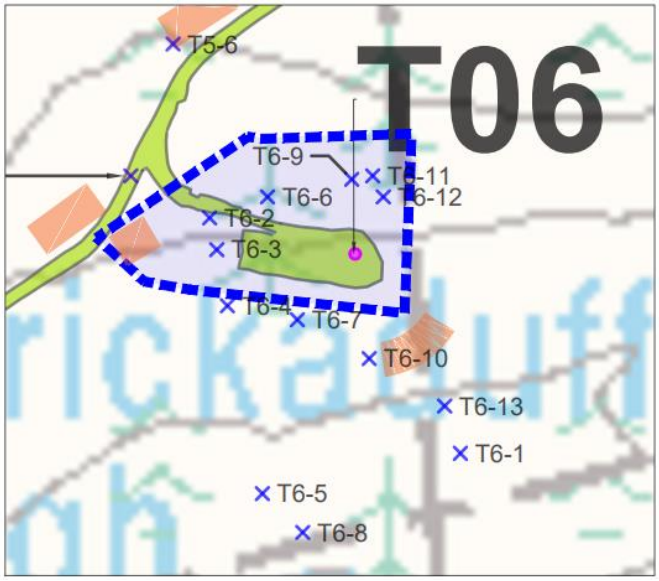
Figure 38 T6 peat stability assessment area

The assessment indicates that this section of the site is stable, and that the safety margin is in excess of 1.0, as required to comply with Eurocode 7. The average overdesign factor is 1.87, values range from 1.05 to 4.62.

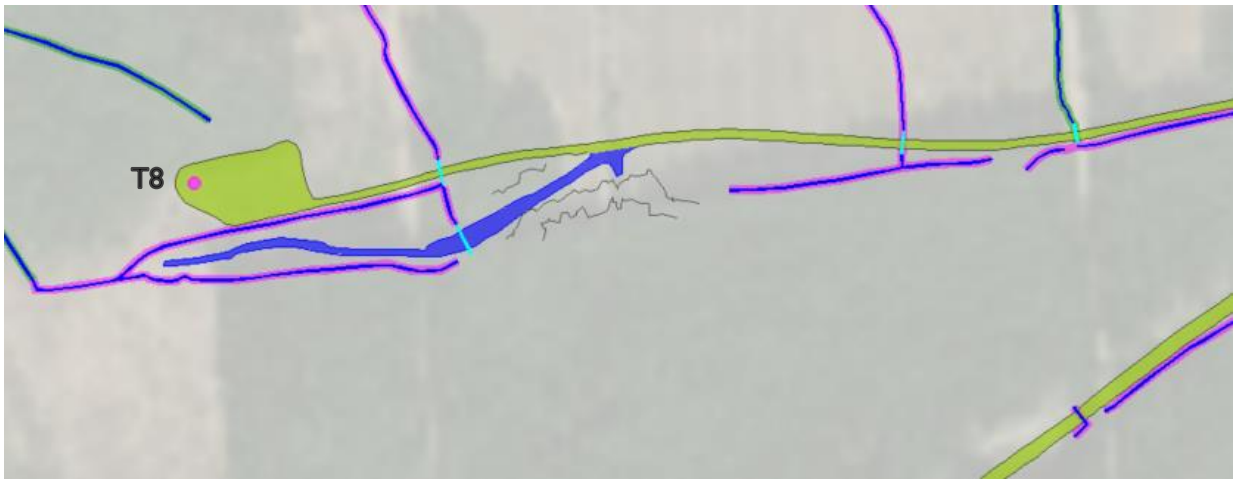
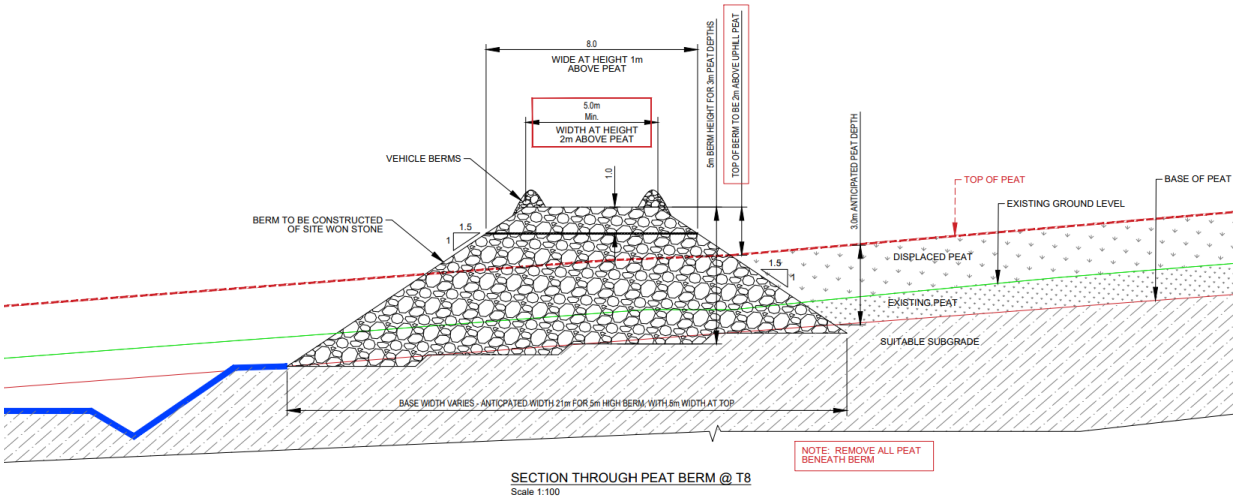
Figure 42 T8 Peat Stabilisation Berm plan

This berm is located on the uphill side of T8 spur road, hardstand and foundation. This berm was constructed through a previous peat movement to enable access to the T8 turbine area and mitigate against further peat movement in this area. The peat movement was from T5/T6 area down toward the main site spine road (Spine Road SR) to the south of T10. The berm was extended from stable ground on the east side and continued through the peat movement area, to just beyond the turbine foundation at the west side. The berm design is included below along with a summary of the overdesign factors against sliding and overturning failure. Note that these calculations are carried out to Eurocode 7 IS EN 1997-1 with partial safety factors for loads and materials also applied.

The stabilising berm provided upslope of T8 to contain displaced peat has a high overdesign factor of 3.65 against sliding under the most onerous Eurocode limit state.

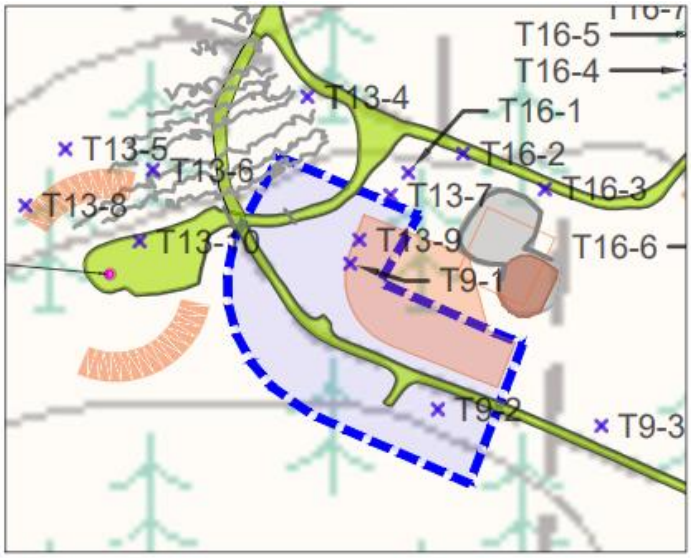
Figure 46 T9 Peat stability assessment area

The assessment indicates that this section of the site is stable, and that the safety margin is in excess of 1.0, as required to comply with Eurocode 7. The average overdesign factor is 3.75, values range from 1.65 to 12.0.
