PEAT STABILITY ASSESSMENT FOR MEENBOG WIND FARM SITE (FT, 2021)

Meenbog Wind Farm

Peat Stability Assessment of Meenbog Wind Farm Site

Abstract: This assessment addresses the stability of the site of the Meenbog Wind Farm, County Donegal following a peat failure at the site on 12 November 2020.

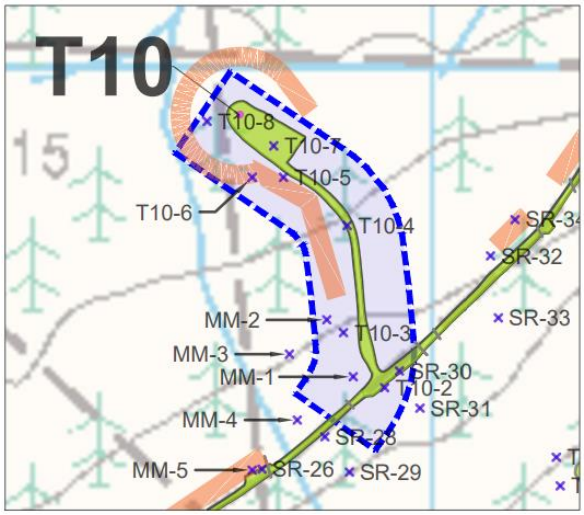
Figure 49 T10 Peat stability assessment area

The assessment indicates that this section of the site is stable, and that the safety margin is in excess of 1.0, as required to comply with Eurocode 7. The average overdesign factor is 2.52, values range from 1.29 to 3.76.

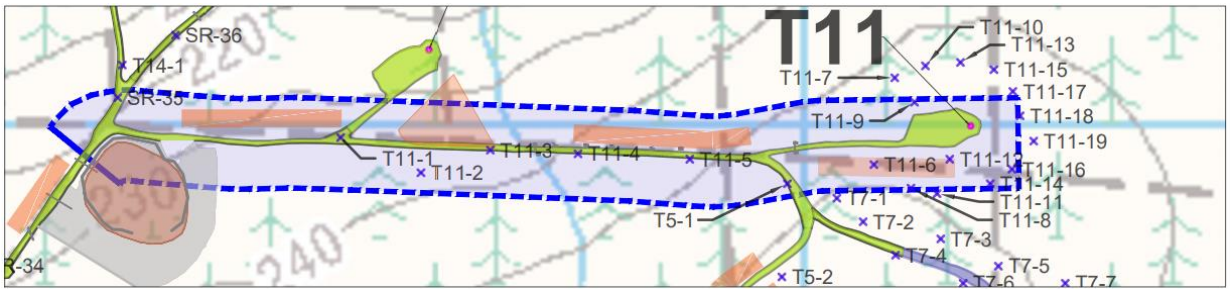
Figure 52 T11 Peat stability assessment area

The assessment indicates that this section of the site is stable, and that the safety margin is in excess of 1.0, as required to comply with Eurocode 7. The average overdesign factor is 2.25, values range from 1.08 to 6.83.

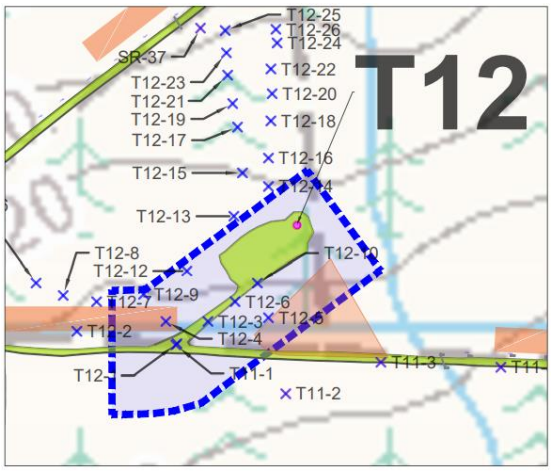
Figure 55 T12 Peat stability assessment area

The assessment indicates that this section of the site is stable, and that the safety margin is in excess of 1.0, as required to comply with Eurocode 7. The average overdesign factor is 3.02, values range from 1.02 to 10.67.

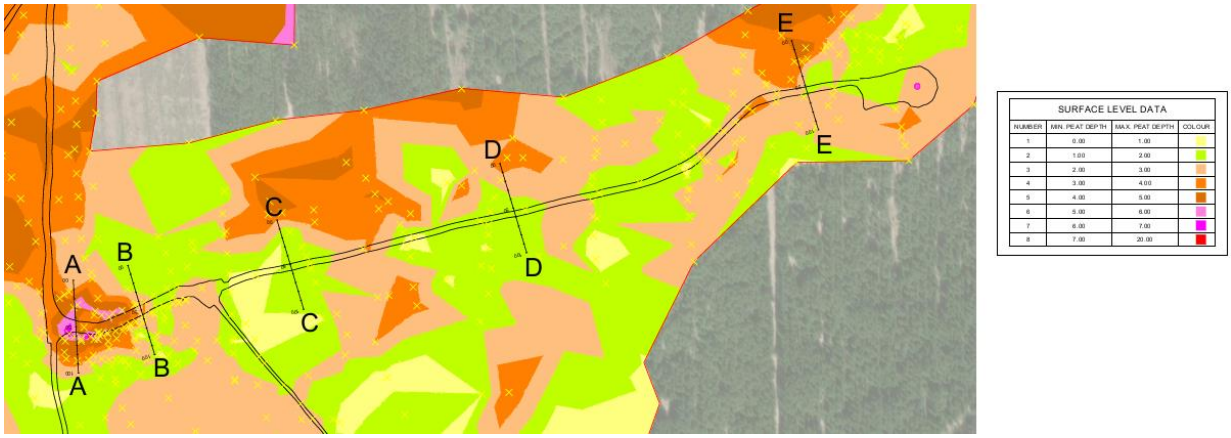
Figure 94 T4 Peat Depth Contour Map

The peat depth map below in Figure 94 indicates the deep peat at the junction, and Sections A-A and B-B show the subsurface slopes. Note that the deepest peat at the westernmost end of the spur road is within a bowl shaped deep pocket of peat, therefore the peat is largely confined as the subsurface is

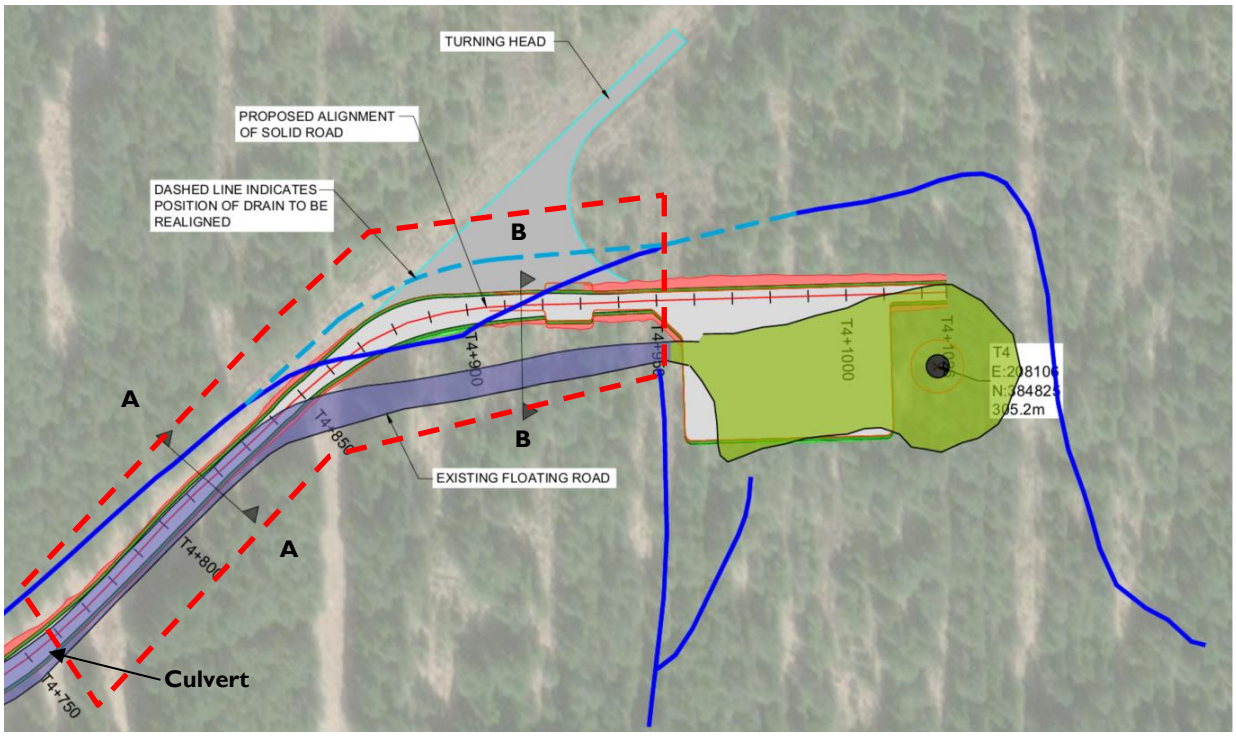
Figure 100 Proposed T4 road upgrade area illustrated with the red dashed line

Following a detailed re-assessment of the T4 floating road a short section of the floating road on the approach to the hardstanding was found to be potentially unstable under heavy crane loading. Point T4-1 below on the final S-bend had an overdesign factor <1 for crane loading, but >1 for all other load case

scenarios including permanent and construction loading. A cautious approach is being taken to increase the factor of safety before any heavy turbine components or cranes are delivered.

It is proposed to rebuild the section of road between the culvert and the hardstanding to solid sub-formation. The final 100m will also be realigned along the original planning alignment, correcting an earlier deviation which was governed by the turbine supplier specification limits for turning at a gradient in excess of 4%.

From the culvert (~Chainage 750) to Chainage 850 (where the road alignments deviate), the existing floating road will be incrementally removed by pulling back the engineering fill material and geogrid, before constructing the new road to solid subgrade using the excavate and replace method. The length of road to be realigned between Chainage 850 and T4 hardstand will be built incrementally using the excavate and replace method. Once this section of new road has been completed, the remaining section of floating road can be removed and the original bog reinstated. A method statement including sequencing of the works is to be prepared prior to construction commencing.

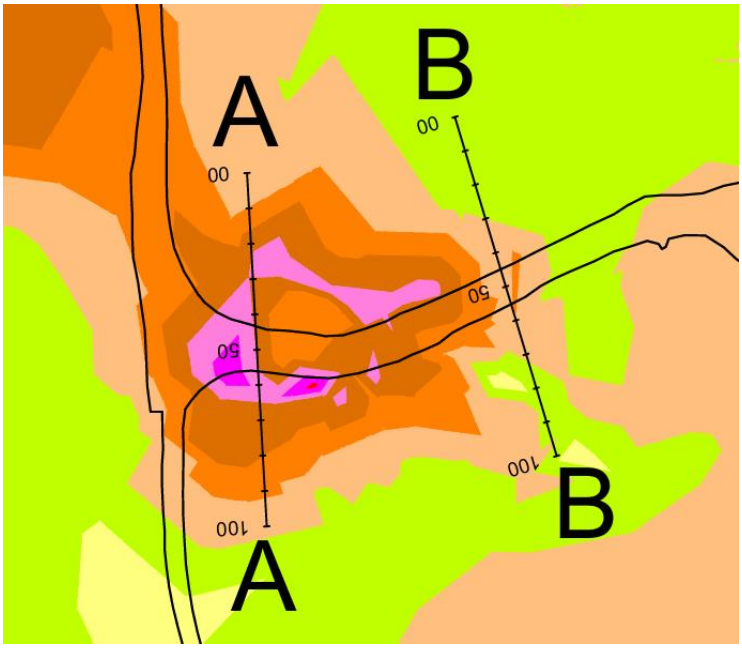
Figure 103 T4 Spur Peat Depths (T1-T2 Junction)

The deeper peat at the junction is shown below in Figure 103, depths between 5-7m were measured locally, but this deep pocket is largely surrounded by shallower peat <2m as indicated by the lighter green contours.

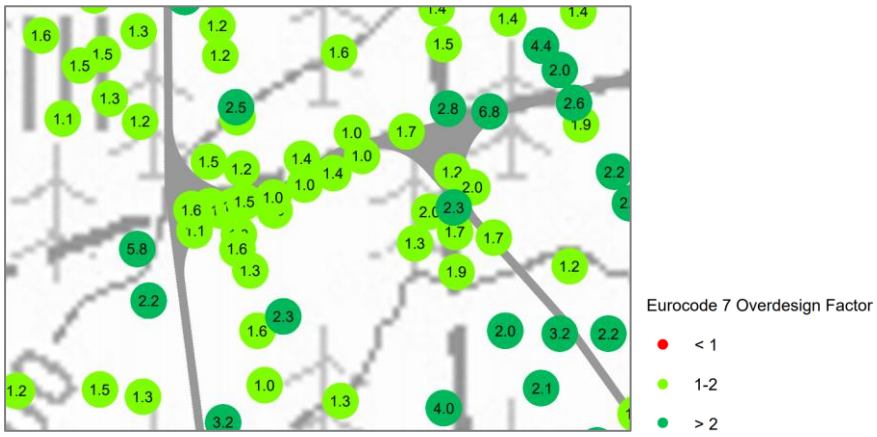
Figure 107 EC7 'overdesign' factors at T1/T2 junction

The EC7 'overdesign' factors indicated an adequate safety margin at all locations in this area. However as noted, visual observations and an assessment of the topography, potential flow paths and proximity of watercourses it was considered that a higher degree of caution is warranted at this locality. It is therefore proposed that, as a precautionary measure, a stabilising barrage will be constructed immediately downslope of the existing floating road between the T1 and T2 junctions.

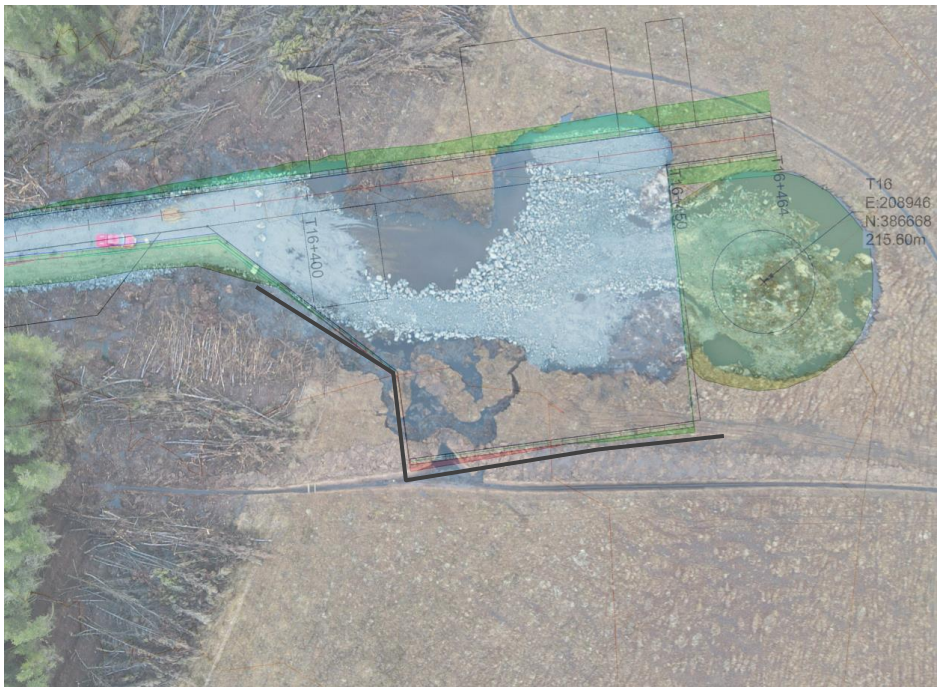
Figure 116 T16 aerial image with design layout

The T16 hardstanding was partially complete when works were halted on site and the image below shows the areas of the hardstanding yet to be constructed. The image illustrates the local area within the hardstanding plan where a local section of peat has displaced on the uphill side of the works. The design and construction methodology of the hardstand was developed in anticipation that such local movements may occur and the solid hardstand acts to control any local movements as the works are

advanced. As the works were suddenly stopped after the T7 slide the hardstand area was yet to be raised to the final level. The area in question is within the footprint of the hardstand and will be removed once the construction of the hardstand recommences. The partially constructed hardstanding provides stability to the upslope peat. Figure 117 below shows the hardstanding construction controlling local movement of peat within the footprint of the works area. The works area is shown in Figure 116 which is a recent aerial image with the design layout overlaid.

As noted above, the peat in the remaining section of hardstanding to be completed is contained and stabilised by the solid road and partially complete section of hardstanding which is on the downslope side of the works area. The turbine formation area has already been excavated as evident in the aerial image above.

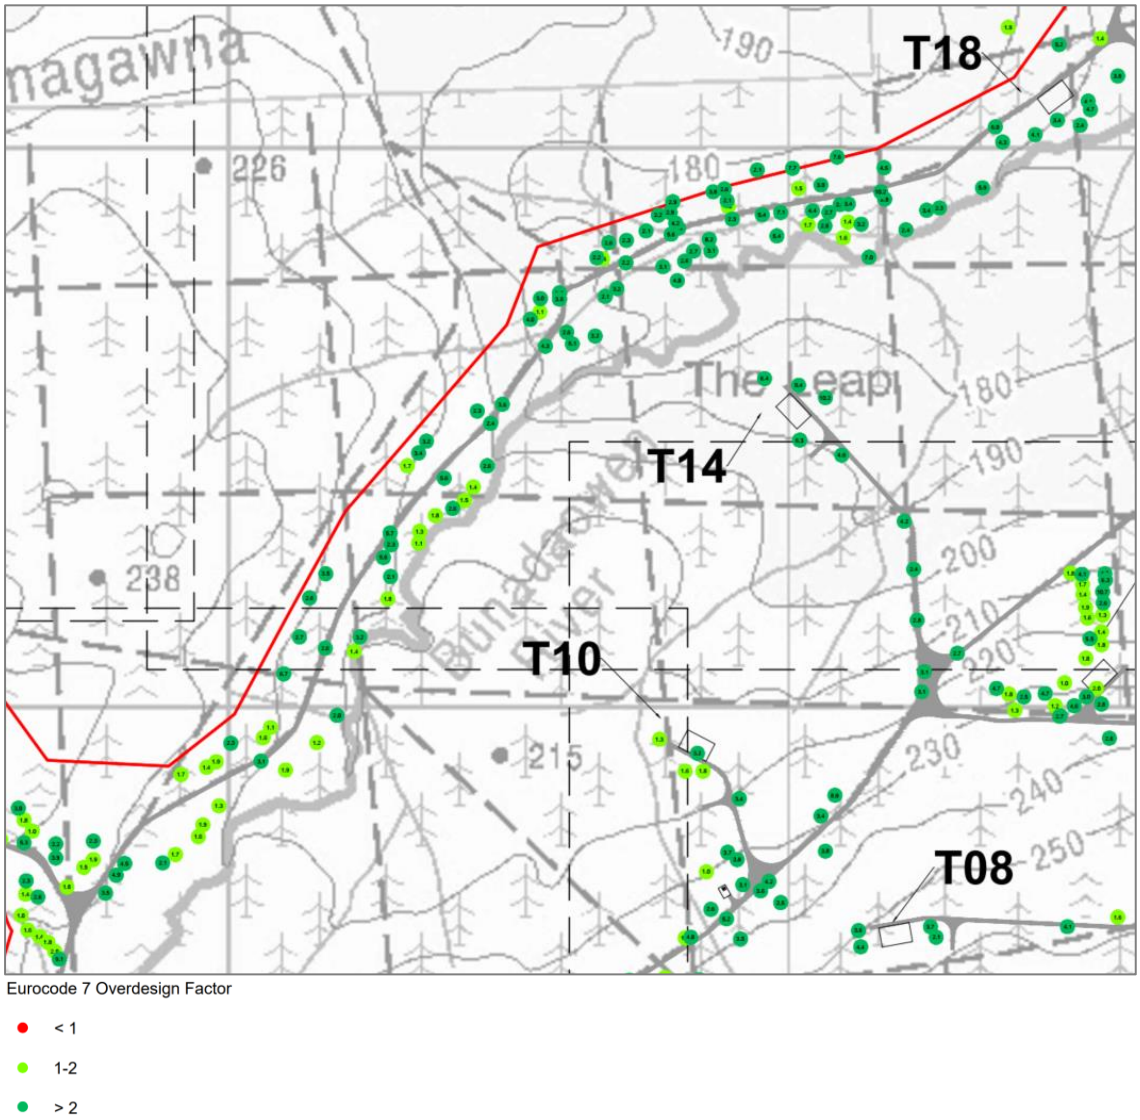
Figure 137 ODF results in this assessment section

The deeper peat areas were assessed in more detail to assess the local subsurface topography and carry out further assessment calculations. It was found that the overdesign factor in the deeper peat area ranged from 2.1 to 4.8 as slopes were generally shallower in this area.

Calculations were also carried out for the peat storage area where an overdesign factor of 1.68 was obtained for the most onerous Eurocode 7 limit state under buoyant conditions.

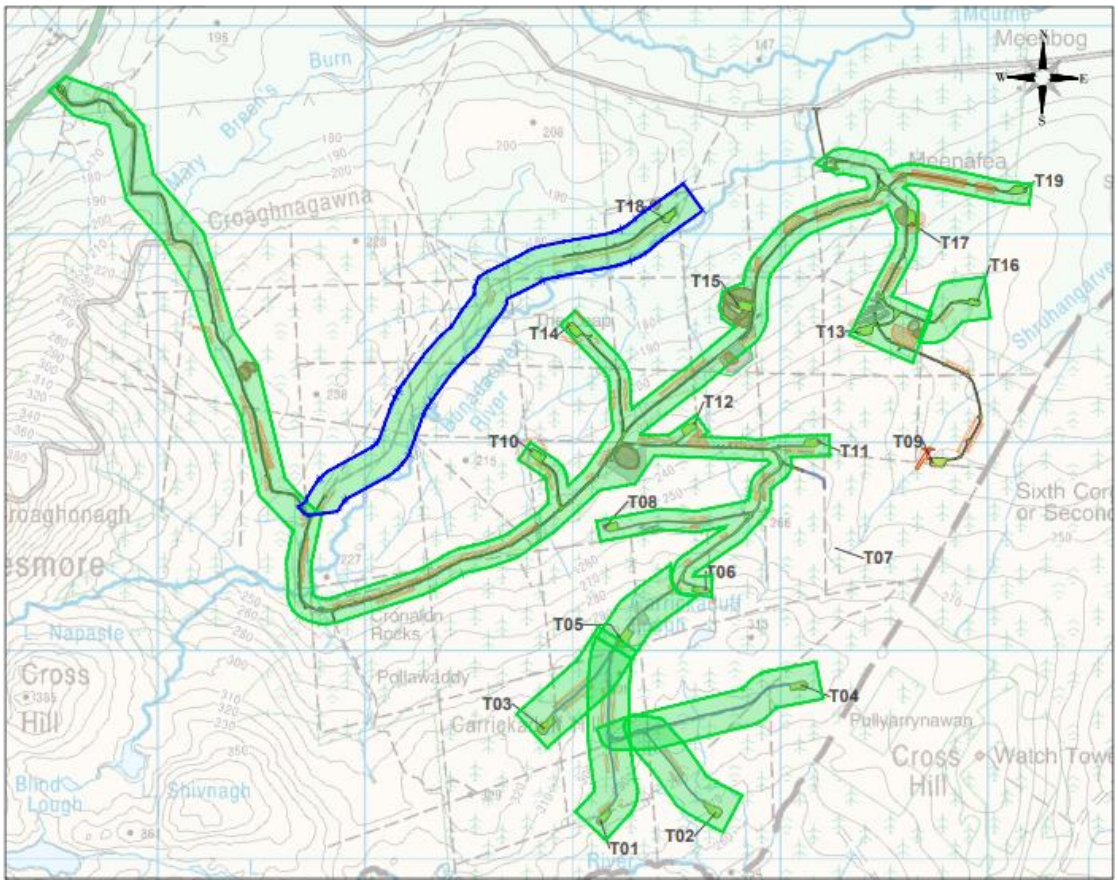
Figure 138 Outlined area has passed the assessment in this section

Zone 2 passes the assessment with an adequate safety margin provided the modification works outlined for the T4 floating road are carried out in accordance with the design, and provided the remaining T18 spur road works are carried out in accordance with the design and control measures outlined in the Fehily Timoney and Ionic report.

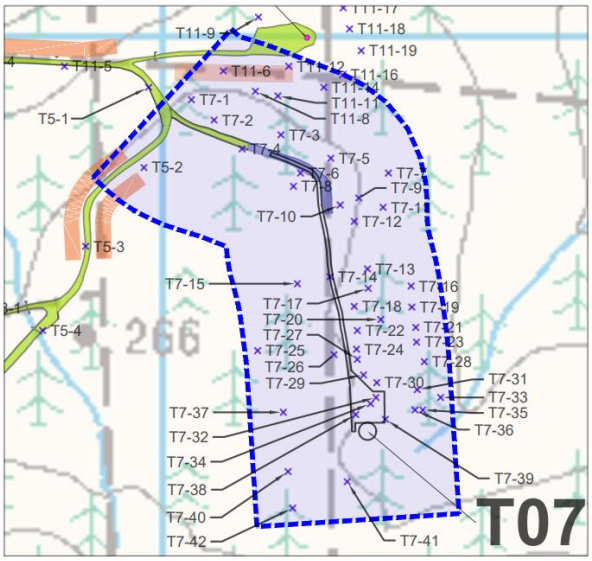
Figure 141 T7 assessment area

A number of assessment points are presented below which indicate an adequate safety margin at all locations other than T7-40 to the south west of the turbine location. Given that the stability calculations did not meet the EC7 requirement under certain loadcase conditions, additional peat probing and shear vane testing was carried out in that area, further details are presented below.

The following table summarises the 'overdesign' factors for this section of the T7 spur road. Note the value <1 at T7-40 which is a distance of 30-50m south west of the works area.

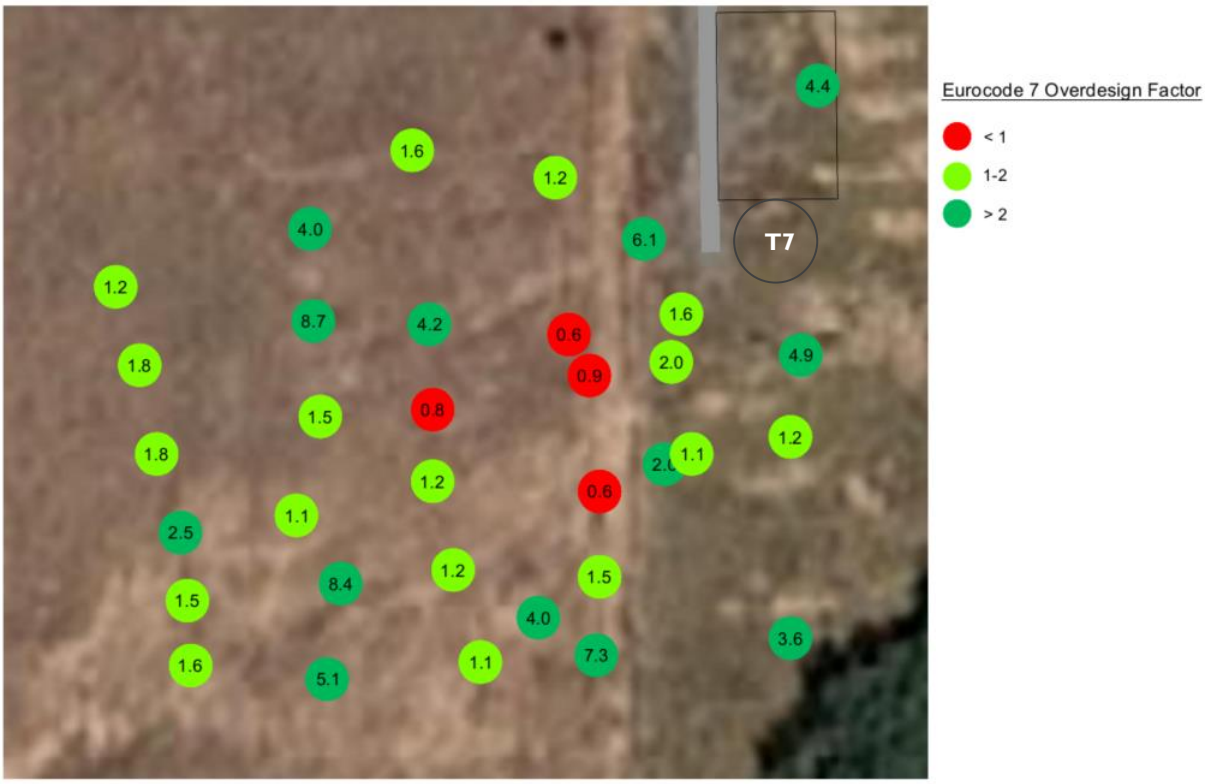
Figure 142 EC7 Overdesign Factors SW of T7

Although no works are proposed in this immediate area (the turbine foundation and hardstanding are east of the road alignment below), a significant number of additional test locations were assessed over a wide area. Subsurface profiles indicate a local bowl shaped deeper pocket of peat which is surrounded by shallower and more stable peat. Note that all green points are stable, with darker green indicating 'overdesign' factors >2.

Sections B-B and C-C below indicates the sub-surface slopes towards the red failure points, so the area is confined in terms of topography, and also surrounded by shallower and higher strength peat. Given the bowl shaped local subsurface topography it is likely that the peat is not just deeper but more heavily saturated and poorly drained, explaining the lower shear strengths.

Although it was not envisaged that tracked machines would need to be working at this distance from the works area, a strict no works zone will be implemented, with no vehicles permitted in the area immediately west and south west of the T7 foundation excavation works area. It should be noted that the area immediately surrounding the foundation indicates high 'overdesign' factors between 1.6 and 4.9. The peat depth at the turbine centre is 1.7m and the proposed foundation blinding level is 1.8m below ground level therefore relatively shallow excavations will be required for the turbine foundation. Further details are presented below in Section 6.1.1 for the proposed construction works. A detailed RAMS will be prepared by MCE prior to works being resumed in this area.

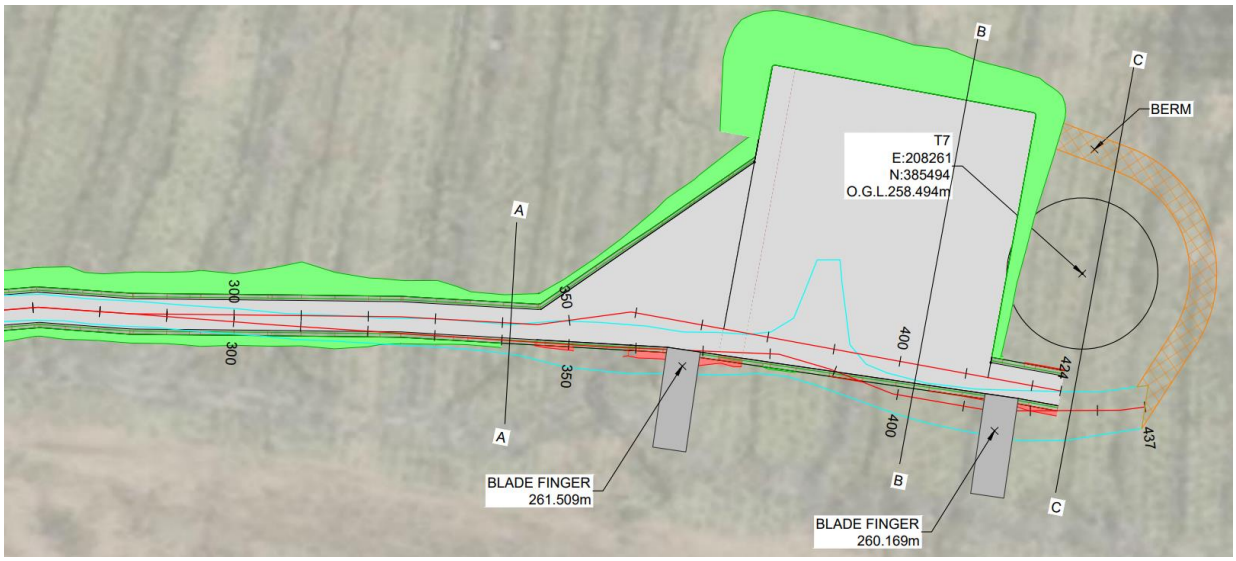
Figure 147 T7 Turbine and Hardstanding plan

The peat depths in the immediate area of the T7 turbine are shallower than along the approach road. The peat depth at the turbine centre is 1.7m, and varies from 1.6 to 2.2m in the hardstanding area, whereas peat depths of up to 3.4m were measured along the access road. As shown above in Figure 147 the overdesign factors in the works area are between 1.6 and 4.9, primarily due to the shallower peat.

Based upon the geotechnical data available it is anticipated that suitable formation will be achieved almost directly below the peat as very shallow mineral deposits exist in this area. The turbine sub-formation will be on the underlying strong phyllite bedrock at an anticipated depth of 2m below original ground level. A deep excavation is not therefore required at T7 but a peat stabilising berm (refer Section 3.3) will be constructed surrounding the foundation area prior to excavation to formation level. Updated RAMS will be prepared along with additional monitoring measures prior to construction of the T7 road, turbine base and hardstanding.

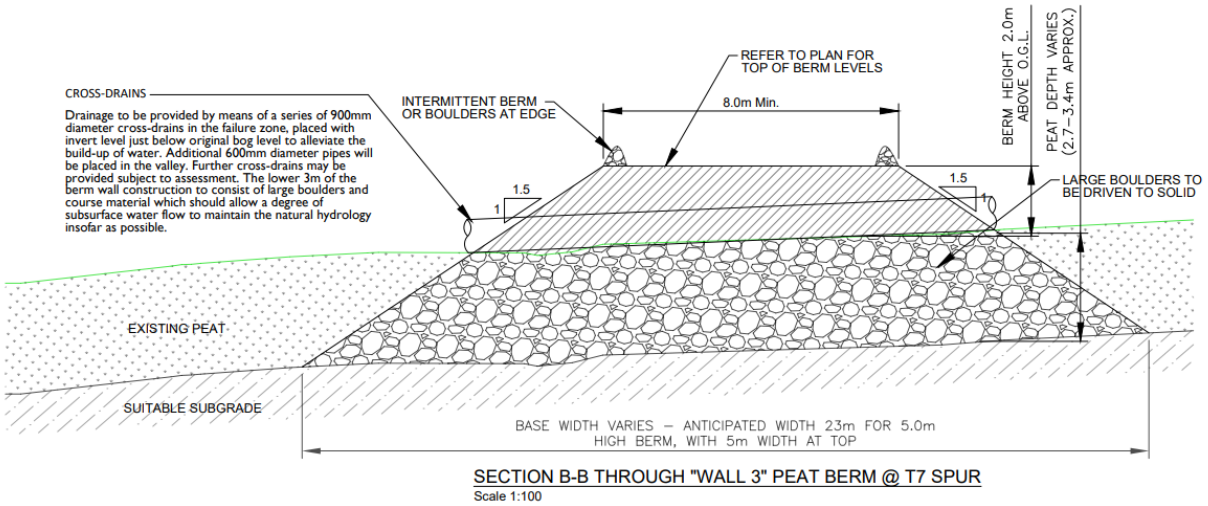
Figure 150 Wall 3 section detail

Wall 3 is located along/adjacent to the T7 spur road. This berm stabilises the failure area uphill of the T7 spur road and continues further south beyond the region of bog that has been compromised. The berm design is included below along with a summary of the factors of safety against sliding and overturning failure. Note that these calculations are carried out to Eurocode 7 IS EN 1997-1 with partial safety factors for loads and materials also applied.

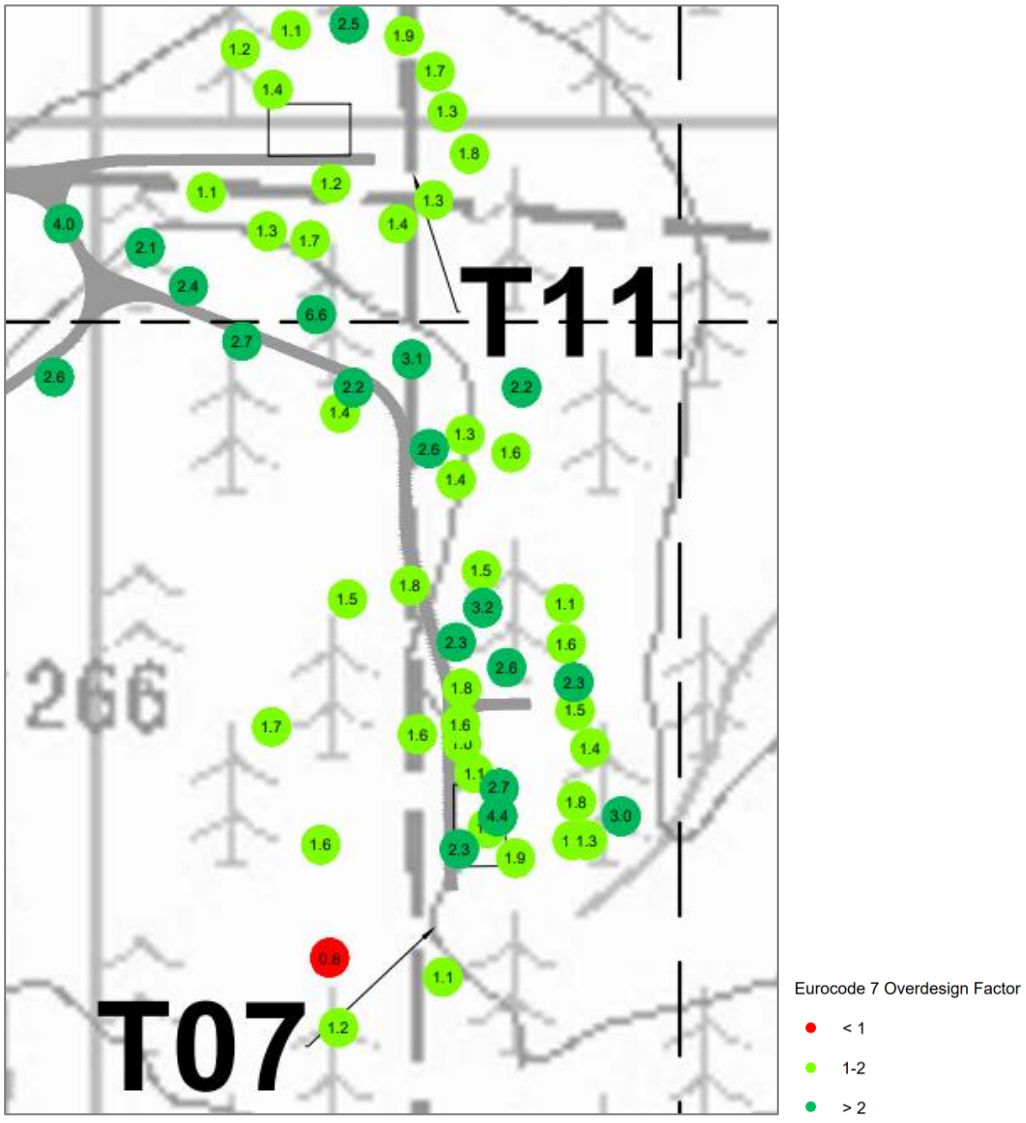
Figure 151 ODF results in this assessment section

The assessment determined the area in question is confined in terms of sub-surface topography, and also surrounded by shallower and higher strength peat. As a precautionary measure a no works zone will be implemented, with no construction vehicles permitted in the area immediately west and south west of the T7 foundation excavation works area.

The assessment indicated high 'overdesign' factors between 1.6 and 4.9 in the area immediately surrounding the foundation. A deep excavation is not required at T7 but a peat stabilising berm will be constructed surrounding the foundation area prior to excavation to formation level. Hardstand excavations will be bounded by Wall 3 on the uphill side and the foundation berm to the south. Updated RAMS will be prepared along with additional monitoring measures prior to construction of the T7 turbine base and hardstanding.

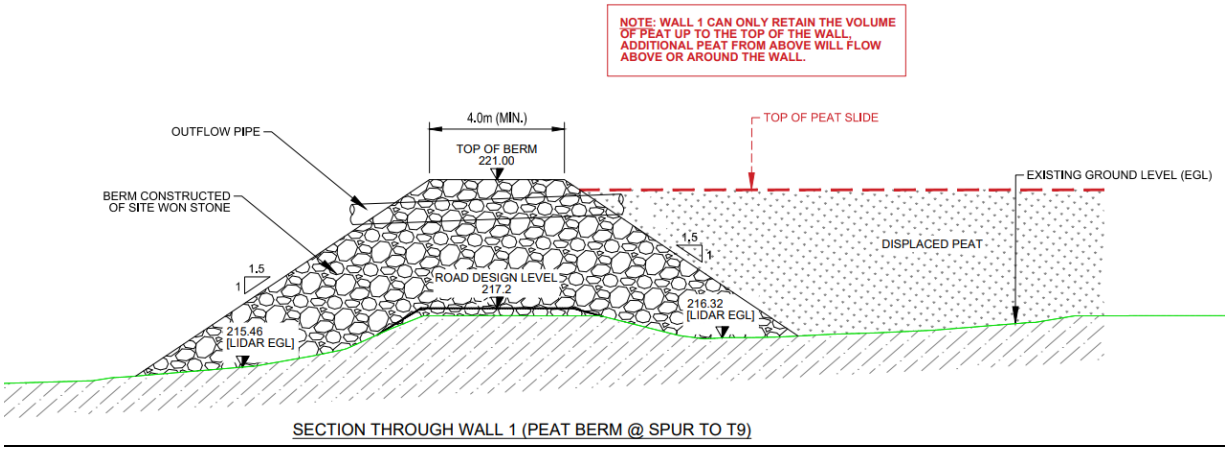
Figure 154 Wall 1 section detail

The level of water and peat contained behind Wall 1 was at 220.3mOD. The top of the berm is at 221.0mOD. Original ground was approximately 216.3m OD on the upslope side of the berm and 215.5mOD on the downslope side.

The berm design is included below along with a summary of the factors of safety against sliding and overturning failure. Note that these calculations are carried out to Eurocode 7 IS EN 1997-1 with partial safety factors for loads and materials also applied.

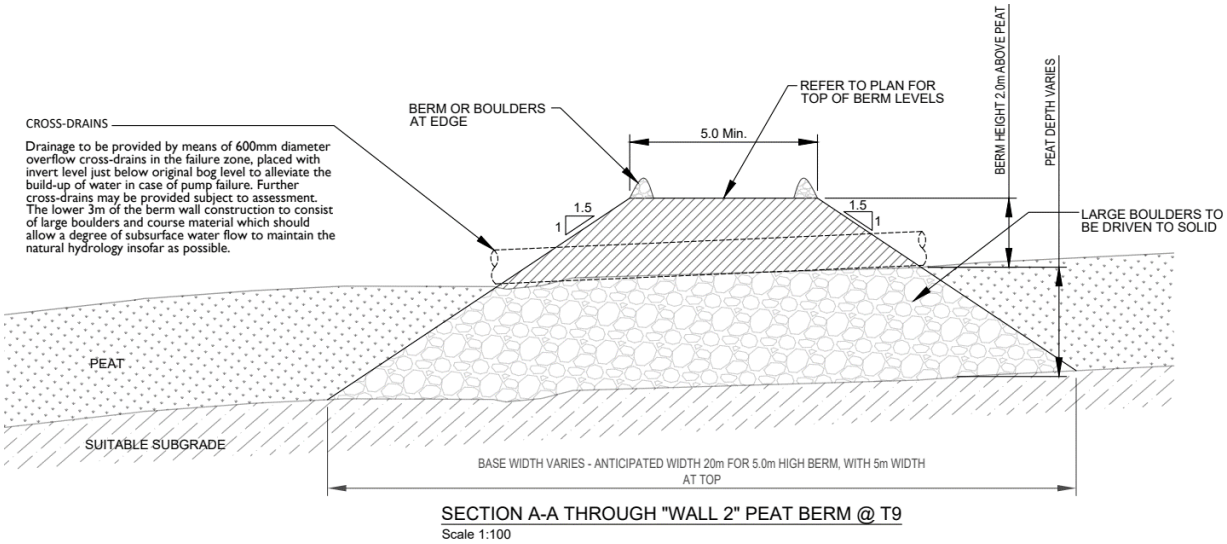
Figure 155 Wall 2 section detail

Wall 2 is located in the vicinity of turbine T9. The berm design is included below along with a summary of the factors of safety against sliding and overturning failure. Note that these calculations are carried out to Eurocode 7 IS EN 1997-1 with partial safety factors for loads and materials also applied. This berm was the last of the three berms to be constructed, once the slide area above Walls 1 and 3 had been stabilised.

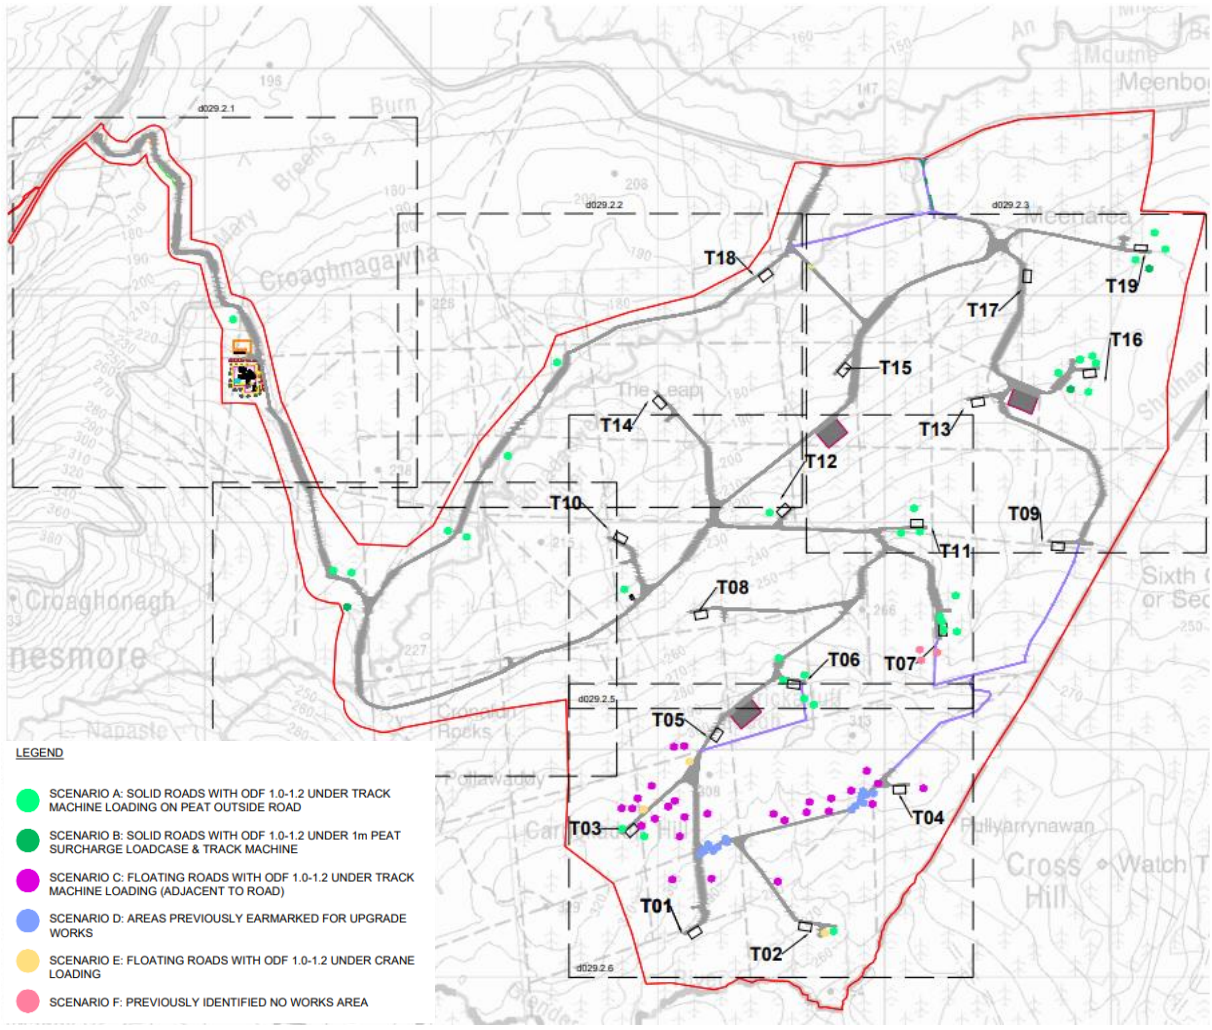
Figure 159 ODF values <1.2 [refer to maps in Appendix I]

SCENARIO	NUMBER
SCENARIO A: SOLID ROADS WITH ODF 1.0-1.2 UNDER TRACK MACHINE LOADING ON PEAT OUTSIDE ROAD	38
SCENARIO B: SOLID ROADS WITH ODF 1.0-1.2 UNDER 1m PEAT SURCHARGE LOADCASE & TRACK MACHINE	3
SCENARIO C: FLOATING ROADS WITH ODF 1.0-1.2 UNDER TRACK MACHINE LOADING (ADJACENT TO ROAD)	28
SCENARIO D: AREAS PREVIOUSLY EARMARKED FOR UPGRADE WORKS	16
SCENARIO E: FLOATING ROADS WITH ODF 1.0-1.2 UNDER CRANE LOADING	3
SCENARIO F: PREVIOUSLY IDENTIFIED NO WORKS AREA	1
TOTAL	**89**

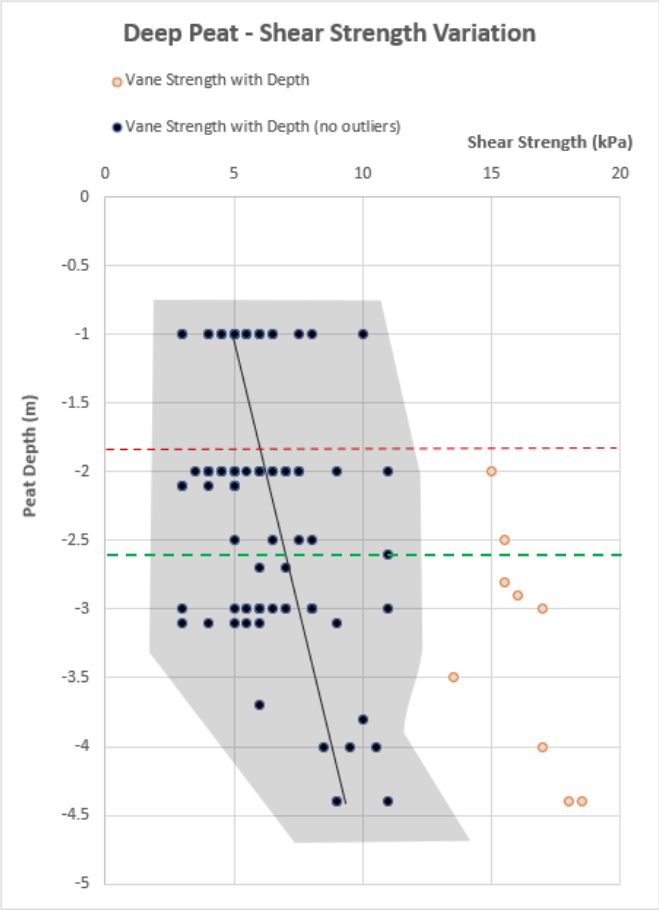
Figure 160 Peat shear strength test results in areas of deeper peat

The test locations with results deeper than 2m are plotted in the following figure, which generally indicates a slight increase in strength with depth for this set of test results. A series of relatively high shear vane results (orange circles) were discounted as outliers. These results were obtained close to base of peat in some locations and may be an indication the test was partially completed in the sub-soil at that depth. These discounted results were not relied upon in the stability assessment or sensitivity analysis calculations. A trend line has been plotted, however it should be noted that this is for illustration purposes and was not used as a design line.

The red dashed line indicates the average depth of peat across the site (approximately 1.8m) and the green dash line indicates the average peat depth (approximately 2.6m) at additional test locations.

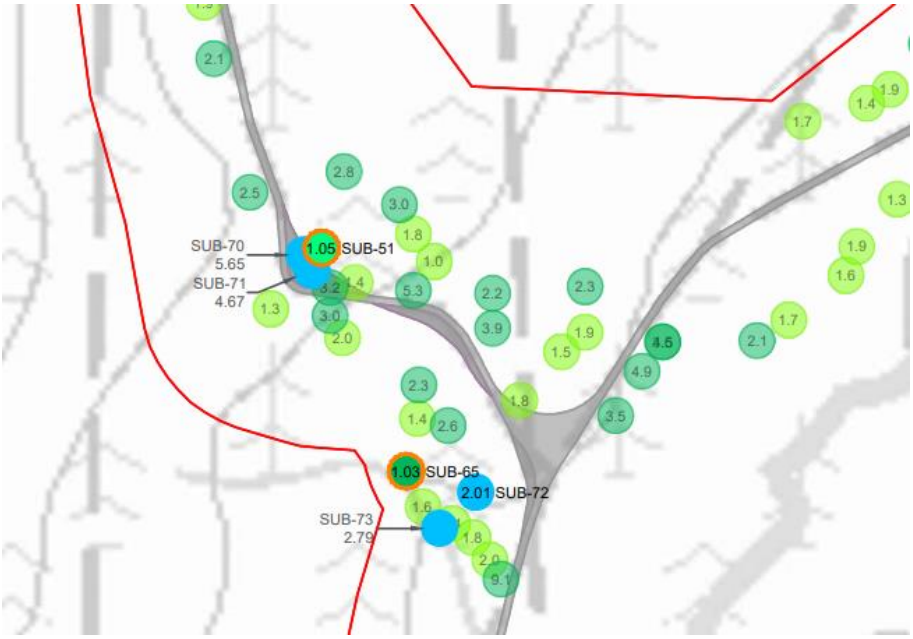
Figure 163 ODF values

An additional assessment was completed at 2 locations between the road and ODF SUB-51. The additional assessment indicates that this area is stable, and that the new ODFs are 5.65 and 4.67. The peat depths in the vicinity of the road are shallow (<1m) whereas the peat depth was 3m at the SUB-51 location. Therefore, the new ODFs (SUB-70 and SUB-71) are more representative of conditions in the vicinity of the road. No vehicles are to track off the existing road without a prior assessment being completed by Ionic.

An additional assessment was completed between the road and ODF SUB-65, as well as another location to the south, where a second shear vane test was completed at depth. The additional assessment indicates that this area is stable, and that the new ODFs are 2.01 and 2.79. The peat depths closer to the road are shallower (1.2 and 2.5m) whereas the peat depth was 5.3m at the SUB-65 location. Therefore, the new ODFs (SUB-72 and SUB-73) are more representative of conditions in the vicinity of the road. No vehicles are to track off the existing road without a prior assessment being completed by Ionic.

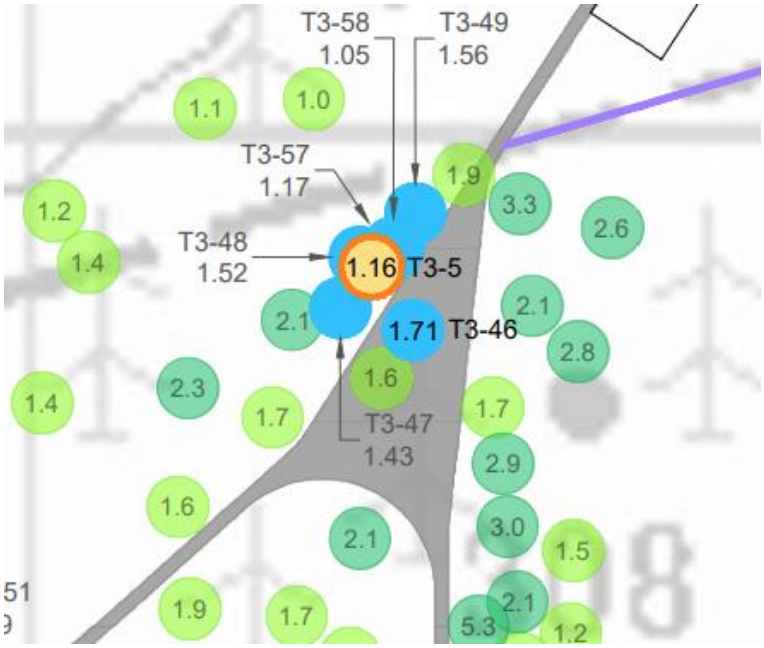
Figure 167 ODF values in the vicinity of T3-5

An additional assessment was completed at 14 locations in proximity to the ODFs in question. The assessment indicates that these areas are stable, and that the ODF values are greater than 1.0, as required to comply with Eurocode 7. Two supplementary assessment points T3-57 and T3-58 returned ODF values of 1.17 and 1.05. Both points are directly adjacent to the point of interest T3-5.

The following figure indicates the ODFs assessed (orange circle) and the supplementary assessment points (blue). Previous ODFs completed for the stability assessment are indicated but faded. T7-57 and T7-58 are immediately adjacent to T3-5 and confirm the previous assessment finding in the immediate location, however the surrounding assessment points confirm higher ODFs in the area.

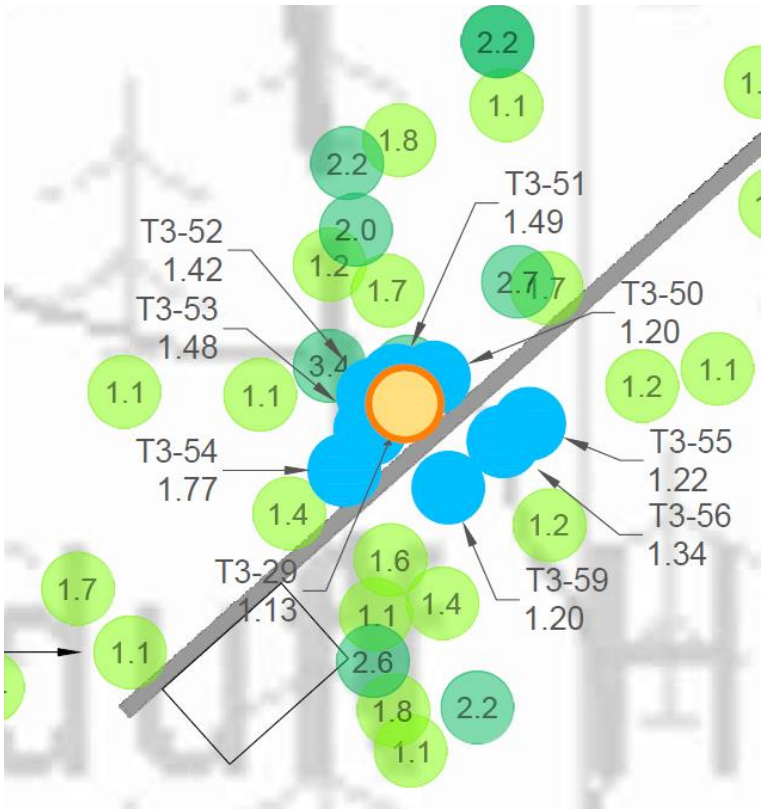
Figure 168 ODF values in the vicinity of T3-29

Supplementary assessment indicates ODF values >1.2 in the area surrounding the areas of interest. Supplementary testing was completed. Peat testing within the bottom 1m of peat has been completed throughout the areas being assessed.

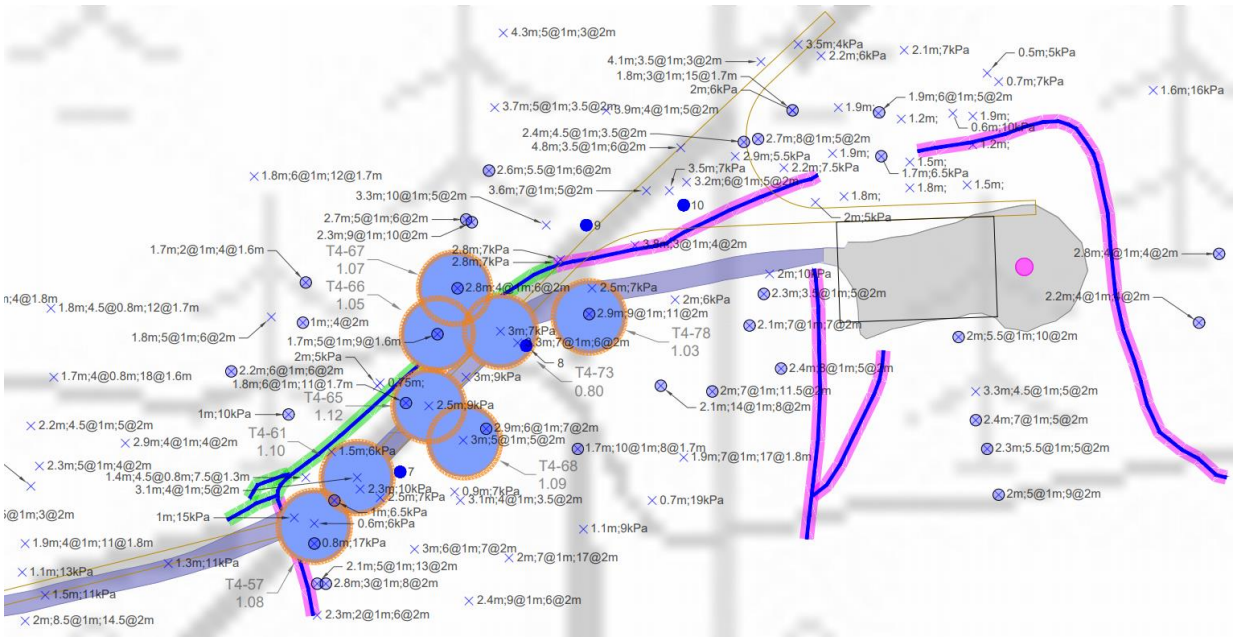
Figure 171 Peat testing – T4 hardstand area

The supplementary testing at T4 access road ensures that shear vane test results were obtained at depth across the works areas and assist in verifying the previous test results and stability assessment. One test at location 10 above indicated a lower shear strength of 3.5kPa at 2m depth, however this area of peat will be removed when the road is reconstructed following the detailed methodology outlined in the RAMS.

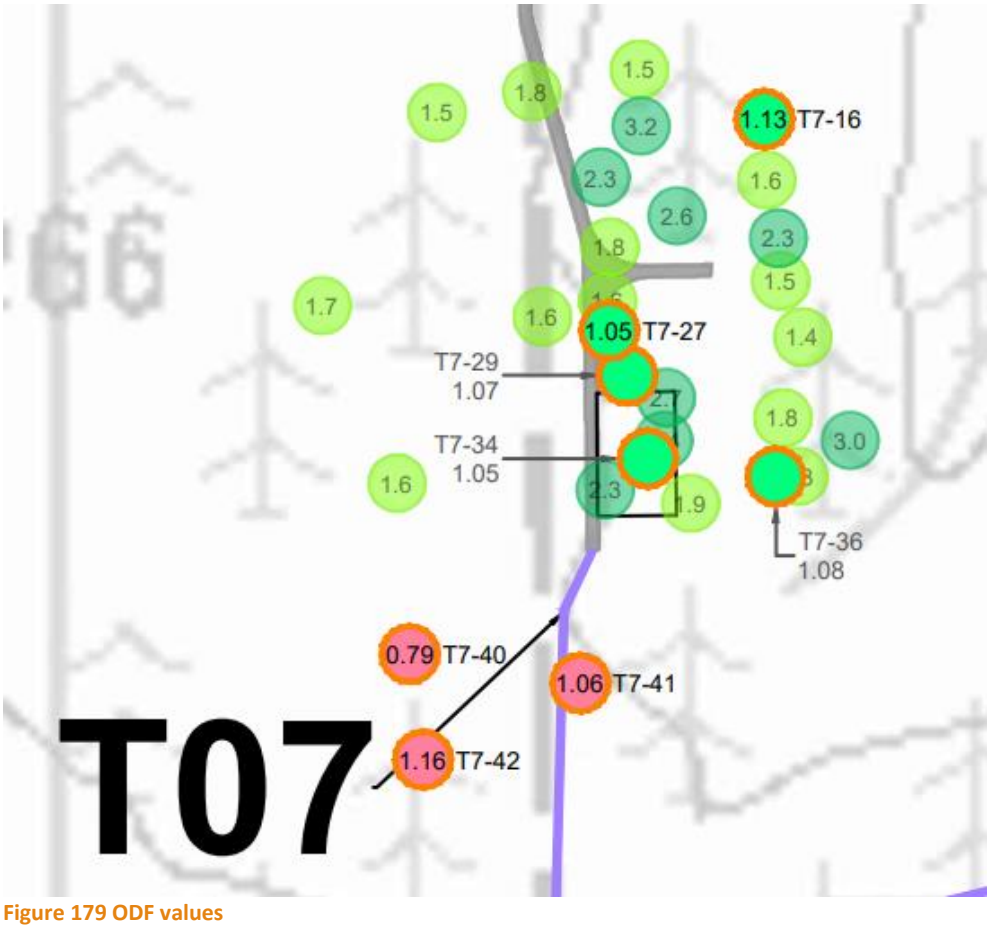
Figure 179 ODF values

Given the extensive testing coverage at this location it was not deemed necessary to complete more testing for this supplementary assessment. The following is an assessment of each ODF point with a value less than 1.2.

- T7-34: This point is surrounded by ODF values of 4.4, 1.9 and 2.3. It is located where the hardstand will be constructed to solid formation.
- T7-36: The ODF is located ~40m downslope of the proposed hardstand. There is an adjacent ODF of 1.3 and 1.8, and it is noted that the peat is shallow at 1.2m depth at this location.

Works will be advanced from solid construction (as previously planned) to avoid the need for plant to track over peat. No vehicles to track onto peat. Signage to be erected to indicate prohibition of construction vehicles tracking off-road. There is a no works zone to be enforced in an area south of T7 turbine works zone.

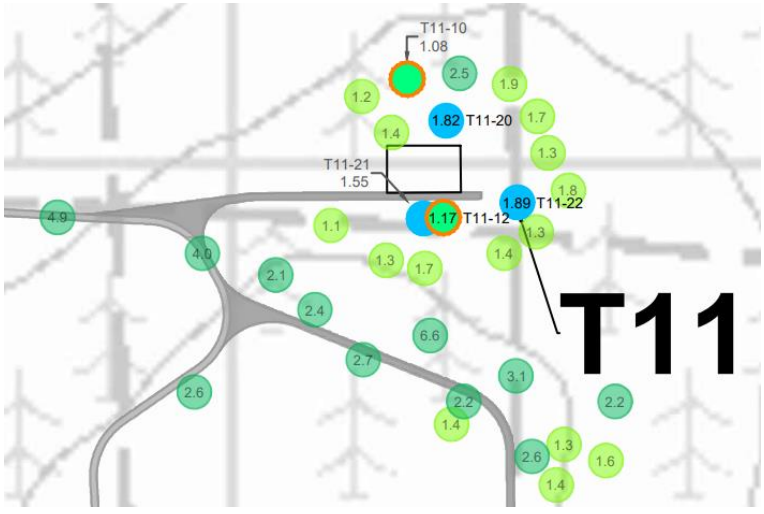
Figure 182 ODF values

Supplementary testing was completed in the area of deeper peat. Peat testing within the bottom 1m of peat has been carried out throughout this area. Existing and supplementary ODF values >1.2 are in proximity to the areas of interest. Vehicles will not be permitted to track over peat without a prior location specific assessment by Ionic.

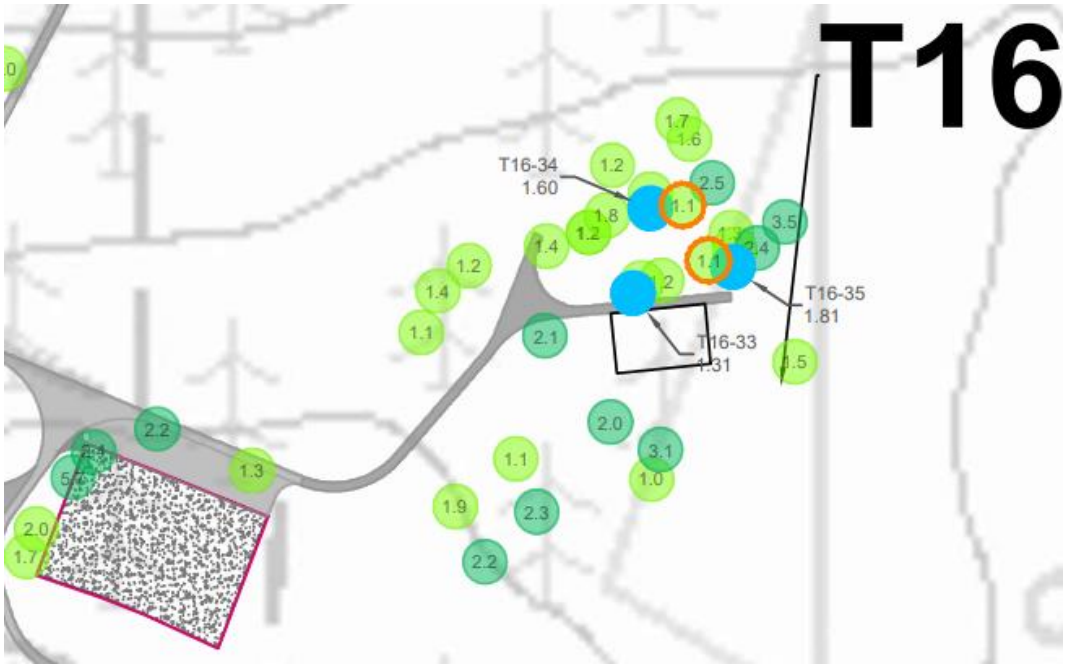
Figure 185 ODF values

Supplementary testing was completed in the area of deeper peat and testing has now been completed within the bottom 1m of peat throughout this area. Existing ODF values >1.2 surround the area of interest, and supplementary assessment points indicate ODF values >1.2.
