PEAT STABILITY ASSESSMENT FOR MEENBOG WIND FARM SITE (FT, 2021)

Meenbog Wind Farm

Peat Stability Assessment of Meenbog Wind Farm Site

Abstract: This assessment addresses the stability of the site of the Meenbog Wind Farm, County Donegal following a peat failure at the site on 12 November 2020.

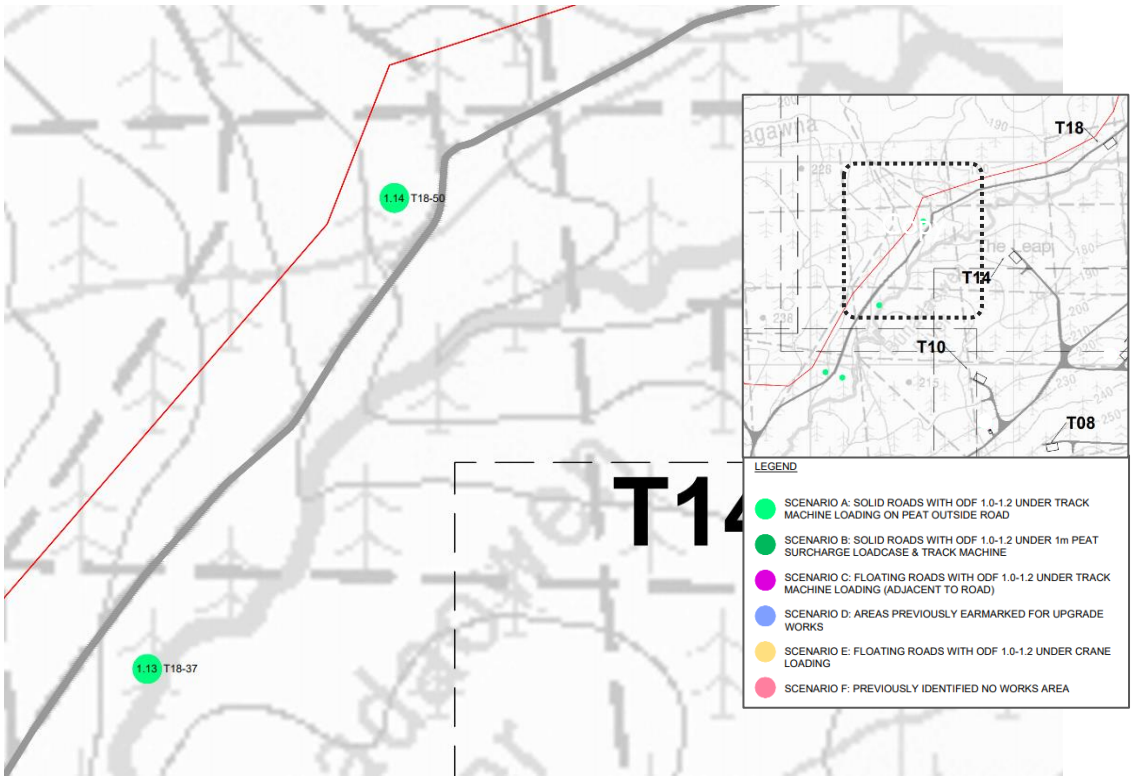
Figure 186 ODF assessment point highlighted by the sensitivity analysis [refer to maps in Appendix I]

The assessment points highlighted for further consideration as part of the sensitivity analysis are presented below.

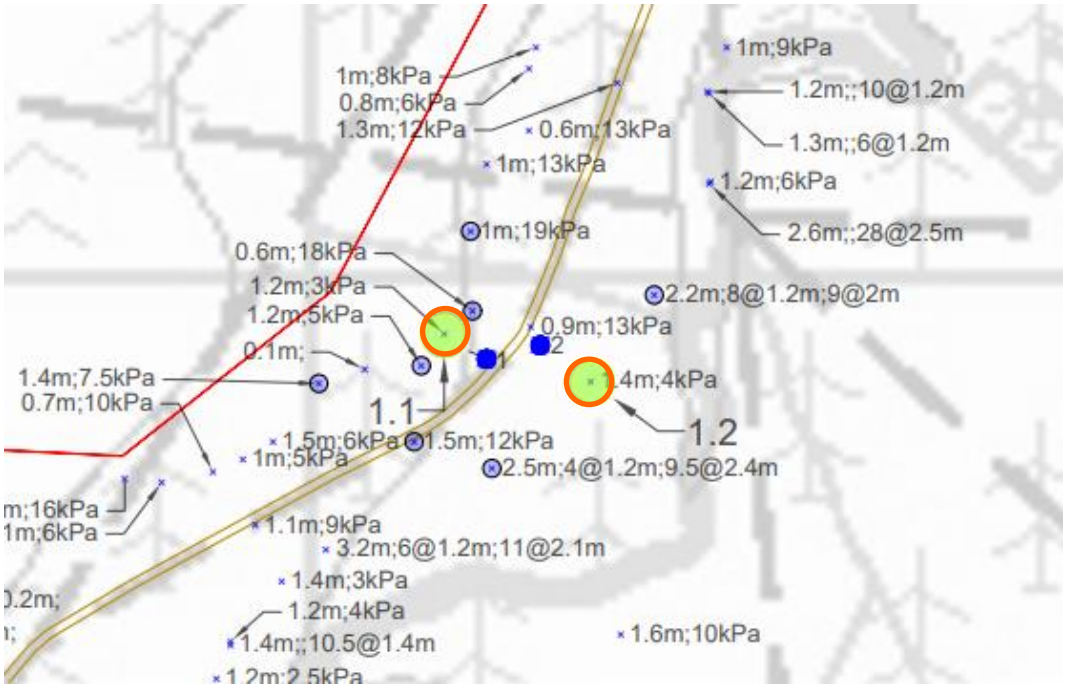
Figure 188 Peat testing locations

The testing completed in the area of T18-19 and T18-24 is indicated in the figure below. Previous tests generally included shear vane test results within the bottom 1m of peat due to the peat depths at this location. Additional tests completed as part of the sensitivity analysis are indicated with dark blue dots. This figure illustrates the extent of peat testing carried out within the bottom 1m of peat at the location.

An additional assessment was completed at 2 locations between the proposed works area and ODFs T18-19 and T18-24. The additional assessment confirms that this area is stable, and that the new ODFs are 1.31 and 1.51. Note that higher readings are generally discounted as the lowest shear strength values are taken from each location for the assessment.

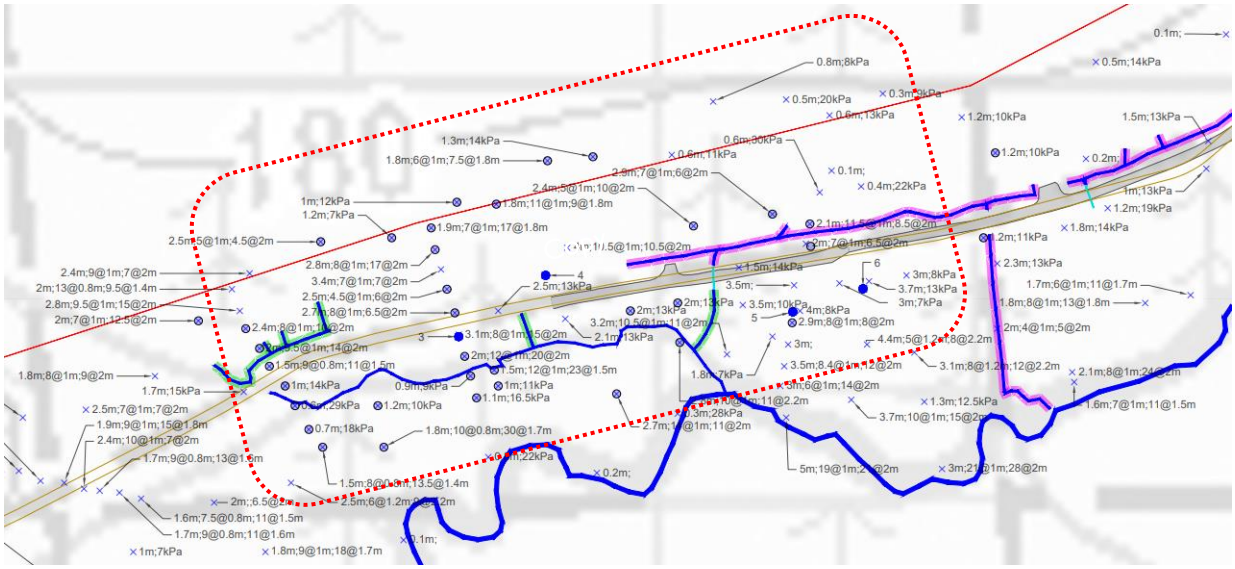
Figure 190 Deeper peat section: peat testing locations

The testing completed along the deeper peat section of the T18 spur road is indicated in the figure below. Previous test locations which included shear vane test results within the bottom 1m of peat are indicated with light blue dots, while additional tests within the bottom 1m of peat completed as part of the sensitivity analysis are indicated with darker blue dots. This figure illustrates the extent of peat testing carried out in the bottom 1m of peat at the location.

The supplementary testing in the deeper peat areas ensures that shear vane test results were obtained at depth across the area and assist in verifying the previous test results and stability assessment.

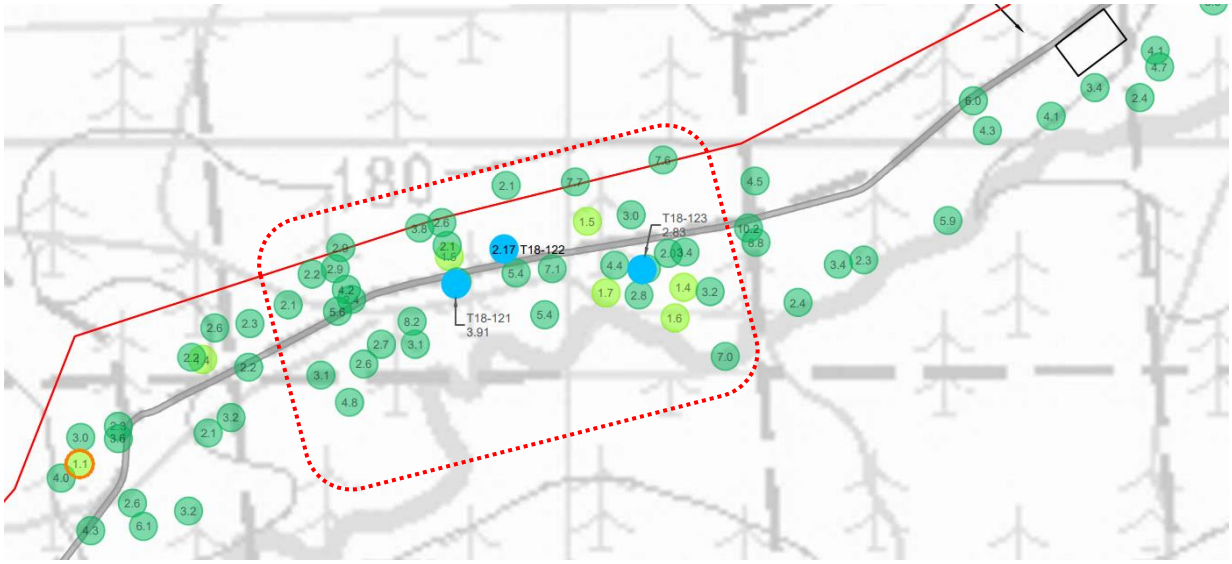
Figure 191 Deeper Peat section: ODF values

The following figure indicates the ODFs in this area and the supplementary assessment points (blue). Previous ODFs completed for the stability assessment are indicated but faded.

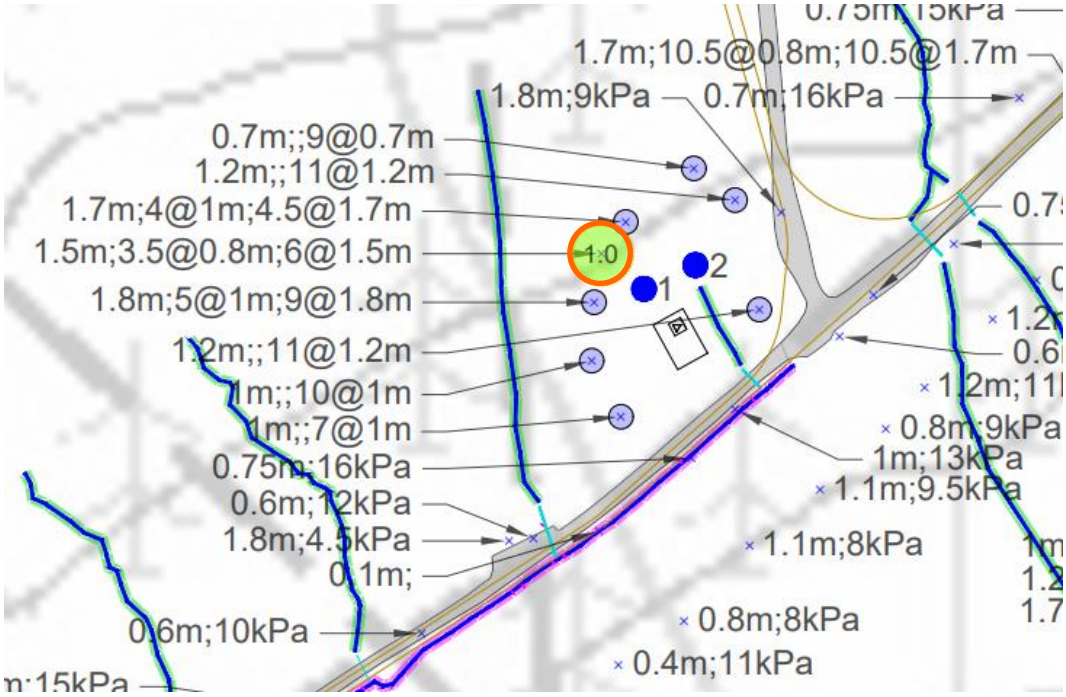
Figure 193 Peat testing locations

The testing completed in this area is indicated in the figure below. Previous tests generally included shear vane test results within the bottom 1m of peat due to the peat depths at this location. Additional tests completed as part of the sensitivity analysis are indicated with dark blue dots. This figure illustrates the extent of peat testing carried out in the bottom 1m of peat at the location.

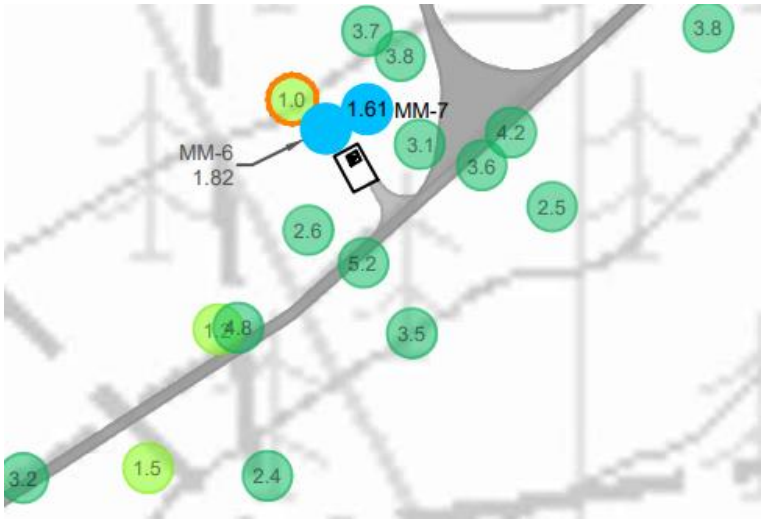
Figure 194 ODF values

The following figure indicates the ODF highlighted by the sensitivity analysis (orange circle) and the supplementary assessment points (blue). Previous ODFs completed for the stability assessment are indicated but faded.

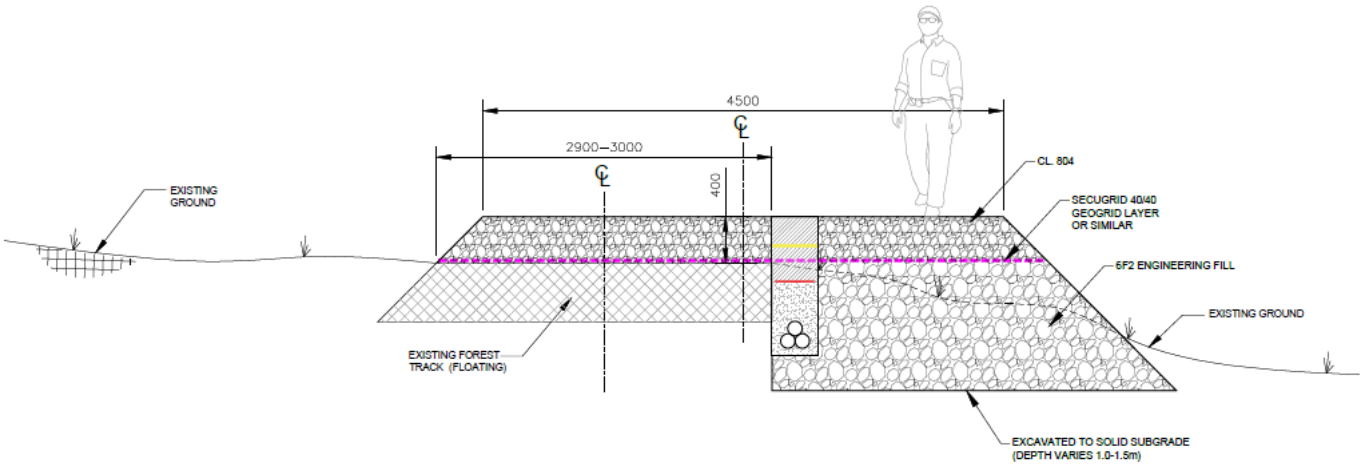
Appendix A Road Cross Section

T18 PROPOSED ROAD UPGRADE SECTION
(FLOATING ROAD WIDENED TO SOLID)
Scale 1:50

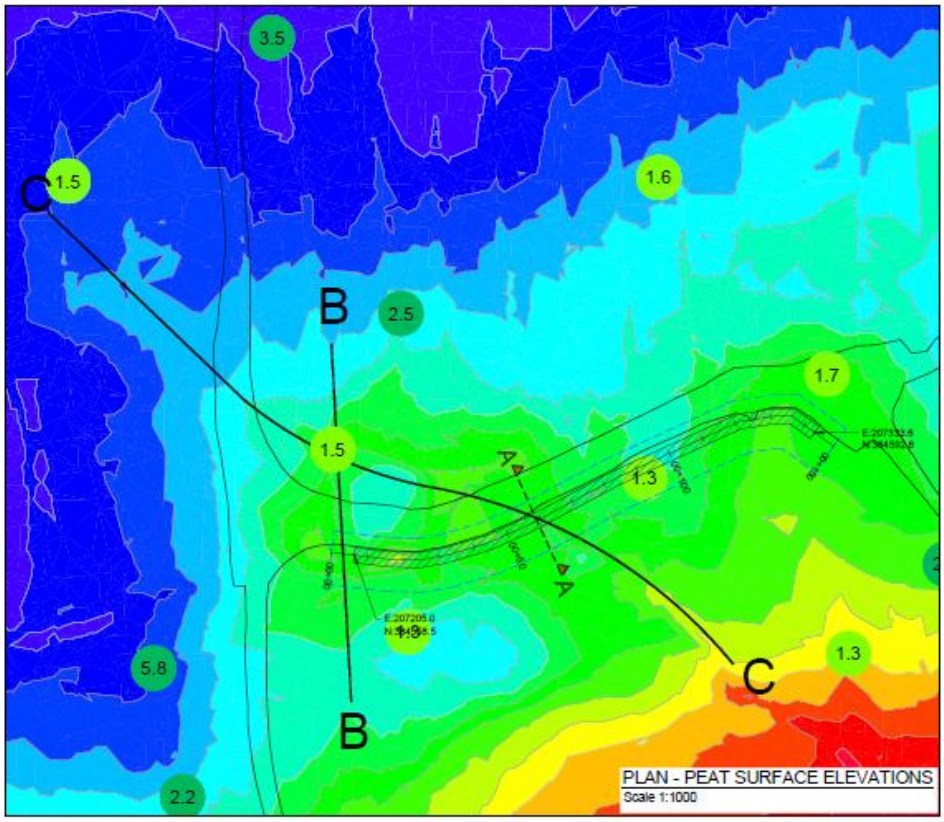
Appendix F Potential Flow Path

Eurocode 7 Overdesign Factor

- < 1
- 1-2
- > 2

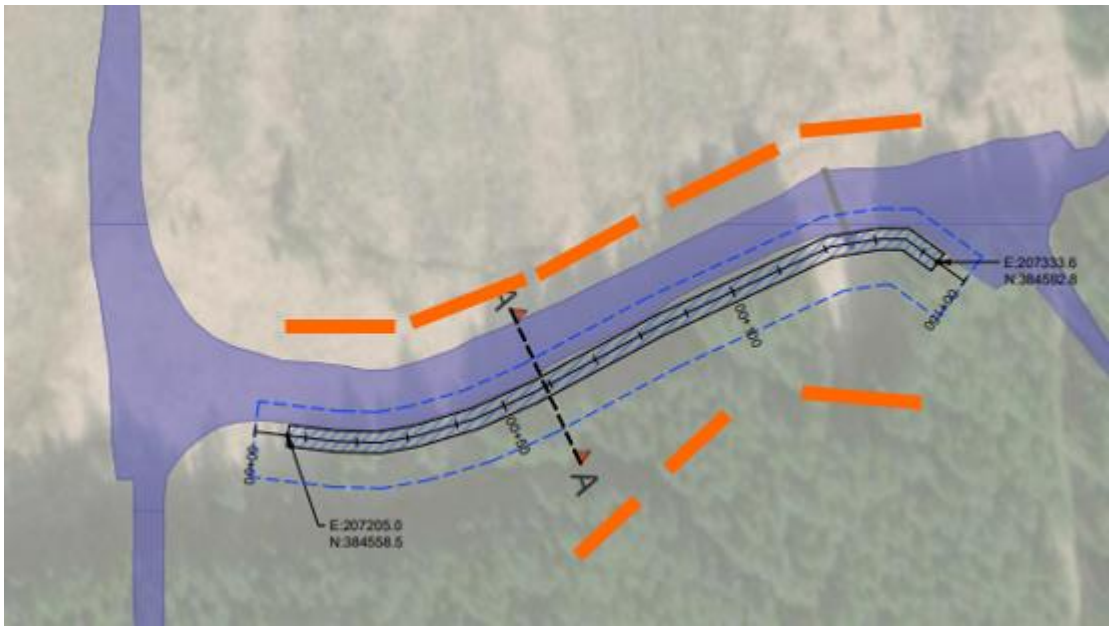
Appendix H Additional Peat Monitoring Locations

Additional Peat Monitoring Posts

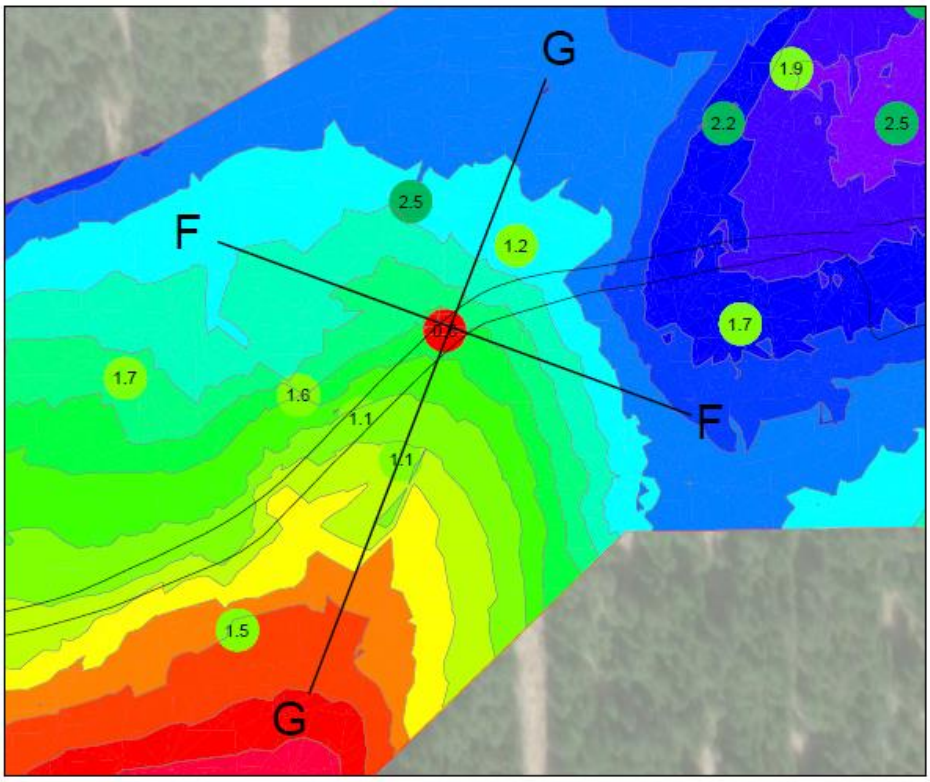
Appendix E Potential Flow Path

Eurocode 7 Overdesign Factor

- < 1
- 1-2
- > 2

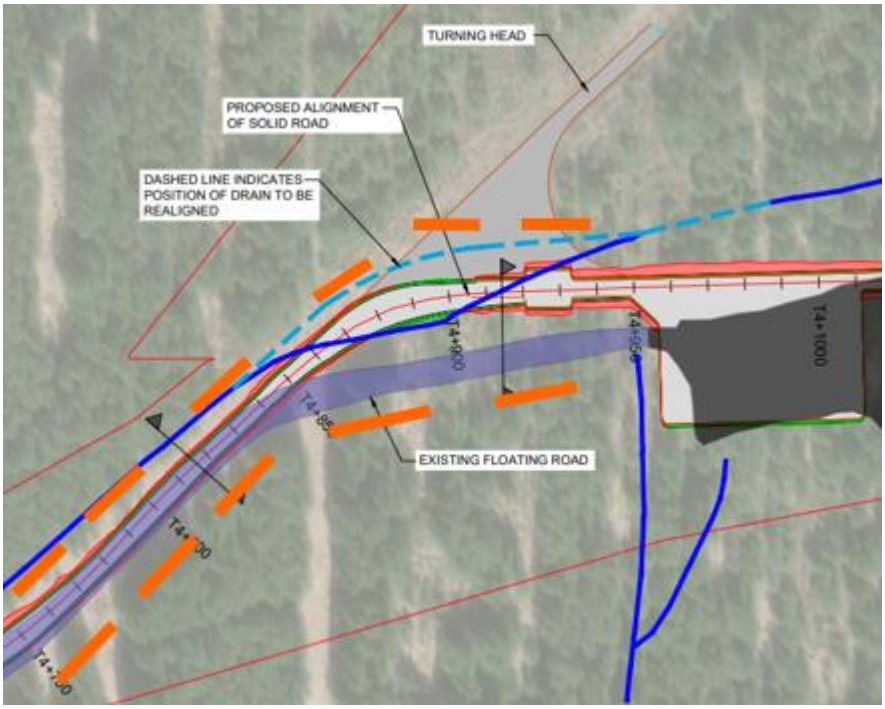
Appendix G Additional Peat Monitoring Locations

Additional Peat Monitoring Posts

Note: Monitoring post locations are indicative. They will be adjusted to suit topography, ensuring adequate distance from active works zone.
