Galway Harbour Company

Galway Harbour Extension

Appendix No. 14

Photographic Surveys of Gate and Wall Repairs, Existing Sea Defence Wall and Ground Damage

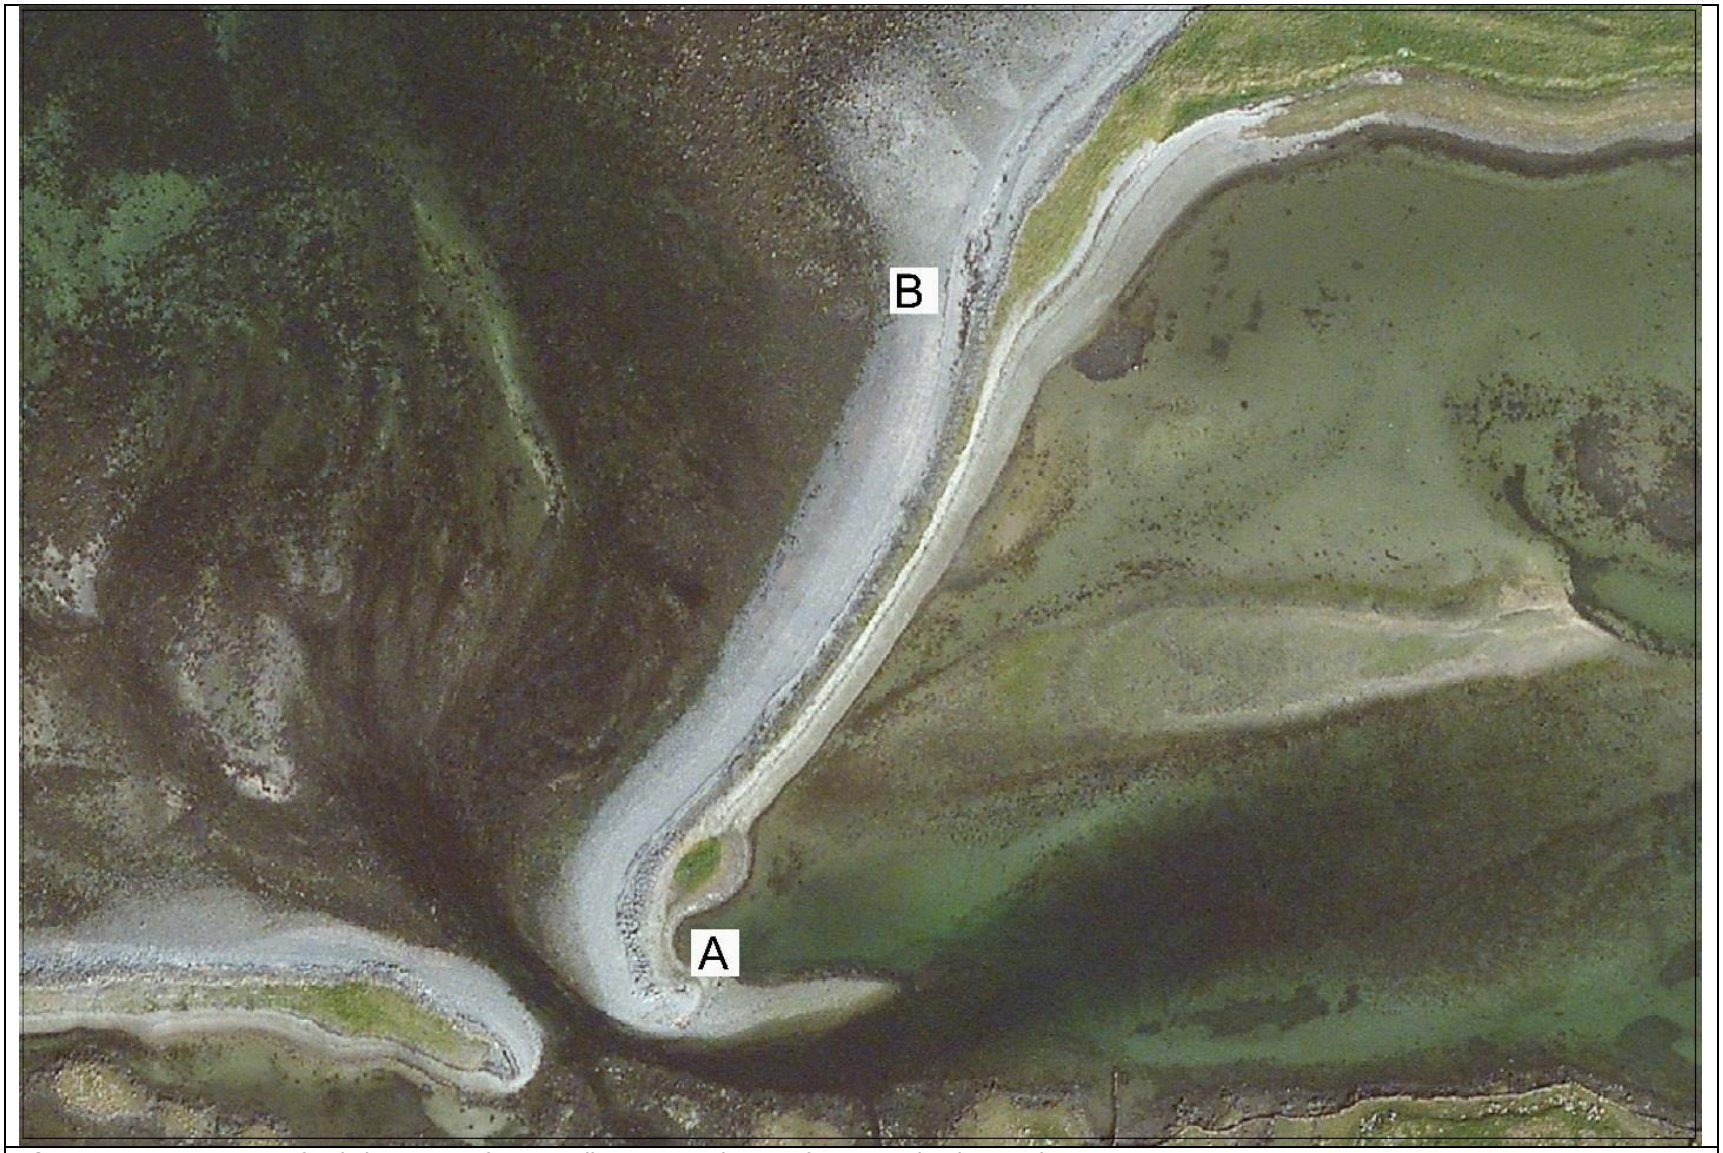
Photo 23- Extent of Existing Sea Defence Wall A-B at Northwest of Lurgan Island, Mweeloon.

23: Extent of existing sea defence wall A-B at northwest of Lurgan, Mweeloon.
