CONSTRUCTION & DEMOLITION WASTE MANAGEMENT PLAN FOR A PROPOSED RESIDENTIAL DEVELOPMENT

MASTERPLAN, SITE 3, SITE 4 AND SITE 5.

APPENDIX 14.1

CB/20/11784WMR01

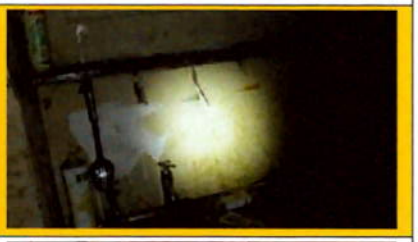
8	No. 5 Moore Street	2nd floor Stairway		Plasterboard linings around door		No visible asbestos containing materials identified

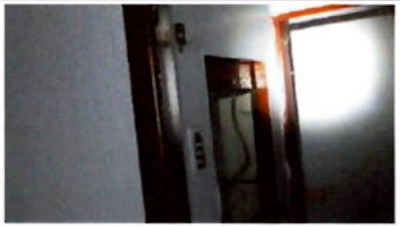
15	No. 8/9 Moore St. No. 11/12 Henry St.	1st floor		Brake shoes to dumb waiter motor		Presumed asbestos						Investigation by a competent contractor prior to work likely to cause disturbance.	
16	No. 8/9 Moore St. No. 11/12 Henry St.	1st floor		WC		No visible asbestos containing materials identified.

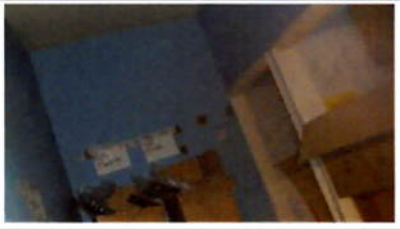
Ref No.	Building or Area of Site	Location or Functional Space	Sample No.	Material Description, surface treatment and condition	Extent	Asbestos identified (presumed, strongly presumed or identified)	Product type	Condition	Surface treatment	Asbestos type	Material assessment score	Recommendations	Photo
5	No. 38 Henry Street	Basement Under footpath		Ceramic tiles to wall and floors in old WC.'s		No visible asbestos containing materials identified							
6	No. 38 Henry Street	Basement Changing rooms				No visible asbestos containing materials identified							
7	No. 38 Henry Street	Stairway to 1st floor				No visible asbestos containing materials identified							
8	No. 38 Henry Street	1st floor Wall at back of store	2029114	Textured paint		No visible asbestos containing materials identified

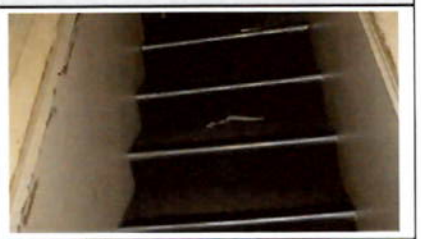
14	No. 38 Henry Street	2nd floor Store rooms				No visible asbestos containing materials identified							
15	No. 38 Henry Street	2nd floor Store room		Integral areas of wall mounted		Presumed to contain asbestos						Investigation by a competent asbestos contractor prior to work likely to cause disturbance.	
16	No. 38 Henry Street	2nd floor Storage areas				No visible asbestos containing materials identified

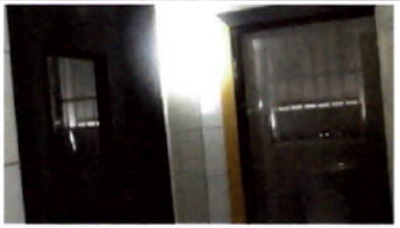
15	22-23 Moore Street	2nd floor Gymnasium				No visible asbestos containing materials identified.							
16	22-23 Moore Street	2nd floor Gymnasium Store room				No visible asbestos containing materials identified.

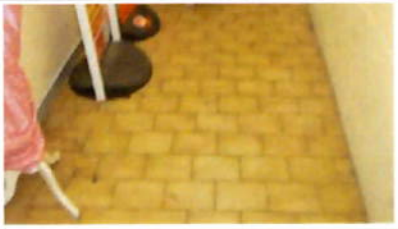
6	No. 6 Moore Street	Ground floor		Plasterboard ceiling tiles in drop ceilings		No visible containing materials identified							
7	No. 6 Moore Street	Ceiling void				No visible containing materials identified							
8	No. 6 Moore Street	Ground floor back of shop		Occupied outlets		No visible containing materials identified

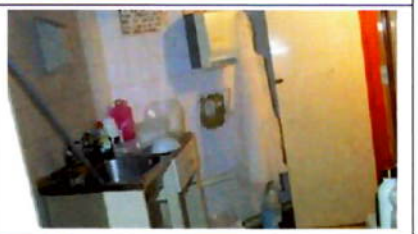
Ref No.	Building or Area of Site	Location or Functional Space	Sample No.	Material Description, surface treatment and condition	Extent	Asbestos identified (presumed, strongly presumed or identified)	Product type	Condition	Surface treatment	Asbestos type	Material assessment score	Recommendations	Photo
1	No. 7 Moore Street	Ground floor areas Retail areas trading at time of visit.				No visible asbestos containing materials identified.							No photo taken
2	No. 7 Moore Street	Stairway to 1st floor				No visible asbestos containing materials identified.							
3	No. 7 Moore Street	1st floor landing		Red lino		NAD							
4	No. 7 Moore Street	1st floor Kitchen				No visible asbestos containing materials identified.

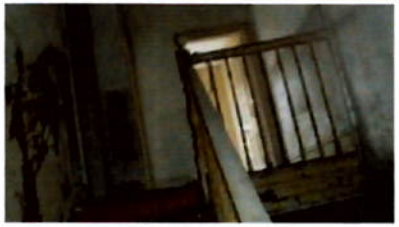
11	No. 7 Moore Street	2nd floor Rooms and areas				No visible asbestos containing materials identified.							
12	No. 7 Moore Street	2nd floor Rooms and areas				No visible asbestos containing materials identified.
