N6 Galway City Ring Road

Lackagh Tunnel: Geotechnical and Hydrogeological Appraisal

GCOB-4.03-4.16

Issue 4 | 28 March 2025

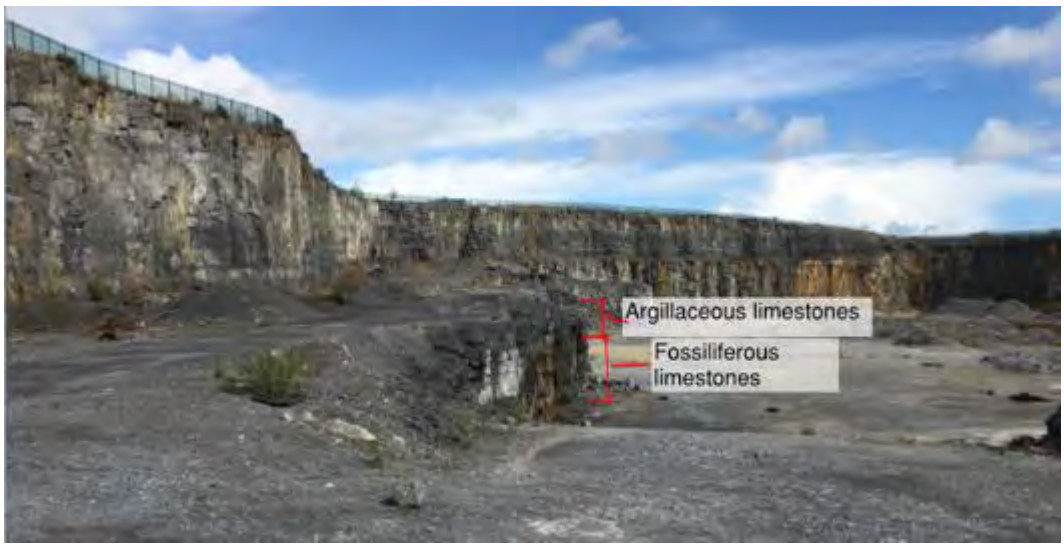
Figure 3.15: Cyclical sequence of Limestones at Lackagh Quarry

Ground conditions at the western face of Lackagh Quarry comprise a cyclical sequence of carboniferous limestones (see Figure 3.15). Each cycle is between 10m and 15m thick and is characterised by thinly bedded, dark mud-rich (argillaceous) limestones which pass upward into thicker bedded, paler non-argillaceous limestones. The darker limestone marks the beginning of the upper bench at the western face, and is generally considered to be stronger than the paler limestones.

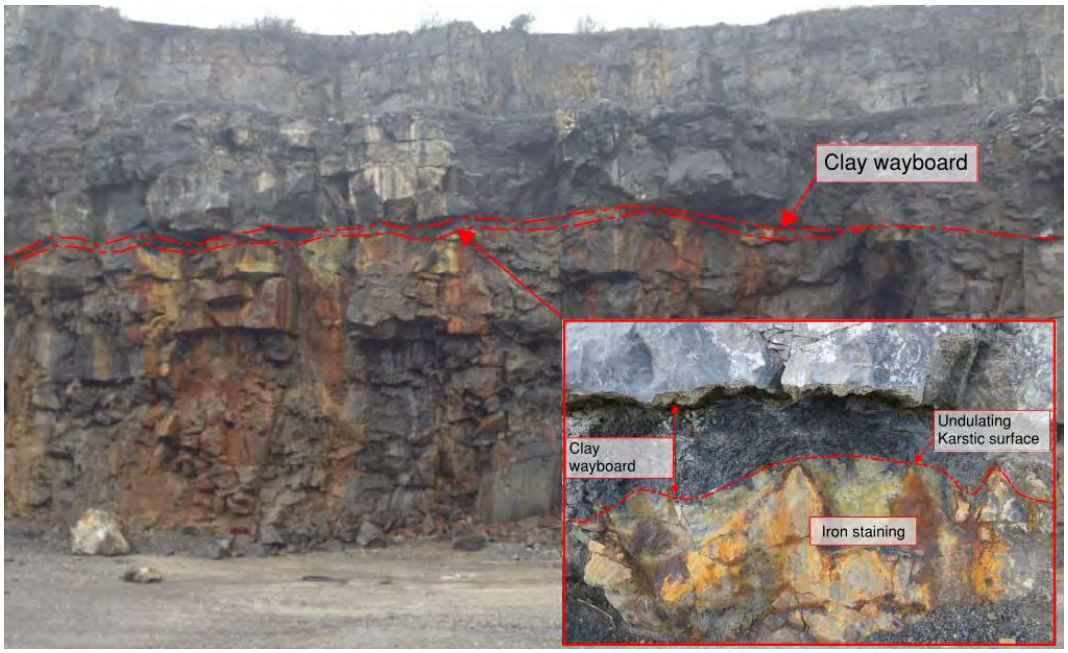
Figure 3.16: Clay wayboard on the quarry face at Lackagh Quarry

A clay wayboard of varying thicknesses from ~30cm to absent is evident on all faces of Lackagh Quarry, refer to Figure 3.16. A thin 20cm band of laminated mudstone, which compares favourably with the material observed on the quarry face, was encountered in BH04, however it is unknown whether this is a continuous layer or a cavity infill. BH04 and BH05 encountered several cavities, some not filled, and some infilled with clay.

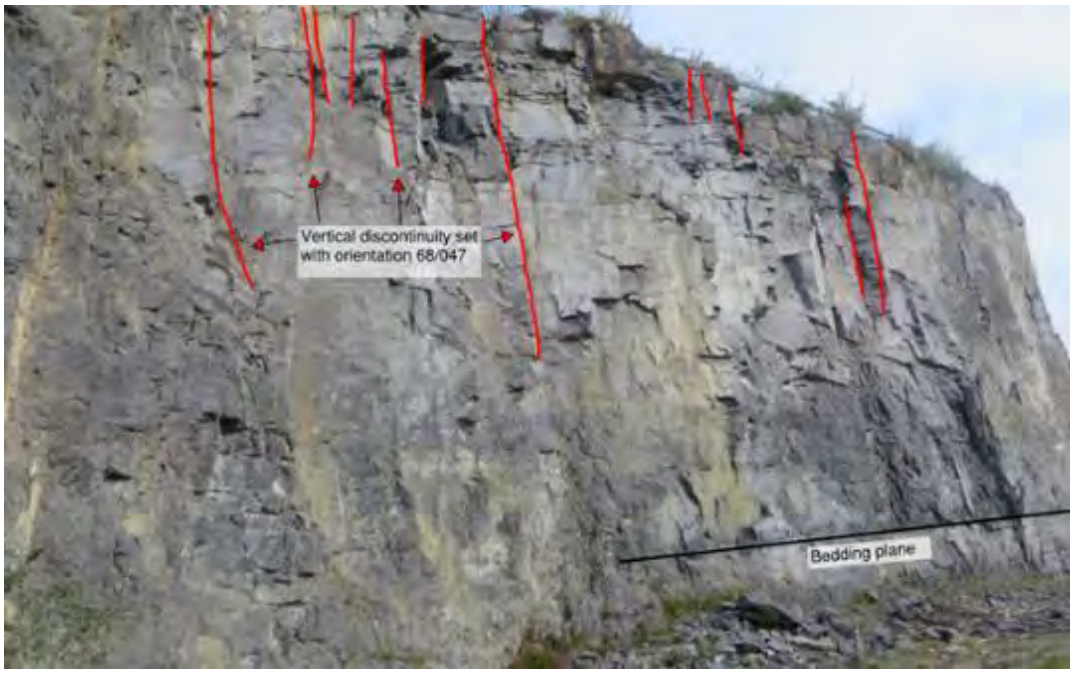
Figure 3.17: Exposed discontinuities on the upper bench

The vertical and horizontal discontinuities are visible on the exposed quarry face and are more evident in the upper bench wall, as the lower bench wall has been heavily affected by blast induced fractures.
