A Survey of Selected Rivers for
the Galway City Transport
Project with Potential for
Margaritifera (Moorkens, 2014a)

A SURVEY OF SELECTED RIVERS FOR THE GALWAY CITY TRANSPORT PROJECT WITH POTENTIAL FOR *MARGARITIFERA*

September 2014

Evelyn A. Moorkens

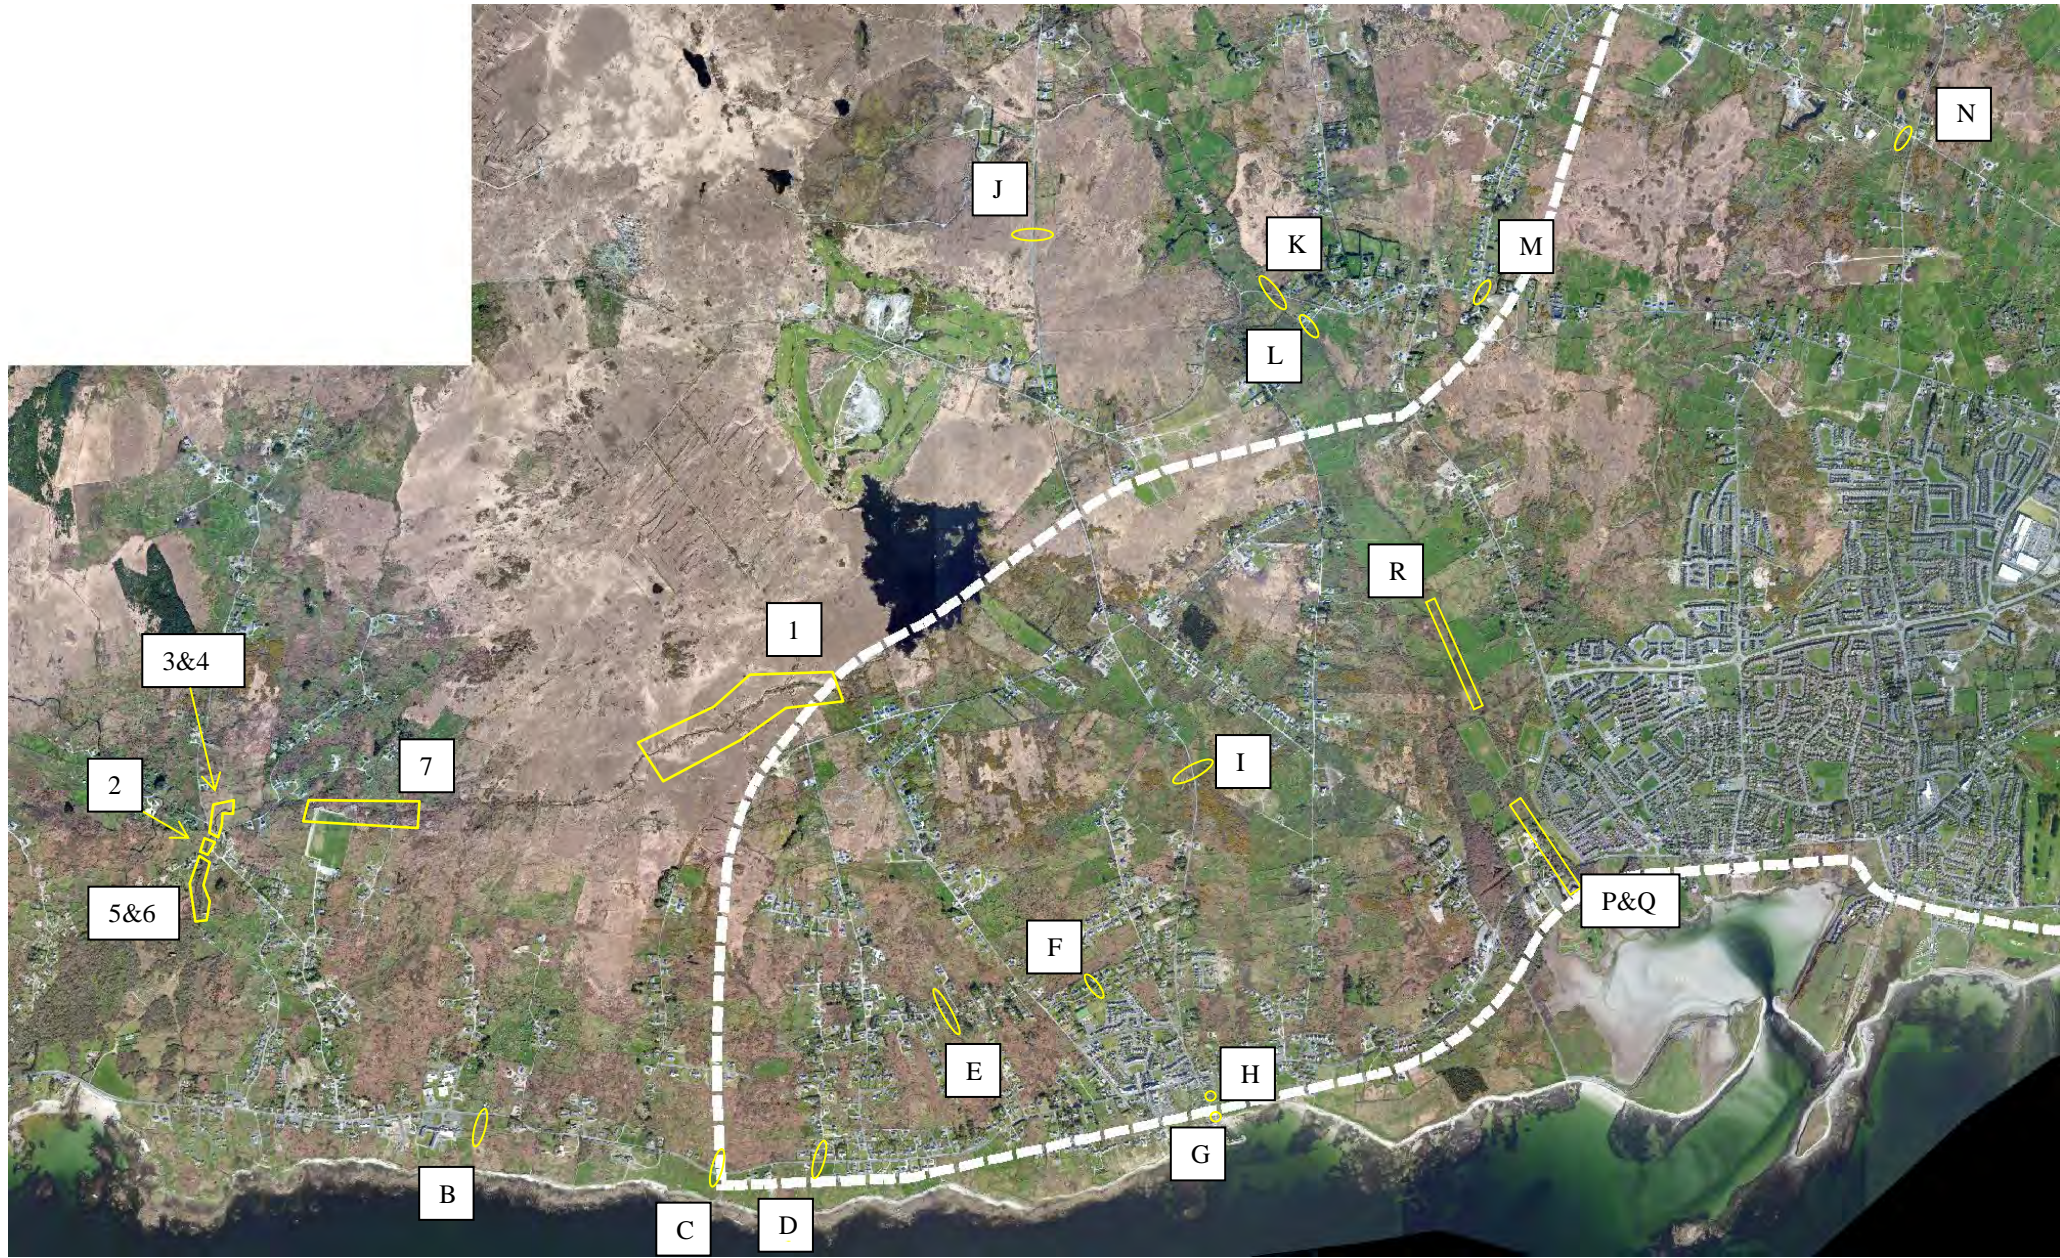
Figure 1: Survey site locations

The streams surveyed are shown in Figures 1, and described in Table 1. No pearl mussel individuals were found in the survey.
