Galway County Council
N6 Galway City Transport Project
Karst Study

Karst Study Report

Issue 1 | 27 February 2015

Ove Arup & Partners Ireland Ltd

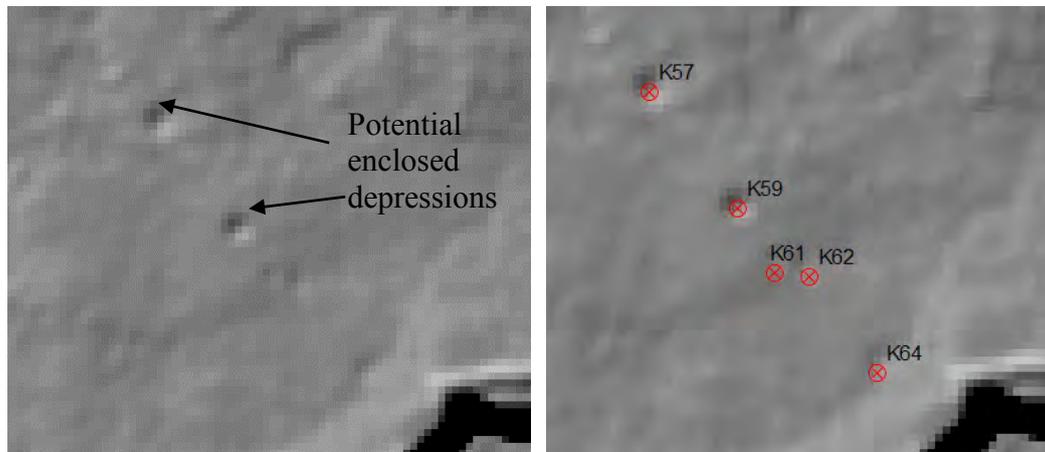
Figure 2 (left) lidar image showing two potential enclosed depressions (K57 & K59) identified from the desk study, Figure 3 (right) karst features confirmed during field survey

Potential features were identified during the desk study and then investigated in the field. **Figure 2** presents the lidar image showing two clear circular shapes interpreted to be karst landforms. However, this image also shows multiple potential surrounding features that are less clear. The potential features (K57 and K59) were visited and confirmed as enclosed depressions during the field survey. Field observations of the surrounding features also confirmed three further enclosed depressions (K61, K62 and K64) as shown in **Figure 3**.

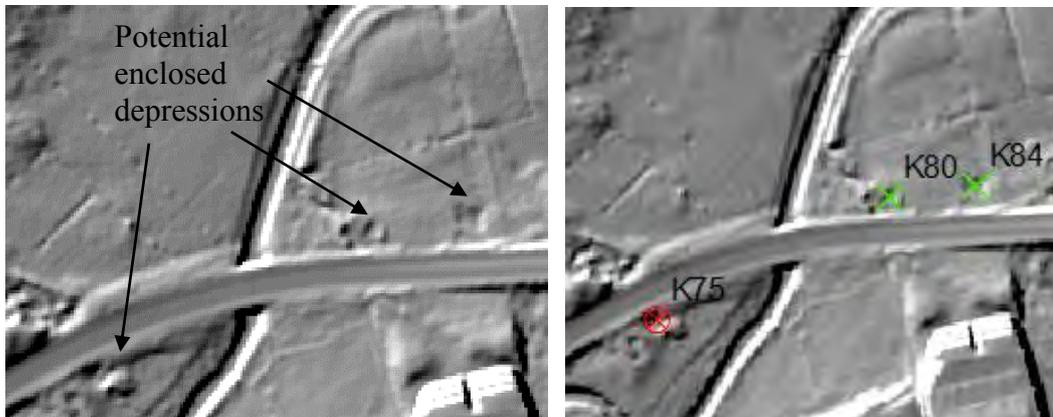
Figure 4 (left) lidar image showing three potential enclosed depressions identified from the desk study, Figure 5 (right) confirmed enclosed depression K75 (red circle) and two non karst features K80 and K84 (green crosses) from the field survey findings

Figure 4 and **Figure 5** shows the lidar image of three potential enclosed depression identified from the desk study. During the site visit K75 was confirmed to be an enclosed depression, however K80 and K84 were mounds and therefore classified as not karst.

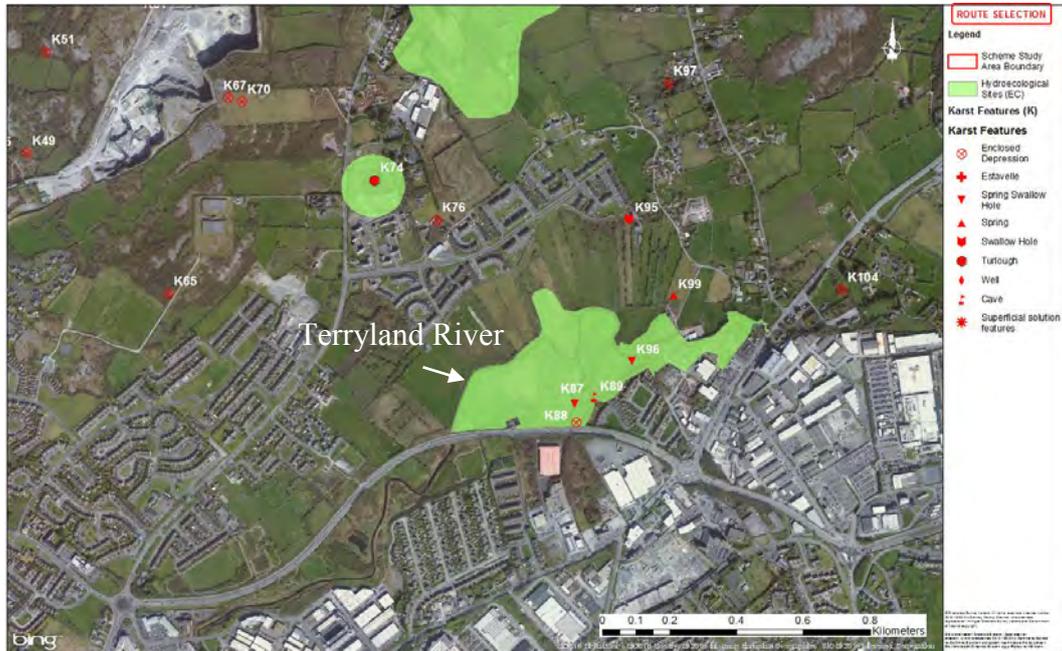
Figure 8 Terryland River karst features and water dependant habitats

The Terryland River extends from the River Corrib north-eastwards for approximately 2.5km where the river has two branches both of which end in karst depressions (K87 and K96) (**Figure 8**). The Terryland River is unusual in that its flow is reversible and either:

Further to the discussion from **Section 5.1**, these findings indicate that there is a southerly flow direction from north of Ballindooley Lough into a likely significant conduit system that includes the sink holes at the Terryland River. Ultimately all groundwater discharges south into Galway Bay.

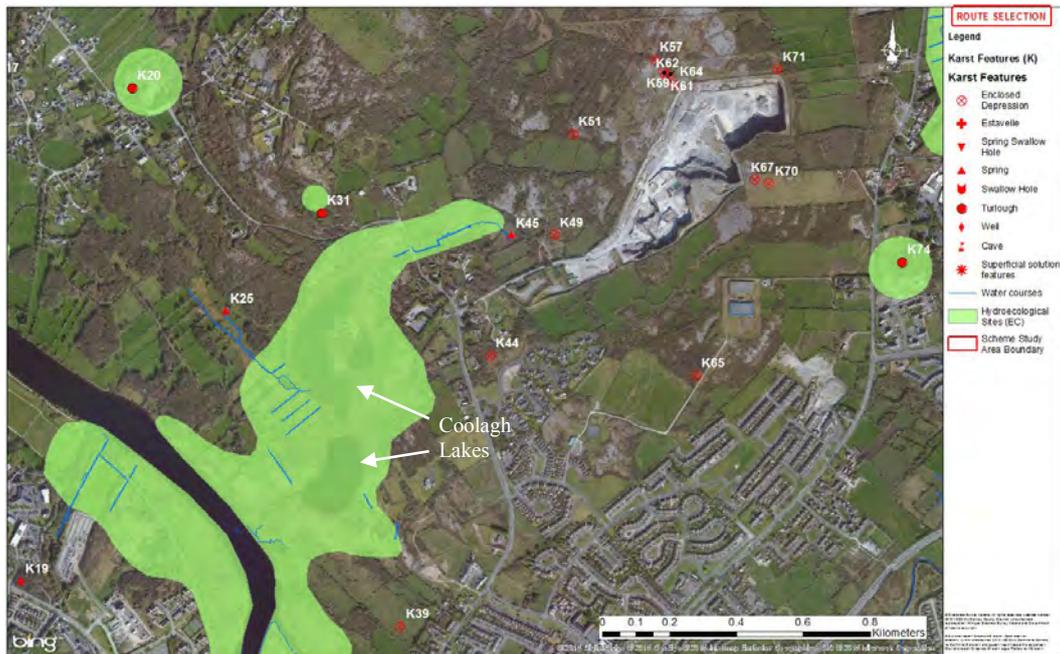
Figure 9 Coolagh Lakes karst features and water dependant habitats

A spring, K25, was identified to the east of Coolagh Lakes (**Figure 9**). Spring K25 provides flow to the Coolagh Lakes, however, flow was not possible to measure during the field survey due to extensive vegetation in the channel flowing from the spring. The elevation of Spring K25 is 6.06 mOD.

It is likely that a significant proportion of discharge into the Coolagh Lakes is from groundwater. However, it is also possible that the River Corrib may be contributing water flow to the lake system. Further analysis of the water balance in the Coolagh lakes would be required to gain a better understanding of the proportion of groundwater contribution to the lake system.

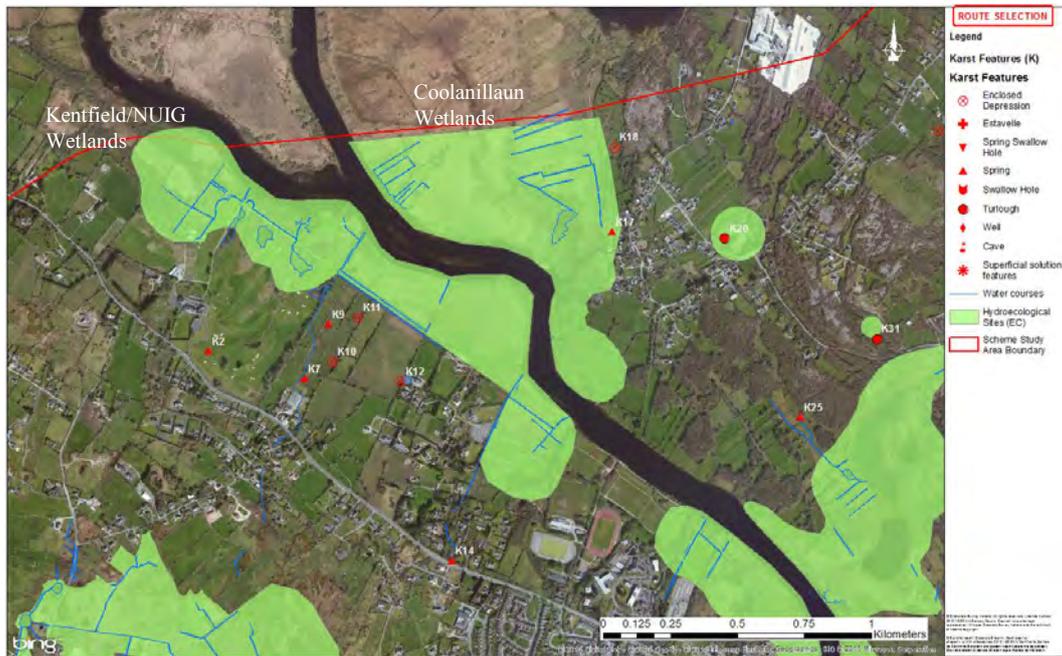
Figure 9 Kentfield/NUIG and Coolanillaun Wetlands karst features and water dependant habitats

The Kentfield/NUIG wetland area to the west of the River Corrib is fed by four springs, K2, K7, K9 and K14 (**Figure 10**). The spring K2 is directly on the contact between the limestone and the granite bedrock. The OSI water line map was used to identify potential springs during the desk study. **Figure 10** shows the flow channels from the springs towards the Kentfield/NUIG wetland and River Corrib.

Spring K17 was identified on the eastern side of the River Corrib in the Coolanillaun wetland, however, it is possible that there are other springs which discharge close to the boundary of the designated wetland habitat. During the field survey additional springs were searched for in the area, however none were found. It is possible that the Spring K17 is connected to the turlough K20. During the field survey the water level elevation in the turlough was 10.42 mAOD. Water elevation in the spring was lower, at 6.12 mAOD, suggesting that the groundwater flow direction is toward the spring from the turlough.

Although springs and groundwater flow are likely to be contributing to the water level, it is also likely that the River Corrib may also be contributing flow to the wetlands.

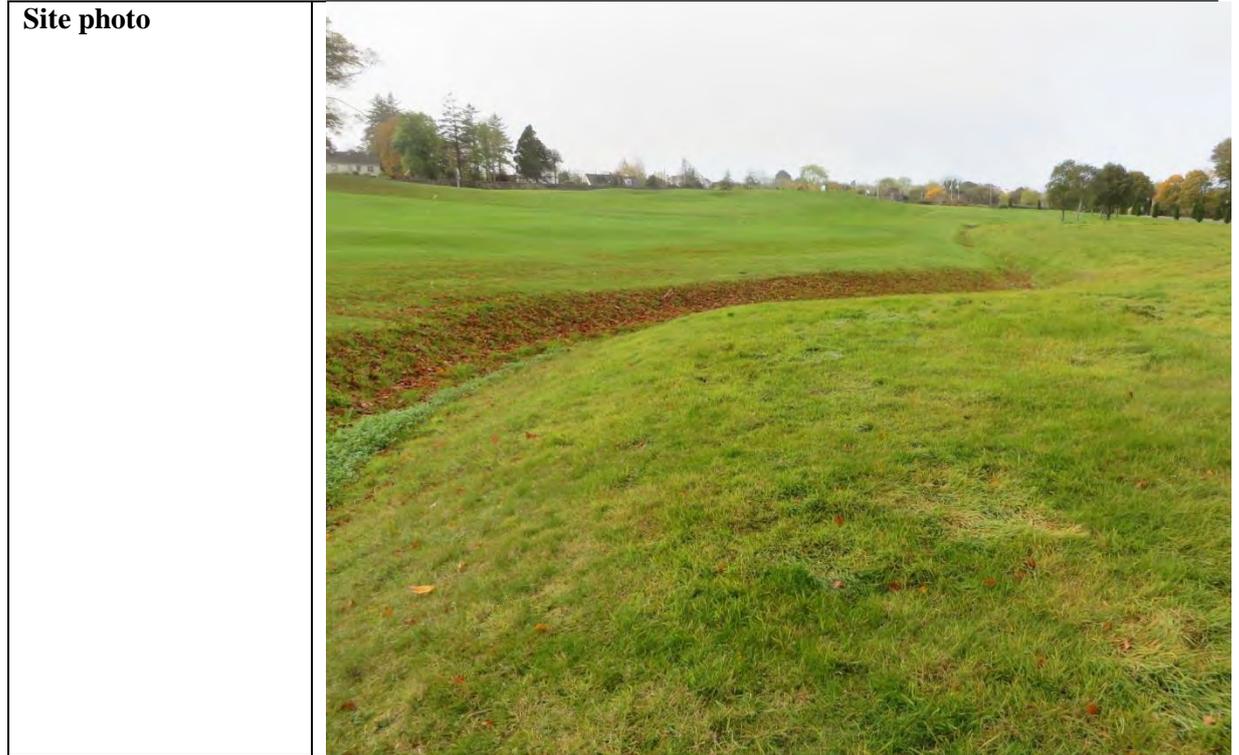
Feature ID	K2
Feature Type	Spring
Coordinates	526837, 728183
Source	Lidar and OSI water line:

Other sources: aerial photography
Field survey date	21/10/2014
Field survey status	Confirmed
Water present	Yes
Additional Information	Spring discharging into drain which discharges into a pond. The drain may be modified and contained little water on day of visit.

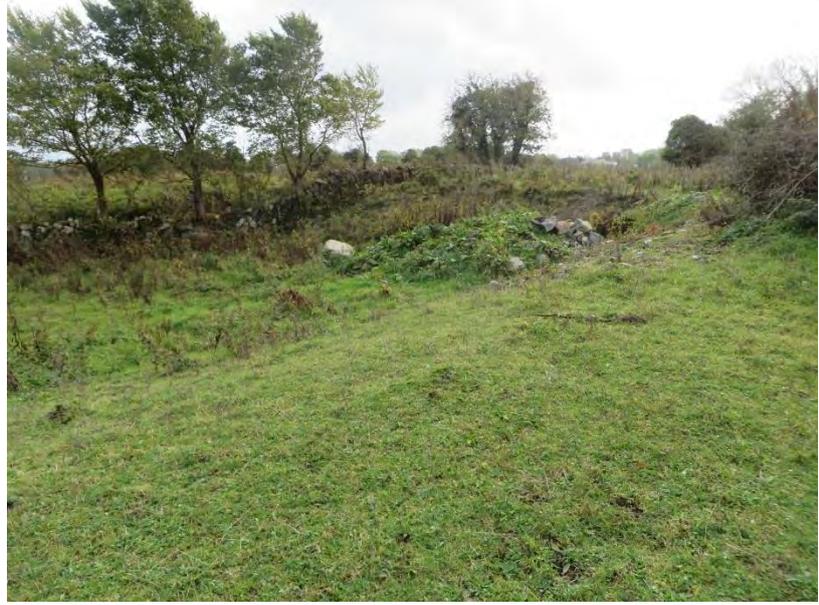
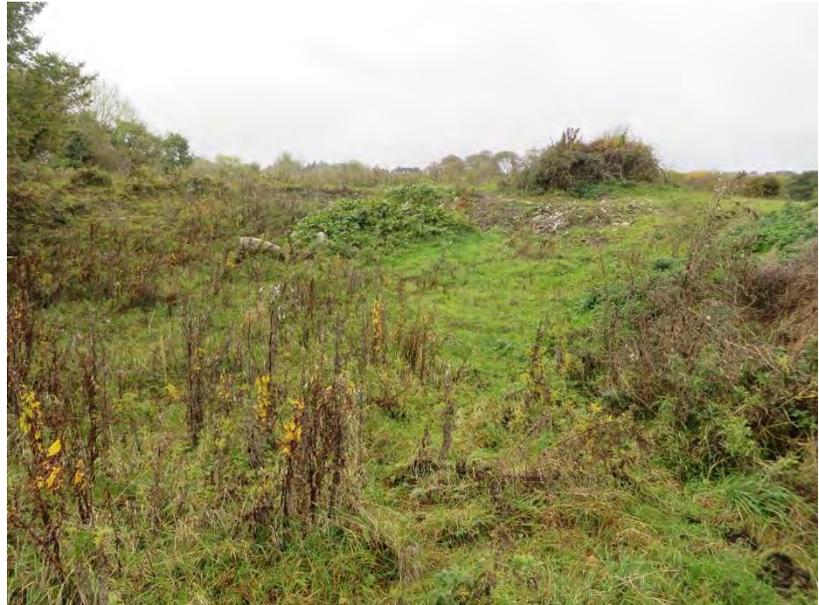
Feature ID	K11
Feature type	Enclosed depression
Coordinates	527396, 728307
Source	Lidar:

Other sources: aerial photography
Field survey date	20/10/2014
Field survey status	Confirmed
Water present	No
Additional Information	15m diameter enclosed depression.

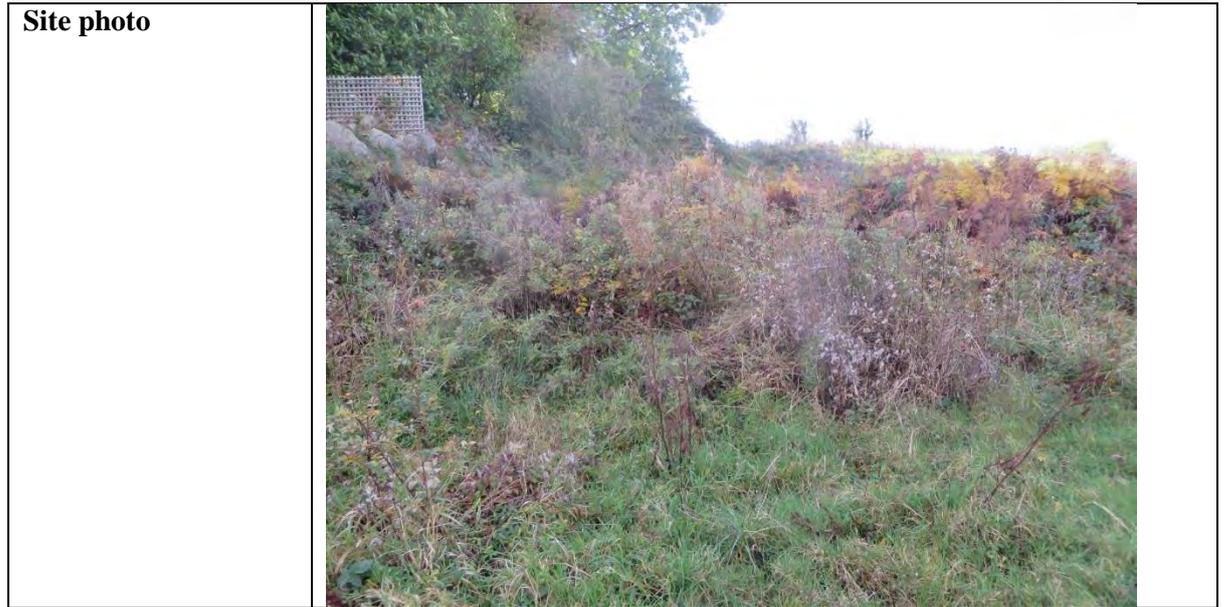
Feature ID	K12
Feature type	Enclosed depression
Coordinates	527555, 728068
Source	Lidar:

Other sources: aerial photography
Field survey date	21/10/2014
Field survey status	Confirmed
Water present	No
Additional Information	20m diameter enclosed depression with gently sloped sides.

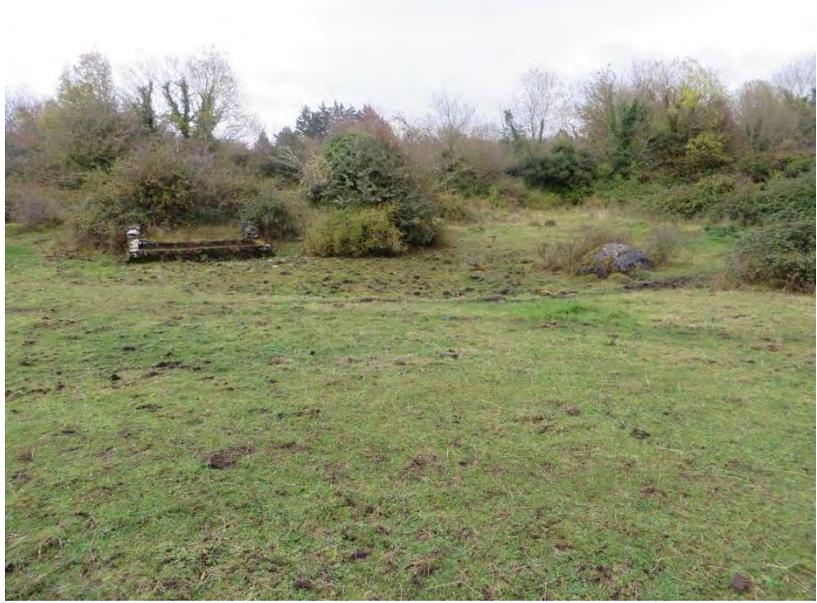
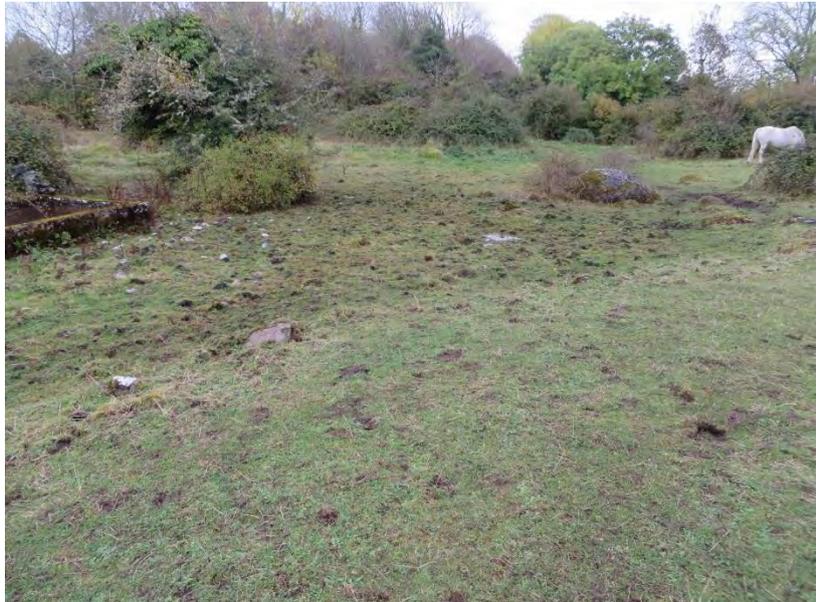
Feature ID	K18
Feature type	Enclosed depression
Coordinates	528356, 728948
Source	Lidar:

Other sources: aerial photography
Field survey date	17/10/2014
Field survey status	Confirmed
Water present	Yes Electrical conductivity: 350 uS/cm Temperature: 14.2 °C pH: 8.72
Additional Information	Water logged depression in field.

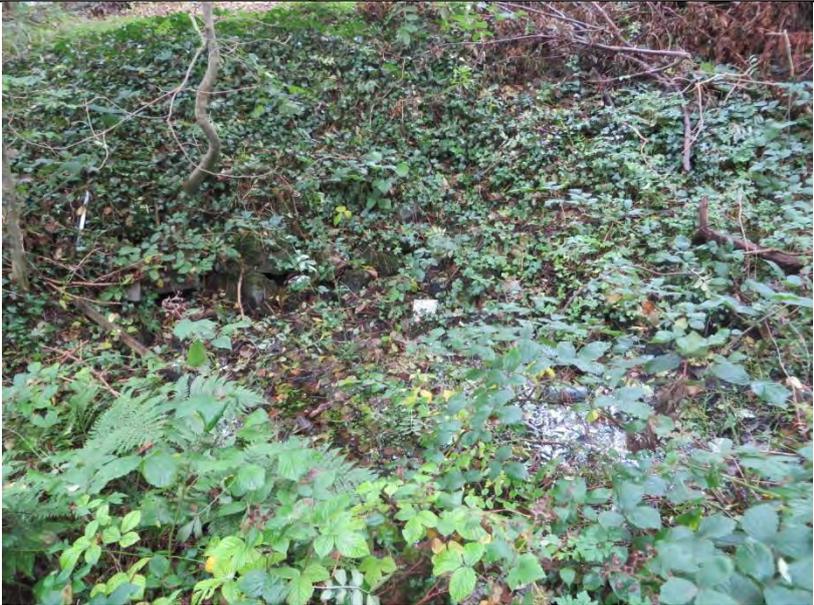
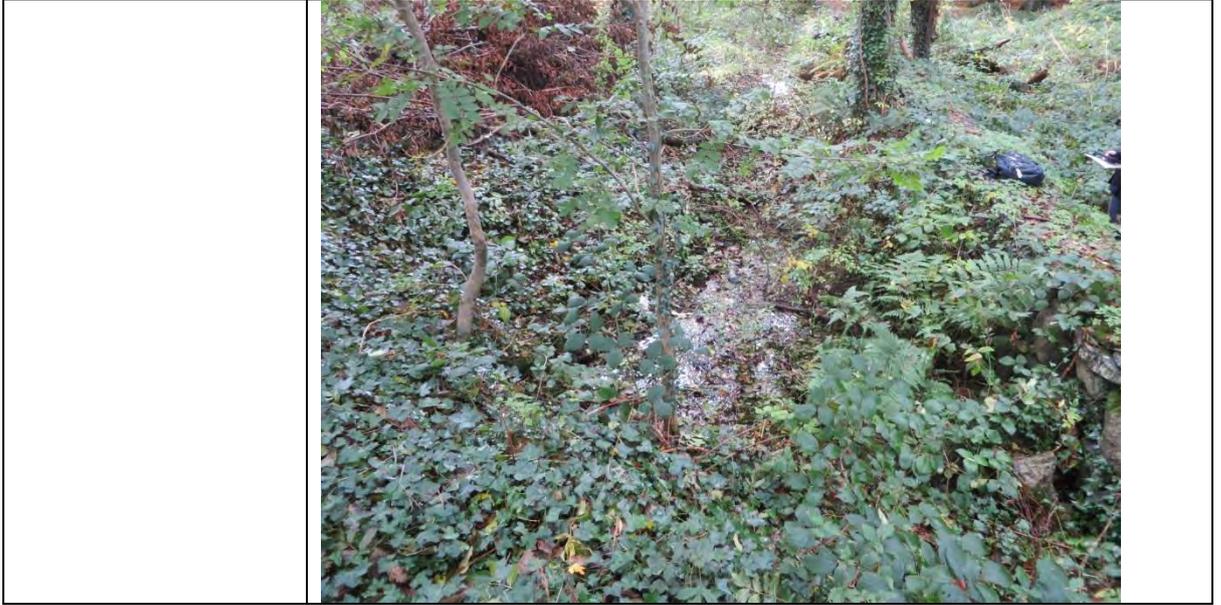
Feature ID	K19
Feature type	Spring
Coordinates	528432, 727120
Source	Lidar and OSI water line:

Field survey date	20/10/2014
Field survey status	Confirmed
Water present	Yes Electrical conductivity: 510 uS/cm Temperature: 14.3 °C pH: 7.62
Additional Information	The spring is discharging from a concrete culvert. The natural spring location may be upgradient of the surveyed location, however no evidence of a channel or spring upgradient was found.
Site photo

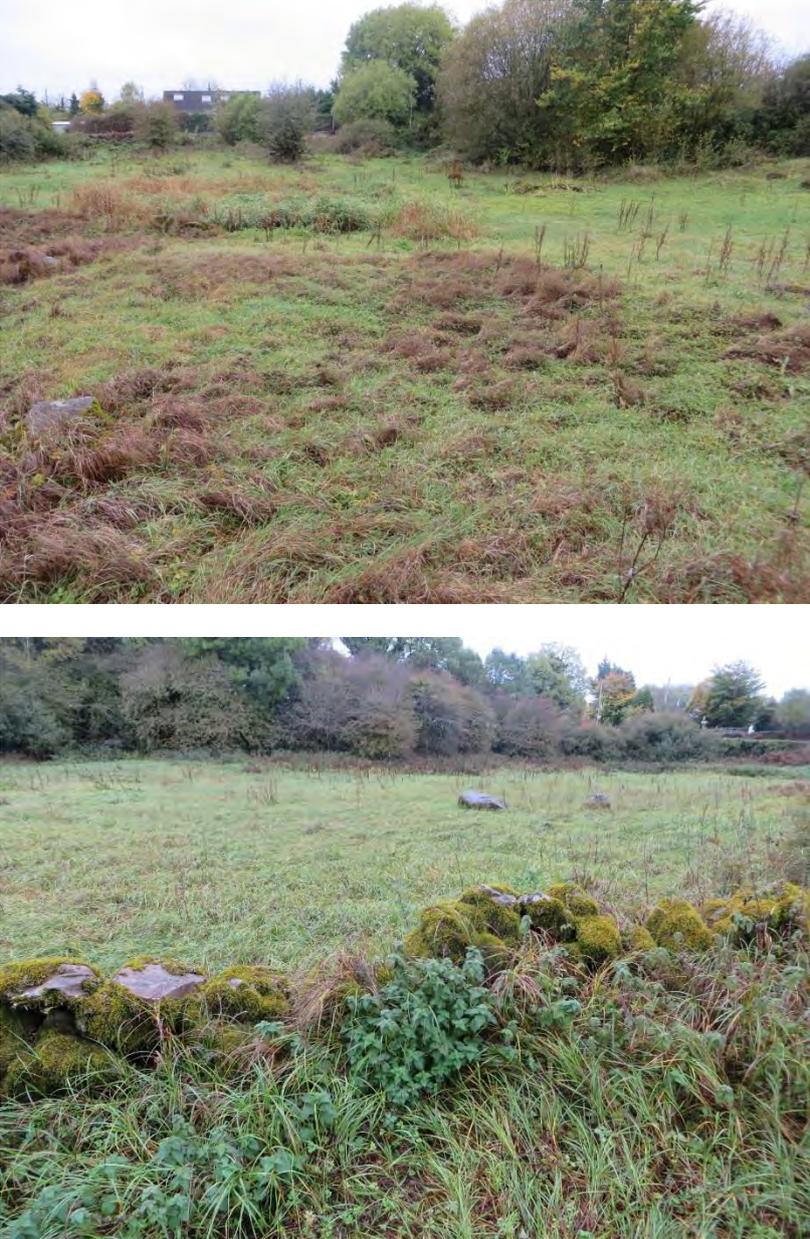
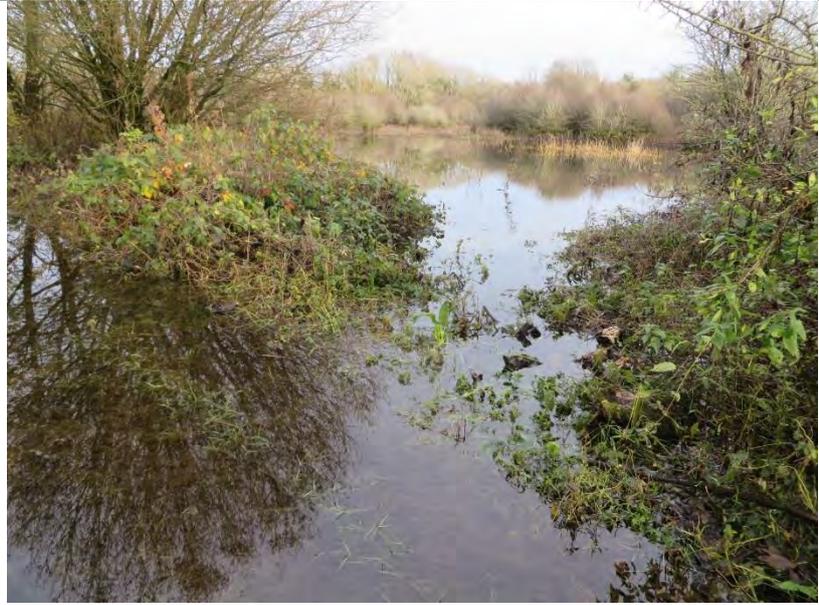
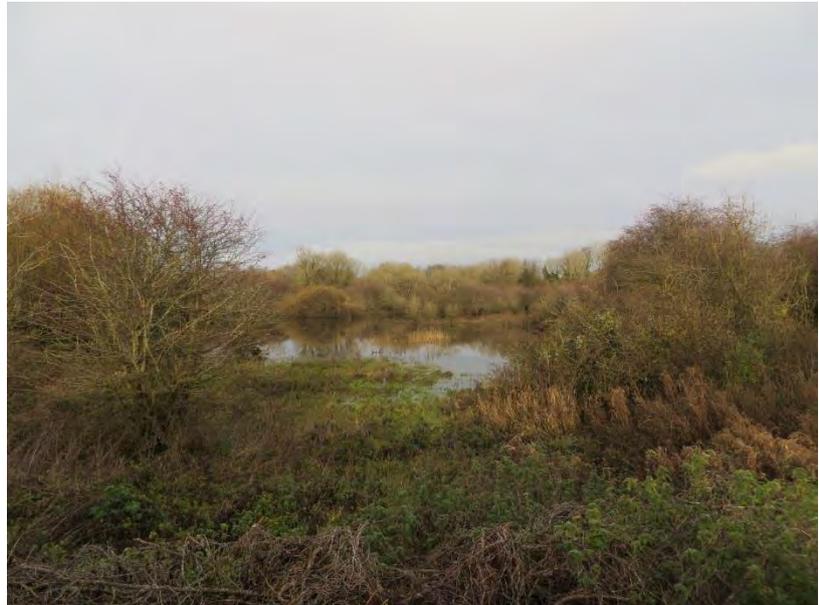
Water elevation	10.42 mAOD
Additional Information	The turlough was visited when empty (17/10/14) and full (11/11/2014). There are no surface water streams contributing flow to the turlough. The topography is relatively flat, although the turlough is at a lower elevation than the surrounding ground level. Therefore it is likely that this feature is a groundwater fed turlough.
Site photos 17/10/2014

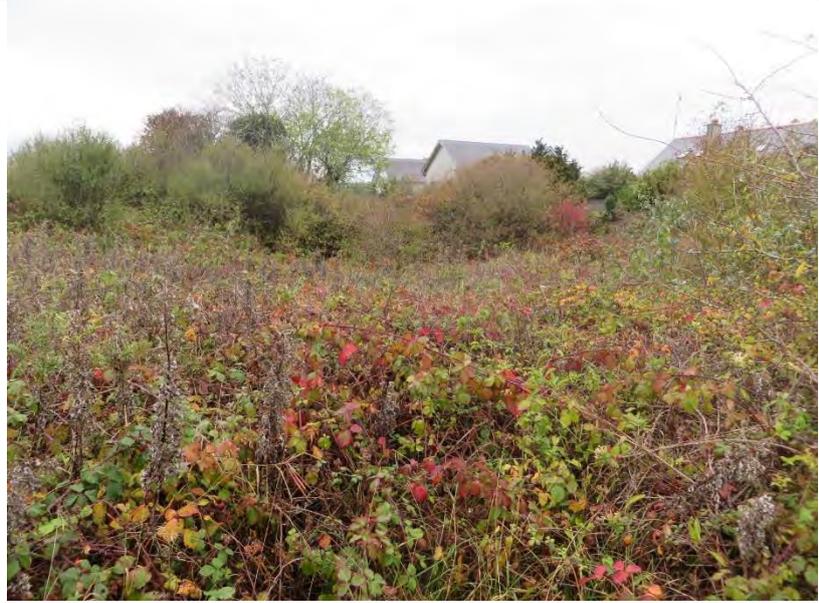
Site photo

Other sources: aerial photography
Field survey date	17/10/2014
Field survey status	Confirmation/identification problem
Water present	No
Additional Information	Area covered in briars and vegetation preventing access.

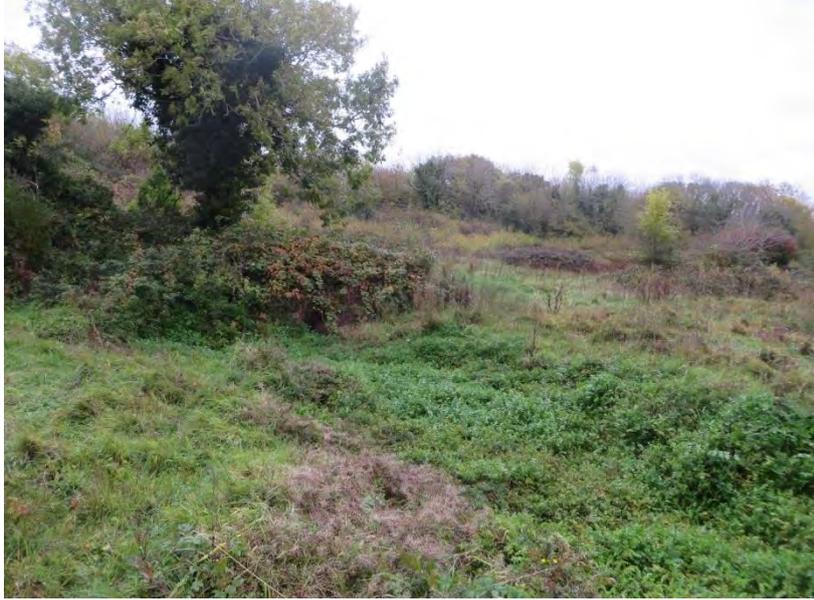
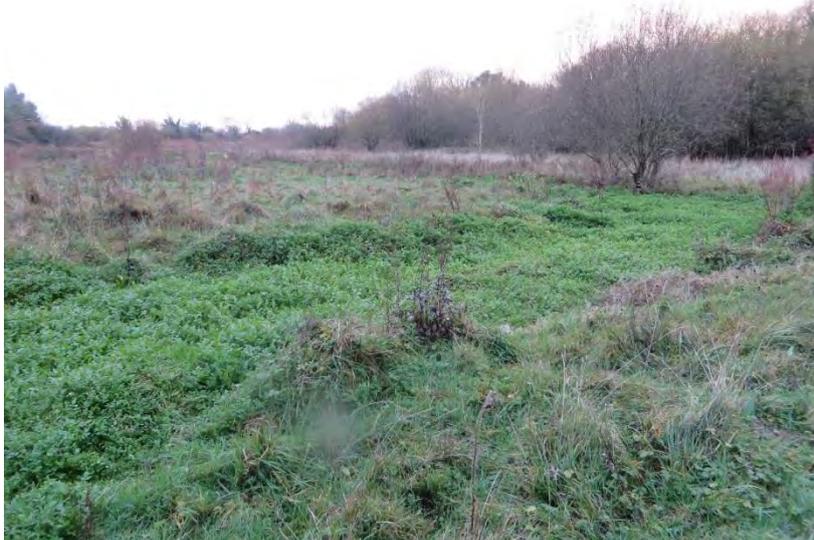
Field survey date	17/10/2014	12/11/2014
Field survey status	Confirmed	Confirmed
Water present	Yes Electrical conductivity: 490 uS/cm Temperature: 10.4 °C pH: 7.74	Yes Electrical conductivity: 480 uS/cm Temperature: 10.7 °C pH: 7.31
Water elevation		Water level elevation: 6.06 mAOD Elevation was recorded where the water is discharging beneath briars.

Additional Information	Stream channel from spring location contains considerable vegetation. Flow not measurable due to thick vegetation within channel Flow from spring discharge point was audible on the 12/11/2014.
Site photo	<p data-bbox="580 336 887 369">Spring discharge location</p>

<p data-bbox="580 1003 1212 1037">Spring discharge channel containing thick vegetation</p>

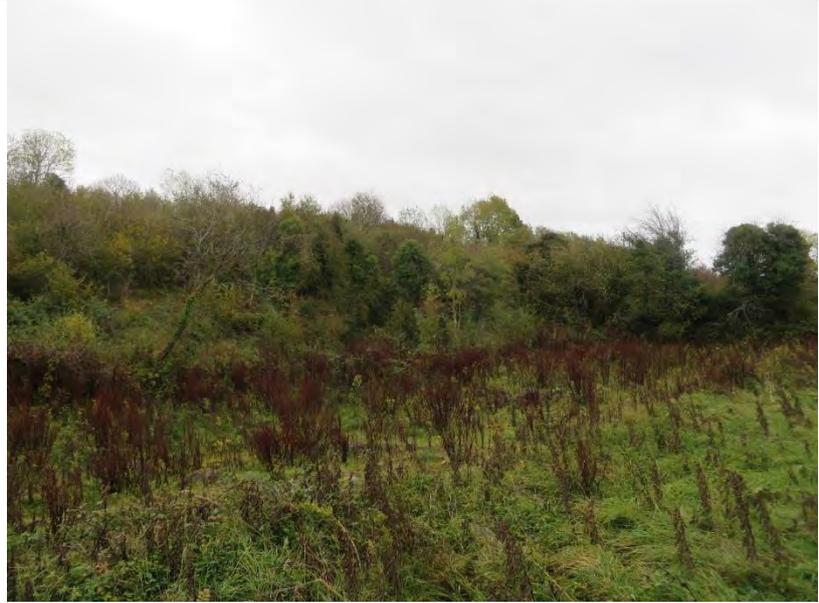
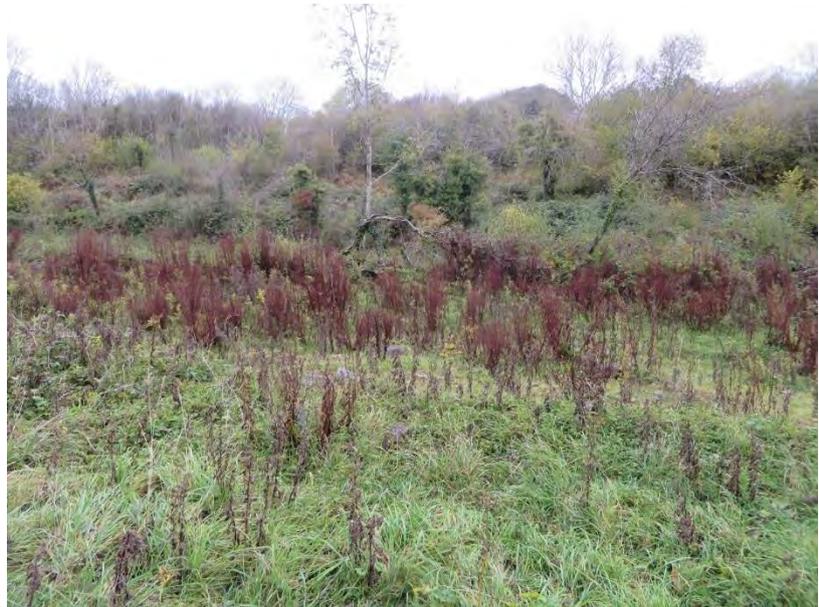
Site photo

Field survey date	17/10/2014
Field survey status	Confirmed
Water present	No
Additional Information	The feature is a linear shaped depression, the base of which is damp and soft.

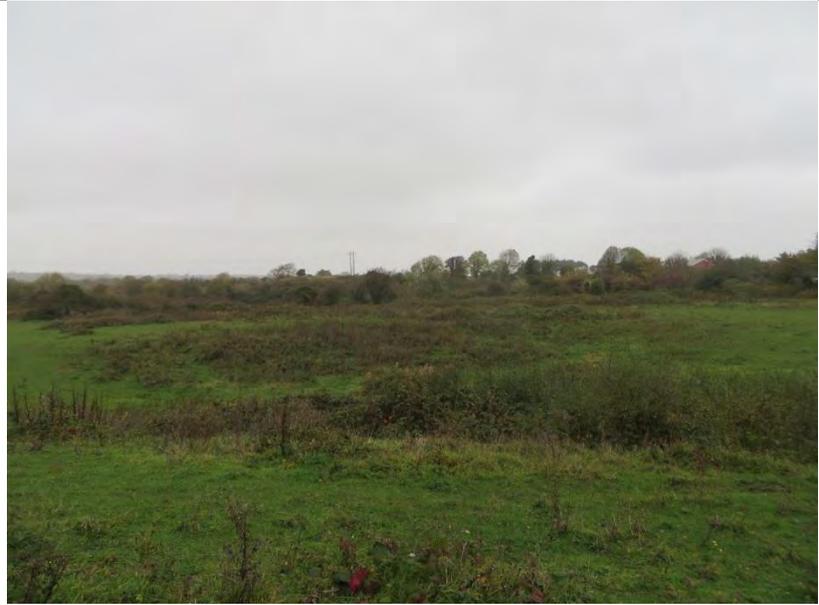
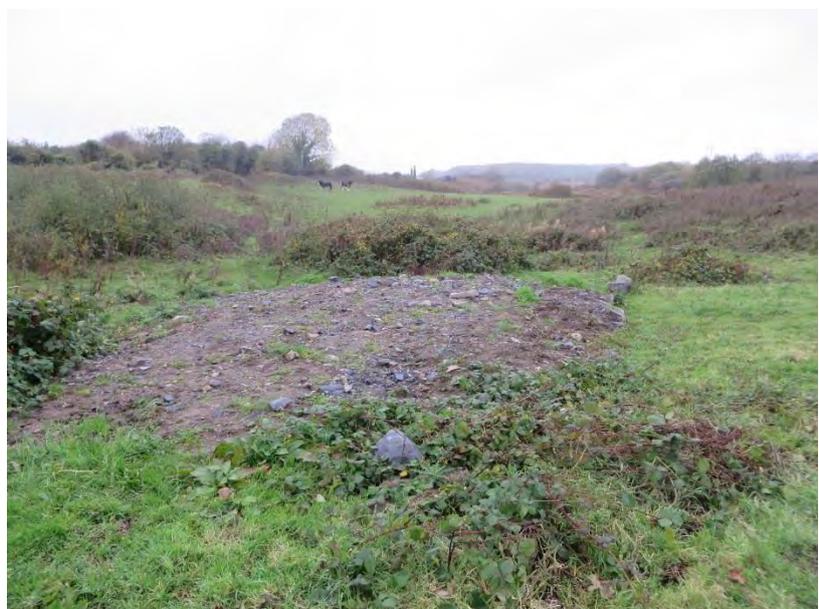
Site photos

Field survey date	20/10/2014
Field survey status	Confirmed
Water present	No
Additional Information	30 m diameter enclosed depression. However this feature is questionable as there may be disposal of material to the east of the depression.

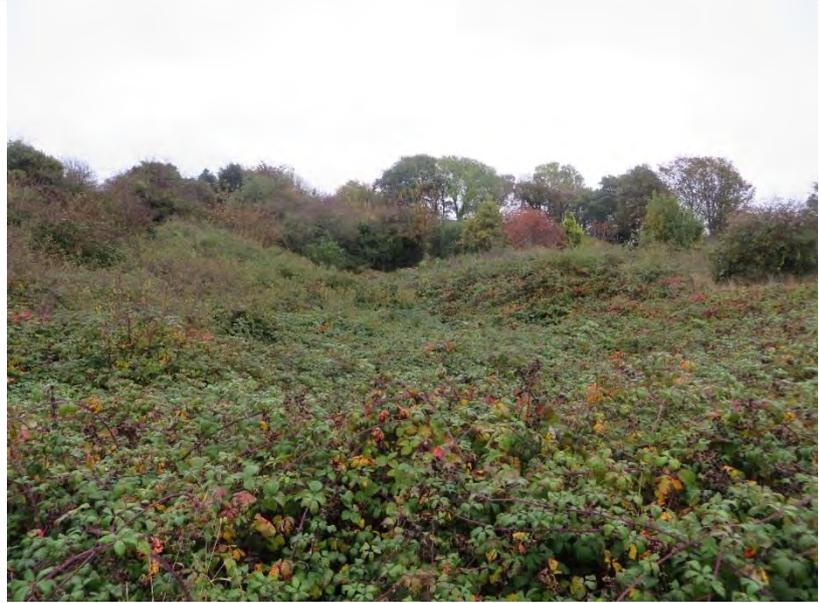
Site photos

Field survey date	20/10/2014
Field survey status	Confirmation/identification problem
Water present	Unknown
Additional Information	May be enclosed depression but access inhibited by dense vegetation

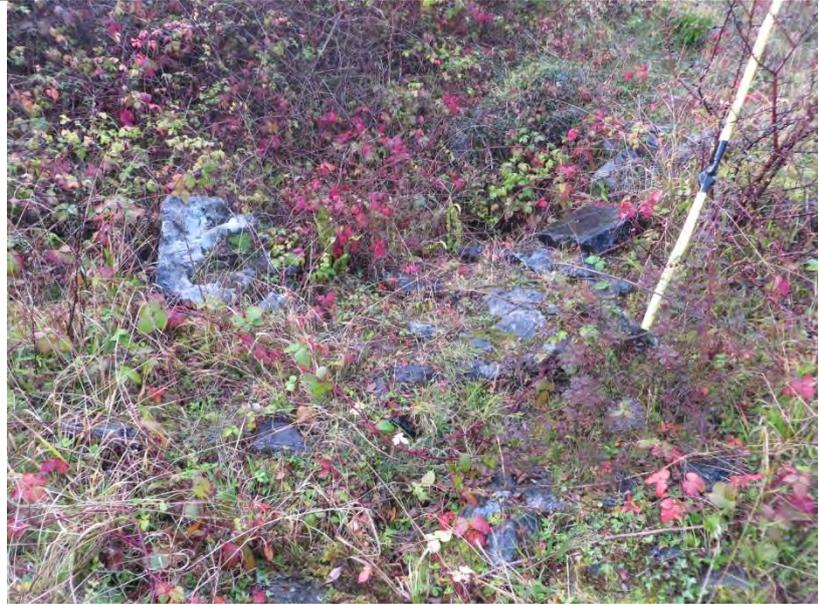
Site photo

Field survey date	16/10/2014
Field survey status	Confirmed
Water present	No
Additional Information	Small depression with rock exposed Approx. 2 m diameter and 1 m depth

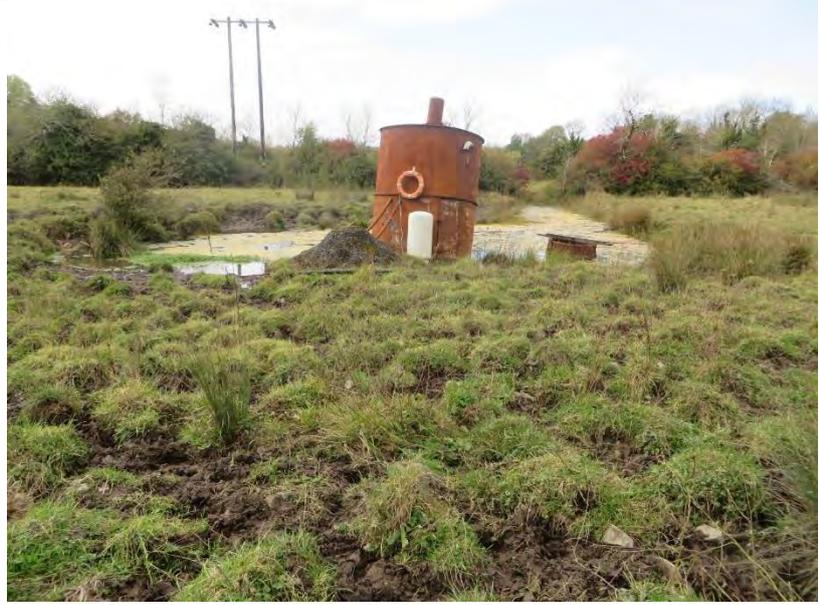
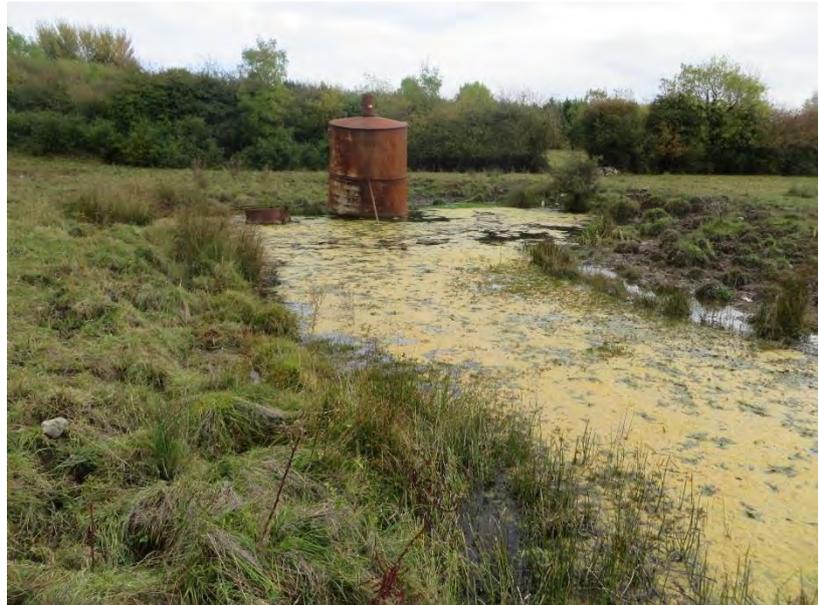
Site photo

Field survey date	16/10/2014
Field survey status	Confirmed
Water present	Yes Electrical conductivity: 680 uS/cm Temperature: 15.1 °C pH: 7.28
Additional Information

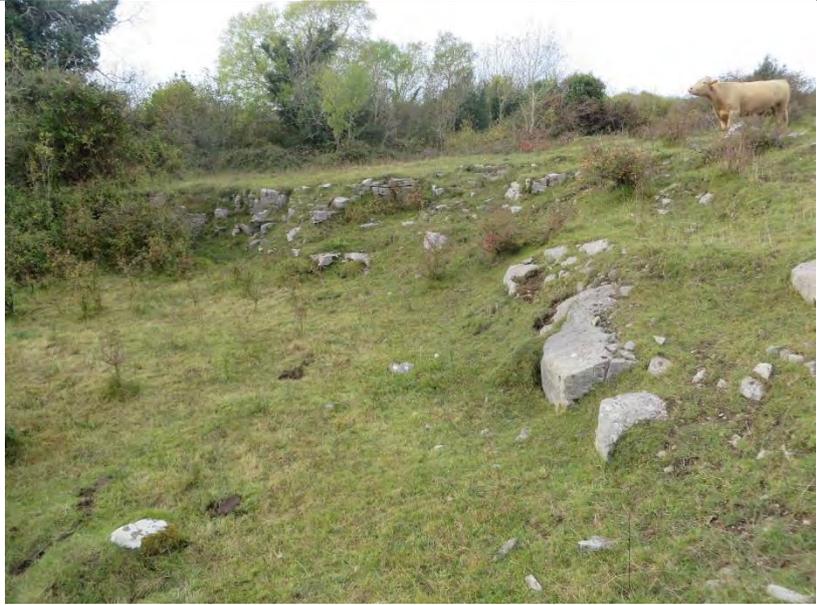
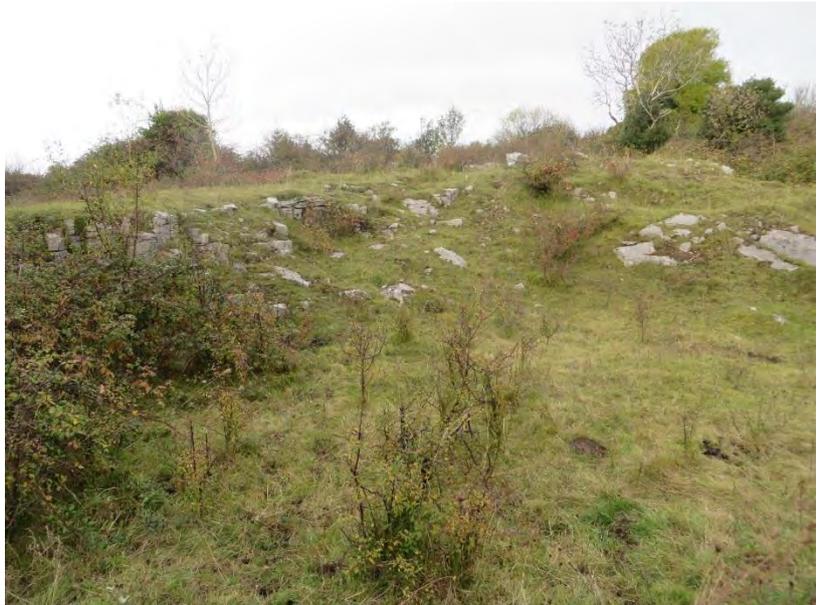
Site photos

Field survey date	16/10/2014
Field survey status	Confirmed
Water present	No
Additional Information	Exposed rock at northern side and gentle slope on Southern side Approx. 20 m diameter 2 m depth

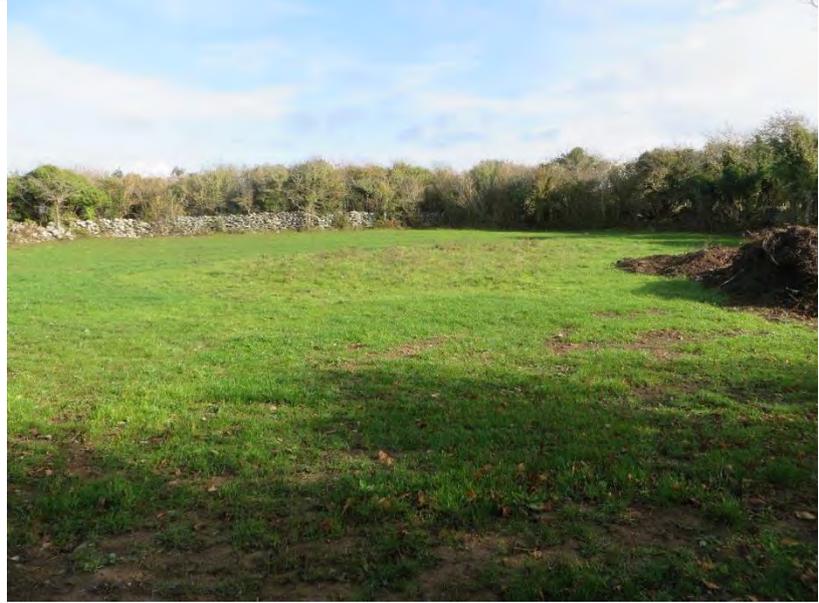
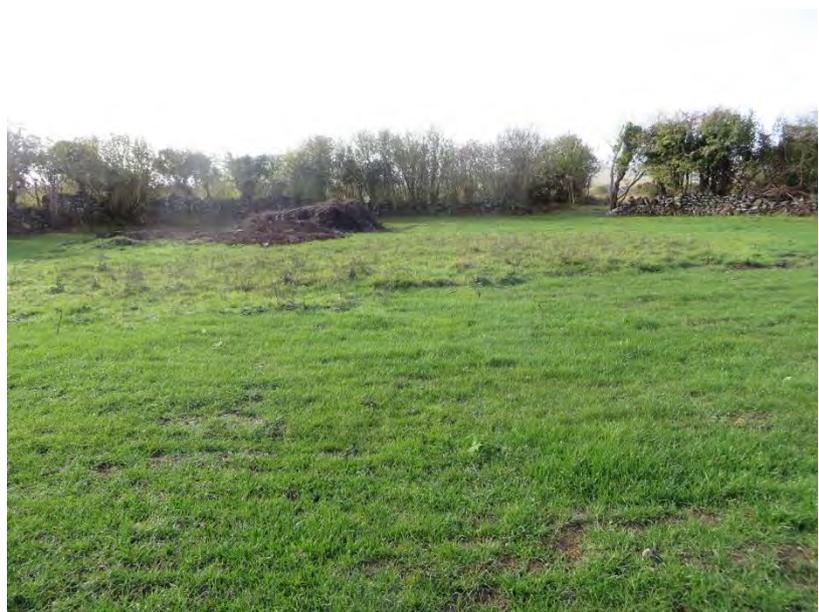
Site photos

Field survey date	16/10/2014
Field survey status	Confirmed
Water present	No
Additional Information	Slight enclosed depression which may be filled in

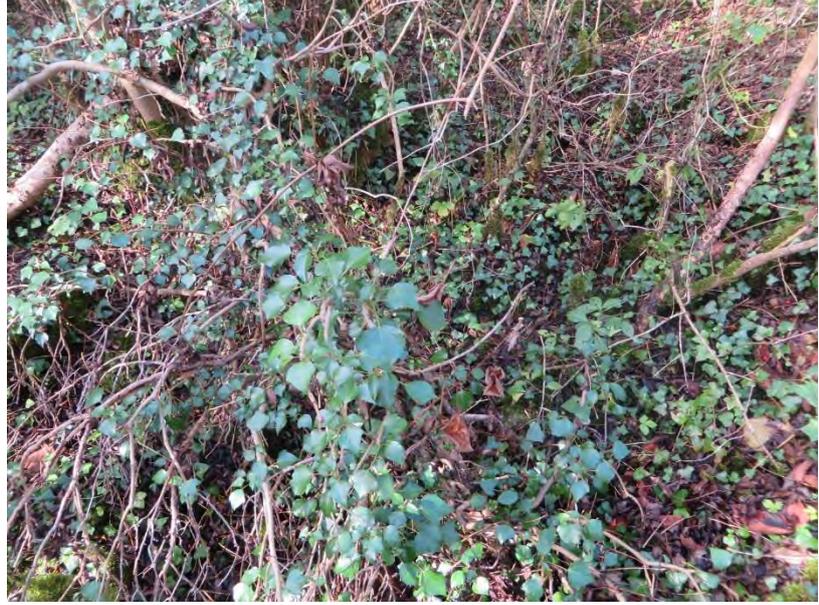
Site photos

Field survey date	16/10/2014
Field survey status	Confirmed
Water present	No
Additional Information	Very small enclosed depression plug hole not obvious but probably due to covering of moss

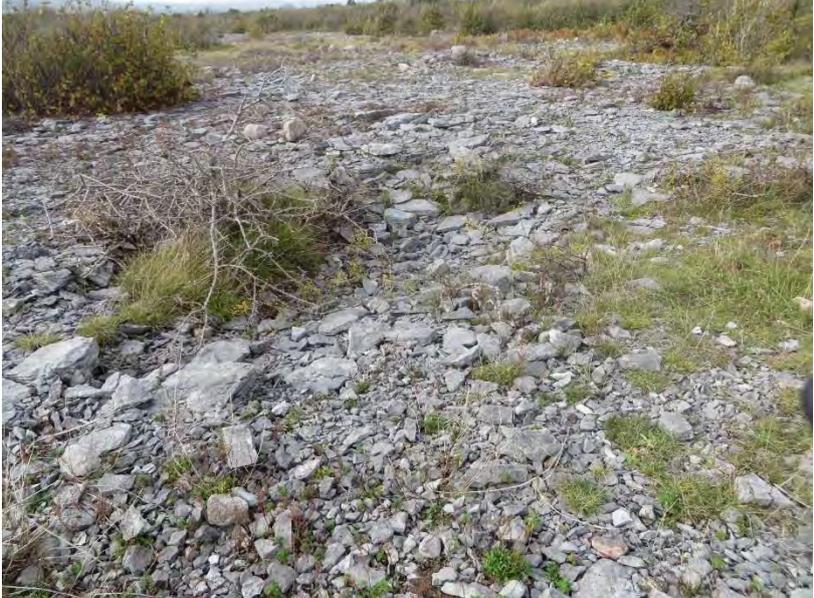
Feature ID	K61
Feature type	Enclosed Depression
Coordinates	530360, 728644
Source	Field Survey
Field survey date	16/10/2014
Field survey status	Confirmed
Water present	No
Additional Information	Approx. 1m diameter Enclosed depression is in line of depressions running east-west
Site photo

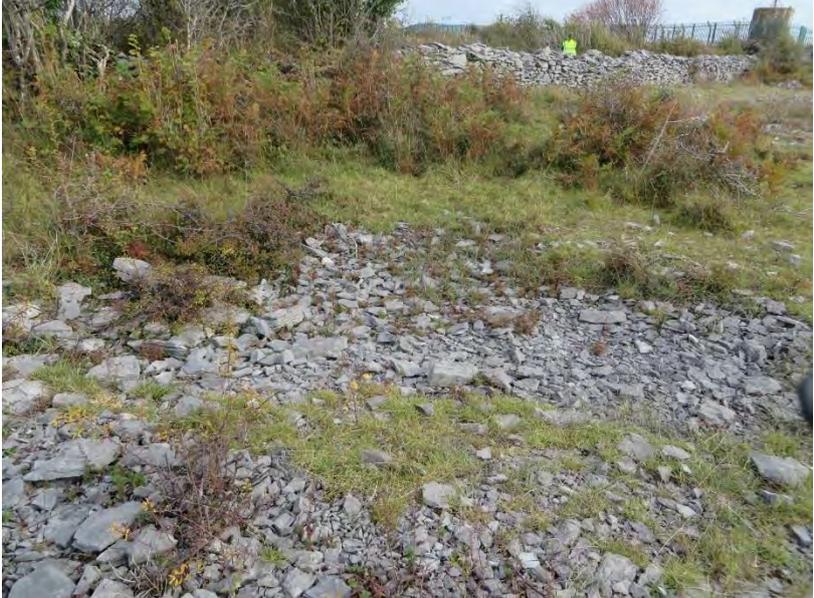
Feature ID	K62
Feature type	Enclosed Depression
Coordinates	530369, 728642
Source	Field Survey
Field survey date	16/10/2014
Field survey status	Confirmed
Water present	No
Additional Information	Approx. 2m diameter and less than 0.5 m in depth. Enclosed depression is in line of depressions running east-west
Site photo

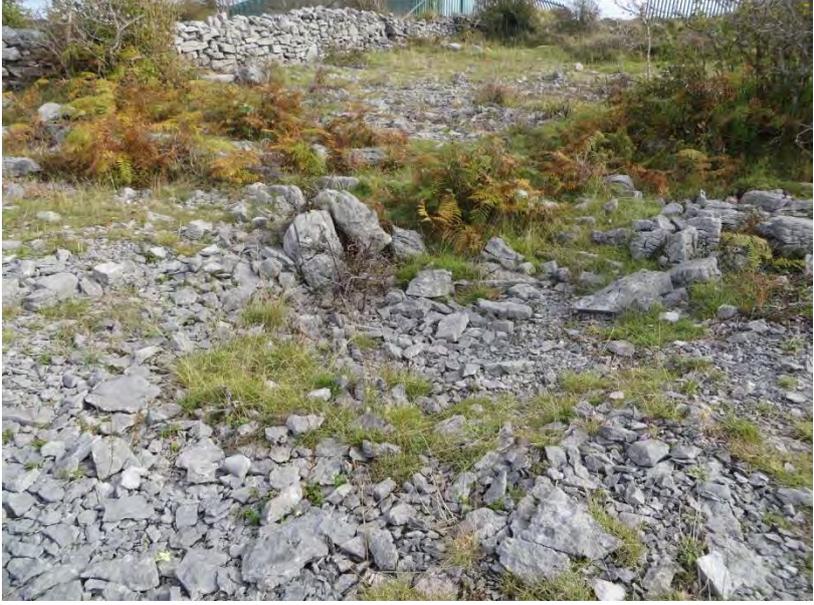
Feature ID	K64
Feature type	Enclosed Depression
Coordinates	530386, 728617
Source	Field Survey
Field survey date	16/10/2014
Field survey status	Confirmed
Water present	No
Additional Information	Approx. 2m diameter and less than 0.5 m in depth. Enclosed depression is in line of depressions running east-west
Site photo

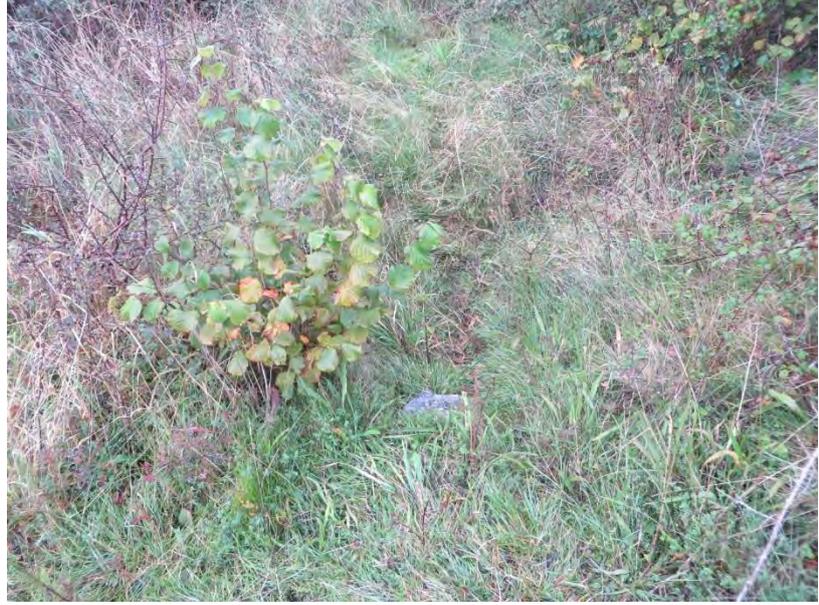
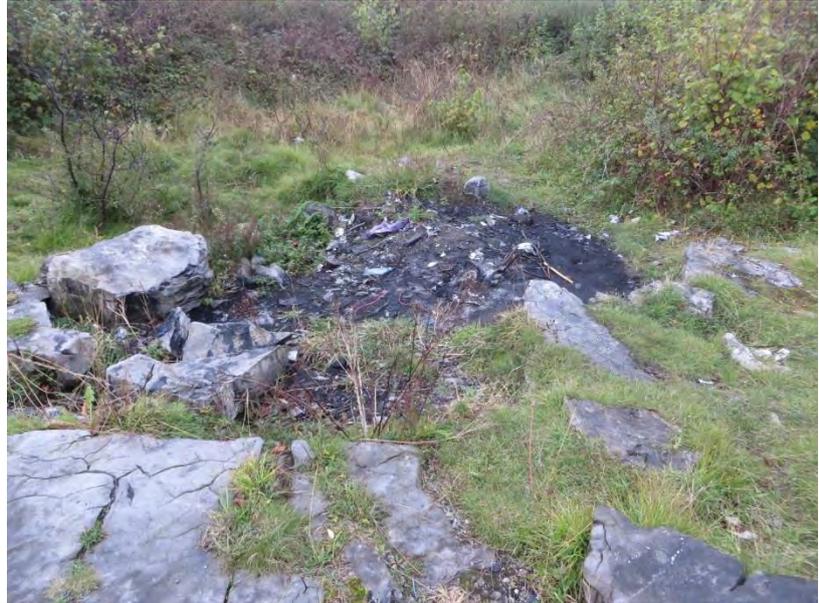
Feature ID	K65
Feature type	Enclosed Depression
Coordinates	530452, 727738
Source	Lidar:

Field survey date	16/10/2014
Field survey status	Confirmed
Water present	No
Additional Information	2 depressions 3 m diameter and 1 m diameter less than 0.5 m depth. Larger depression is filled with a fire pit
