Galway County Council
N6 Galway City Transport Project
Karst Study

Karst Study Report

Issue 1 | 27 February 2015

Ove Arup & Partners Ireland Ltd

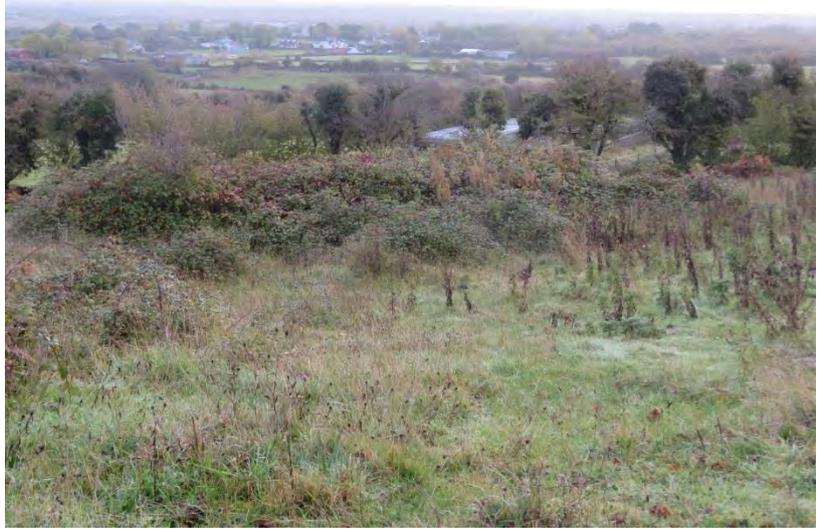
Feature ID	K66
Feature type	Enclosed Depression
Coordinates	530474, 729558
Source	Lidar:

Field survey date	17/10/2014
Field survey status	Confirmation/identification problem
Water present	Unknown
Additional Information	Circle of brambles. Looks like a dip in the middle but covered in brambles preventing access.

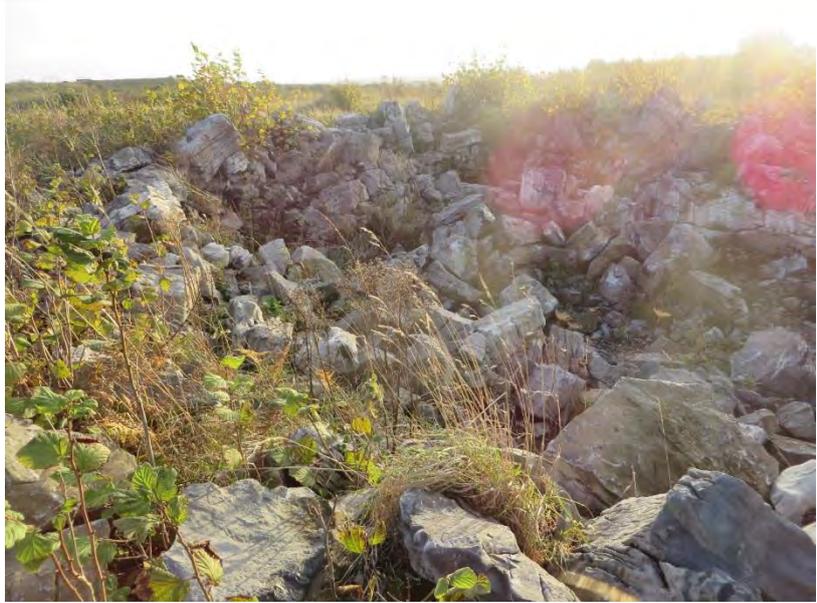
Feature ID	K67
Feature type	Enclosed Depression
Coordinates	530629, 728329
Source	Lidar:

Field survey date	21/10/2014
Field survey status	Confirmed
Water present	No
Additional Information	Numerous boulders in depression Approx. 20 x 10m diameter and depth of 2m

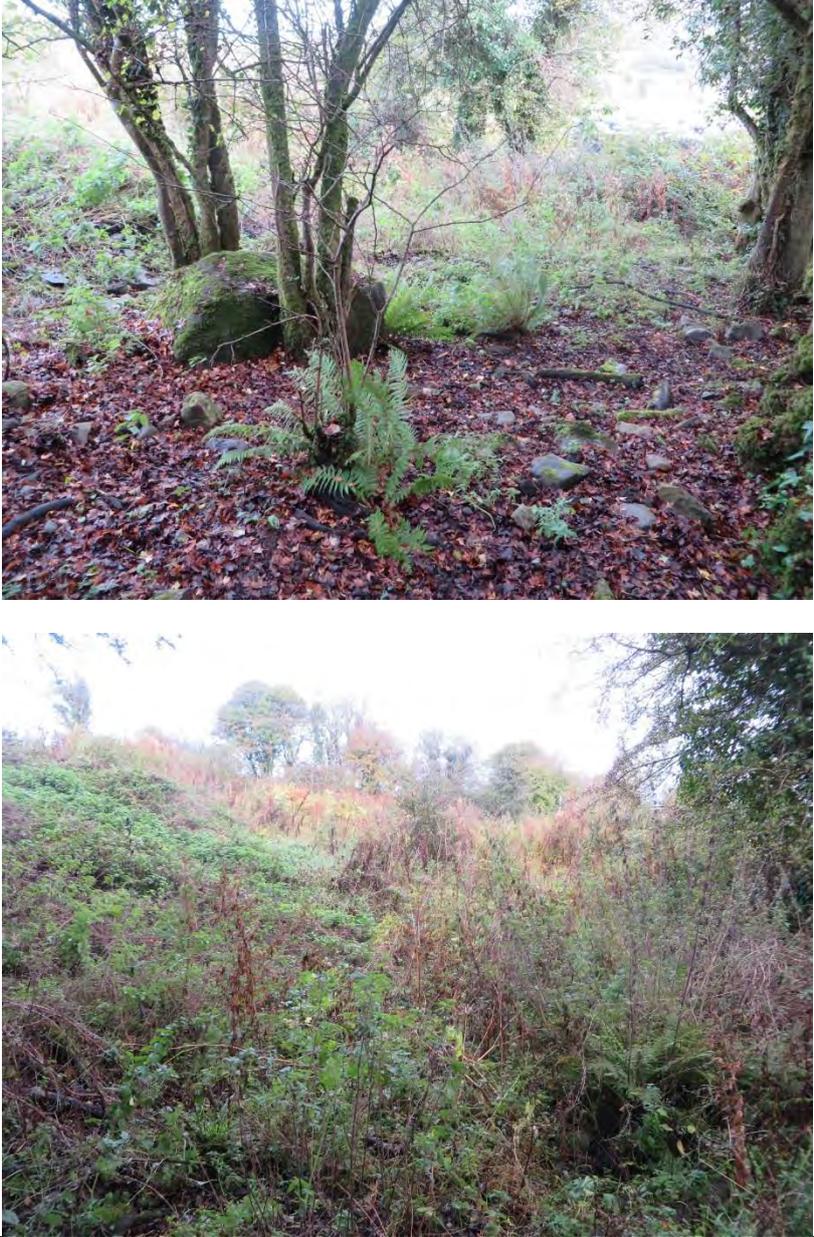
Feature ID	K69
Feature type	Enclosed depression
Coordinates	530669, 729123
Source	Field Survey
Field survey date	16/10/2014
Field survey status	Confirmed
Water present	No
Additional Information	Two adjacent enclosed depressions; 10 x 30m diameter and 5m diameter
Site photo

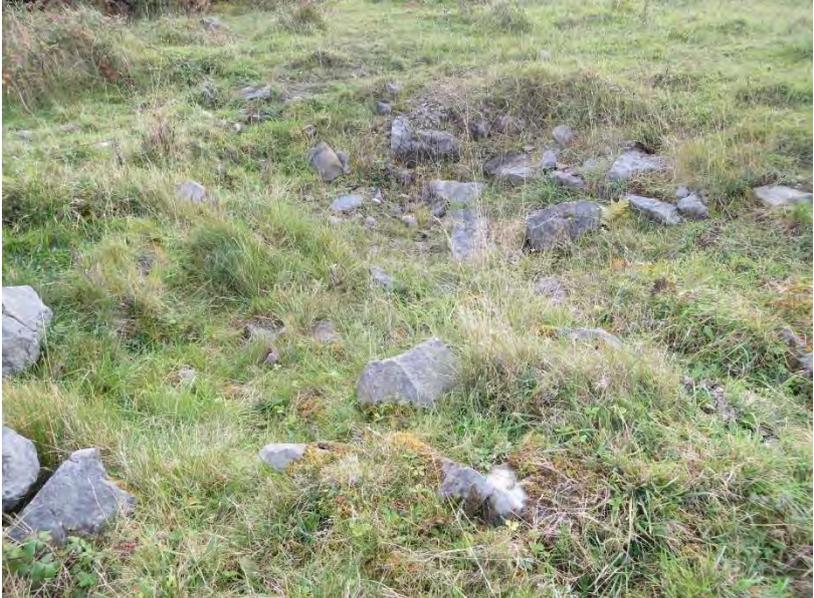
Feature ID	K71
Feature type	Enclosed depression
Coordinates	530694, 728662
Source	Field Survey
Field survey date	16/10/2014
Field survey status	Confirmed
Water present	No
Additional Information	2m by 4m along slope line Small depression near top of slope contains exposed rock
Site photo

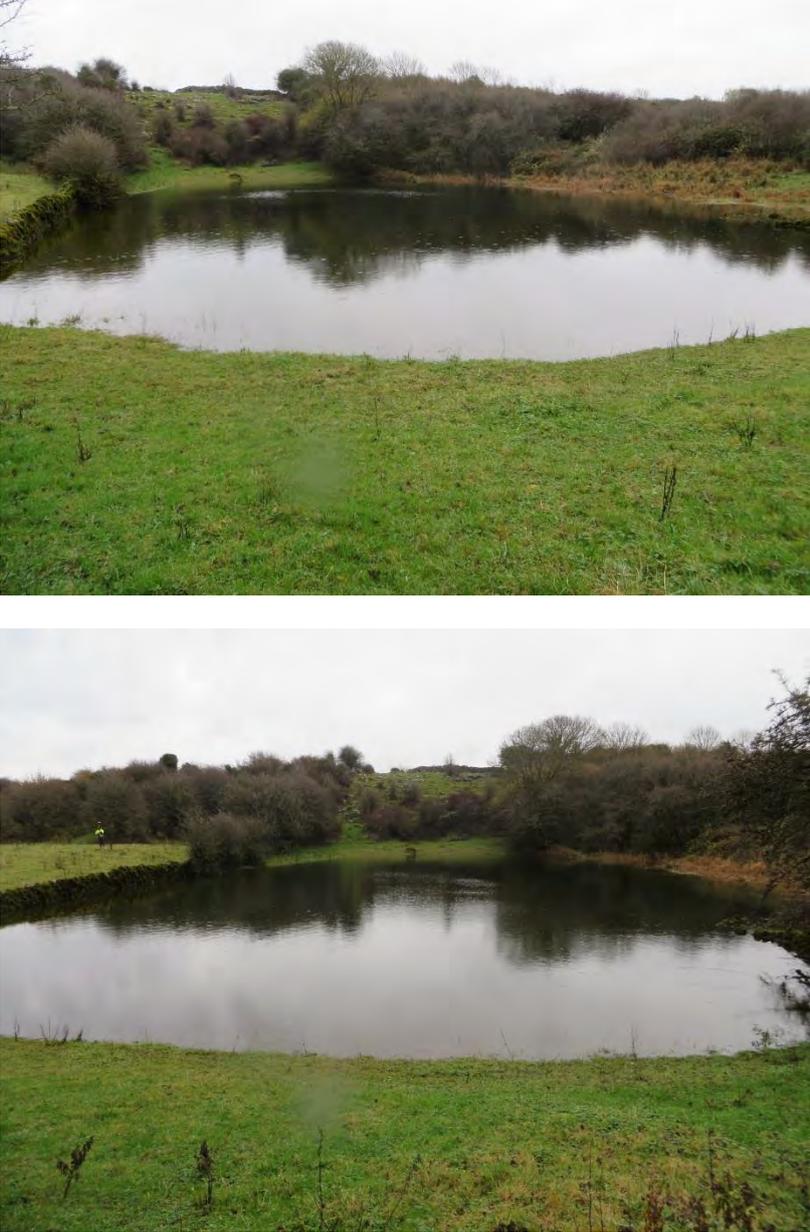
Feature ID	K72
Feature type	Turlough
Coordinates	530946, 729099
Source	Scott Cawley Ecologists Surveys
	Lidar:

Field survey date	12/11/2014
Field survey status	Confirmed
Water present	Yes Electrical conductivity: 513 uS/cm Temperature: 9.2 °C pH: 7.37
Water elevation	14.13 mAOD

Additional Information	Turlough visited while in flood Estimated highest extend of water is 15.37 mAOD measured in adjacent field
Site photo

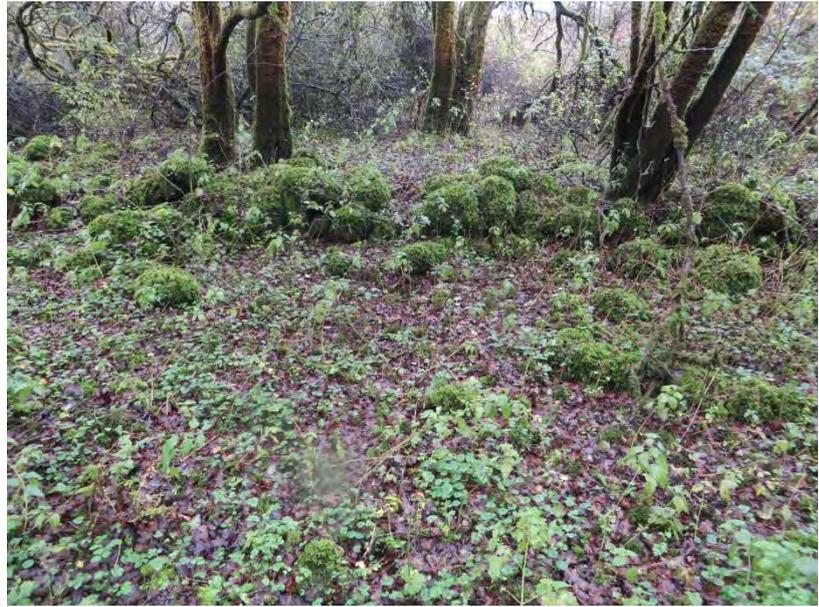
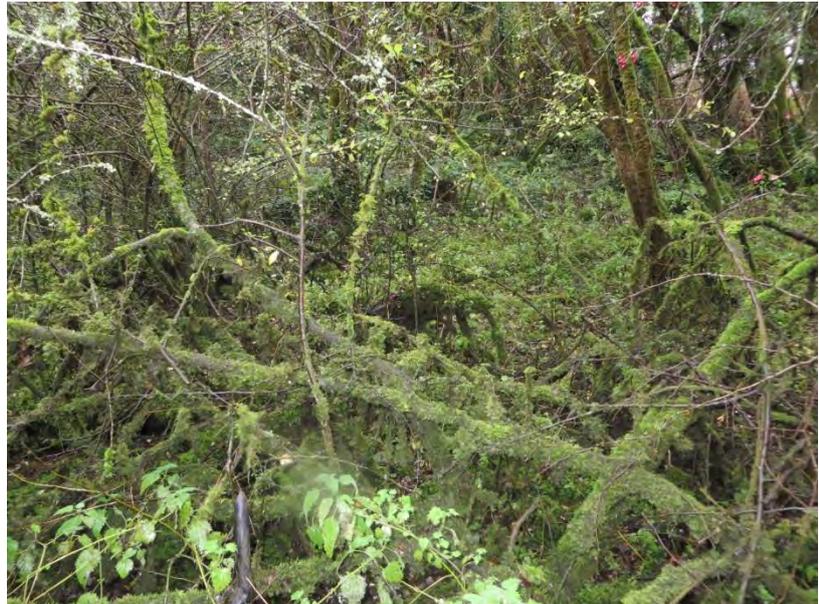
Feature ID	K73
Feature type	Enclosed depression
Coordinates	530964, 729035
Source	Lidar:

Field survey date	12/11/2014
Field survey status	Confirmed
Water present	No
Ground level elevation	15.46 mAOD, Estimated elevation. Elevation not recorded within feature due to tree coverage. Elevation reading taken 20 m south and approx. 1m higher elevation (actual recorded elevation was 16.456)
Additional Information	Area mossy and covered with trees

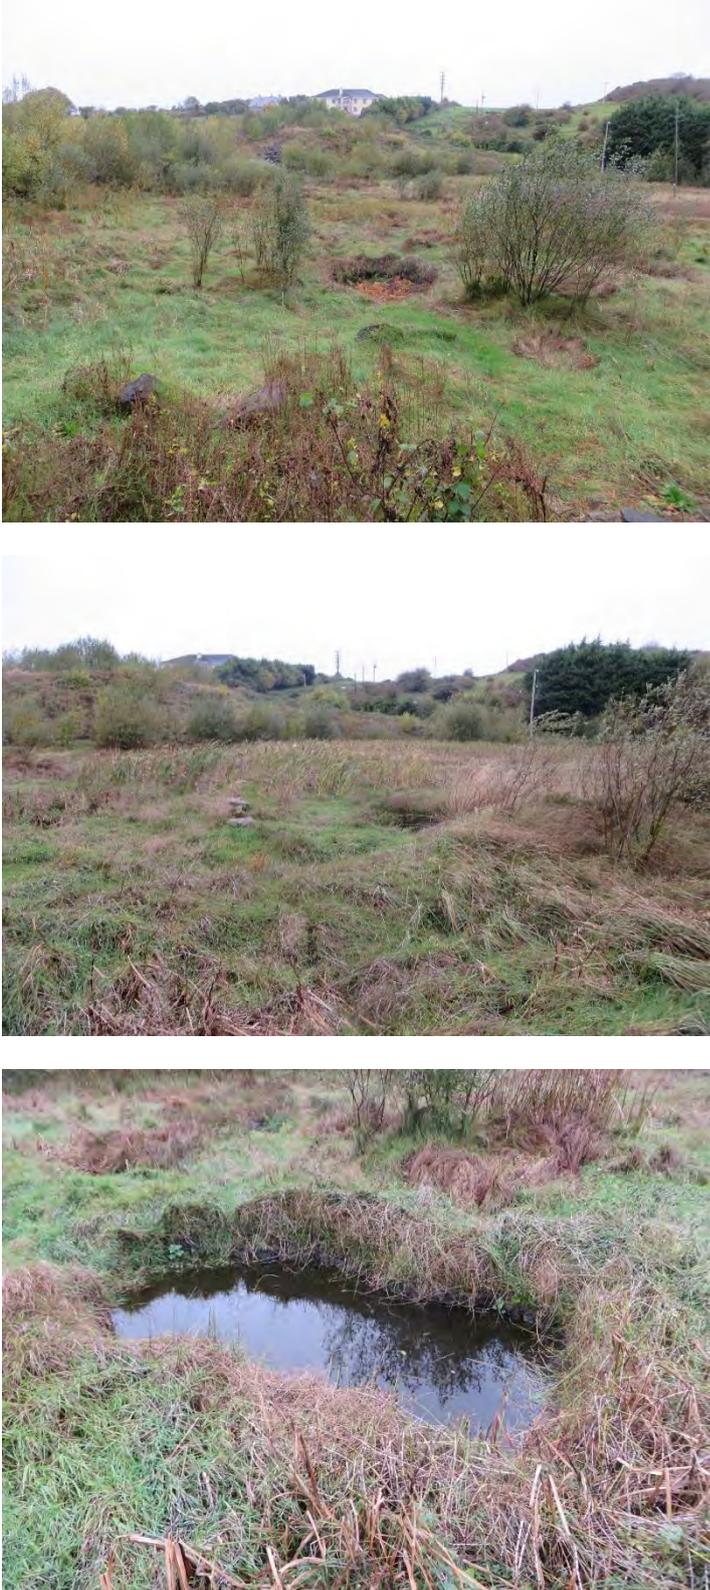
Feature ID	K74
Feature type	Turlough
Coordinates	531066, 728080
Source	Scott Cawley Ecologists Surveys
	Lidar:

Field survey date	12/11/2014
Field survey status	Confirmed
Water present	Yes Electrical conductivity: 551 uS/cm Temperature: 8.1 °C

pH: 7.42
Water level elevation	9.70 mAOD
Additional Information	Questionable turlough. May be a wetland rather than a turlough. The area contains numerous rectangular hollows filled with water. It is unlikely that the hollows are natural but are most likely manmade.
Site photo

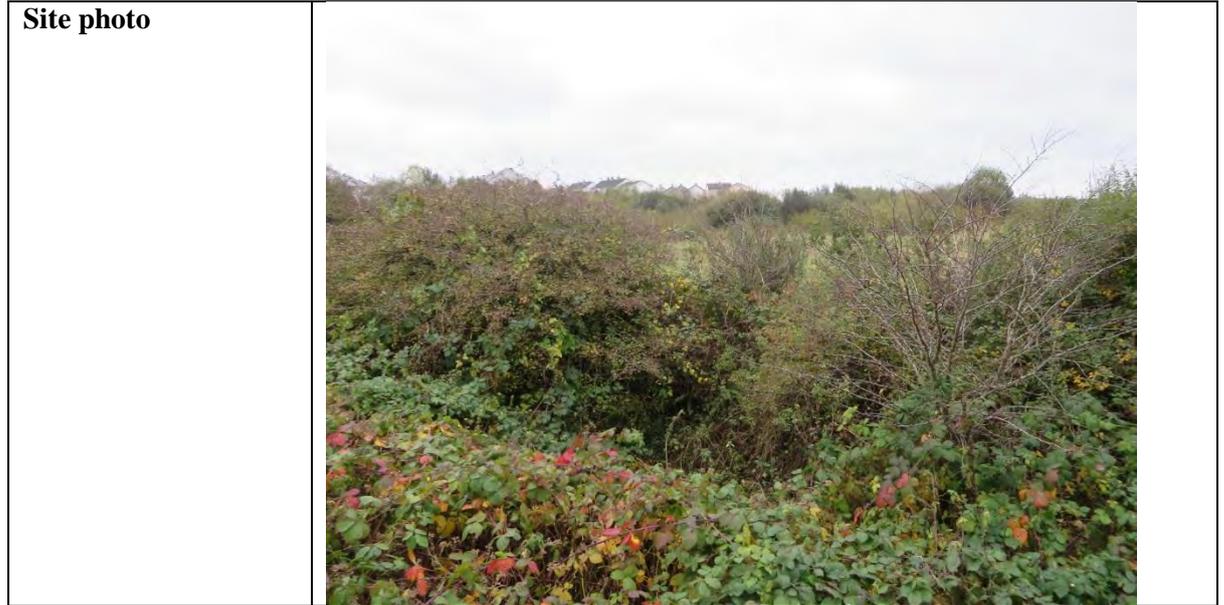
Feature ID	K75
Feature type	Enclosed Depression
Coordinates	531193, 727242
Source	Lidar:

Field survey date	22/10/2014
Field survey status	Confirmation/identification problem
Water present	Unknown
Additional Information	Cannot access depression. Access hindered due to dense vegetation.

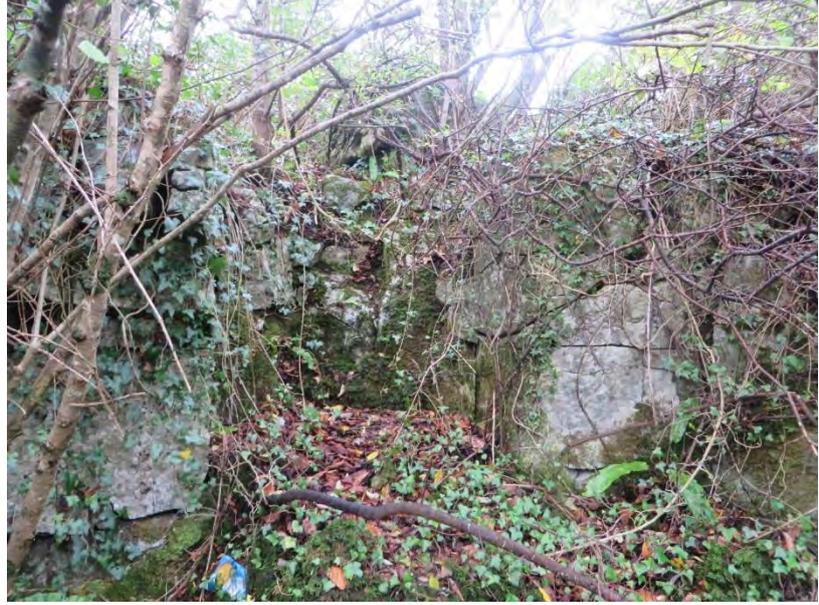
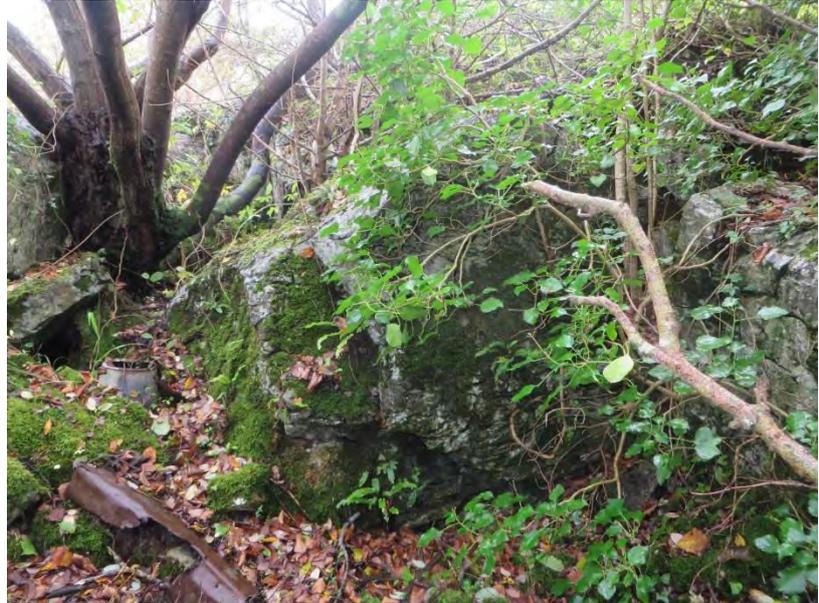
Feature ID	K76
Feature type	Enclosed Depression
Coordinates	531254, 727960
Source	Lidar:

Field survey date	20/10/2014
Field survey status	Confirmed
Water present	No
Additional Information	10m diameter 4m depth. Steep sides with exposed rock May also be as result of rock excavation

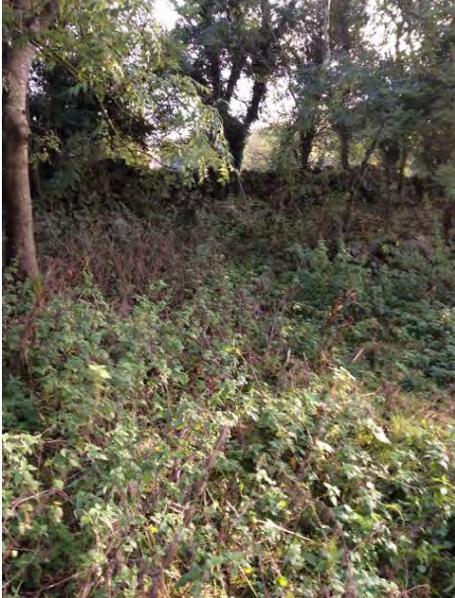
Feature ID	K82
Feature type	Enclosed depression
Coordinates	531437, 729244
Source	Field Survey
Field survey date	16/10/2014
Field survey status	Confirmed
Water present	No
Additional Information	10 m diameter. Possible enclosed depression slightly questionable
Site photo

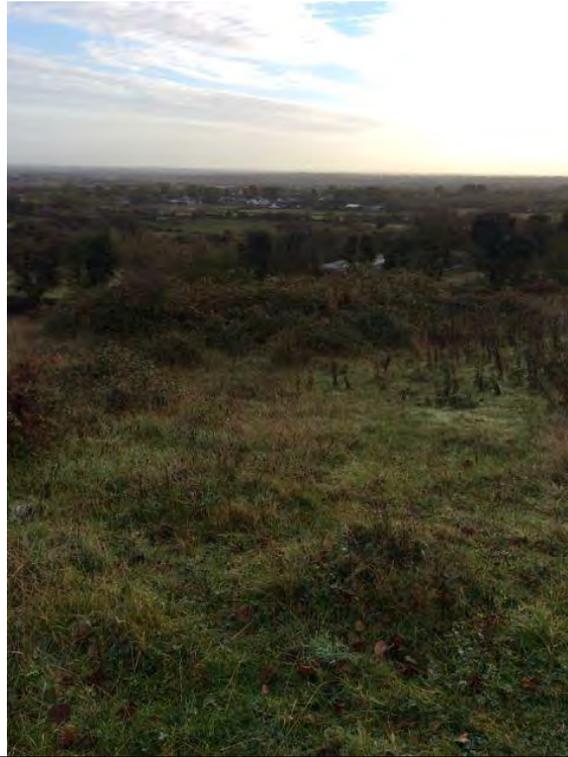
Site photo

Field survey date	12/11/2014
Field survey status	Confirmation/identification problem
Water present	Unknown
Additional Information	Could not access very overgrown

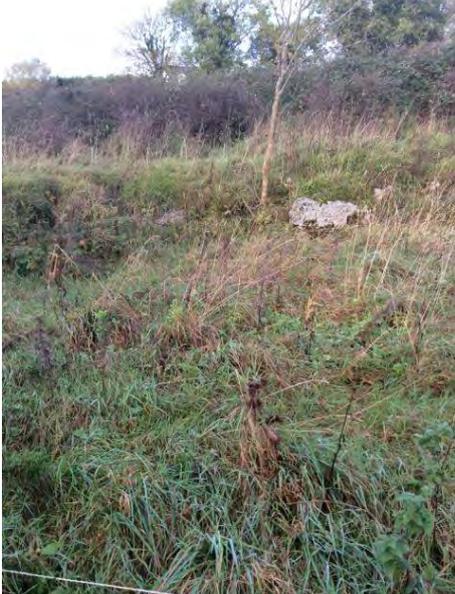
Feature ID	K85
Feature type	Enclosed depression
Coordinates	531456, 729194
Source	Field Survey
Field survey date	16/10/2014
Field survey status	Confirmed
Water present	No
Additional Information	10 m diameter semicircle intercepted by wall/road (N84). Possible enclosed depression slightly questionable as it could be as a result of excavation for N84 road construction
Site photo

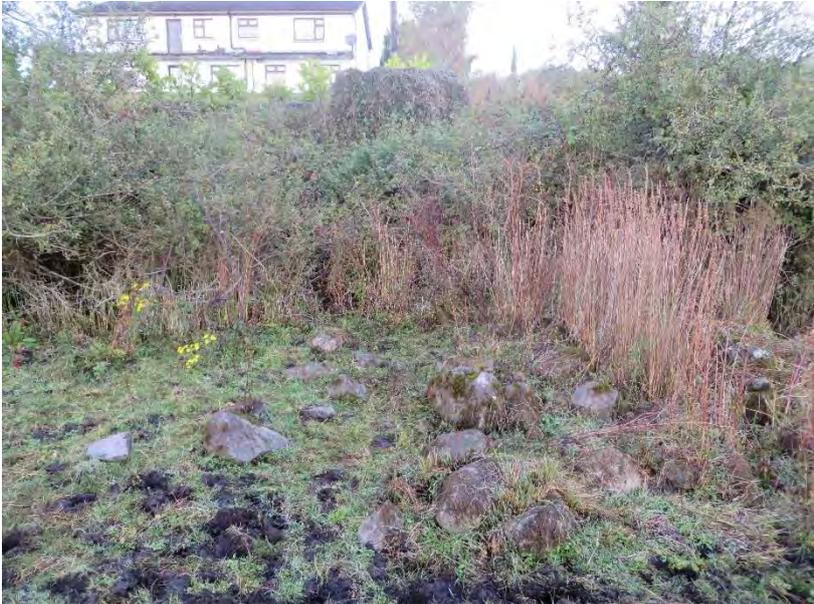
Feature ID	K86	
Feature type	Estavelle	
Coordinates	531476, 729108	
Source	EIS N6 Galway City Outer Bypass Vol 2 2006	
Field survey date	16/10/2014	11/11/2014
Field survey status	Confirmed	Confirmed
Water present	No	Yes Electrical conductivity: 590 uS/cm Temperature: 9 °C pH: 7.52 No flow to permit flow measurement
Water elevation	n/a	8.927
Additional Information	Drain runs from estavelle location near break in slope towards Ballindooley lough	
Site photo	<p>Estavelle location</p>

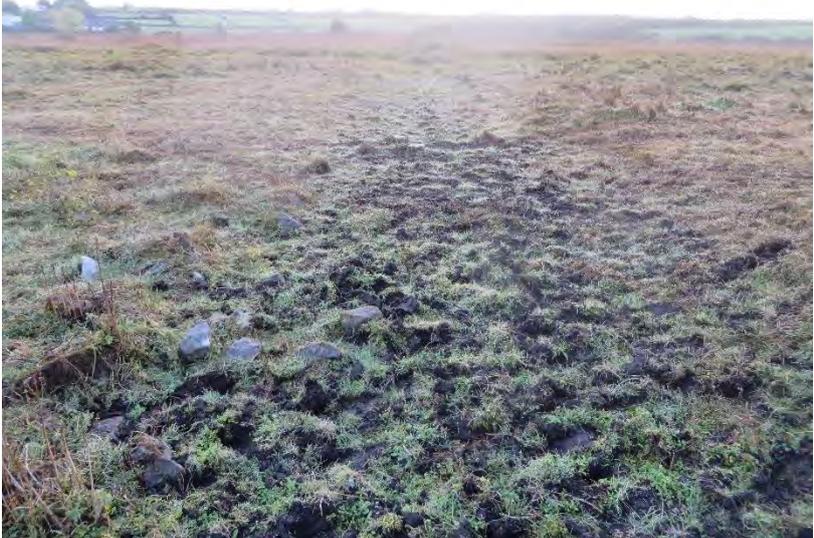
<p>Shallow ditch running between the estavelle and Ballindooley Lough:</p>

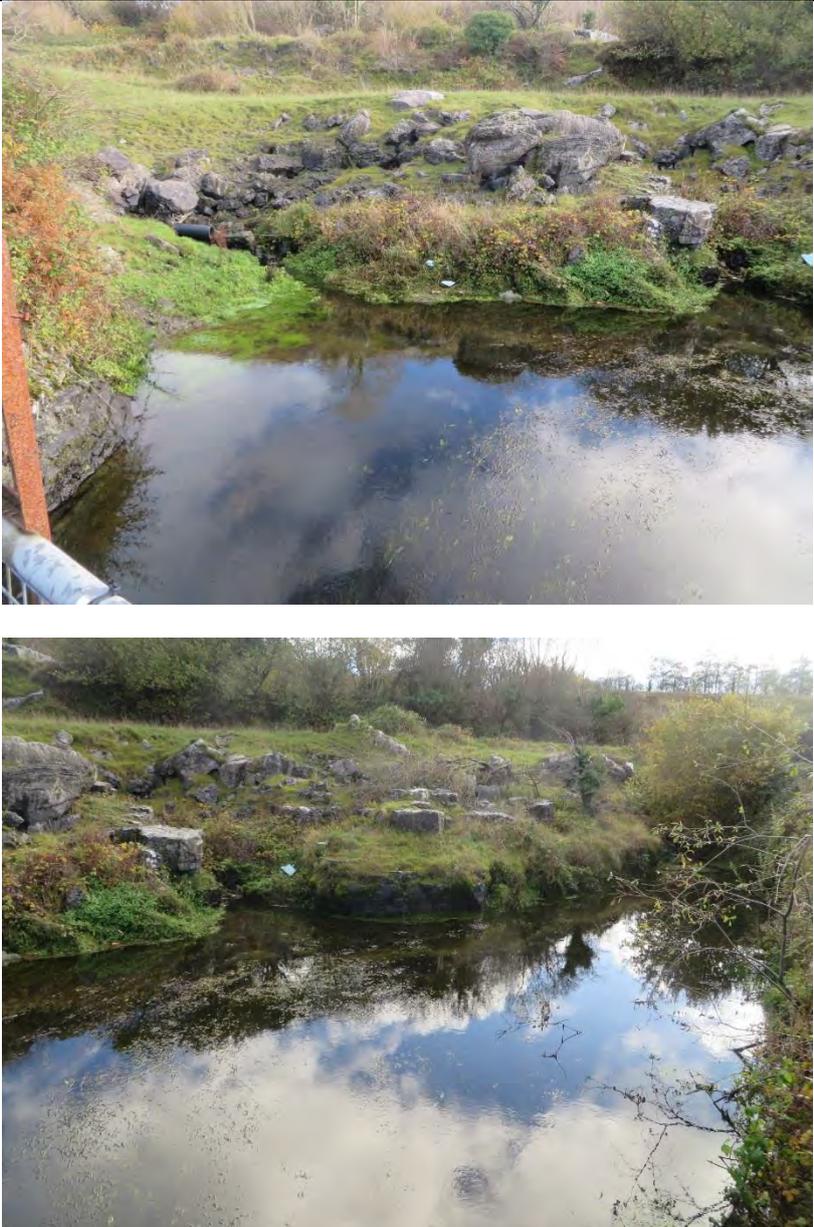
Water present	Yes Electrical conductivity: 320 uS/cm Temperature: 11.4 °C pH: 7.76 Flow direction into swallow hole No flow measurement taken	Yes Electrical conductivity: 781 uS/cm Temperature: 10.3 °C pH: 7.5 Flow direction into swallow hole Flow: 400 l/s
Water level elevation	n/a	1.79 mAOD
Additional Information	Terryland River discharges into or can be fed by this spring / swallow hole. The Feature contains three discrete discharge points to ground where flow was visible discharging to ground during both field survey visits.	
Site photo

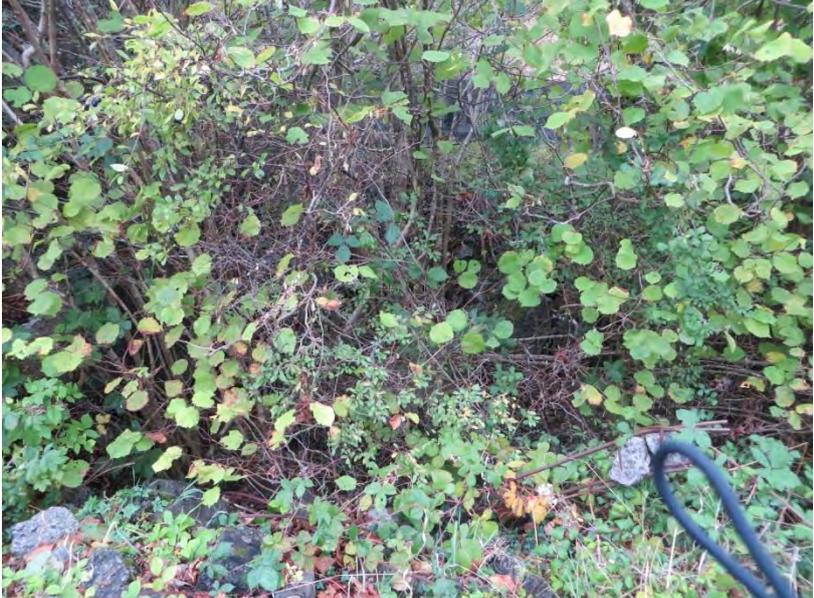
Feature ID	K88
Feature type	Enclosed depression
Coordinates	531671, 727351
Source	Field Survey
Field survey date	22/10/2014
Field survey status	Confirmed
Water present	No
Additional Information	Approximate dimensions: 30m x 5m Elongated depression in an east-south-east west-north-west direction. The ESE wall is approx. 4m high. The depression contains numerous trees.
Site photo

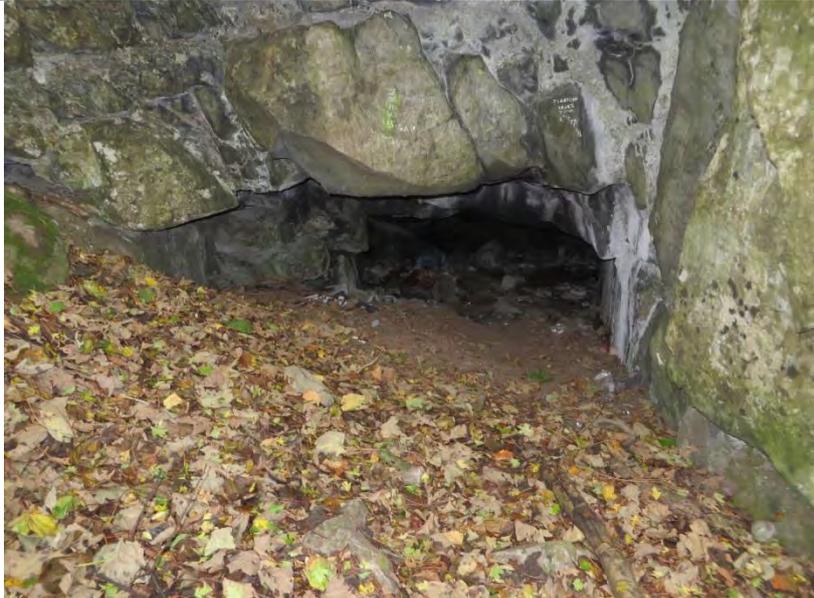
Field survey date	22/10/2014
Field survey status	Confirmed
Water present	No
Additional Information	Approx. 3m wide x 1 m high opening to cave
Site photo

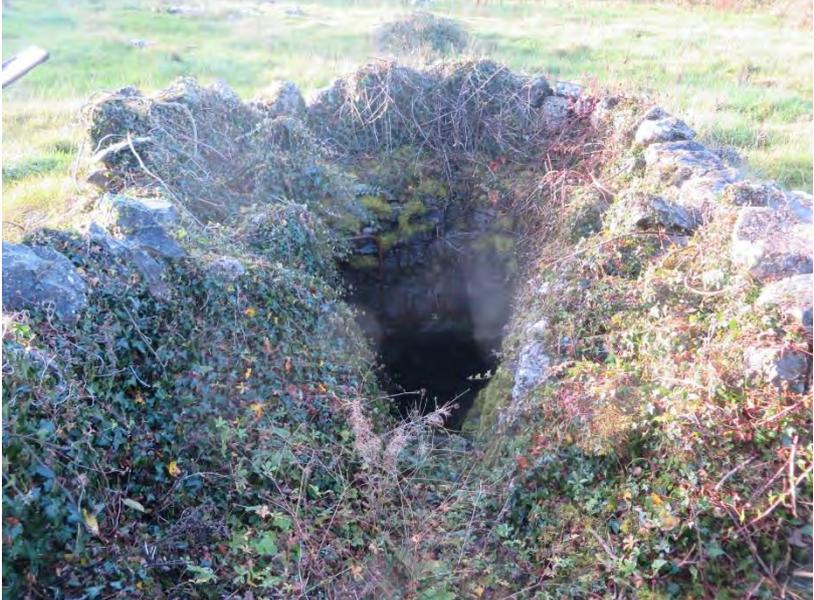
Feature ID	K92
Feature type	Well
Coordinates	531781, 729453
Source	Field Survey
Field survey date	21/10/2014
Field survey status	Confirmed
Water present	Yes Electrical conductivity: 370 uS/cm Temperature: 11.1 °C pH: 7.61
Additional Information	Approximate dimension: 2m diameter Old well surrounded by stone wall
Site photo

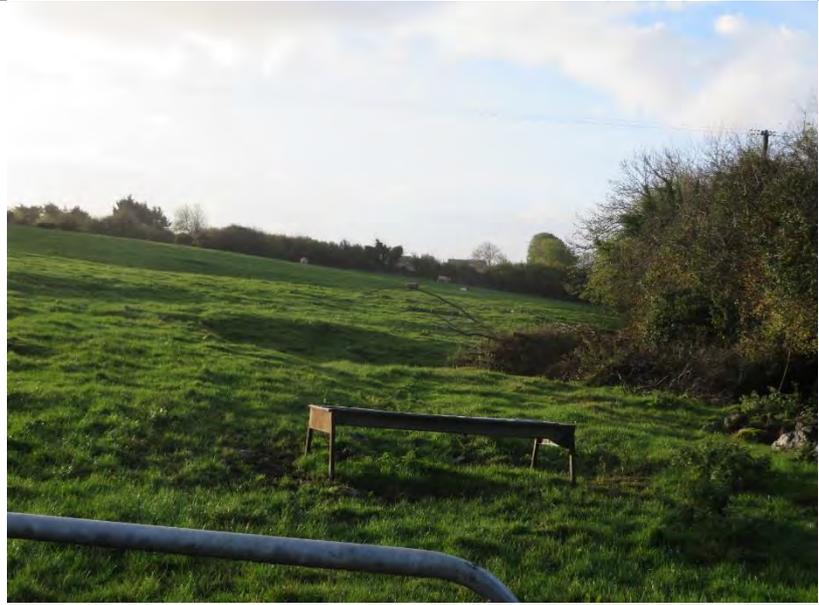
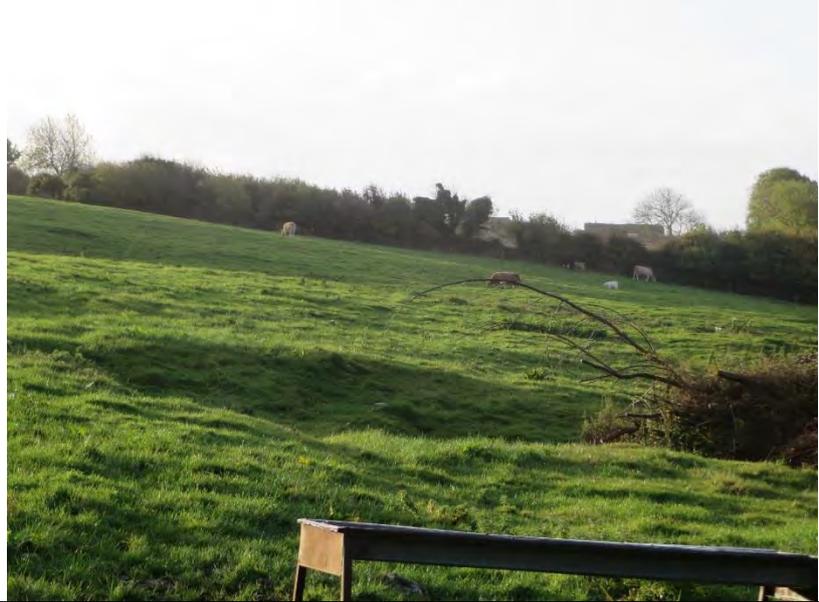
Site photo

To the northwest there is an enclosed depression (K94) and a well (K92) and these again indicate a karstic flow path, most likely a conduit. Considering the rising topography both of these linear clusters of karst landforms suggest that two main fractures may provide conduit flow that feeds in to towards Ballindooley Lough.

Field survey date	21/10/2014
Field survey status	Confirmed
Water present	No
Additional Information	Approx. 15m diameter Access inhibited due to cattle in field

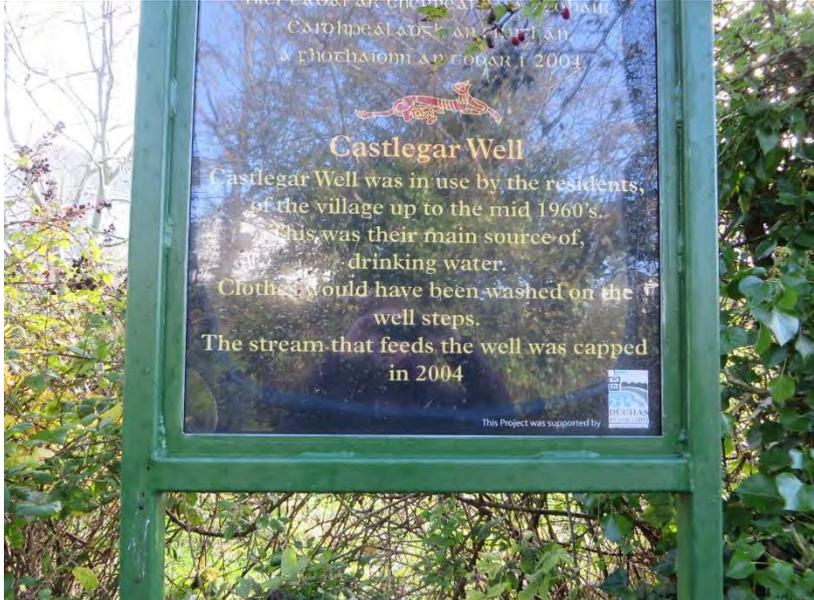
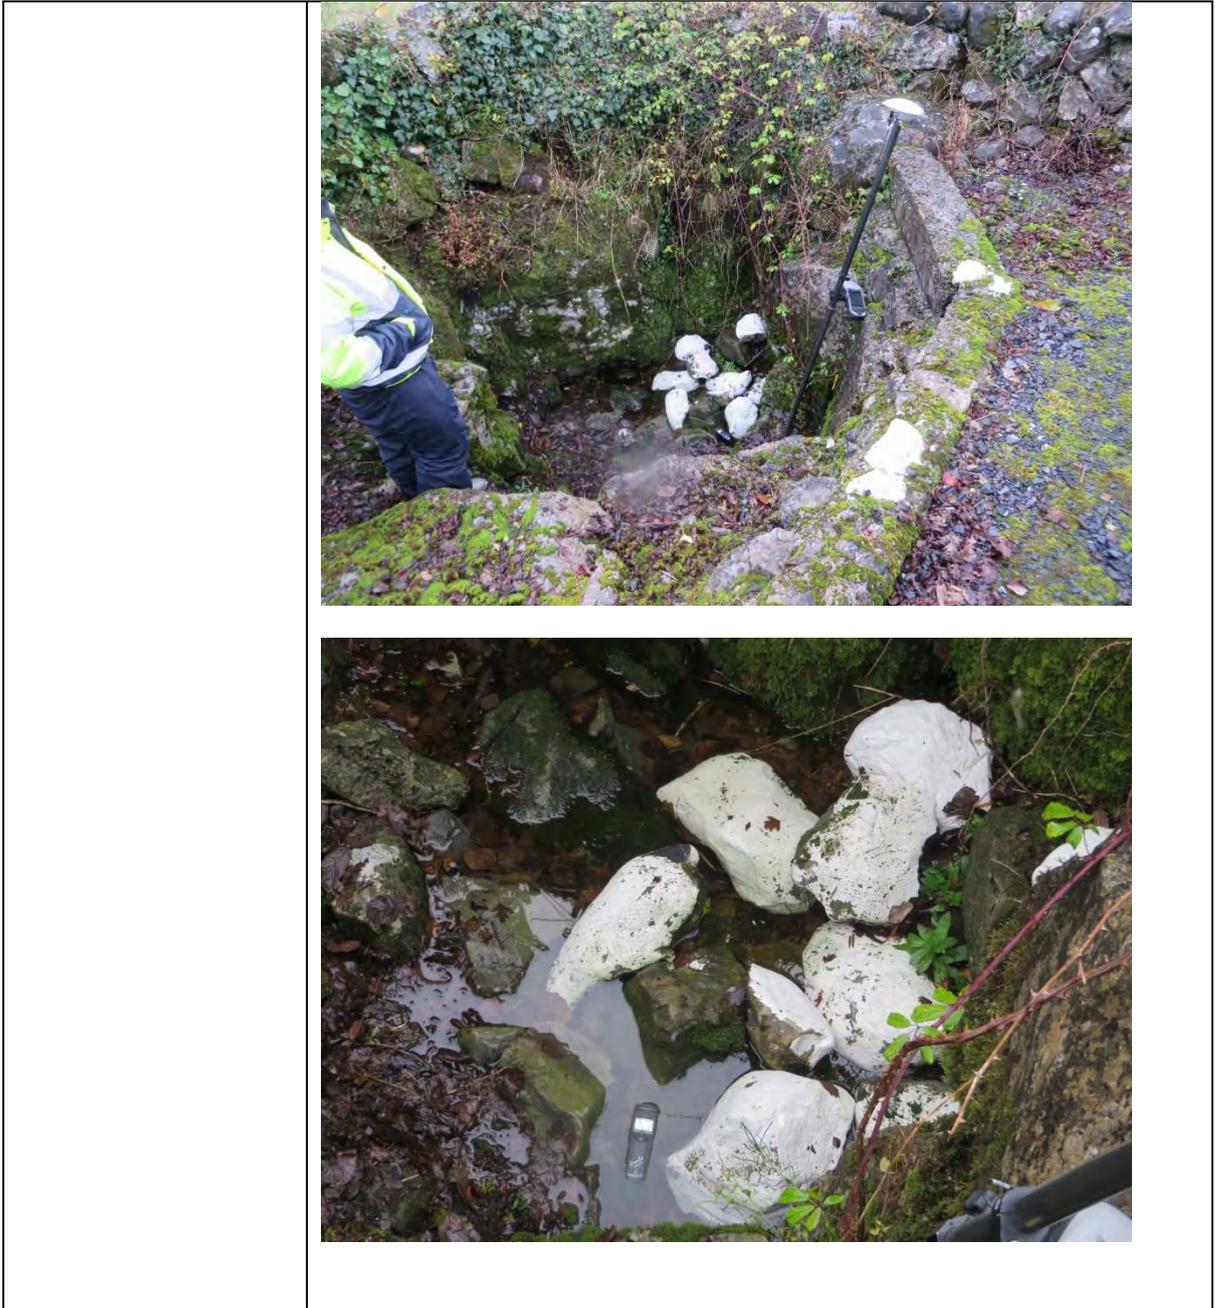
Field survey date	12/10/2014	12/11/2014
Field survey status	Confirmed	Confirmed
Water present	No	Yes Electrical conductivity: 728 uS/cm Temperature: 10.9 °C pH: 7.06
Water level elevation	n/a	3.73 mAOD
Additional Information	Approx. 2 m diameter Notice beside swallow hole states that the feature is known as Castlegar well. It also notes that the stream that feeds the well was capped in 2004.	
Site photo

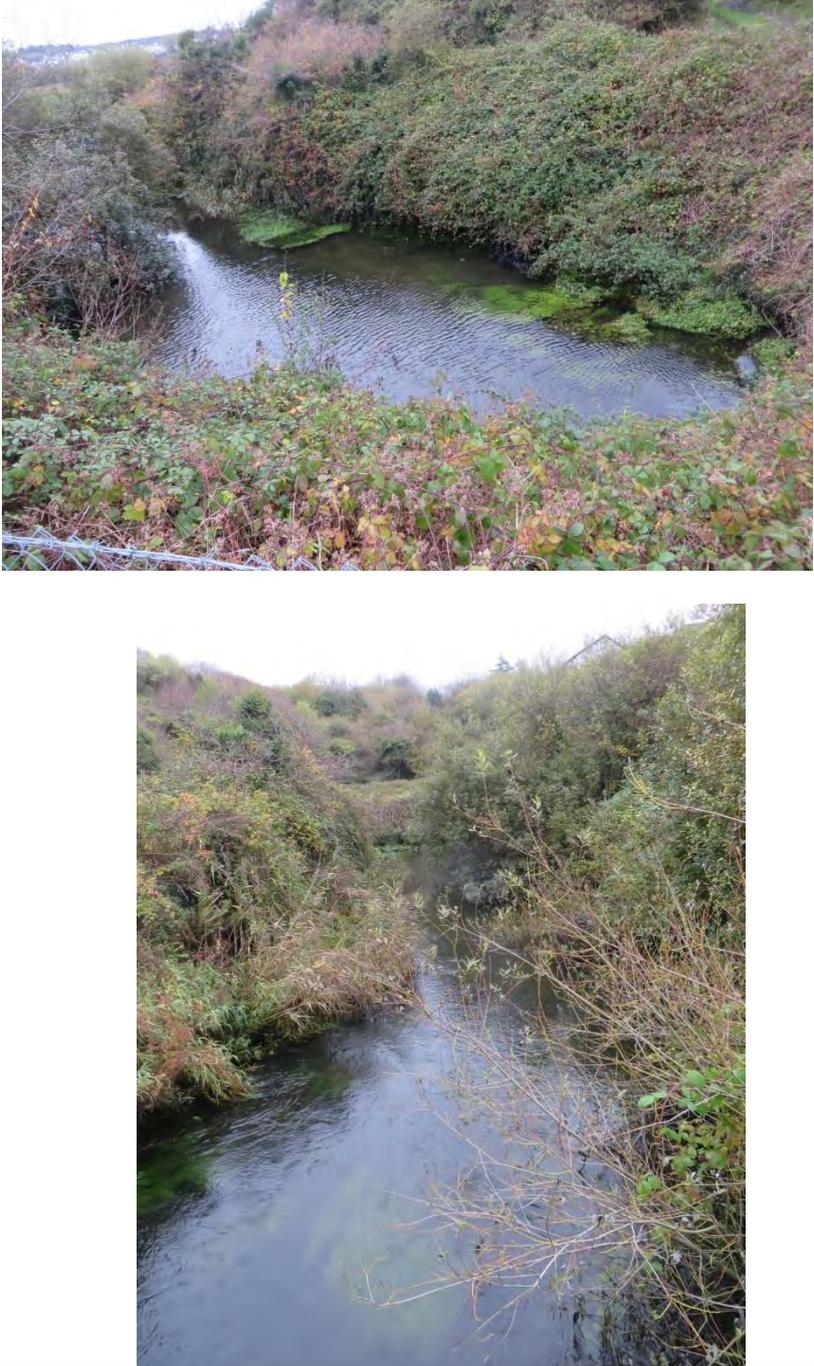
Field survey date	22/10/2014	12/11/2014
Field survey status	Confirmed	Confirmed
Water present	Yes Electrical conductivity: 370 uS/cm Temperature: 11.3 °C pH: 7.76 Flow direction into swallow hole No flow measurement taken	Yes Electrical conductivity: 576 uS/cm Temperature: 10.6 °C pH: 7.52 Flow direction into swallow hole Flow: 765 l/s
Water level elevation	n/a	1.77 mAOD
Additional Information	Terryland River discharges into or can be fed by this spring / swallow hole.	
Site photo

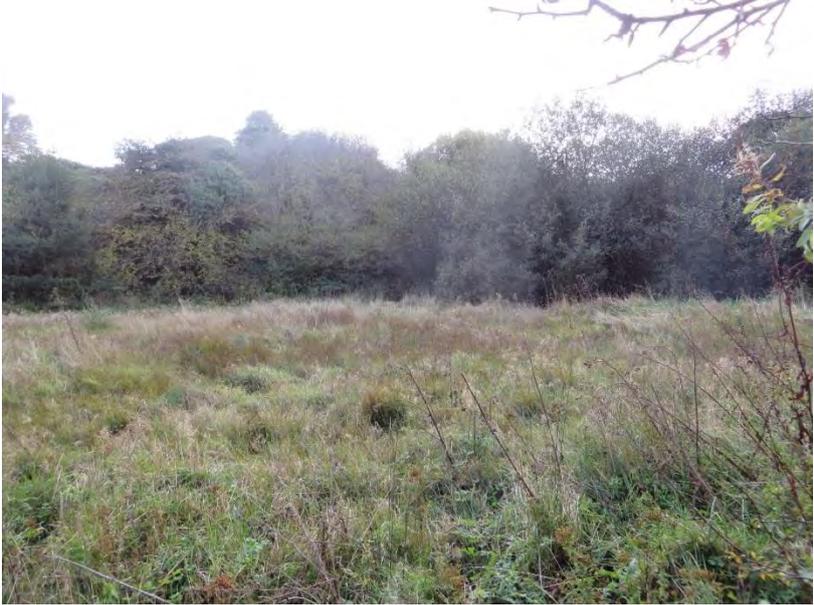
Additional Information	Approx 40 m diameter flat bottom depression. Soft muddy base. Dug well 1 identified at 531947, 728372 (See figure). Dug well 2 identified at 531934, 728379.
Site photo

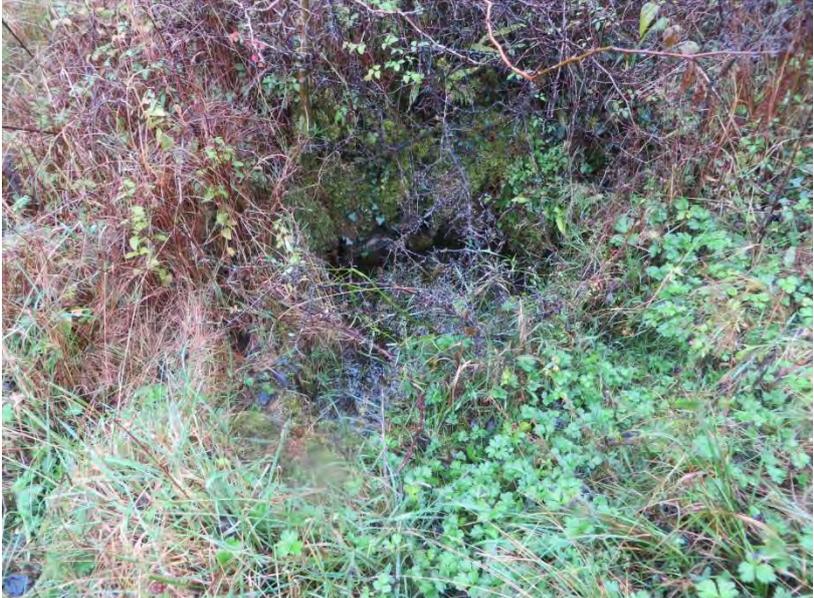
<p>Dug well 1</p>

Field survey date	21/10/2014	12/11/2014
Field survey status	Confirmed	Confirmed
Water present	No	Yes Electrical conductivity: 219 uS/cm Temperature: 8.1 °C pH: 6.4
Elevation measurements	n/a	Ground level in centre of depression: 12.11 mAOD Water levels: Dug Well 1: 12.17 mAOD (531947, 728372) Dug Well 2: 12.22 mAOD (531934, 728379)

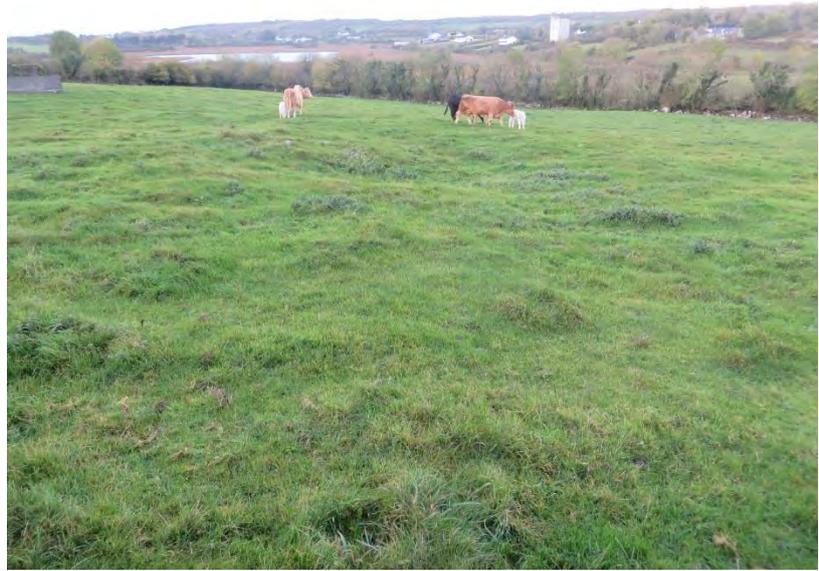
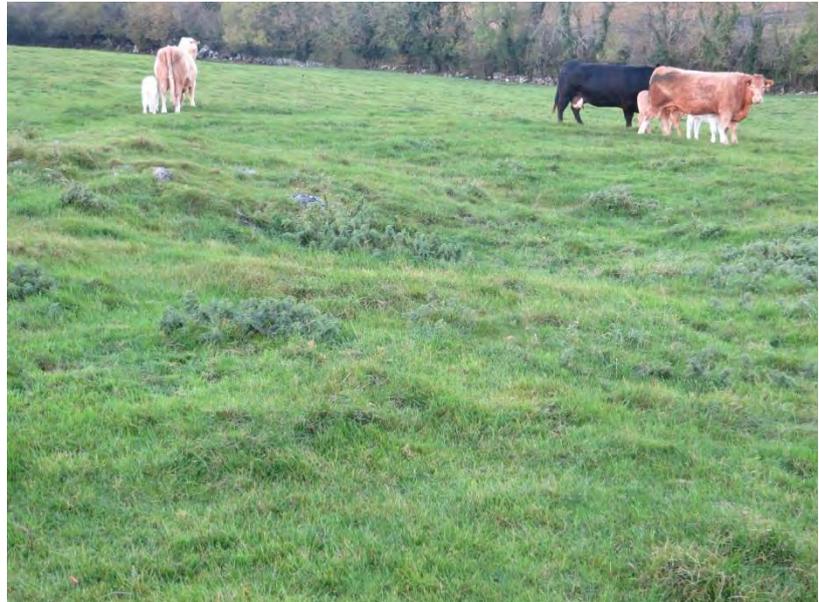
Site photos

Field survey date	21/10/2014
Field survey status	Confirmed
Water present	No
Additional Information	Approx. 3m diameter depression

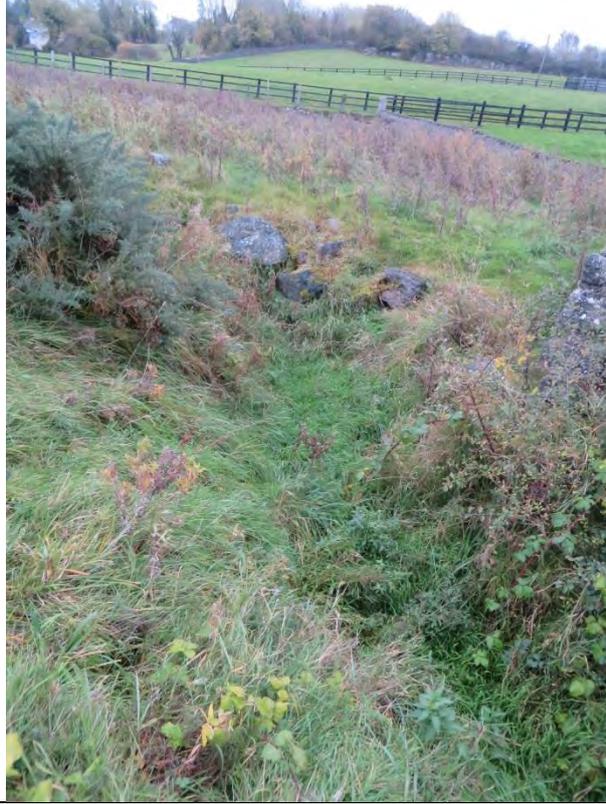
Site photos

Field survey date	21/10/2014	12/11/2014
Field survey status	Confirmed	Confirmed
Water present	No	Yes Electrical conductivity: 995 uS/cm Temperature: 12 °C pH: 7.06 Flow not great enough for flow measurement
Additional Information	Drain leading from spring towards Terryland River

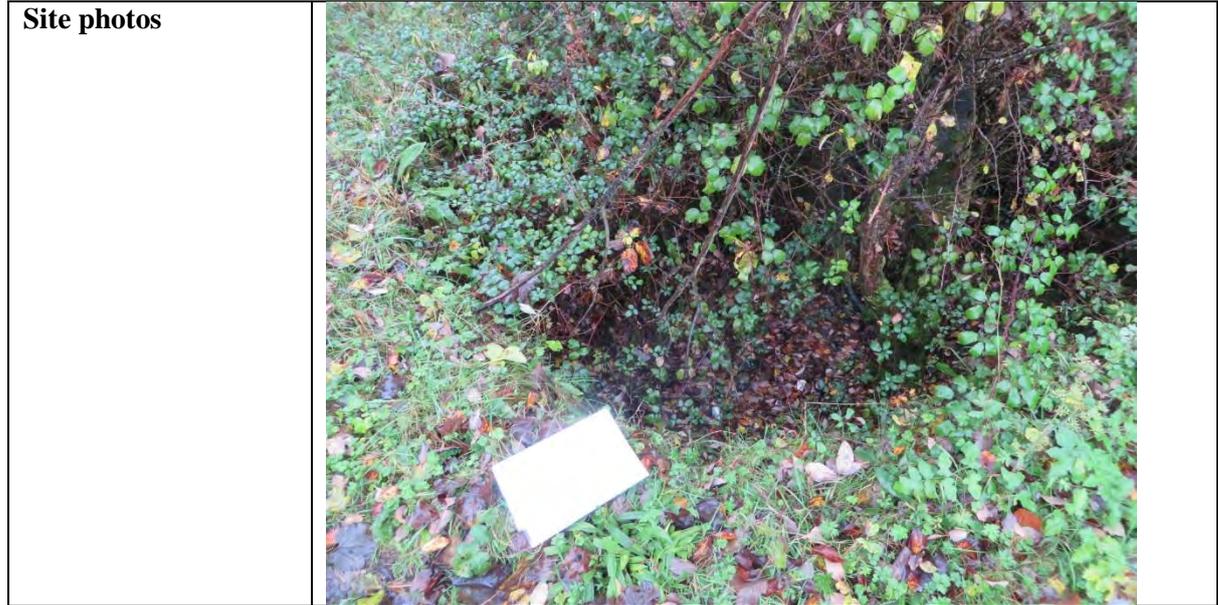
Field survey date	12/11/2014
Field survey status	Confirmed
Water present	No
Ground level elevation	24.01 mAOD at base of depression
Additional Information	Approx. dimensions: 3m diameter, 2m depth. Very steep sides. Almost looks like an old manmade well.

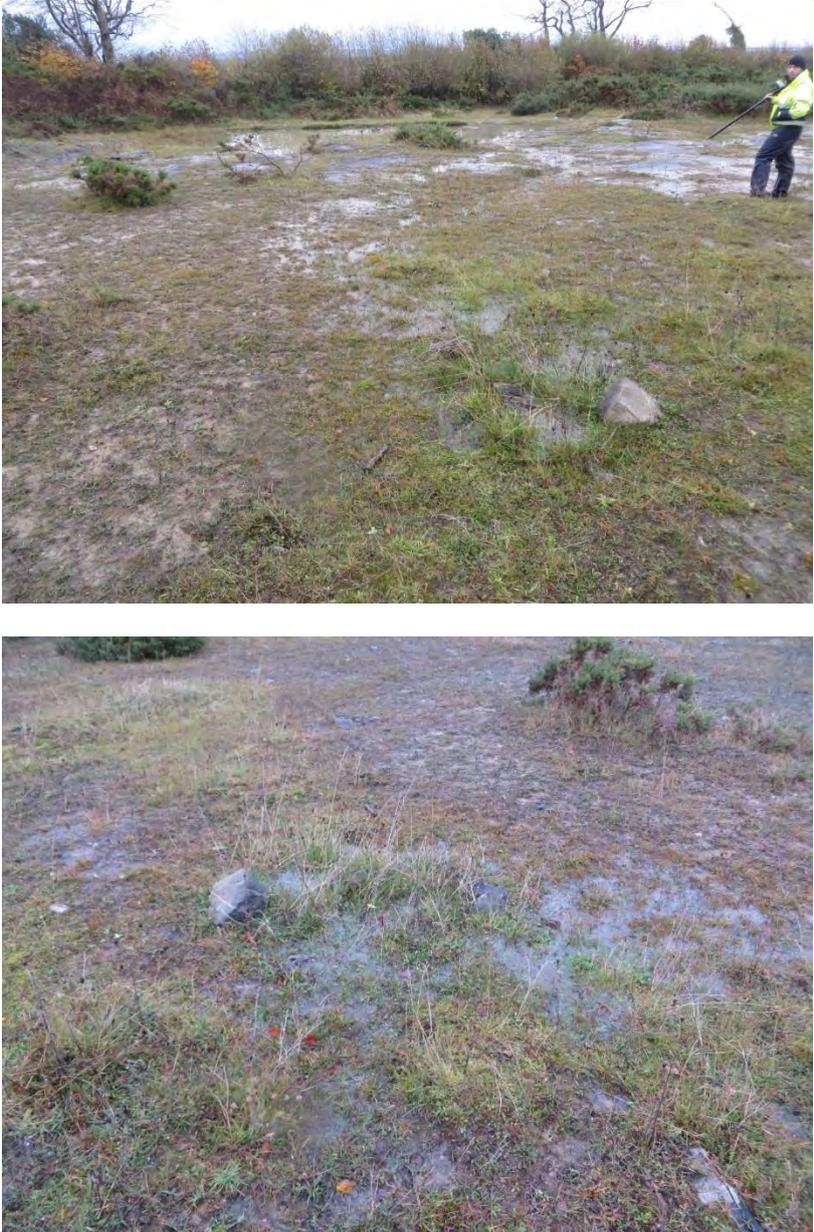
Feature ID	K129
Feature type	Spring
Coordinates	533701, 726678
Source	Field Survey
Field survey date	13/11/2014
Field survey status	Confirmed
Water present	Yes Electrical conductivity: 470 uS/cm Temperature: 11.2 °C pH: 7.68
Water level elevation	55.95 mAOD
Additional Information	Small stream from spring feeding K130 enclosed depression. Very low flow cannot get flow measurement
Site photos
