Galway County Council
N6 Galway City Transport Project
Karst Study

Karst Study Report

Issue 1 | 27 February 2015

Ove Arup & Partners Ireland Ltd

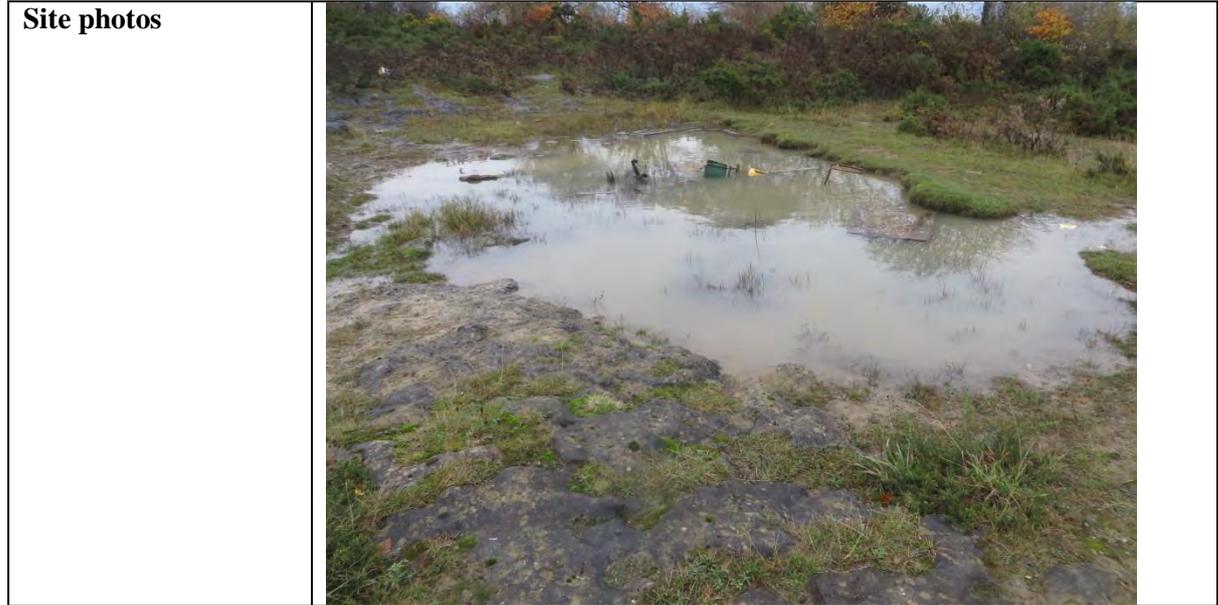
Field survey date	13/11/2014
Field survey status	Confirmed
Water present	Yes Electrical conductivity: 199 uS/cm Temperature: 7.1 °C pH: 8.13
Elevation levels	Base of enclosed depression: 54.74 mAOD Water level elevation: 55.01 mAOD
Additional Information	Enclosed depression filled with water from stream k314.

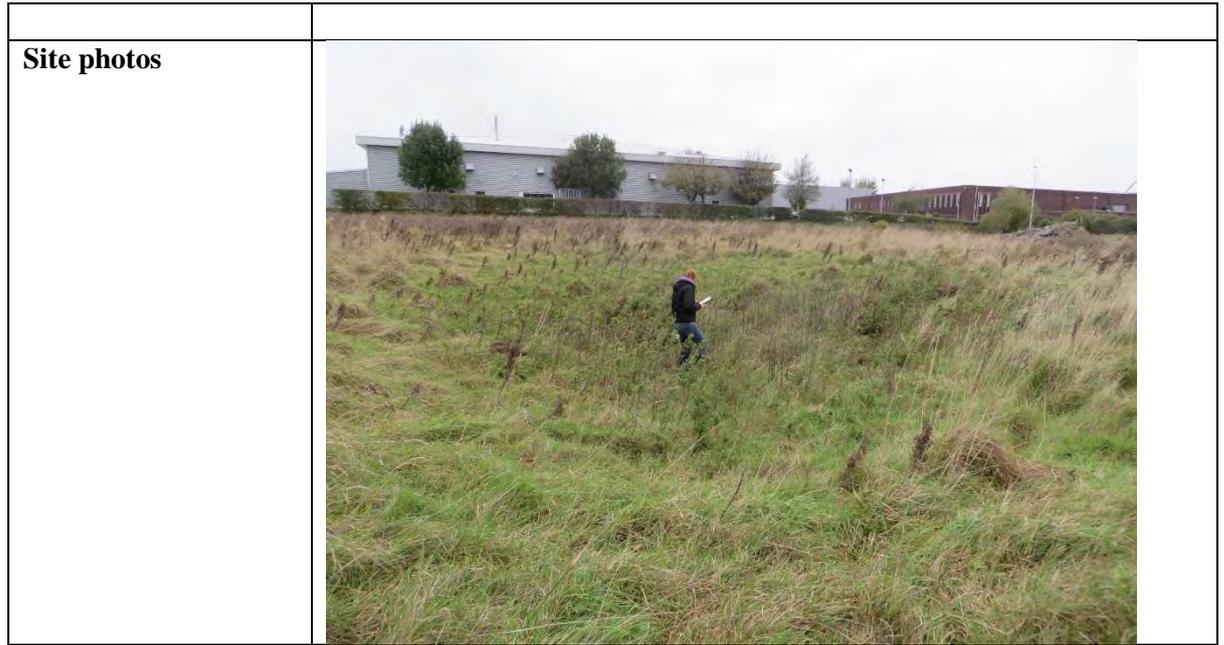
Field survey date	22/10/2014
Field survey status	Confirmed
Water present	No
Additional Information	Approx. dimensions: 10m diameter and 1.5m depth

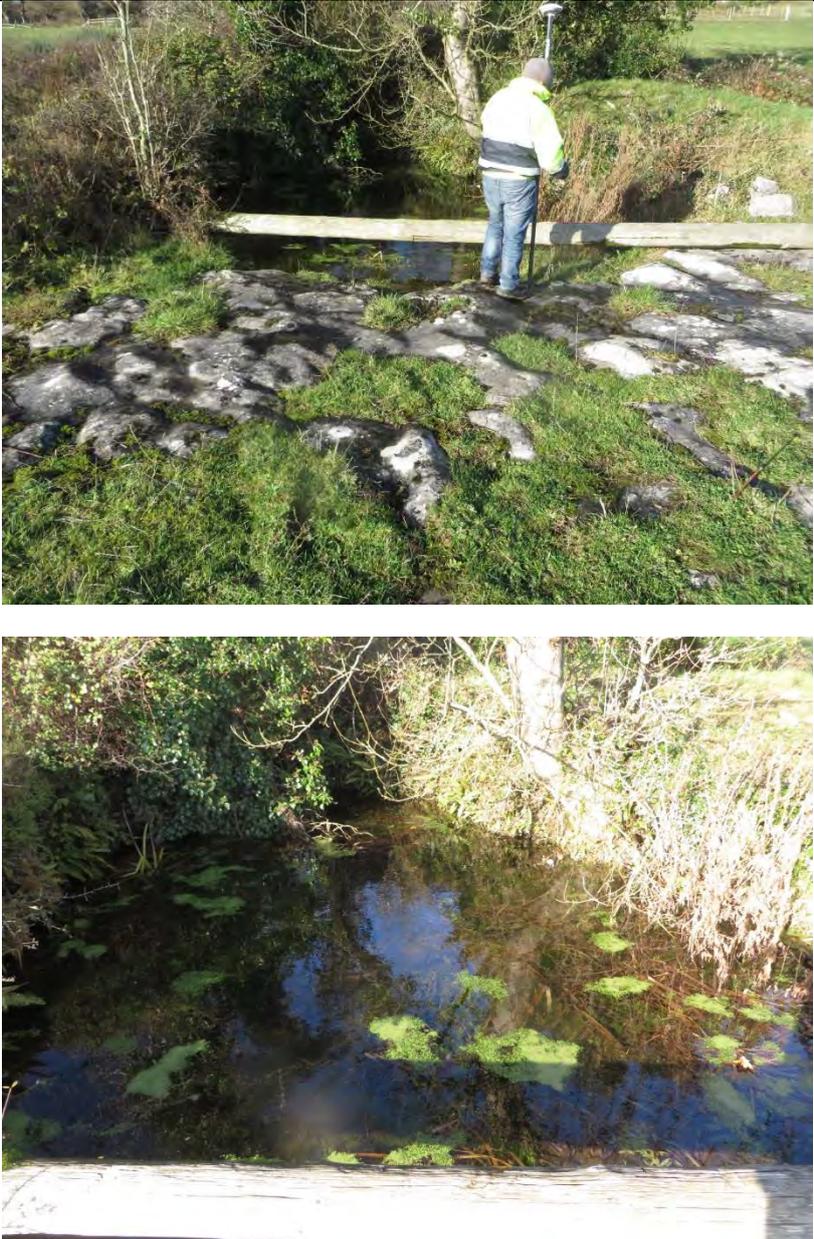
Field survey date	14/11/2014
Field survey status	Confirmed
Water present	Yes Electrical conductivity: 553 uS/cm Temperature: 11.5 °C pH: 7.27
Water elevation	46.03 mAOD
Additional Information	Initially identified in the desk study as a potential enclosed depression. Approx. 3m diameter pond

<p>No flow out of spring during field survey.</p>
<p>Site photos</p>

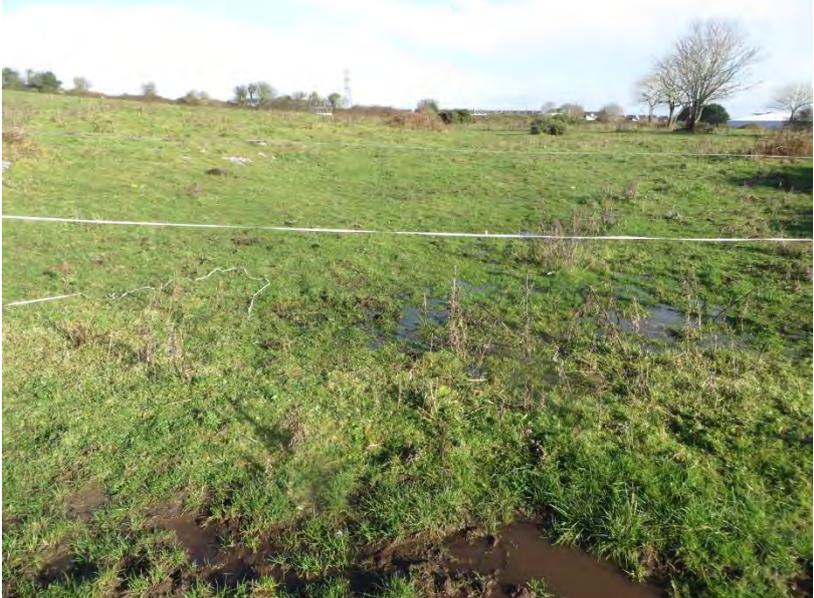
Feature ID	K135
Feature type	Enclosed Depression
Coordinates	533959, 726688
Source	Field Survey
Field survey date	14/11/2014
Field survey status	Confirmed
Water present	Yes
Additional Information	Very shallow and wide depression.
Site photos

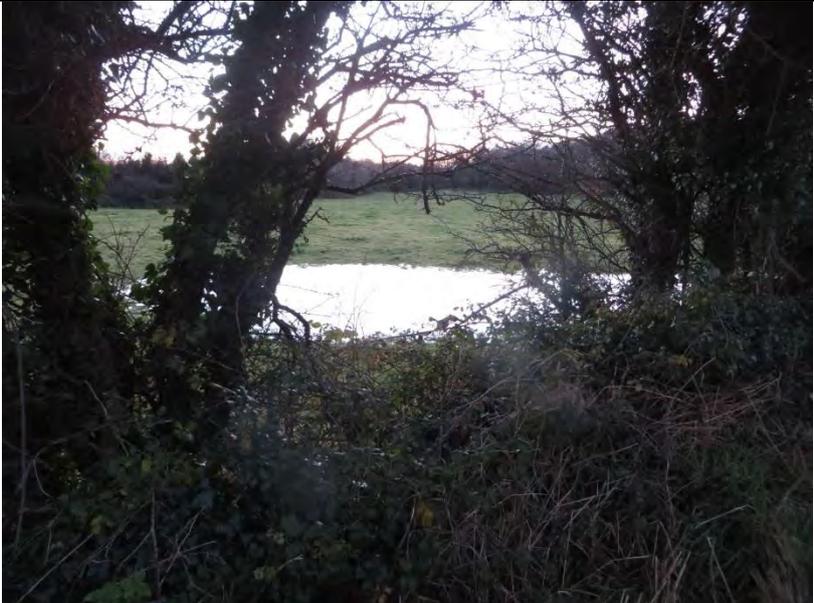
Feature ID	K140
Feature type	Spring
Coordinates	534085, 725198
Source	Field Survey
Field survey date	13/11/2014
Field survey status	Confirmed
Water present	Yes
Additional Information	Field with areas of flooding. A local informed that there were springs in the field.
Site photos

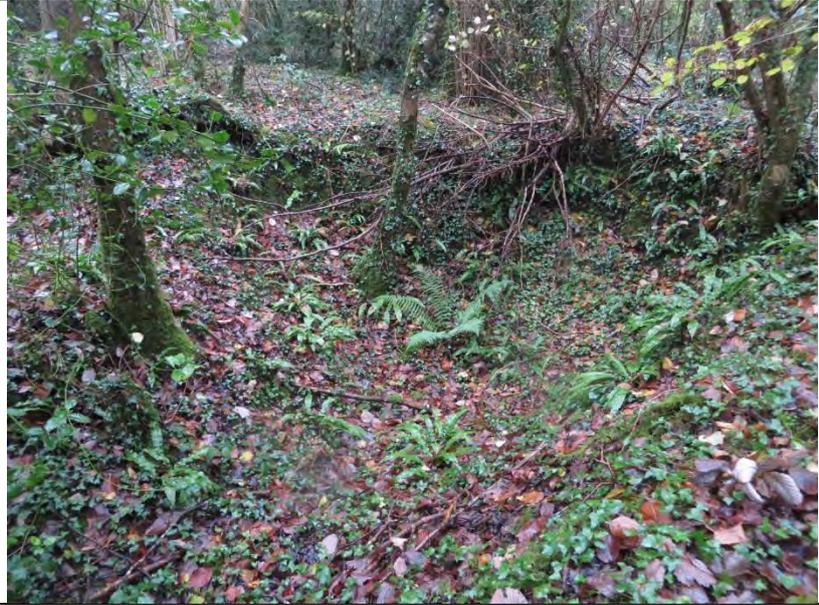
Field survey date	13/11/2014
Field survey status	Confirmed
Water present	No
Additional Information	Approx. 5m diameter, but not circular. Adjacent to K152.

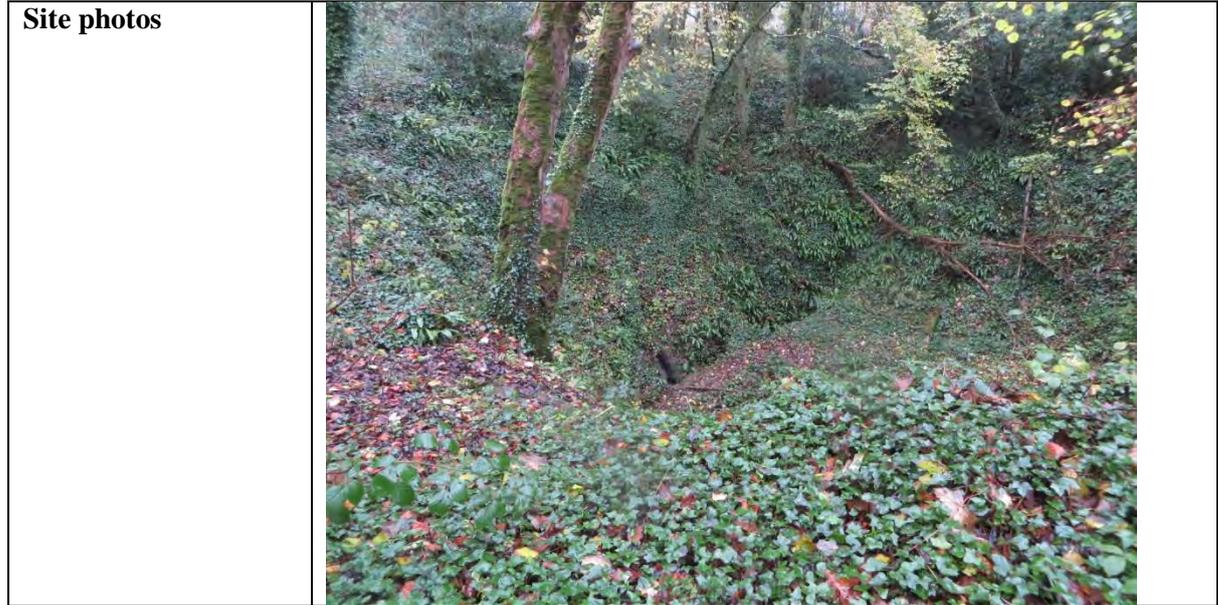
Field survey date	13/11/2014
Field survey status	Confirmed
Water present	No
Additional Information	Approx. 7m diameter. Adjacent to K151

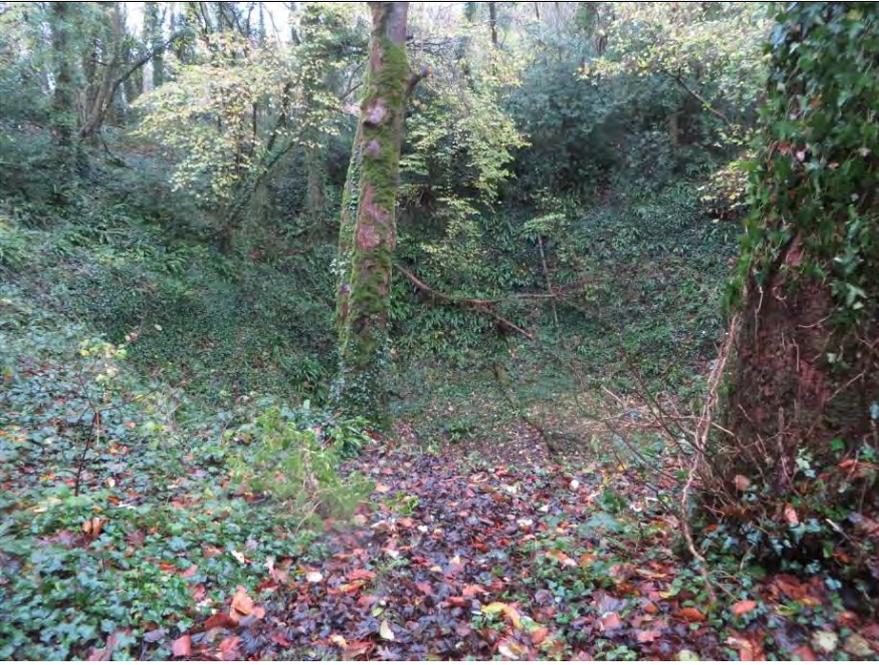
Field survey date	13/11/2014
Field survey status	Confirmed
Water present	No
Additional Information	<p>Approx. dimensions: 40 m diameter 20 m deep. Potential plug hole evident The large enclosed depression is fenced off preventing access. A plug hole opening is evident at the base of the enclosed depression. This may contain water, however access is not possible due to protective fencing.</p>
Site photos

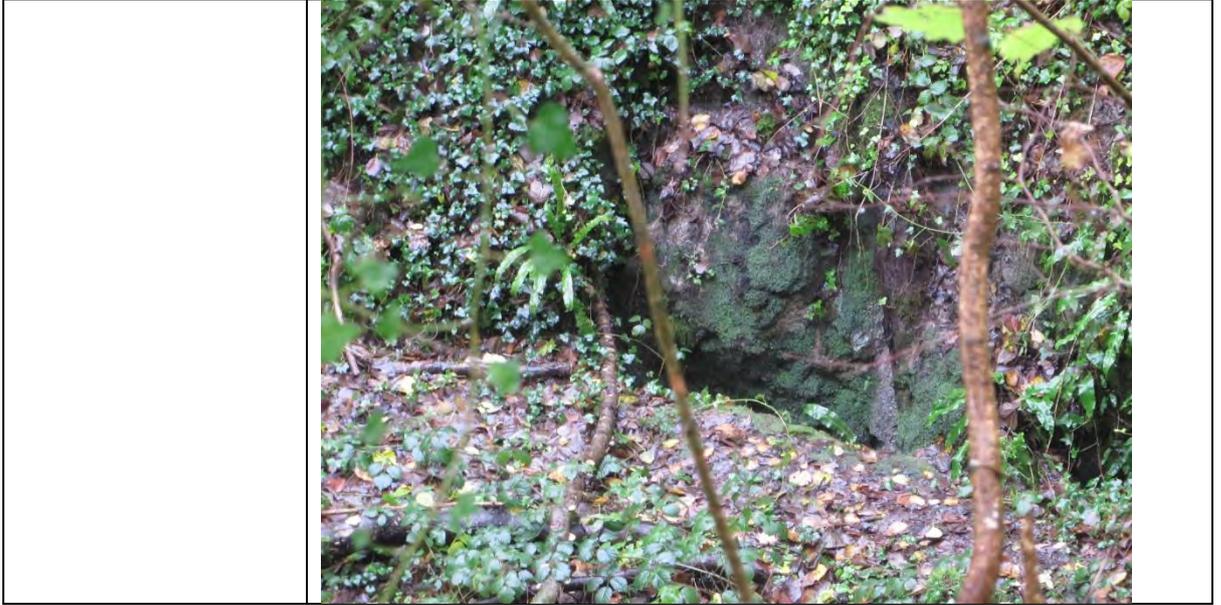
<p data-bbox="584 1832 1181 1868">Plug hole / opening at base of enclosed depression</p>

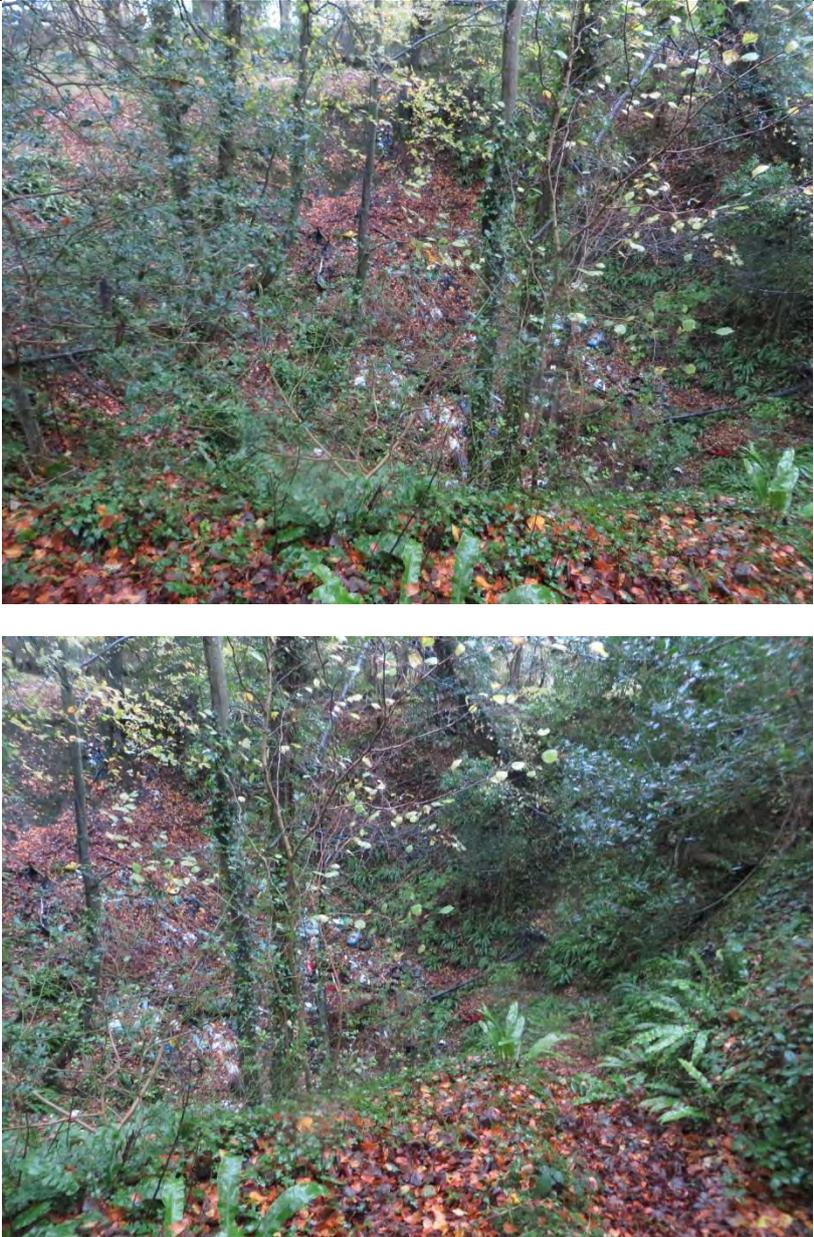
Field survey date	13/11/2014
Field survey status	Confirmed
Water present	No
Additional Information	Approx. dimensions: 30 m diameter 20 m deep. Contains waste Possible plug hole identified
Site photos

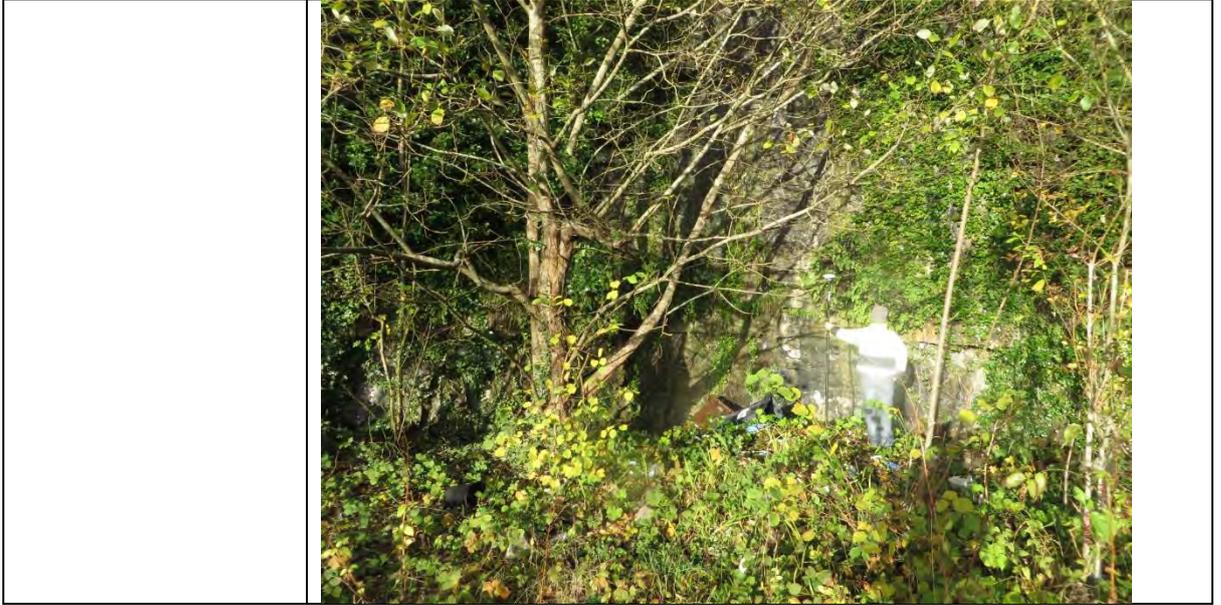
Field survey date	14/11/2014
Field survey status	Confirmed
Water present	Yes Electrical conductivity: 490 uS/cm Temperature: 12 °C pH: 8.23
Additional Information	Feature is located in old quarry. Water is discharging from fractures approx. 5m above ground level. It is likely that the natural flow and location of the spring has been modified due to the quarry excavation.
Site photos

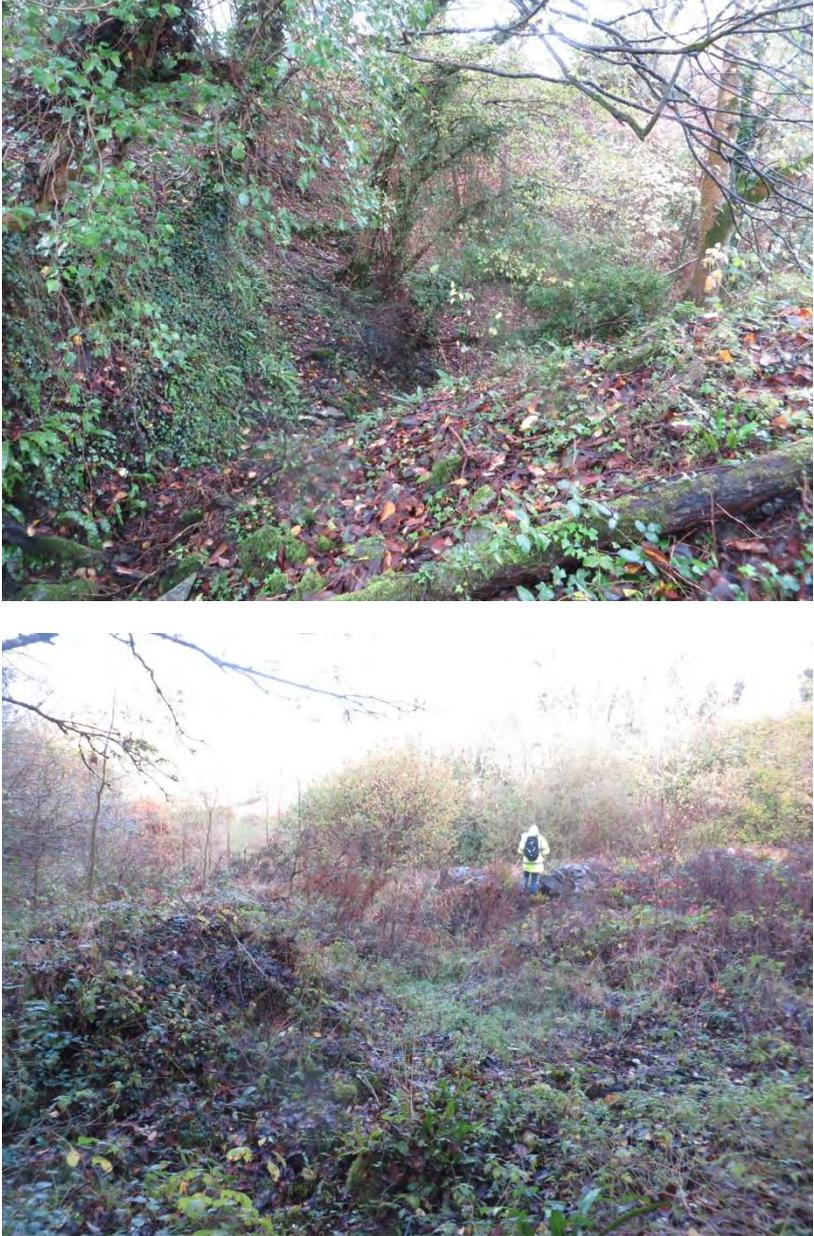
Field survey date	14/11/2014
Field survey status	Confirmed
Water present	No
Ground level elevation	Elevation within depression 13.39 mAOD. This is not the base of the depression
Additional Information	Very large depression. Large part of enclosed depression is filled in with waste and material.
Site photos

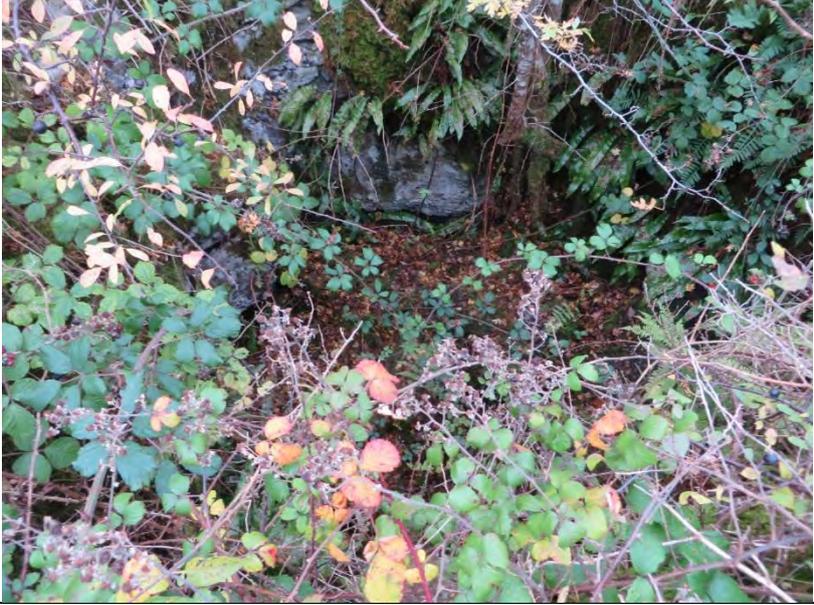
Feature ID	K170
Feature type	Well
Coordinates	534787, 728293
Source	Field survey
Field survey date	22/10/2014
Field survey status	Confirmed
Water present	No
Additional Information	Dug well Approx. 3m diameter and 2m to base Base of well is covered in moss covered rocks
Site photos

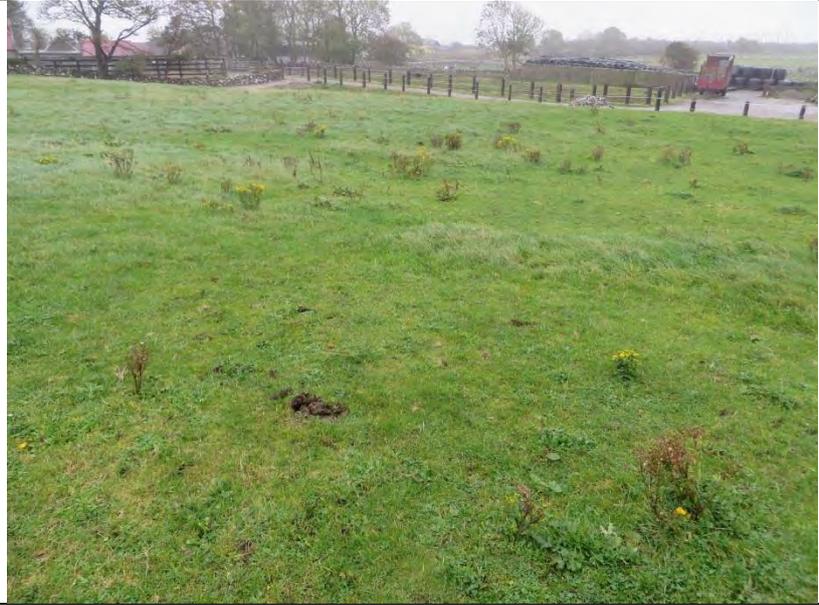
Field survey date	23/10/2014
Field survey status	Confirmed
Water present	No
Additional Information	Very shallow depression

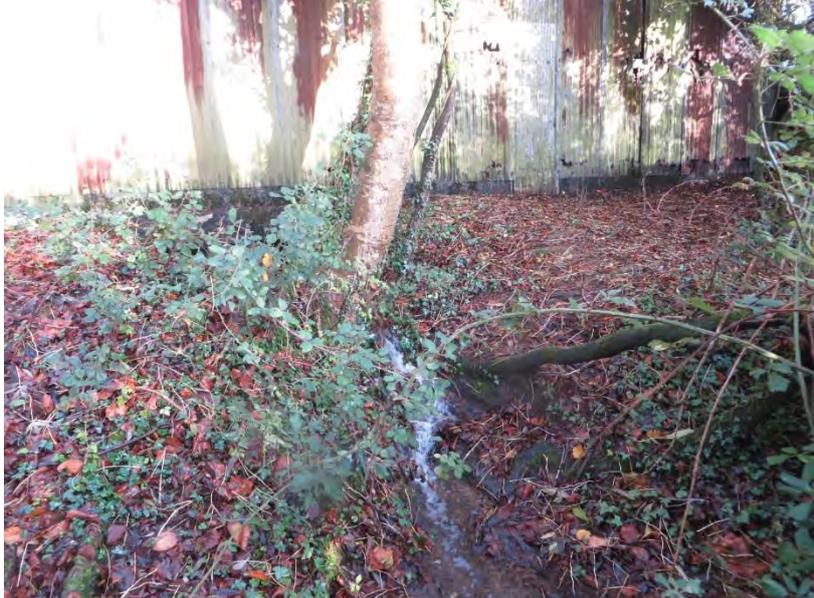
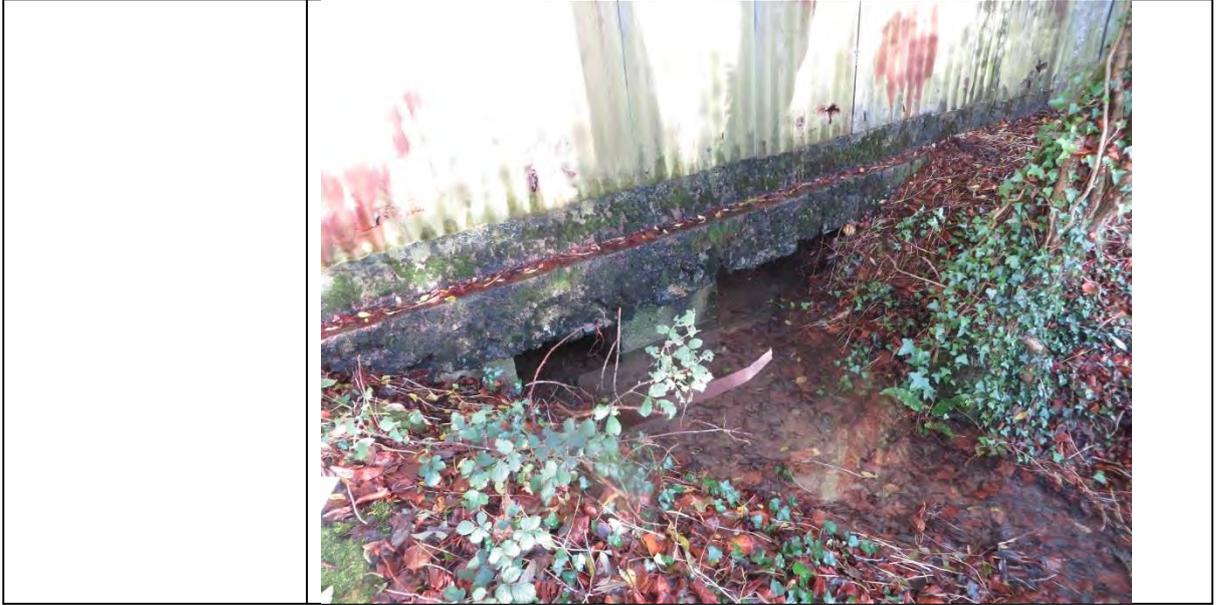
Field survey date	14/11/2014
Field survey status	Confirmed
Water present	Yes Electrical conductivity: 510 uS/cm Temperature: 9.7 °C pH: 7.88 Flow: 6.3 l/s
Water level elevation	25.22 mAOD
Additional Information	Spring discharges from under an old mill building.
Site photos

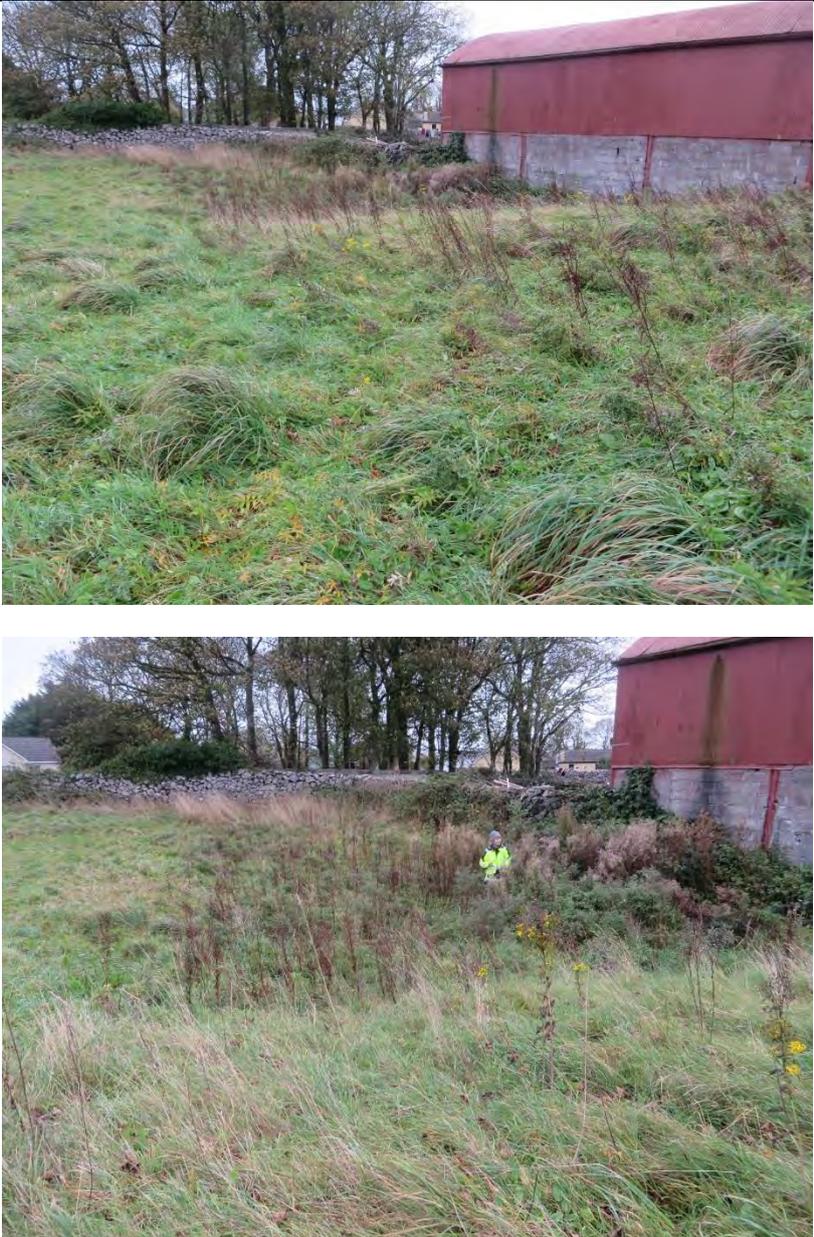
Feature ID	K175
Feature type	Enclosed depression
Coordinates	534857, 727168
Source	Field survey
Field survey date	23/10/2014
Field survey status	Confirmed
Water present	No
Additional Information	Approx. dimensions: 20m diameter, 2m depth
Site photos

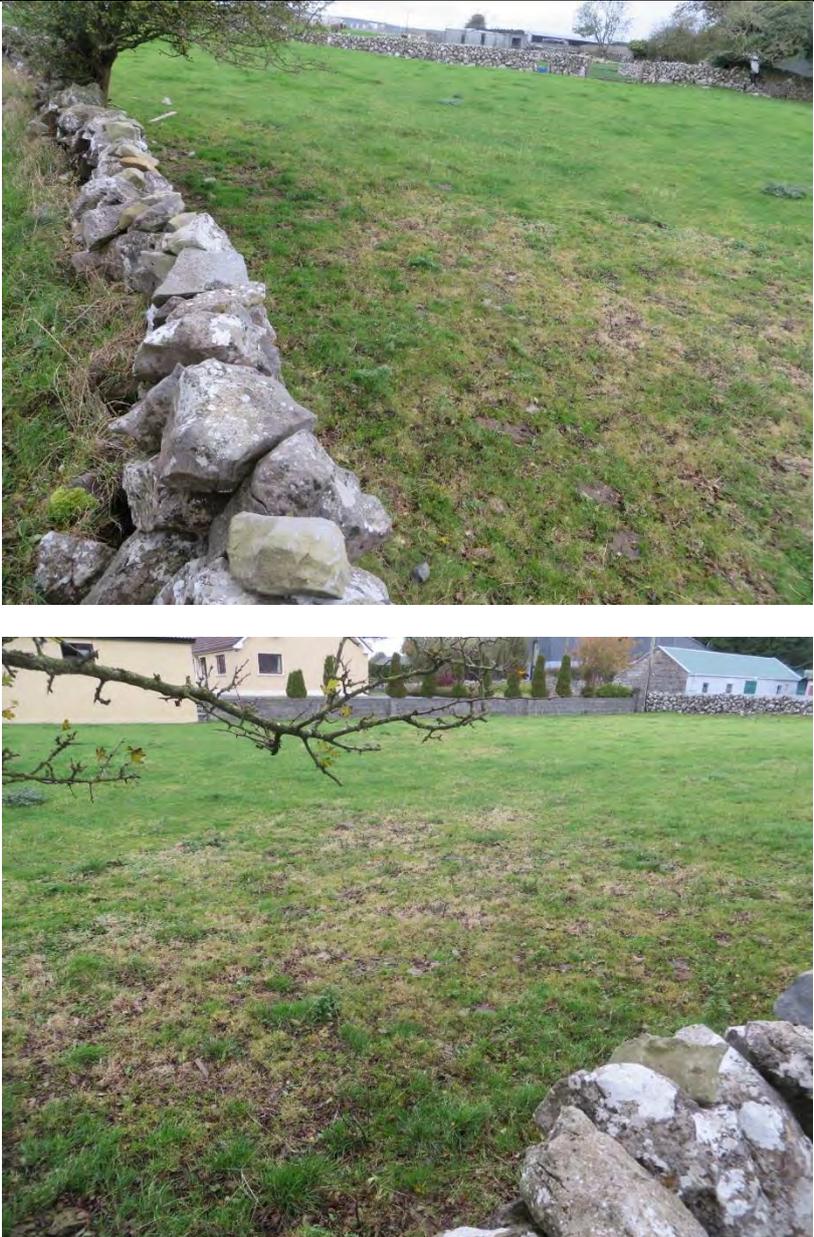
Feature ID	K179
Feature type	Enclosed depression
Coordinates	534990, 727121
Source	Field survey
Field survey date	23/10/2014
Field survey status	Confirmed
Water present	No
Additional Information	Approx. dimensions: 20m diameter semicircle
Site photos

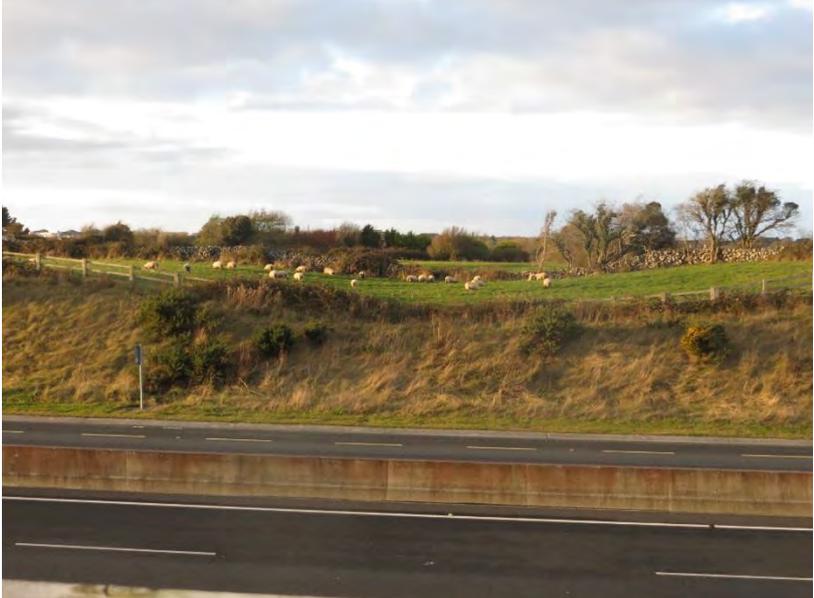
Feature ID	K193
Feature type	Enclosed depression
Coordinates	535482, 727051
Source	Field survey
Field survey date	17/11/2014
Field survey status	Confirmed
Water present	No
Additional Information	Approx. 30m diameter depression cut in half by M6 motorway
Site photos

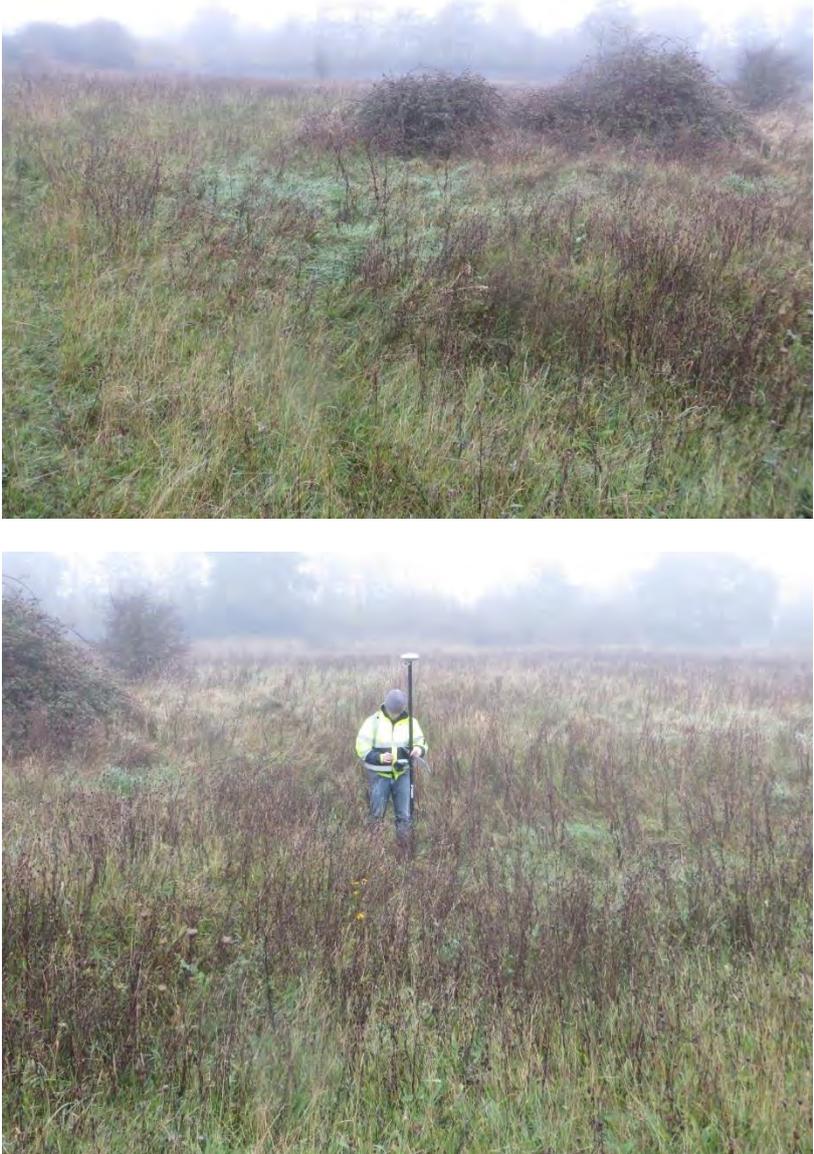
Feature ID	K201
Feature type	Enclosed depression
Coordinates	536027, 725739
Source	Field survey
Field survey date	18/11/2014
Field survey status	Confirmed
Water present	No
Ground level elevation	29.92 mAOD at base of enclosed depression
Additional Information	Approximate dimensions: 2 m diameter less than 1 m depth
Site photos

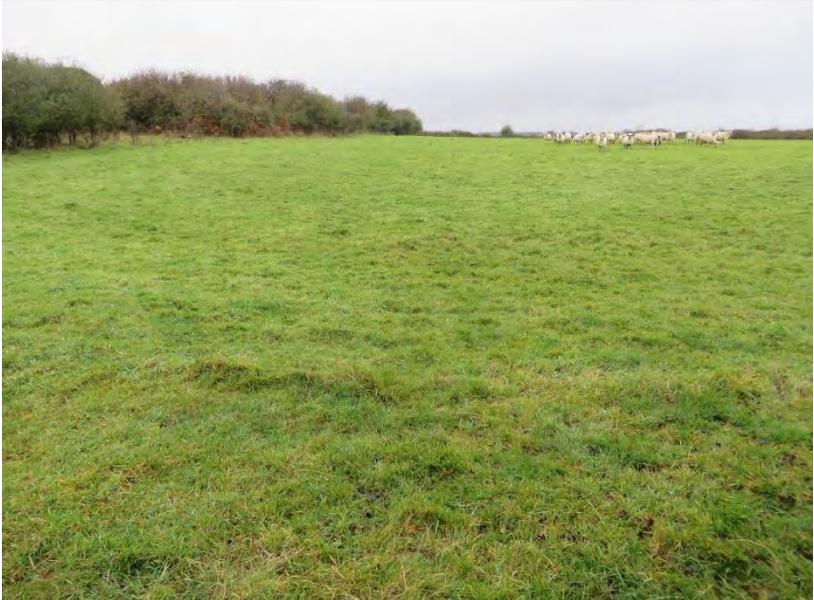
Feature ID	K202
Feature type	Enclosed depression
Coordinates	536033, 726313
Source	Field survey
Field survey date	23/11/2014
Field survey status	Confirmed
Water present	No
Additional Information	Very shallow enclosed depression Approx. 20m diameter
Site photos

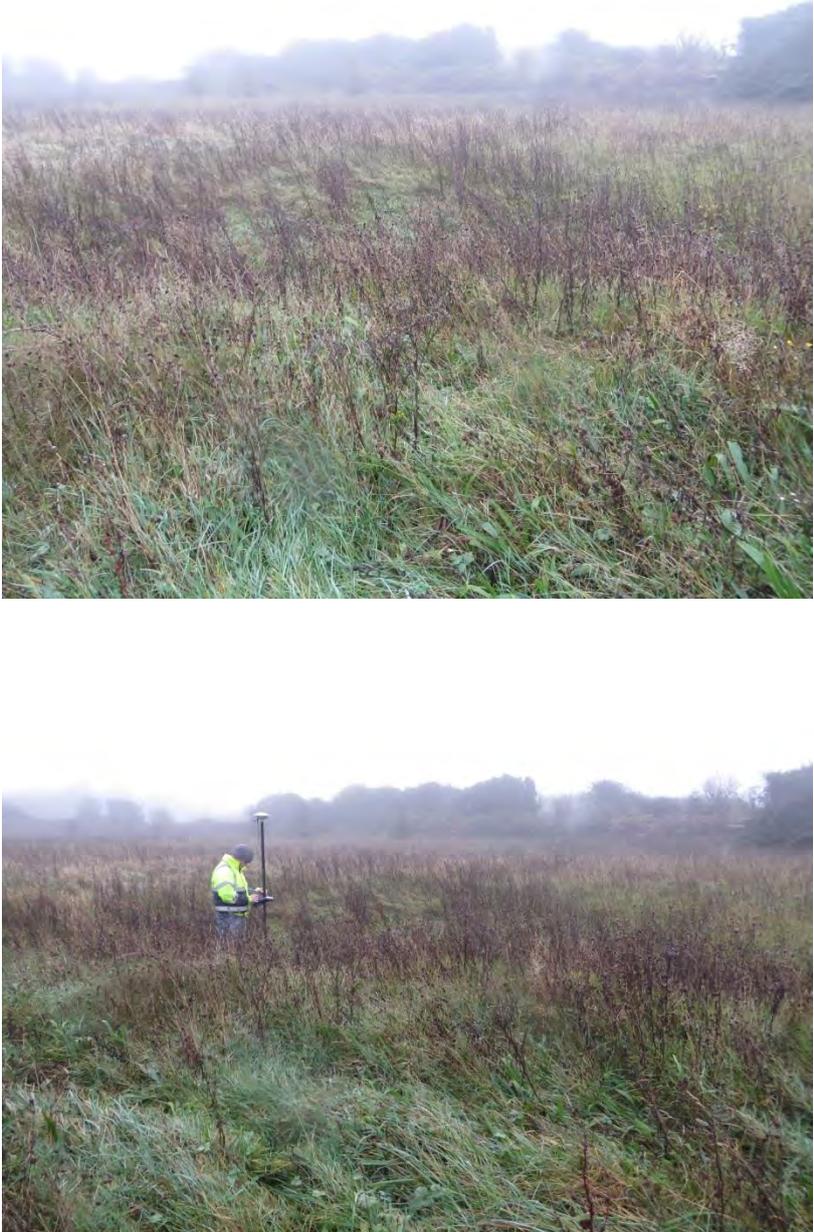
Feature ID	K203
Feature type	Enclosed depression
Coordinates	536033, 725740
Source	Field survey
Field survey date	18/11/2014
Field survey status	Confirmed
Water present	No
Ground level elevation	29.44 mAOD
Additional Information	Small enclosed depression Approximate dimensions: 5m x 2 m less than 1 m deep
Site photos

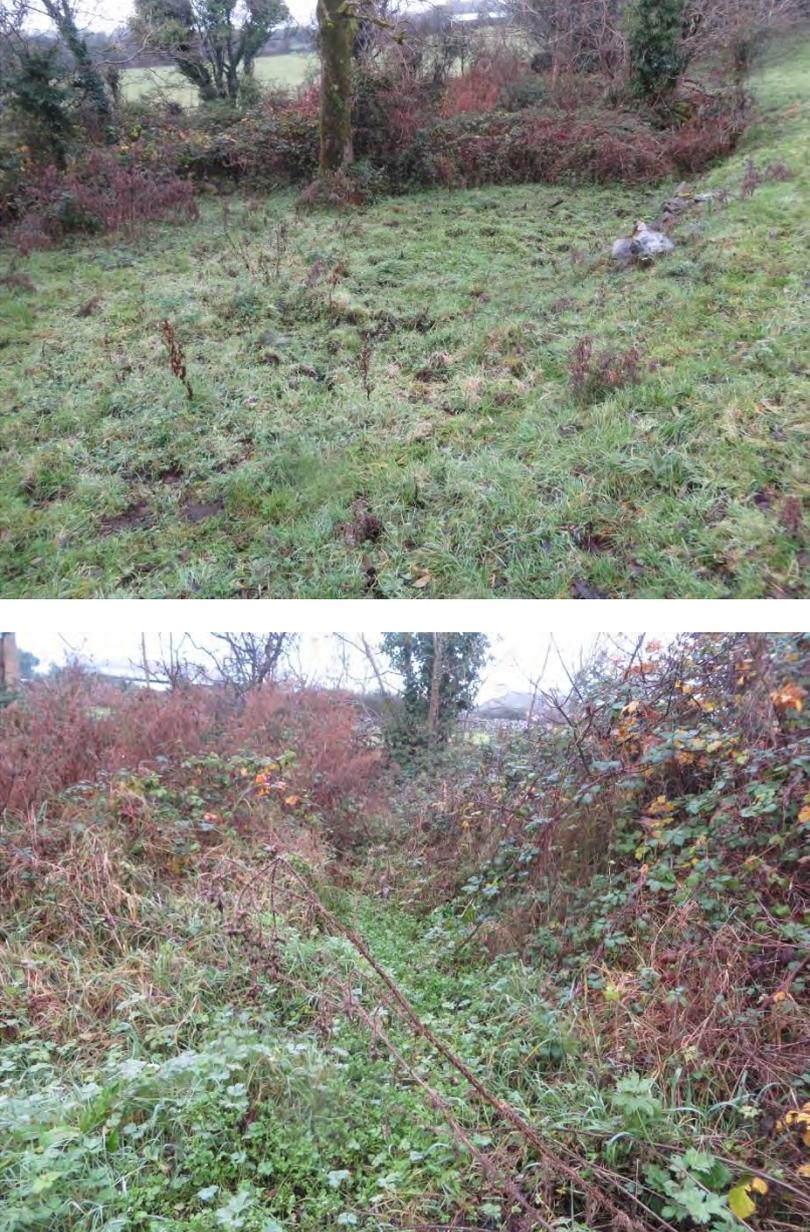
Field survey date	18/11/2014
Field survey status	Confirmed
Water present	Yes Electrical conductivity: 704 uS/cm Temperature: 9.8 °C pH: 7.88
Water level elevation	26.37 mAOD
Additional Information	The spring is at the base of a depression. The ground is very soft and covered in vegetation. Water is present, however due to the low water

<p>levels and vegetation flow not measurable. The spring discharge area is approx. 20 m diameter. The landowner lives in the house across the road and informed us that the spring has been used in the past as the drinking water supply but is currently not in use.</p>
<p>Site photos</p>

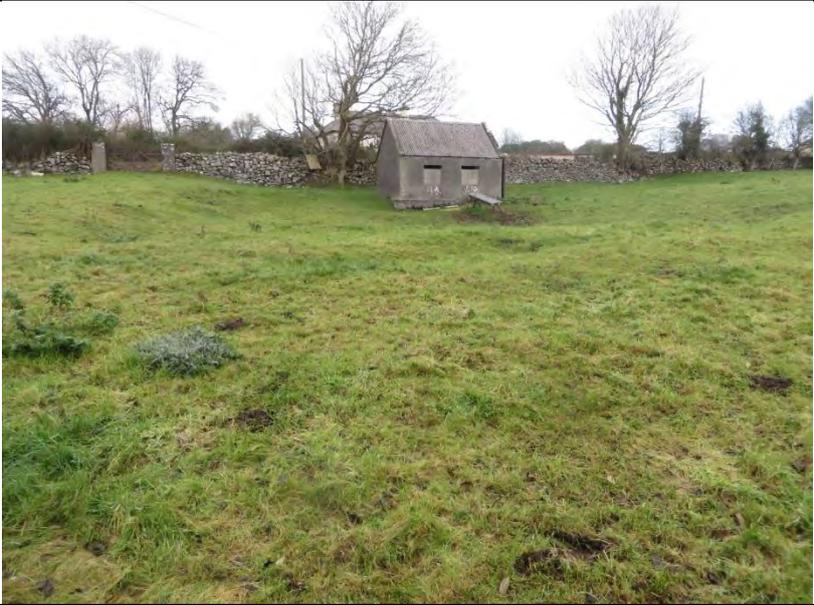
Feature ID	K213
Feature type	Enclosed Depression
Coordinates	536132, 726003
Source	Field survey
Field survey date	18/11/2014
Field survey status	Confirmed
Water present	No
Additional Information	Approx. dimensions: 20 m diameter. The depression may contain some fill or modification
Site photos

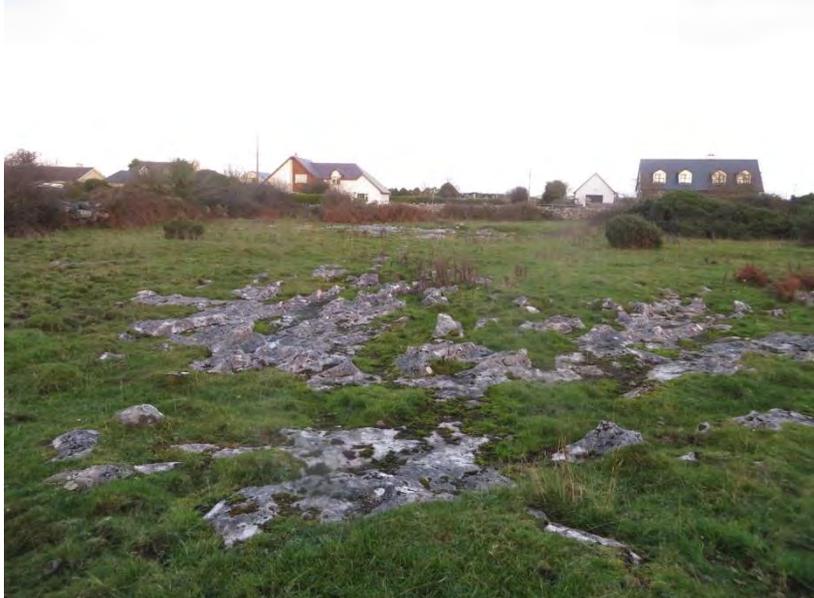
Field survey date	17/11/2014
Field survey status	Confirmed
Water present	No
Additional Information	Superficial solution features. Small shallow dips and small patches of outcrop.
Site photos
