## Appendix No 8

Third Party Planning Appeal of the decision by Meath County Council to  
grant planning permission for development Planning Reference Number:  
22331 Meath CoCo.

# WHY MINE WASTE IMPOUNDMENTS EXPERIENCE STABILITY FAILURES

**W. Allen Marr**

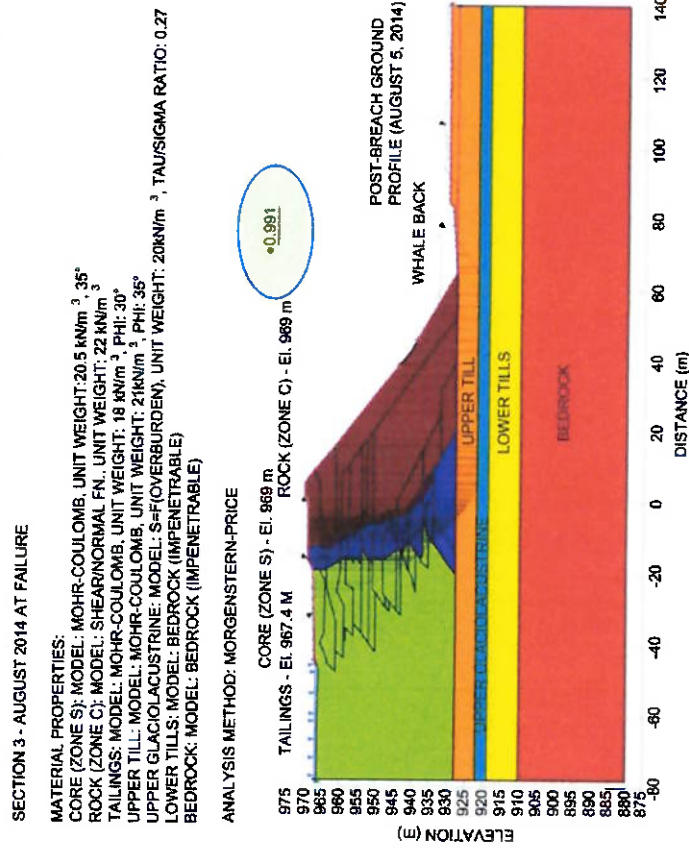
FIGURE 6.2.1: DETAILED SECTION USED FOR LIMIT EQUILIBRIUM ANALYSIS (HIGH WATER TABLE, UNDRAINED STRENGTH RATIO 0.27)

- ...indicate that the foundation [GLU] was brought to failure under *fully drained* conditions, until the undrained strength was reached...
