Appendix A. Survey Record Sheet

Address: 48 Prospect Avenue, Botanic, Dublin 9

Property ID No: ML BS-002-B120

Area: Immediately east of the alignment. Alignment intersects/passes under the north west corner of the building. Situated north of proposed Glasnevin Station.

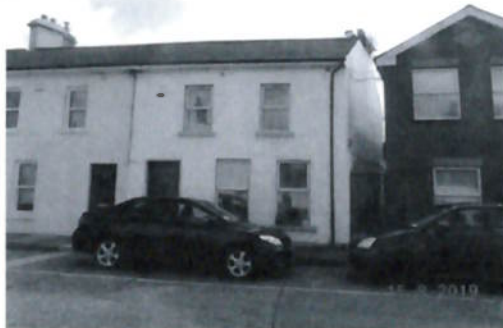
Front elevation, facing west

Slight cracking to reveals of front main entrance door.

Very fine cracking through the first floor level window cills as viewed from the front elevation.

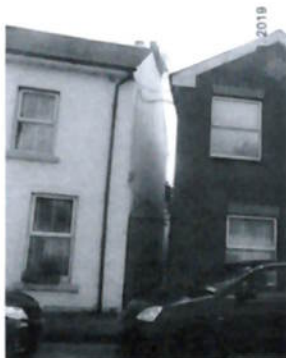
Right-hand side elevation, facing south

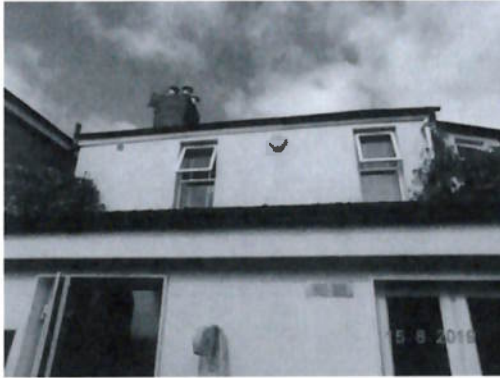
Rear elevation, facing east. Also containing single storey extension.

Mastic seal noted to some joints of the roof tiles to the rear extension lean-to roof. Owner has advised there was a previous leak around the velux roof light serving the kitchen, but has not manifested after remedial works where undertaken.

Very slight cracking off kitchen window head.
