**External Envelope:
Glass & Aluminium and
Stone Façade Elements**

CADENZA METROLINK INTERFACE

Credenza, Earlsfort Terrace, Dublin

**Document No:
1087-BDA-XX-ZZ-RP-Y-0001-C01**

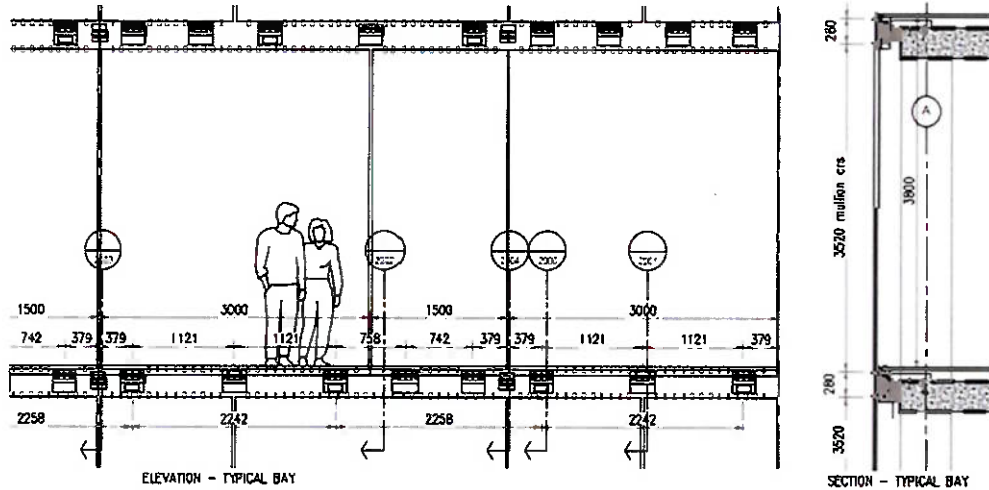
Figure 3 EWS 001 typical bay

Each panel of glass sits on a dedicated horizontal profile at each floor level. Vertical differential movement of floor slabs supporting panels of glass is accommodated by silicone pointing externally and gaskets internally. Vertical differential movement capacity is limited by the lengths of the toggles at the head of each glass panel, and the silicone pointing. Lateral differential movement (racking) is accommodated by the toggles sliding in the top edge profile of the double glazed units. The glass-to-glass corners are restricted by the limits of silicone pointing.

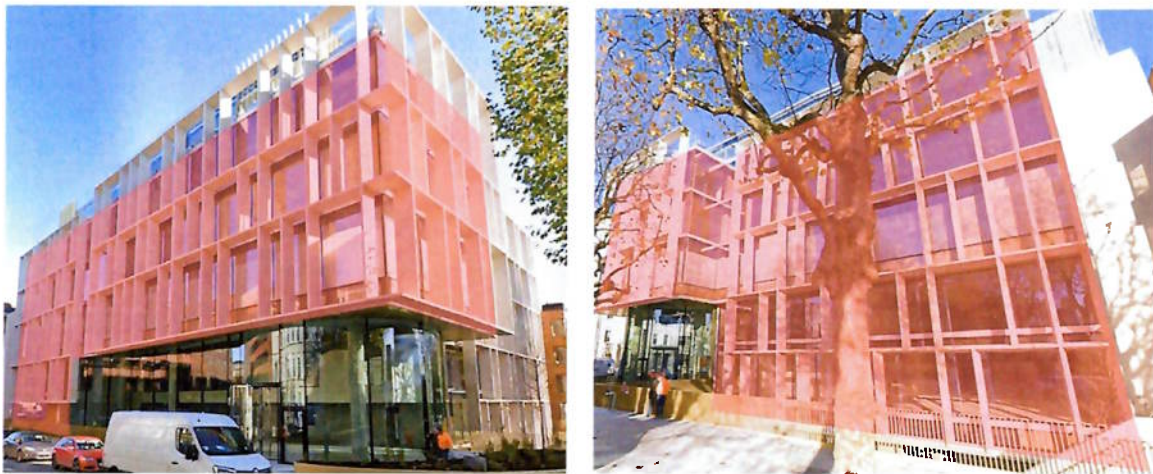
Figure 4 EWS 001 East and South elevations

- 1) The window wall system EWS-001 is susceptible to damage, breaking glass, if there is differential deflection of the primary structure at one column. The worst-case condition is at the South-East corner where there is a glass to glass corner. This is likely to be over-stressed if the predicted settlement noted in ML1-JAI- EIA-ROUT-XX-DR-Y-21146 rev P02 occurs.

Should the primary structure deform due to tunnelling below the building, there is a likelihood the façade system will suffer damage. Damage can occur due to differential settlement of a column along the elevation. With the current tunnel position as illustrated in Figure 10 above, the highest risk location for damage to EWS-001 is the SW corner as there is a predicted differential settlement of 25mm between gridlines C and D along the South elevation. If the tunnel were to be positioned 15m to the West, which is still within the maximum proposed horizontal LoD, the worst case differential deflection would be mid-elevation on the Southern elevation.

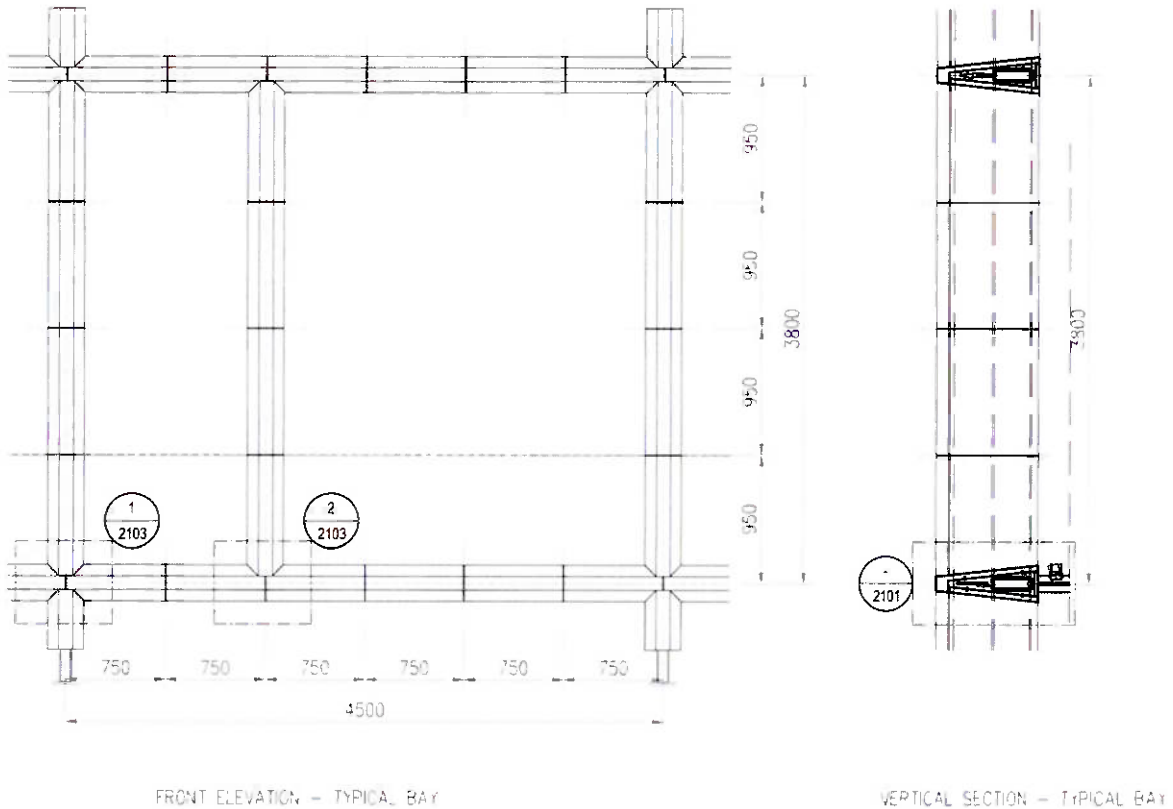
Figure 5 EWS 002 Stone Veil typical bay, elevation and section

Vertical differential movement of floor slabs is accommodated by sliding brackets as the veil moves independently to the slabs in the vertical direction. Vertical differential movement capacity is limited by the lengths of the slots in the restraint brackets at each floor level.

Deflection of the Level 5 slab directly effects the shape of the veil on elevation as it is all suspended from this slab. Vertical deformation of the veil from the rectilinear grid installed on-site is accommodated by the flexing of horizontal members and silicone pointing between stone pieces.

Differential movement (racking) of the primary structural floors causes the veil suspension structure to deform out of square. Flexing at horizontal to vertical frame joints is restricted by flexing of the interlocking bracketry and the silicone pointing in stone to stone joints.

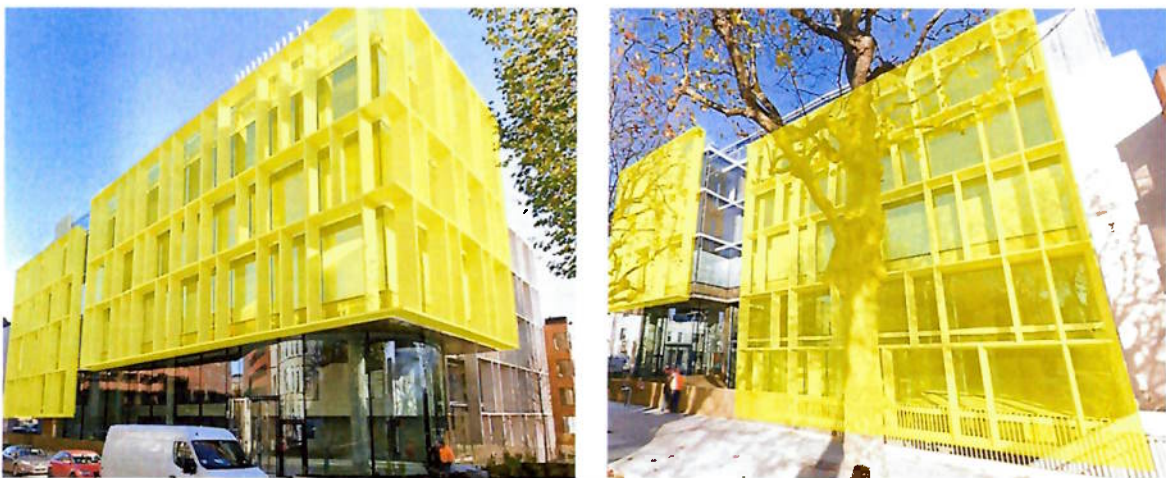
Figure 6 EWS 002 Stone Veil East and South elevations

- 2) The stone veil EWS-002 which is suspended from Level 05 slab is susceptible to damage, over-stressing of bracket assemblies, and possible stressing of stone if there is differential deflection of the primary structure at one column. The worst-case condition is on the South-East corner. The stone veil steel sub-structure will suffer stresses outside of its original design intent.

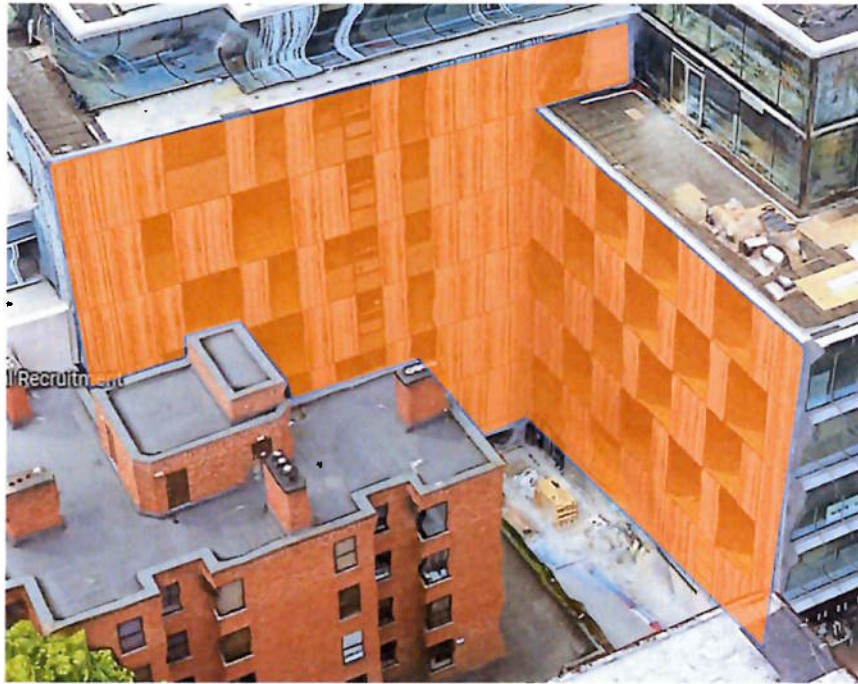
Figure 7 EWS-003 South and East elevations

- 3) The recessed South and East elevations, EWS-003, are clad with a toggle glazed stick curtain wall. This is susceptible to damage. The worst-case condition is on the western end of the South elevation where it approaches the core. The predicted settlement noted in ML1-JAI- EIA-ROUT-XX-DR-Y-21146 would result in glass racking and impacting aluminium frames causing breakage.

Each panel of glass sits on a dedicated extruded aluminium horizontal profile at each floor level. Vertical differential movement of floor slabs supporting panels of glass is accommodated by silicone pointing externally and gaskets internally. Vertical differential movement capacity is limited by the lengths of the toggles at the head of each glass panel, and the silicone pointing. Lateral differential movement (racking) is accommodated by the toggles sliding in the top edge profile of the double glazed units. Racking of glass in the aluminium grid is restricted by the vertical mullions and associated toggles restraining the glass.

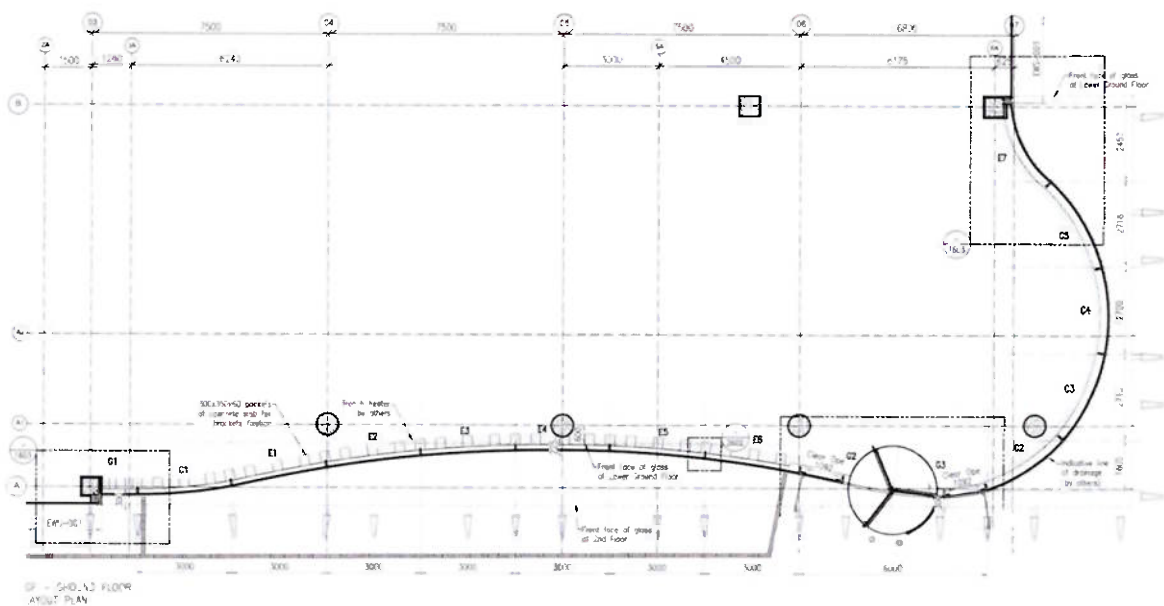
Figure 8 EWS 006 Entrance Glazing Double height curved glass. Plan view. (South is to the right of this image).

The entrance glazing is a bespoke glazing system formed from curved double-glazed units up to 6.7m tall restrained by stainless steel flat plates at glass to glass joints. Due to their size and shape, the double glazed units are formed from laminated annealed glass rather than heat treated or toughened glass. This makes the glass particularly susceptible to breakage due to localised stresses.

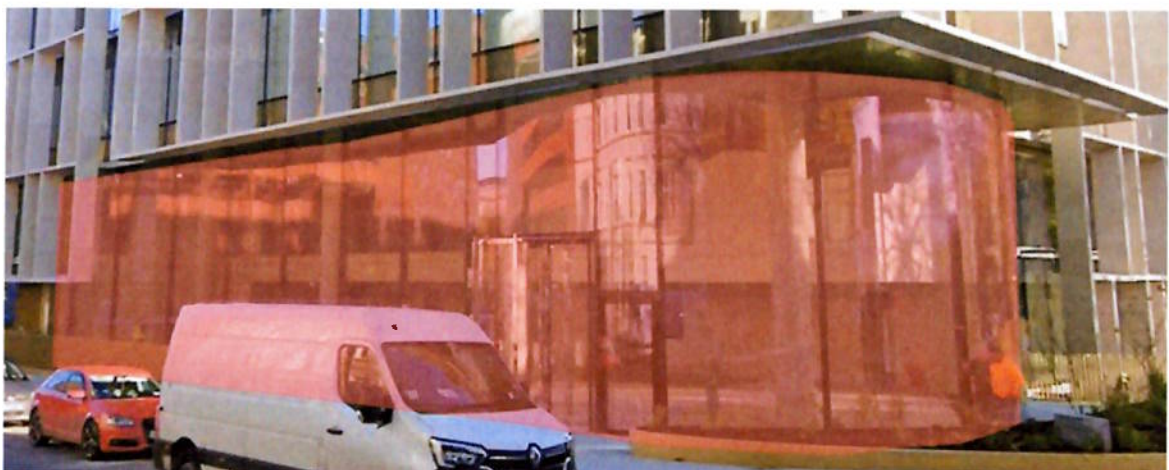
Figure 9 E'WS 006 Entrance Glazing elevation scope, 6.7m bespoke curved glass screen

- 4) The ground level entrance glazing EWS-006 stands on Level G slab. It is susceptible to damage, breaking glass, if there is differential deflection of the primary structure at one column. Due to the tight tolerances of the system we believe any movement outside of the current design intent could cause failure. In theory it is not affected by ground settlement based on the current TII tunnel location. However, if the tunnel alignment moves to the West, even within its permitted LoD, it is likely create settlement conditions under this screen causing damage.

Vertical differential movement of floor slabs is accommodated by sliding brackets at the head of the screen. Vertical differential movement capacity is limited by the lengths of the slots in the restraint brackets at the underside of Level 2 slab. Deflection of the Level G slab directly effects

the curved glass units on this elevation as they are all standing on this slab. Vertical deformation of the Level G slab is accommodated by rubber packers between glass panels and the steel vertical fins.

Lateral differential movement (racking) of the primary structural floors causes the entrance glazing screen to 'rack' out of square.

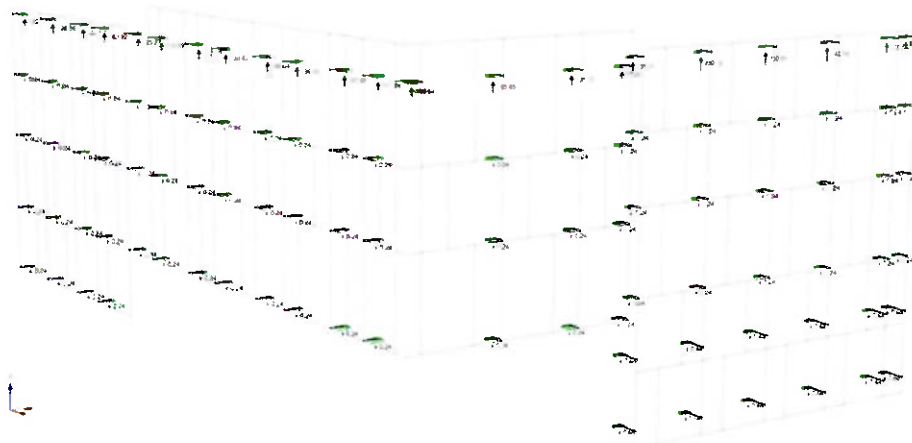
Figure 14 EWS-002 Steel frame with bracket locations.

Similar to EWS-001, above, the worst-case condition for the stone-clad veil is differential deflection of a primary structure column. The diagram below indicates the gridwork of steel framing with stone cladding applied. All deadload is carried at Level 5, and wind-loads are accommodated at discrete brackets to the slab edges below.

The steel frame is designed to accommodate live-load deflections of the Level 5 slab and to withstand wind loads. The stone-to-stone joints are all 8mm with a non-staining silicone. Stone to bracket joints are 23mm to allow for differential movement between slabs of approximately

10mm. Horizontal stones are individually fixed to the steel structure via aluminium profiles and under-cut anchors. Vertical stones are connected back to the veil structure using stainless steel dowels into the edges of 40mm limestone pieces.

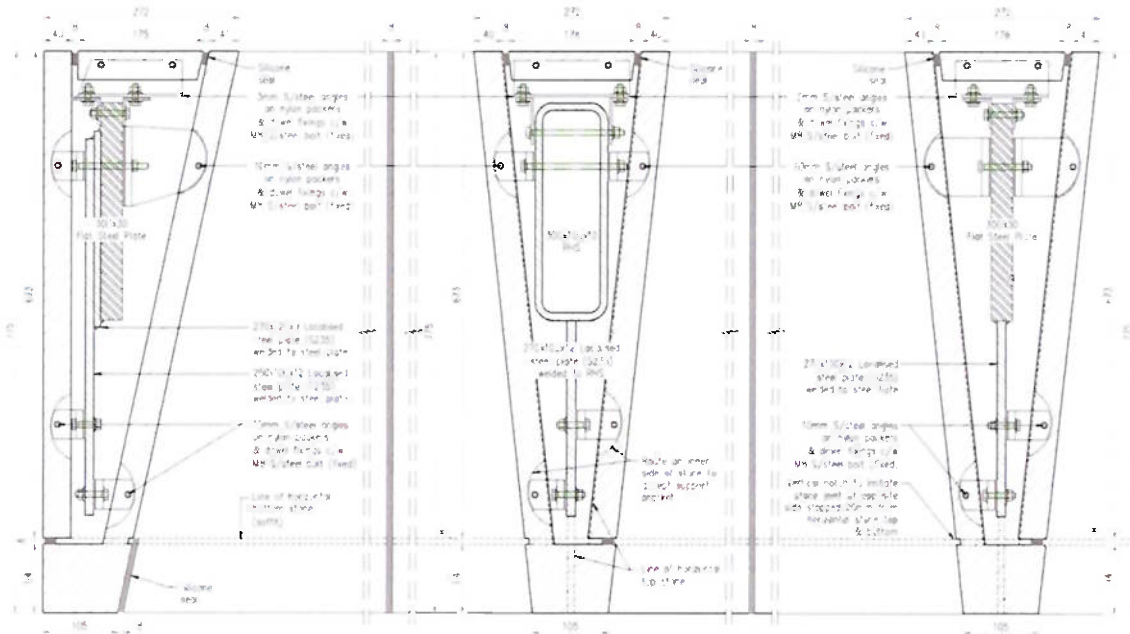
Figure 15 EWS-002 Plan section of stone profiles with support structure.

As can be seen from the diagrams above, the structure supporting the veil is entirely bespoke. Stone, being a fragile material, is extremely limited in its capacity to accommodate movement.

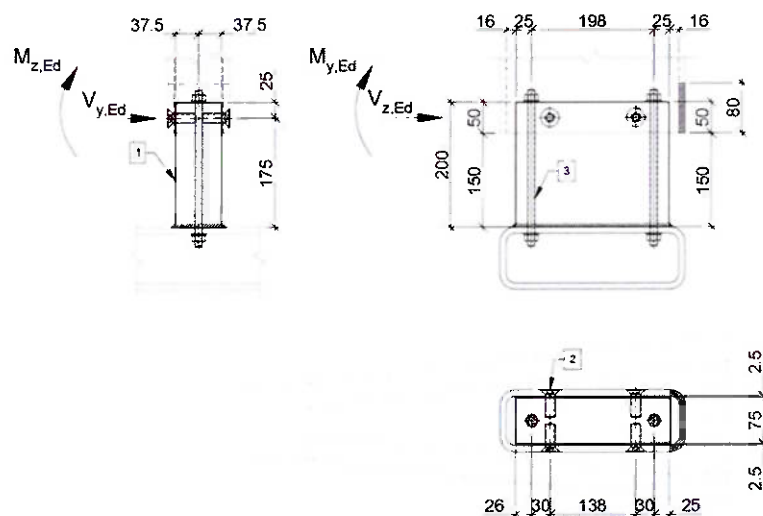
Figure 18 EWS-002 Example of veil steelwork connections

The differential settlement of a column causes rotation of the connection between horizontal and vertical veil elements. These connections are typically formed with countersunk fixings tapped into a block of stainless steel. These connections were not designed to accommodate significant rotation. Detailed analysis would be required to determine how these connections react and whether the horizontal beams of the veil would rotate at these connections or be forced to go into bending ('S' shaped bend on elevation). If over-stressed the connections could fail.

If the horizontal beams or vertical mullions go into bending due to differential settlement, this could cause over-stressing of the fixings in the stone exceeding permissible safety factors and/or causing cracking of the stone.

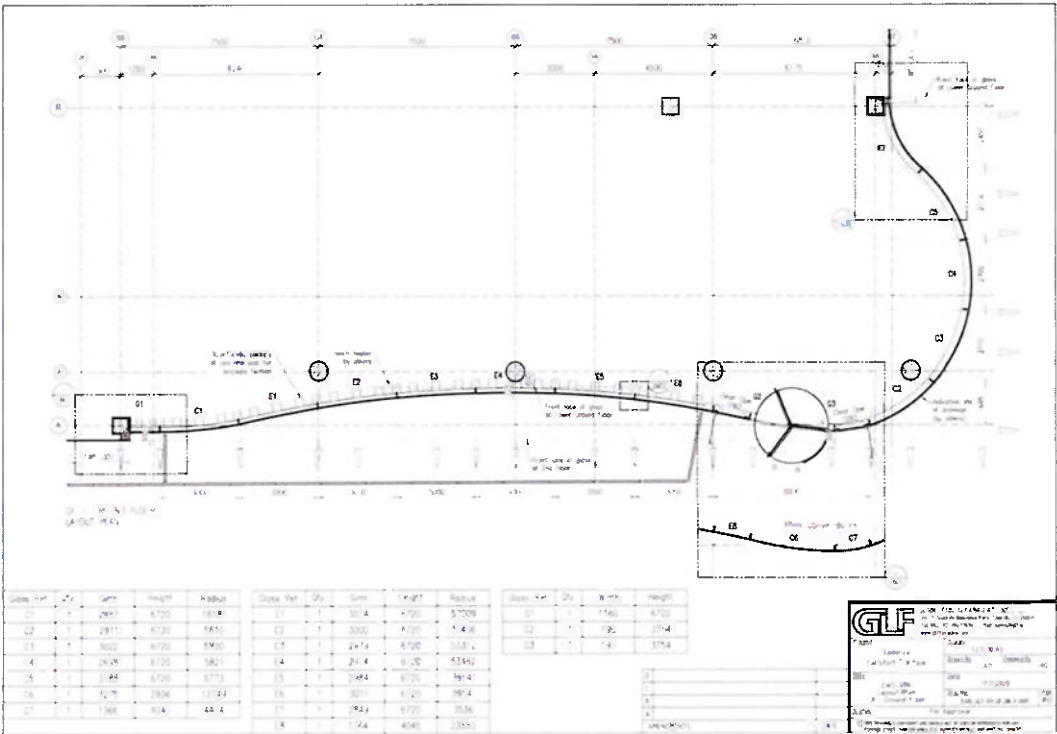
Figure 21 EWS-006 General arrangement and panel dimensions (South is to the right of this image).

The entrance glazing is the most challenging façade system on the project and the most likely to suffer damage should there be differential settlement of the primary structure. As illustrated in Figure 10, if the TII works are positioned as intended, the entrance glazing should not suffer differential settlement. However, If the tunnel were to be positioned up to 15m to the West, which is still within the maximum proposed horizontal LoD, the worst case differential settlement would be applied to this screen across the South elevation where the glass is tightly curved and least able to accommodate racking on elevation.

The curved panels of glass are approximately 6.7m tall. The widest panel is 3.188m wide. To put this into context, 6m x 3.2m is the largest standard size of glass available. In order to get glass 6.7m tall, the float-line where the glass is changed from molten material to solid sheet, requires a special instruction to cut over-sized pieces. These then require specialist transport to the glass processor's facility as standard glass transporting trucks (called 'floatliners') are set up for carrying 6m lengths. Due to their size, the glass processor requires specialist equipment to convert the individual sheets of glass into laminated curved glass and then assemble into curved double glazed units. Due to the geometry of the building, each double-glazed unit in EWS-006 is unique.

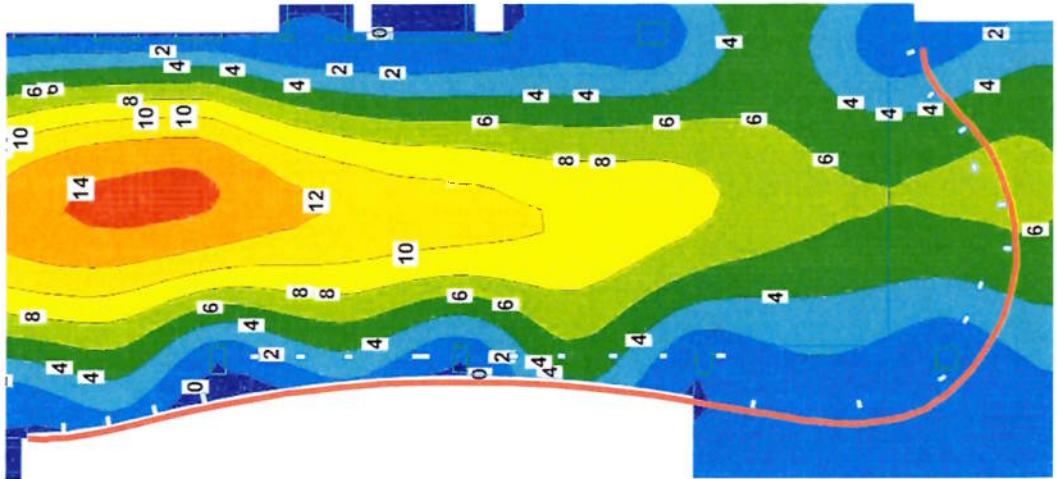
Figure 22 EWS-006 Level G slab deflections taking into account all design loads and creep.

The EWS-006 screen has been designed to stand on the Level G slab. Deflections of the slab were agreed by the designers and accommodated in GLF's detail design of the support system. The diagram below indicates the long-term deflection of the Level G slab taking into account live loads and long-term creep. The maximum deflection figures were derived from this.

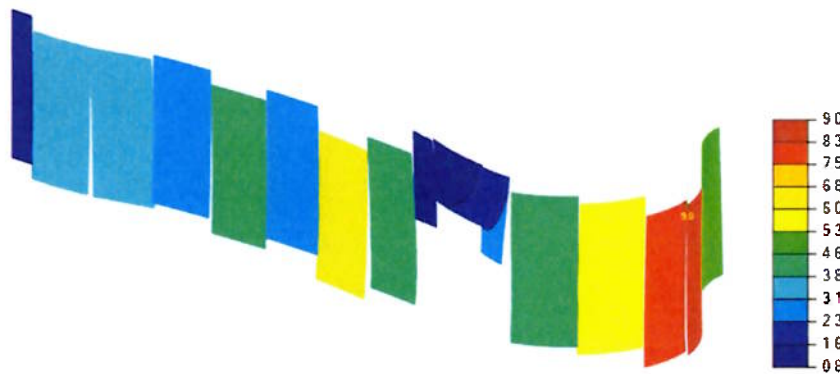
Figure 24 EWS-006 Total displacement of glazing panels including movement due to self-weight

As can be seen from the table above, the maximum predicted deflection after installation of the glass is 6.2mm. This does not take into account deflection of the slab which occurs during the loading of the glass onto the slab. This was included, and the total deflection, worst-case is less than 10mm as illustrated in the diagram below.

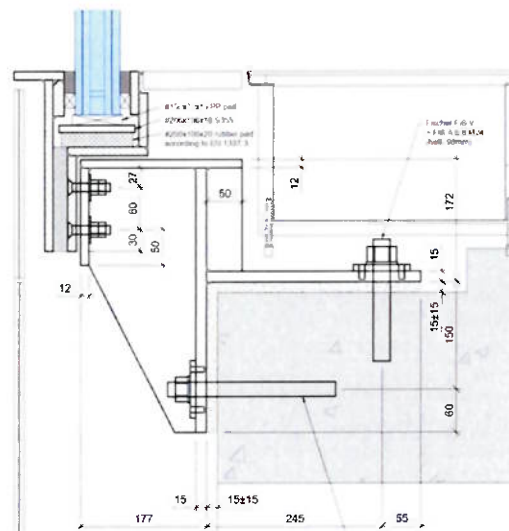
Figure 27 EWS-600 Base detail, deadload support.

It is also possible the concentration of load on one deadload support at the base of the glass would over-stress the glass causing failure.
