**External Envelope:
Glazing, Insulated Render and
Stone Façade Elements**

AERCAP HOUSE METROLINK INTERFACE

Aercap House, St. Stephens Green, Dublin

**Document No:
PR-24-018-BDA-XX-ZZ-RP-Y-0001-C01**

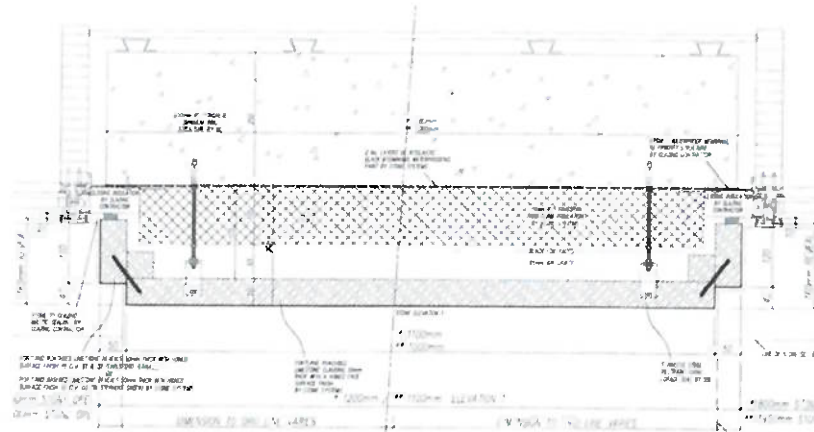
Figure 6 Typical stone pier plan section

The stone on Aercap House is categorised as a low strength limestone. The stone on Aercap House is 50mm thick supported on stainless steel shelf angles at each floor level. Should the primary structure deform due to tunnelling below the building, there is a likelihood the façade system will suffer damage. Damage can occur due to differential settlement of a column along the elevation. With the current tunnel position as illustrated in Figure 1 above, the highest risk locations for damage to the Portland stone cladding are the North and South elevations.

As the stone is restrained by local stainless steel rods which can accommodate some bending, the stone is likely to move less than this, but as the structure moves, stress in the stone to fixing interface will increase. The stone to stone joints are open and such racking could result in closing of joints at interfaces with canopies on the South elevation. Stone to stone contact could result in cracking. In worst case scenario, stone could be over-stressed locally, crack and fall.
