**External Envelope:
Glass & Aluminium and
Stone Façade Elements**

CADENZA METROLINK INTERFACE

Cadenza, Earlsfort Terrace, Dublin

**Document No:
1087-BDA-XX-ZZ-RP-Y-0001-C02**

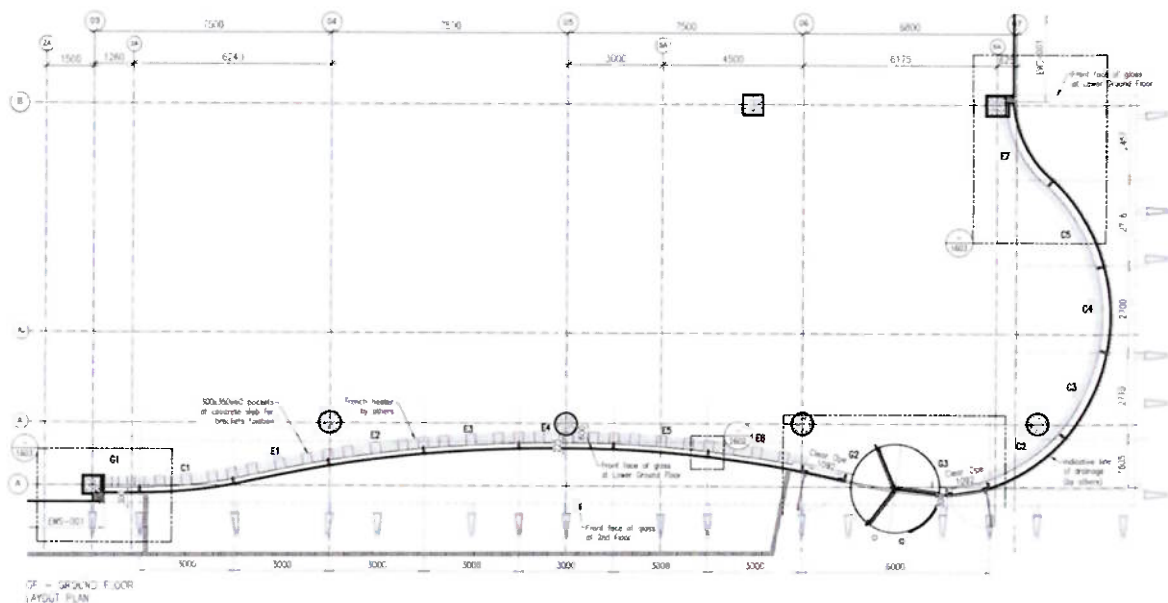
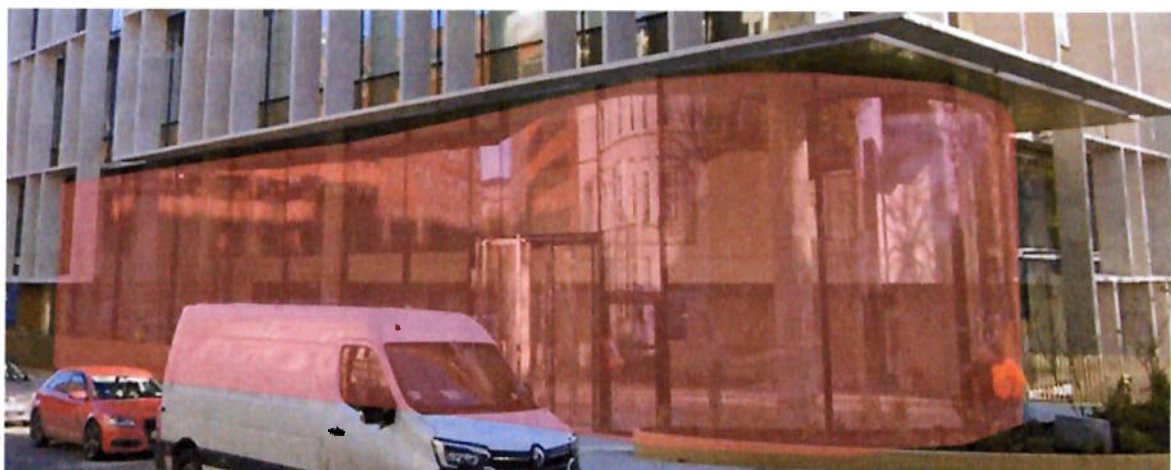
- 4) The ground level entrance glazing EWS-006 stands on Level G slab. It is susceptible to damage, breaking glass, if there is differential deflection of the primary structure at one column. Due to the tight tolerances of the system we believe any movement outside of the current design intent could cause failure. In theory it is not affected by ground settlement based on the current TII tunnel location. However, if the tunnel alignment moves to the West, even within its permitted LoDs, it is likely create settlement conditions under this screen causing damage, breaking glass.

The entrance glazing is a bespoke glazing system formed from curved double-glazed units up to 6.7m tall restrained by stainless steel flat plates at glass to glass joints. Due to their size and shape, the double glazed units are formed from laminated annealed glass rather than heat treated or toughened glass. This makes the glass particularly susceptible to breakage due to localised stresses.

Figure 8 EWS 006 Entrance Glazing. Double height curved glass. Plan view. (South is to the right of this image).

Figure 9 EWS 006 Entrance Glazing elevation scope. 5.7m hespoke curved glass screen

We recommend the façades on Cadenza are monitored prior to the TBM arriving, during the TBM tunnelling under the building and for a period afterwards in order to fully understand and see in real-time the deformation of the facades and ensure against damage.

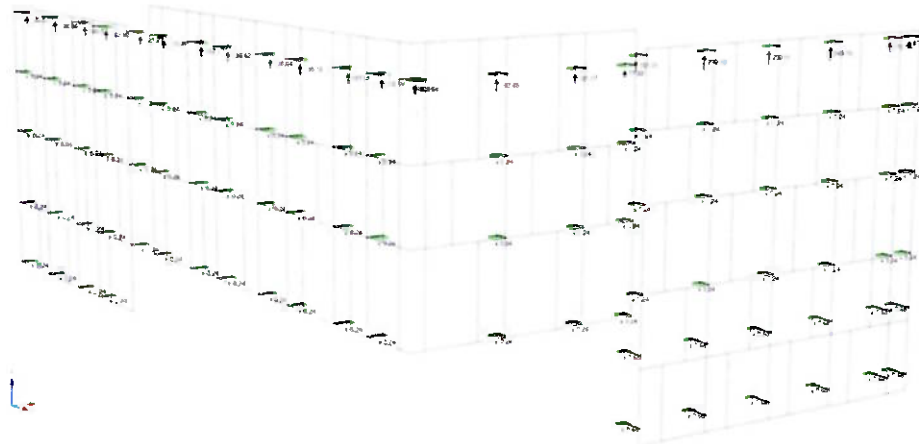
Figure 14 E:VS-C02 Steel frame with bracket locations.

Similar to EWS-001, above, the worst-case condition for the stone-clad veil is differential deflection of a primary structure column. The diagram below indicates the gridwork of steel

framing with stone cladding applied. All deadload is carried at Level 5, and wind-loads are accommodated at discrete brackets to the slab edges below.

The steel frame is designed to accommodate live-load deflections of the Level 5 slab and to withstand wind loads. The stone-to-stone joints are all 8mm with a non-staining silicone. Stone to bracket joints are 23mm to allow for differential movement between slabs of approximately 10mm. Horizontal stones are individually fixed to the steel structure via aluminium profiles and under-cut anchors. Vertical stones are connected back to the veil structure using stainless steel dowels into the edges of 40mm limestone pieces.

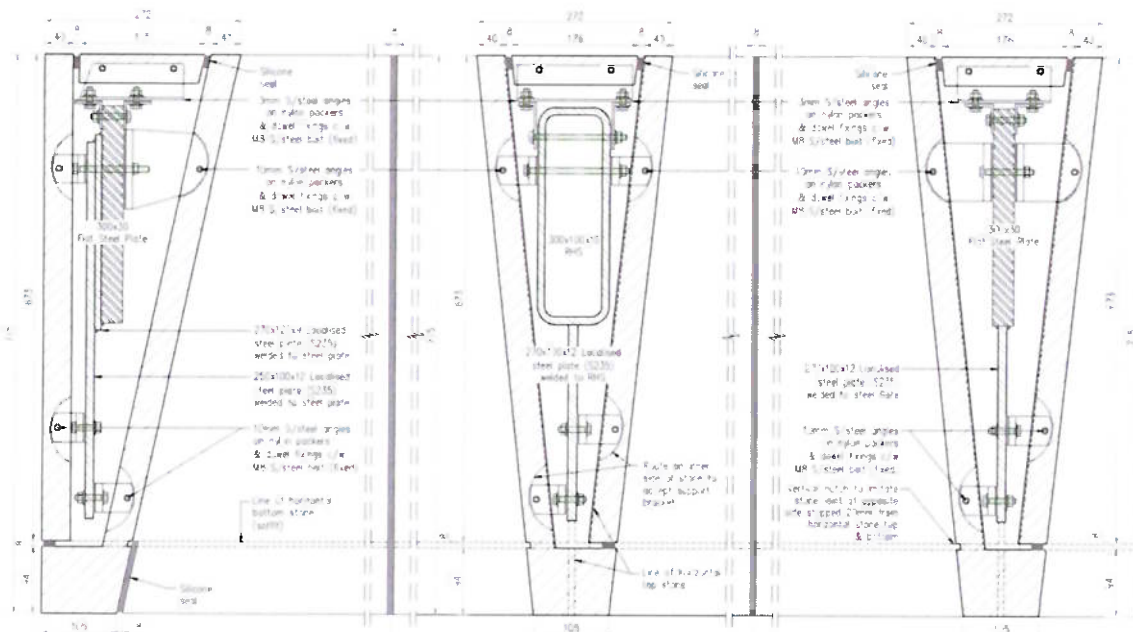
Figure 15 EWS-002 Plan section: of stone profiles with support structure.

As can be seen from the diagrams above, the structure supporting the veil is entirely bespoke. Stone, being a fragile material, is extremely limited in its capacity to accommodate movement.

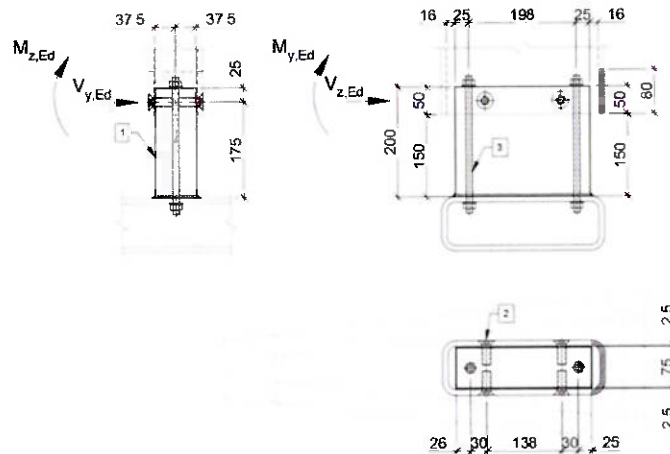
Figure 18 EWS-002 Example of veil steelwork connections

The differential settlement of a column causes rotation of the connection between horizontal and vertical veil elements. These connections are typically formed with countersunk fixings tapped into a block of stainless steel. These connections were not designed to accommodate significant rotation. Detailed analysis would be required to determine how these connections react and

whether the horizontal beams of the veil would rotate at these connections or be forced to go into bending ('S' shaped bend on elevation). If over-stressed the connections could fail.

If the horizontal beams or vertical mullions go into bending due to differential settlement, this could cause over-stressing of the fixings in the stone exceeding permissible safety factors and/or causing cracking of the stone.

In a worst case scenario this could result in pieces of stone falling onto the public pavement below.

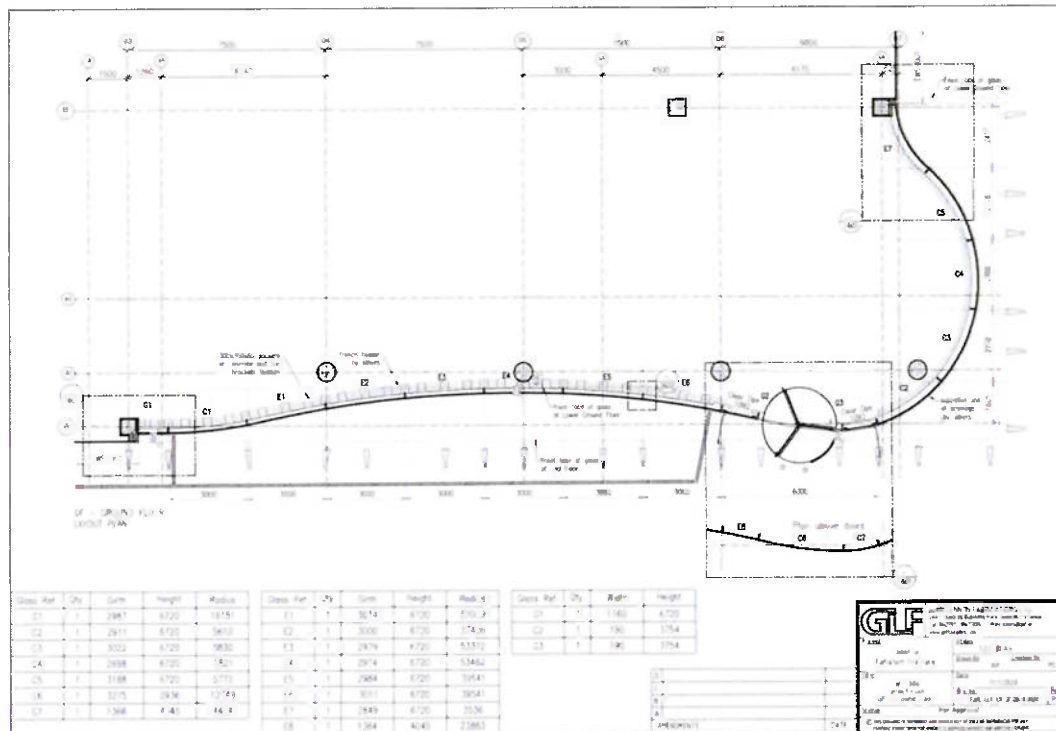
Figure 21 EWS-006 General arrangement and panel dimensions (South is to the right of this image).

The entrance glazing is the most challenging façade system on the project and the most likely to suffer damage should there be differential settlement of the primary structure. As illustrated in Figure 10, if the TII works are positioned as intended, the entrance glazing should not suffer differential settlement. However, If the tunnel were to be positioned up to 15m to the West, which is still within the maximum proposed horizontal LoD, the worst case differential settlement would be applied to this screen across the South elevation where the glass is tightly curved and least able to accommodate racking on elevation.

The curved panels of glass are approximately 6.7m tall. The widest panel is 3.188m wide. To put this into context, 6m x 3.2m is the largest standard size of glass available. In order to get glass 6.7m tall, the float-line where the glass is changed from molten material to solid sheet, requires a special instruction to cut over-sized pieces. These then require specialist transport to the glass processor's facility as standard glass transporting trucks (called 'floatliners') are set up for carrying 6m lengths. Due to their size, the glass processor requires specialist equipment to convert the individual sheets of glass into laminated curved glass and then assemble into curved double glazed units. Due to the geometry of the building, each double-glazed unit in EWS-006 is unique.

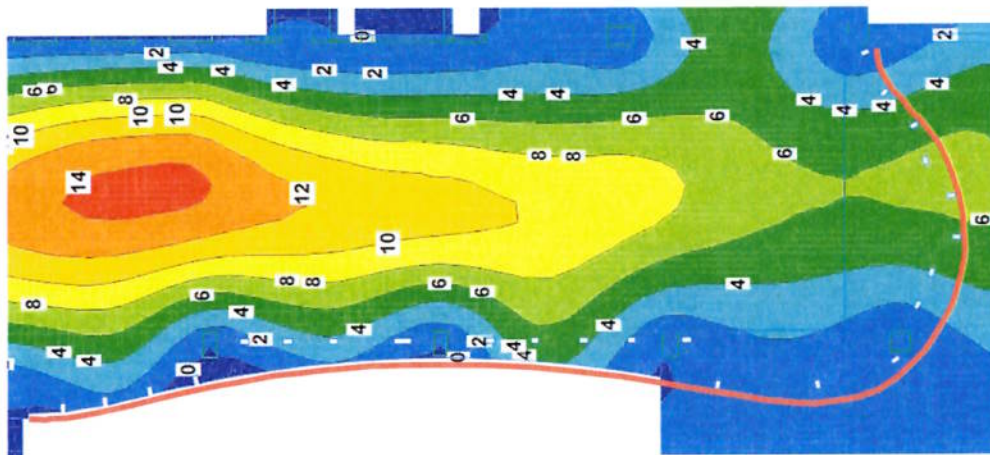
Figure 22 EWS-006 Level G slab deflections taking into account all design loads and creep.

The EWS-006 screen has been designed to stand on the Level G slab. Deflections of the slab were agreed by the designers and accommodated in GLF's detail design of the support system. The diagram below indicates the long-term deflection of the Level G slab taking into account live loads and long-term creep. The maximum deflection figures were derived from this.

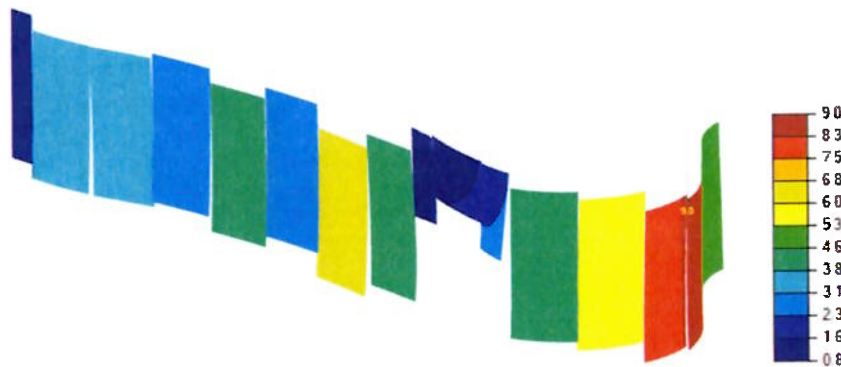
Figure 24 EWS-006 Total displacement of glazing panels including movement due to self-weight

As can be seen from the table above, the maximum predicted deflection after installation of the glass is 6.2mm. This does not take into account deflection of the slab which occurs during the loading of the glass onto the slab. This was included, and the total deflection, worst-case is less than 10mm as illustrated in the diagram below.

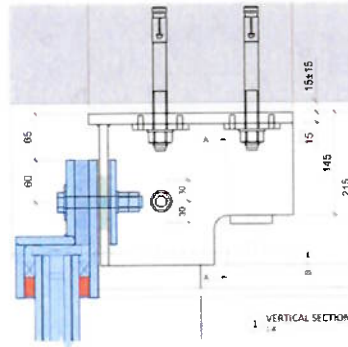
*Figure 26 EWS-006 Head restraint detail.*

The double-glazed panels are restrained to only move vertically when the slab deflects. This lateral restraint is provided by a **factory applied curved angle assembly structural silicone bonded to the glass (structural silicone shown red in the diagram below) at the head of each unit.** This in turn engages with a local bracket fixed to the soffit of the slab above. The **bracket has vertical slots are shown in green below** allowing for deflection of the L01 slab while restraining movement along the screen (in and out of the page in this diagram).

Should settlement due to MetroLink works cause the Level G slab deflect more than anticipated in the current design, it is possible the permissible long-term shear load in the structural silicone at the head detail will be exceeded. If the head restraint were to fail, allowing the panel of glass to rotate in plane (along the elevation), there is a high risk of glass breakage due to metal to glass contact and/or glass to glass contact.

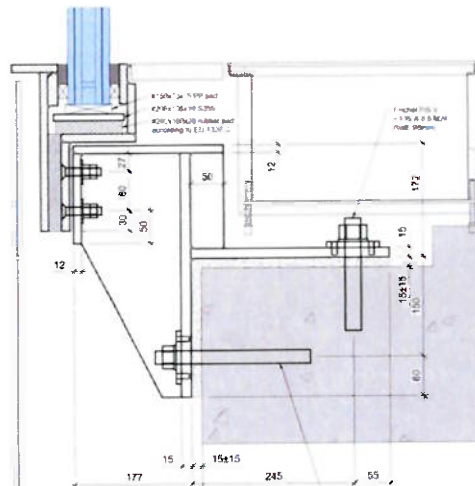
*Figure 27 EWS-600 Base detail, deadload support.*

It is also possible the concentration of load on one deadload support at the base of the glass would over-stress the glass causing failure.
