**Project Metrolink Railway Order  
Estuary to Charlemont via Dublin Airport  
(ABP-314724-22)**

Statement of Evidence

Tunnelling Induced Ground Movements & Building Damage Assessment for the  
**Cadenza Building**, Earlsfort Terrace, Dublin 2

**Lowered Tunnel Level**

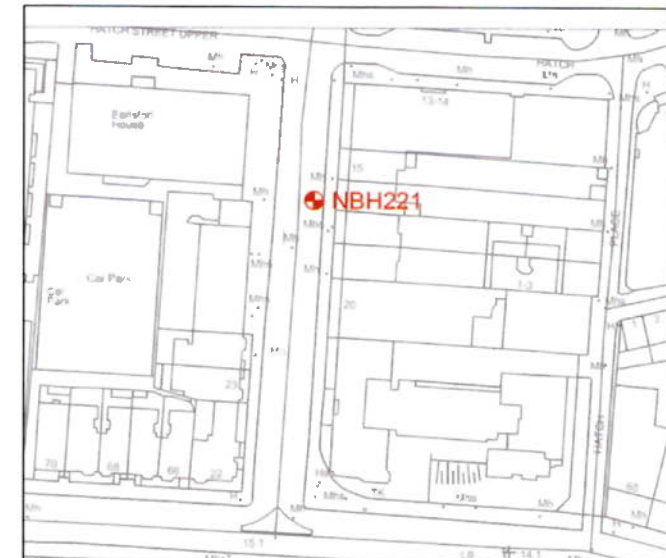
- NBH92 & NBH93 do not exist
- Borehole NBH-221 only Metrolink SI data relevant to Cadenza Building.
- SI Location plan in the EIAR should be updated (Ch. 20)

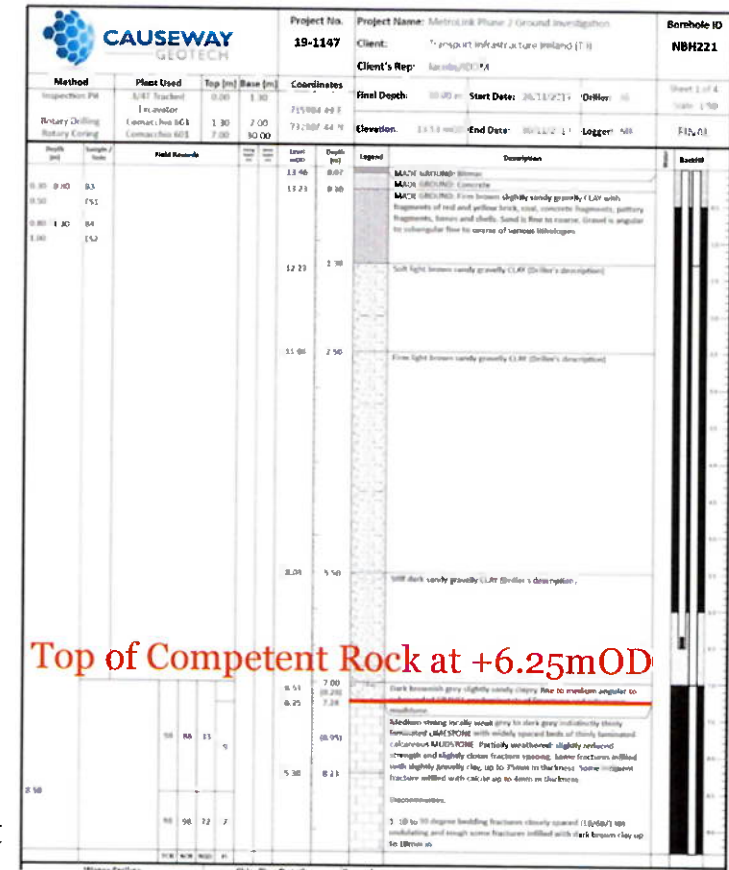
- Geological Profile in Appendix A20.9 of the EIAR shows rock at **+0.0mOD** under Cadenza Building & between **- 2.5mOD** and **+2.0mOD** under Arthur Cox Building.
- Top of competent rock at **+6.25mOD** in Borehole NBH-221
- Geological profile in EIAR is incorrect and should be updated to reflect actual rock levels - Relevant to further Phase 3 assessment and construction monitoring
