# Geotechnical Karst Risk Assessment

Document Ref. 22098-R-03-02

Project Title Cooloo Wind Farm

Date 19/09/2025

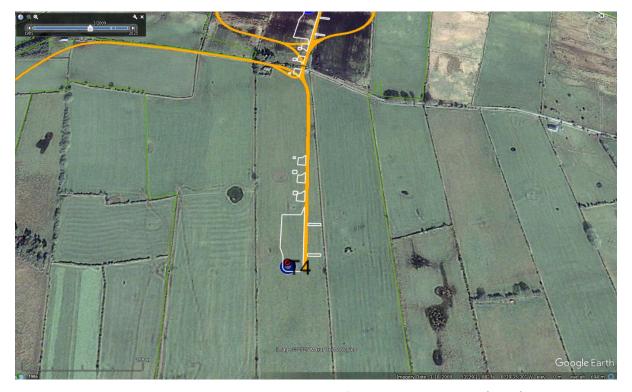
Figure 2-1: Google Earth aerial imagery for the area around T4 (2009).

Due to the nature of changes in vegetation and land use, as well as seasonal variations in water tables and hydrological conditions, the identification of features must take into account multi-temporal imagery. An example of this is visible for the area surrounding T4, as seen in Google Earth aerial imagery from 2009 (Figure 2-1), 2018 (Figure 2-2) and 2025 (Figure 2-3). A number of features which may be identified as possible enclosed depressions/dolines are visible in the imagery from 2009 and 2018, but many are obscured by vegetation and water table changes in 2025.

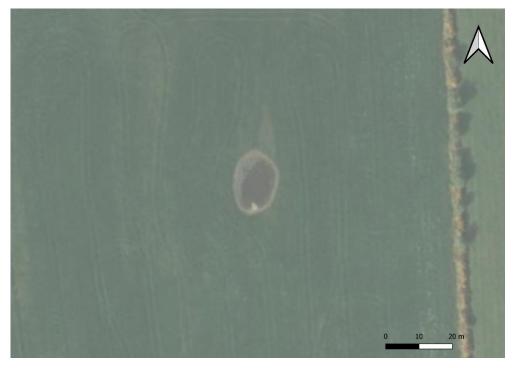
Figure 3-1: Karst feature K6 (Bing aerial, 2025).

Karst feature K6 provides an example of the doline features identified within the Proposed Wind Farm site boundary. This feature was identified from aerial imagery (Figure 3-1) and LiDAR (Figure 3-2), investigated and confirmed on-site (Figure 3-3).
