# **ENVIRONMENTAL IMPACT ASSESSMENT REPORT**

### Appendix 19-1 Asbestos Survey Report

## ASBESTOS SURVEY REPORT

**Location:** The Cleeves Site,  
North Circular Road, Limerick

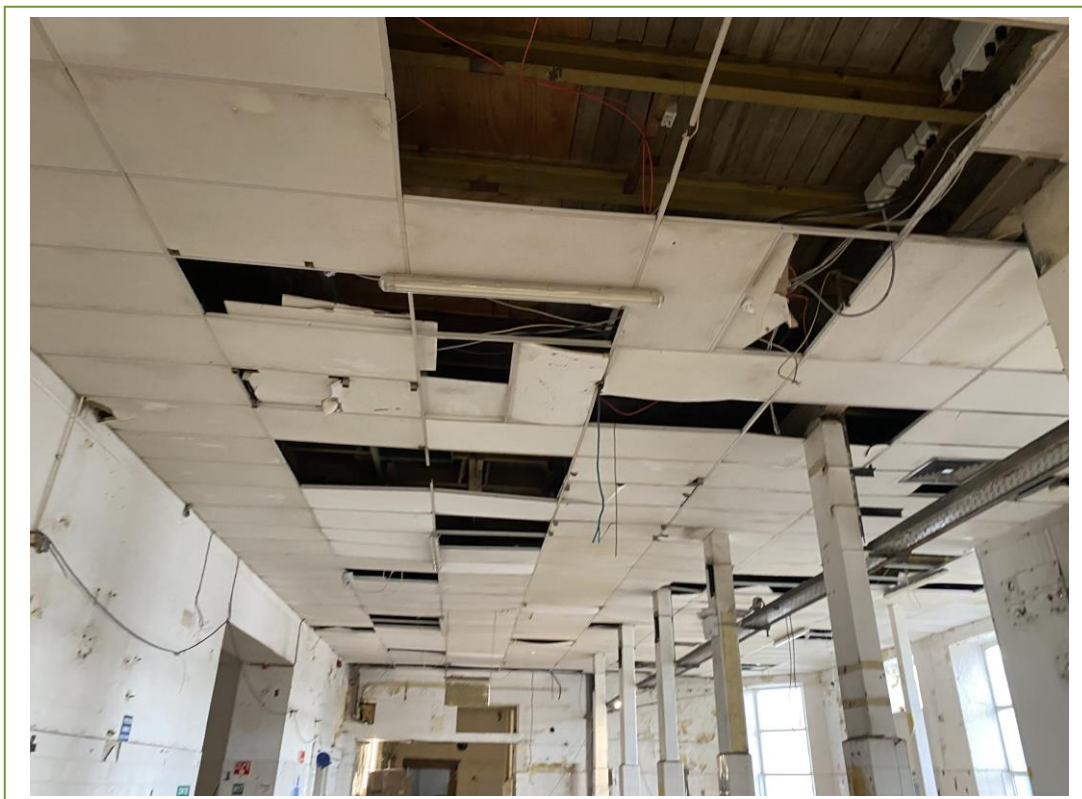
Plasterboard ceiling tiles in building 5

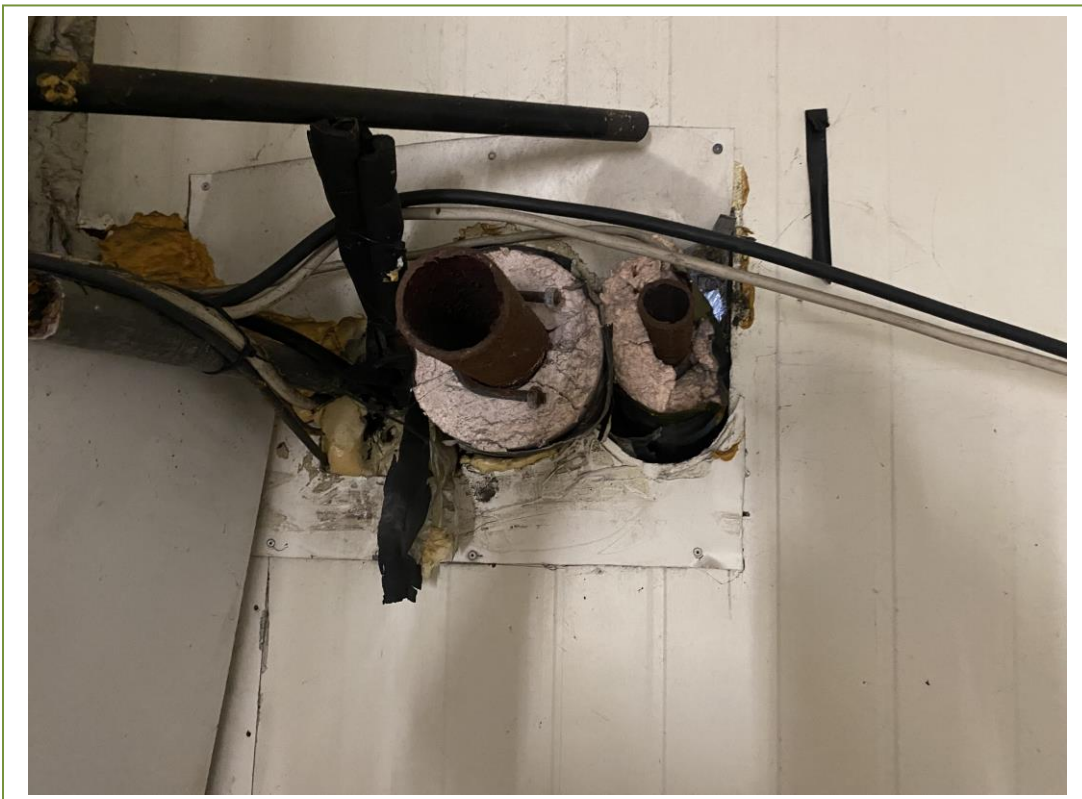
Pipework insulation sampled in building 5

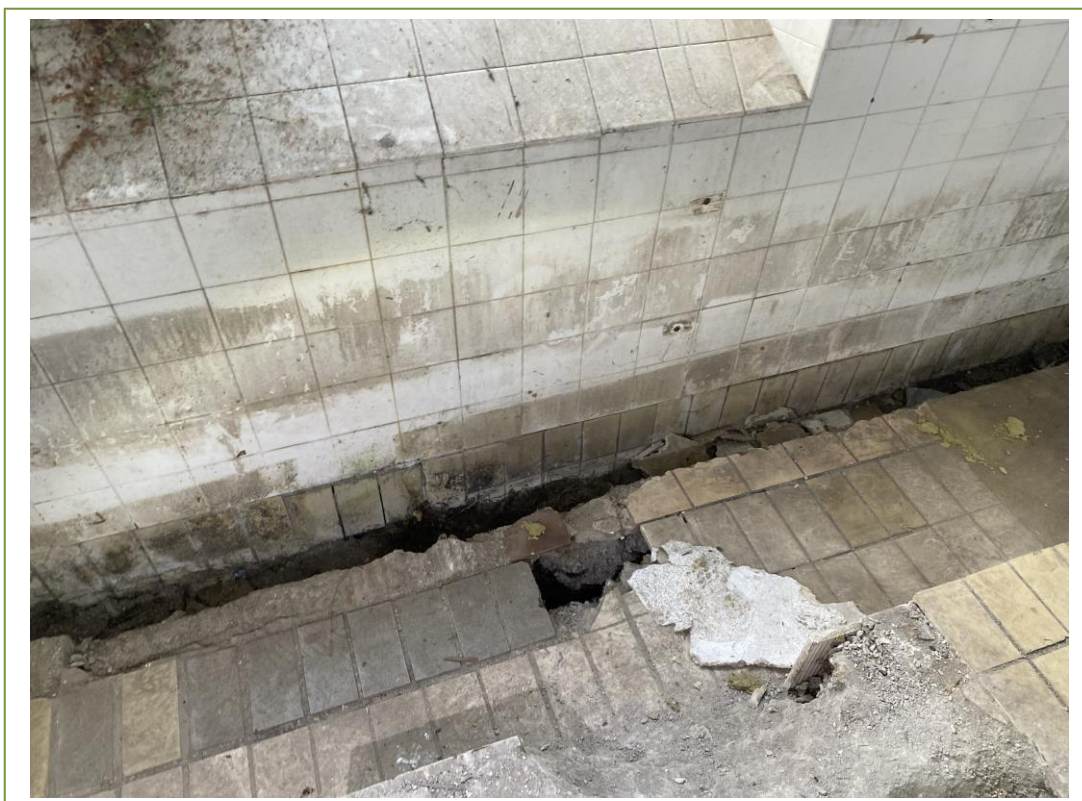
Ceramic floor tiles in building 5

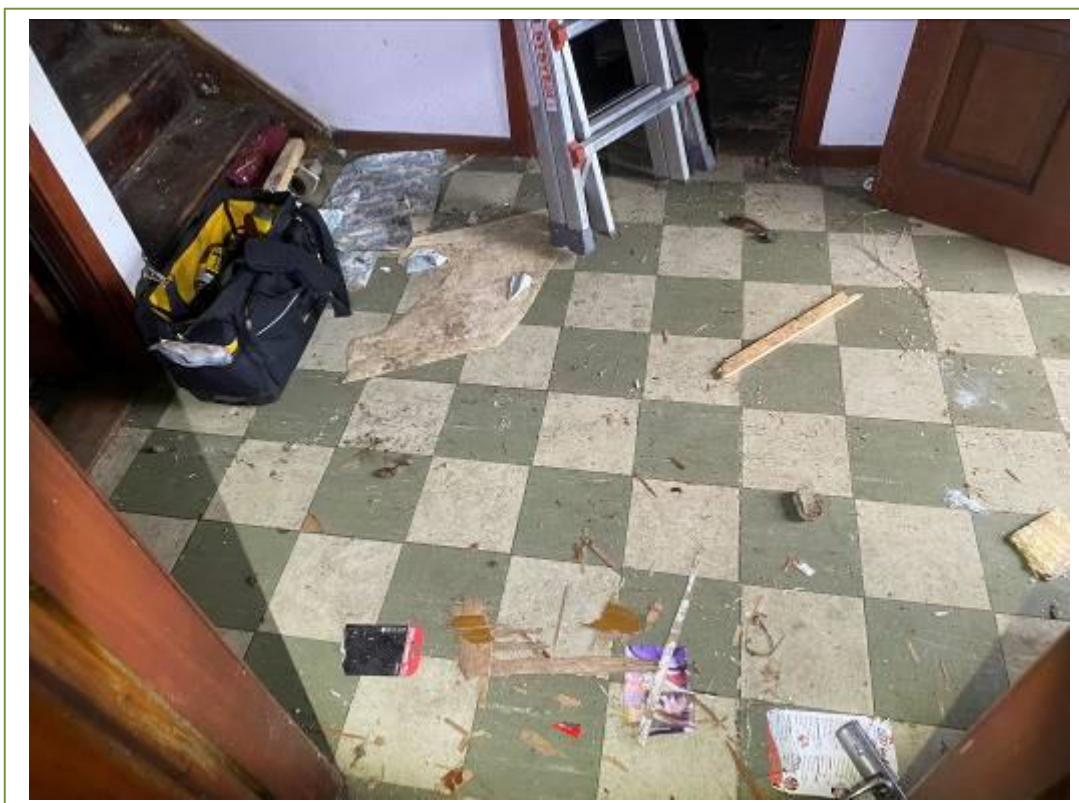
Floor tiles sampled from the hallway

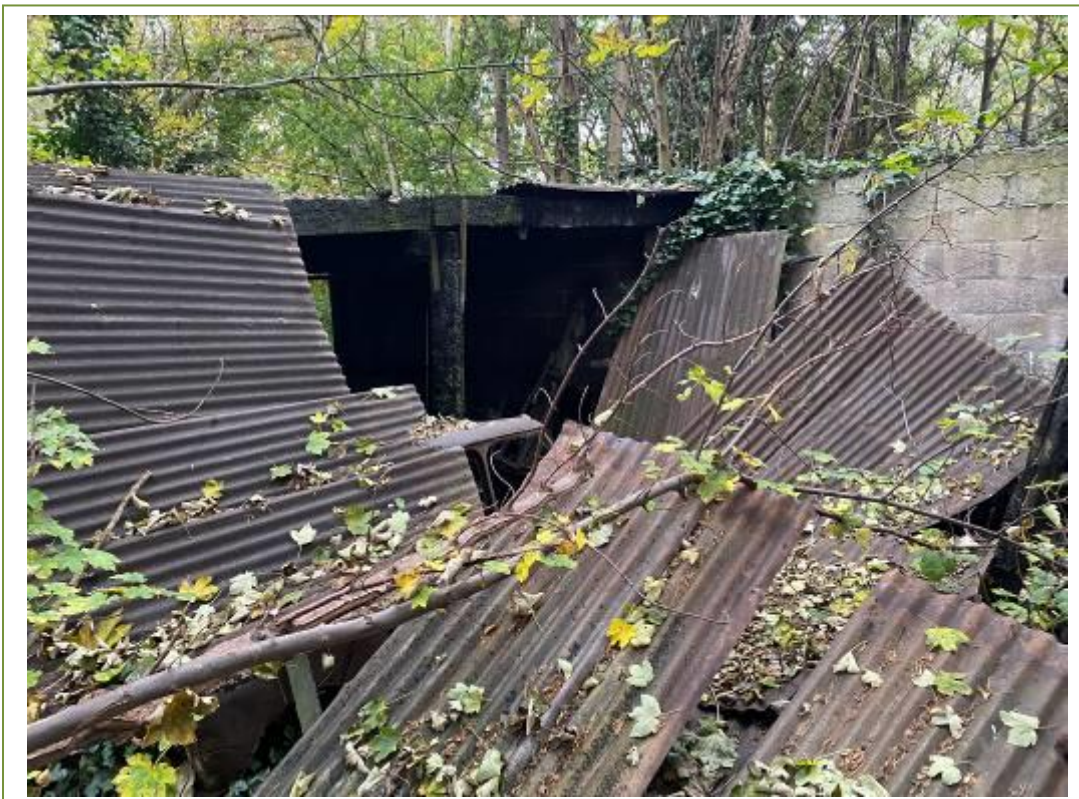
Metal cladding on the rear outbuilding
