Hydrant Testing Report

Naas, Co. Kildare

Client:	Donnacadh O'Brien Associates
Site Contact:	Richard Kiernan
Project:	Hydrant Testing & 7 Day Logging Naas, Co. Kildare
Technician:	Aaron Hogan
Start/Finish of Survey	17/01/2023

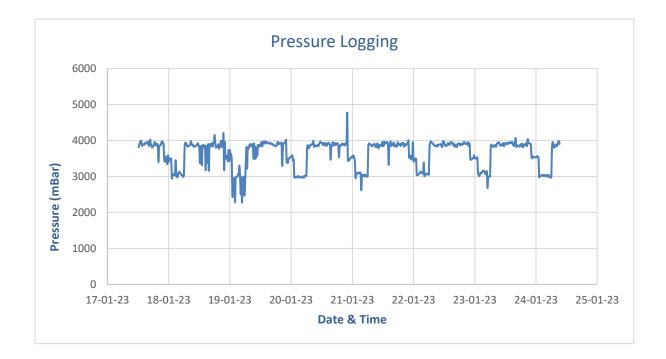
Figure 1: 7-Day Static Pressure Logging Results

Pressure loggers were deployed on the Fire Hydrants on 17th January 2023 to record pressure over a 7-day logging period. The graph below shows the pressure logging results which show the day night variation in pressure. There is a pressure reducing valve in operation in the area reducing pressure from 1:00a.m to 6:00am.

Based on the downloaded pressure data, the static pressure varies from 3.0 bar at night to 4.0 bar during the day.

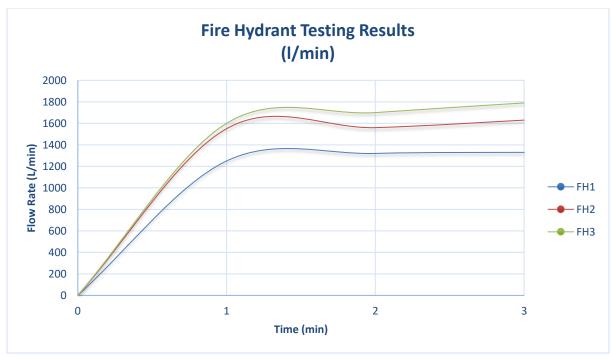
Figure 2: Fire Hydrant Flow Test Results

FH No.	Flow Rate L/Min	Static Pressure (bar)	Residual Pressure (bar)		
FH1	1300	3.5	2.8		
FH2	1580	3.5	2.3		
FH3	1697	4.0	3.2
