Preliminary Design Report Addendum (TII Departure No. 36213)

N2 Road, Ardee (Ardee 2040 Regeneration Project)

Title: STAGE 2 ROAD SAFETY AUDIT

VERSION: March 2025 Addendum FINAL (28-3-2025)

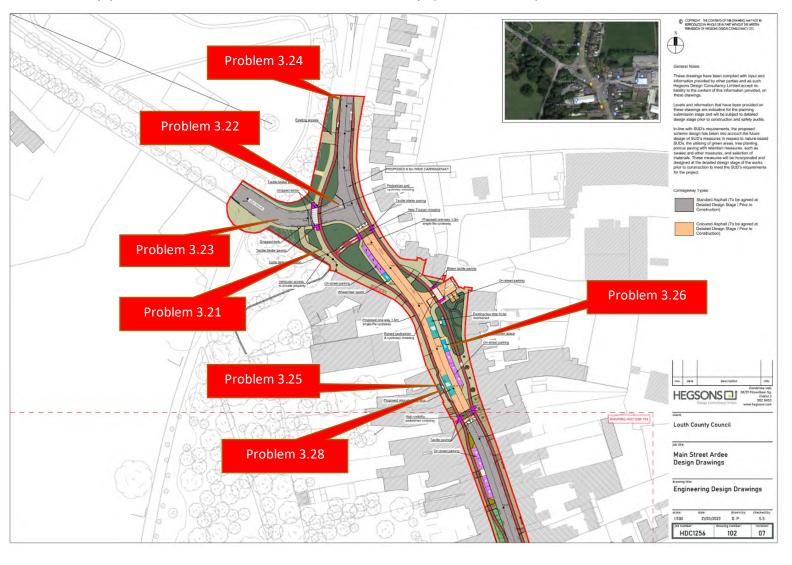
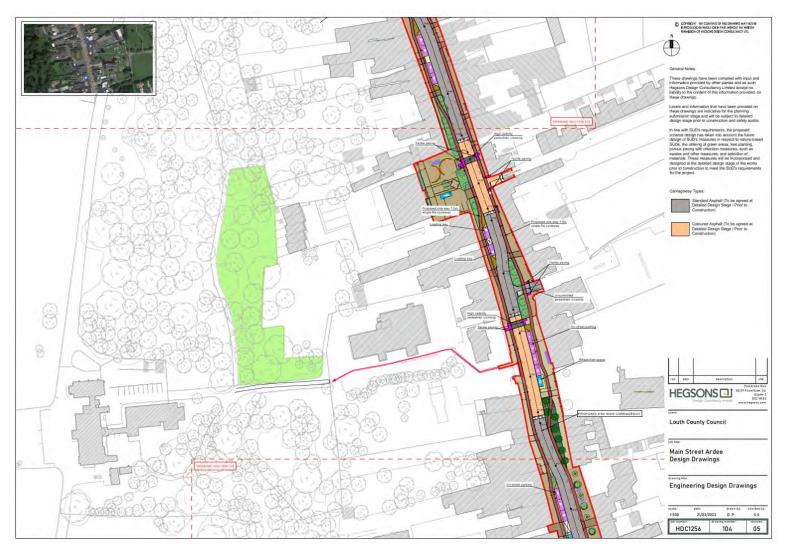
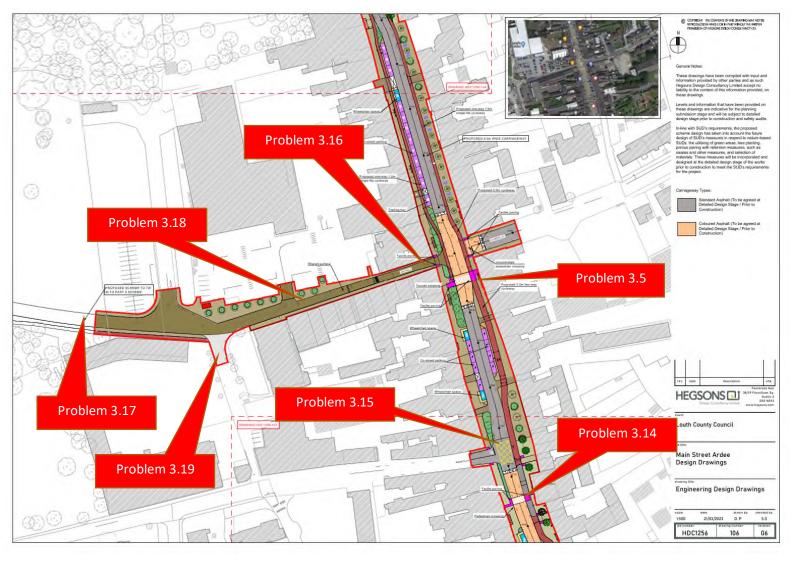
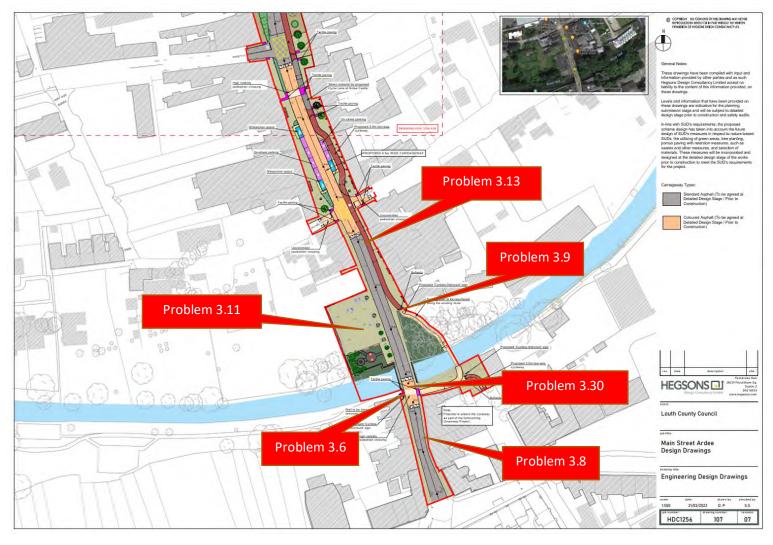
Appendix A – Problem Location Map (June 2024)

Although the scheme promotes vulnerable road users and active travel there is a risk that the reduction of parking areas will lead to illegal parking on the footpaths and cycle tracks thereby rendering them unsafe for vulnerable road users. Traffic wardens are generally only present in Ardee one day per week to enforce compliance.

There are some substantial utility poles in the footpaths along the scheme. It is unclear if these poles are to be removed. If they are to remain they present hazards for pedestrians who may collide with them if not looking up, or if the pedestrians are visually impaired and also the poles reduce the effective width of the footpath to such an extent that some pedestrians may step onto the carriageway to avoid them thereby increasing the risk of being struck by a passing vehicle.

It is recommended that sufficient alternative parking spaces be provided close to the Main Street to facilitate those trading in the area. Signage to direct drivers to these parking areas may be required until they are well established for those who can no longer park along the Main Street.

It is recommended that the poles be removed.

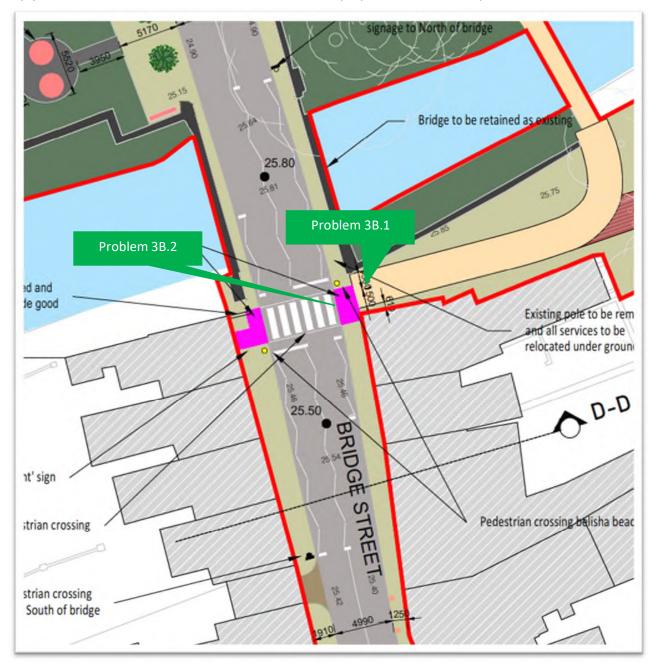
Appendix A – Problem Location Map (March 2025)

There is a pinch point in the carriageway south of the bridge. Wide vehicles currently operate an informal shuttle system to pass each other. This may not be possible with the introduction of the new crossing as vehicles may be stuck in position while queuing at the signals. This could lead to side-swipe collisions, damage to bollards and mounting of the footpath. It is noted from the site visit that queuing on the N2 is common for long periods of each day. (It was observed during the most recent site visit that flexible bollards in the footpath at this location have been struck many times and have collapsed)
