Derrylea Road Arborist Report

Arboricultural Report

Project: Derrynadarragh Wind Farm

Underground Cabling

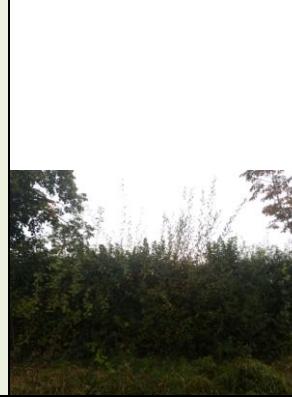
T2008	Common ash (<i>Fraxinus excelsior</i>)	Tree	Height (m): 14 Stem Diam(mm): 600# Spread (m): 4N, 4E, 4S, 5W Crown Clearance (m): 4 Lowest Branch (m): 4(E) Life Stage: Early Mature Rem. Contrib.: 20+ Years	Hedgerow tree with good unions and crown density.	B2	Radius: 7.2m. Area: 163 sq m.	Physiological Condition: Good Structural Condition: Good Public Amenity Value: Moderate Inspection Limitations: Vines Bat Habitat: Low	Pre construction: No action required. During construction: Protect trees with protective barriers - as shown on plans. Post construction: No action required.
