ST. EDMUNDSBURY HOSPITAL, LUCAN, CO. DUBLIN

Volume 1 Part 1: Conservation Report -
Architectural Inventory, Condition Report & Appraisal

November 2023

Ref: 22037

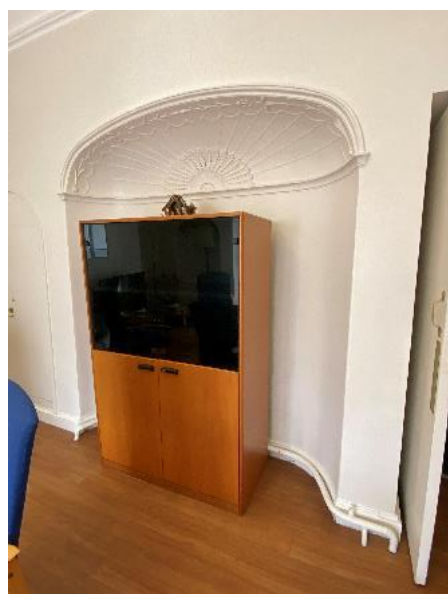
Fig.60: North wall, alcove with plasterwork

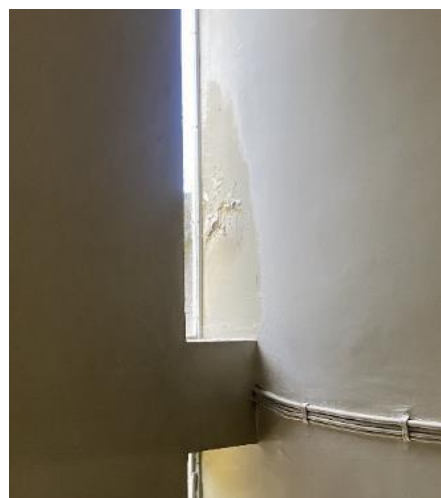
Fig.92: B-09, paint finish is lifting from the wall.

B-09: Horizontal crack to the west wall

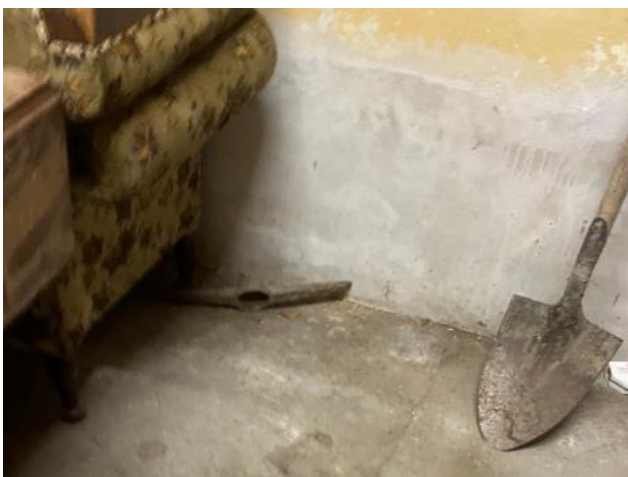
Fig.95: B-22, Inappropriate cementitious render, at bottom section of wall

B-22: Several cracks to the east, west and south walls.
